COAL ASH CORROSION RESISTANT MATERIALS TESTING

Topical Report: Removal of Section "C"

THE BABCOCK & WILCOX COMPANY

The “Coal Ash Corrosion Resistant Materials Testing Program” is being conducted by The Babcock & Wilcox Company (B&W), the U.S. Department of Energy (DOE) and the Ohio Coal Development Office (OCDO) at Reliant Energy’s Niles plant in Niles, Ohio to provide full-scale, in-situ testing of recently developed boiler superheater materials. Fireside corrosion is a key issue for improving efficiency of new coal fired power plants and improving service life in existing plants.

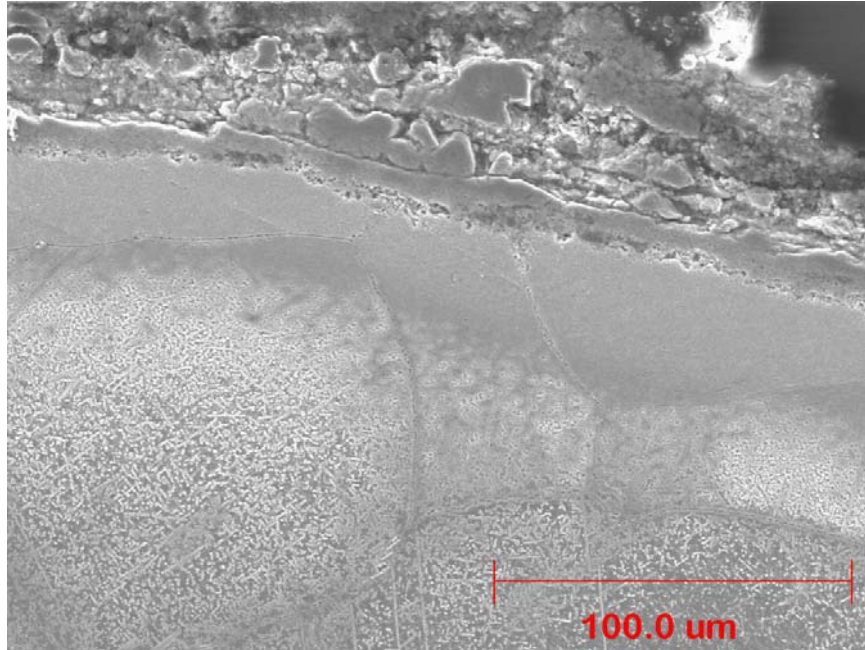
Figure F-15 (Cont.): Microstructure: 310 Ta

(c) External Scale/Metal Interface (SEI - High Magnification)

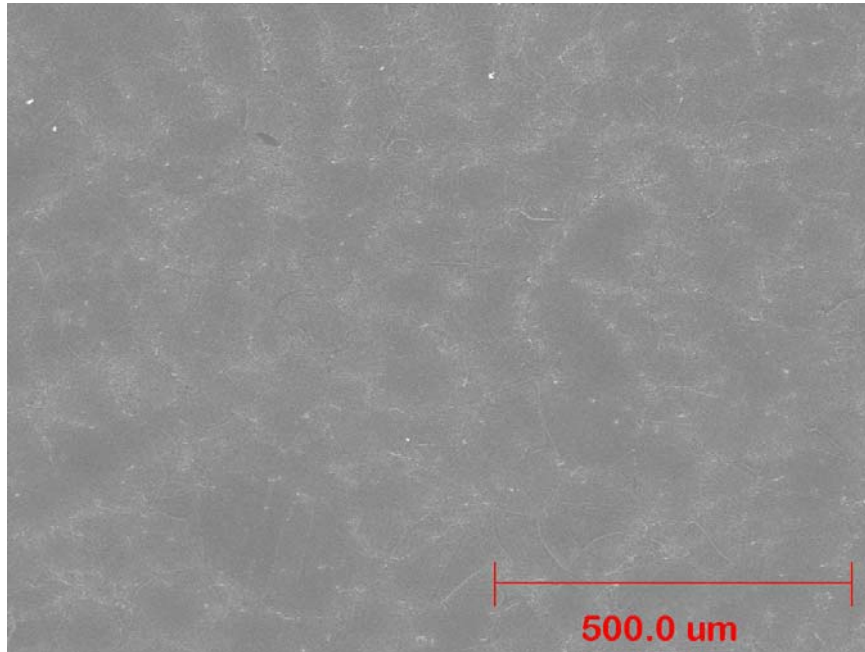
Figure F-16: Mid-Wall Microstructure: 310 Ta

(SEI - Low Magnification)

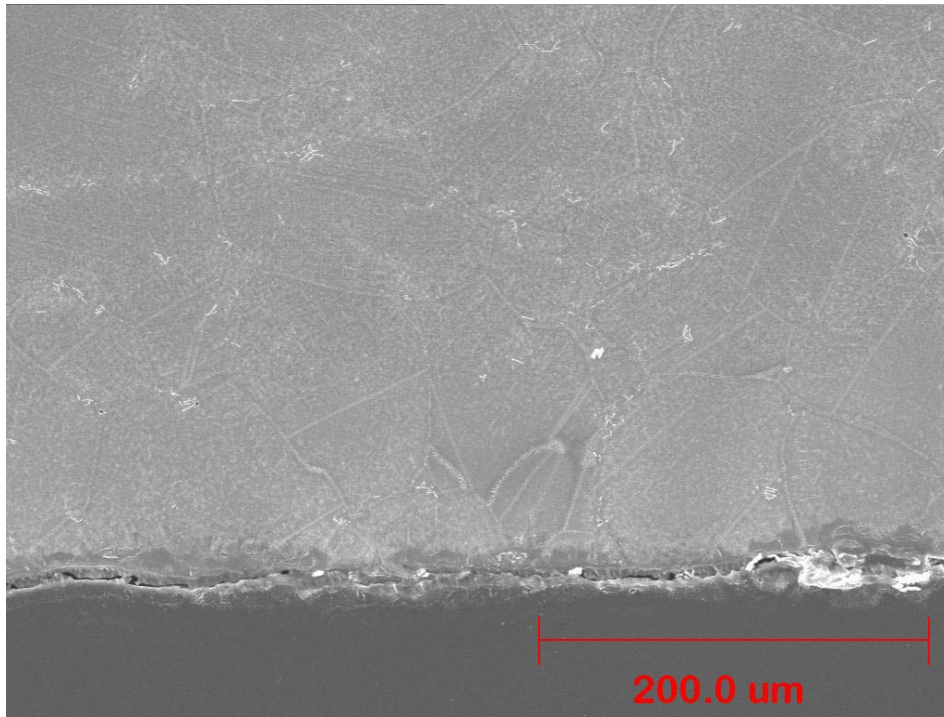
Figure F-17: Microstructure: 310 Ta

Internal Surface Appearance

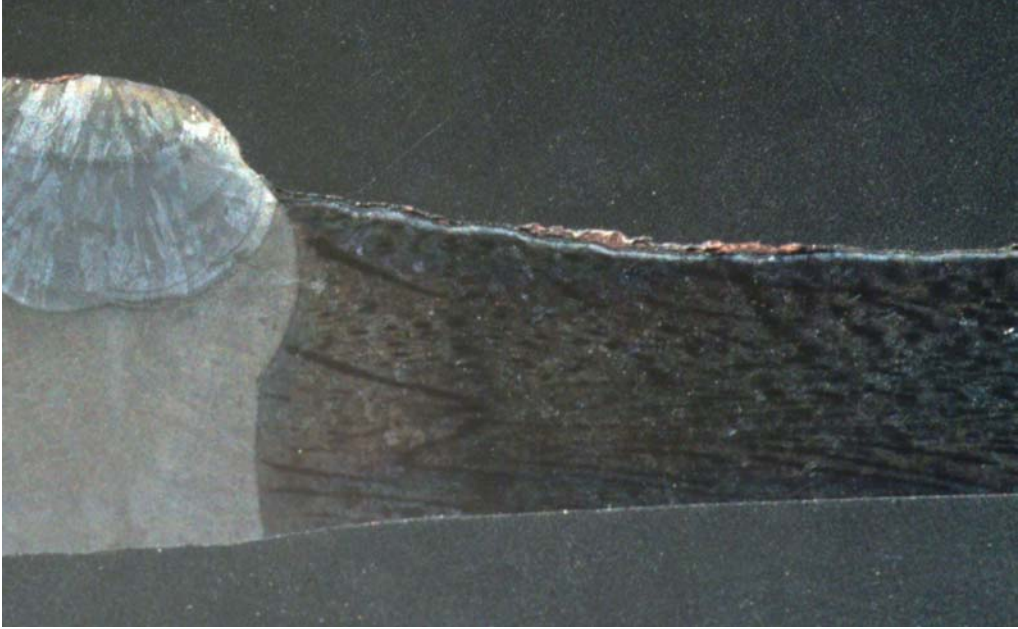
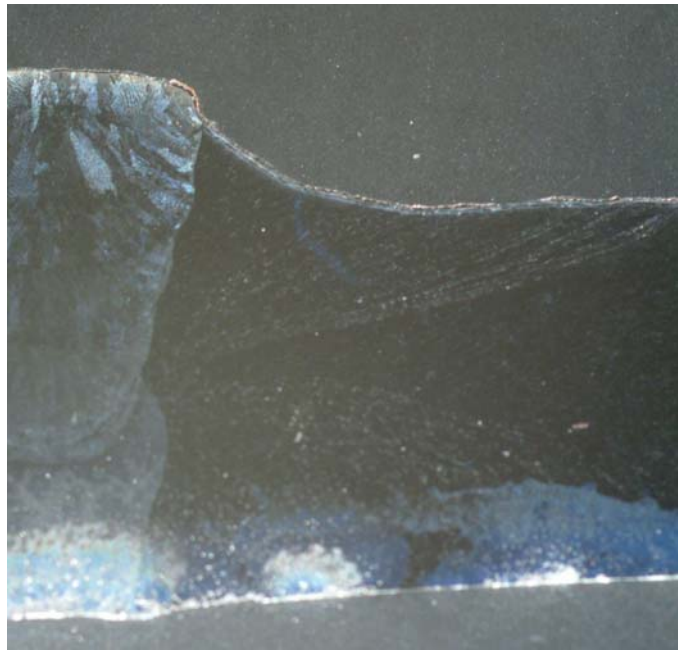
Figure F-18: Longitudinal Cross-Section: 310 Ta Adjacent to Welds

(a) TP 310 Ta Adjacent to Weld "N"

(b) TP 310 Ta Adjacent to Weld "X"

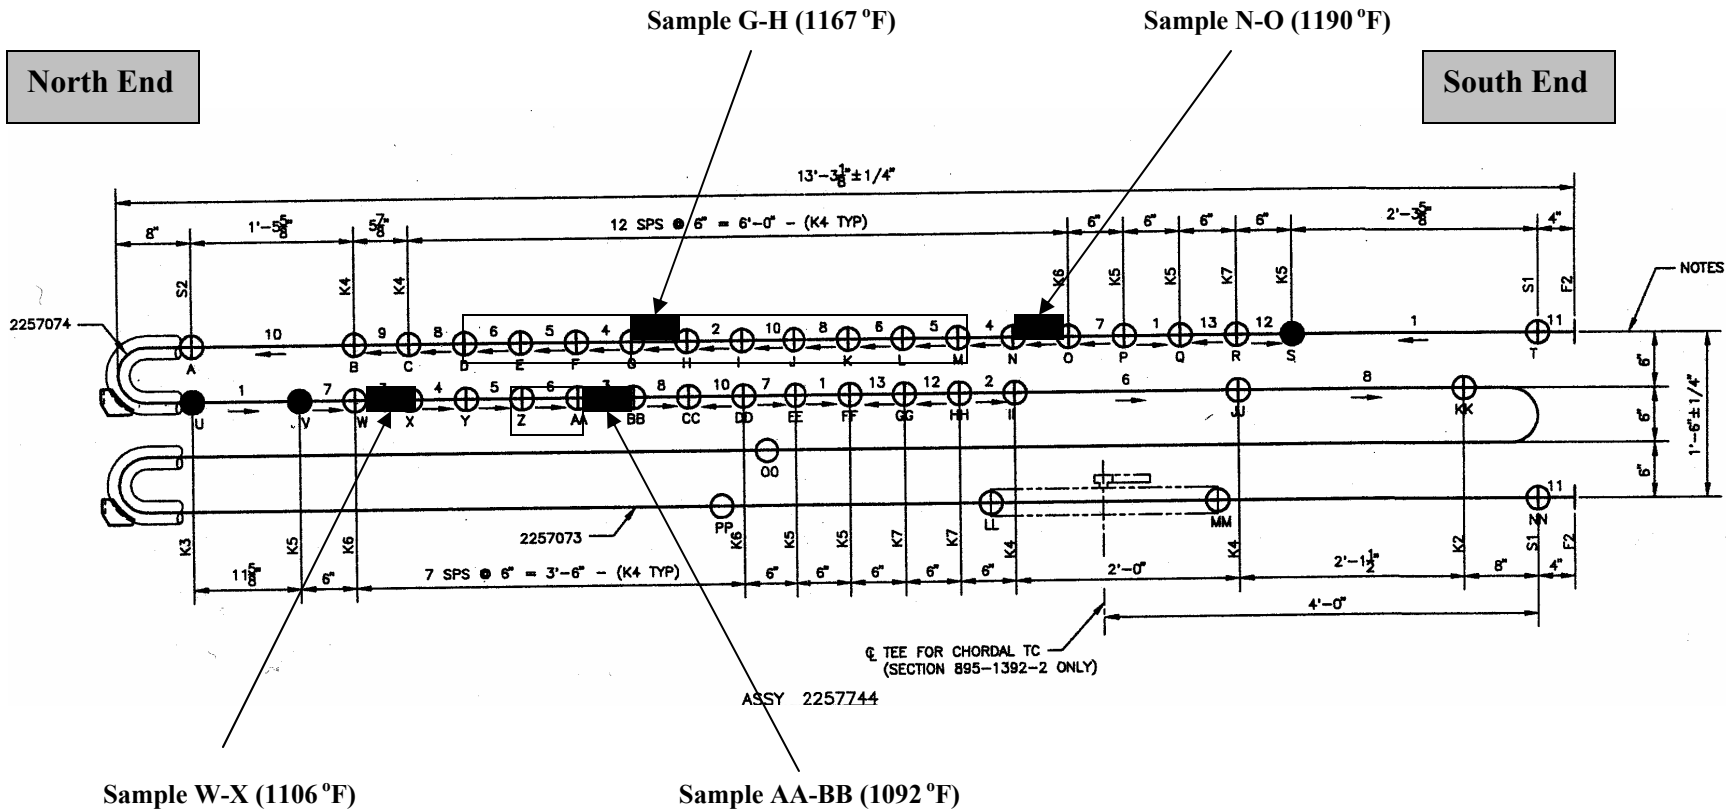
Figure G-1: Schematic Drawing Showing Position of 310 HCbN (HR3C) Tube Samples Within Test Section C

Issue	Discussion
Sample Location and Orientation.	<ul style="list-style-type: none">• In assessing the data for Section C, it is important to understand that some tube samples had to be removed from the section early due to excessive thinning. The schematic in Figure G-1 shows the relative positions of the 310 HcBn samples in all three sections. Also, shown are the positions of all of the excessively thinned tubes that were removed and replaced in order to extend the life of Section C.• One 310 HcBn sample was removed early. Sample G-H was removed in November 2001, (i.e. shortly after Section A was removed from service for evaluation). Samples N-O, W-X and AA-BB survived for the full Section C exposure period.• The sample that was removed early was set aside for later analysis, and has been included in the current evaluation along with the other tube samples that made up Section C.• Also shown in this figure is the calculated average surface metal temperature at each location.

1. Drawing shown in same relative orientation as per the actual installation.
2. This group of tube samples was removed from service in November 2001 - highlighted in red.
3. This group of tube samples was removed from service in June 2002 - highlighted in yellow.

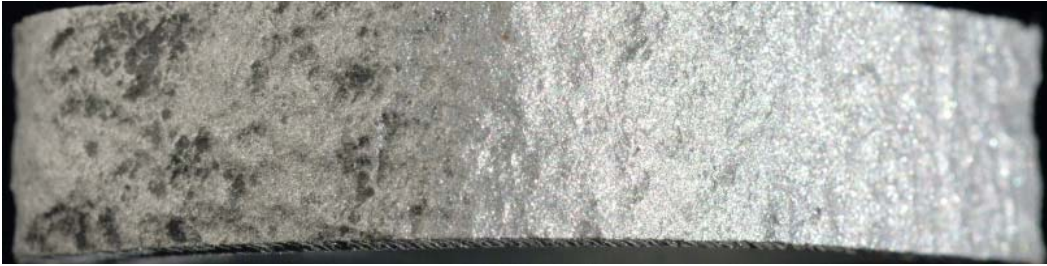
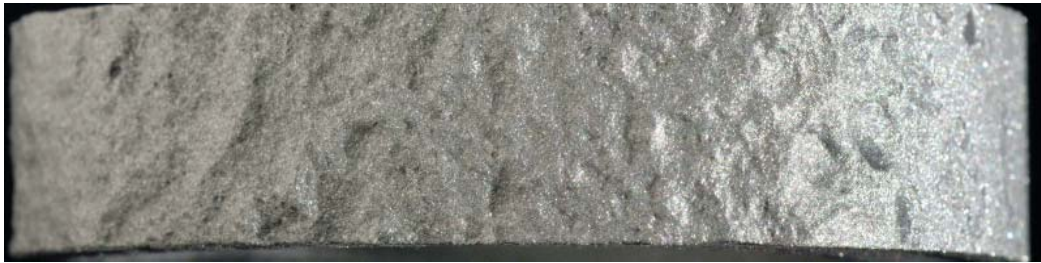
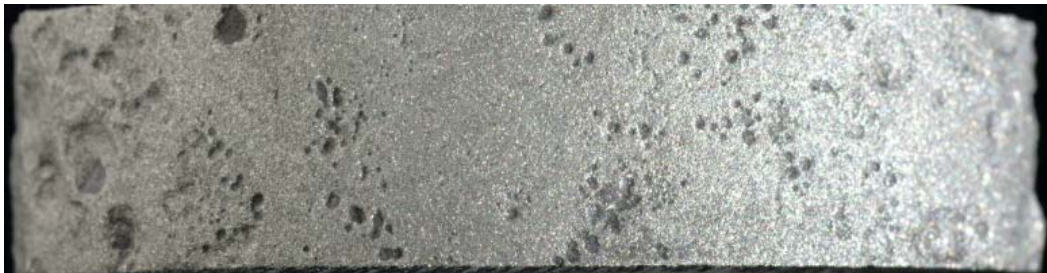
Figure G-8: OD Surface Appearance After Grit Blast

Grit-Blasted Surface Appearance	<ul style="list-style-type: none"> • Figures G-8 through G-11 show the appearance of the external surface of the 310 HCbN tube samples after grit-blasting to remove deposit and scale. The 12 o'clock and 3 o'clock positions for all four samples show the appearance of general wastage due to fireside corrosion. • The 6 o'clock position shows some evidence of pitting for all four samples; otherwise, it was relatively unaffected, and exhibited little or no wastage at this surface.
Wall Thickness Loss Determined	<ul style="list-style-type: none"> • Tube cross-sections were prepared to allow for measurement of wall thickness to determine metal loss due to exposure. These are shown in silhouette in Figures G-12 through G-15. • The same relative "o'clock" positions were maintained as discussed earlier. Measurements were taken at eight evenly spaced locations about the tube circumference. These were then compared with measurements taken at these same locations prior to exposure. • The before and after measurements were documented in the table that accompanies each figure. These form the basis for the "delta" calculation to determine the amount of wall thickness lost.

12 O'Clock
(201 mils lost)

3 O'Clock
(205 mils lost)

6 O'Clock
(6 mils lost)

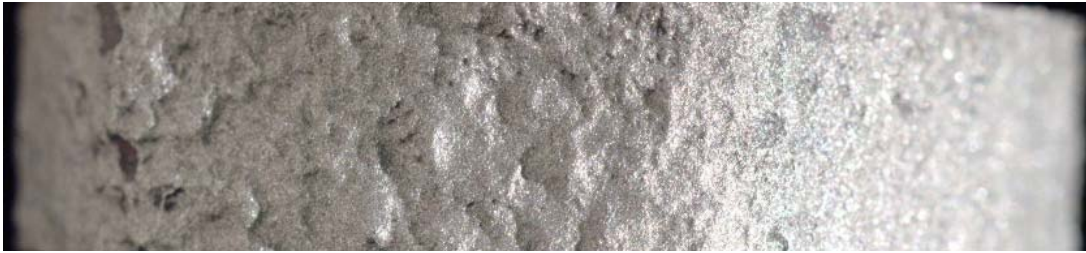
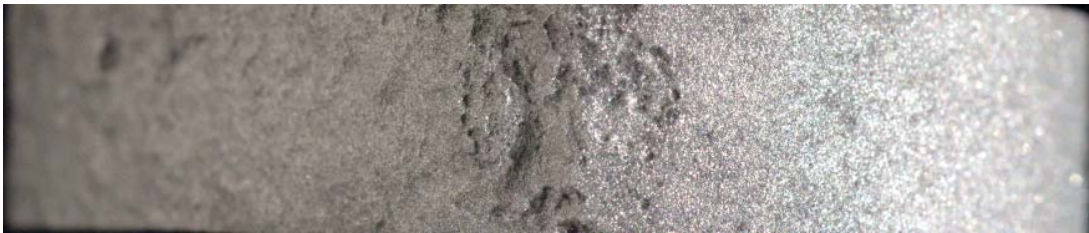
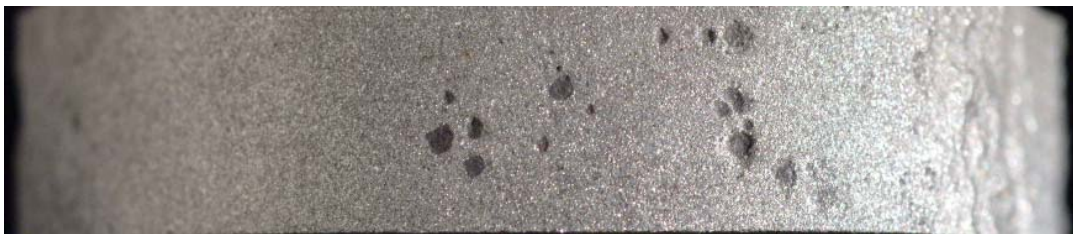
Figure G-9: OD Surface Appearance After Grit Blast

One 310 HCbN sample in Section C, Sample G-H experienced a significantly high rate of metal loss (141 mils per year*) that it was removed and replaced after 18.6 months of exposure, i.e. shortly after Section A was removed for examination. Sample N-O remained in Section C for continued testing and experienced a high rate of metal loss to the point where, less than 25% of the wall remained at the time that Section C was removed from service. The other two 310 HCbN samples, which experienced lower exposure temperatures, experienced little if any additional corrosion relative to the samples from Section A. The reason for this is not clear.

12 O'Clock
(146 mils lost)

3 O'Clock
(173 mils lost)

6 O'Clock
(2 mils lost)

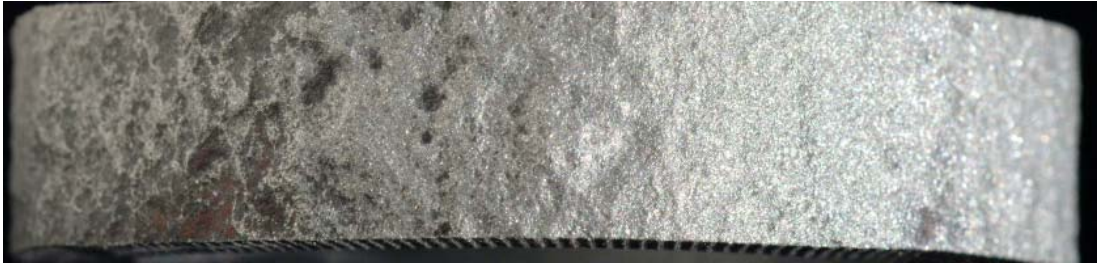
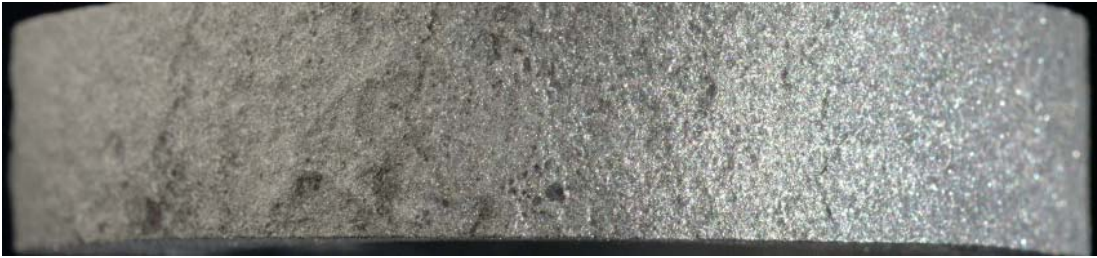
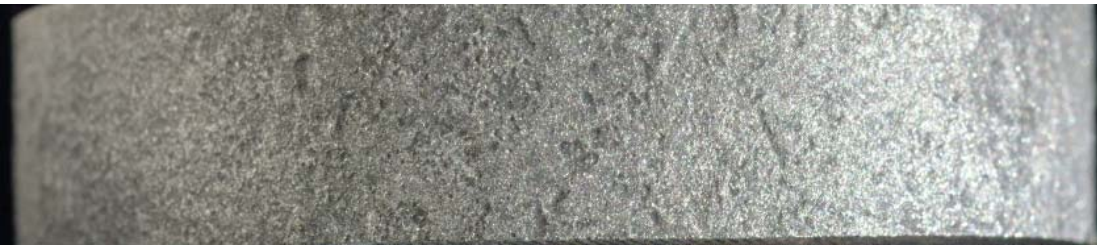
Figure G-10: OD Surface Appearance After Grit Blast

12 O'Clock
(61 mils lost)

3 O'Clock
(45 mils lost)

6 O'Clock
(7 mils lost)

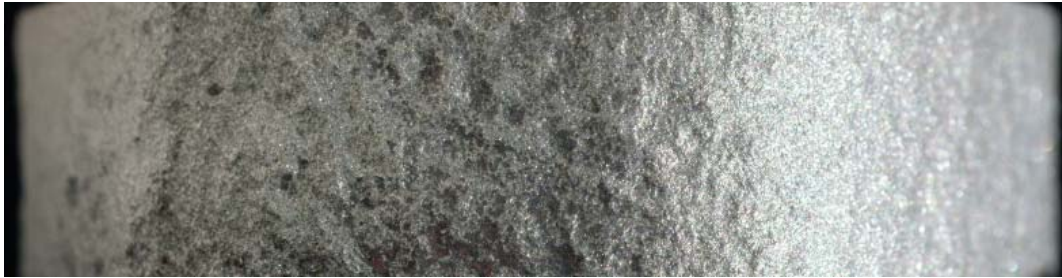
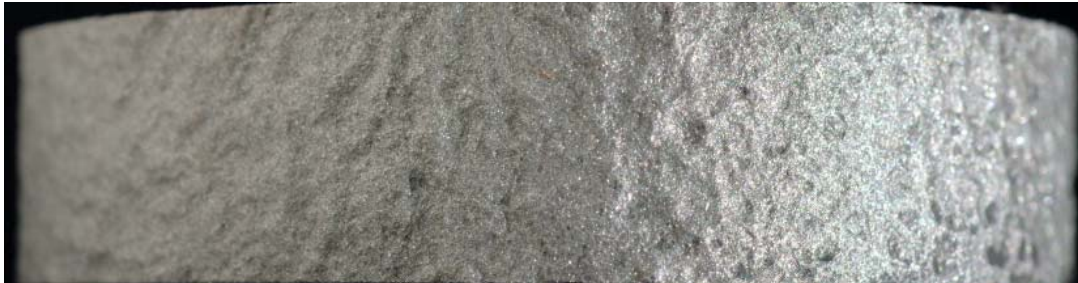
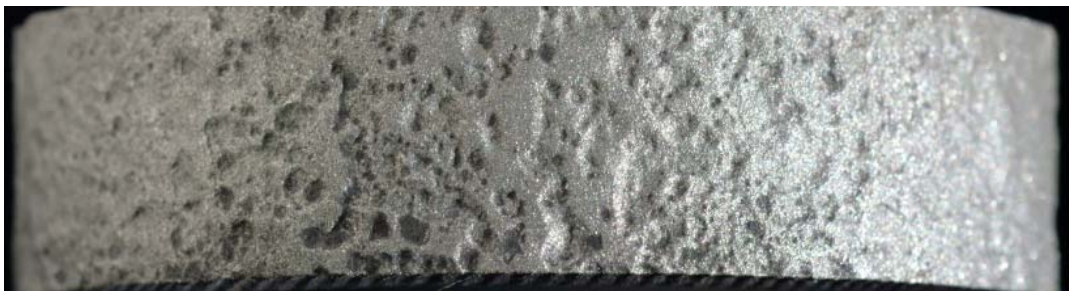
Figure G-11: OD Surface Appearance After Grit Blast

12 O'Clock
(146 mils lost)

3 O'Clock
(148 mils lost)

6 O'Clock
(7 mils lost)

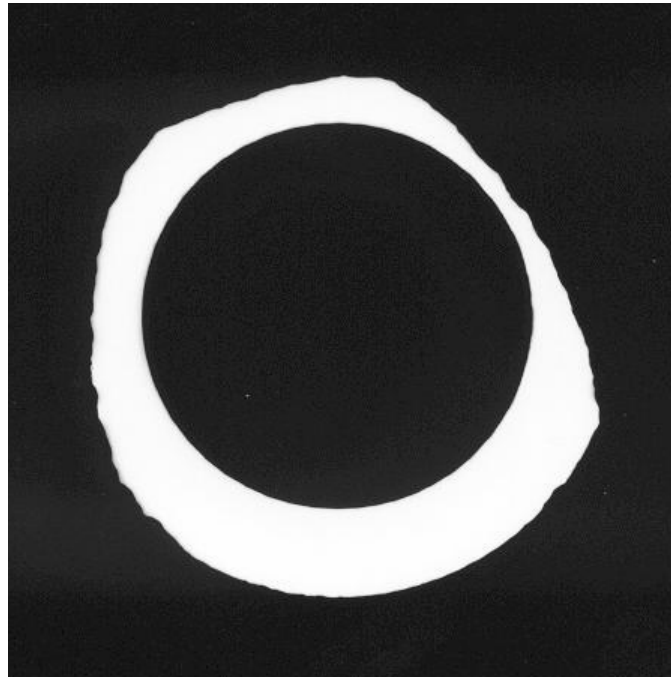
Sample Location: N-O
Maximum Rate: 133 mils/yr
Maximum Loss Orientation: Approx. 2 o'clock
Average Surface Metal Temperature: 1190 °F

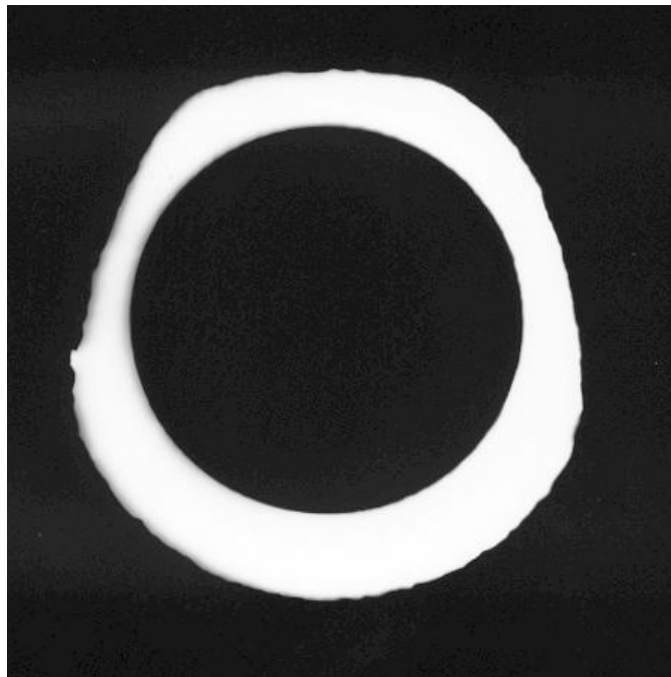
Figure G-15: Silhouette and Wall Thickness Measurements for Sample AA-BB

Sample Location: AA-BB
Maximum Rate: 79 mils/yr
Maximum Loss Orientation: Approx. 9:30 o'clock
Average Surface Metal Temperature: 1092 °F

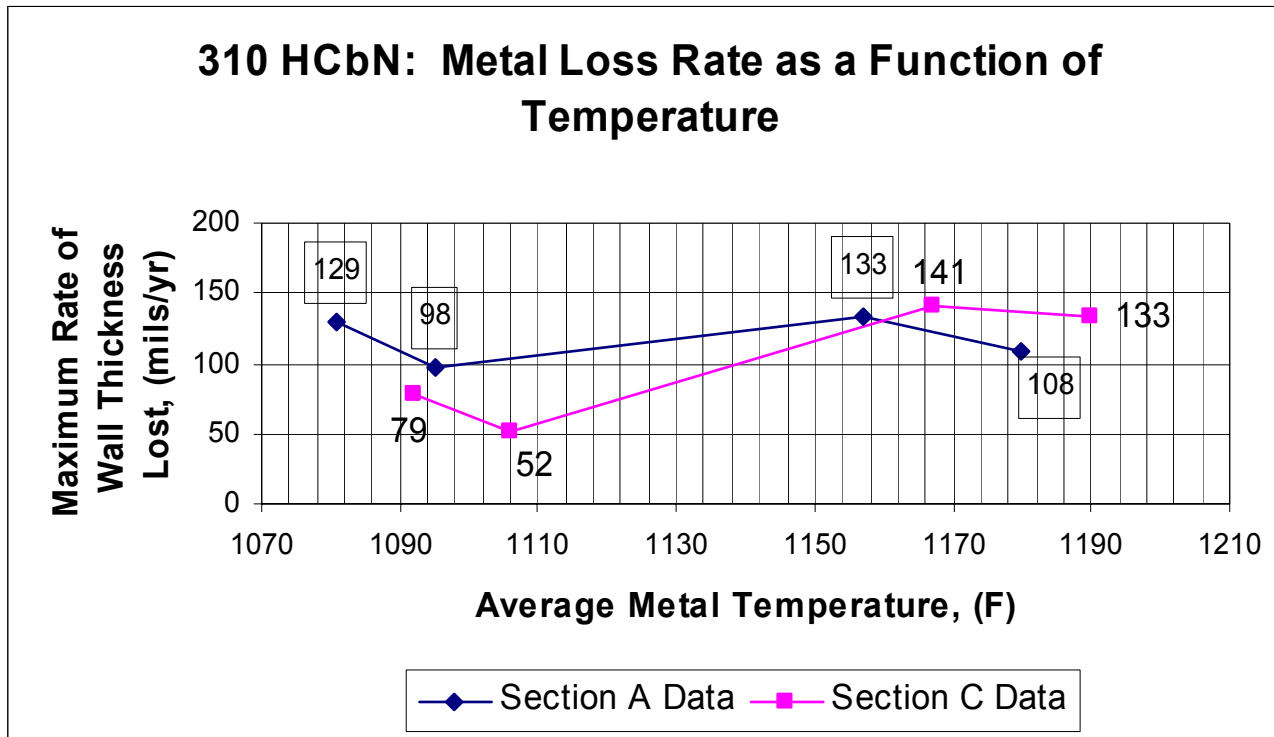
Figure G-16: Metal Loss Rate as a Function of Average Surface Metal Temperature

Note: In analyzing these data it is important to understand that the one of the three Section C samples was removed early due to excessive corrosion losses. Sample G-H (1167 F) was removed in November 2001, shortly after Section A was removed for evaluation. Sample N-O (1190 F), Sample W-X (1106 F), and Sample AA-BB (1092 F) were removed with the remaining Section C samples in May 2003.

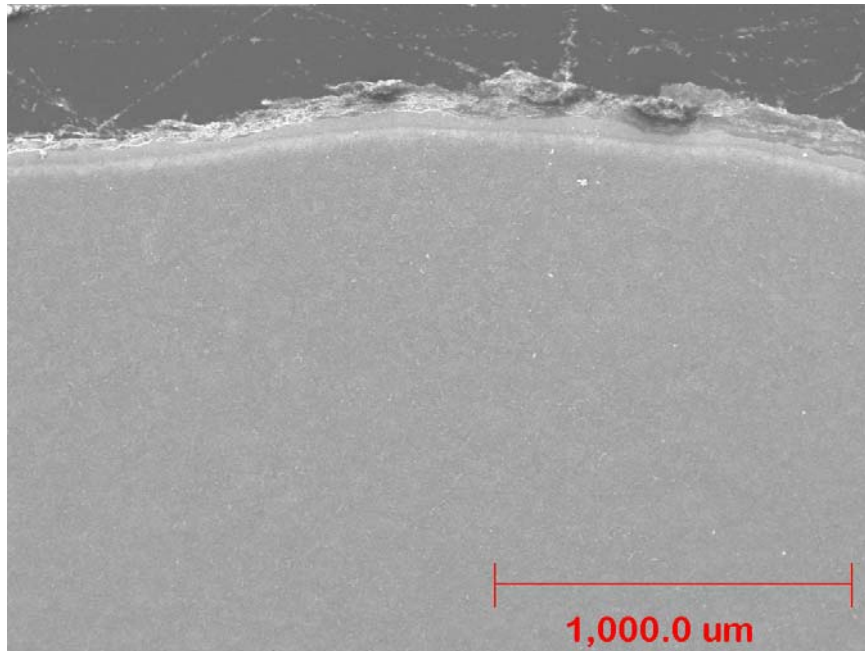
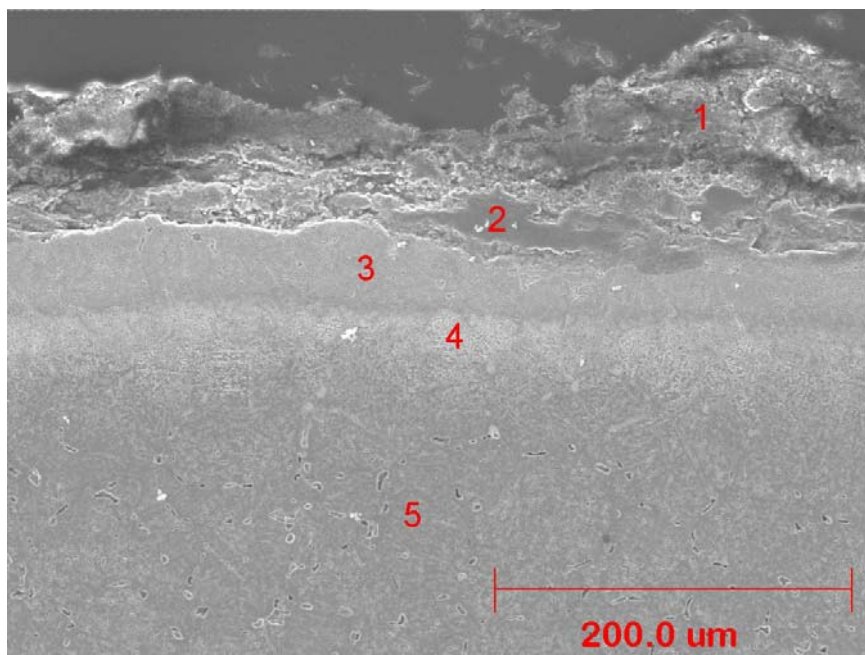
Figure G-18: Microstructure: 310 HCBN

Issue	Discussion
Metallurgical Analysis – SEM, Continued.	<ul style="list-style-type: none"> ○ <u>Tightly adhering scale</u> – this is seen continuous along the surface. EDS analysis will later show that this is a chromium-, nickel-, and iron-rich -oxide. ○ <u>Thick and very porous deposit/scale conglomerate</u> – many spherical particles are noted along with what appears to be islands of scale (metal oxides). <ul style="list-style-type: none"> ● Figures G-19 shows the appearance of the tube microstructure at mid-wall. ● Figure G-20 shows the appearance of the internal metal surface for Sample N-O. Little if any oxide scale is visible at this surface.
Metallurgical Analysis – Weld Cross Section.	<ul style="list-style-type: none"> ● Figure G-21 shows a longitudinal profile (at the 12 o’clock orientation) of the 310 HCbN samples adjacent to the welds in Section C. Three welds were cross sectioned. These were identified as “N”, “X” and “BB” in the schematic shown in Figure G-1. ● An Inconel 625 weld metal was used throughout Section C. The cross sections show that the 310 HCbN heat affected zones are not preferentially attached, in fact, the wall thickness for the tube sample tapers from the weld toward the middle of the tube length.

(a) External Scale/Metal Interface (SEI - Low Magnification)

(b) External Scale/Metal Interface (SEI - Intermediate Magnification)

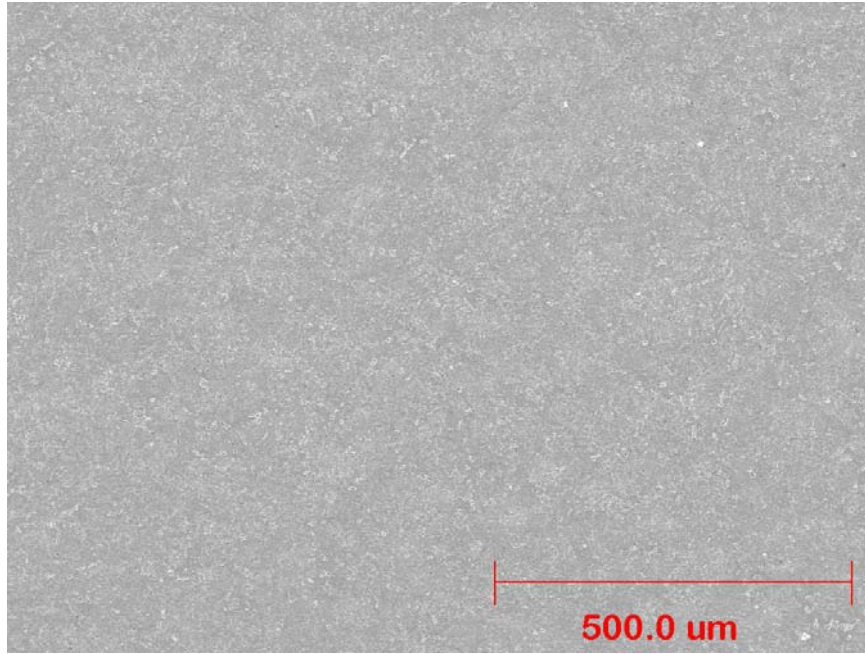
Figure G-19: Mid-Wall Microstructure: 310 HCbN

(SEI - Low Magnification)

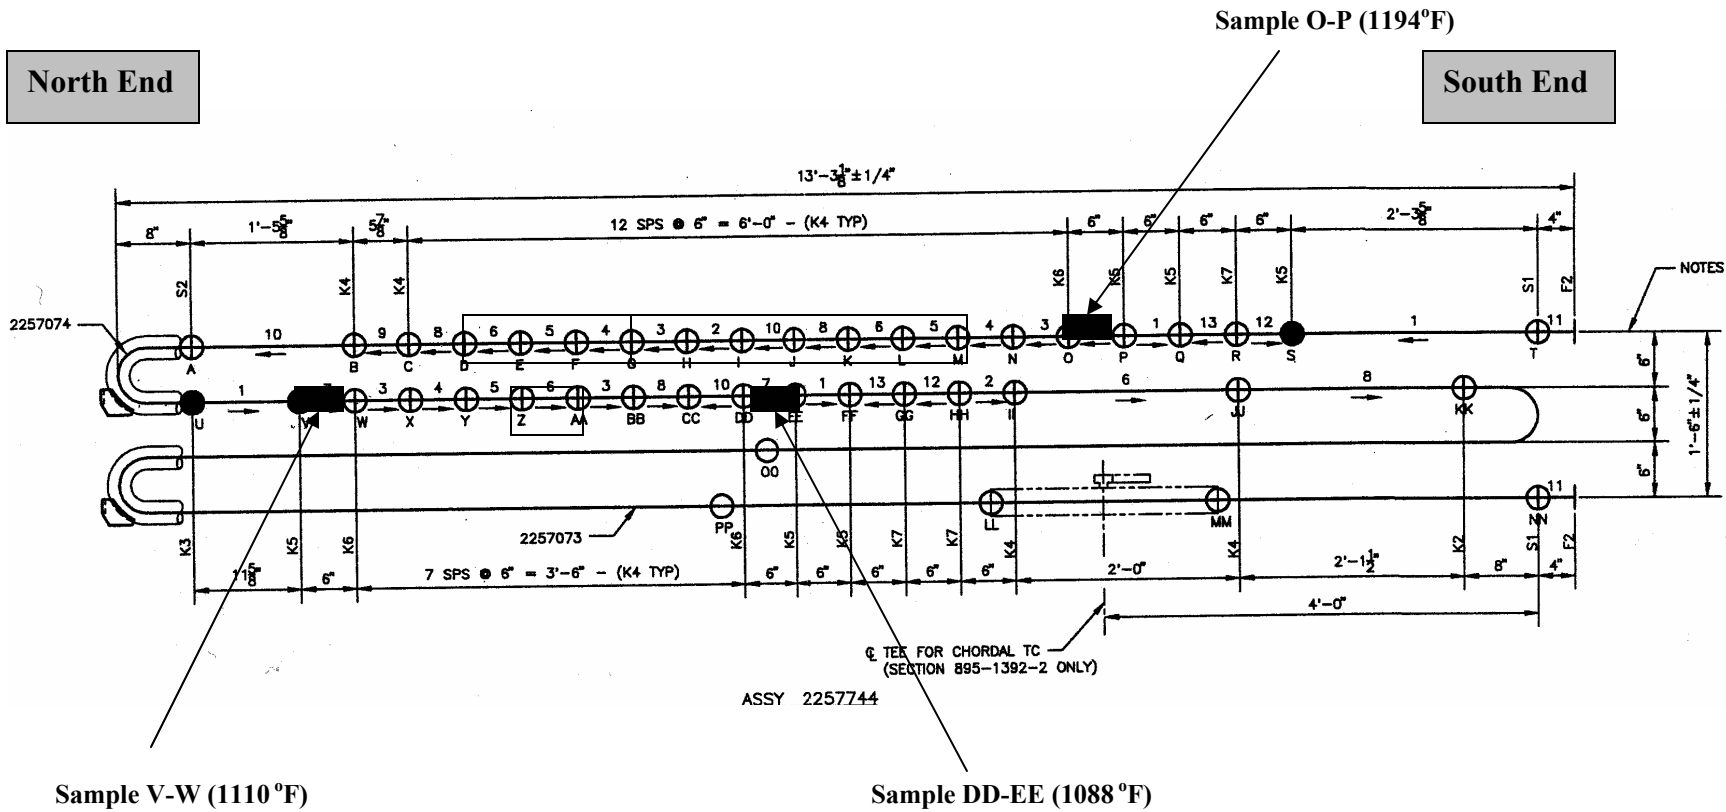
Figure H-1: Schematic Drawing Showing Position of HR 120 Tube Samples Within Test Section C

Issue	Discussion
Sample Location and Orientation.	<ul style="list-style-type: none">• The schematic in Figure H-1 shows the relative positions of the three HR 120 samples in Test Section C. Note that none of the HR 120 samples were included in the tube lengths that were removed early and replaced, i.e. in November 2001 or in June 2002.• Also, shown is the calculated average surface metal temperature at each location.
Composition Verification.	<ul style="list-style-type: none">• The HR 120 tubing for this program came from one heat of material (Heat 854487538) supplied from Haynes International, Inc.• The table in Figure H-2 provides a nominal HR 120 composition from Haynes literature. It also provides the reported heat analysis.<ul style="list-style-type: none">○ It is interesting to note that while the heat supplied met the constraints of the nominal composition, it was somewhat lean in alloying element additions: molybdenum (actual 0.23% versus 2.5% max nominal), cobalt (0.088% versus 3% max), and tungsten (not detectable versus 2.5% max).• During the Section A evaluation, detailed composition verification was undertaken for each tube sample that was removed from service. This served, in part, to verify that the each tube material was located at its' proper position within the test section.• Based on the good results for Section A, it was decided that it would be unnecessary to analyze each and every tube sample for composition verification. Rather, it was decided to select a representative sample from each tube material type for confirmatory analysis.• During the Section A evaluation, the energy dispersive spectrographic (EDS) capabilities of the scanning electron microscope (SEM) were used to perform semi-quantitative analyses of each of the twelve different candidate tube materials. Comparison of these EDS results showed reasonably good correlation with results obtained using quantitative analytical techniques, including optical emission spectrometry.• Based on this, it was decided that the accuracy provided by EDS would suffice for composition verification, but that more detailed analyses would be undertaken if questions arose.• The results of the EDS analysis of tube sample O-P confirmed that the correct material was used at this location.

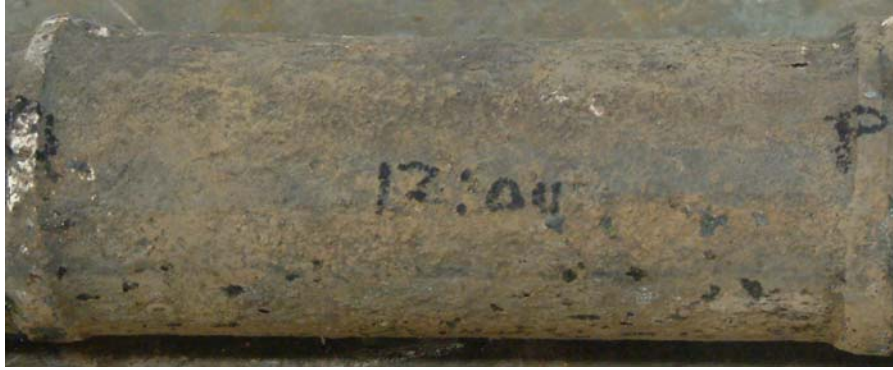
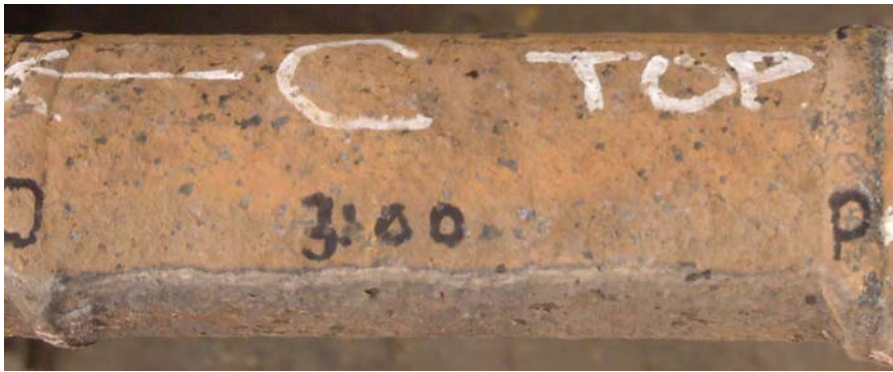
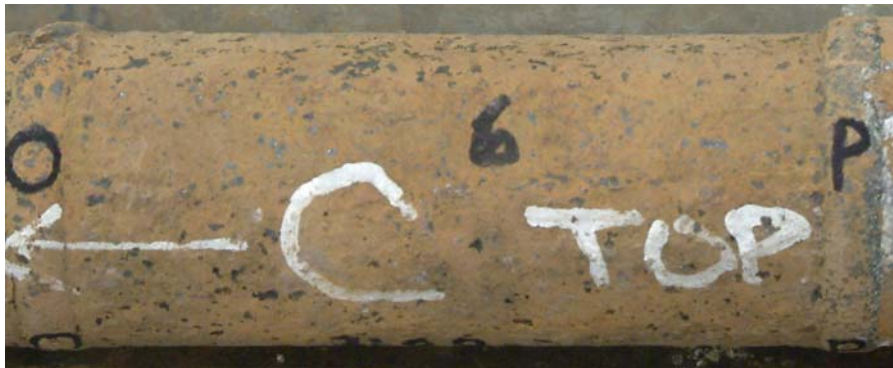
Figure H-4 As-Received Appearance of Sample O-P (HR 120)

(Average surface metal temperature: 1194°F)

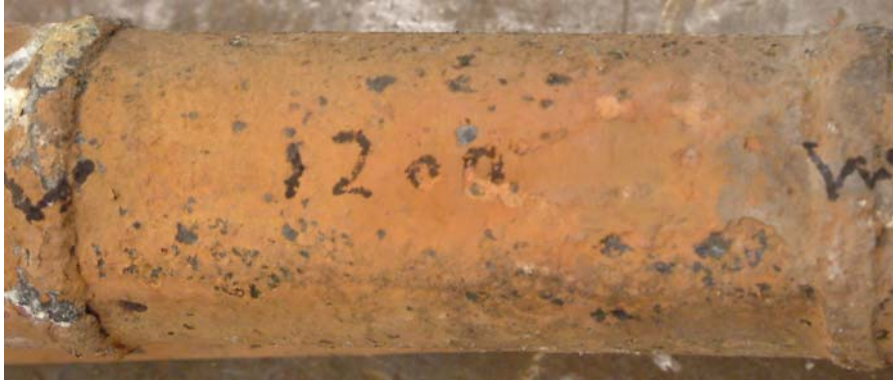
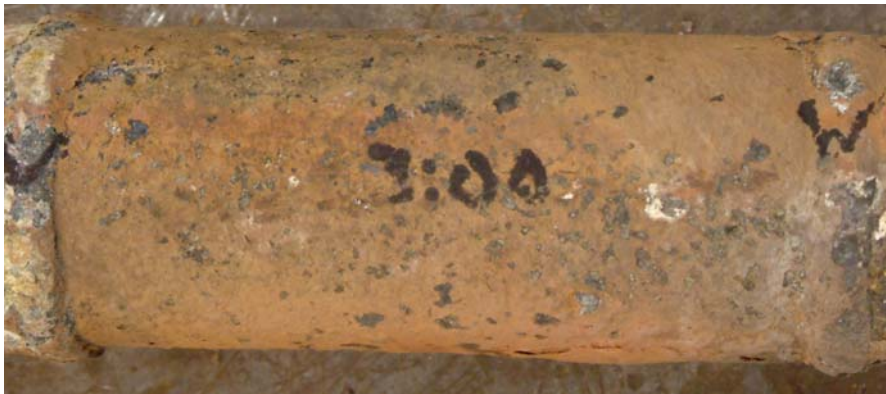
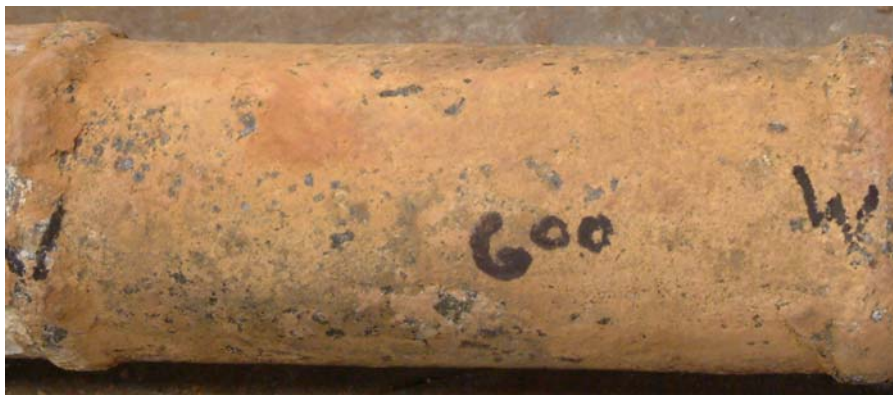
Figure H-5 As-Received Appearance of Sample V-W (HR 120)

(Average surface metal temperature: 1110 °F)

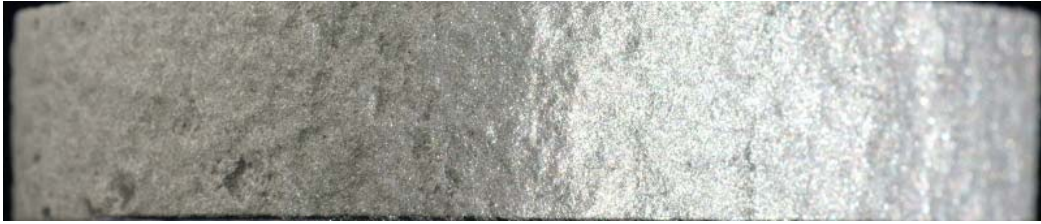
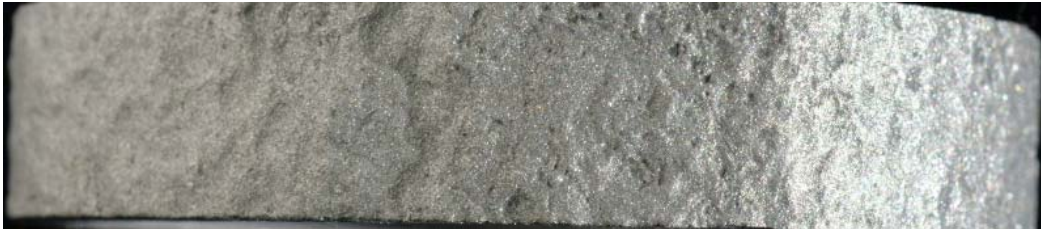
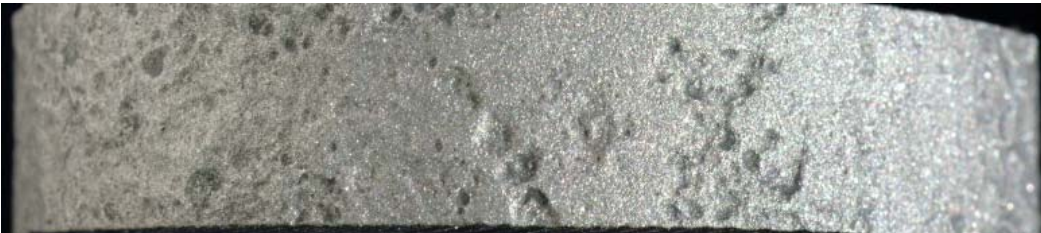
Figure H-7: OD Surface Appearance After Grit Blast

12 O'Clock
(204 mils lost)

3 O'Clock
(208 mils lost)

6 O'Clock
(0 mils lost)

Material: HR 120
Sample: O-P

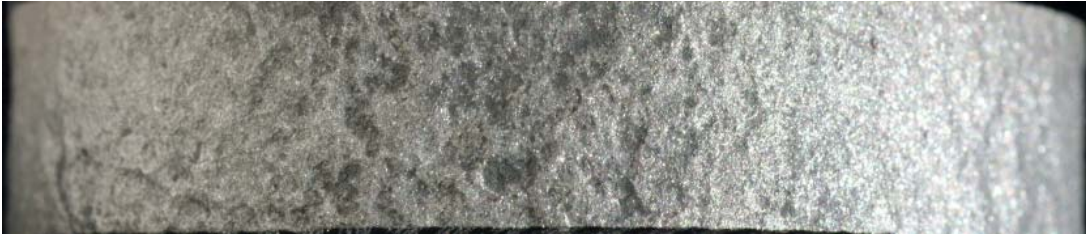
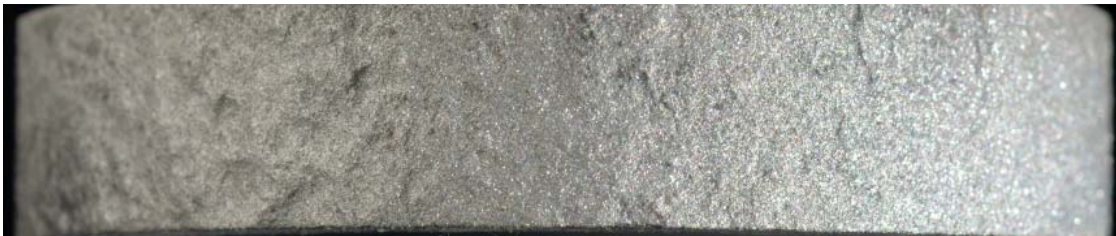
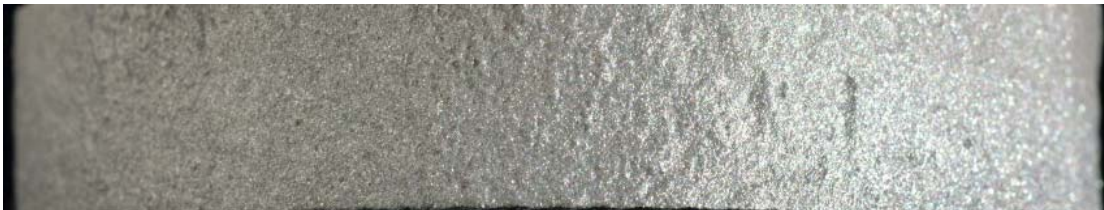
Figure H-8: OD Surface Appearance After Grit Blast

12 O'Clock
(76 mils lost)

3 O'Clock
(43 mils lost)

6 O'Clock
(2 mils lost)

Material: HR 120
Sample: V-W

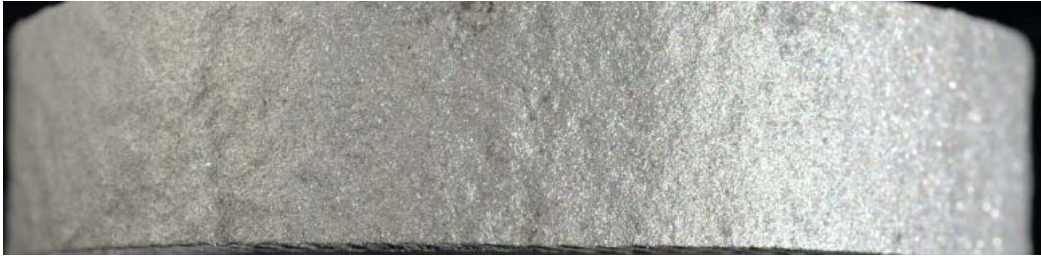
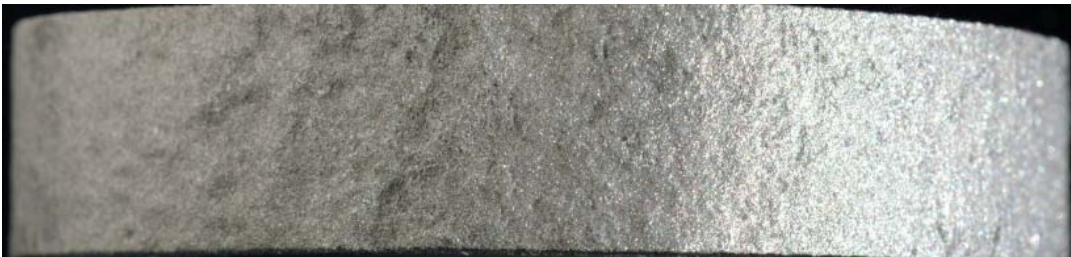
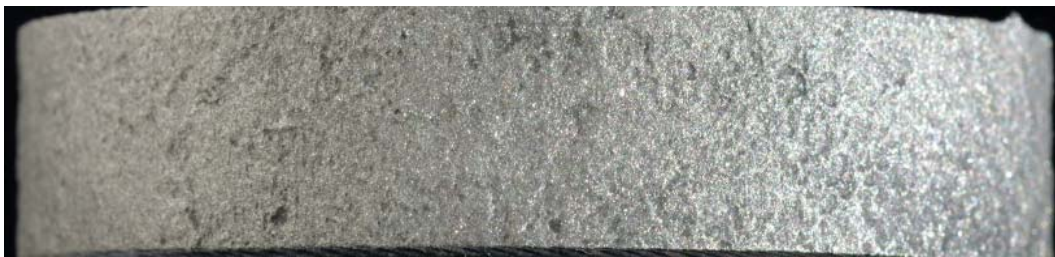
Figure H-9: OD Surface Appearance After Grit Blast

12 O'Clock
(131 mils lost)

3 O'Clock
(177 mils lost)

6 O'Clock
(11 mils lost)

Material: HR 120
Sample: DD-EE

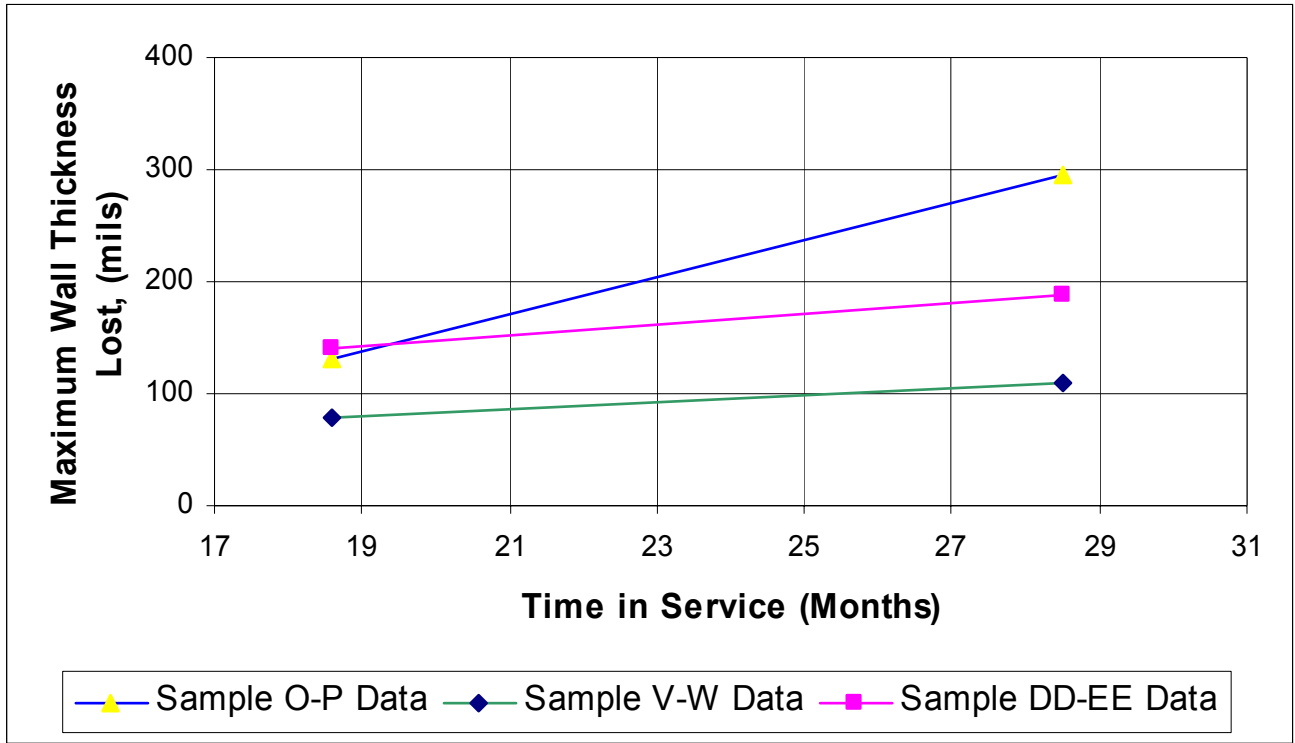
Figure H-14: Metal Loss as a Function of Time

Issue	Discussion
Wall Thickness Loss as a Function of Time and Location	<ul style="list-style-type: none"> • The chart in Figure H-14 plots metal loss as a function of time for each sample location for Sections A and C. with samples from Section C having experienced generally longer exposure times. • It was noted that metal loss rate increased as a function of time for Sample O-P at the highest exposure temperature. Likewise it was noted that the rate decreased with time for Samples V-W and DD-EE. This suggests that the straight line fit shown in Figure H-14 may pertain.
Metallurgical Analysis – SEM	<ul style="list-style-type: none"> • Sample O-P was selected for a detailed SEM/EDAX assessment of the constituents and structure in the vicinity of the external and internal surfaces. This sample was selected based on the fact that it was experiencing metal wastage at about the maximum rate. The focus of this investigation was in the region of the tube where the maximum amount of material was lost. • Figures H-15a and b show the secondary electron images of the scale/metal interface for Sample O-P. Six distinct regions are in evidence. These regions are, starting within the metal and working out: <ul style="list-style-type: none"> ○ <u>Base metal</u> – oxalic acid etch delineates grain boundaries, carbides and inclusions. ○ <u>Diffusion zone – light etching</u> – this region is obvious as a light-appearing band that is parallel to the metal surface, perhaps see most clearly in Figure H-15b. This band is approximately one-half grain wide, and affects only those grains contiguous with the surface. Later EDS analysis will show that this region is very similar in composition to the bulk tube, with the possible exception that the sulfur content may be somewhat increased in this area. ○ <u>Diffusion zone – dark etching</u> – This constitutes the leading edge of the grains as they interface with the scale. EDS analysis later shows that this zone is depleted in chromium (11.2% versus roughly 24%). ○ <u>Tightly adherent scale</u> – this is seen continuous along the surface. EDS analysis will later show that this is predominantly a chromium-rich oxide with a significant amount of sulfur present. ○ <u>Bulk Deposit</u> - The deposit was comprised of oxides of iron, silicon, and aluminum. Arsenic was noted, as were sulfur and possibly carbon. • Figure H-15b shows the six locations selected for EDAX analysis. The results of these follow • Figure H-16 shows the appearance of the mid-wall microstructure for HR 120. • Figure H-17 shows the internal metal surface for Sample O-P. It appears to be coated with a 1 mil thick oxide.

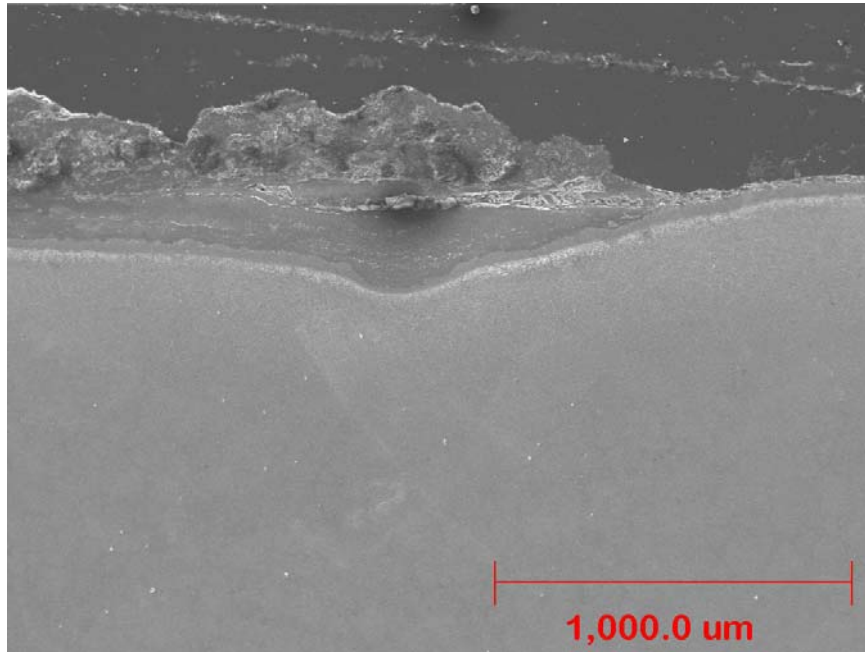
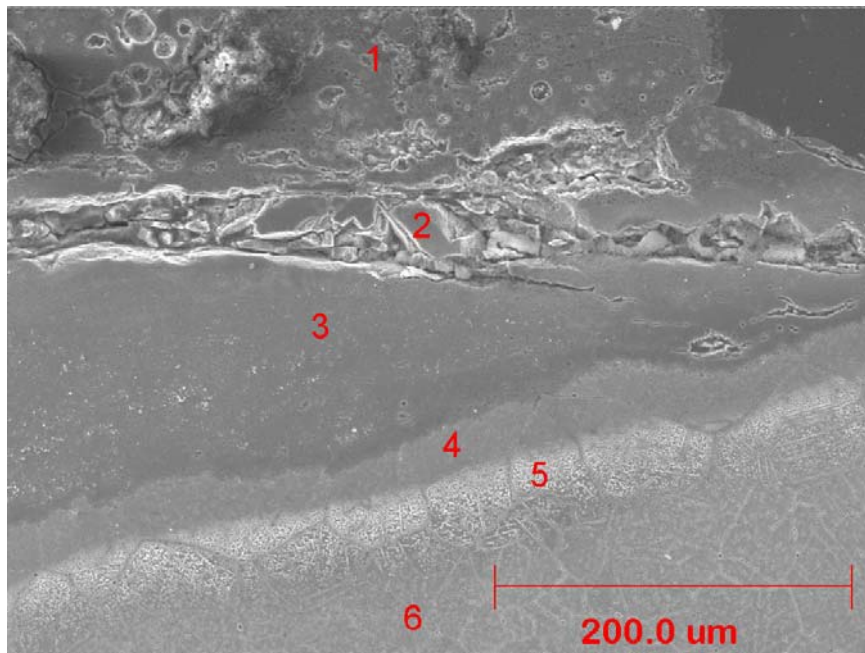
Figure H-15: Microstructure: HR 120

EDS Analysis Results	<ul style="list-style-type: none"> • The table in Figure H-19 provides a summary of the EDAX analyses of the numbered in Figure H-15b. Also shown in this table is a summary of the spectrographic analysis reported earlier, Figure H-2. • Review of this table suggests the following: <ul style="list-style-type: none"> • <u>Area 1: Bulk deposit/scale analysis</u> – Potassium is present, as are sulfur and phosphorous. An iron oxide is likely, as are aluminum, silicon and titanium oxides. The analysis suggests that the carbon content is relatively high, however, these results need to be considered carefully given the inherent inaccuracies in EDS carbon analysis. • <u>Area 2: Loosely adhering deposit/scale</u> – This appears to be chromium-, iron-, and nickel-rich oxide. Sulfur is present. • <u>Area 3: Tightly adhering scale</u> - This is the chromium-rich scale that is immediately adjacent to the metal surface. Again high sulfur is indicated. • <u>Area 4: Diffusion zone – dark etching</u> – This region that abuts the tightly adhering scale is depleted in chromium. • <u>Area 5: Diffusion zone – light etching</u> – The presence of a significant amount of sulfur is the only thing that distinguishes this region from the bulk tube metal.. • <u>Bulk EDS analysis</u> – This analysis compares well with the reference spectrographic analysis.
