COAL ASH CORROSION RESISTANT MATERIALS TESTING

Topical Report: Removal of Section "C"

THE BABCOCK & WILCOX COMPANY

The “Coal Ash Corrosion Resistant Materials Testing Program” is being conducted by The Babcock & Wilcox Company (B&W), the U.S. Department of Energy (DOE) and the Ohio Coal Development Office (OCDO) at Reliant Energy’s Niles plant in Niles, Ohio to provide full-scale, in-situ testing of recently developed boiler superheater materials. Fireside corrosion is a key issue for improving efficiency of new coal fired power plants and improving service life in existing plants.

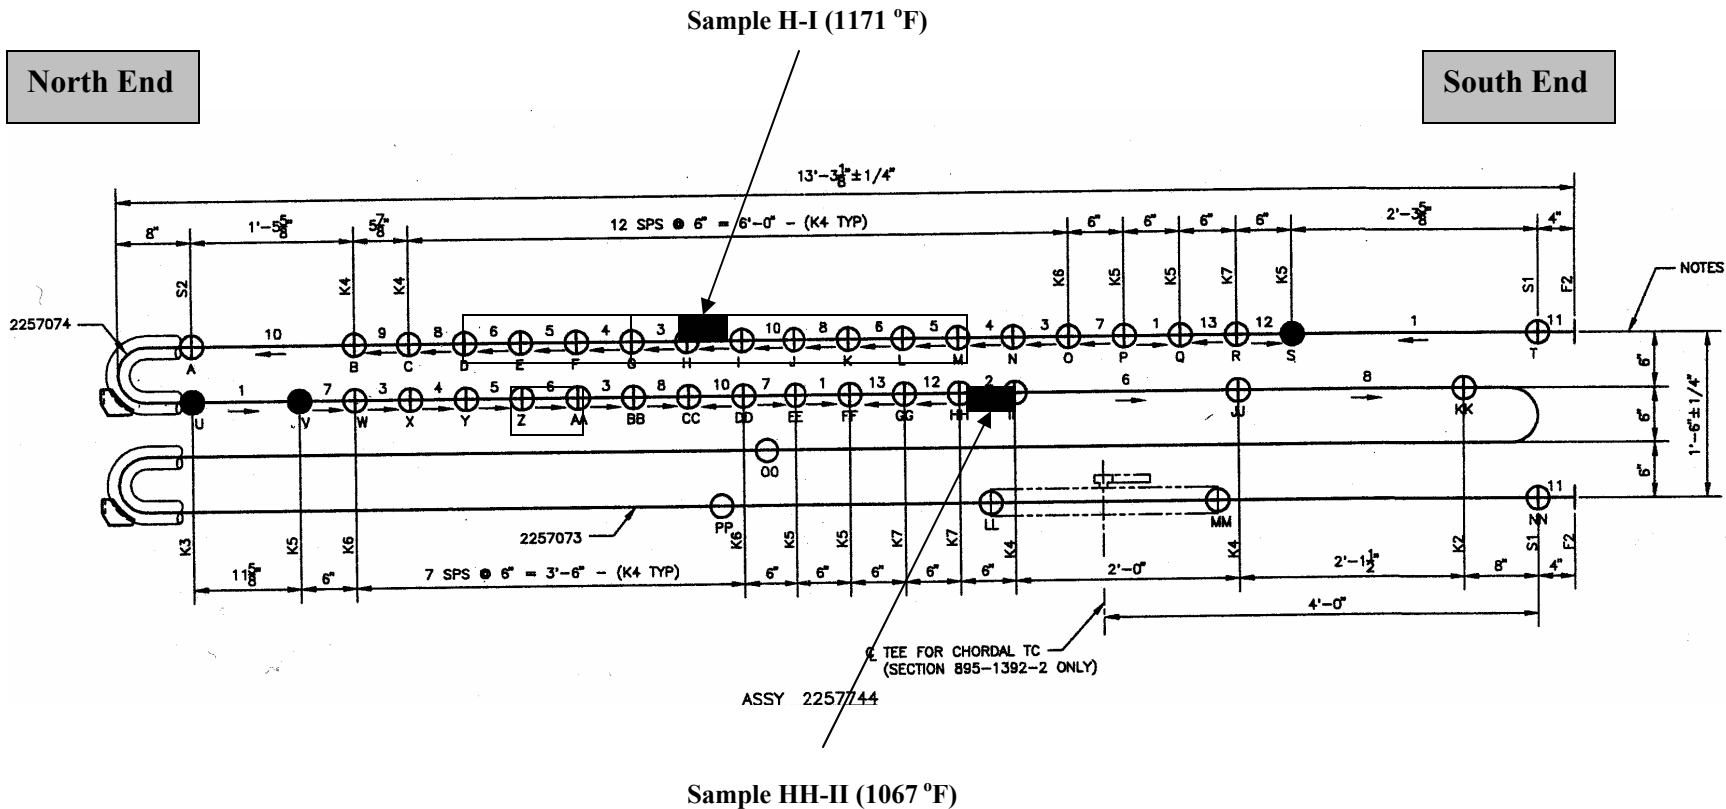
Figure I-1: Schematic Drawing Showing Position of Thermie Tube Samples Within Test Section C

Issue	Discussion
Sample Location and Orientation.	<ul style="list-style-type: none">• In assessing the data for Section C, it is important to understand that some tube samples had to be removed from the section early due to excessive thinning. The schematic in Figure I-1 shows the relative positions of the Thermie samples in all three sections. Also, shown are the positions of all of the excessively thinned tubes that were removed and replaced in order to extend the life of Section C.• One Thermie sample was removed early. Sample H-I was removed in November 2001, (i.e. at the same time that Section A was removed from service for evaluation). Sample HH-II survived for the full Section C exposure period.• The Sample HH-II, that was removed early, was set aside for later analysis, and has been included in the current evaluation along with the other tube samples that made up Section C.• Also shown in this figure is the calculated average surface metal temperature at both locations.

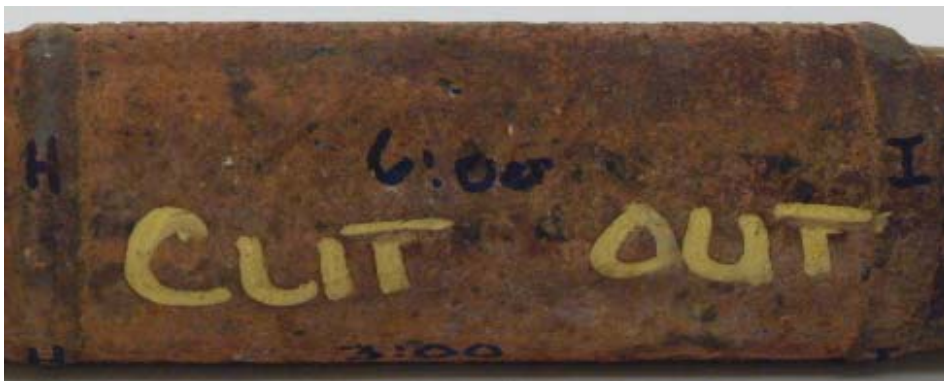
Figure I-4 As-Received Appearance of Sample H-I (Thermie)

(Average surface metal temperature: 1171 °F)

Note: this tube was removed from service on 11/6/01.

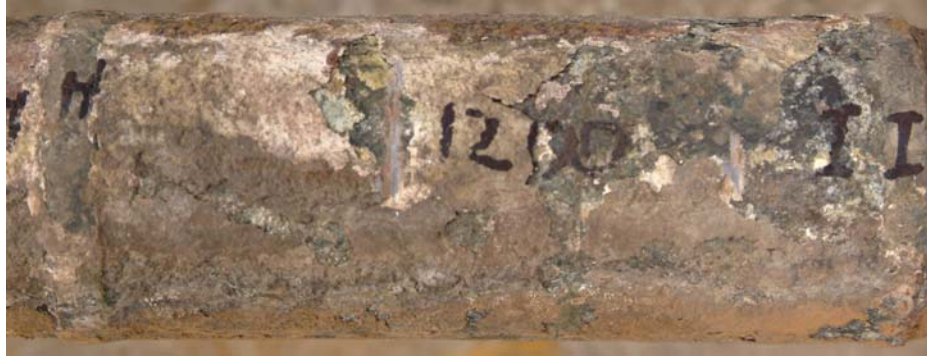
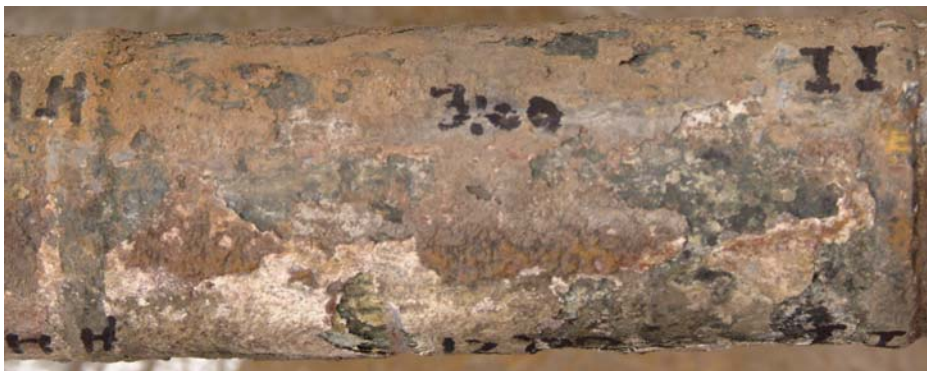
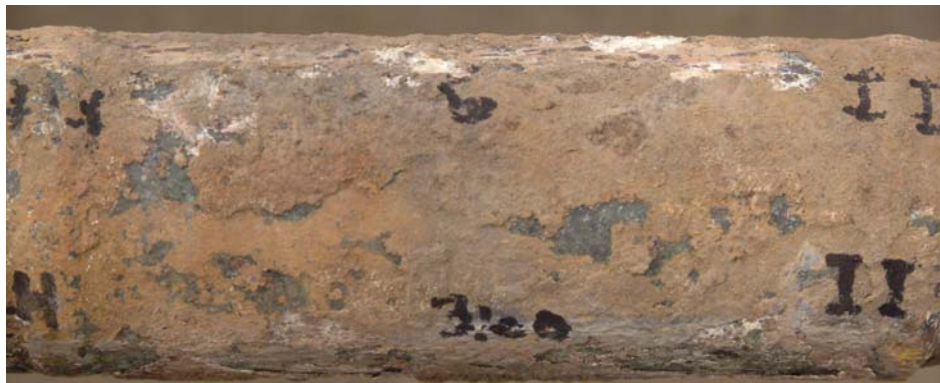
Figure I-5 As-Received Appearance of Sample HH-II (Thermie)
(Average surface metal temperature: 1067°F)

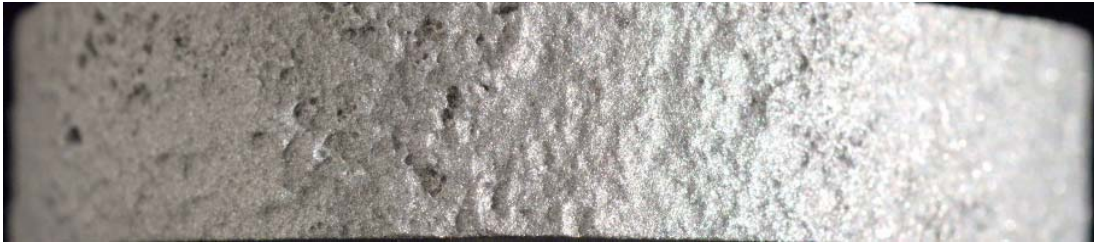
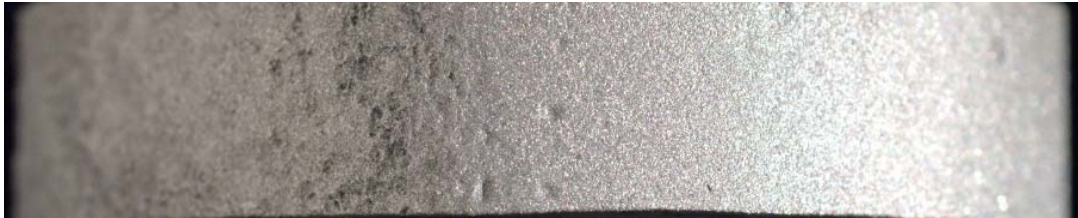
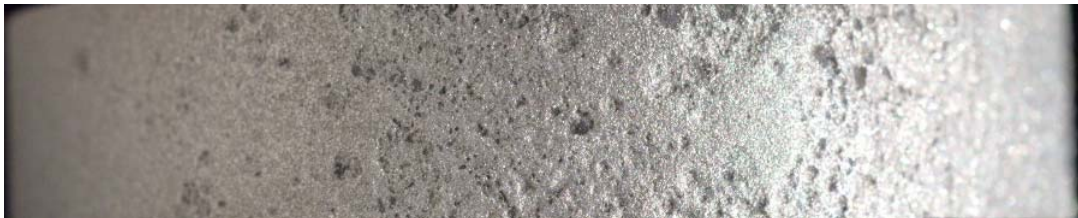
Figure I-6: OD Surface Appearance After Grit Blast

Grit-Blasted Surface Appearance	<ul style="list-style-type: none"> • Figures I-6 and I-7 show the appearance of the external surface of the Thermie tube samples after grit-blasting to remove deposit and scale. • The 12 o'clock and 3 o'clock positions for Samples H-I clearly show the appearance of general wastage due to fireside corrosion. Some level of pitting also is suggested at the 6 o'clock position for this sample. • Wastage and pitting are much less evident for Sample HH-II.
Wall Thickness Loss Determined	<ul style="list-style-type: none"> • Tube cross-sections were prepared to allow for measurement of wall thickness to determine metal loss due to exposure. These are shown in silhouette in Figures I-8 and I-9. • The same relative "o'clock" positions were maintained as discussed earlier. Measurements were taken at eight evenly spaced locations about the tube circumference. These were then compared with measurements taken at these same locations prior to exposure. • The before and after measurements were documented in the table that accompanies each figure. These form the basis for the "delta" calculation to determine the amount of wall thickness lost. • Note that for some positions in Sample H-I, the delta is negative. This is believed due to wall thickness variability and difficulty in locating the exact location of the "before" measurement.

12 O'Clock
(86 mils lost)

3 O'Clock
(0 mils lost)

6 O'Clock
(6 mils lost)

Material: Thermie
Sample: H-I

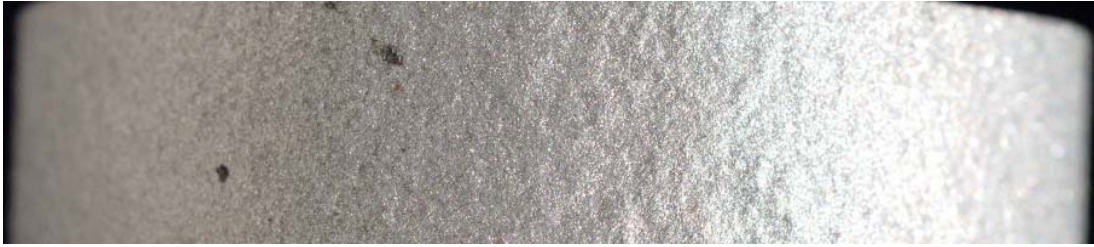
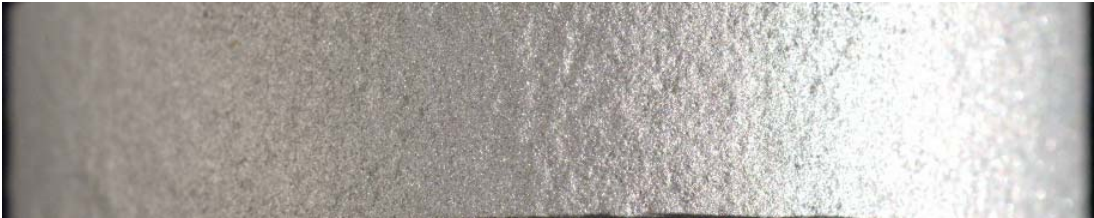
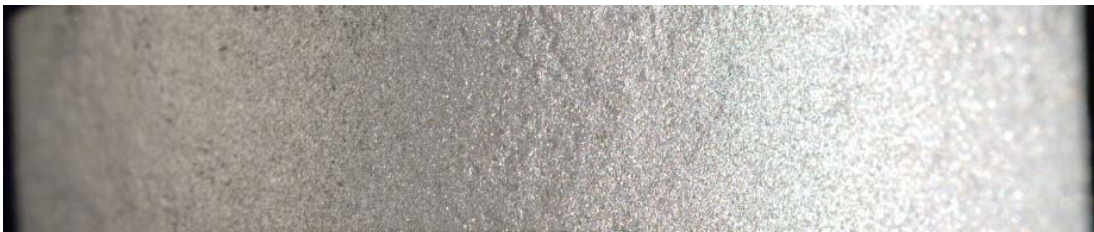
Figure I-7: OD Surface Appearance After Grit Blast

12 O'Clock
(39 mils lost)

3 O'Clock
(55 mils lost)

6 O'Clock
(6 mils lost)

Material: Thermie
Sample: HH-II

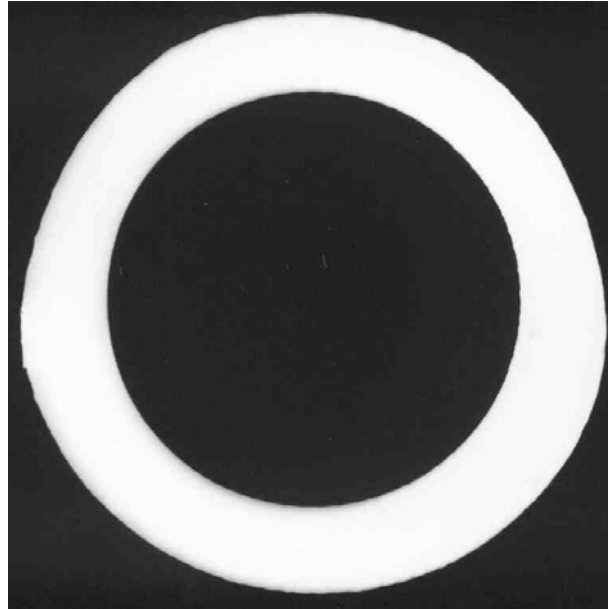
Figure I-9: Silhouette and Wall Thickness Measurements for Sample HH-II

1067 °F

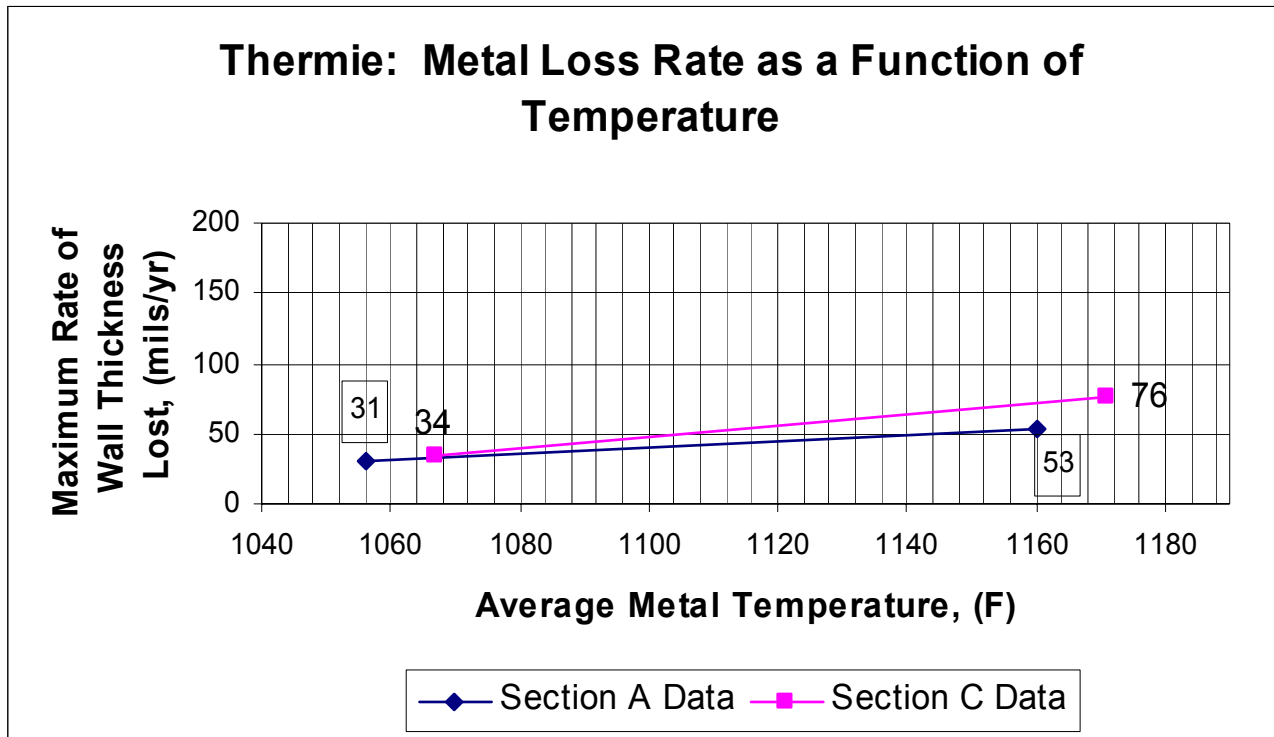
Figure I-10: Metal Loss Rate as a Function of Average Surface Metal Temperature

Note: In analyzing these data it is important to understand that the one of the two Section C samples was removed early due to excessive corrosion losses. Sample H-I (1171 F) was removed in November 2001. Sample HH-II was removed with the remaining Section C samples in May 2003.

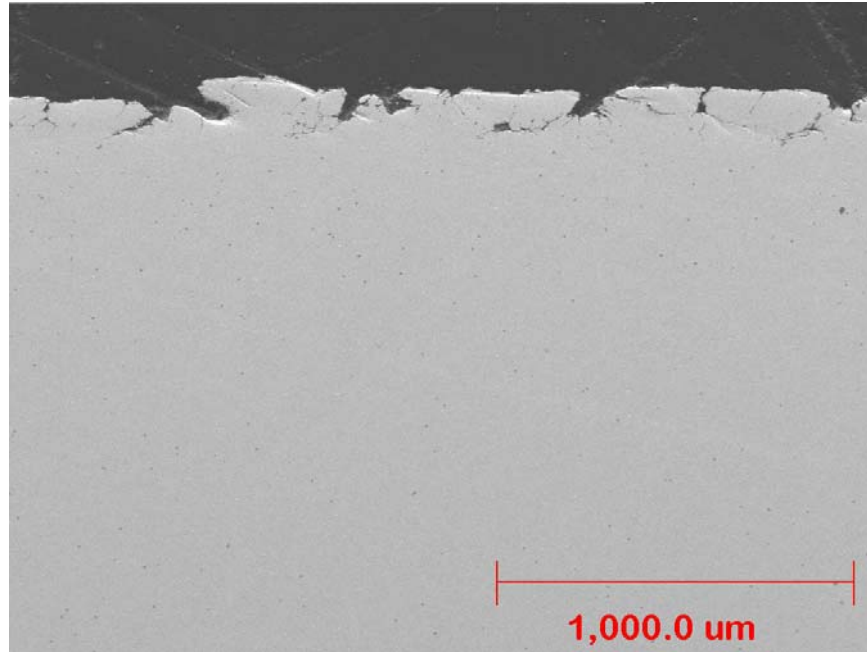
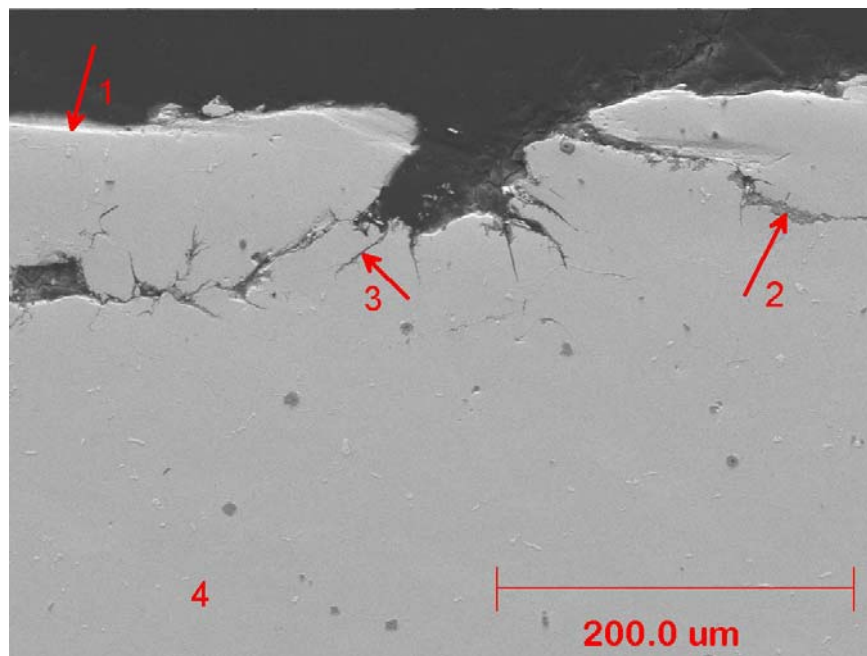
Figure I-12: Microstructure: Thermie

Metallographic examination of a Sample HH-II in Section C revealed evidence of significant grain boundary penetration at the external surface of the tube. It should also be noted that, for Section A, the metallographic examination focused on Sample H-I, instead of Sample HH-II, and that Sample HH-II has a much larger grain size than Sample H-I. It is not clear whether this difference in microstructure gave rise to the observed difference in mechanism.

Visual examination of the scale adjacent to the metal surface revealed the chalky-white appearance associated with alkali-iron-sulfates. Thus, the required corrosive elements likely were available to test the performance limits of this alloy.

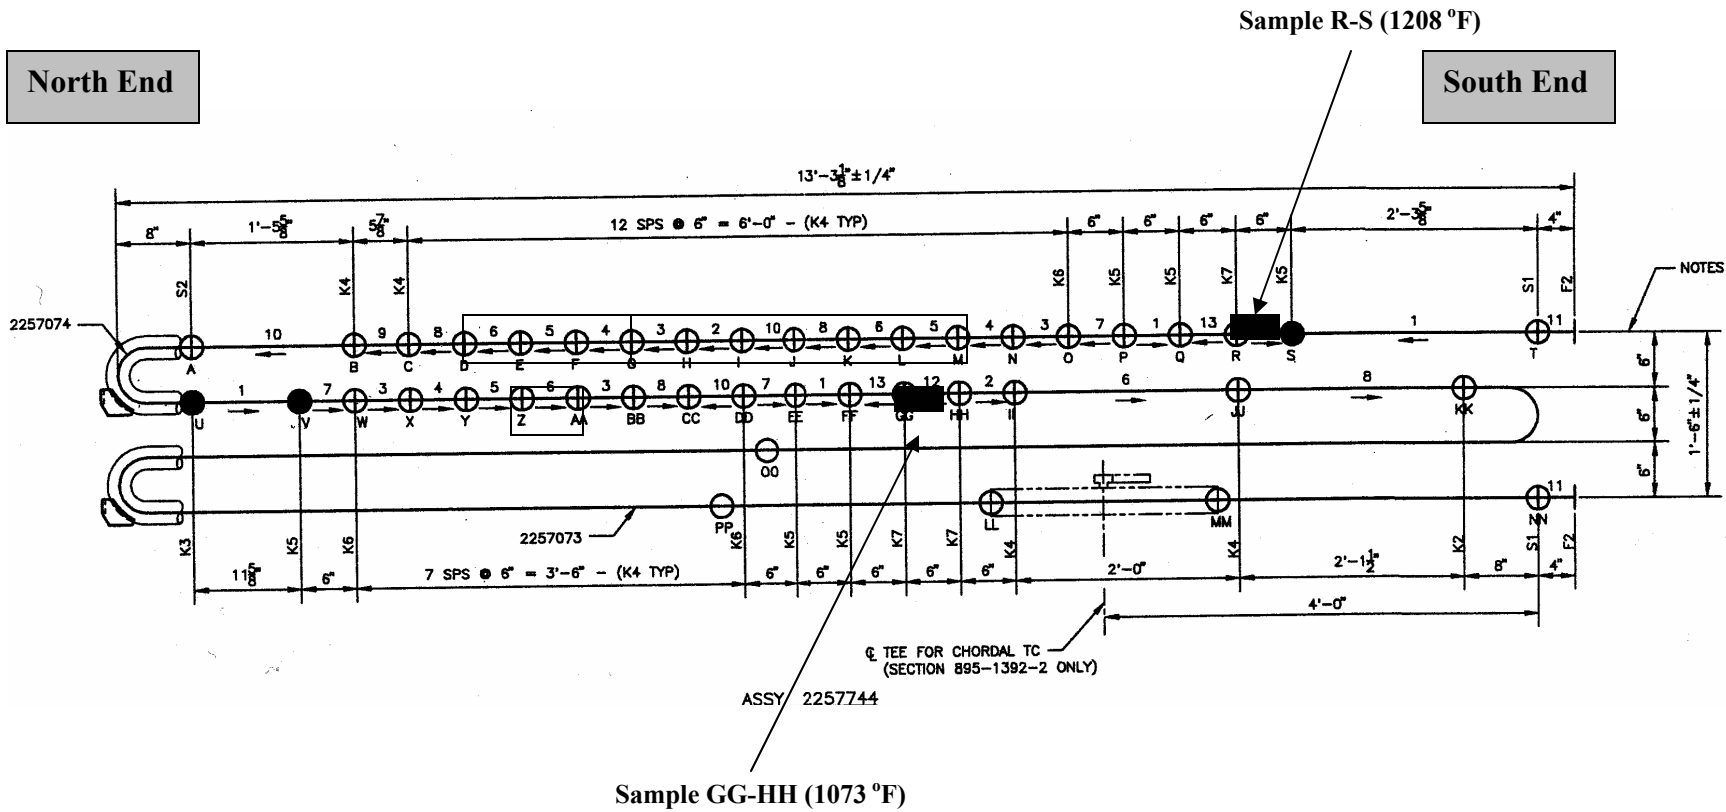
Figure J-1: Schematic Drawing Showing Position of IN52 Weld Overlay Tube Samples Within Test Section C

1. Drawing shown in same relative orientation as per the actual installation.
2. This group of tube samples was removed from service in November 2001 - highlighted in red.
3. This group of tube samples was removed from service in June 2002 - highlighted in yellow.

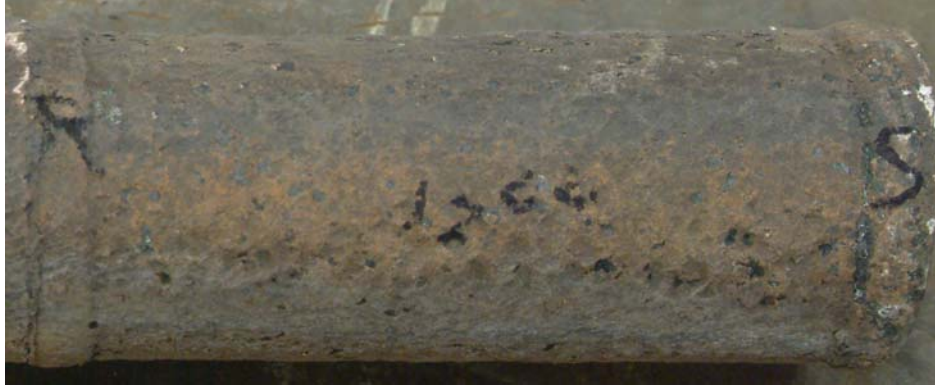
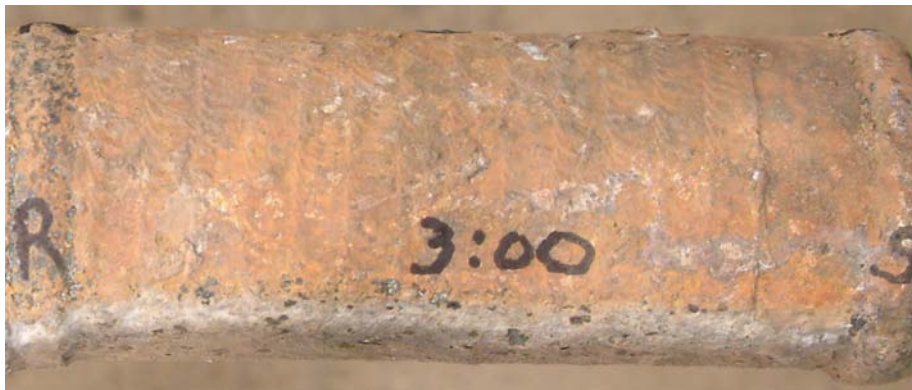
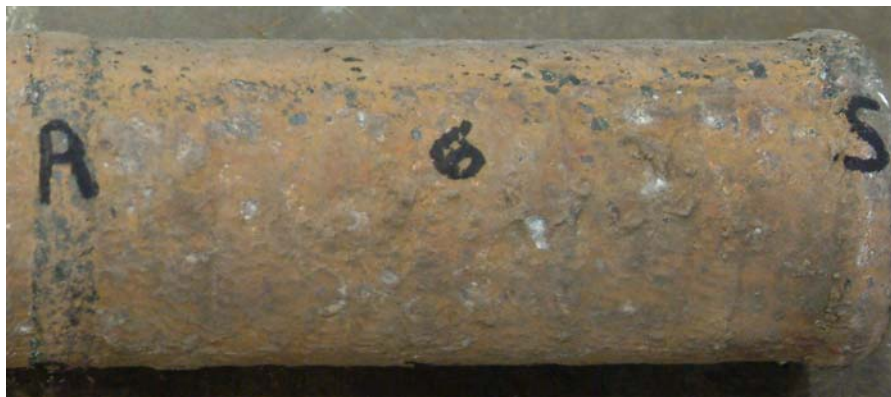
Figure J-4: As-Received Appearance of Sample R-S (IN52 Weld Overlay)

(Average surface metal temperature: 1208 °F)

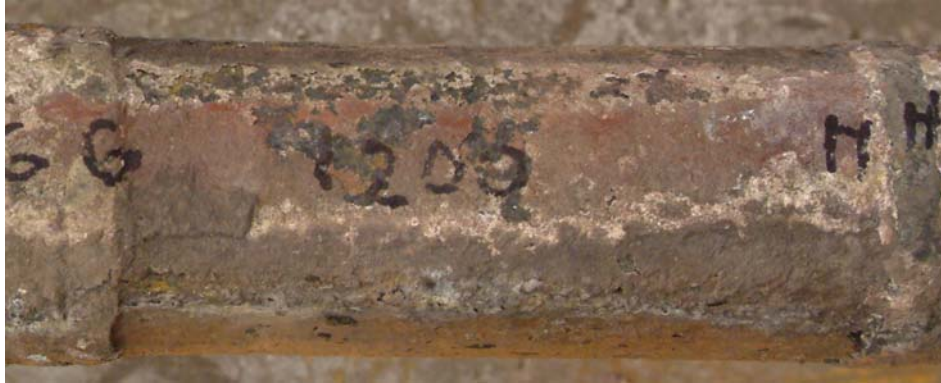
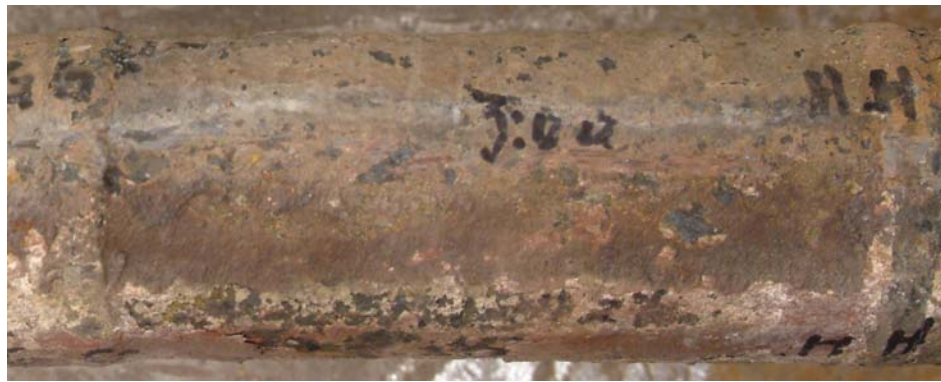
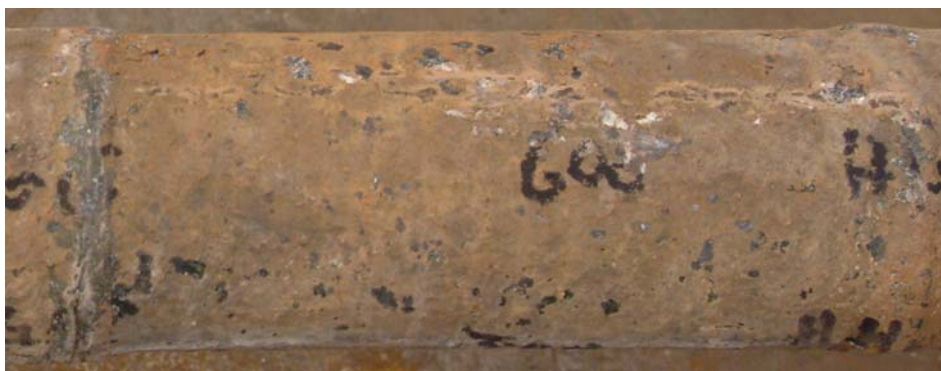
Figure J-5: As-Received Appearance of Sample GG-HH (IN52 Weld Overlay)

(Average surface metal temperature: 1073 °F)

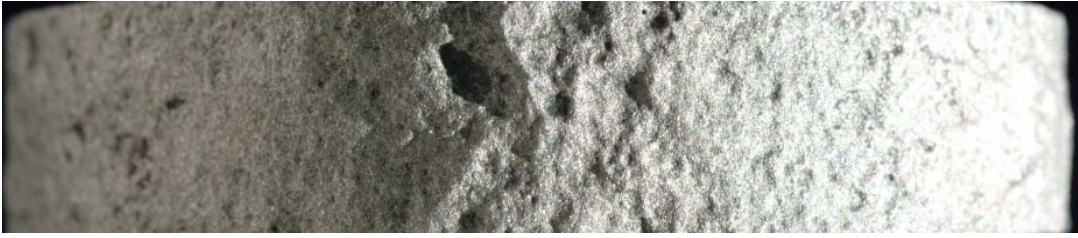
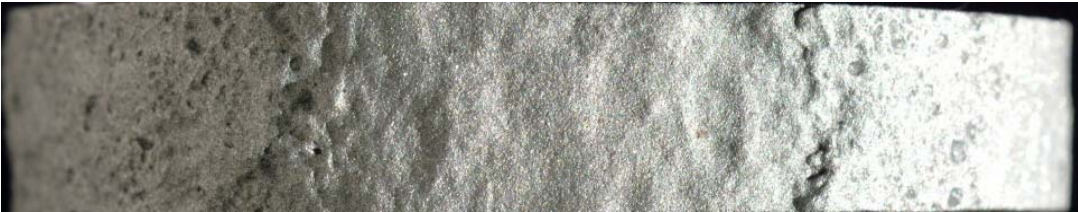
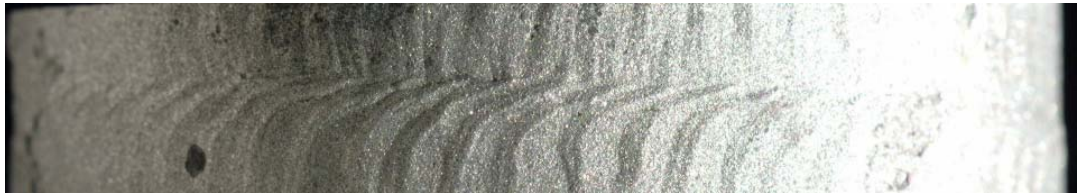
Figure J-6: OD Surface Appearance After Grit Blast

The IN52 Weld Overlay experienced an intermediate rate of metal loss (48 mils per year to 63 mils per year*) in the service environment of Test Section C. The 80 mil thick IN 52 weld overlay was found to have been completely breached during their 2.38 years of exposure. Now that the overlay has been breached, the performance of this material will be based on the scaling resistance of the underlying 800H base metal. As this point, slightly more than half of the original wall thickness remains for Sample GG-HH which experienced a lower corrosion rate than Sample R-S which experienced a higher average surface metal temperature (1208 F vs 1073 F). This increased rate of metal loss at lower temperatures is consistent with the results found for the other high-nickel, high-chromium alloys provided by Special Metals Corporation.

12 O'Clock
(N/A mils lost)

3 O'Clock
(91 mils lost)

6 O'Clock
(3 mils lost)

Material: IN52 Weld Overlay
Sample: R-S

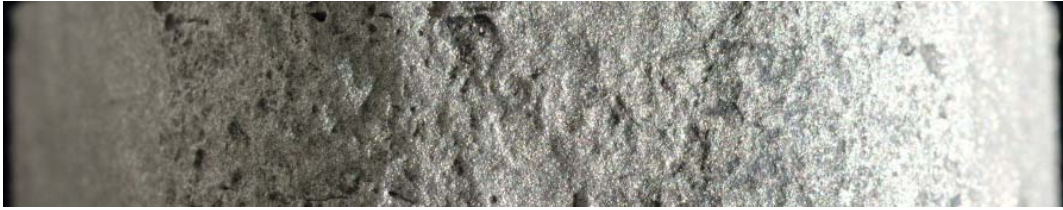
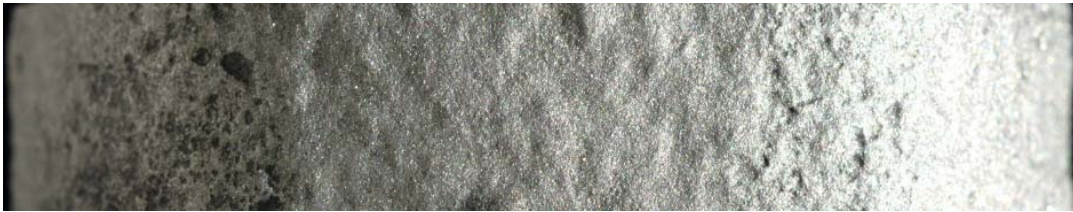
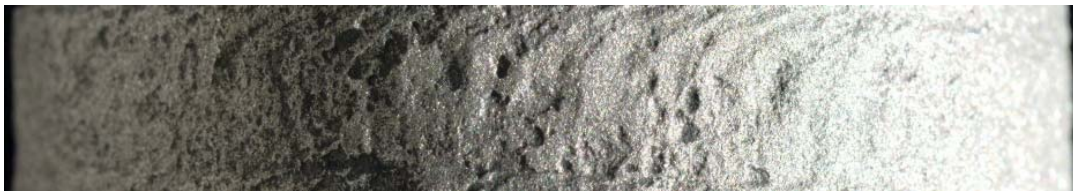
Figure J-7: OD Surface Appearance After Grit Blast

12 O’Clock
(N/A mils lost)

3 O’Clock
(106 mils lost)

6 O’Clock
(0 mils lost)

Material: IN52 Weld Overlay
Sample: GG-HH

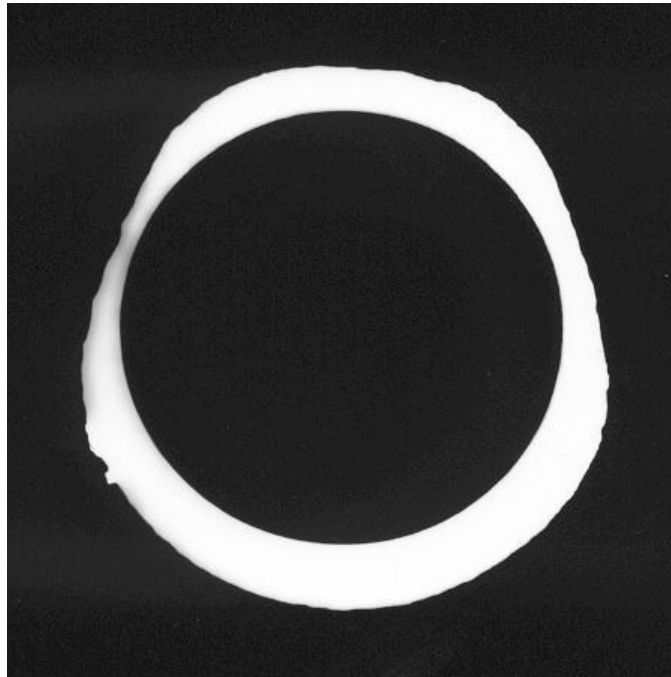
Figure J-9: Silhouette and Wall Thickness Measurements for Sample GG-HH

Sample Location: GG-HH
Maximum Rate: 63 mils/yr
Maximum Loss Orientation: Approx. 10 o'clock
Average Surface Metal Temperature: 1073 °F

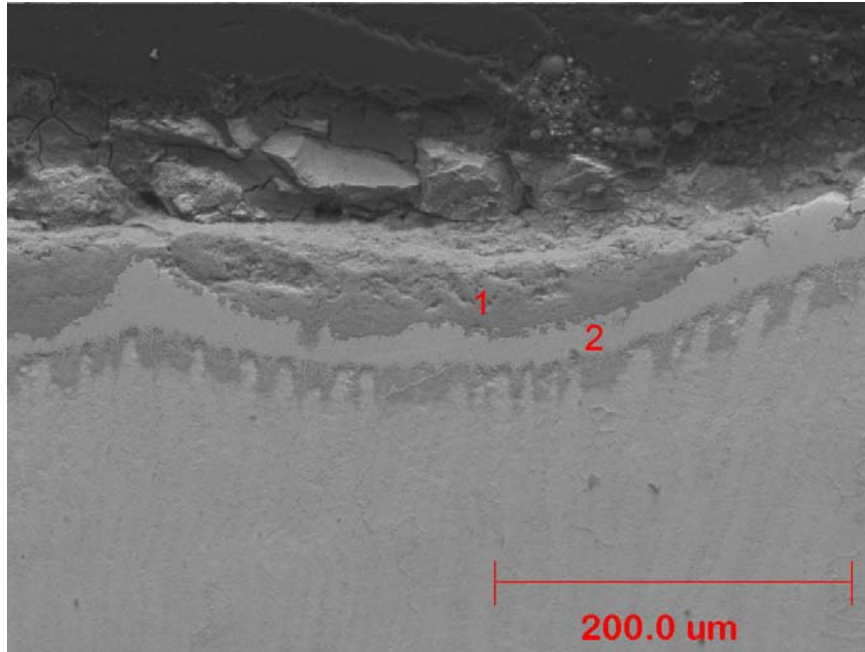
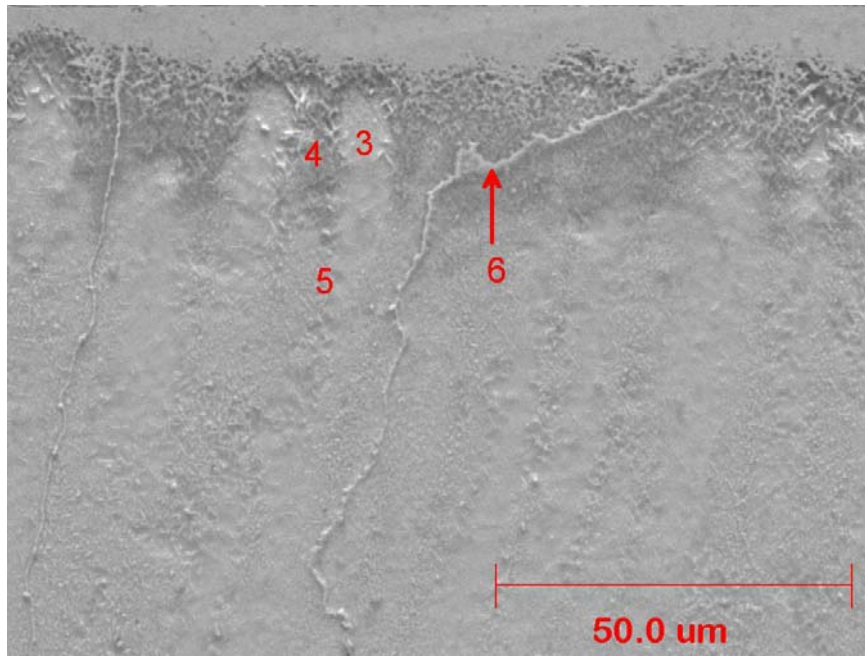
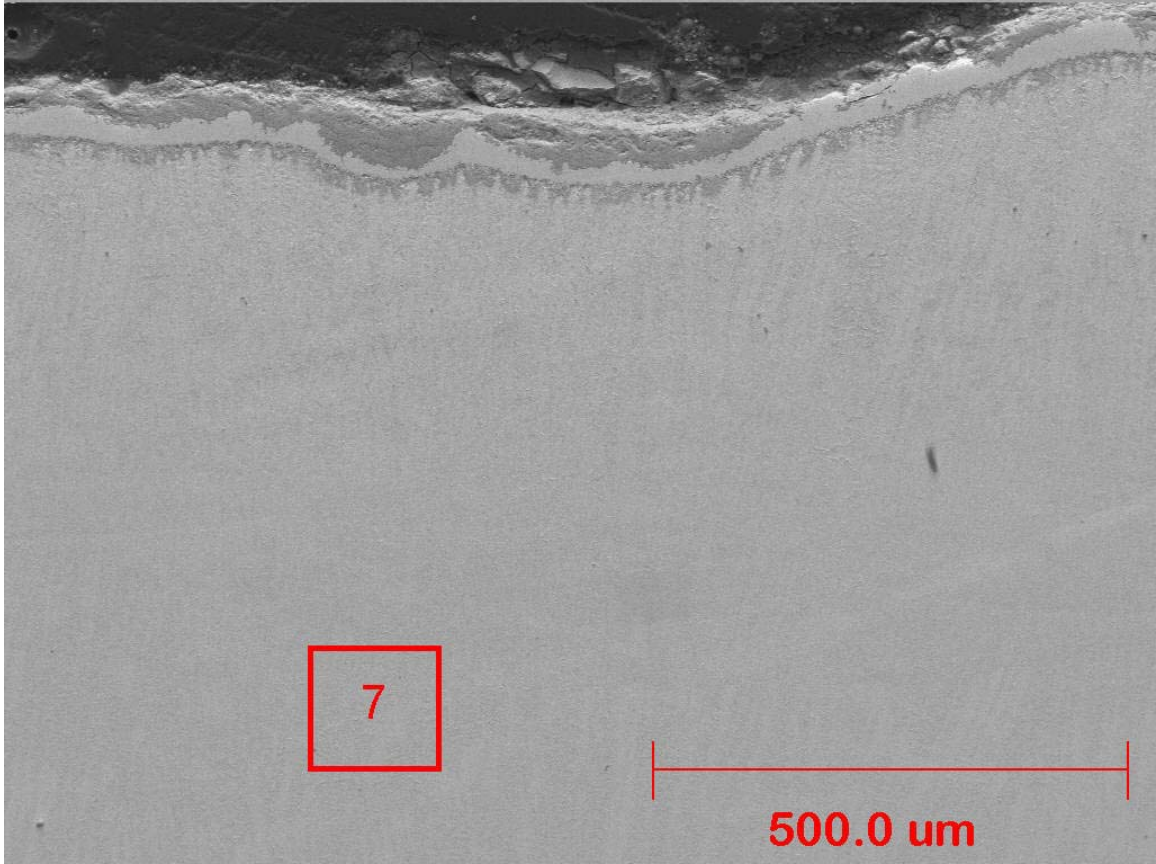
Figure J-12 Microstructure: IN52 Weld Overlay

No significant amount of deposit was found on these samples. Analysis of the scale showed a high level of sulfur confirming the presence of a potentially aggressive environment. The loss of wall thickness in these samples further bears this out.

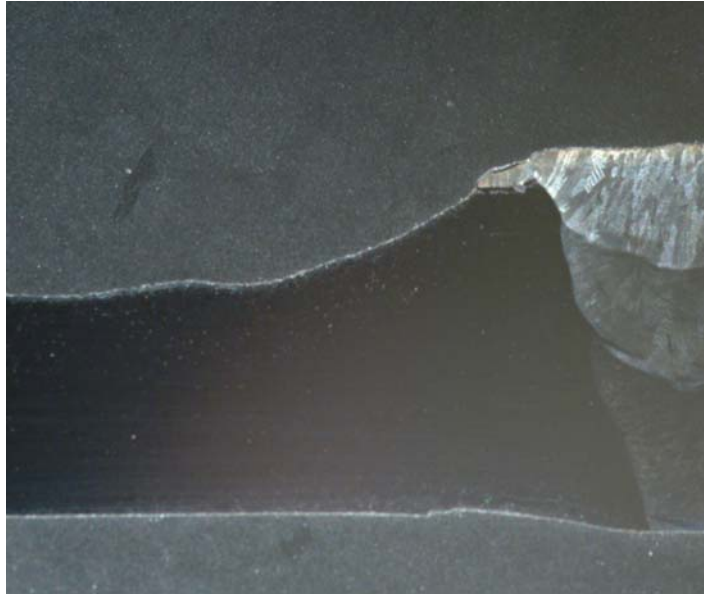
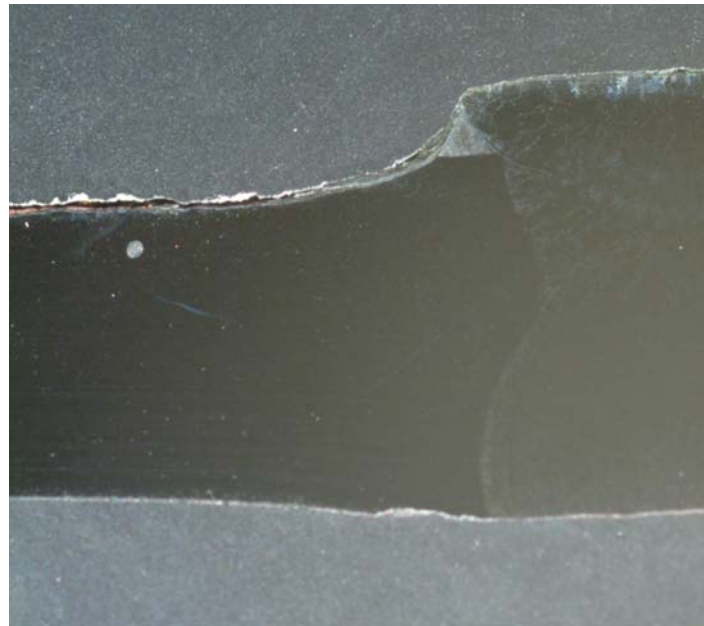
Figure J-14: Longitudinal Cross-Sections: IN52 Weld Overlay Adjacent to Welds

(a) IN52 Weld Overlay Adjacent to Weld "R"

(b) IN52 Weld Overlay Adjacent to Weld "HH"

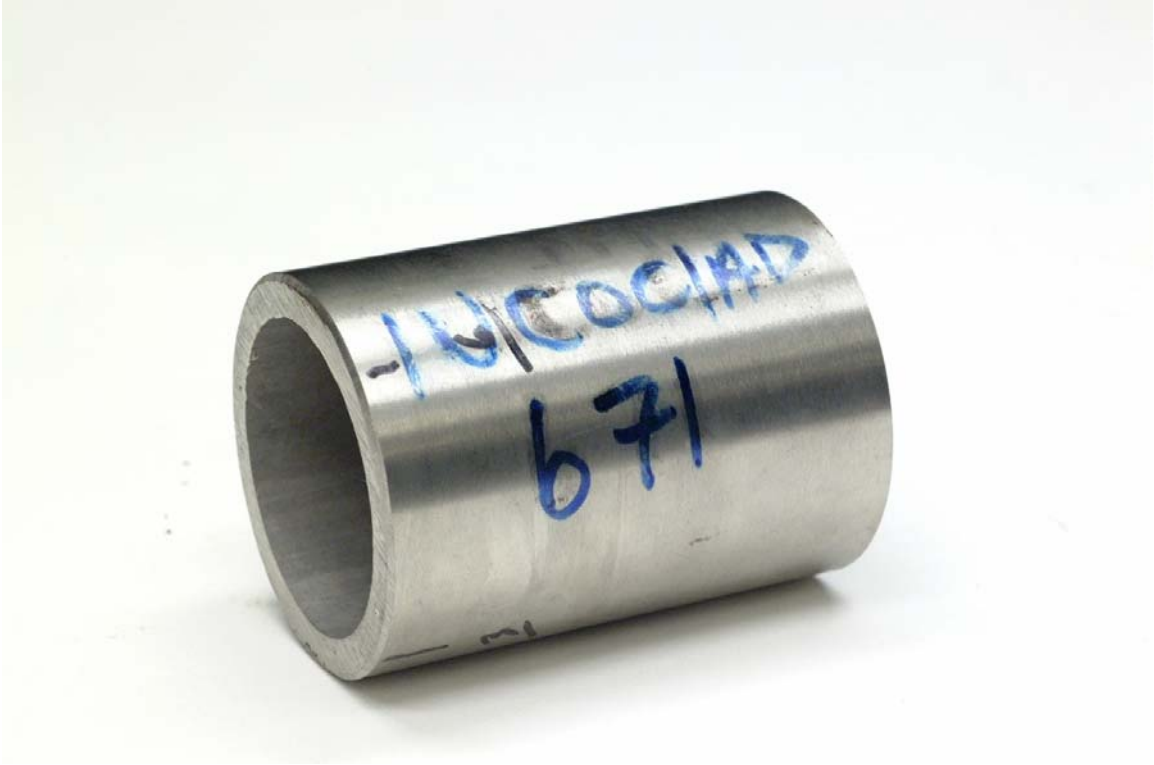
Figure K-3: Appearance of Inco 671 Tube Sample Prior to Service

As-Received Appearance	<ul style="list-style-type: none">• Figure K-3 shows the typical appearance of the Incoclad 671 samples as they were received from SMC. This tube has a total wall thickness of about 260 mils, with a 75 mil thick outer layer of IN671 to provide corrosion resistance, and an inner supporting layer of 800H.• Figures K-4 through K-6 document the appearance of the external surface of the Incoclad 671 tube samples after they had been removed from service. Three views are provided for each tube: 12 o'clock (the view that faces on-coming gas flow), 3 o'clock (the view where the gas flow is tangent to the surface), and 6 o'clock (the view that shows the back-side of the tube relative to the gas flow direction..

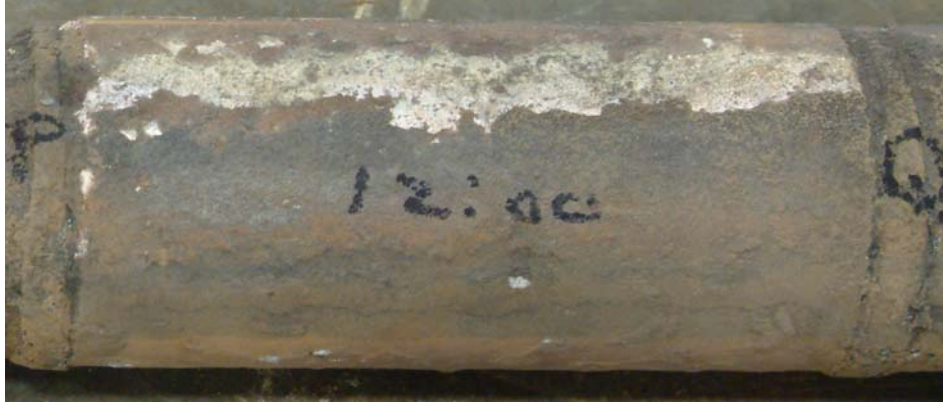
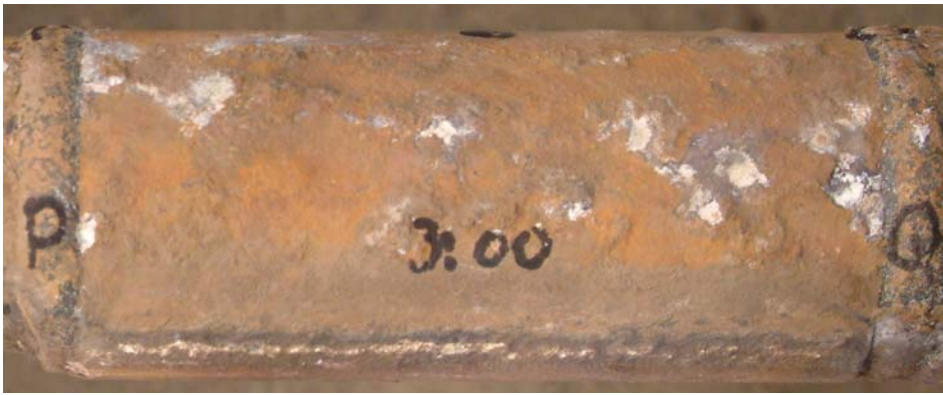
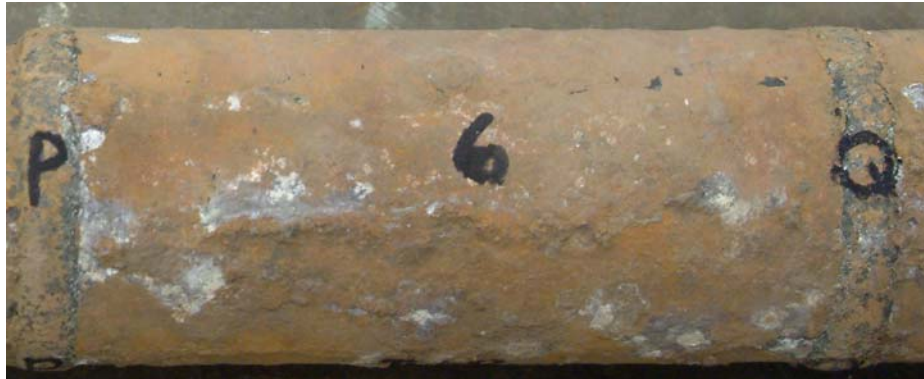
Figure K-4: As-Received Appearance of Sample P-Q (Incoclad 671)

(Average surface metal temperature: 1203 °F)

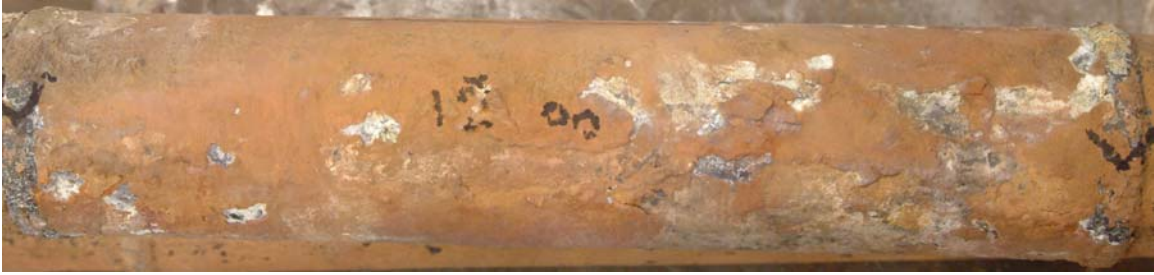
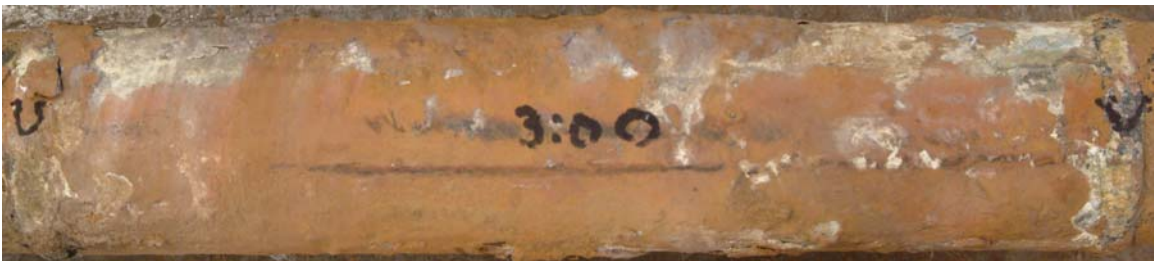
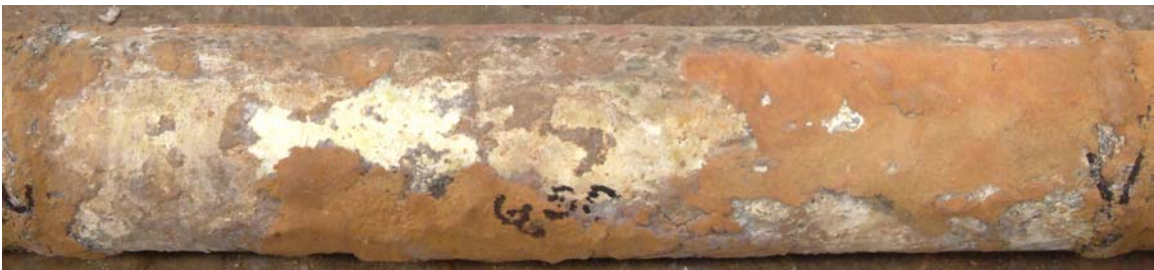
Figure K-5 As-Received Appearance of Sample U-V (Incoclad 671)

(Average surface metal temperature: 1121 °F)

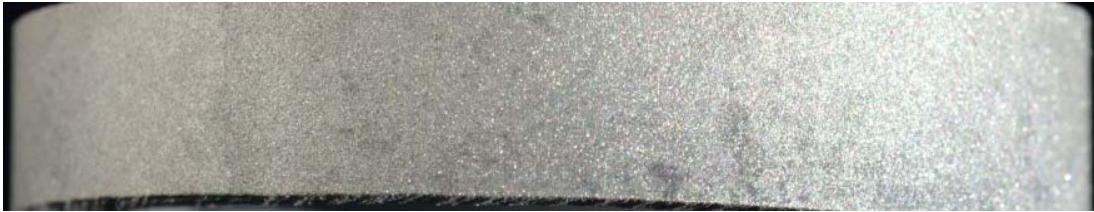
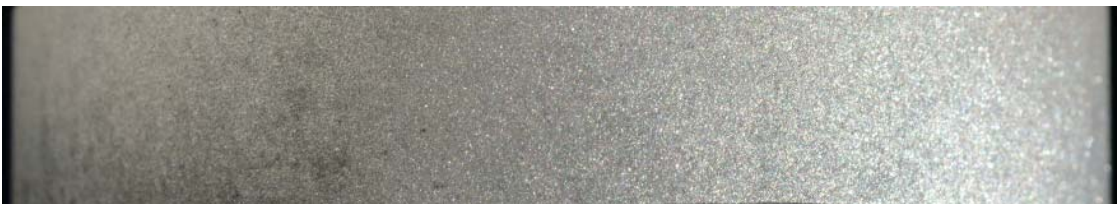
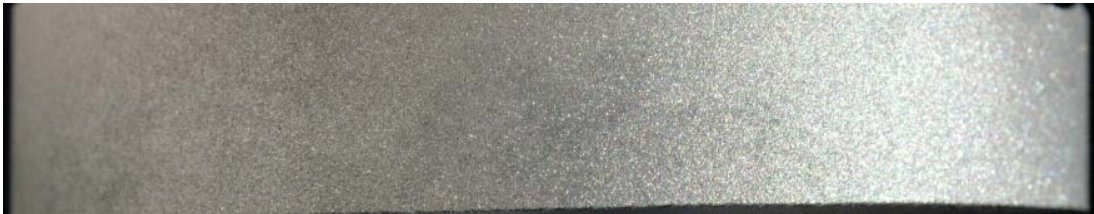
Figure K-7: OD Surface Appearance After Grit Blast

12 O'Clock
(0 mils lost)

3 O'Clock
(0 mils lost)

6 O'Clock
(0 mils lost)

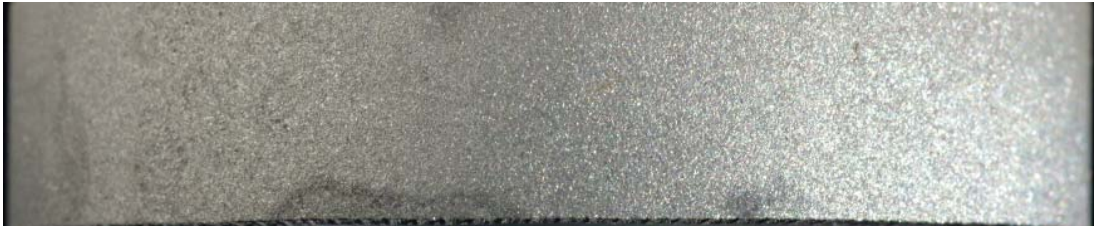
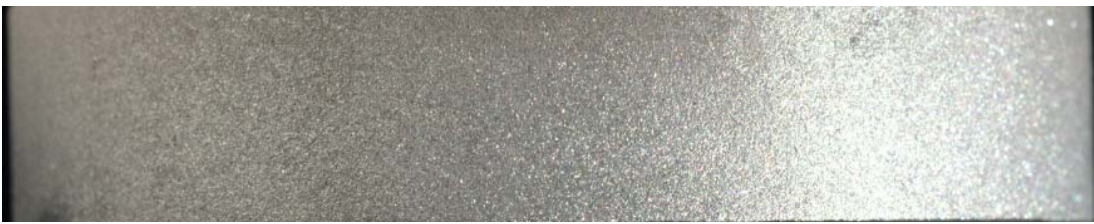
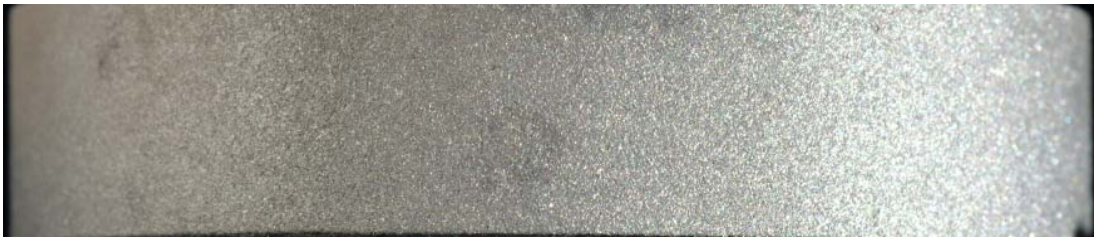
Figure K-8: OD Surface Appearance After Grit Blast

12 O'Clock
(3 mils lost)

3 O'Clock
(1 mils lost)

6 O'Clock
(0 mils lost)

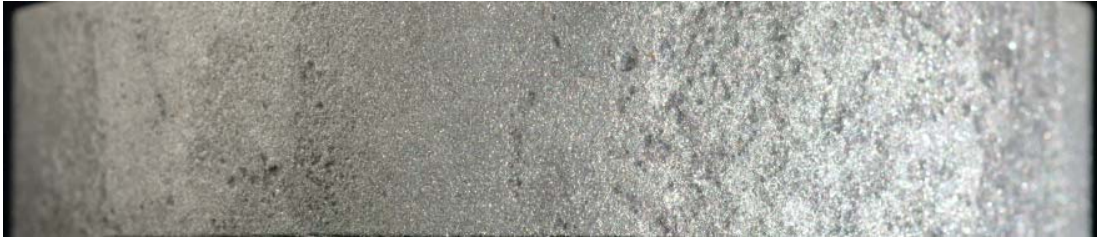
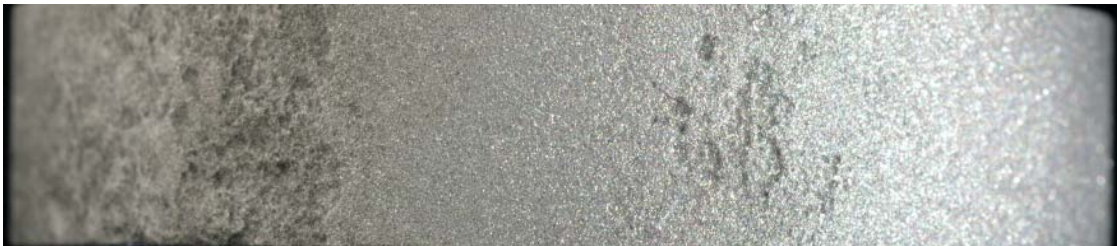
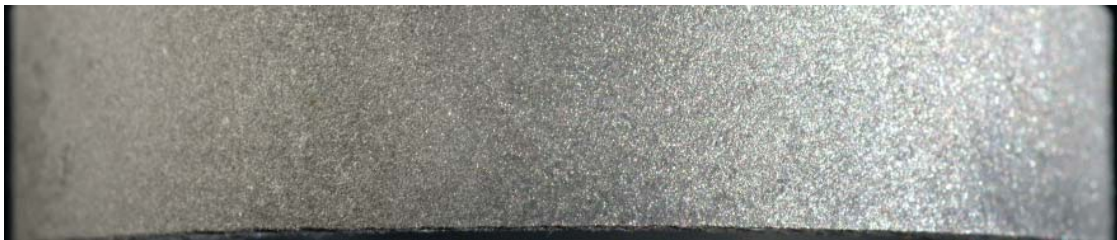
Figure K-9: OD Surface Appearance After Grit Blast

12 O'Clock
(4 mils lost)

3 O'Clock
(0 mils lost)

6 O'Clock
(0 mils lost)
