COAL ASH CORROSION RESISTANT MATERIALS TESTING

Topical Report: Removal of Section "C"

THE BABCOCK & WILCOX COMPANY

The “Coal Ash Corrosion Resistant Materials Testing Program” is being conducted by The Babcock & Wilcox Company (B&W), the U.S. Department of Energy (DOE) and the Ohio Coal Development Office (OCDO) at Reliant Energy’s Niles plant in Niles, Ohio to provide full-scale, in-situ testing of recently developed boiler superheater materials. Fireside corrosion is a key issue for improving efficiency of new coal fired power plants and improving service life in existing plants.

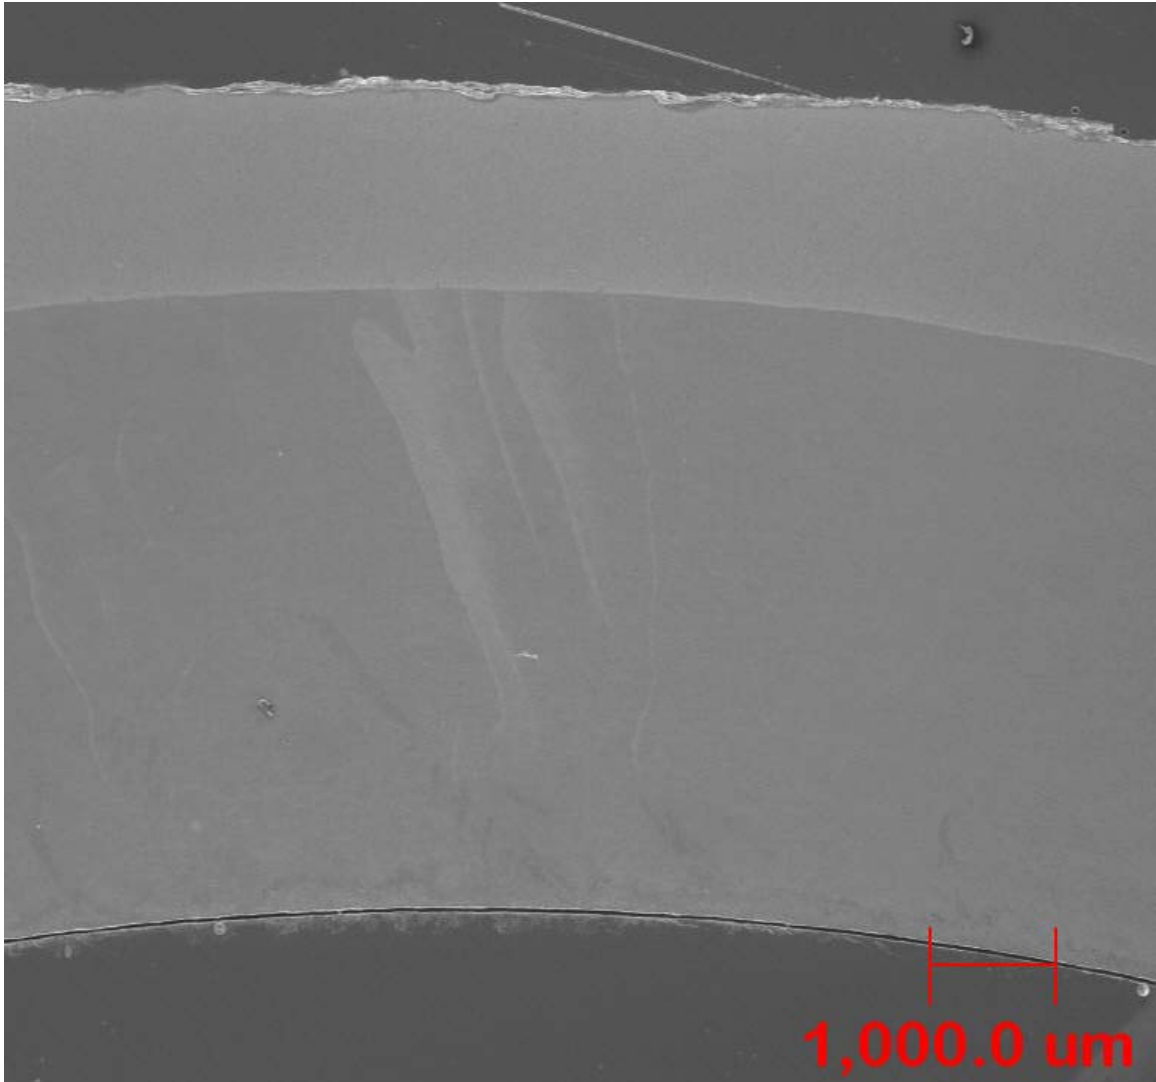
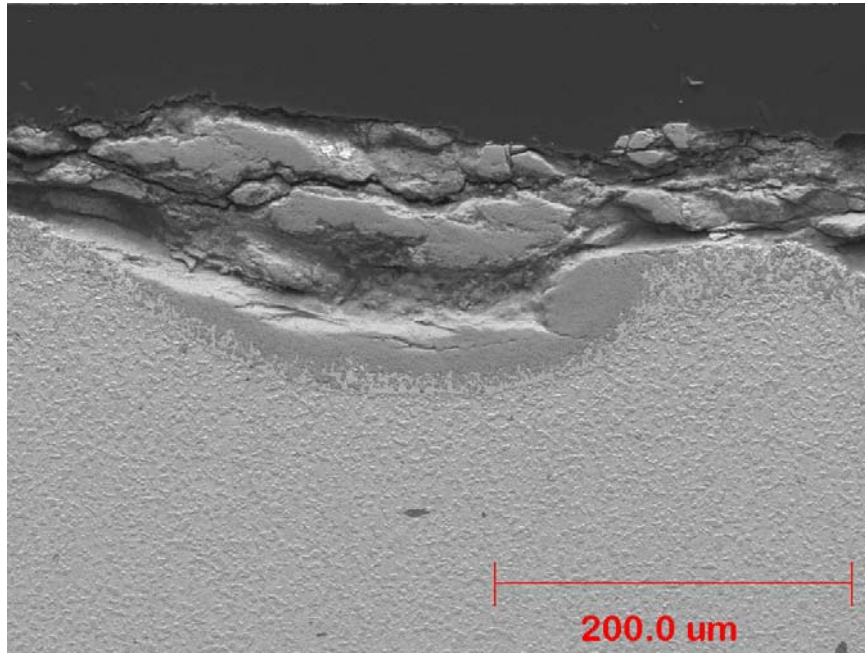
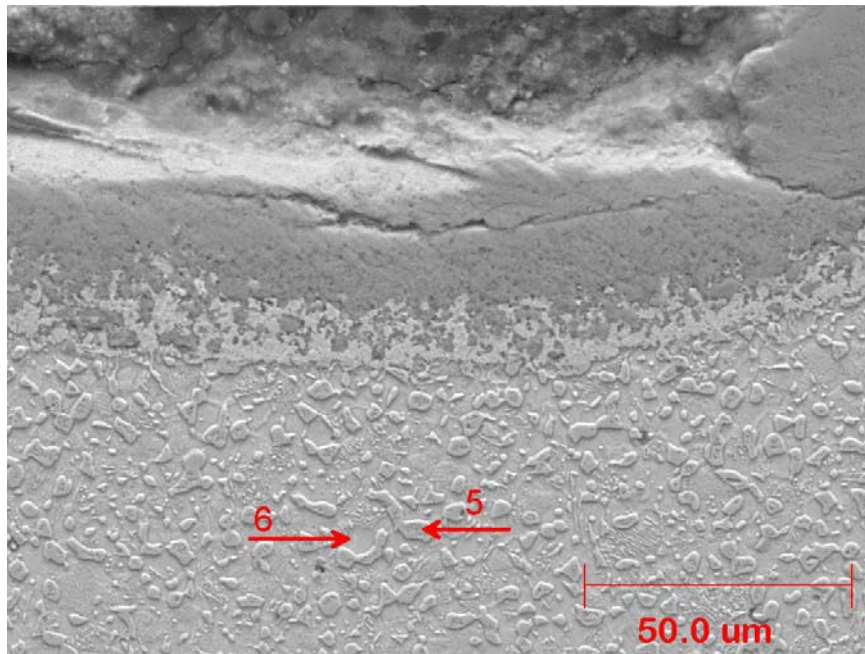
Figure K-15: Low Magnification Image Showing Cross-Section Through Thinnest Region of Sample EE-Ff (Incoclad 671)

Issue	Discussion
EDAX Analysis Results, Continued	<ul style="list-style-type: none"> • The table in Figure K-18 provides a summary of the EDS analyses of the numbered locations in Figure K-15b and d. Also shown in this table is a summary of the spectrographic analysis reported earlier, see Figure K-2. • Review of this table suggests the following: <ul style="list-style-type: none"> • <u>Areas 1: Bulk deposit/scale analysis</u> – Alkali metals and sulfur are present. The relatively high chromium content suggests that a significant percentage of the chromium-oxide scale was included in this analysis. The oxides of iron, aluminum, and titanium also are indicated. An iron oxide is likely, as are aluminum, silicon and titanium oxides. • <u>Area 2: Adherent scale</u>– This scale is predominantly a chromium-rich oxide with a significant amount of sulfur noted. • <u>Area 3: Diffusion zone - adjacent to the scale/metal interface</u> – This zone is depleted in chromium (21.7% vs roughly 50% in the bulk tube). • <u>Area 4: Bulk metal analysis</u> – This confirms that the sample was correctly identified as Incoclad 671. • <u>Area 5: Shallow etching region in cladding</u> – This constituent of the microstructure is rich in chromium (nominally 85% Cr / 15% Ni). • <u>Area 6: Deep etching region in cladding</u> – This constituent of the microstructure is rich in nickel (nominally 70% Ni / 30% Cr).

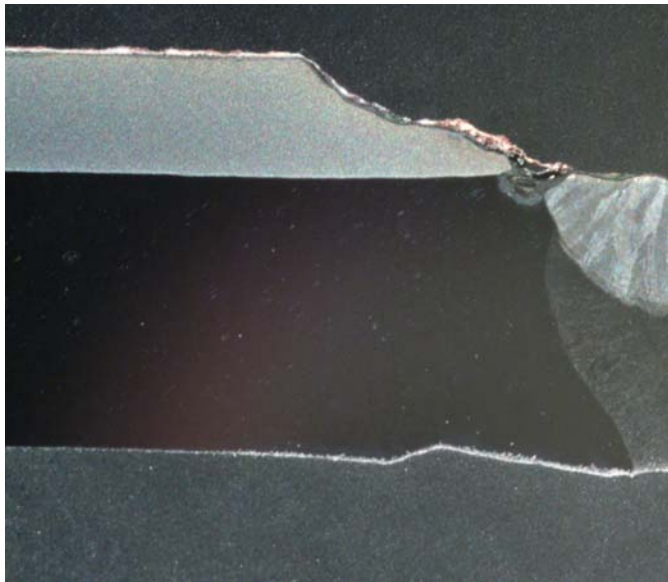
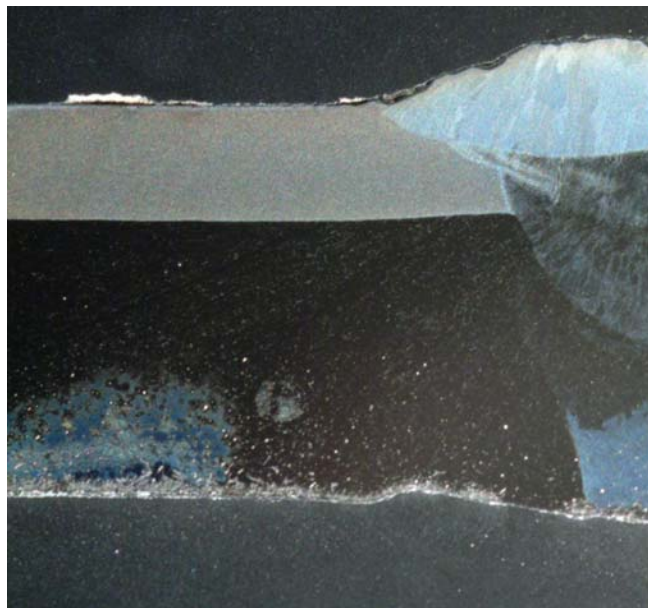
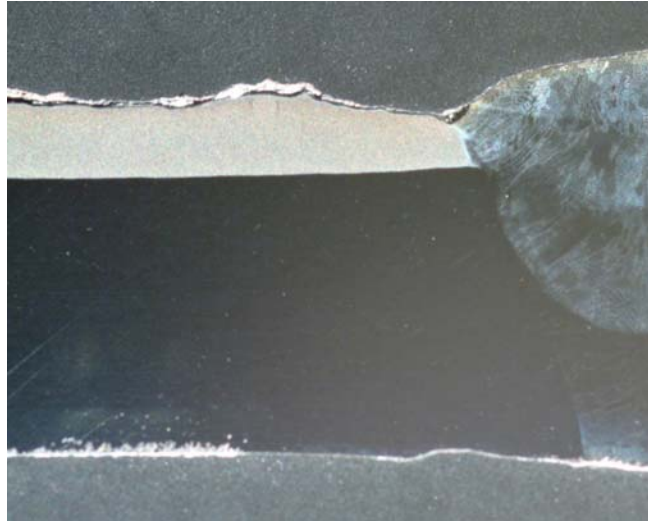
Figure K-17: Longitudinal Cross-Sections: Incoclad 671 Adjacent to Welds

Metallurgical Analysis – Weld Cross Section.	<ul style="list-style-type: none"> • Figure K-17 shows a longitudinal profile (at the 12 o’clock orientation) of the Incoclad 671 samples adjacent to the welds in Section C. The welds in question are those identified as welds “P”, “V”, and “FF”, see Figure L-1 for locations • Examination of Figure K-17a suggests that the Inconel 625 weld filler metal was less resistant to corrosion than the clad tube adjacent to the weld at location “P”. It is believed that dissolution of the Inconel 625 filler metal is the principle reason for the local loss of cross section at this weld. This suggests that a different filler metal may have been a better choice at this location.

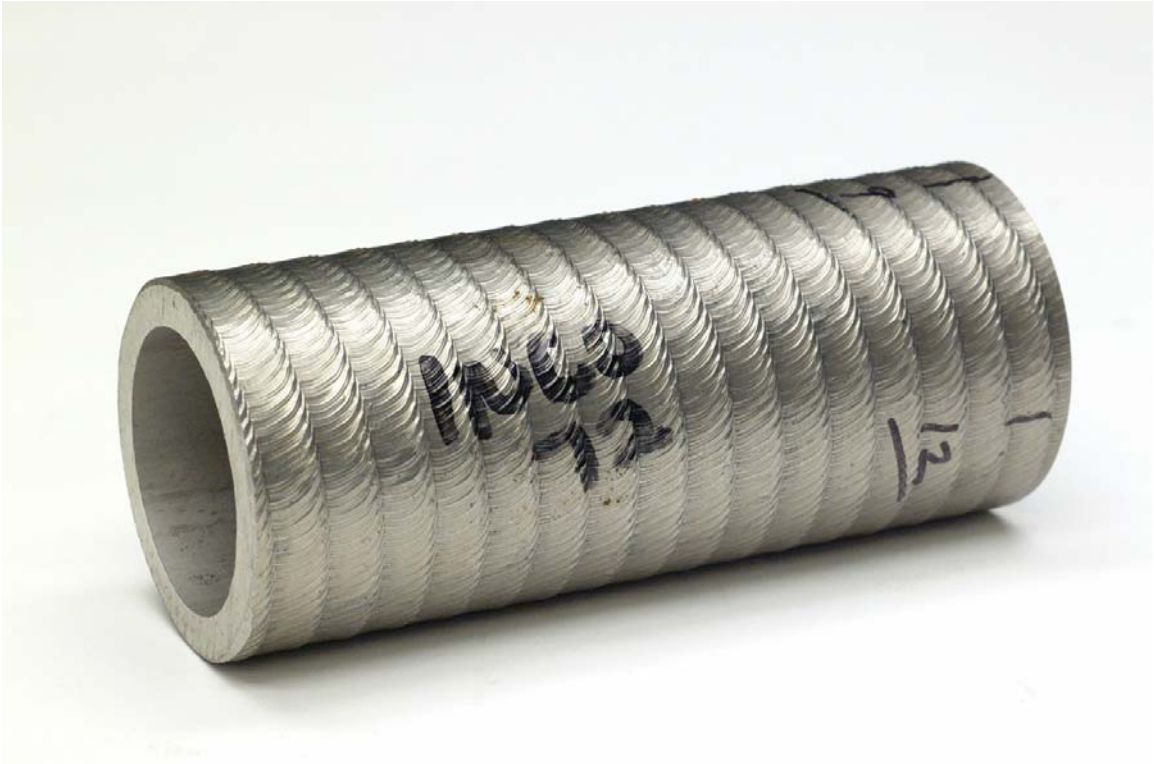
Figure L-3: Appearance of IN72 Weld Overlay Tube Sample Prior to Service

As-Received Appearance	<ul style="list-style-type: none">• Figure L-3 shows the appearance of the archive sample for IN72 Weld Overlay material. This photograph documents the condition of the tube sample as it was delivered from SMC. The weld bead surface profile is clearly visible in this view. The cladding thickness was measured to be approximately 80 mils. Thus, it comprised about 27% of the total wall thickness of 292 mils.

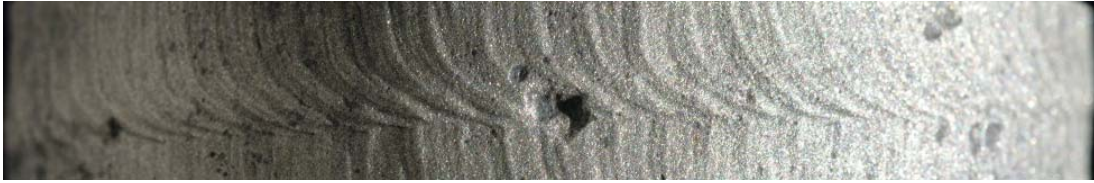
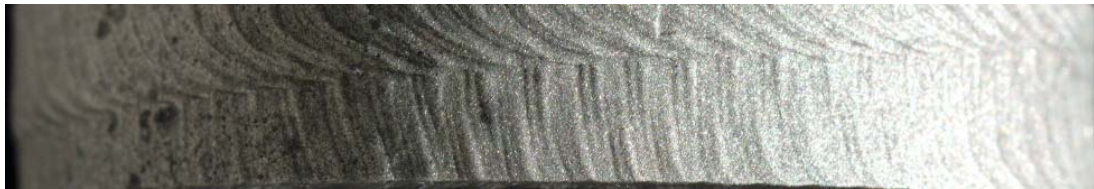
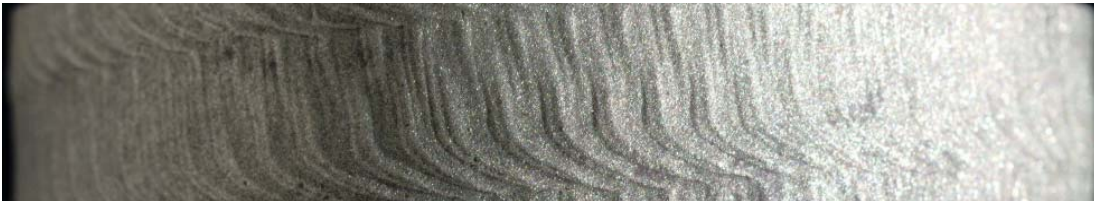
Figure L-5 As-Received Appearance of Sample FF-GG (IN72 Weld Overlay)

(Average surface metal temperature: 1079°F)

12 O'Clock
(N/A mils lost)

3 O'Clock
(0 mils lost)

6 O'Clock
(0 mils lost)

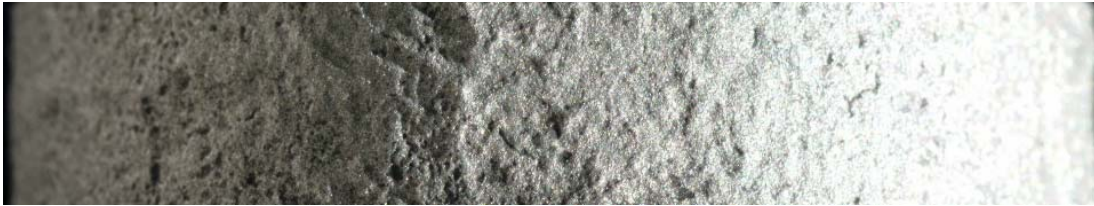
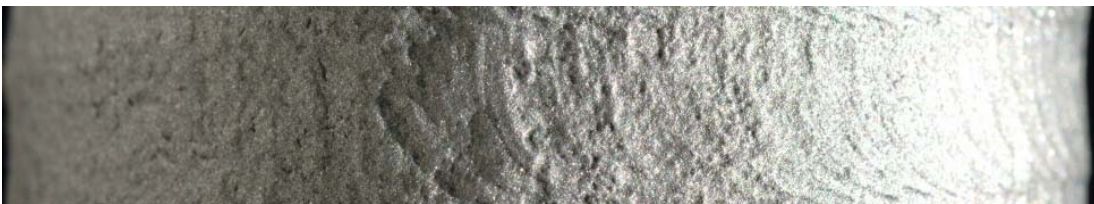
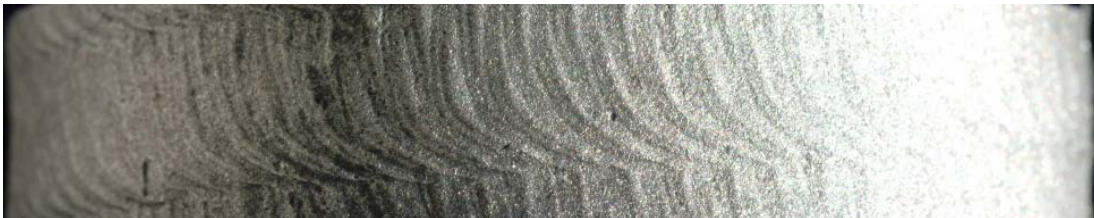
Figure L-6: OD Surface Appearance After Grit Blast

Grit-Blasted Surface Appearance	<ul style="list-style-type: none">• Figures L-6 and L-7 show the appearance of the external surface of the IN 72 Weld Overlay tube samples after grit-blasting to remove deposit and scale. The 12 o'clock and 3 o'clock positions for Sample FF-GG show the appearance of general wastage due to fireside corrosion.• Scattered pitting is in evidence at the 12 and 3 o'clock positions for Sample Q-R.
Wall Thickness Loss Determined	<ul style="list-style-type: none">• Tube cross-sections were prepared to allow for measurement of wall thickness to determine metal loss due to exposure. These are shown in silhouette in Figures L-8 and L-9.• The same relative "o'clock" positions were maintained as discussed earlier. Measurements were taken at eight evenly spaced locations about the tube circumference. These were then compared with measurements taken at these same locations prior to exposure.• The before and after measurements were documented in the table that accompanies each figure. These form the basis for the "delta" calculation to determine the amount of wall thickness lost. Note that in some cases, the delta is negative (particularly around the 6 o'clock position). This is believed due to wall thickness variability and difficulty in locating the exact location of the "before" measurement.• Sample FF-GG experienced the maximum wall thickness reduction due to corrosion of 14 mils per year. As was mentioned in the overview section of this report, an additional 8 mils per year would need to be included if one were to take into account weld cracking that intersects the external surface.

Material: IN72 Weld Overlay
Sample: Q-R

12 O'Clock
(N/A mils lost)

3 O'Clock
(8 mils lost)

6 O'Clock
(0 mils lost)

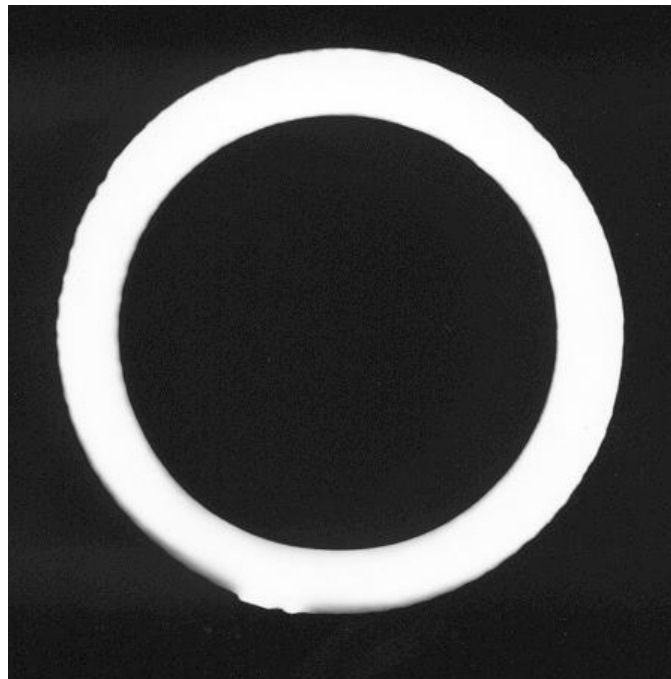
Sample Location: Q-R
Maximum Rate: 6 mils/yr
Maximum Loss Orientation: 7:30 o'clock
Average Surface Metal Temperature: 1208 °F

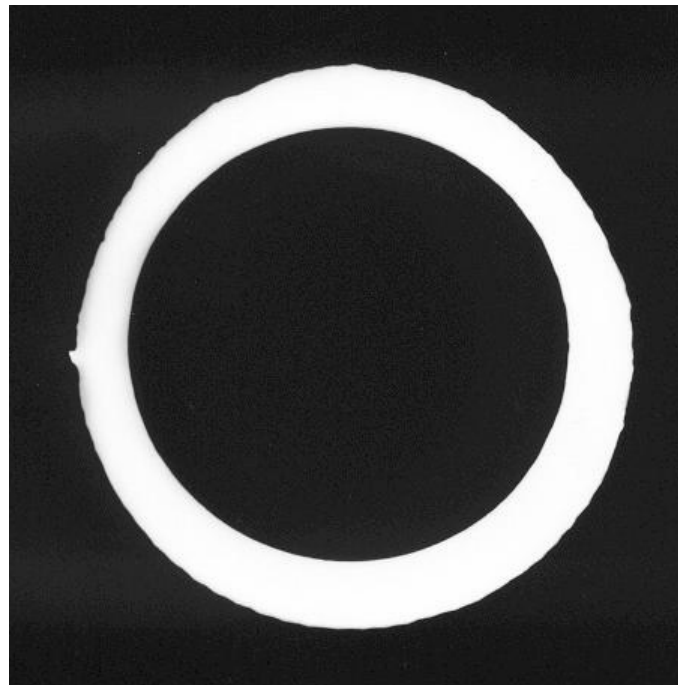
Figure L-9: Silhouette and Wall Thickness Measurements for Sample FF-GG

Sample Location: FF-GG
Maximum Rate: 14 mils/yr
Maximum Loss Orientation: Approx. 10 o'clock
Average Surface Metal Temperature: 1079°F

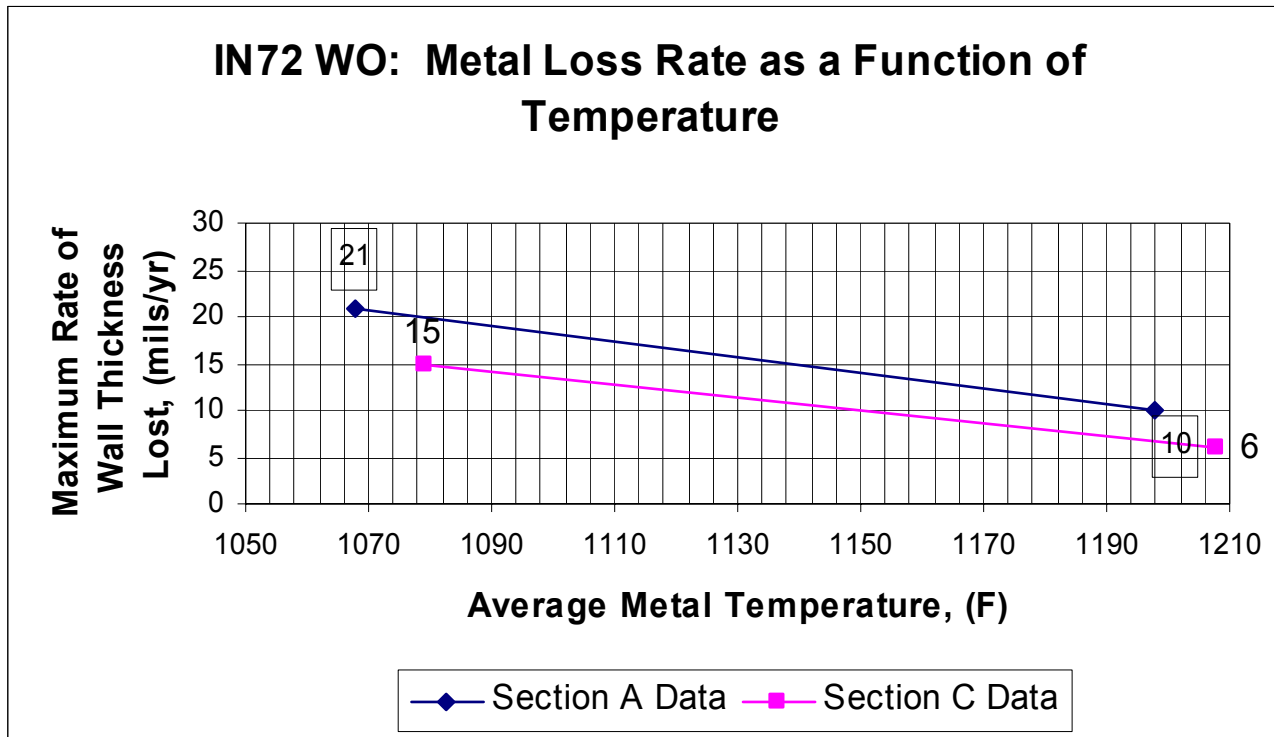
Figure L-10: Metal Loss Rate as a Function of Average Surface Metal Temperature

Issue	Discussion
Wall Thickness Loss Versus Average Metal Temperature	<ul style="list-style-type: none">• The chart in Figure L-10 plots the maximum wall thickness lost against the calculated average metal temperature for the two IN72 Weld Overlay samples in Section C. The data from the Section A samples also are plotted. <u>Note that these data do not take into account the additional wall thickness that would be lost due to internal weld cracking.</u>• The hot corrosion rate for the Section C samples was slightly lower than the rate for Section A samples, but both were found to be very low. Again it was noted that the rate was higher at the lower exposure temperature, as is consistent with the grit blasted surface images shown in Figures L-6 and L-7.
Wall Thickness Loss as a Function of Time and Location	<ul style="list-style-type: none">• The chart in Figure L-11 plots metal loss as a function of time for each sample location for both Sections A and C, with samples from Section C having experienced generally longer exposure times. <u>Note again that these data do not take into account the additional wall thickness that would be lost due to internal weld cracking.</u>• The chart shows a straight line fit to the maximum metal loss data points for Samples Q-R and FF-GG for both Sections A and C. Evaluation of the rate of metal loss data depicted in Figure L-10 suggests that a straight line fit would not likely be appropriate for these samples in that the rate of metal loss decreased from Section A to Section C for both samples under consideration.

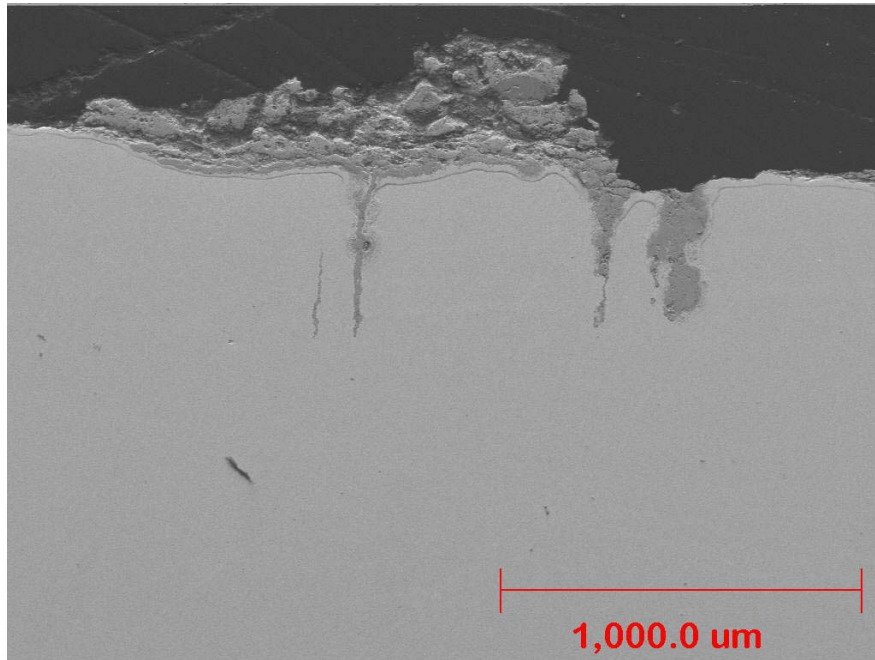
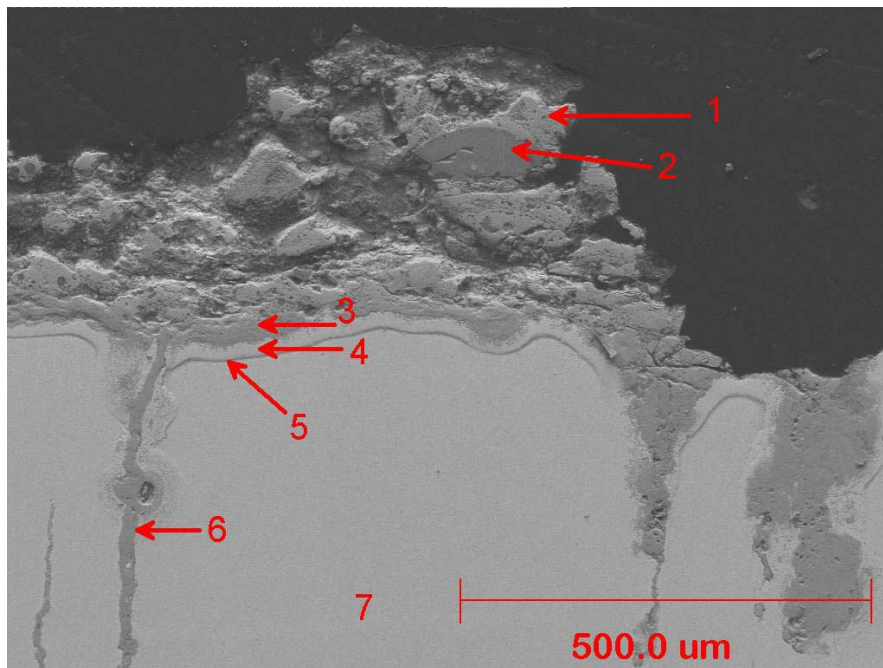
Figure L-12: Microstructure: IN72 Weld Overlay

Metallurgical Analysis – SEM	<ul style="list-style-type: none">• Sample FF-GG was selected for a detailed SEM/EDS assessment of the constituents and structure in the vicinity of the external and internal surfaces. This sample was selected for evaluation due to its higher rate of corrosion based on diameter measurements.• Figure L-12 shows back-scattered electron images (BEI) of the external surface of Sample FF-GG. This mode of imaging was chosen because it highlights differences in atomic weight.• Figures L-12a and b show BEI of the external scale/metal interface for Sample FF-GG. Also shown in this image are the scale-lined weld cracks that have intersected corrosion that is progressing inward from the external surface.• The numbers on Figure L-12b show the locations of EDS analyses to further characterize these regions. The results of these are provided in a later section of this report.• Figure L-12c provides the appearance of a shallow pit found on the surface of Sample FF-GG. These were found typically to be under a local build-up of deposit on the tube surface.

(a) External Scale/Metal Interface (BEI - Low Magnification)

(b) External Scale/Metal Interface (BEI - Intermediate Magnification)

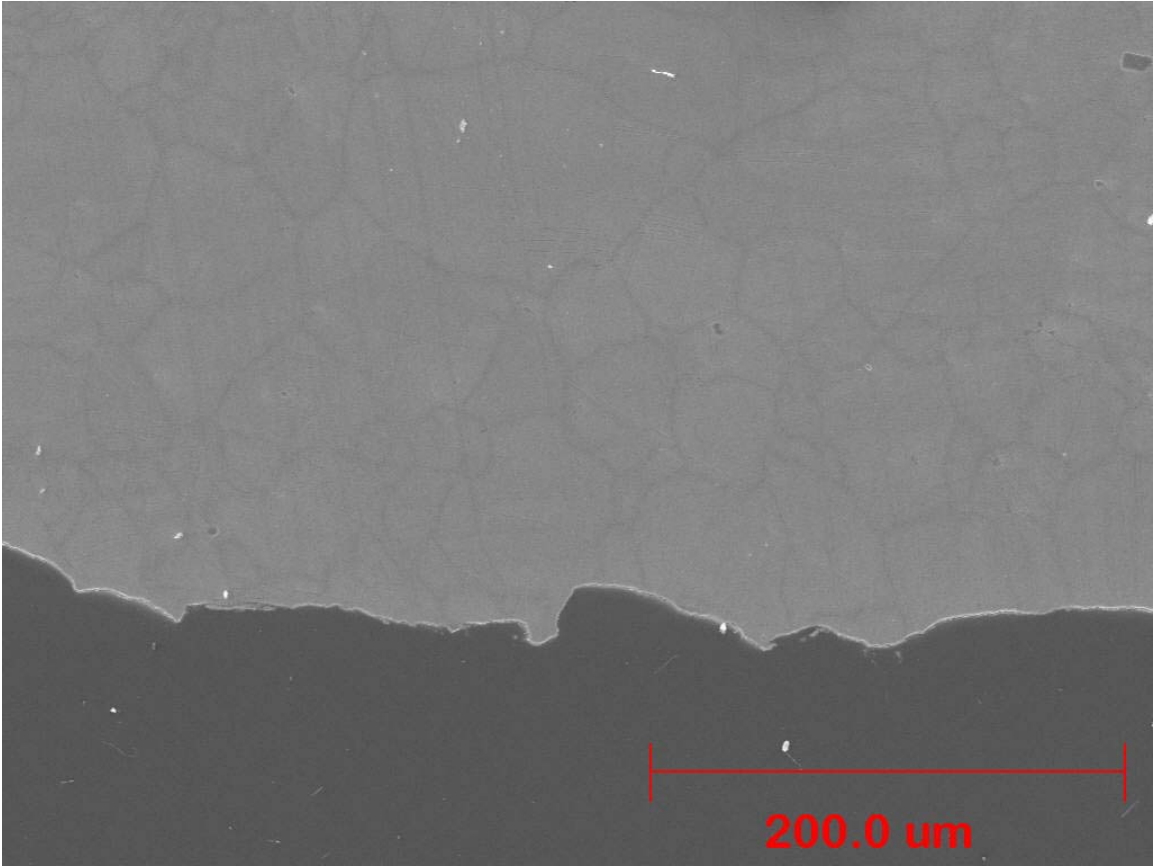
Figure L-13: Microstructure: IN72 Weld Overlay

Internal Surface Appearance

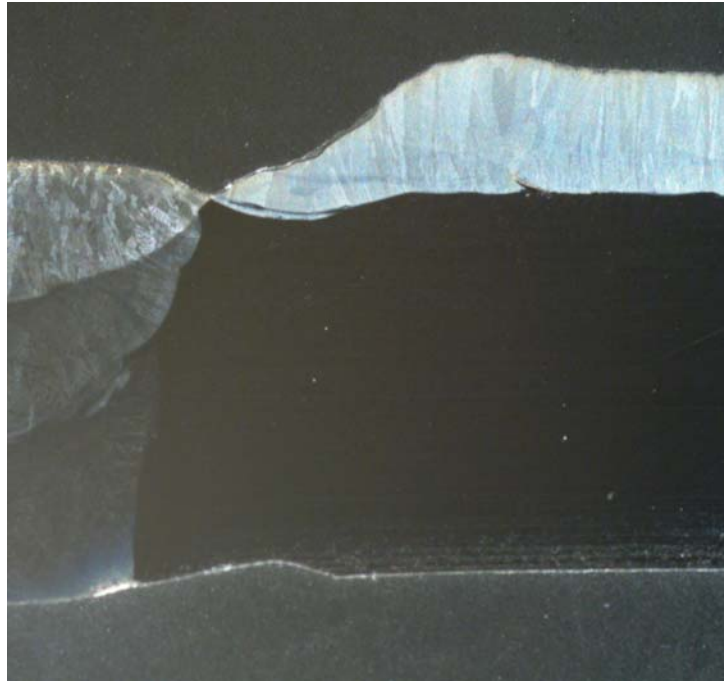
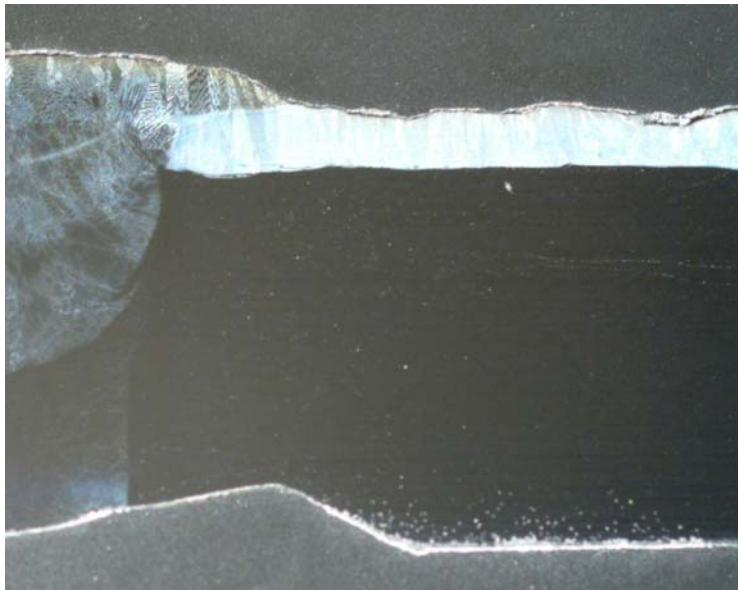
Figure L-14: Longitudinal Cross-Sections: IN72 Weld Overlay Adjacent to Welds

Metallurgical Analysis – Weld Cross Section.	<ul style="list-style-type: none"> • Figure L-14 shows a longitudinal profile (at the 12 o’clock orientation) of the IN72 Weld Overlay samples adjacent to the welds in Section C. The welds in question are those identified as welds “R” and “FF”, see Figure L-1 for locations • Evaluation of the images in Figure L-14 suggests that the Inconel 625 weld filler metal was less resistant to corrosion than the adjacent IN72 weld overlay. It is believed that dissolution of the Inconel 625 filler metal is the principle reason for the local loss of cross section at the weld at location “R”. This suggests that IN72 filler metal may have been a better choice at this location.

(a) IN72 Weld Overlay Adjacent to Weld "R"

(b) IN72 Weld Overlay Adjacent to Weld "FF"
