Electrical and Material Characterization of Field-aged 400 kV Silicone Rubber Composite Insulators

This paper presents the electrical and material characteristics of field-aged silicone rubber composite insulators, which have been deployed for 15 years on a 400 kV transmission line in a coastal region of the UK. There were no indications of reduced performance in service. Observations indicate non-uniform aging of the insulators on the different surfaces of the insulator sheds and core, along the insulator string length and in the different compass orientations. A uniquely large number of contact angle measurements, made on each of the insulators' different surfaces, confirm the visual aspect of non-uniform aging. Electrical investigations of the insulators have been performed in terms of leakage current analysis, ac flashover / withstand and switching-surge impulse flashover. A correlation is seen between the ac leakage current and the hydrophobicity measurements. Energy dispersive X-ray (EDX) and Fourier transform infrared spectroscopy (FTIR) analysis of the changes of the materials' surface chemistry is presented. The role of solar radiation and organic growth appears critical

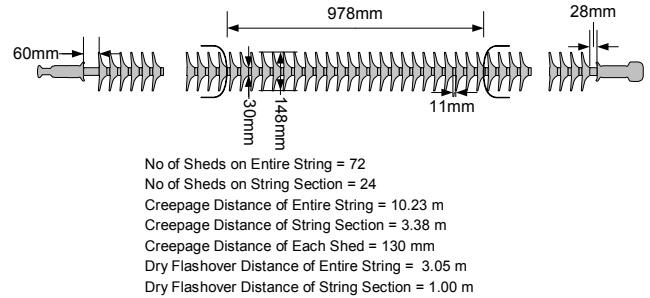
To correlate the deterioration in electrical performance with the variation in hydrophobicity along the insulator string, the strings were divided up into $\frac{1}{3}$ -sections (24 sheds) using domed electrodes, as illustrated in Figure 4. Three types of electrical tests were performed on the string sections: 250 μ s/2.5 ms impulse flashover investigations, ac withstand / flashover, and ac leakage current measurements. These tests were carried out under both dry and wet spray conditions to IEC 60060 [7]. The results for the field-aged insulator were compared to a similar new insulator string.

Figure 4. $\frac{1}{3}$ Insulator string sections used in electrical tests

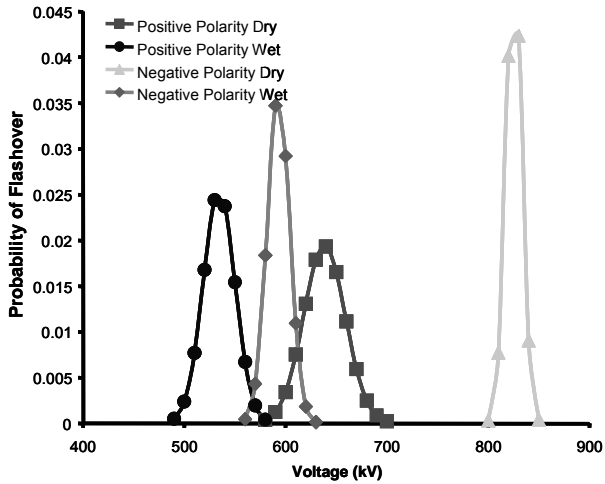
Table 1 shows the mean, the standard deviation (σ), and the largest and smallest values (max and min) measured of V_{50} . As would be expected, for both the new and the field-aged insulators, the dry negative polarity impulse level is much larger than the dry positive polarity impulse level. For new insulators, tested under wet conditions, despite there being a greater percentage decrease in the negative polarity impulse level than the positive polarity impulse level, this relationship still remains true. The probability distribution of the V_{50} impulse flashover levels for all the new insulator string sections is shown in Figure 5.

Figure 5. Statistical variation in impulse flashover levels for new insulators.

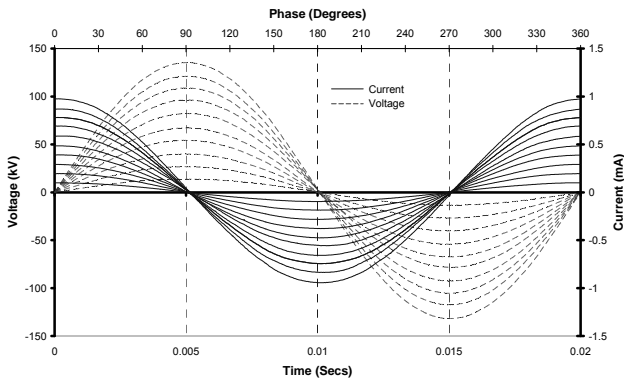
Figure 8. Current and voltage for a new insulator mid-1/3 section under wet test conditions.

Figure 8 shows current and voltage waveforms for a new insulator mid-1/3 string section tested under wet conditions. From this figure, it is apparent that the insulator still presents a capacitive load, with approximately a 90° phase shift between the current and voltage waveforms. Figures 9 –11 show the top, mid- and bottom-1/3 sections of a typical field-aged insulator string. From these figures, deterioration in the electrical performance of the insulators is evident, which results from a deterioration in hydrophobicity along the insulator string.
