Building Performance Evaluation – A design approach for refurbishment of a small traditional building in Scotland

J. A. Foster¹, S. A. Foster², T. R. Sharpe¹ and A. Poston¹.

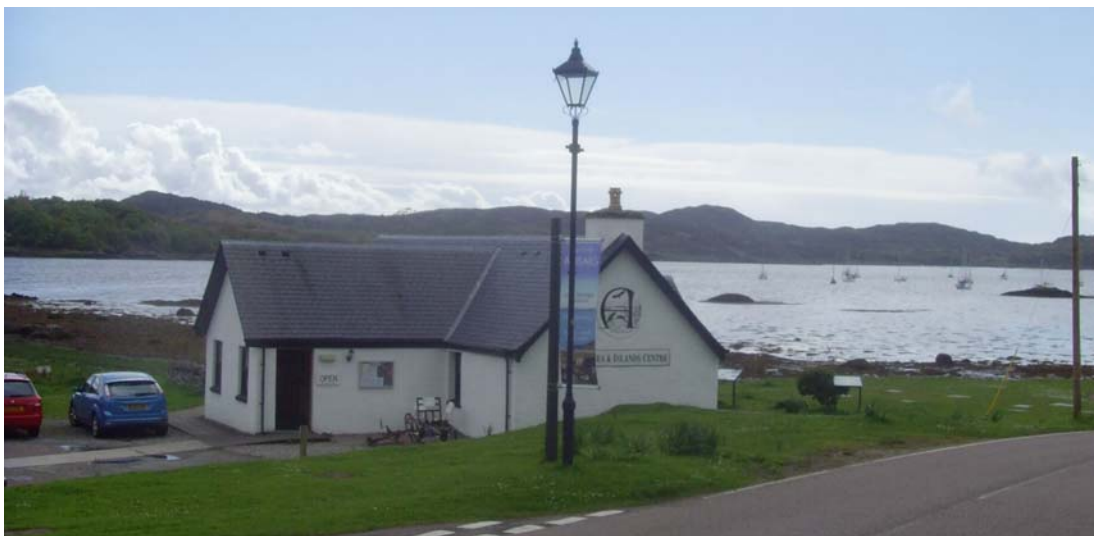
Figure 1. View of LSIC building, north facing entrance and reception and north gable wall of exhibition area.

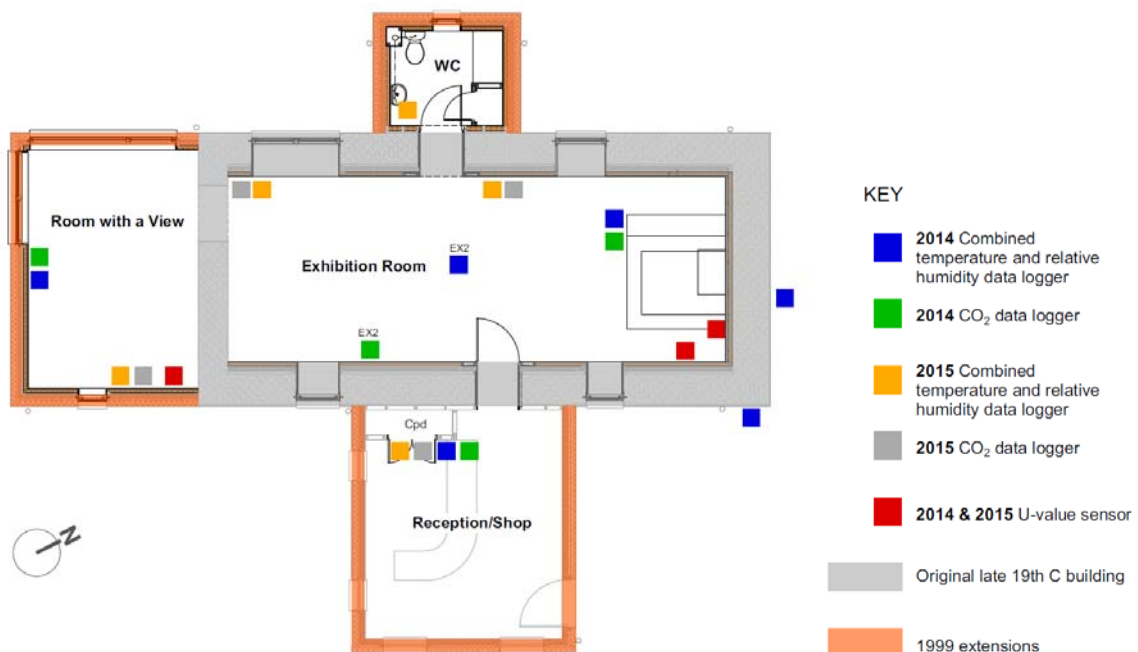
Figure 2. Plan view of LSIC building, indicating the historic core, 1999 extensions and location of monitoring apparatus for pre and post-refurbishment BPE.
