Damage Assessment and Refurbishment of Steam Turbine Blade/Rotor Attachment Holes

D G Hattingh ^{*1}, M N James ^{*1,2}, M Newby ³, R Scheepers ³ and P Doubell ³

³ Eskom Holdings SOC Ltd,
Rosherville Johannesburg, SOUTH AFRICA
newbym@eskom.co.za

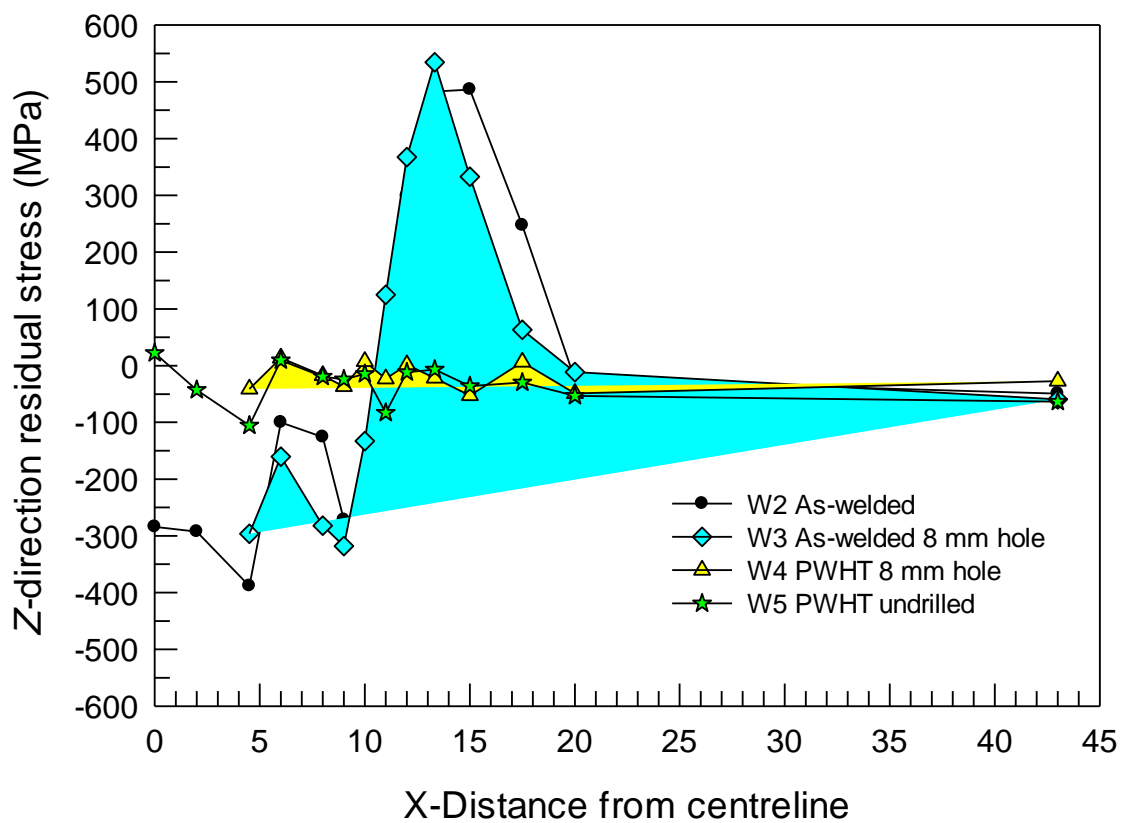
The calculated residual stress values for all three coordinate directions are given in Figure 17 for the various measurement positions in the x -direction. The key coordinate directions for crack initiation and growth are x and z and the data show that the PWHT process is very effective in relaxing the substantial residual stress peaks in the weld zone. Reductions are achieved in the x -direction stress (Figure 17a) from peak values around -380 MPa near the HAZ boundary in specimens W2 and W3 to values below 100 MPa at similar positions in specimens W4 and W5. In the case of the z -direction stresses (Figure 17b) the reduction is even more marked, from peak tensile values of circa 500 MPa in W2 and W3 to values close to zero in W4 and W5. It is also apparent that drilling an 8 mm diameter hole in the as-welded specimen leads to a positive residual stress near the edge of the hole in the x -

Figure 17b Mid-depth residual stress ($y = 9$ mm) in the z-coordinate direction for all specimens.

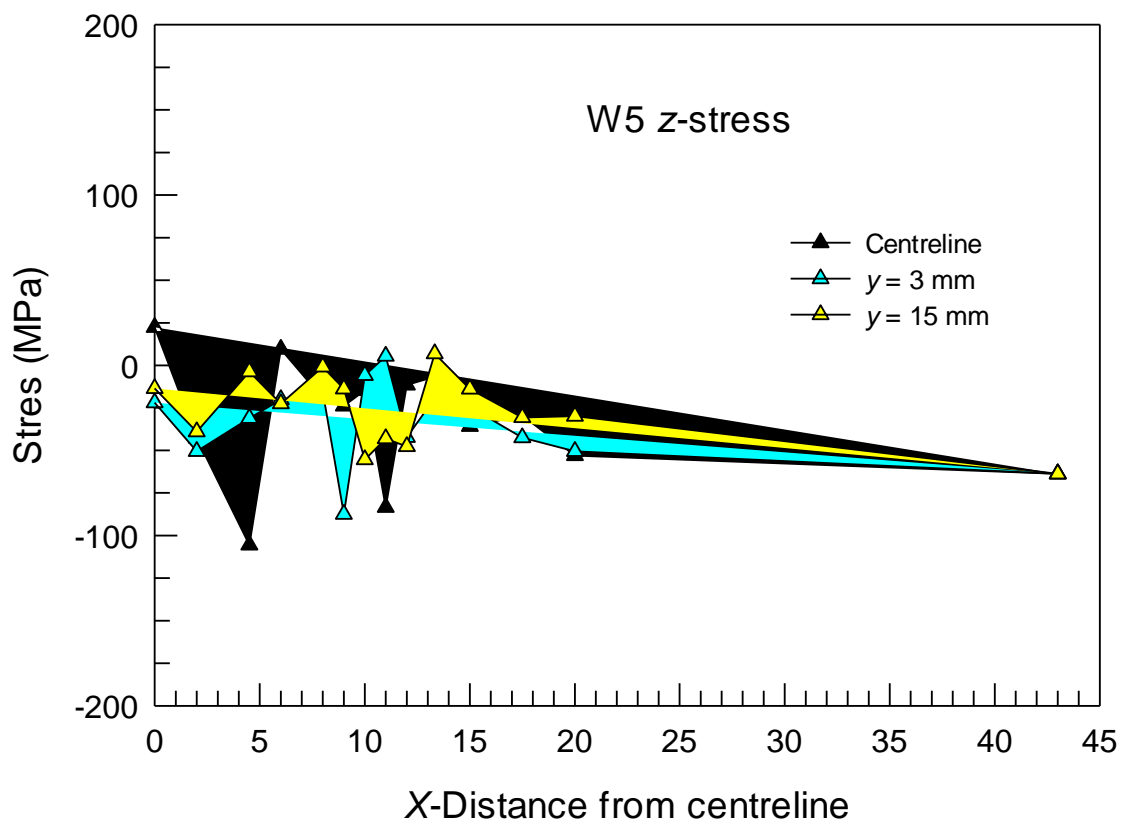
It is also interesting to compare the residual stress levels at the three different *y*-positions where measurements were made, i.e. 3 mm, 9 mm and 15 mm below the top surface of the specimen. Figure 18 shows this data for the *z*-coordinate direction in specimens W5 (undrilled PWHT) and W4 (drilled PWHT). In all cases, peak stress values in the *x* and *z*-coordinate directions do not exceed approximately 100 MPa.

Figure 18a Stress at all three depths in the z-coordinate direction for the undrilled PWHT specimen W5.

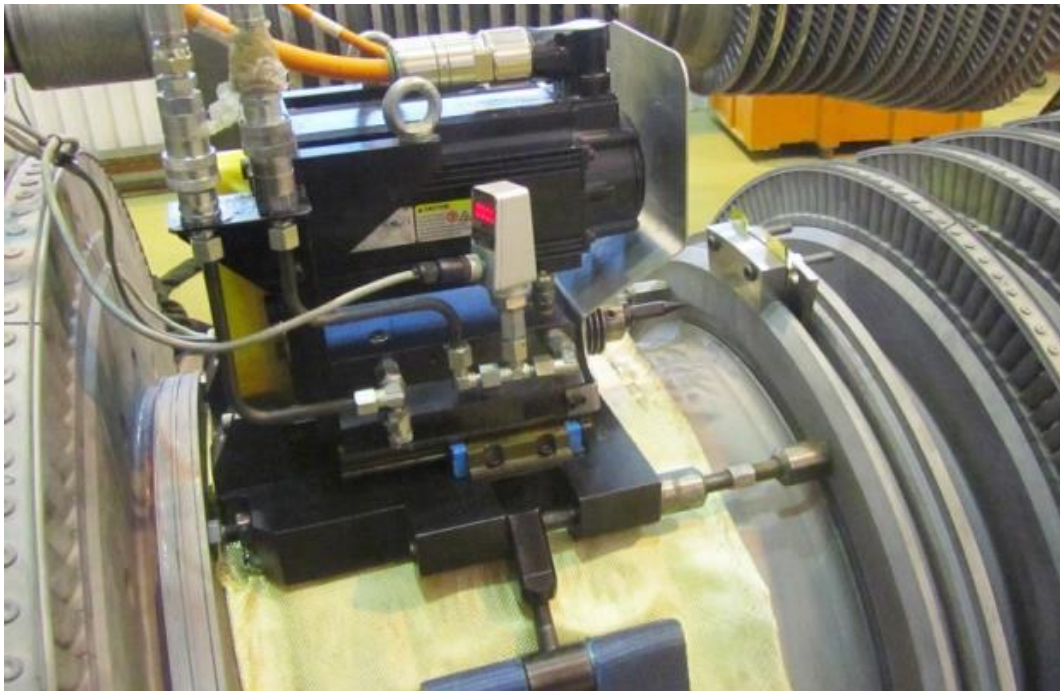
Figure 20 Illustration of the bespoke FHHP platform in position on a stream turbine rotor. It uses the registered WeldCore® process and in this case, is being used to extract samples for creep damage analysis.

A FHPP technique has been developed for use with a bespoke welding platform that is suitable for cost-effective repair of disc/blade attachment hole cracking in-situ on a steam turbine rotor (Figure 20). The WeldCore® process has been registered and can also be used to extract samples for creep damage analysis. The case study presented in this paper relates to cracking experienced at the attachment holes of finger-pinned stage 1 LP steam turbine blades on a 200MW unit. Neutron diffraction residual strain scanning was performed at the ILL in Grenoble, France on test specimens machined from ex-service rotors, intended to simulate various stages in the repair process (see Figure 3); as-welded and undrilled (W20, as-welded and subsequently drilled for the blade attachment pin (W3), undrilled and PWHT (W5), drilled and PWHT (W4). PWHT has been shown to substantially reduce the peak magnitudes of the residual stress associated with the welding process, from peak tensile values of around 500 MPa in W2 and W3 to values close to zero in W4 and W5. Drilling an 8 mm hole in the as-welded specimen (W3), to simulate a new pin attachment
