# Dynamic investigation on the Mirandola bell tower in post-earthquake scenarios

**Abstract** After the seismic events of the 20th and 29th of May 2012 in Emilia (Italy), most of the monumental and historic buildings of the area were severely damaged. In a few structures, partial collapse mechanisms were observed (e.g. façade tilting, out-of-plane overturning of panels...). This paper presents the case-study of the bell tower of the Santa Maria Maggiore cathedral, located in Mirandola (Italy). The dynamic response of the structure was evaluated through operational modal analysis using ambient vibrations, a consolidated non-destructive procedure that estimates the dynamic parameters of the bell-tower. The dynamic tests were carried out in pre-intervention and post-intervention conditions in order to understand the sensitivity of dynamic measurements to safety interventions. Furthermore, a comparative study is made with similar cases of undamaged masonry towers up to the 6th mode. Finally, an investigation on the state of connections and of the building itself is carried out via FE model updating.

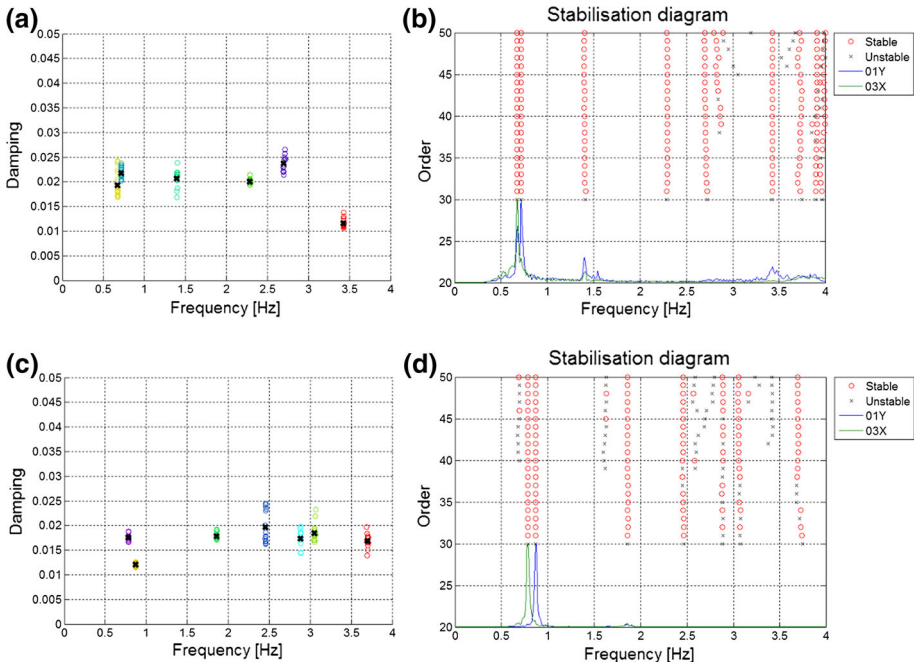
**Fig. 7** Bell-tower modal identification results (frequency-damping clustering and stabilisation diagram): **a**, **b** PR-I, **c**, **d** PS-I. The stabilisation parameters chosen for the graph were:  $\delta f = 0.005$ ,  $\delta \zeta = 0.1$ ,  $MAC = 0.95$

Figure 7 shows the stabilisation diagrams obtained for some of the signals made available by dynamic monitoring. The identification procedure entails a series of pre-processing operations on the signals (mean removal, de-trending, filtering) carried out by an expert operator in order to ease the identification process of the algorithm. For a detailed discussion on the identification process for masonry structures one can refer to Ceravolo et al. (2016).

From the modal frequencies and from  $\Delta f$  it can be clearly noticed how the installation of the safety interventions mitigated the effects of the extensive damage suffered by the bell-tower (De Stefano and Ceravolo 2007). In fact, the first two bending modes (Table 1) increased of the 16 and 21 %, from 0.68 and 0.72 to 0.79 and 0.87 Hz; whereas the first torsional mode had an increase of 32 %, from 1.41 to 1.86 Hz. For what concerns the damping ratios, the trend is not as clear. Anyhow, 6 out of the 8 modes listed in Table 1 show an increase in the damping ratios after the interventions.

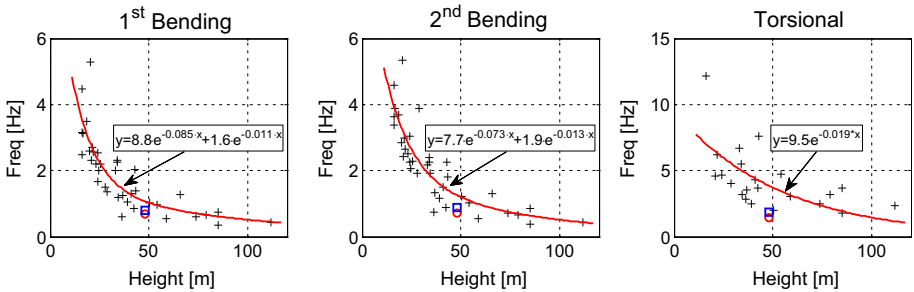
The first three modes of the bell tower were then compared with those of about 40 masonry towers or bell towers from across Europe. This highlighted how the two flexural modal frequencies of the damaged scenario are significantly lower than the typical ones of other bell-towers of comparable height. From these same data it can be inferred that the torsional mode is even more distant from the “ideal” trend of frequency as a function of

height represented by the lines in Fig. 8. This is most probably a symptom of a severely damaged structure, where box-like behaviour has been strongly affected. In fact, stiffness along the plane of the masonry walls is relatively less affected by the presence of cracks than torsional stiffness, which is influenced by the state of the connections between orthogonal wall panels. The full list of bell tower modes, up to the sixth, can be found in Table 2.

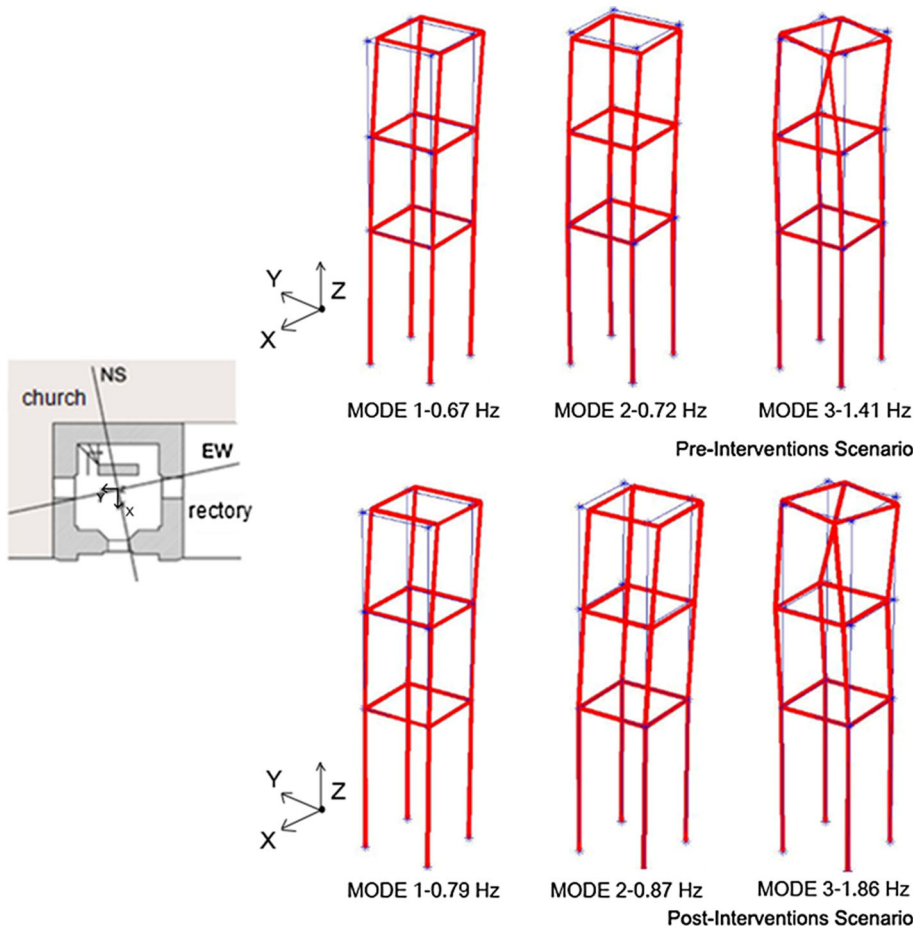
**Fig. 9** Bell-tower identified frequencies and modal shapes in the PR-I scenario and the PS-I scenario

It is also worth noting that, in the PR-I condition, the first and the second flexural modal shapes, directed along E–W and N–S directions respectively, show a coupled behaviour and a value of Modal Assurance Criterion (MAC) of 0.495, whereas after the strengthening interventions they appear almost perfectly aligned with the principal axes of the tower, the MAC decreases to 0.001 (Fig. 9).

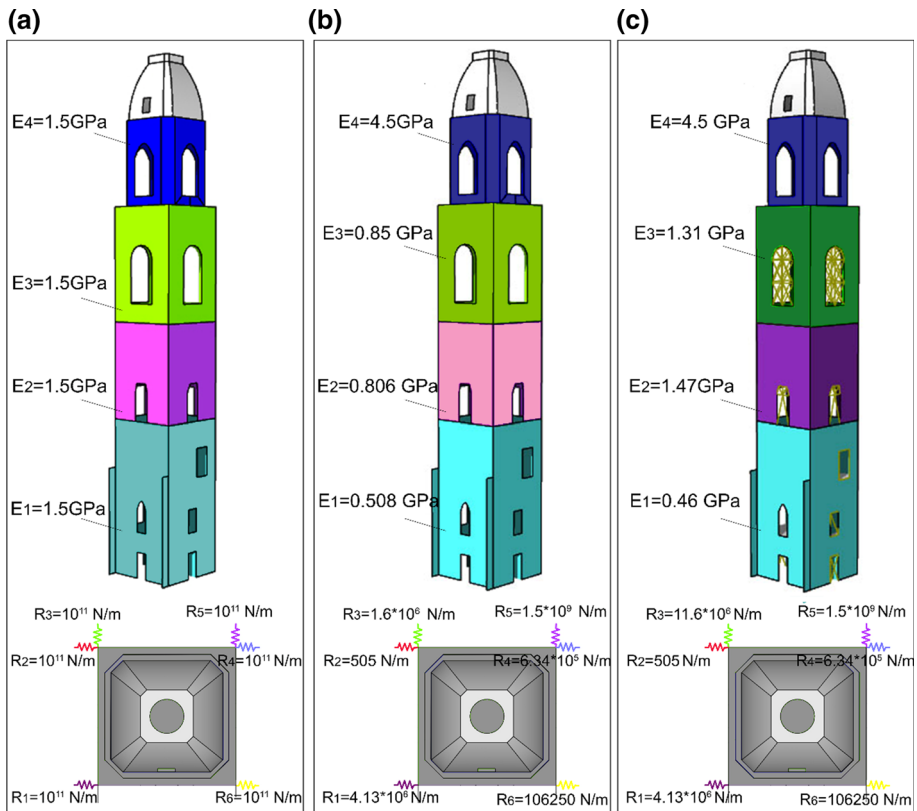
**Fig. 14** Model updating results: initial values (a) and the updated values for the pre-intervention scenario (b) and in the post-intervention scenario (c)

The results of the updating procedure provide further information about the bell-tower damage state (Fig. 14b): the value of 0.508 GPa for the Young modulus of the first sub-part and the others of the upper levels, 0.806 GPa for the second level and 0.85 GPa for the third one, refer to heavily cracked regions of the building. Moreover, these results suggest that the first sector is strongly influenced by adjacent bodies, that have stiffened the basement of the tower, especially on the west side, where the spring-element  $R_1 = 4.13 \times 10^6$  N/m represent the external wall of the church’s nave; and on the east-side where  $R_5 = 1.5 \times 10^9$  N/m,  $R_4 = 6.34 \times 10^5$  N/m,  $R_6 = 106,250$  N/m model the rectory building.

connection with the surrounding buildings. The first sub-part, where there are only the wooden false works in correspondence of the opening, does not show any significant variation in the Young's modulus parameter. On the other hand, the second sub-part is the most influenced by the safety interventions (tie-rods are located on this level), the related Young's modulus parameter has a significant increase from the value of 0.805–1.47 GPa (parameter  $E_2$ , Fig. 14c). The third sub-part, also affected by the installation of tie rods, reveals a relevant increase of stiffness with a Young's modulus value of 1.31 GPa respect the starting updated value of the pre-intervention scenario (parameter  $E_3$ , Fig. 14c). These results highlight how the equivalent stiffness is modified in correspondence of the areas that underwent more invasive interventions. Therefore, the updated model has been a valid support to confirm the experimental model and measurements, and also to plan any additional tests on the bell-tower.

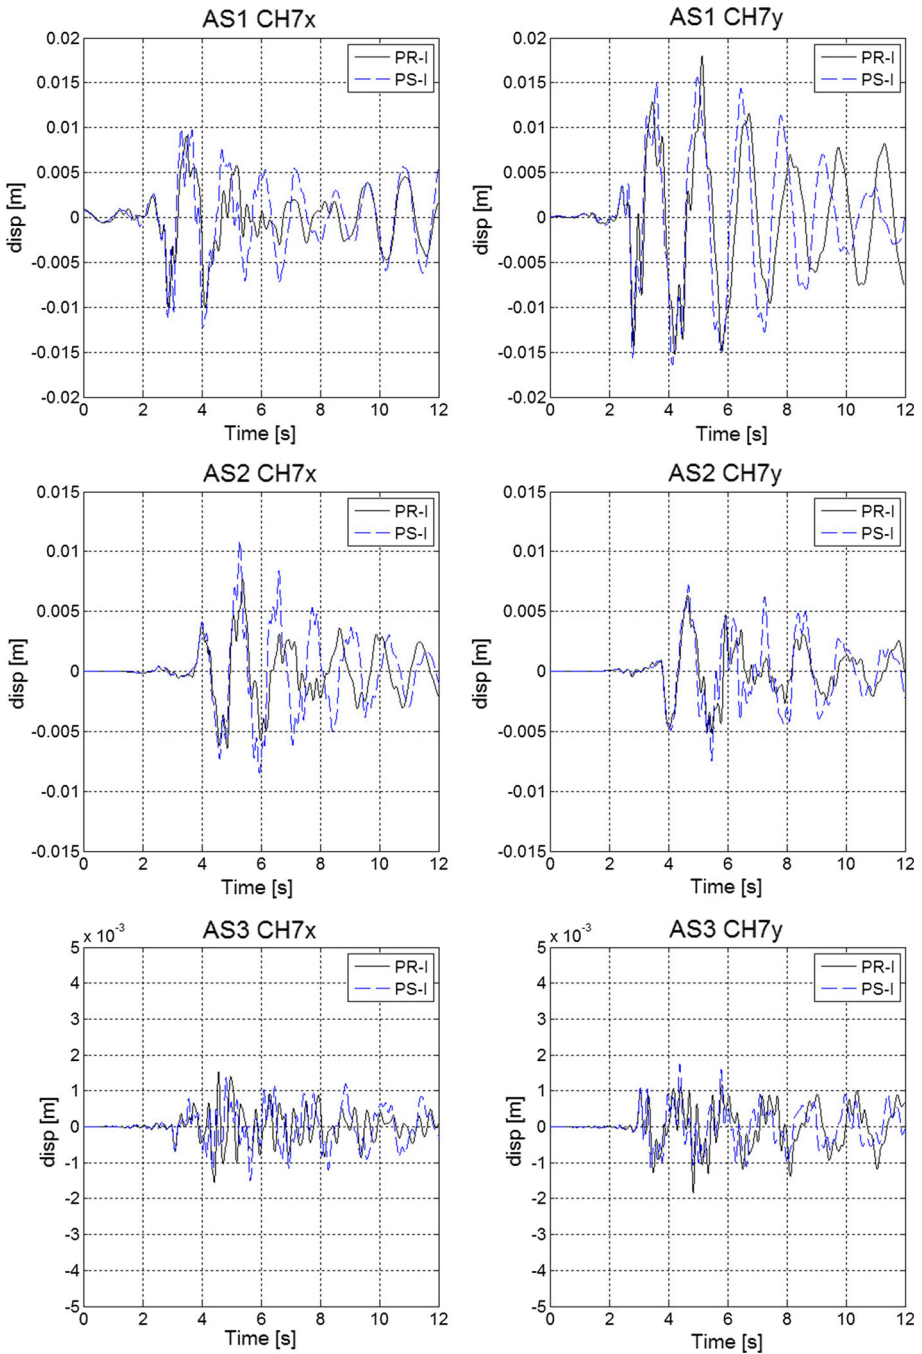
**Fig. 16** Comparison between the displacement responses related to CH7-position (direction  $x$ —first column, direction  $y$ —second column) in the pre (red line) and post (blue line) condition

The maximum displacements values are obtained for the CH-7 position, located in a higher, thus more flexible region of the tower, where the most severe damages were assessed (see Fig. 2). Observing the time-history responses in Fig. 16 and the results in Table 6 it is possible to notice how the amplitude of the response in the PR-I and PS-I configurations is quite similar with all the three aftershocks. As shown in Fig. 16, the response in the direction of the x and y reveals quite similar results between PR-I and PS-I differing only by the time of occurrence of the peak displacement. Only the responses to AS1 and AS3 aftershocks show an improvement of global behaviour when considering the maximum response in terms of displacement.
