Quantitative Analysis and Treatment of Pennsylvania Blue Marble at the Philadelphia Merchants' Exchange

Presented to the Faculties of the University of Pennsylvania in Partial Fulfillment of the Requirements for the Degree of Master of Science in Historic Preservation.

Felicia Lyles McBratney

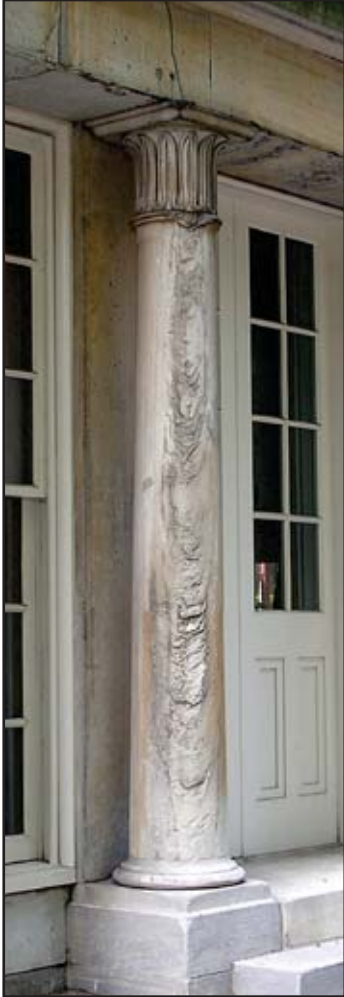
Freeze-thaw action occurs preferentially in the capillary spaces between mica inclusions inherently present in the stone or accessory minerals. When water enters these spaces and freezes, the resulting expansion causes the stone to delaminate along these veins. This process results in the exposure of new marble surfaces that are exposed to the attack of air pollutants with the consequent formation of more gypsum, as shown in Figure 1.3.

Figure 1.3: North Elevation, columns 7 and 8, summer 2004

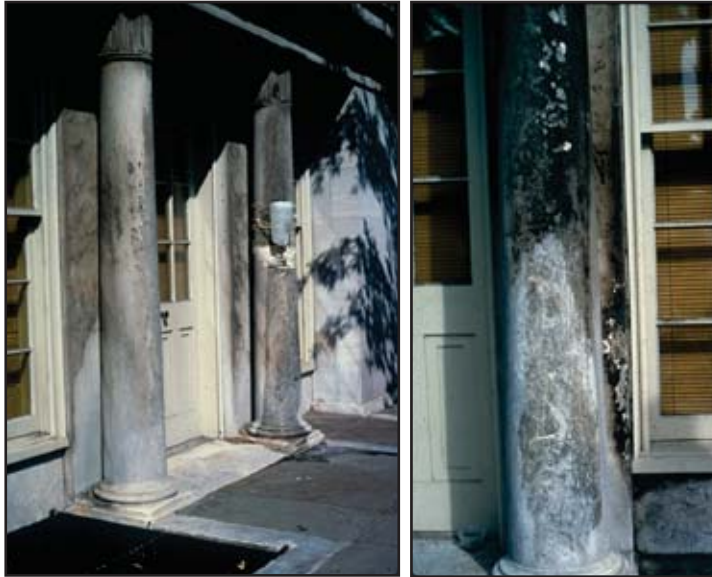
Conservation treatment tests were also undertaken by Lewin. Due to the substantial amount of gypsum crusts present cleaning tests were performed. This established whether the gypsum could thoroughly be removed without "resorting to heroic measures" and to reveal the condition and degree of soundness of the underlying stone.²³ Two of the most heavily sulfated ground floor columns were selected for the test cleaning²⁴ "Philadelphia city water was allowed to drip slowly and continuously over the stone surface for 6-8 hours."²⁵ Analyses of the stone surface pre and post treatment was conducted. Post treatment analyses showed that 90 to 95% of the gypsum had been

Figure 2.9: (left) Merchants' Exchange, South elevation – cleaning of column 2, circa 1984. *From INHP Archives.*

Figure 2.10:(right) Merchants' Exchange, South elevation – after cleaning of column 2, circa 1984. *From INHP Archives.*

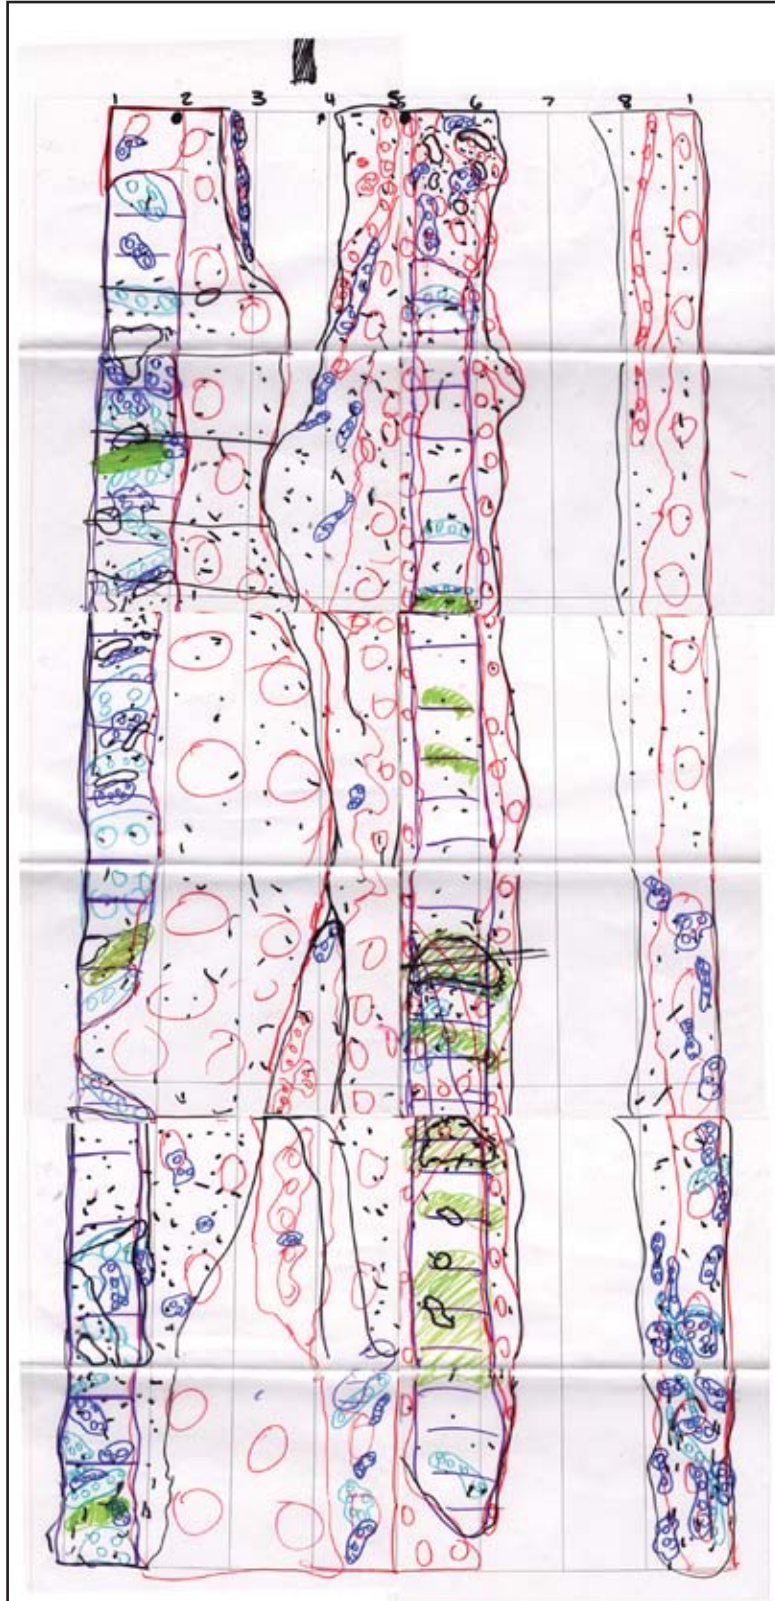
Figure 4.5: Scanned conditions drawing, column montage; South elevation, column 5

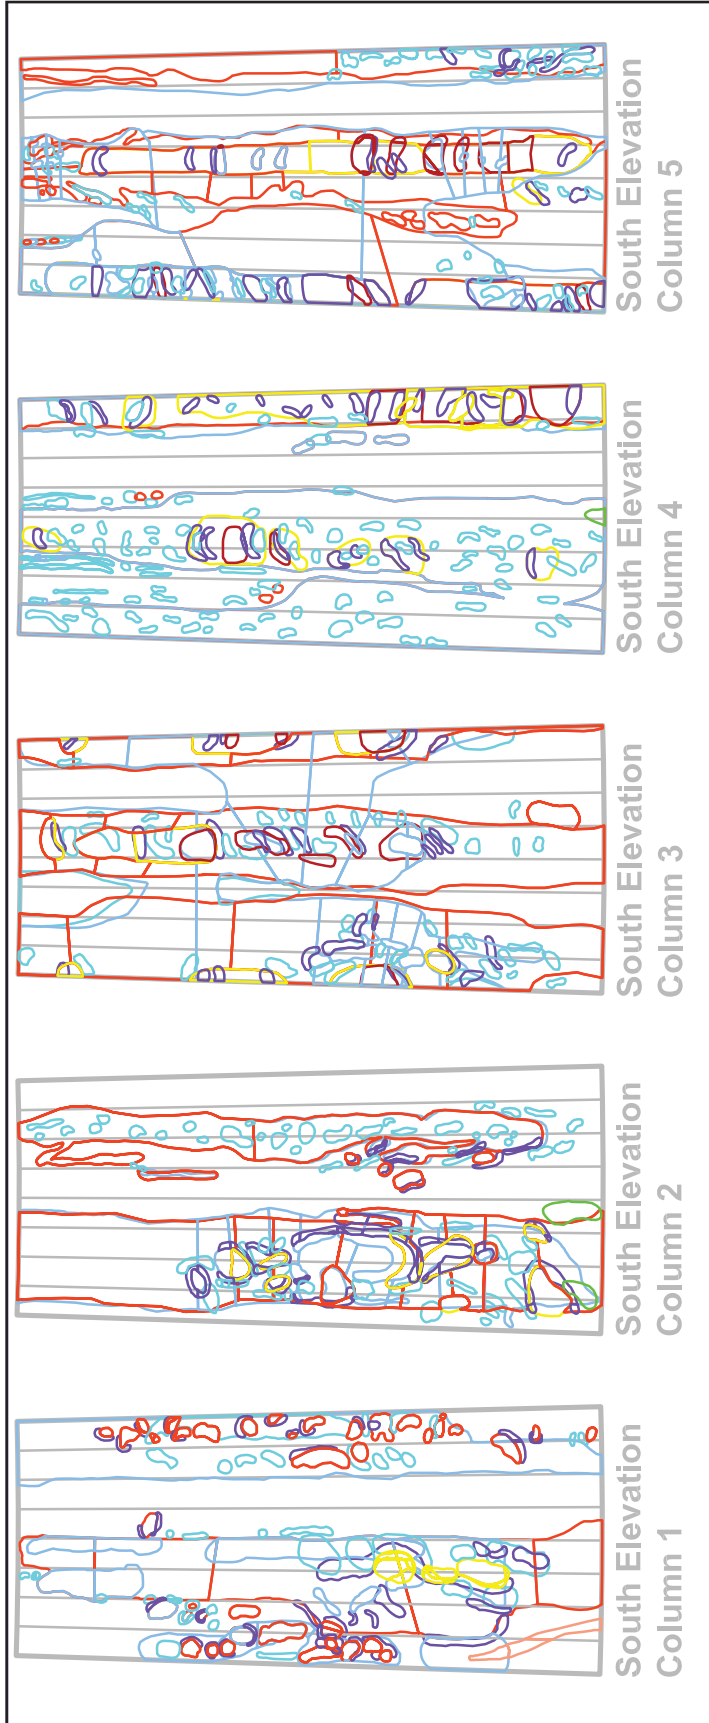
Figure 4.6: CAD drawing produced from field drawings; South elevation, columns 1-5

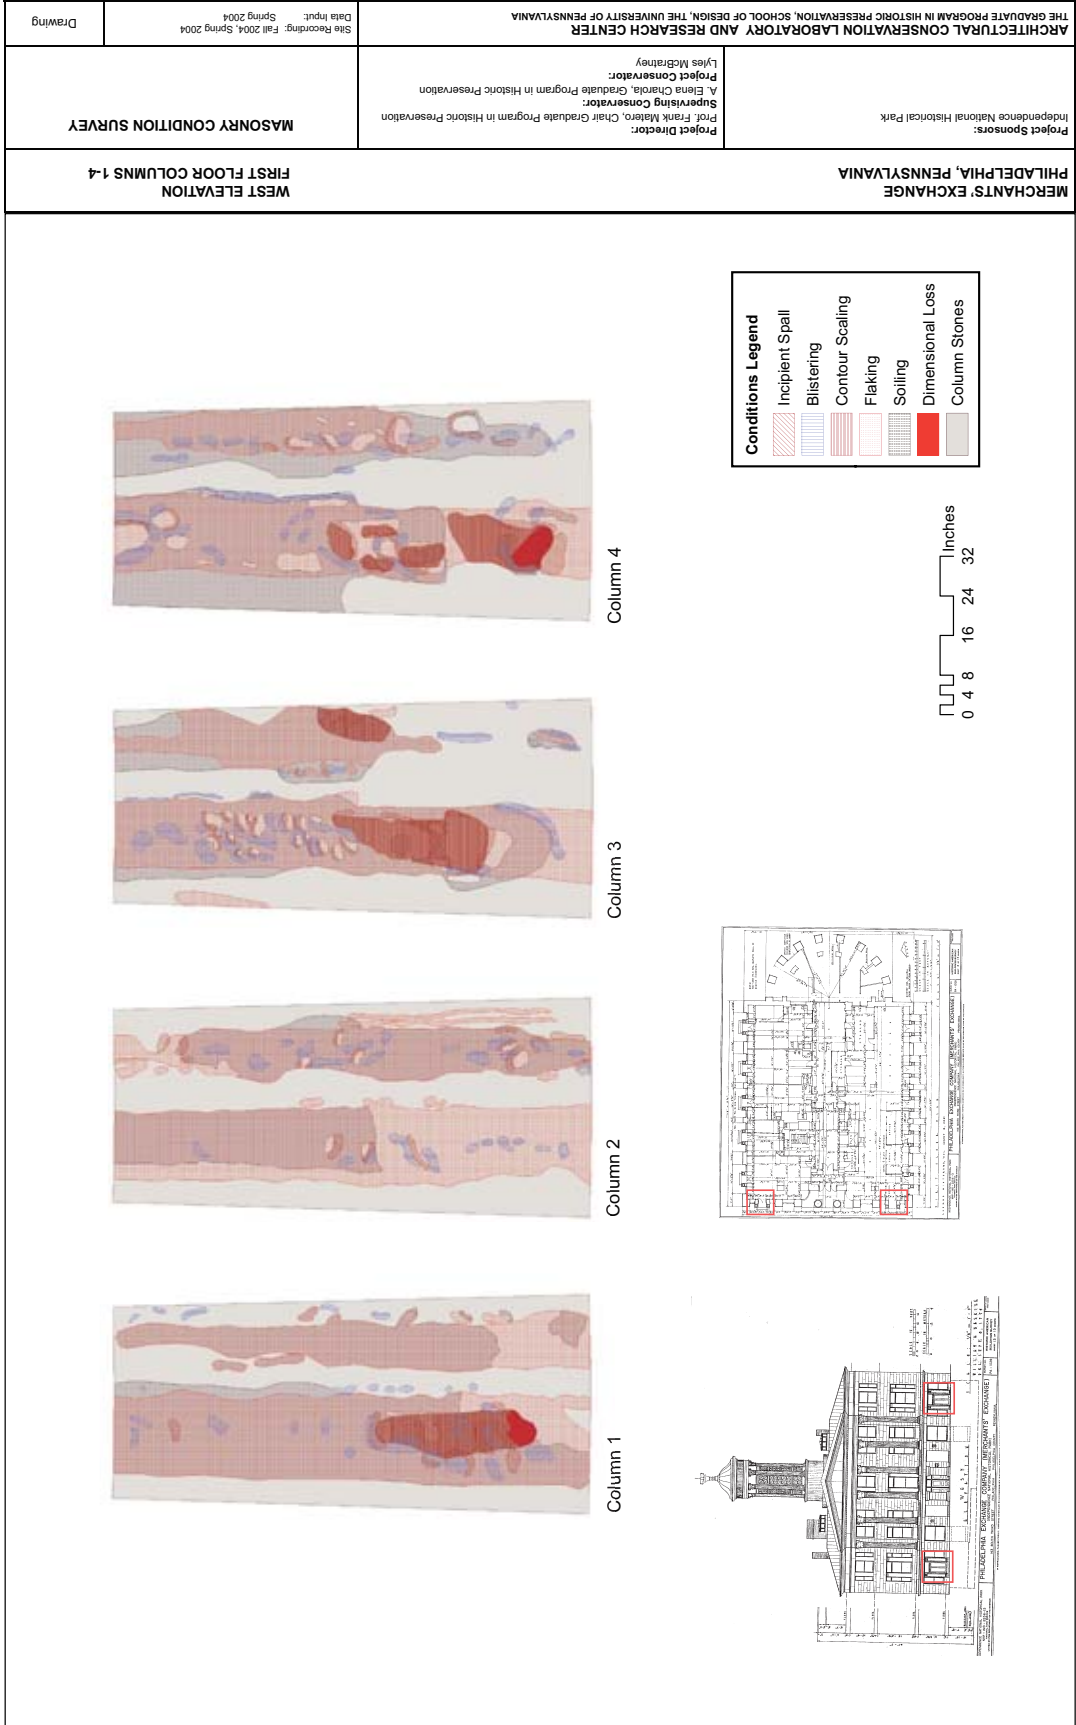
The twenty-four columns on three different facades were analyzed to understand the current conditions as a function of location, past treatments, and other recorded conditions. The GIS maps which were created from the AutoCAD conditions drawings, served to process this information.⁶ There are two types of GIS maps. The first is the condition survey of the columns, which shows the major deterioration types of symptomatic deterioration and their pattern on the stone surface. The second type are drawings based on calculated areas of conditions. The area in inches of the conditions were calculated for each column and the drawings produced represent the columns ranked in relationship to those having the highest area of a certain condition to those with the lowest.

Figure 4.8: GIS Masonry Condition Survey Drawing: Type I.

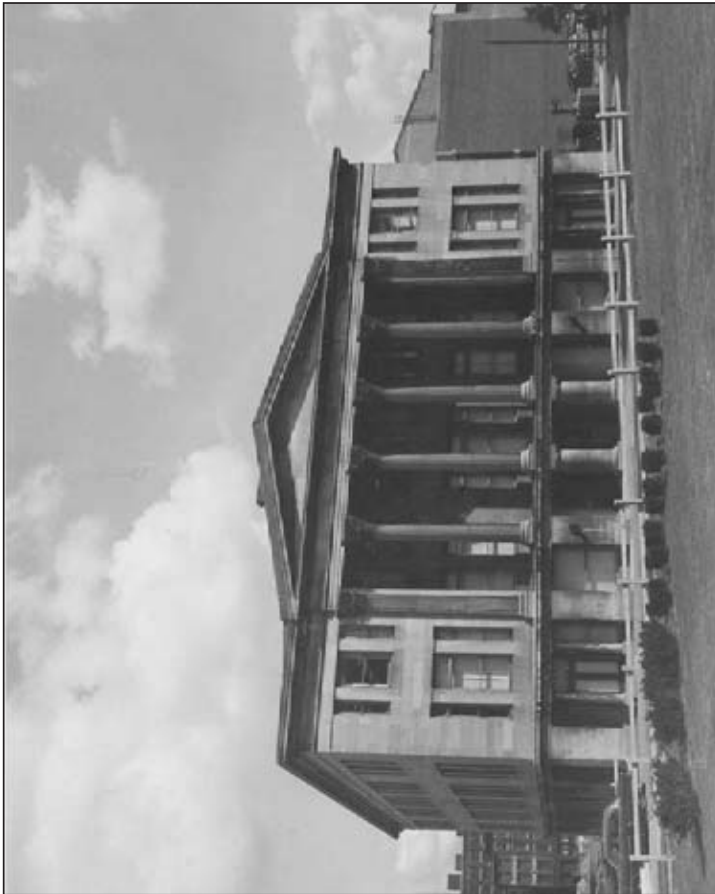
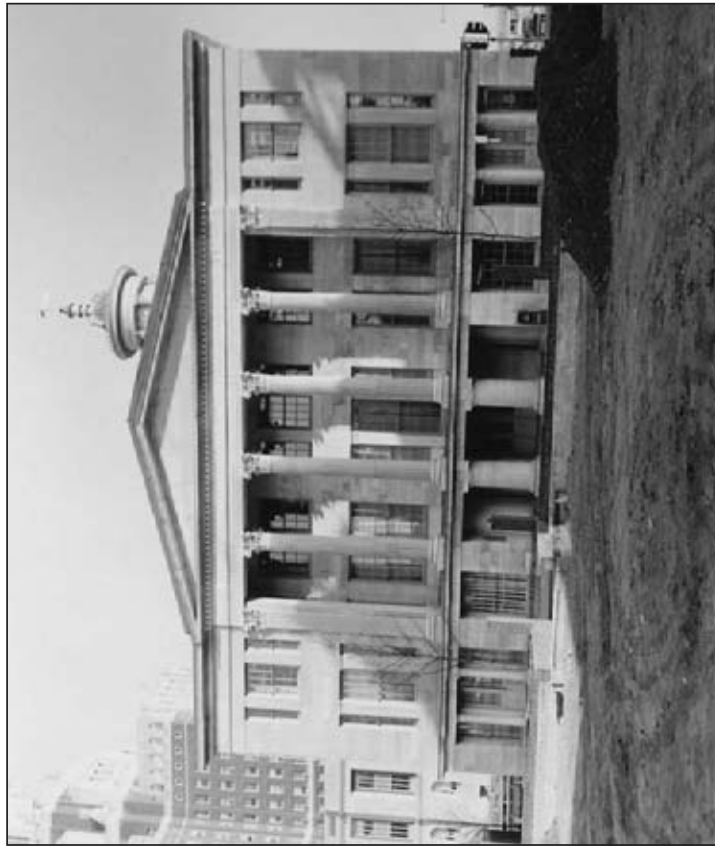
A good first impression can already be obtained by comparing Figures 4.10 and 4.11. These photographs show the west façade of the building in 1959 (25 years after construction) and in 1965, soon after cleaning. Although the pictures are not taken from the same angle, it is easy to see the difference in appearance of the whole façade. The older pictures show the black deposit on the columns—really evident on those on the second floor. And careful analysis of the photograph shows that the four bottom columns are equally soiled.

Figure 4.10:
West Elevation
Source: INHP Archives
Creator: W. A. McCullough
Date: October 1959

Figure 4.11:
West Elevation, after restoration
Source: INHP Archives
Creator: W. A. McCullough
Date: November 1965

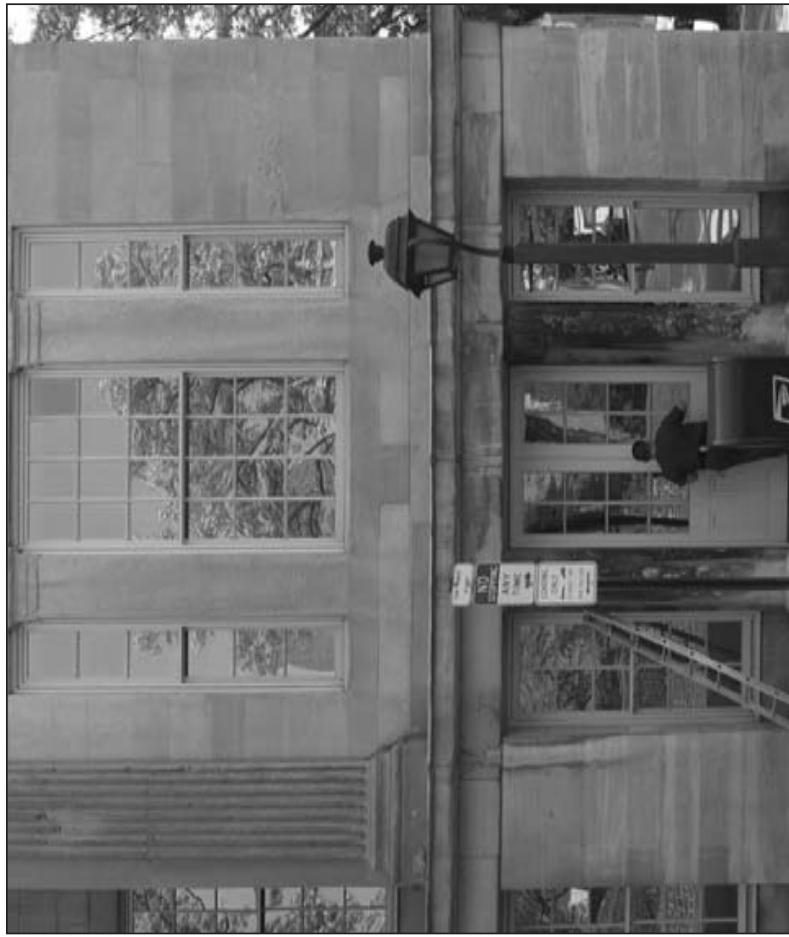
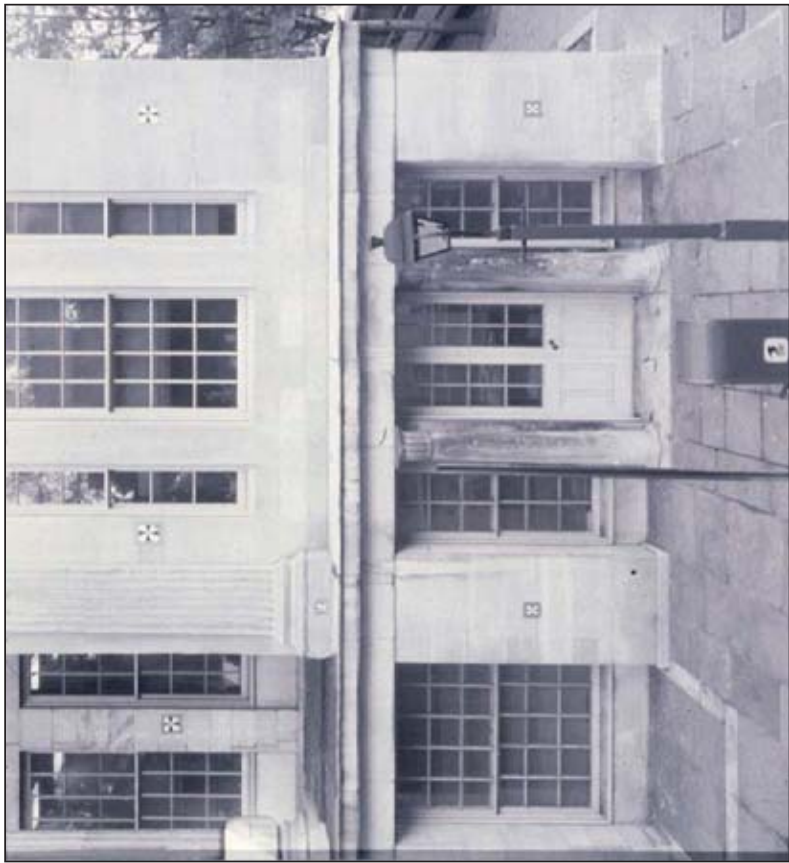
off. A significant increase in soiling can be seen in the later photograph (Fig. 4.13, 2004 – 39 years after cleaning) as compared to the earlier one (Fig. 4.12, 1958—24 years after construction).

Figure 4.13:
 West Elevation, columns 3 and 4
 Source: University of Pennsylvania
 Date: Summer 2004

Figure 4.12:
 West Elevation at south corner, columns 3 and 4
 Source: INHP Archives
 Date: October 30, 1958, W.A. McC.

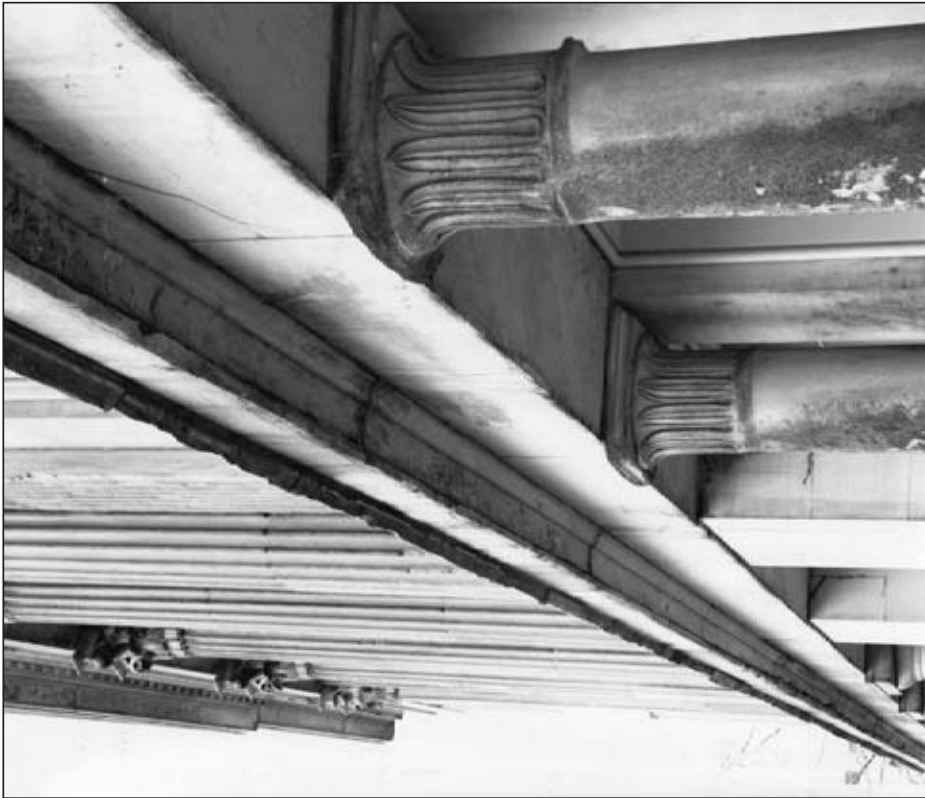
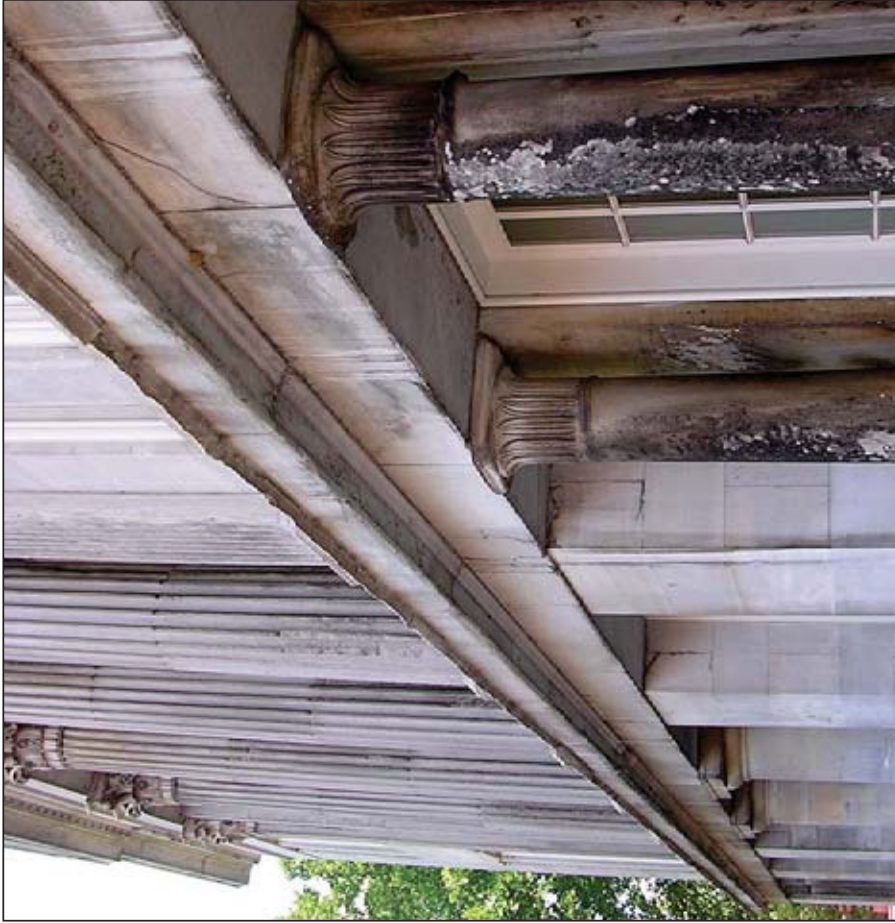
Another set of close-up photographs of these same columns is shown in Figures 4.14 and 4.15. Figure 4.14 was taken in 1984, twenty years after the cleaning of the building, while Figure 4.15 was taken 20 years later. The latter shows significant soiling and fresh blistering and flaking. This heavy soiling can be attributed to the continual exposure of the columns to vehicular traffic along Third Street, which is an important emission source for carbon and other particles in the emission of motor vehicles.

Figure 4.14:
West Elevation, columns 3 and 4
Source: INHP Architects' office
Creator: William Brookover
Date: March 3, 1984

Figure 4.15:
West Elevation, columns 3 and 4
Source: University of Pennsylvania
Date: November 2004

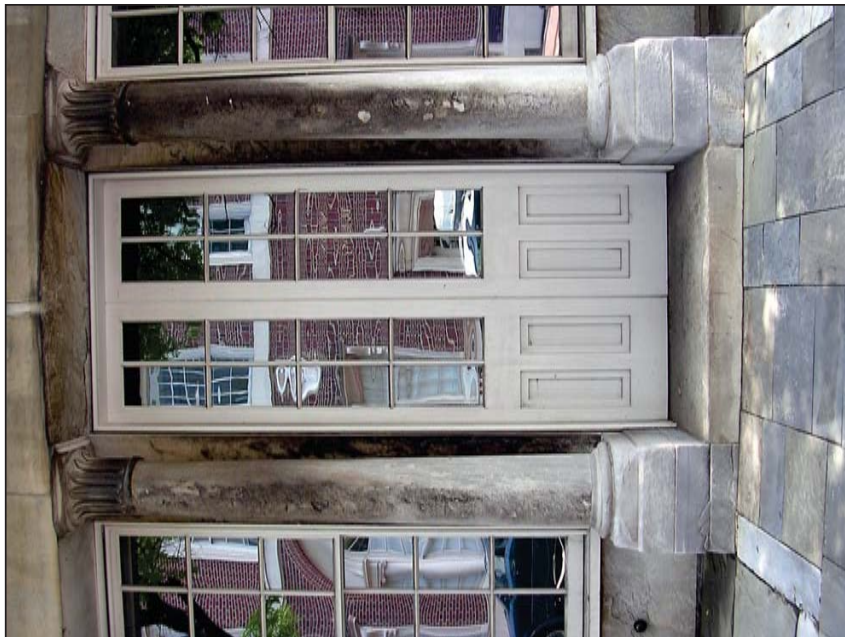
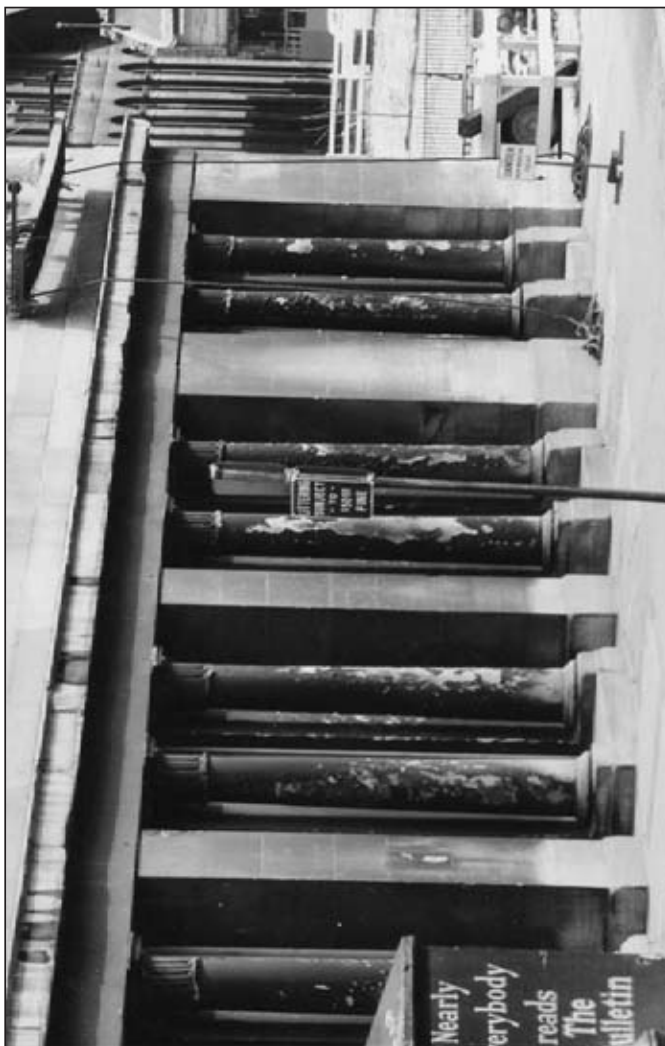
Figure 4.16 shows the general appearance of this elevation prior to cleaning in an undated photograph. Figure 4.17 shows columns 9 and 10 on the south elevation as they appear currently. The comparison of the lower part of these columns can be made between a photograph of 1961 (27 years after construction) (Fig. 4.18) and that taken in 2004 (39 years after cleaning) (Fig. 4.19). What is evident is that there has been a decrease of soiling in the years after the cleaning. However, deterioration has continued, as can be observed in the highlighted areas on column 9 in Figures 4.18 and 4.19 that shows an area with more loss than it had 43 years previously. Differences in deterioration between paired columns can be attributed to variations in the amount and distribution of the inclusions in the marble and which determine their sensitivity to freeze-thaw damage. Thus, column 9 shows more deterioration than column 10. And this difference is maintained over time.

Figure 4.17:
South Elevation, columns 9 and 10
Source: University of Pennsylvania
Date: Summer 2004

Figure 4.16:
South Elevation, columns 4-10
Source: INHP Archives
Date: Unknown

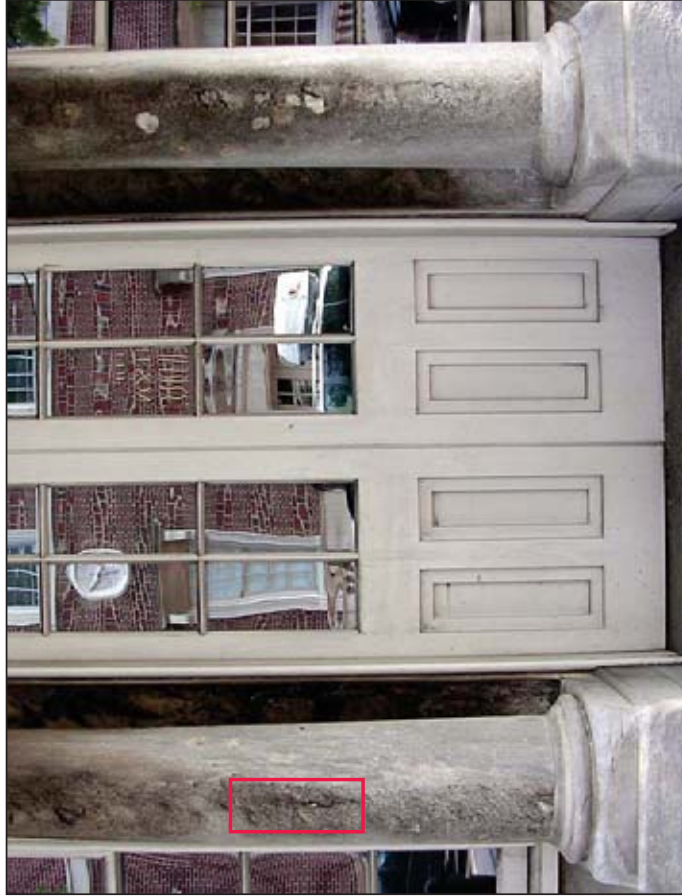
Figure 4.19:
South Elevation, columns 9 and 10
Source: University of Pennsylvania
Date: Summer 2004

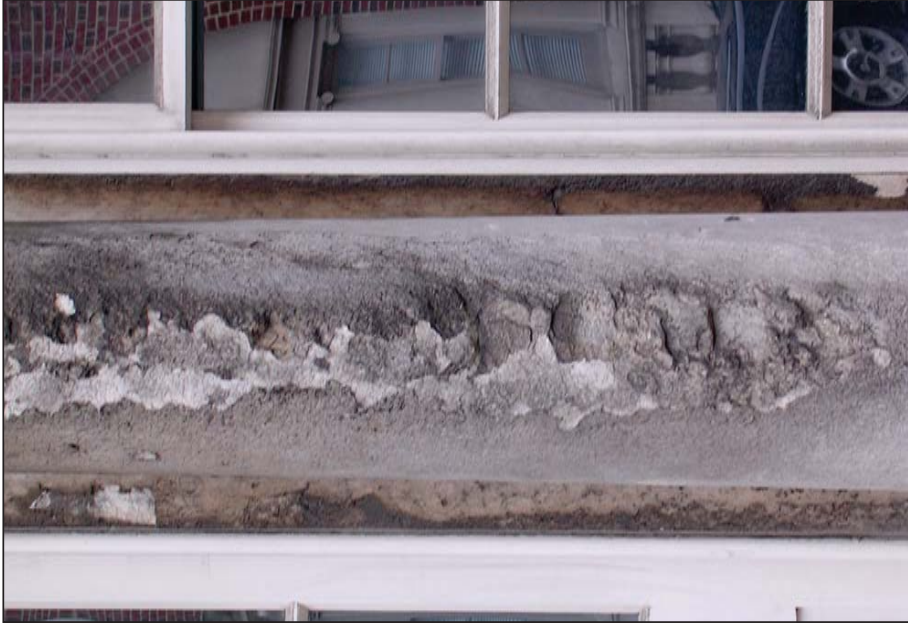
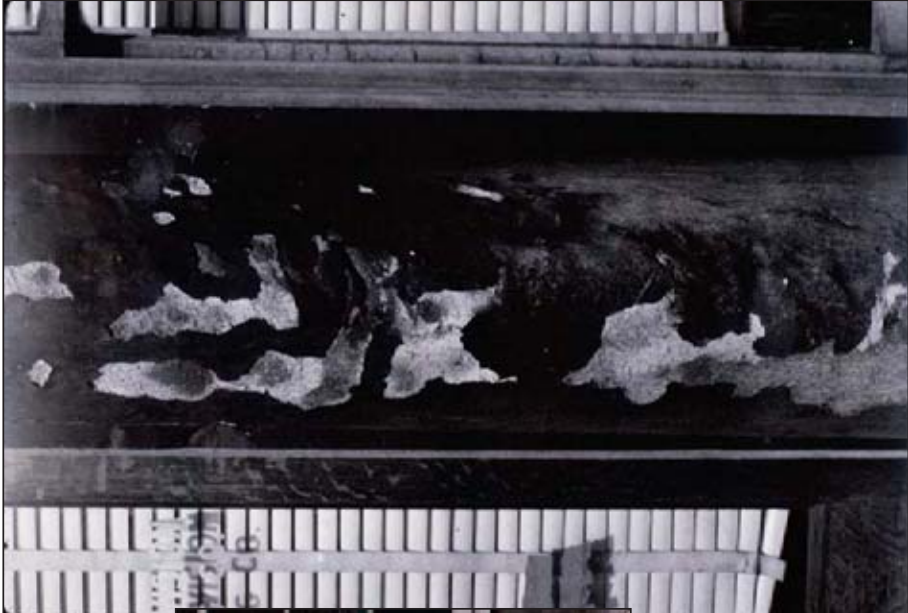
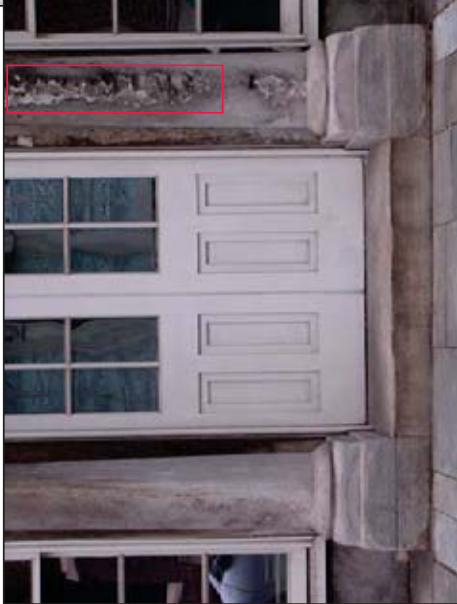
Figure 4.20 shows columns 7 and 8 of the same elevation in 2004. Detail of the lower center part of column 8 can be compared in photographs from 1952 (Fig. 4.21) and 2004 (Fig. 4.22). Again it can be observed that the soiling has decreased, 18 years of

Figure 4.22:
 South Elevation, detail of column 8
 Source: University of Pennsylvania
 Date: Summer 2004

Figure 4.21:
 South Elevation, second entrance from east,
 detail of column 8
 Source: INHP Archives
 Date: March 20, 1952

Figure 4.20:
 South Elevation, columns 7 and 8
 Source: University of Pennsylvania
 Date: Summer 2004

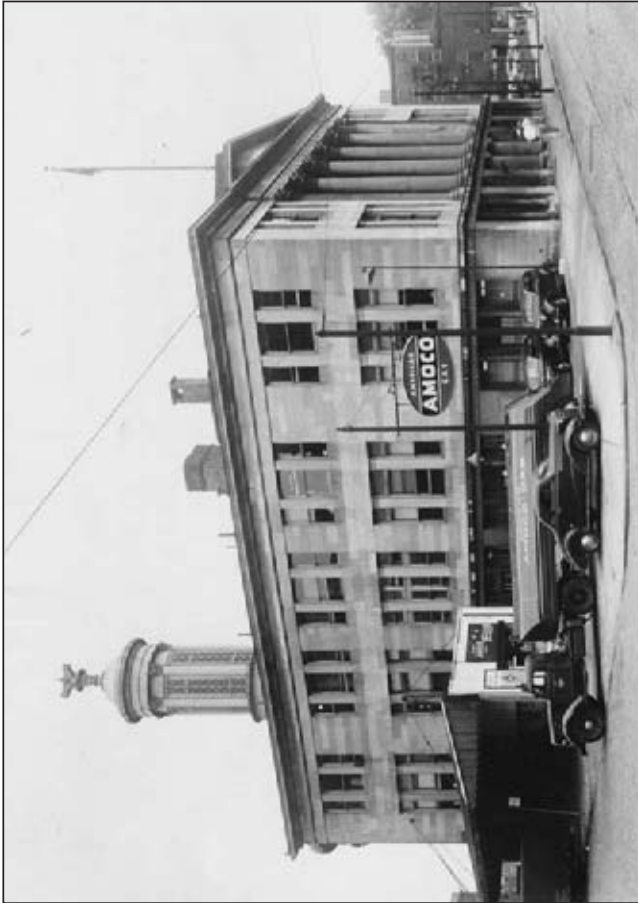
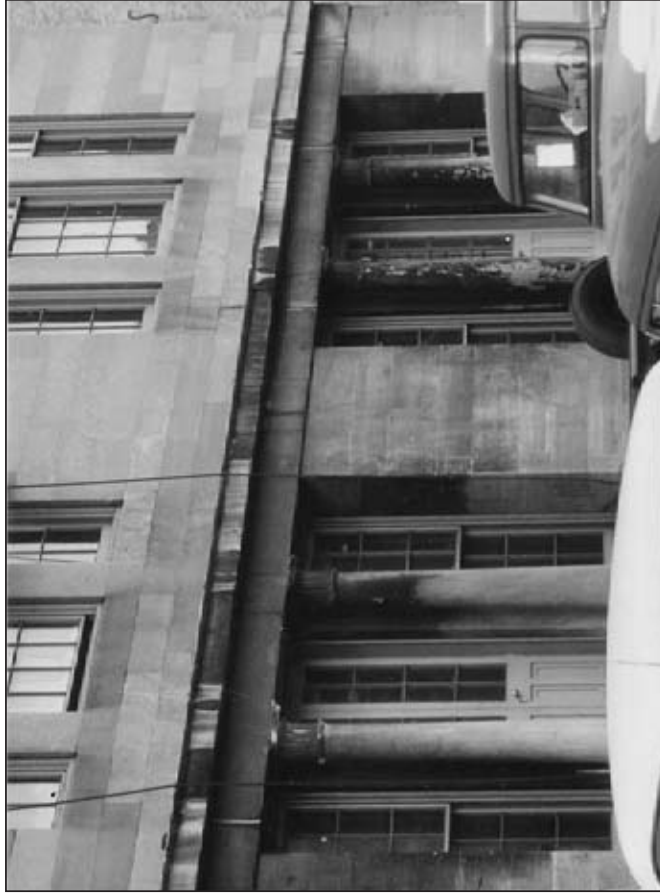
Figure 4.23 shows a general view of the north elevation of the building a few years before its cleaning. Clearly visible are the service station, which was located right across it and the allowed parking of cars and trucks. Figure 4.24 shows columns 7-10 in more detail in a picture taken prior to cleaning.

Figure 4.23:
North Elevation
Source: INHP Archives
Creator: C.E. Peterson
Date: April 19, 1960

Figure 4.24:
North Elevation, Columns 7-10
Source: INHP Archives
Creator: W. A. McCullough
Date: April 5, 1961

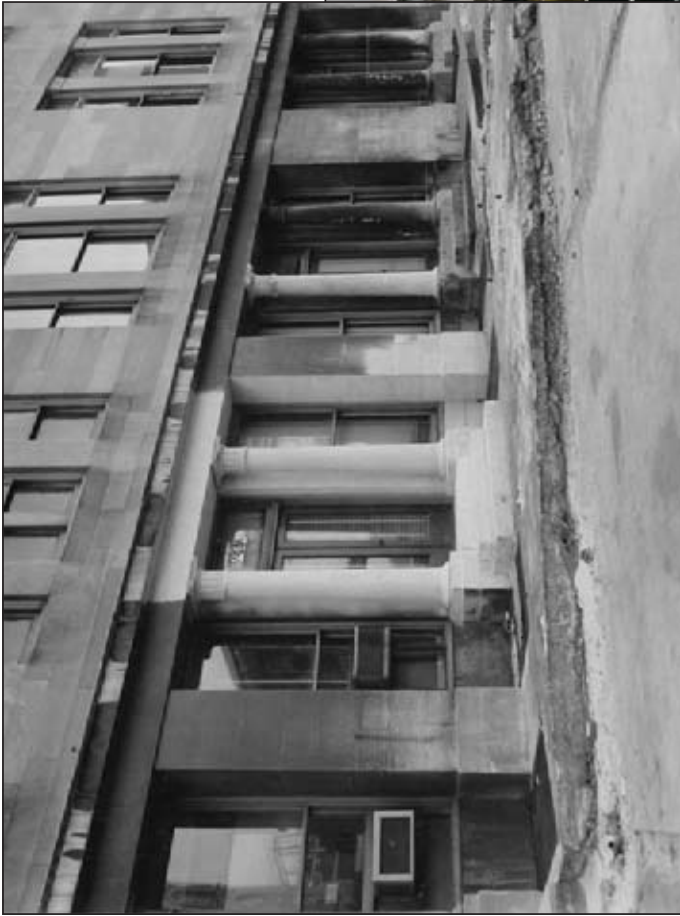
Figure 4.25:
North Elevation, columns 5-10
Source: INHP Archives
Date: December 2, 1953
Columns 5-6 was sandblasted, Column 7 was recarved

Figures 4.25 and 4.26 show the section with columns 5-10 on the north façade. Columns 5 and 6 were sandblasted in 1953 and column 7 was re-carved in 1953, removing all soiling thoroughly, and in the case of column 7, refinishing the surface. All three of them were also cleaned again in 1964-65 with high pressure water spray. The current state of these columns, as shown in Figure 4.26, shows that these 3 columns would appear cleaner and columns 8, 9 and 10 which were cleaned by high pressure water spray in 1963-65. However, closer photographs of the pair of columns 7 and 8 show that photographs can be misleading as seen in Figures 4.28 and 4.29. These were taken in 1983 and 2004 respectively. And no significant soiling difference can be found between the re-carved (#7) and the washed (#8) column.

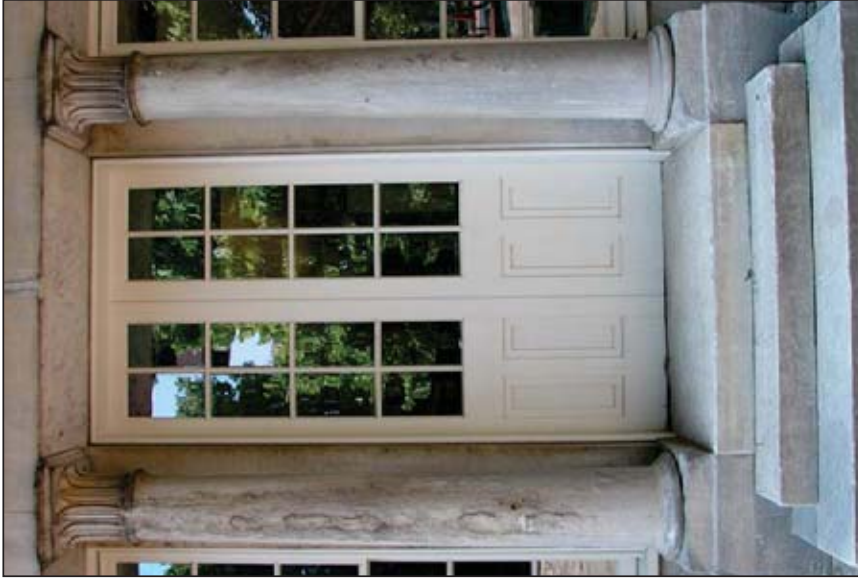
Figure 4.29:
North Elevation, columns 5 and 6
Source: University of Pennsylvania
Date: Summer 2004

Figure 4.29 shows the pair of columns that was sandblasted and eventually washed in their present state. It is clear that there is a difference in deterioration that can be mainly attributed to differences in the nature of the marble. Column #5 shows a higher degree of deterioration than column #6.

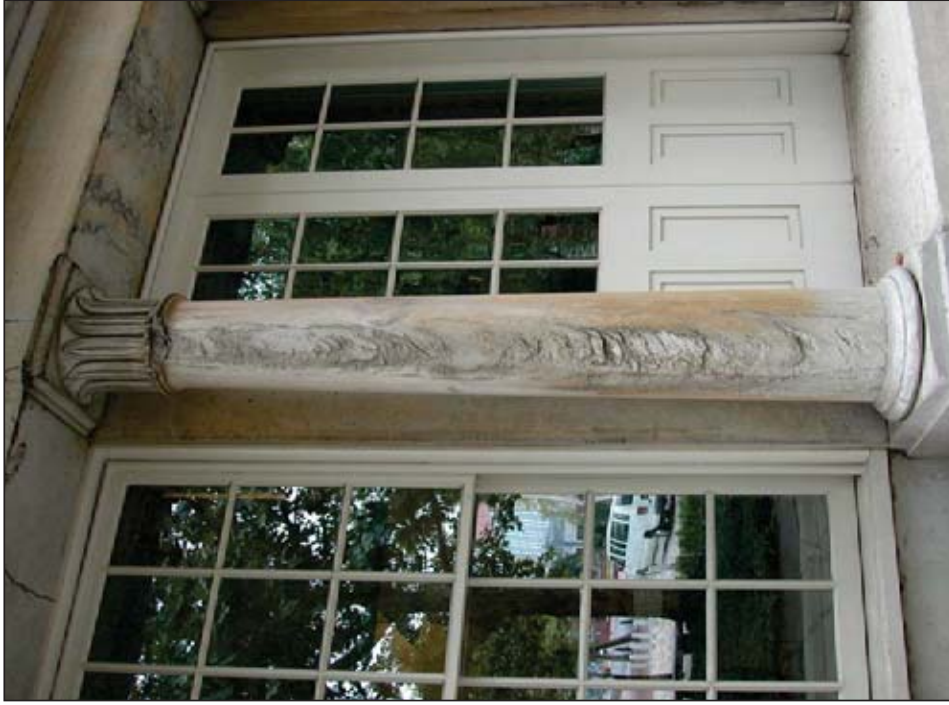
Figure 4.31:
North Elevation, column 9
Source: University of Pennsylvania
Date: Summer 2004

The last example taken for discussion is column #9 shown prior to cleaning in Figure 4.30 and in its present state Figure 4.31. The deterioration evident in the historic photograph does not appear to have increased significantly. The soiling accumulated in the first 23 years is far more than that in the subsequent 39 years after cleaning. This is

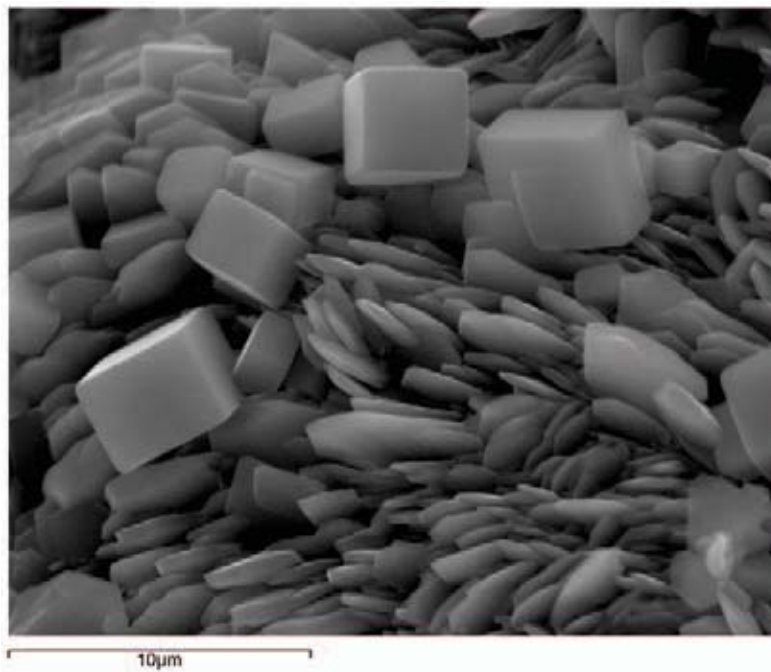
Figure 4.35:
Sample ID: W-4 Before Sample Location: West elevation, column 4
SEM Photomicrograph, 4500x, detail of the platy gypsum crystals and cubic halite crystals as seen in Figure 4.35

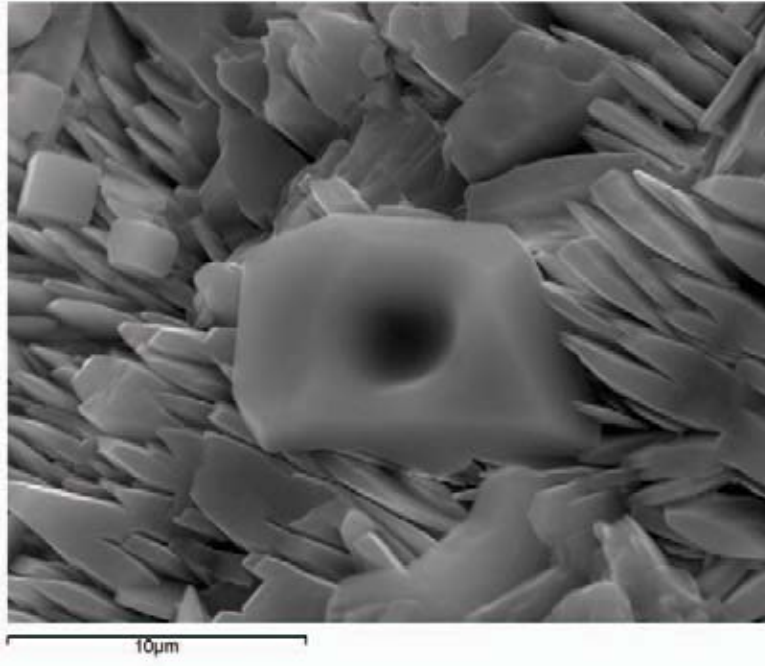
Figure 4.36:
Sample ID: W-4 Before Sample Location: West elevation, column 4
SEM Photomicrograph, 5000x, dissolution and recrystallization of salts are evident from the rounded shape in the center of the cubic halite crystal

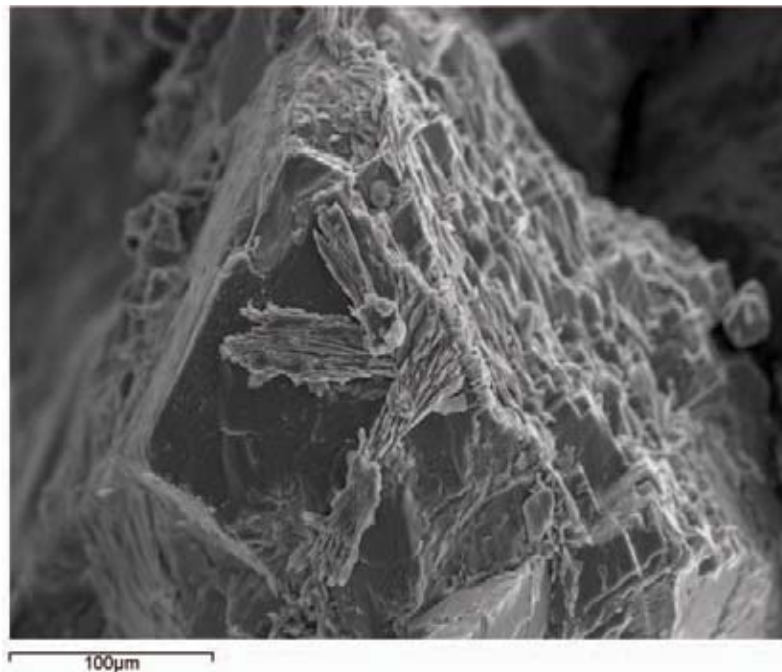
Figure 4.37:
Sample ID: W-4 Before Sample Location: West elevation, column 4
SEM Photomicrograph, 300x, low magnification photomicrograph showing the gypsum crystal growth of the surface of the marble calcite crystal

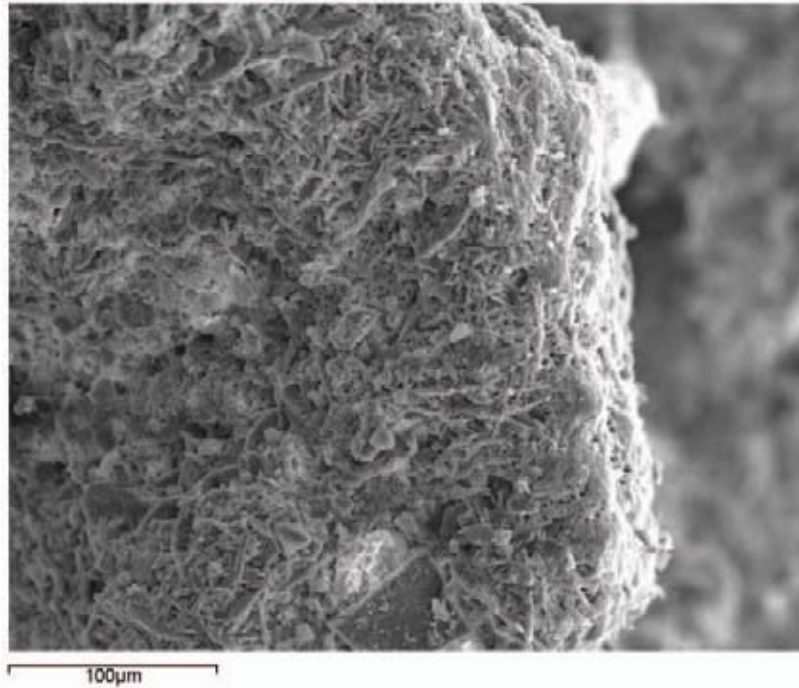
The sample obtained from north elevation, column nine showed much less soiling than that of the west elevation samples. This again can be attributed to the exposure of the columns. The west elevation columns are much more exposed to sulfur oxides and pollutant particles produced by traffic along the west elevation. Surface etching of the calcite crystals was also less prevalent on the north elevation. Extensive microcracking and loosely adhered calcite grains were also evident.

Figure 4.38:
Sample ID: N-9 Before Sample Location: North elevation, column 9
SEM Photomicrograph, 300x, low magnification photomicrograph showing external black crust attached to the underlying stone

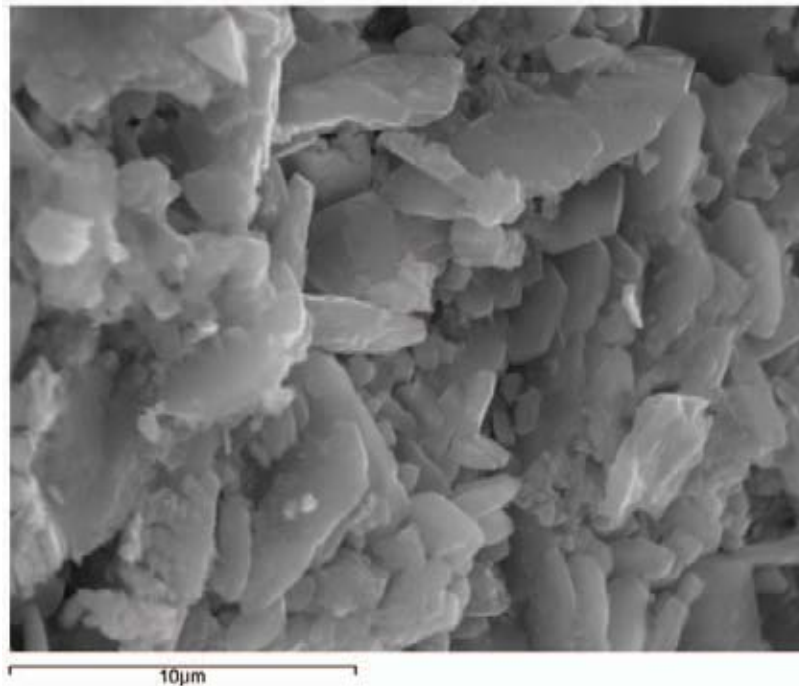
Figure 4.39:
Sample ID: N-9 Before Sample Location: North elevation, column 9
SEM Photomicrograph, 5000x, detail of the external black crust showing gypsum crystals and amorphous particles

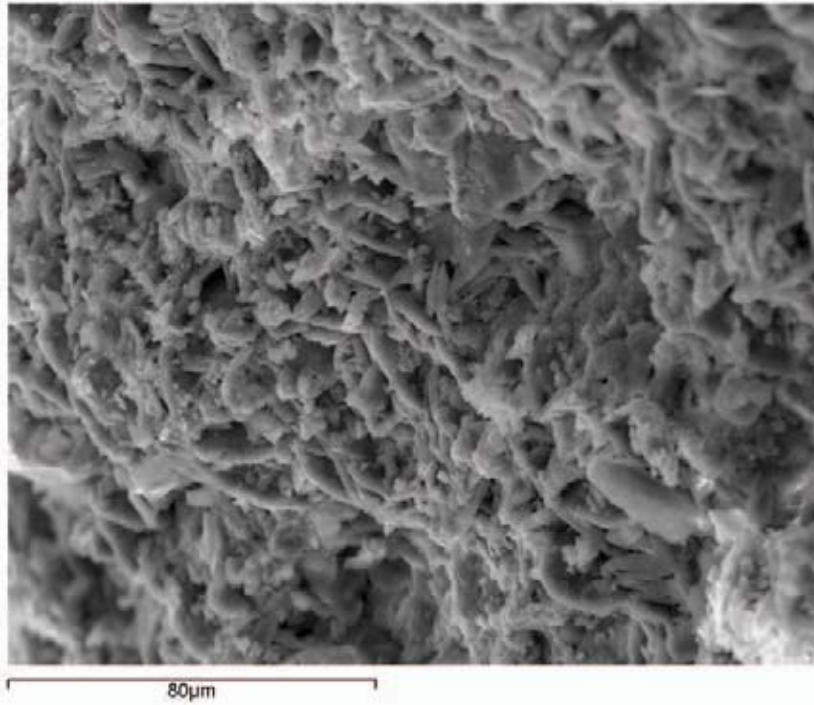
Figure 4.40:
Sample ID: N-9 Before Sample Location: North elevation, column 9
SEM Photomicrograph, 650x, another view of the external black crust on the surface
of the stone

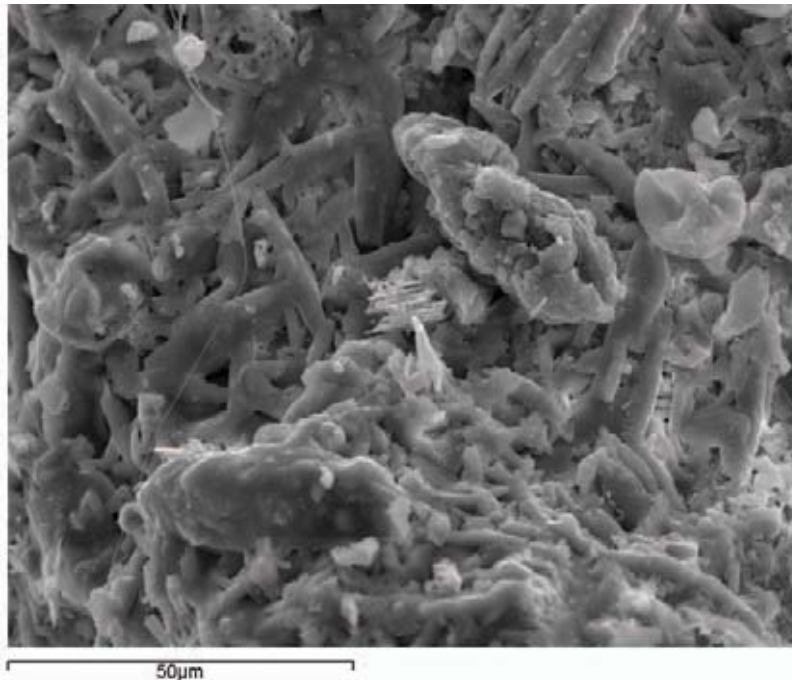
Figure 4.41:
Sample ID: N-9 Before Sample Location: North elevation, column 9
SEM Photomicrograph, 1000x, detail of the surface black crust as seen in Figure
4.40
