Quantitative Analysis and Treatment of Pennsylvania Blue Marble at the Philadelphia Merchants' Exchange

Presented to the Faculties of the University of Pennsylvania in Partial Fulfillment of the Requirements for the Degree of Master of Science in Historic Preservation.

Felicia Lyles McBratney

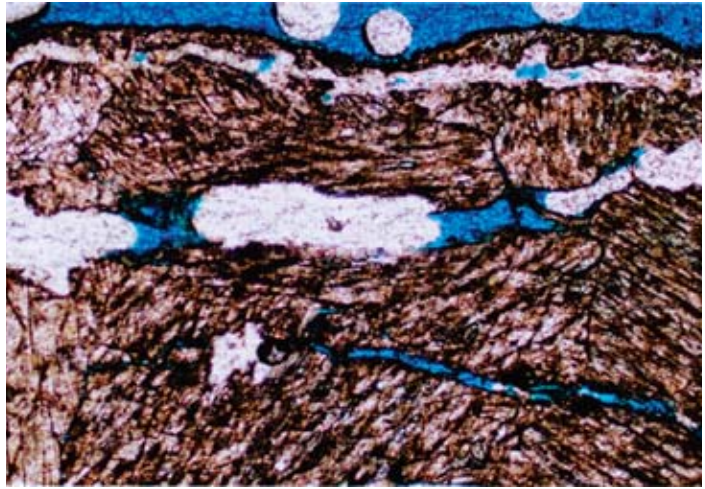
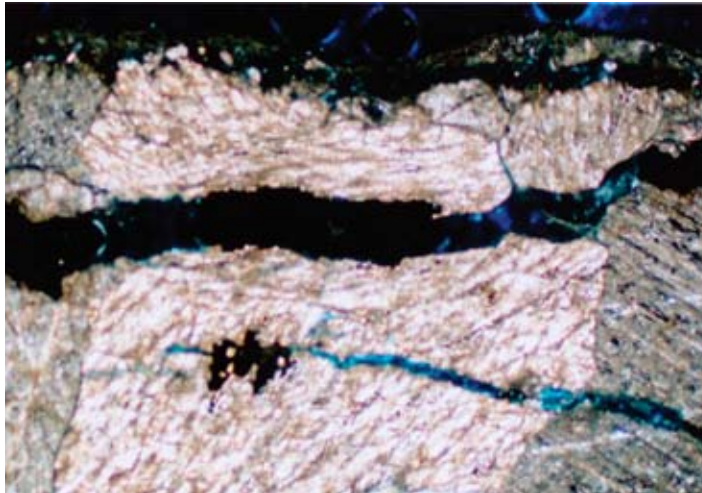
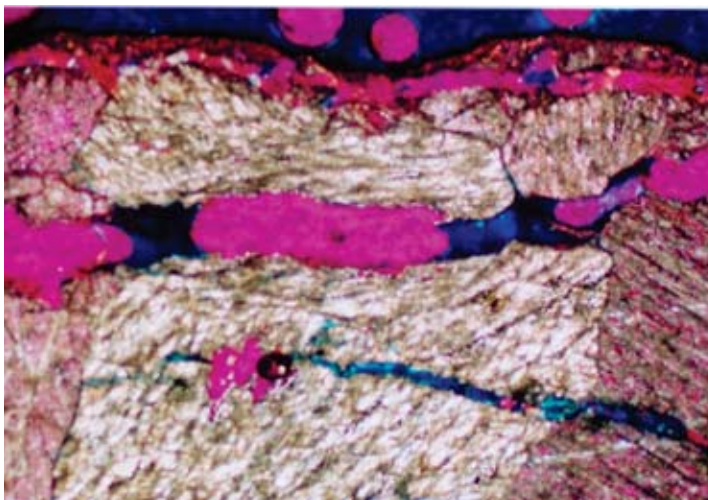
PLM Photomicrographs
Nikon Optiphot 2-POL
Sample ID: W-2
Sample Location: West elevation,
column 2
Comments: note the dark crust on
the external surface of the stone
(top) and microcracking near the
surface of the stone

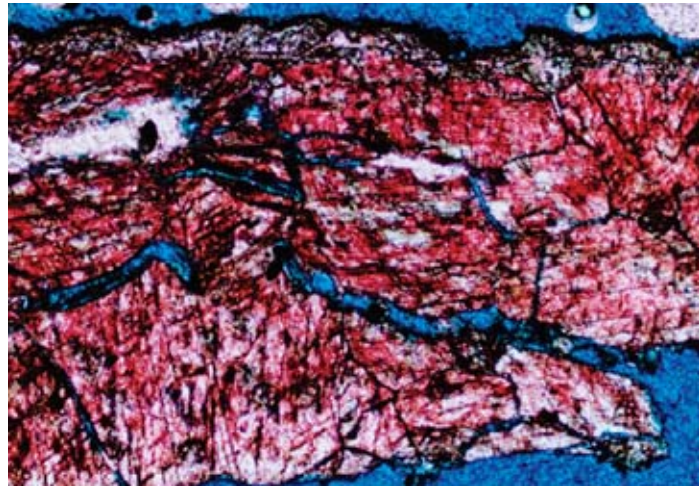
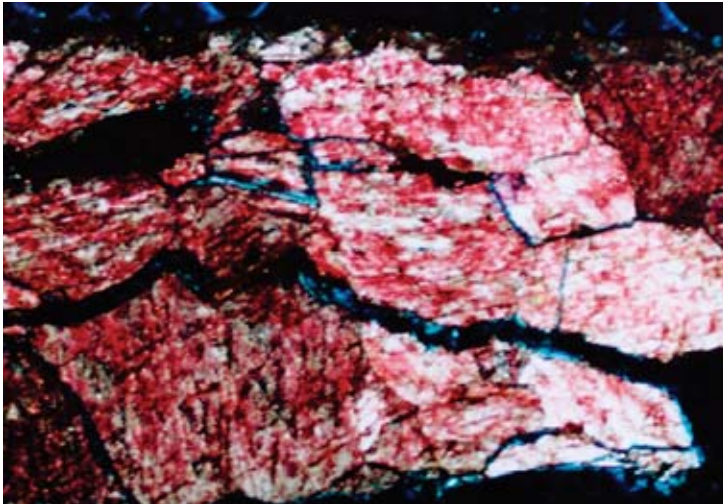
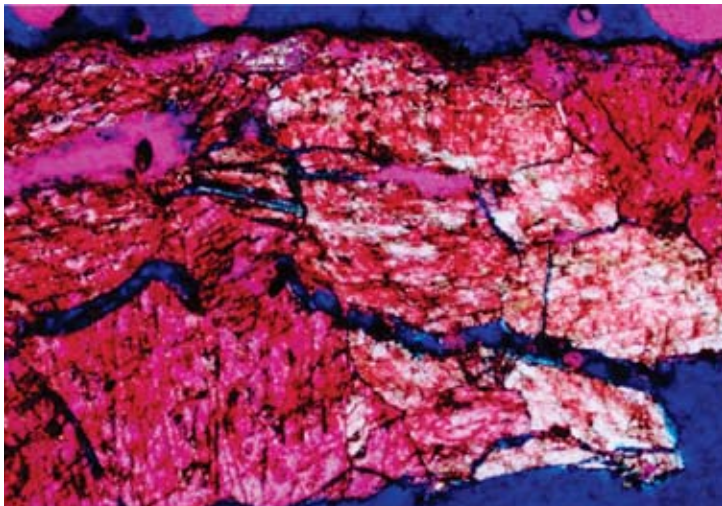
Comments: note the dark crust on
the external surface of the stone
(top) and microcracking near the
surface of the stone
(sample is stained with red
alizarin stain for calcium
carbonate)

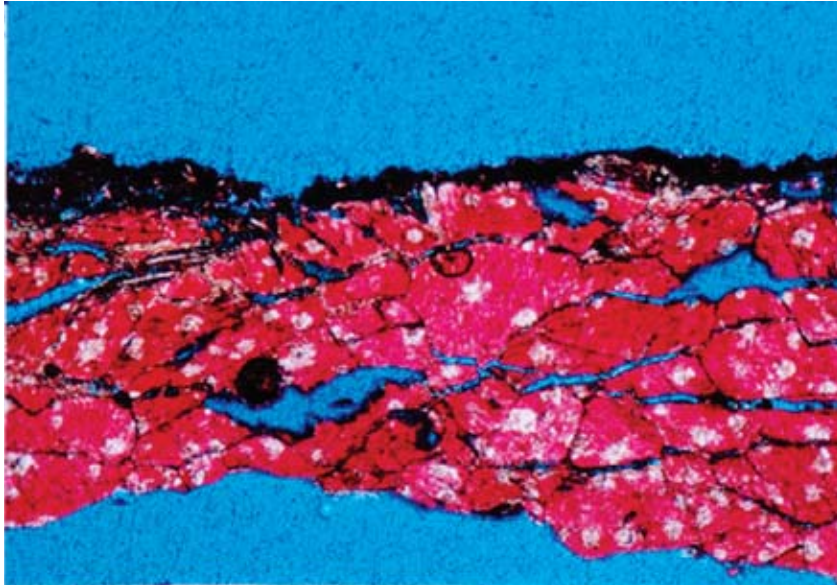
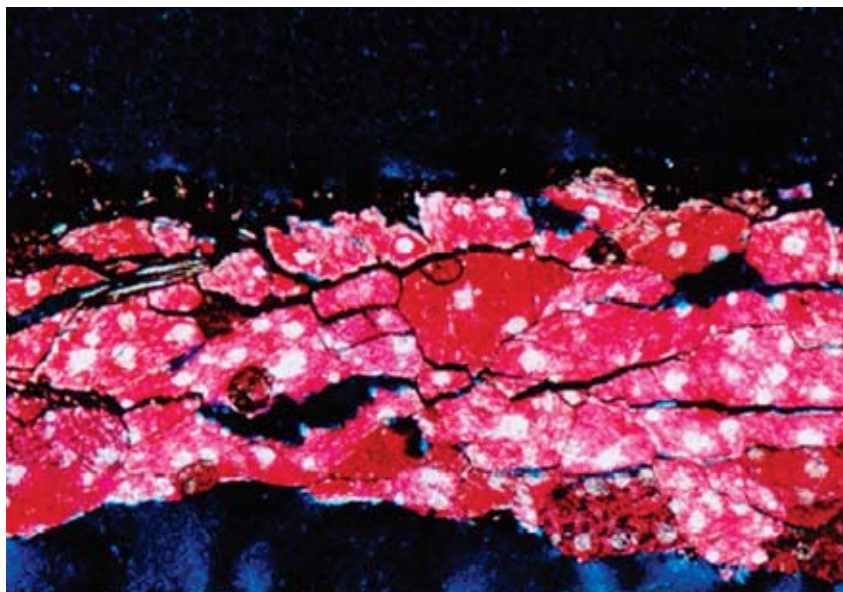
Comments: note the thick black surface crust on the external surface (top) and detached grain boundaries

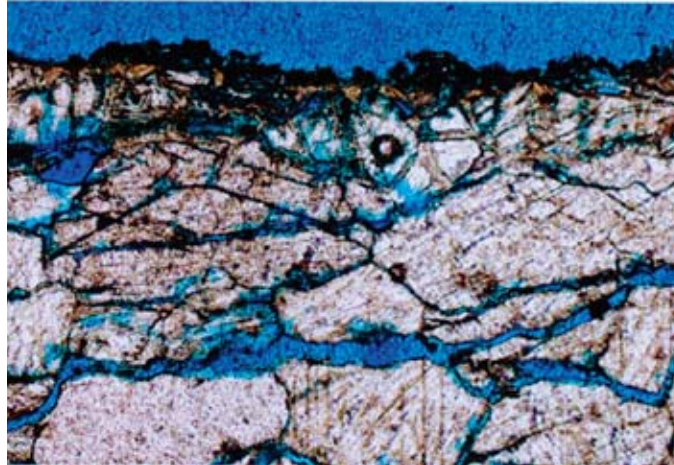
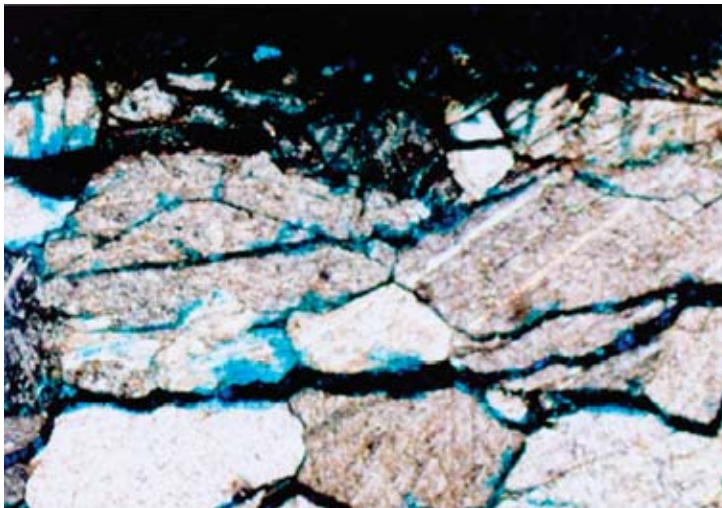
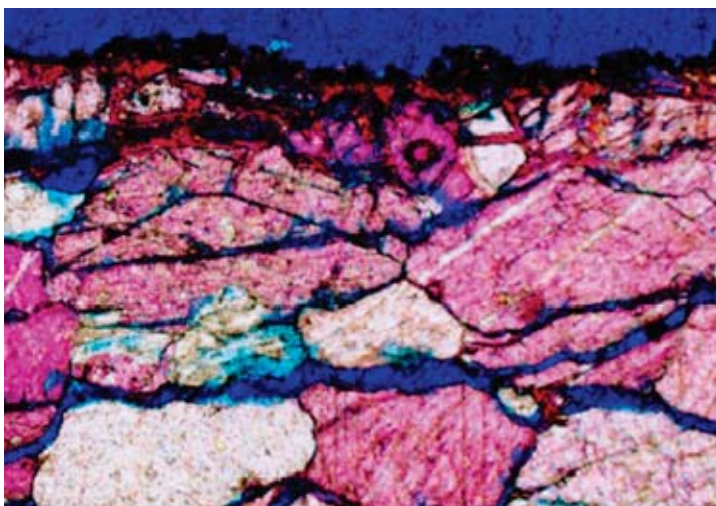
Comments: note the surface
etching and black crust on the
external surface of the stone
(top). the sample also shows
grain boundary detachments and
microcracking

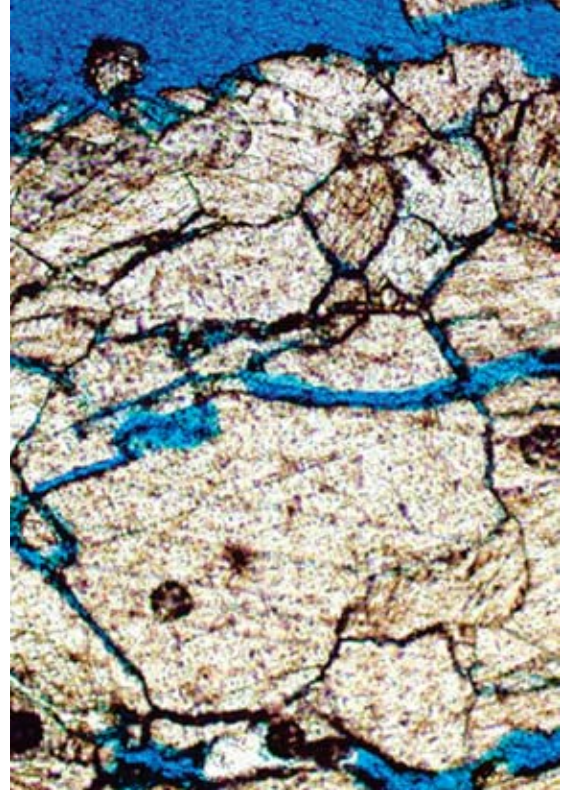
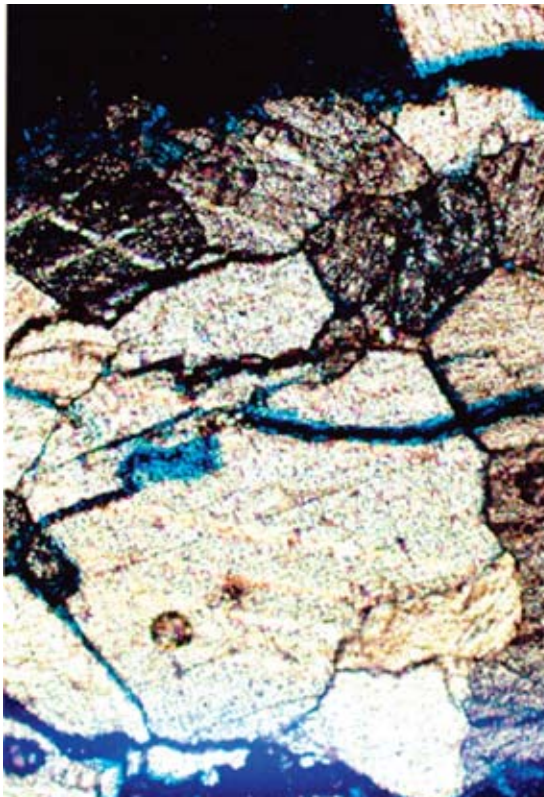
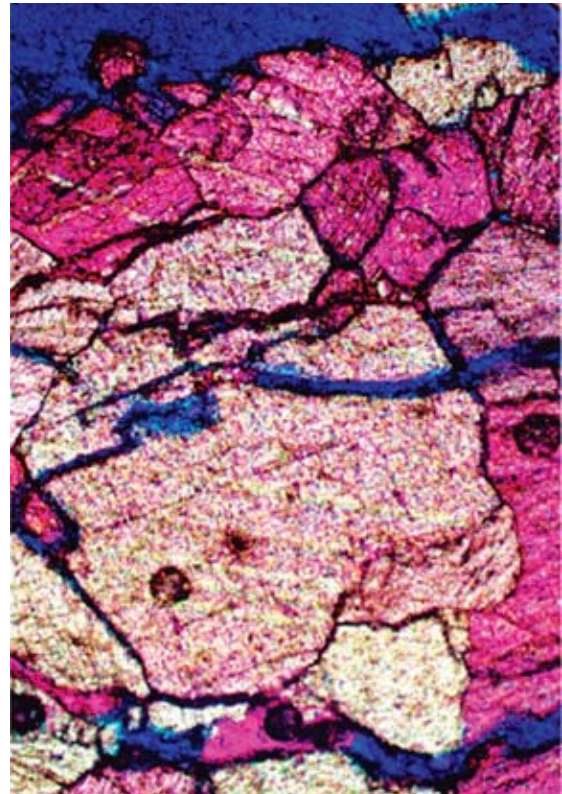
PLM Pre-treatment Analysis:
PLM Photomicrographs
Nikon Optiphot 2-POL
Sample ID: N-9 Before
Sample Location: North elevation, column 9
Comments: note the sample exhibits less black surface crust than the west and south column samples. also note the microcracking and surface etching (top) external surface of the stone sample

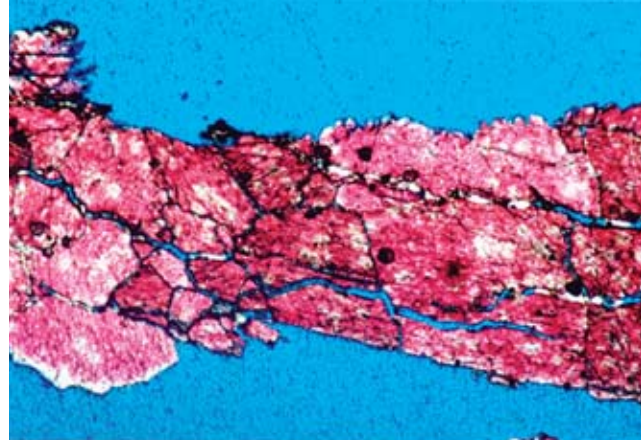
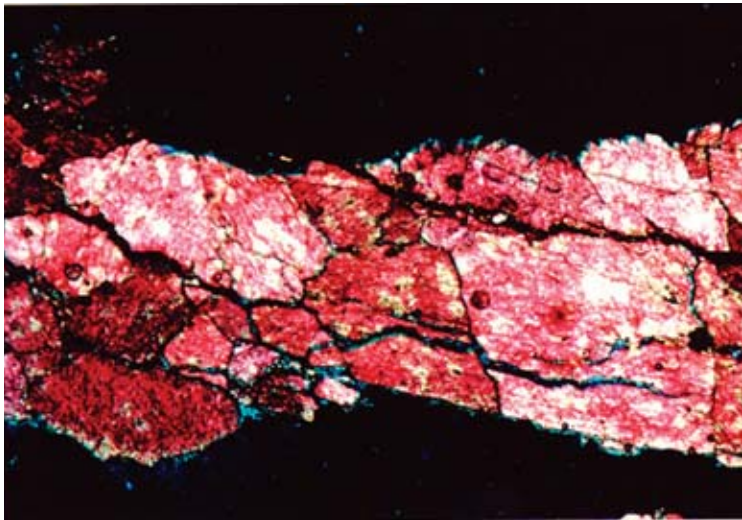
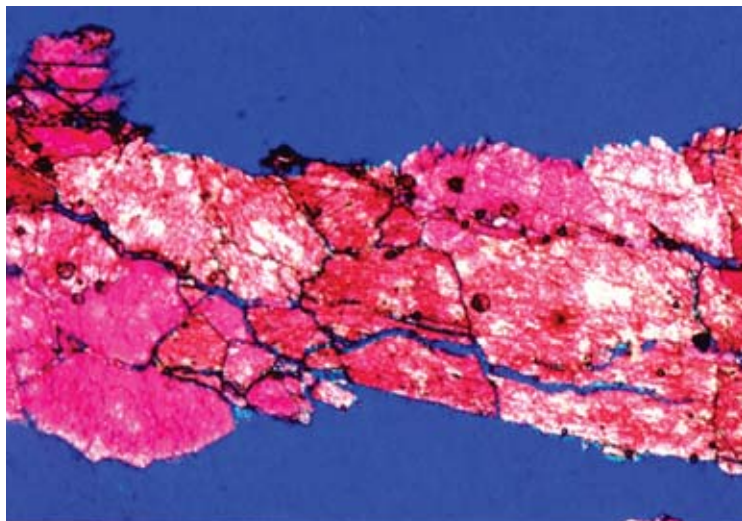
Comments: same sample as above
shown under lower magnification; note
the grain boundary detachment and
microcracking; also note the less soiled
surface than seen on the west and south
elevation column samples

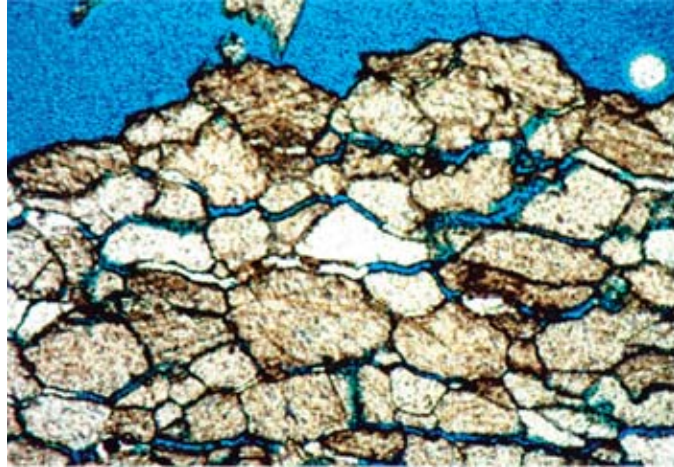
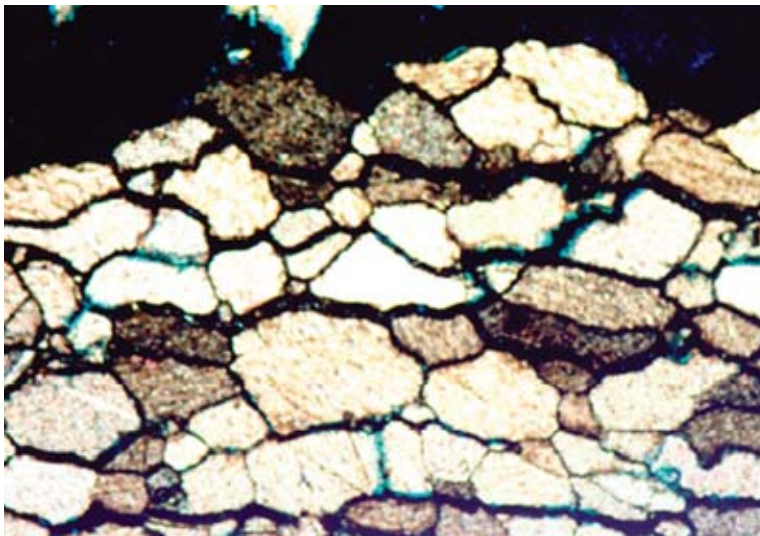
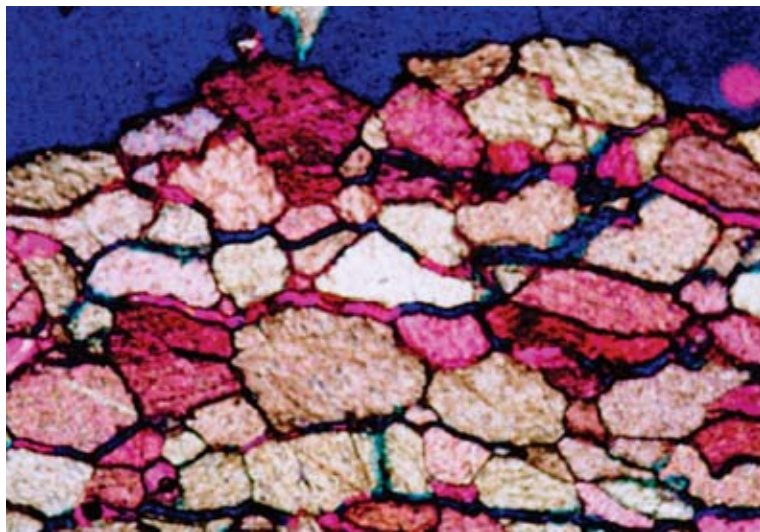
The sample obtained from south elevation, column 4 had heavy soiling as did the west elevation sample and exhibited grain boundary failure with loosely adhered calcite grains. However, the amount of surface etching was not as extensive as it was on the west façade. As explained, in the photographic comparison, the trees along the south may be acting a buffer from deposits of sulfur oxides settling on the stone surface.

PLM Pre-treatment Analysis:
PLM Photomicrographs
Nikon Optiphot 2-POL
Sample ID: S-4 Before
Sample Location: South elevation,
column 4
Comments: note the thin black
surface crust on the external surface
of the stone (top); severe grain
boundary detachment

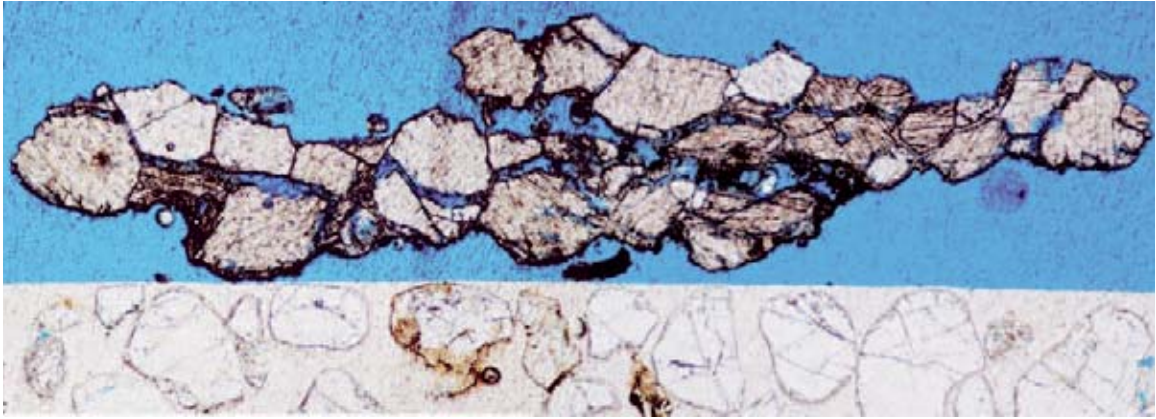
Figure 5.7:

The sample from the west elevation, column 4, had a layer of soiling on the external surface of the flake, as did the sample examined prior to treatment. Soiling also appeared on the internal surface of the flake and within the micro cracks of the flakes. The sample displayed extensive microcracking and the calcite crystals on the external surface were extremely etched and eroded. The calcite grains are also loosely attached to one another which results in flaking and disaggregation and provides at a microscopic level pores for water and other foreign materials to dwell. There does not seem to be much of a difference in appearance as compared to the sample examined prior to treatment.

Note the bottom of the sample is the external surface of the stone sample.

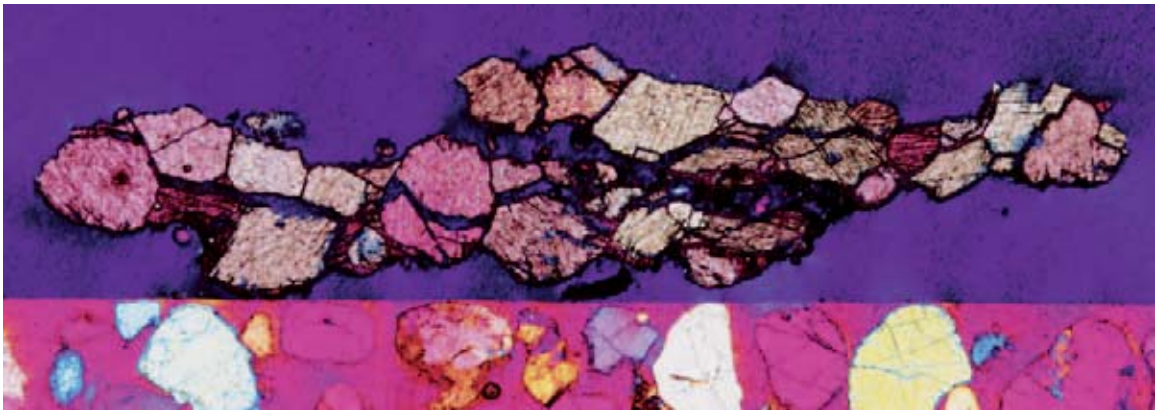
Figure 5.8:

Nikon Optiphot 2-POL, Cross Polarized Light, 5x, note the grain boundary detachment

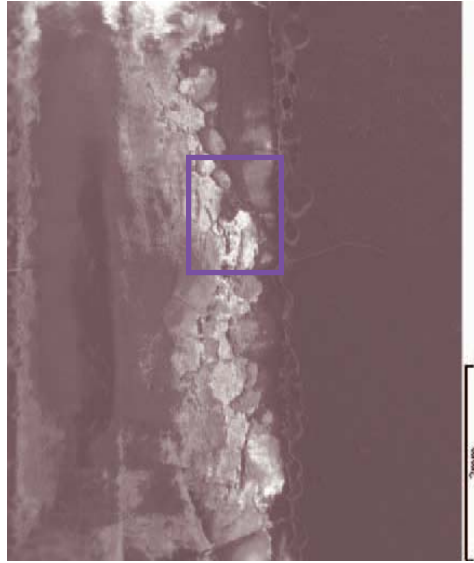
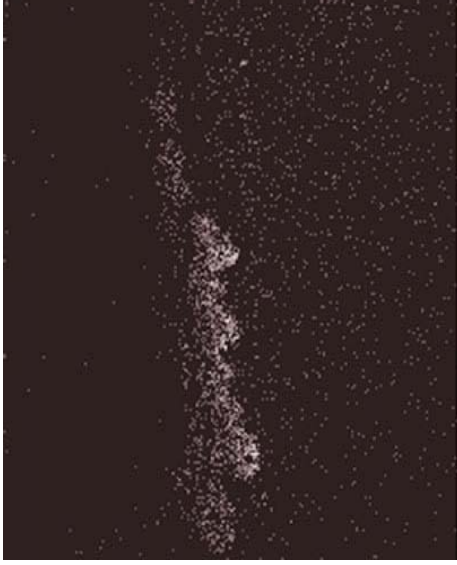
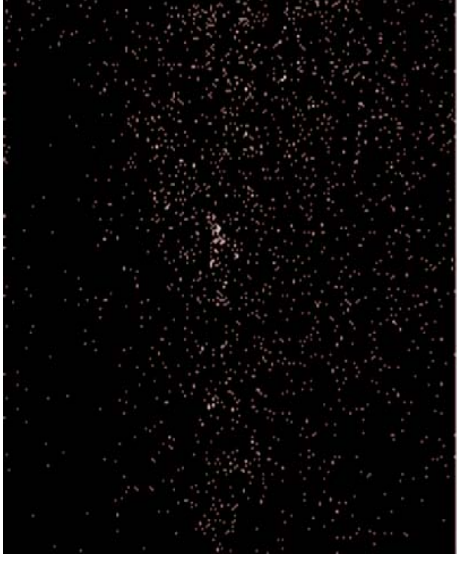
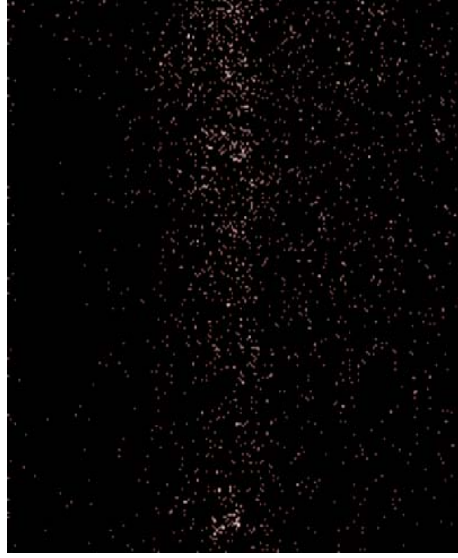
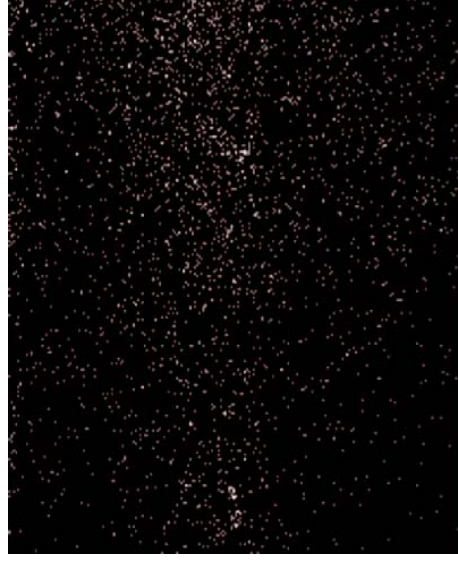
SEM-EDS Analysis:
 SEM photomicrograph and Elemental Dot Maps
 Magnification: 20x
 Sample ID: W-4 After
 Sample Location: West elevation, column 4, treated area
 Comments: Note the concentration of calcium ions on the exterior surface (bottom) of the sample and also the presence of sulfur on the exterior surface. Note the detection of sodium and chloride ions on the exterior surfaces of some of the calcite grains, which may be the presence of sodium chloride as seen in the pretreatment SEM images.

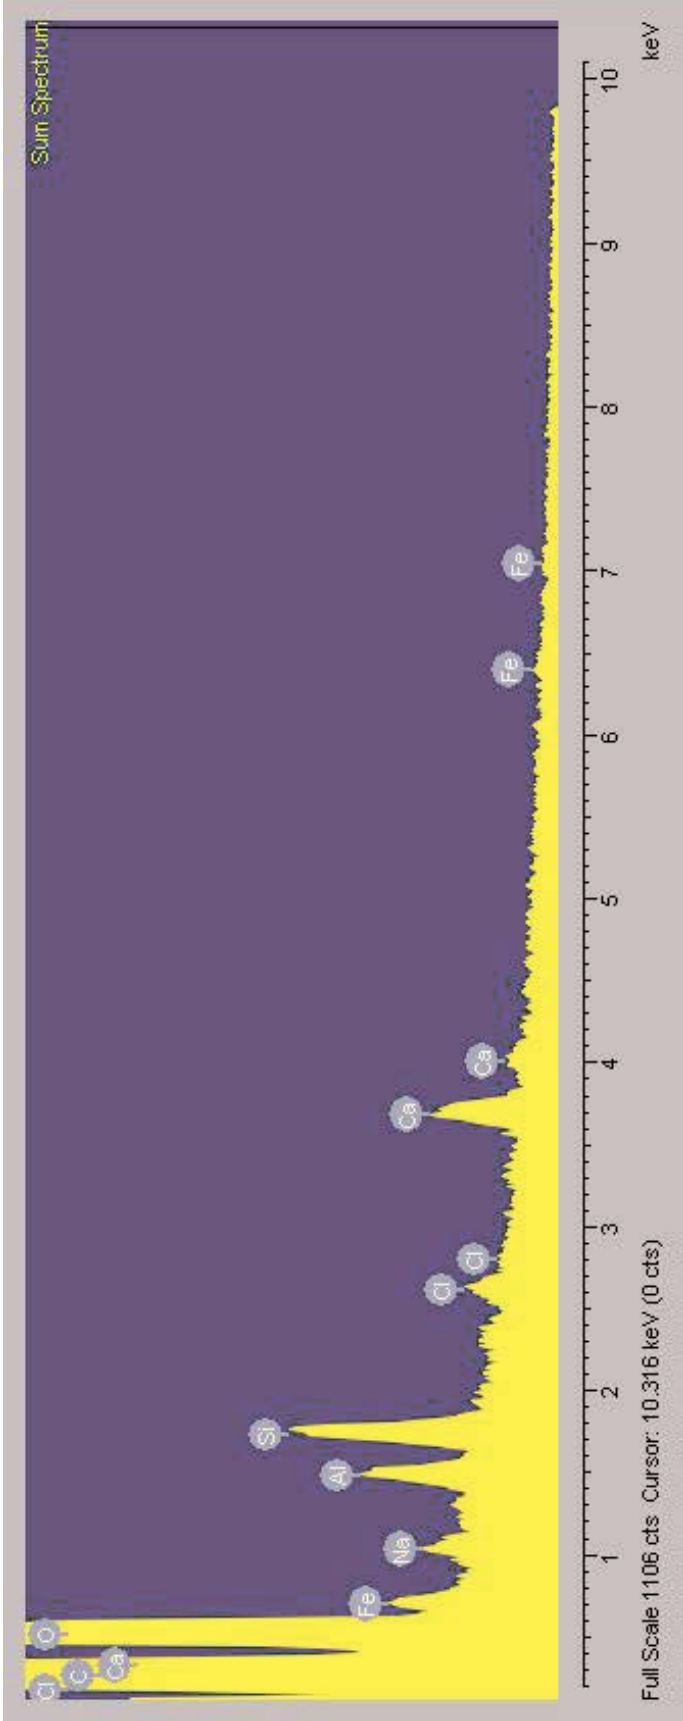
Figure 5.14:

Note the absence of sulfur (S) and barium (Ba) peaks as seen in the elemental spectrum of the same sample at a higher magnification.

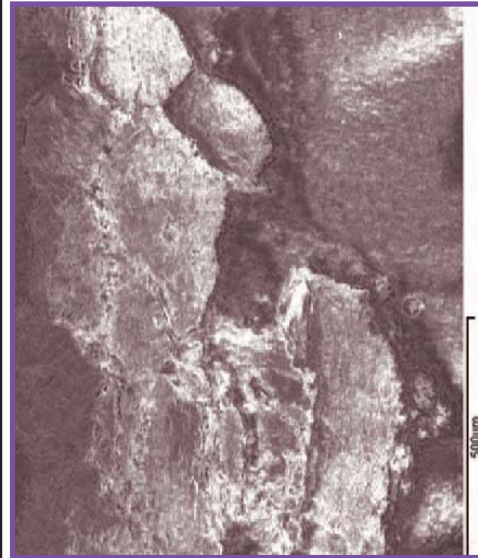
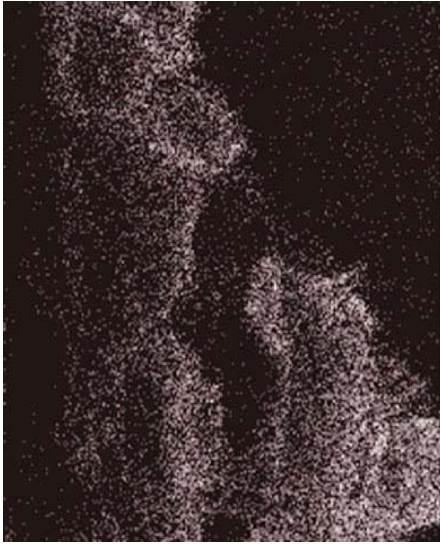
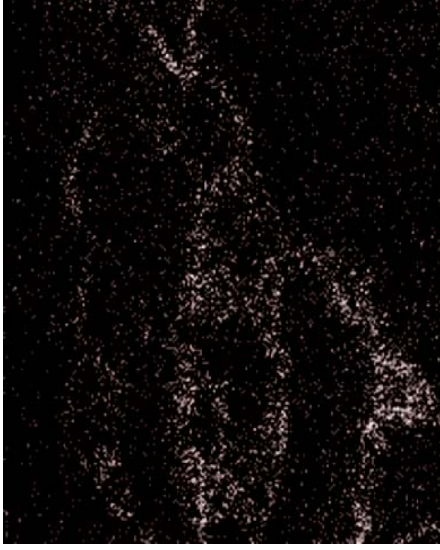
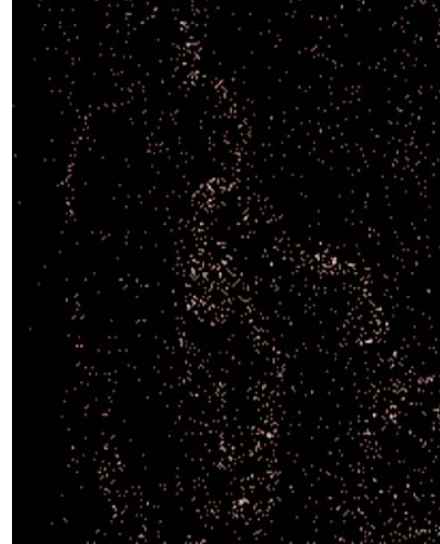
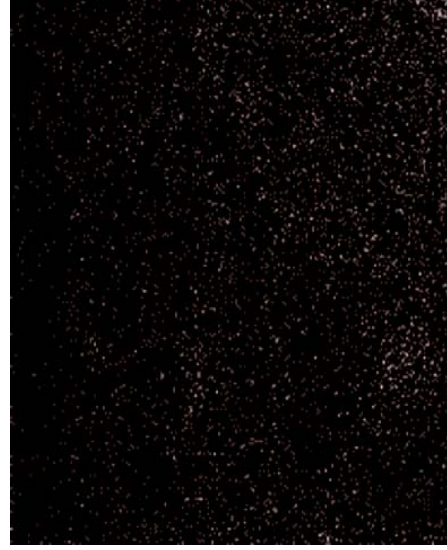
spaces indicating that the sulfur present was bound to the barium, leading to the conclusion that conversion of the gypsum (calcium sulfate dihydrate) to barium sulfate was successful. Although conversion does occur, the degree of conversion may vary depending on the texture and microstructure of the sample. These may be some of the reasons that explain why barium was only detected in one sample. It should also be noted that the barium ion was only detected at a high magnification, while at a lower magnification the barium signal was swamped by the higher amount of calcium present. The same sample was examined at a lower magnification and no barium was found. Sodium and chloride ions were detected as well, confirming the presence of sodium chloride, as observed in the pre-treatment SEM photomicrographs of similar samples.

SEM-EDS Analysis:
 SEM photomicrograph and Elemental Dot Maps
 Magnification: 100x
 Sample ID: W-4 After
 Sample Location: West elevation, column 4, treated area
 Comments: Note the concentration of calcium ions on the exterior surface (bottom) of the sample and the pattern of sulfur and barium ions between the grain boundaries. Chloride ions were also detected between the grain boundaries of the calcite crystals.

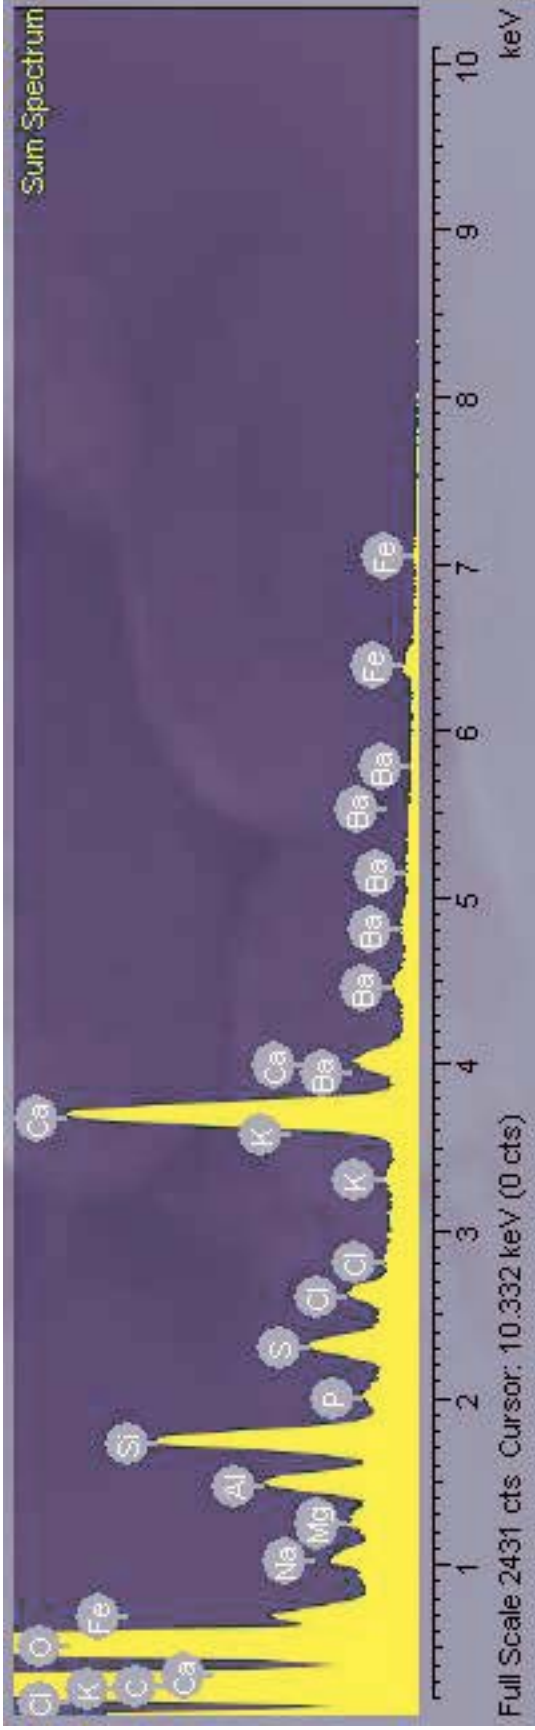
Figure 5.20:

Note the peaks of barium (Ba) and sulfur (S) indicating the presence of those elements.

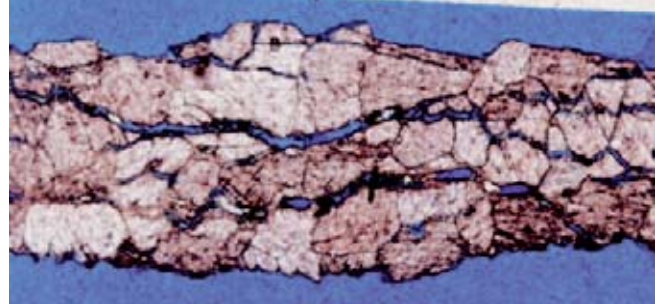
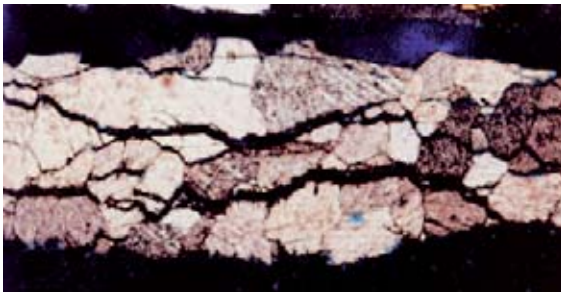
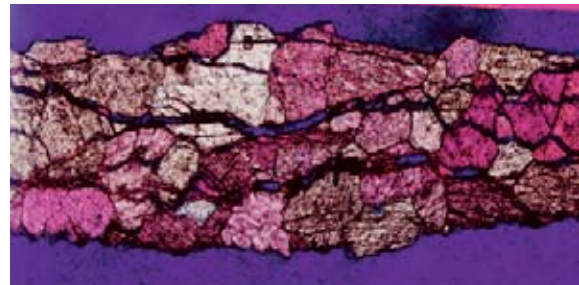
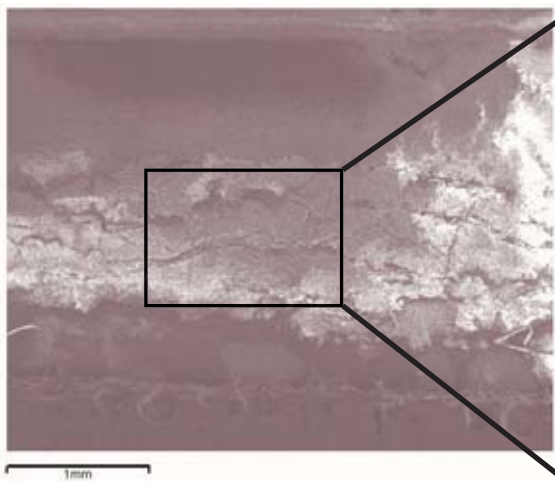
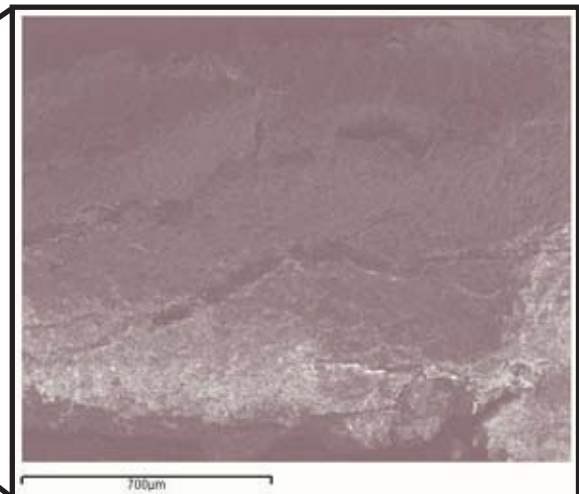
The sample obtained from south elevation, column 4 had soiling similar to the west and north elevation samples and exhibited serious microcracking with loosely adhered calcite grains. Overall, there was not a large difference as seen using polarized light microscopy between those samples taken prior to treatment and those taken post treatment.

PLM and SEM Analysis:
 PLM and SEM photomicrographs
 Sample ID: S-4 After
 Sample Location: South elevation,
 column 4, treated
 Comments: Note the microcracking
 and grain boundary separation. There
 is also a layer of amorphous particles
 on the external surface of the stone.
 The external surfaces of the calcite
 grains are also etched and rigid as com-
 pared to those on the internal surface.
 (the bottom is the external surface of
 the stone)

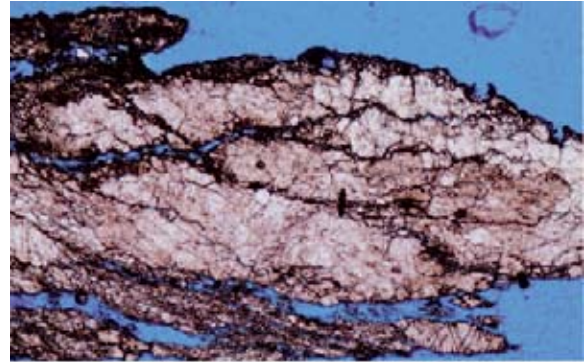
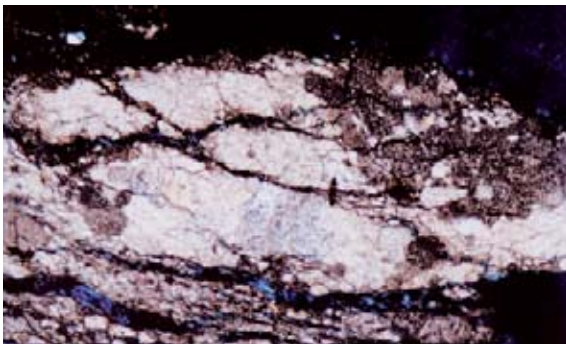
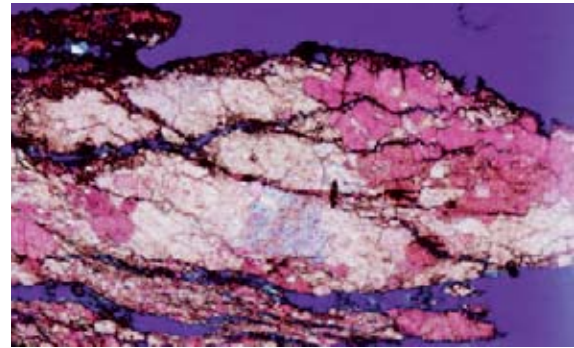
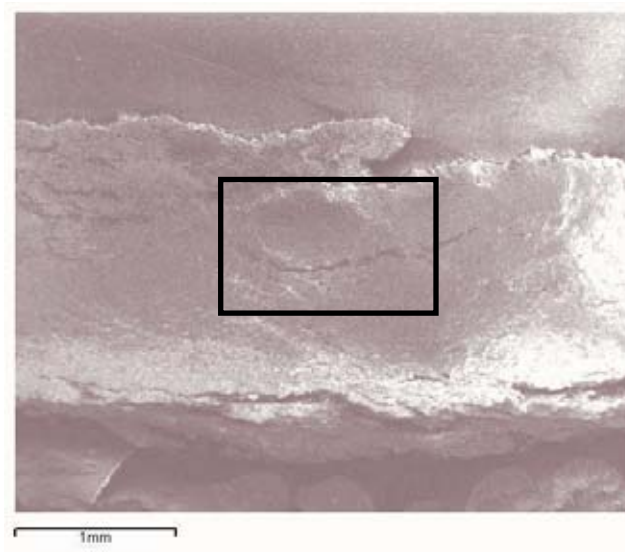
The sample obtained from north elevation, column nine showed soiling like that of sample obtained from the west elevation. Surface etching of the calcite crystals is also present on the north elevation sample. Extensive microcracking and loosely adhered calcite grains were also evident. There is also the presence of small crystals near the surface, which can be seen under cross polarized light at a higher magnification.

PLM and SEM-EDS Analysis:
PLM and SEM photomicrographs
Sample ID: N-9 After
Sample Location: North elevation,
column 9, treated area
Comments: Note the grain boundary
detachment and the dark layer of soil-
ing on the external surface of the stone
sample. (the top is the external surface
of the stone)

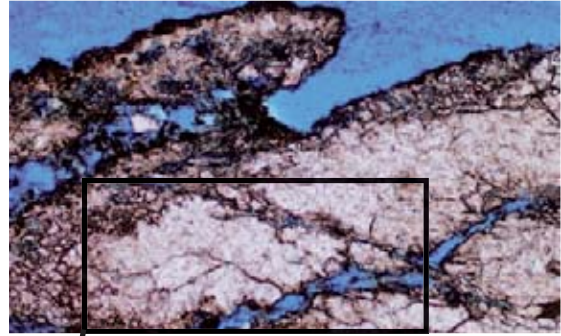
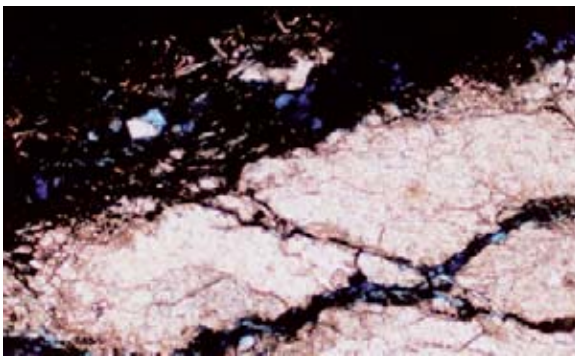
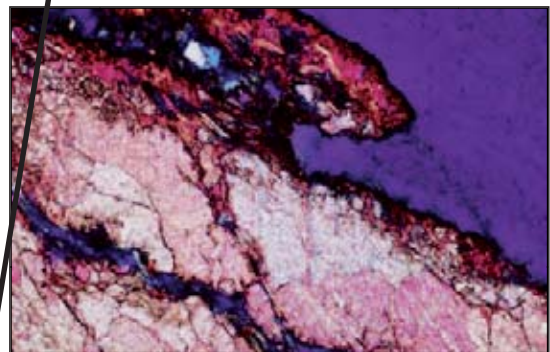
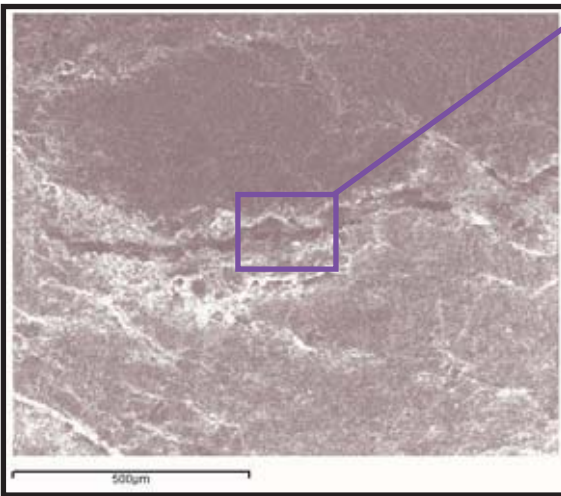
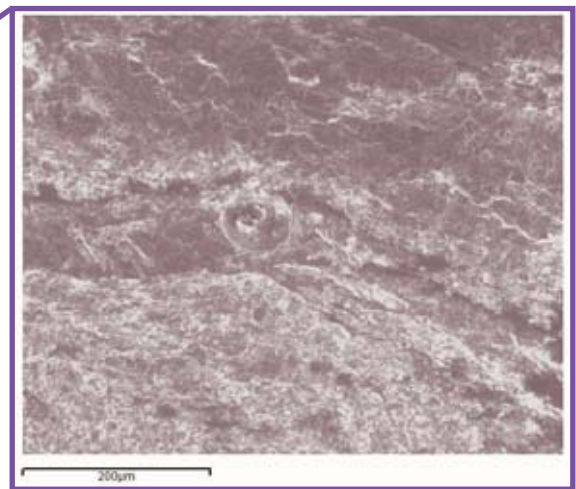
PLM and SEM-EDS Analysis:
 PLM and SEM photomicrographs
 Sample ID: N-9 After
 Sample Location: North elevation,
 column 9, treated area
 Comments: Note the dark layer
 of amorphous particles attached to
 external surface of the stone
 (the top is the external surface of
 the stone)

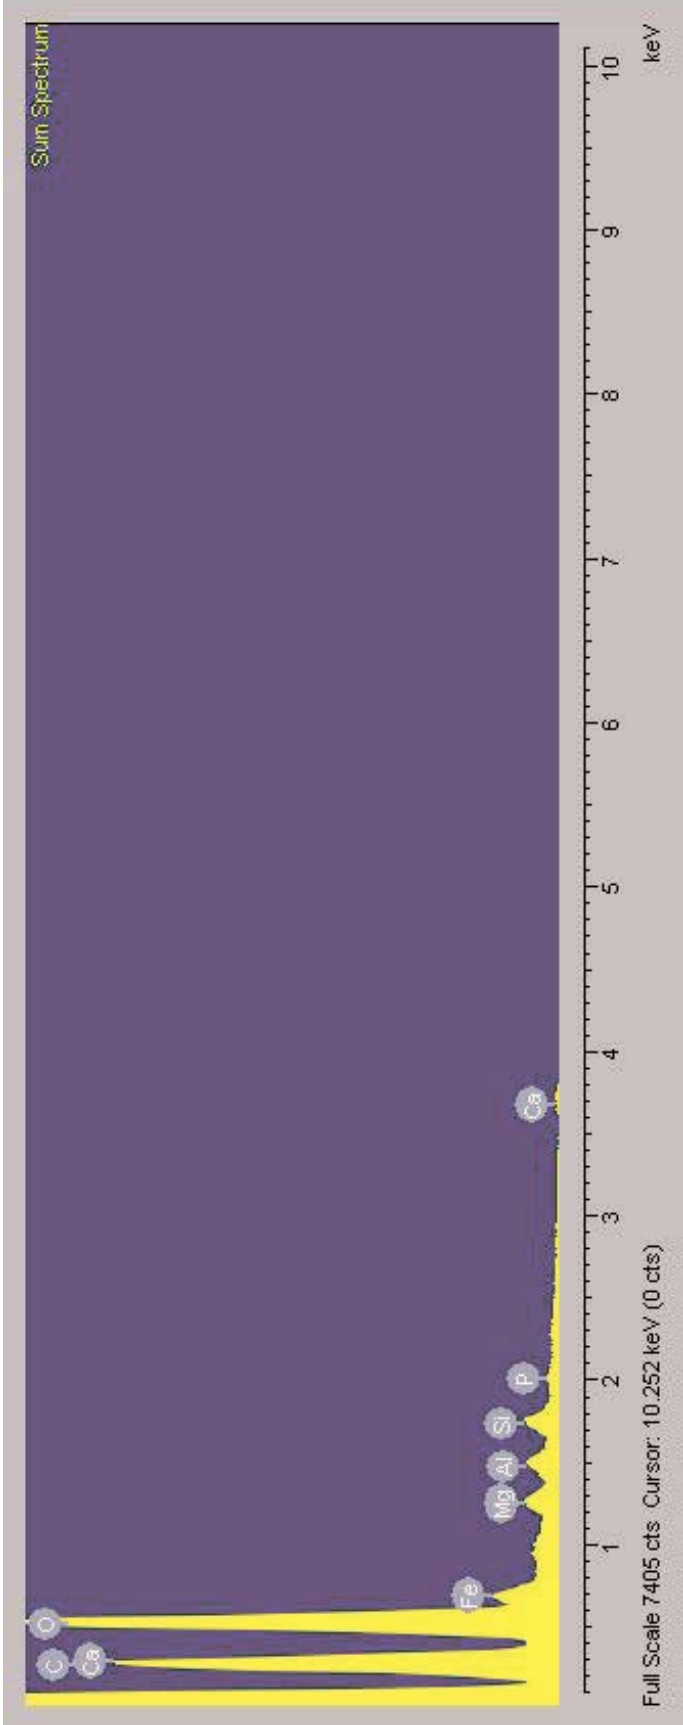
Figure 5.37:

Note the absence of sulfur and barium peaks as seen in the elemental spectrum from Sample W-4 After, examined under the same magnification.

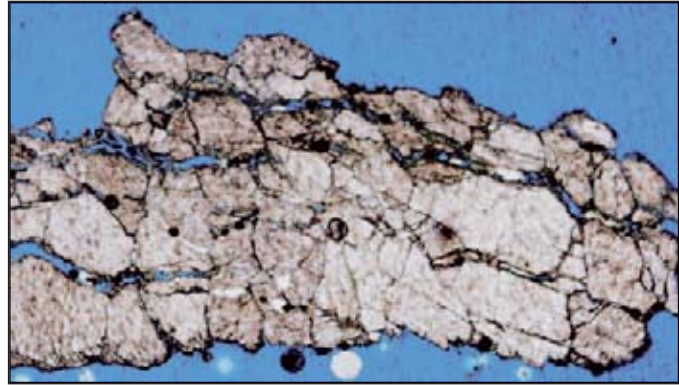
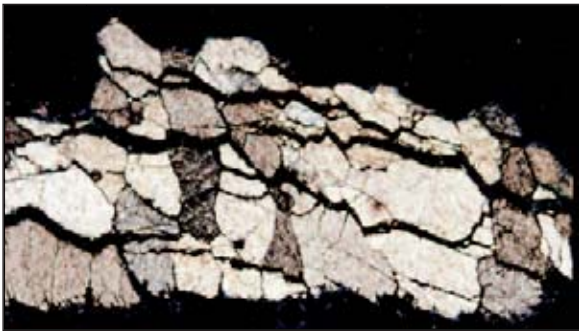
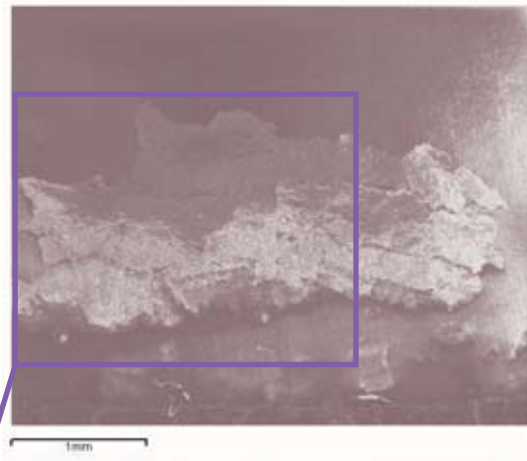
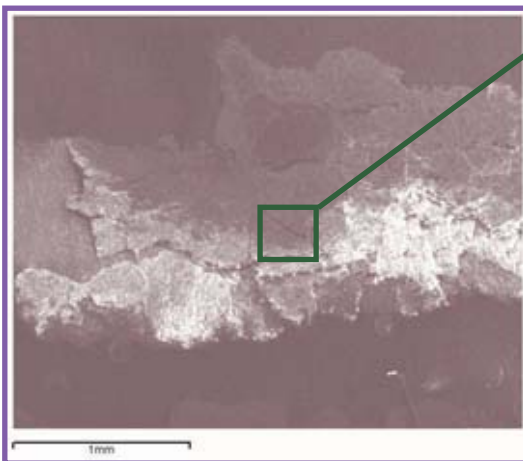
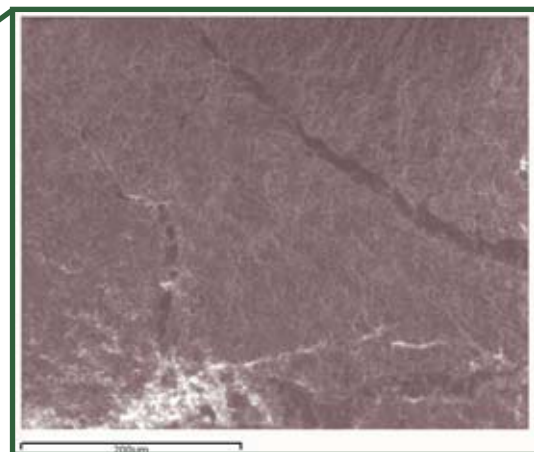
The sample that had been treated by Prof. Lewin in the early 1980's, sample S-2 from south elevation, column 2, did not show the presence of the barium ion. Approximately 20 years have elapsed since the treatment was applied, mechanical wear may have eliminated some of it. The fact that no sulfur was detected in this sample supports this conclusion.

Comments: Note the calcite grain detachment and the dark layer of surface soiling on the external surface of the stone sample.

(the bottom is the external surface of the stone)

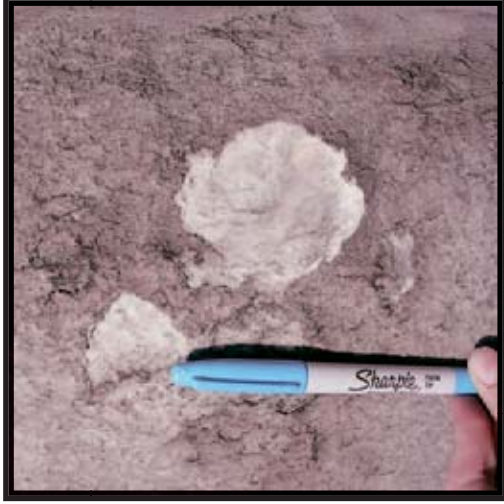
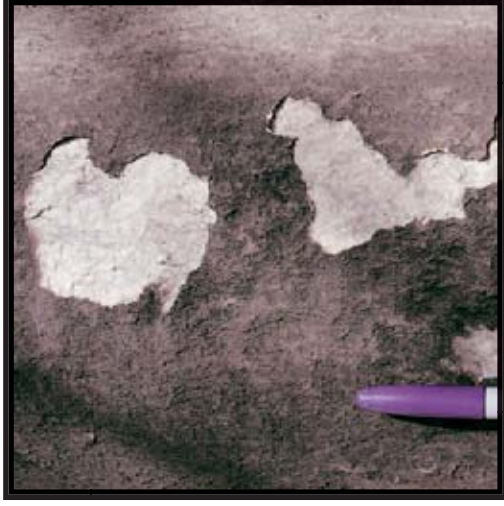
(a) flaking resulting from popped blisters

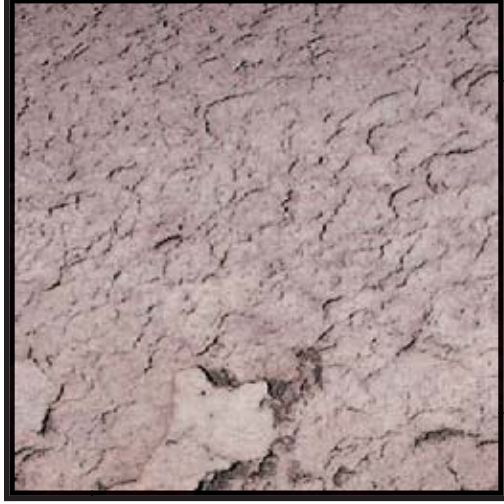
(b) general area of flaking

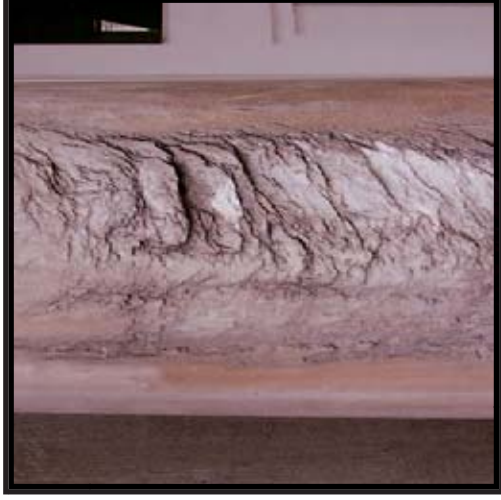
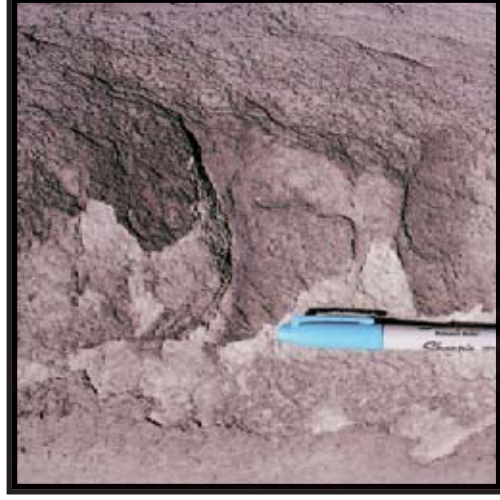
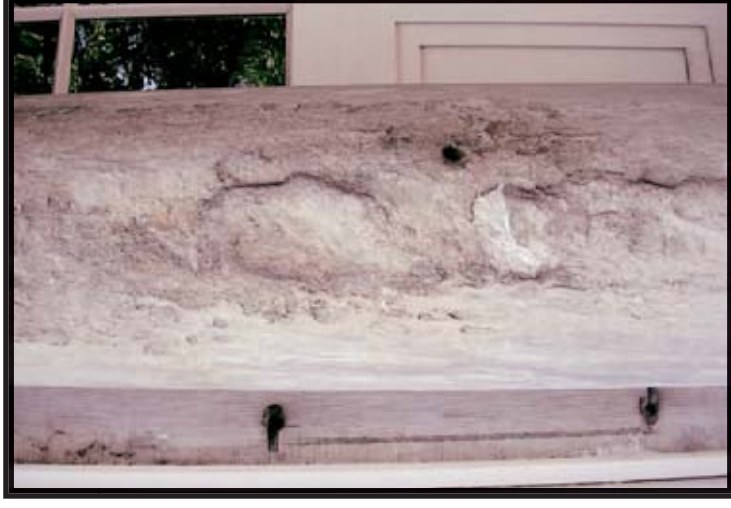
Incipient spalling

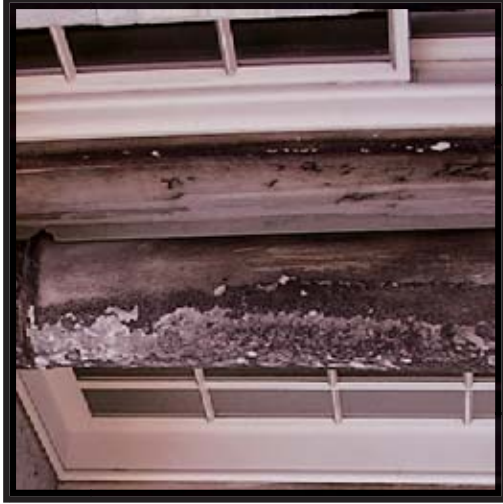
(a) blistering in areas of flaking and contour scaling

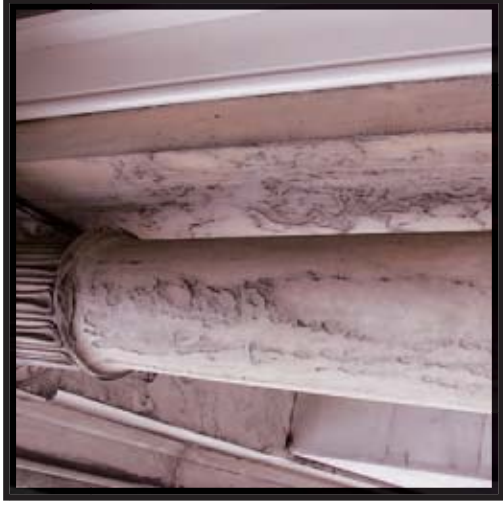
(b) blistering along mineral inclusions
