Quantitative Analysis and Treatment of Pennsylvania Blue Marble at the Philadelphia Merchants' Exchange

Presented to the Faculties of the University of Pennsylvania in Partial Fulfillment of the Requirements for the Degree of Master of Science in Historic Preservation.

Felicia Lyles McBratney

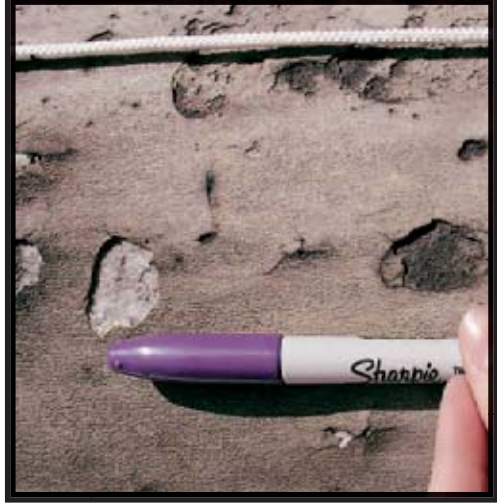
small blisters detaching from stone surface

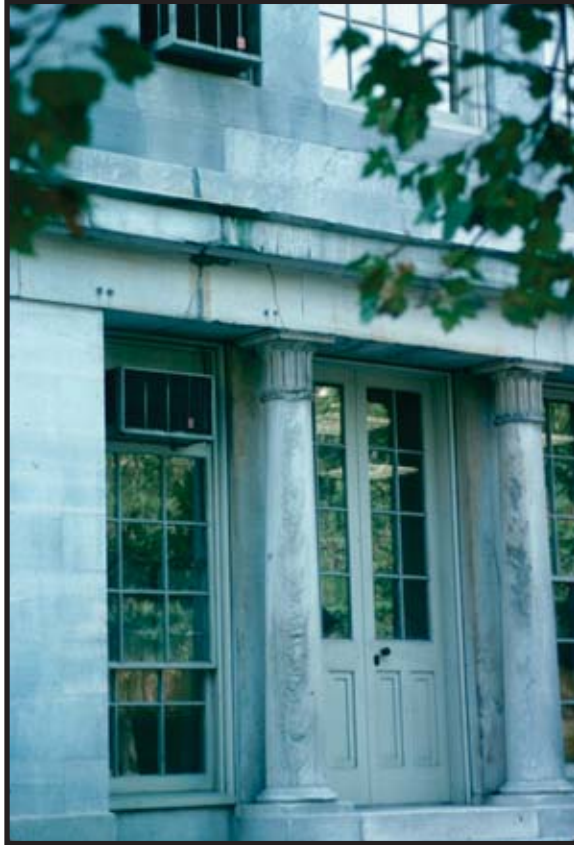
Figure C.9:
North elevation first floor, west
bay, October 1975?
Columns 9 and 10
Source: INHP Archives

Comments: Column 9 exhibits
contour scaling forming u-shaped
scales along the length of the
column with some mild soiling.
Column 10 exhibits flaking and
mild soiling in the areas of
flaking.

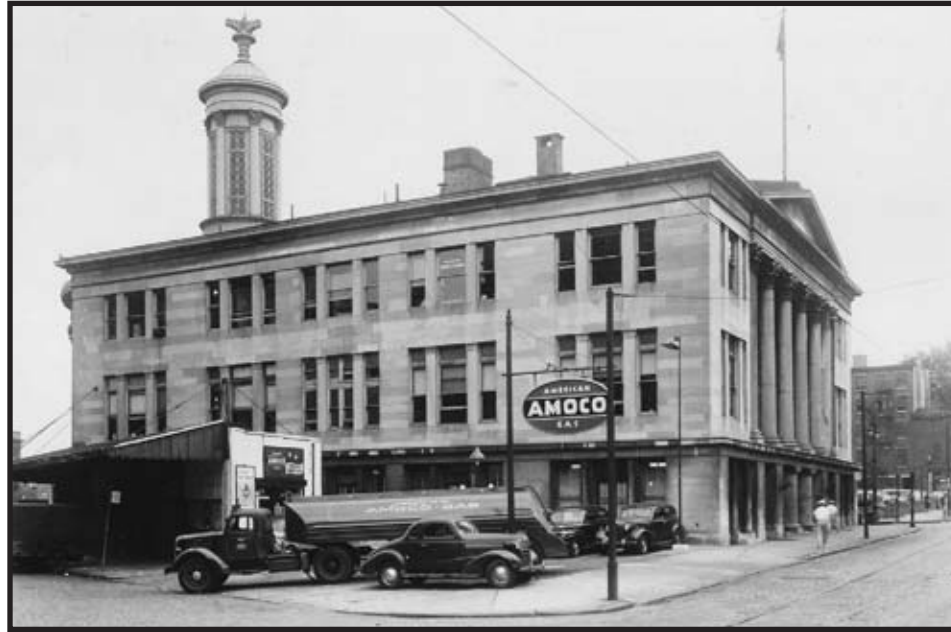
Figure C.13:
North elevation, contextual image Source:INHP Archives
Creator: C.E. Peterson Date: April 19, 1960

Comments: The surrounding conditions on the north façade of the Merchants' Exchange have drastically changed. The historic photograph shows a darkened soiled façade behind a gas station with parking next to the building. The current photograph shows that these surrounding conditions have been removed, Dock Street was blocked off in 1962 and the location of the gas station and parking has been filled with sidewalks and plantings.

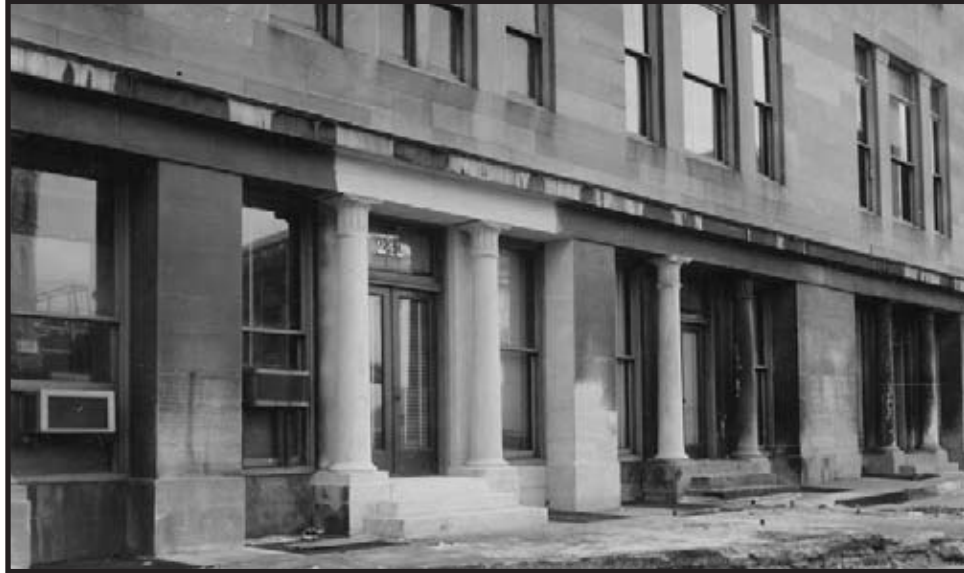
Figure C.15:
North elevation, columns 5-10
Source: INHP Archives
Caption: Merchants' Exchange: 2 columns treated by sandblasting and 1
column carved by stone cutter
Creator: Paul J. F. Schumacher
Date: December 2, 1953

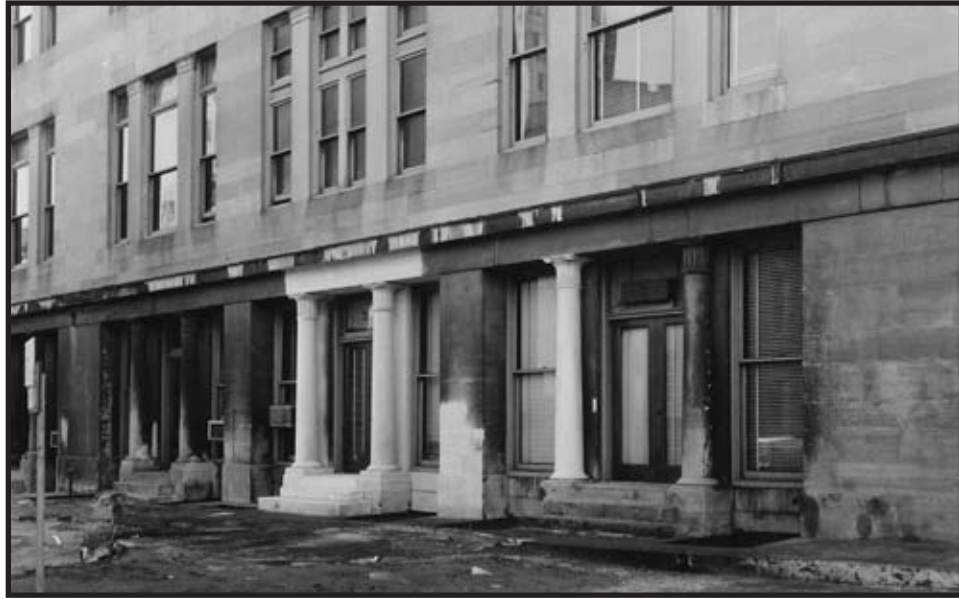
Figure C.17:
North elevation, columns 6-10
Source: INHP Archives
Caption: Merchants' Exchange: 2 columns treated by sandblasting and 1
column carved by stone cutter
Creator: Paul J. F. Schumacher
Date: December 15, 1953

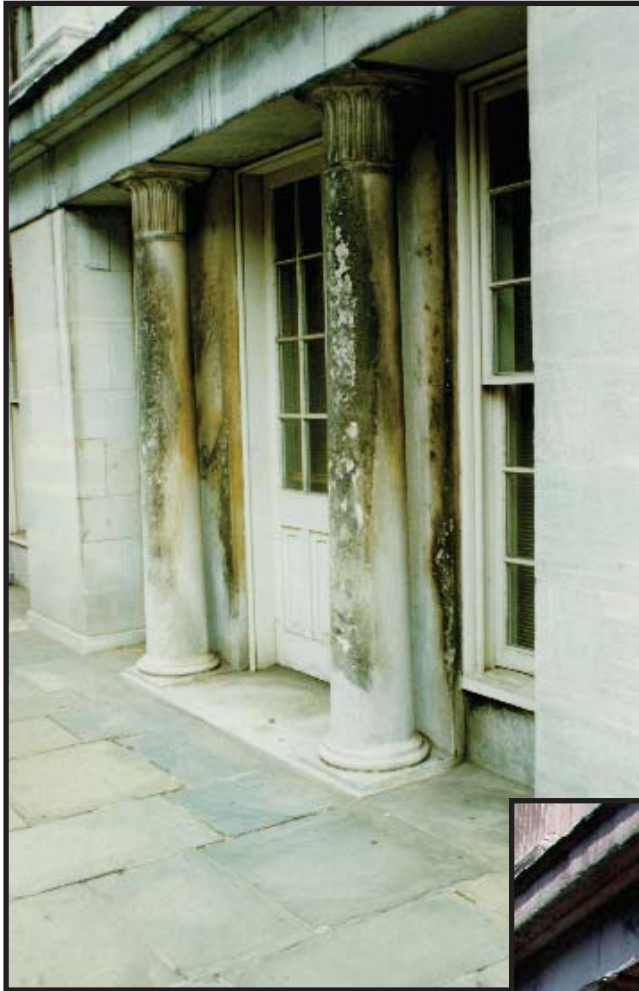
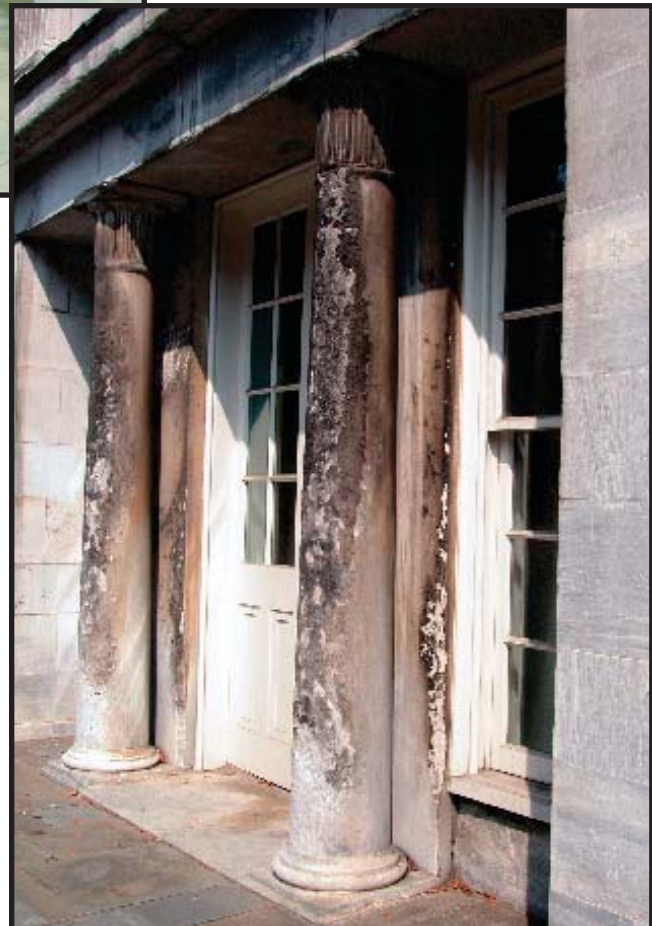
Comments: The current photograph appears to have larger area of fresh blistering and flaking that are marked by the absence of soiling on both columns 3 and 4. There seems to be advanced soiling, flaking, and blistering, which can be attributed to the continued vehicular traffic along the west elevation. On column 4, areas that were freshly flaking or blistering in the historic photograph have soiled.

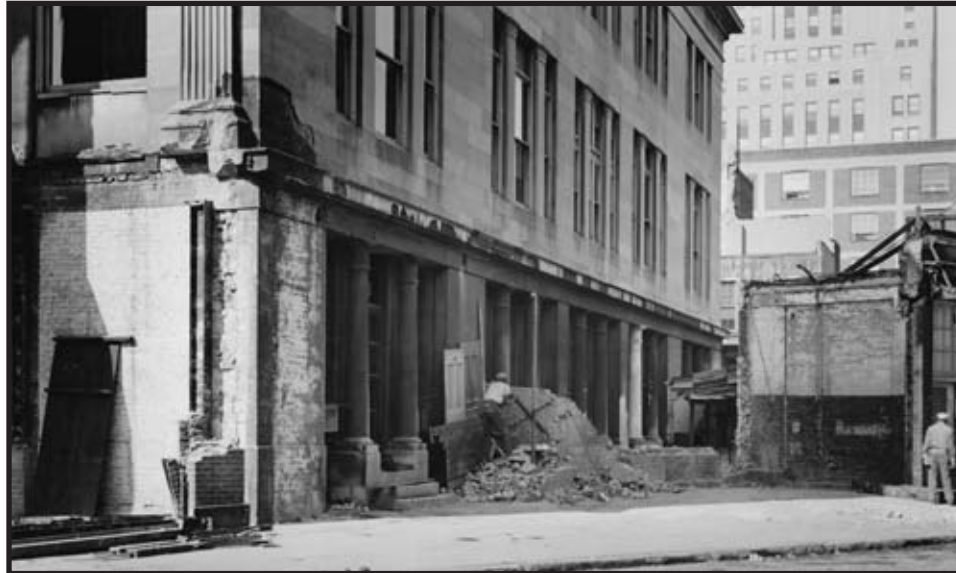
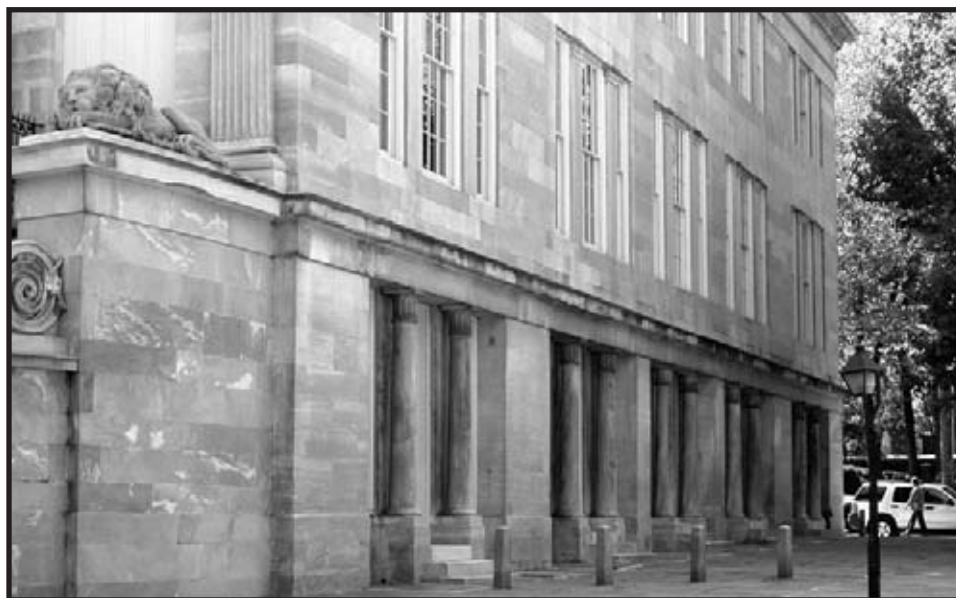
Comments: Notice the re-carved column (#7) in the historic photograph. The produce stalls are being removed, changing the surrounding environmental conditions around the columns. During the wrecking of the produce stalls, possible mechanical damaged could have occurred. Notice the black soiling of the columns in the historic photograph has been removed.

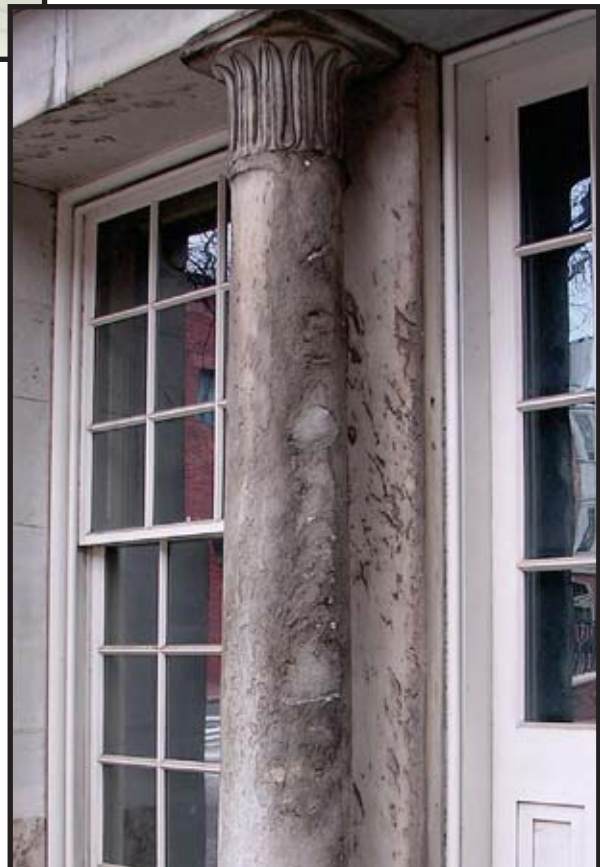
Comments: The most evident deterioration mechanisms shown in the historic photograph are contour scaling and dimensional loss. The caption of the photographs mentions a "fill", which is no longer present. There is a clear up-side-down u-shaped pattern of contour scaling which follows the stone's orientation and correlates to the location of mica mineral inclusions. The action of contour scaling is compounded by the presence of salts and freeze-thaw action. This deterioration pattern is evident in both the historic and current photographs.

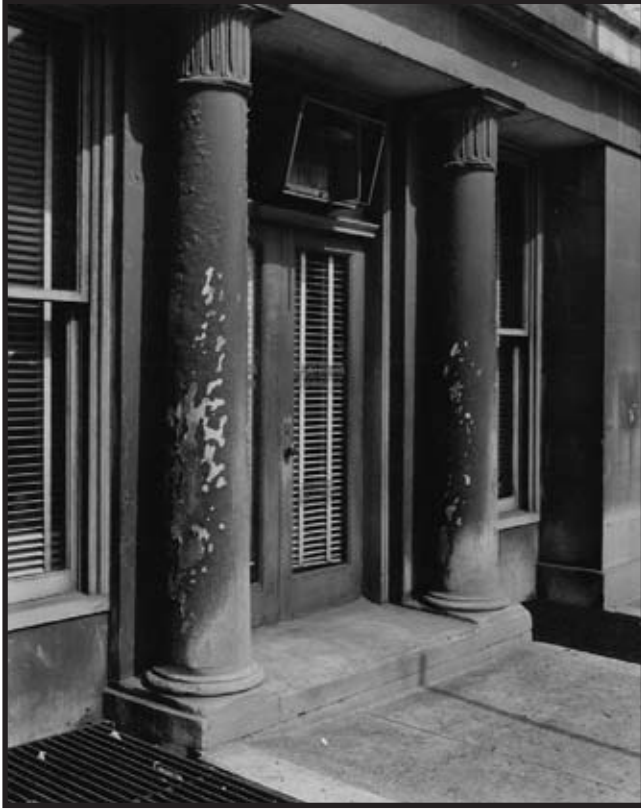
Figure C.50:
South elevation, columns 3 and 4
Source: INHP Archives
Caption: Merchants' Exchange:
South wall, second entrance
from west end. Detail showing
disintegration of first floor marble
columns
Creator: Knickerbocker (Housam)
Date: March 20, 1952
