Managing Change: The Role of Documentation and Condition Survey at Mesa Verde National Park

Frank G. Matero

Journal of the American Institute for Conservation, Vol. 42, No. 1, Architecture Issue. (Spring, 2003), pp. 39-58.

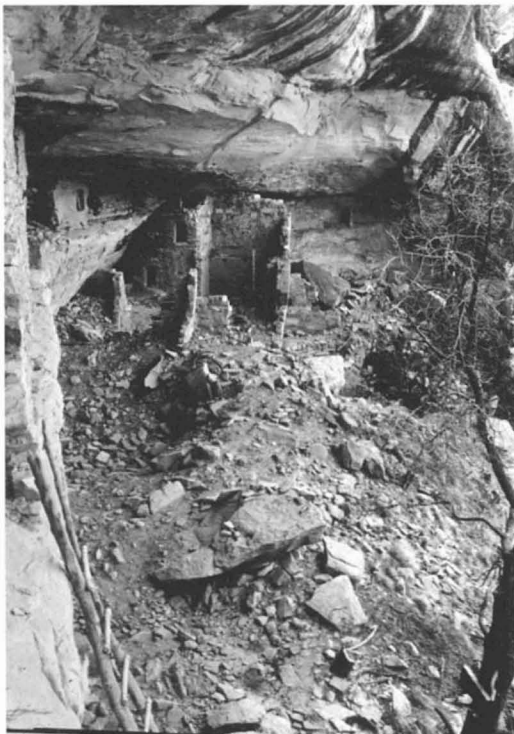
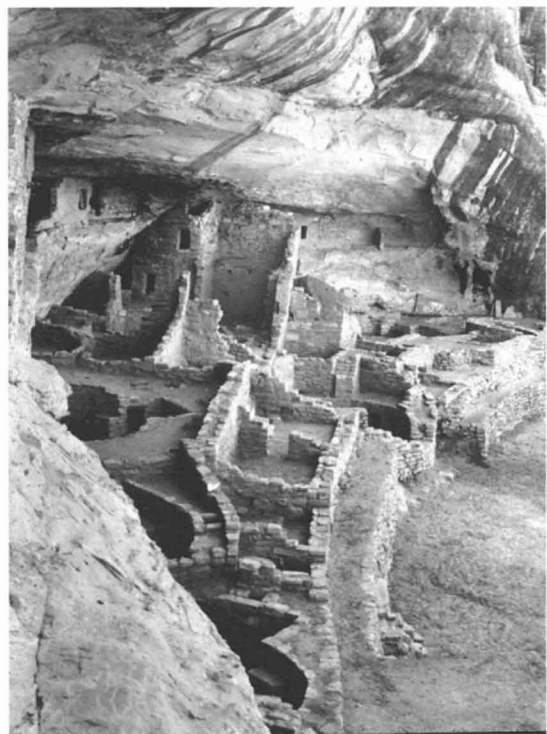
Fig. 3. Mug House, before (a) and after (b) excavation and stabilization in 1959–60. Courtesy of NPS-MEVE

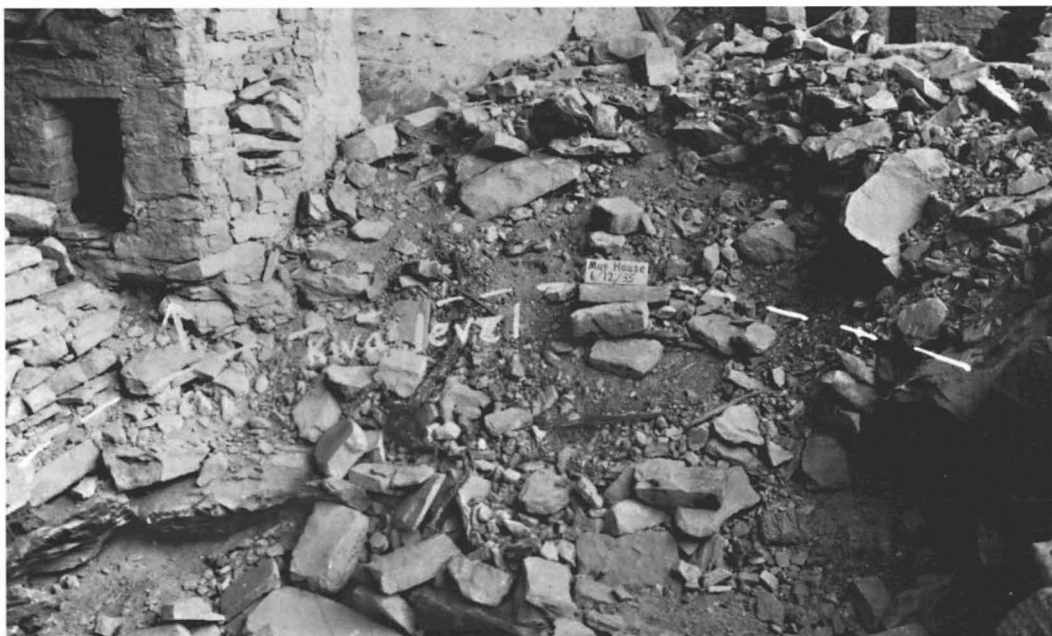
In Kiva C (and most other kivas), nearly all loss has occurred across the upper walls and along the upper quarter of the lower banquette walls (fig. 8, see page 61). This loss pattern is due to the overall vulnerability of these areas to weather exposure during occupation from roof leaks (prehistoric repairs are often found in the upper walls), after abandonment from associated roof collapse, and after excavation and rebuilding during stabilization. Early prestabilization photographs of Kiva C (1935) show masonry and roof collapse, exposed upper walls, and total plaster loss (fig. 9). The lower banquette walls—being concealed and possibly protected by fallen roof and debris—were observed in 1935 to be generally intact, a situation common for many kivas in cliff sites. A comparison of the extent of surviving plaster evident immediately after excavation and stabilization in 1959–60 to today overwhelmingly illustrates the loss of plaster that often results after excavation. At Kiva C more than 25% (surface area) of the existing plaster finishes recorded in 1960 was subsequently lost over the next 40 years of exposure, most of the loss occurring along the upper banquette.

Fig. 9. Kiva C. Mug House, 1935, before repair. Courtesy of NPS-MEVE
