Conservation Plan for the Suddards-Manuel-Clark Funerary Monument, The Woodlands Cemetery, Philadelphia, PA

A thesis in Historic Preservation Presented to the Faculties of the University of Pennsylvania in Partial Fulfillment of the Requirements for the Degree of MASTER OF SCIENCE IN HISTORIC PRESERVATION, 2009.

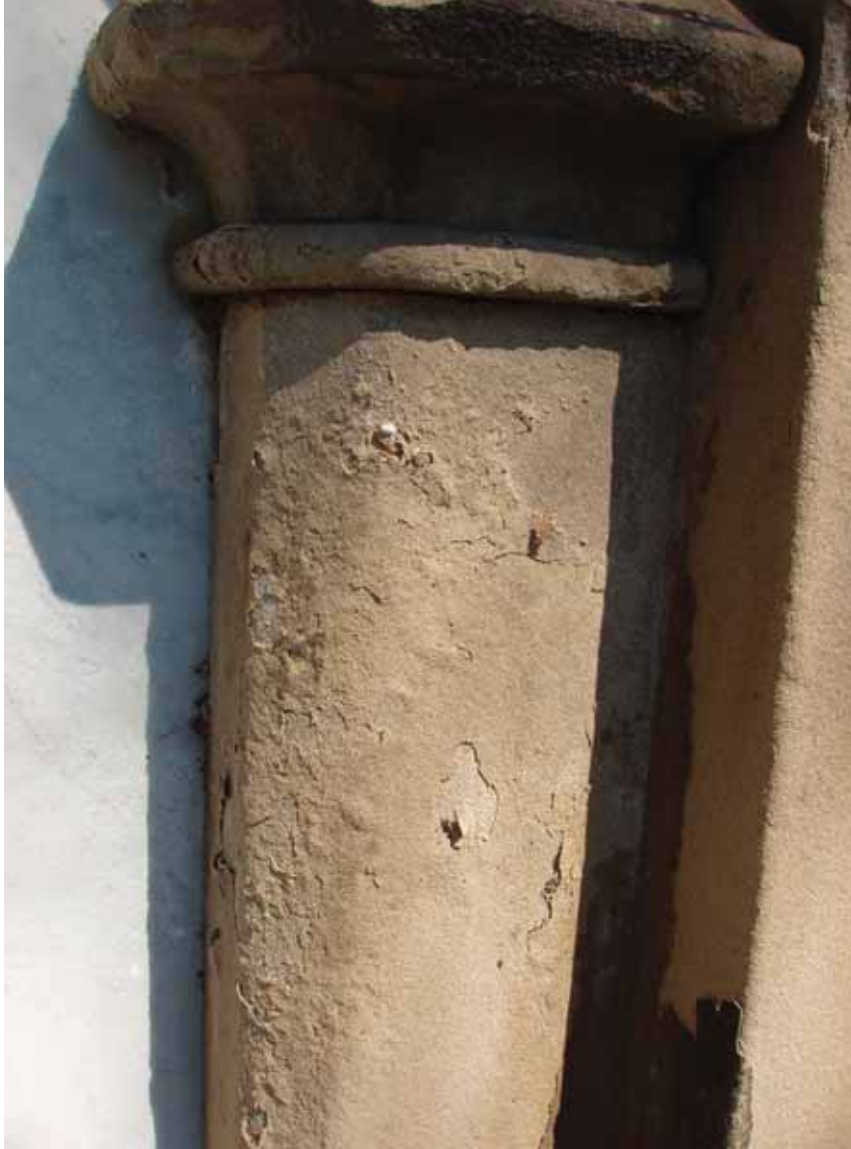
Figure 4.1 Sample area of flaking (Source: E. Kemery, 2009)

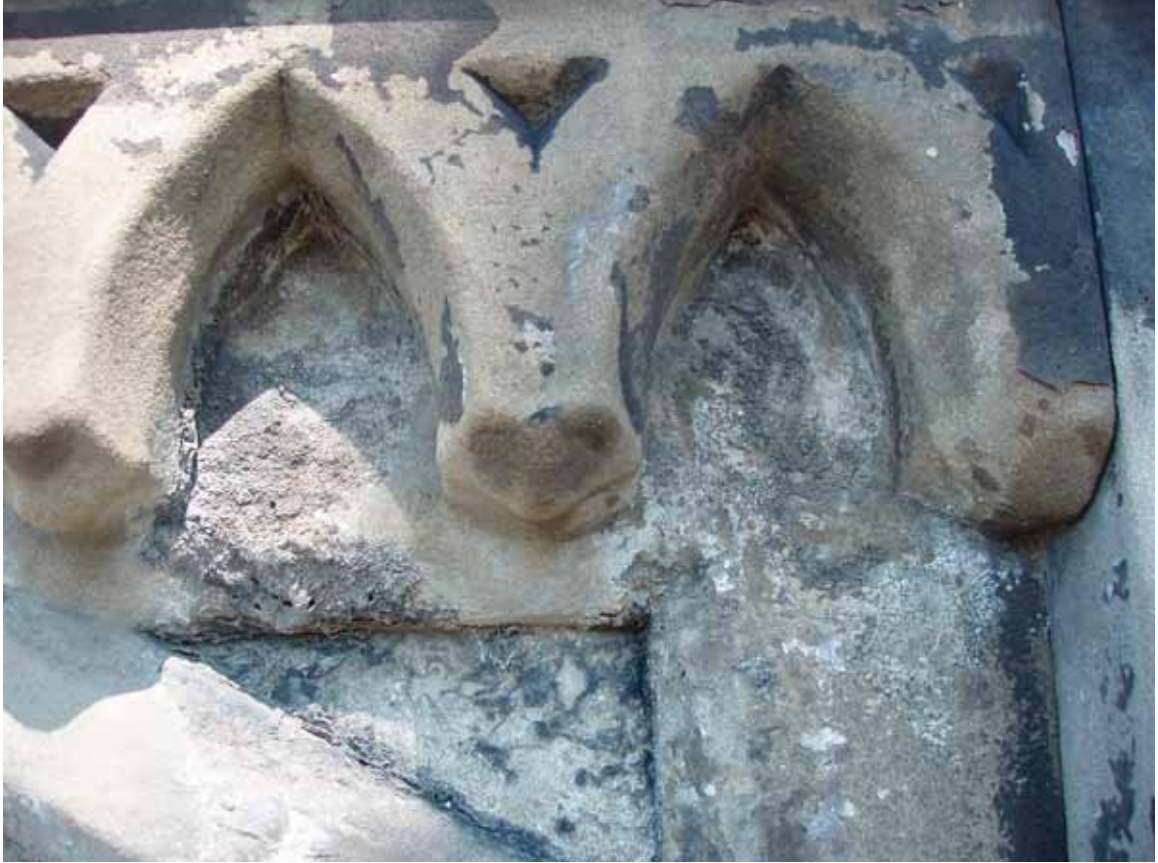
Figure 4.2 Sample area of blisters (Source: E. Kemery, 2009)

The moisture content in the samples is related to the relative humidity of their environment and the pore structure of the material. Blisters collected from protected areas beneath the blind arcades have both the highest moisture content and soluble salt content. The blisters are also very often located with visible efflorescence and subflorescence. The sandstone spall that was tested should give a somewhat representative moisture and soluble salt content for the Suddards-Manuel-Clark stone; however, the sample was located in close proximity to blistering, which may have attributed to its soluble salt content. The moisture content of the sandstone is lower than that of the flakes. This disparity could have easily been predicted as flaking is detachment of non-original surface; where original surface has been lost, it is not unexpected that porosity and permeability would be greater. The face of the stone beneath hardened crusts is often weaker in strength than both the crust and the sound stone behind it. The flakes also often occur in conjunction with subflorescence which

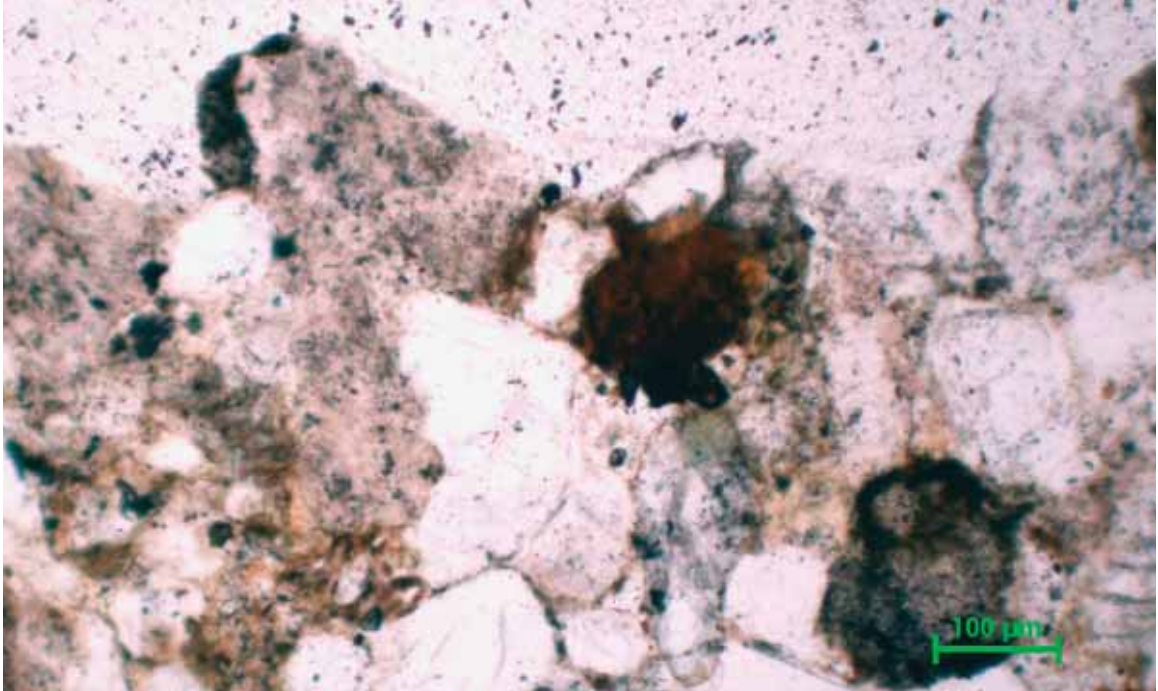
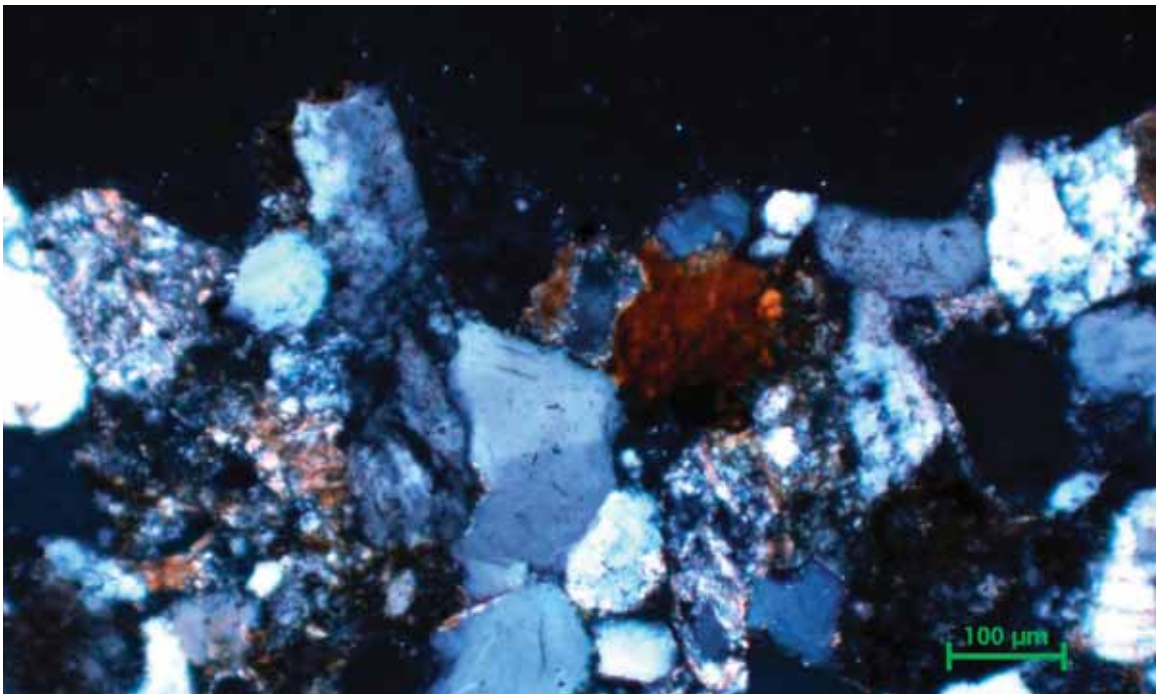
Figure 4.7 Sandstone surface; thin section in plane polarized light, 100x, Nikon Optiphot 2-Pol Microscope (Source: E. Kemery, 2009)

Figure 4.8 Sandstone surface; thin section in cross-polarized light, 100x, Nikon Optiphot 2-Pol Microscope (Source: E. Kemery, 2009)

Examination of the surface of the sample shows where grains of quartz have been lost. Under cross-polarized light, quartz crystals appear gray to blue. They exhibit extinction but are not very birefringent. Calcite, though difficult to detect, is gray in plane polarized light. When viewed under crossed-polars, it exhibits “mostly pale pinks and greens,” which were very intermittent but still visible.⁷⁷ When measured, the percent area of pores to quartz grains of five sample areas averaged 15.66% to 76.30% respectively. While this is a relatively high percentage of quartz, there exist sandstones with even higher pore to grain ratios.⁷⁸ This low porosity is what gives this sandstone that gives it its strength and resistance to weathering. It is a very high quality stone that is sound and in relatively good condition. Surface alteration is largely related to surface hardening from mineral transport resulting in a case-hardened crust, increasing or decreasing the porosity of the stone respectively. Error in these calculations is solely based on the limitations of the NIS Elements BR software. The software differentiates between components by their color threshold, counts the objects and then calculates their total area percentage of the sample.

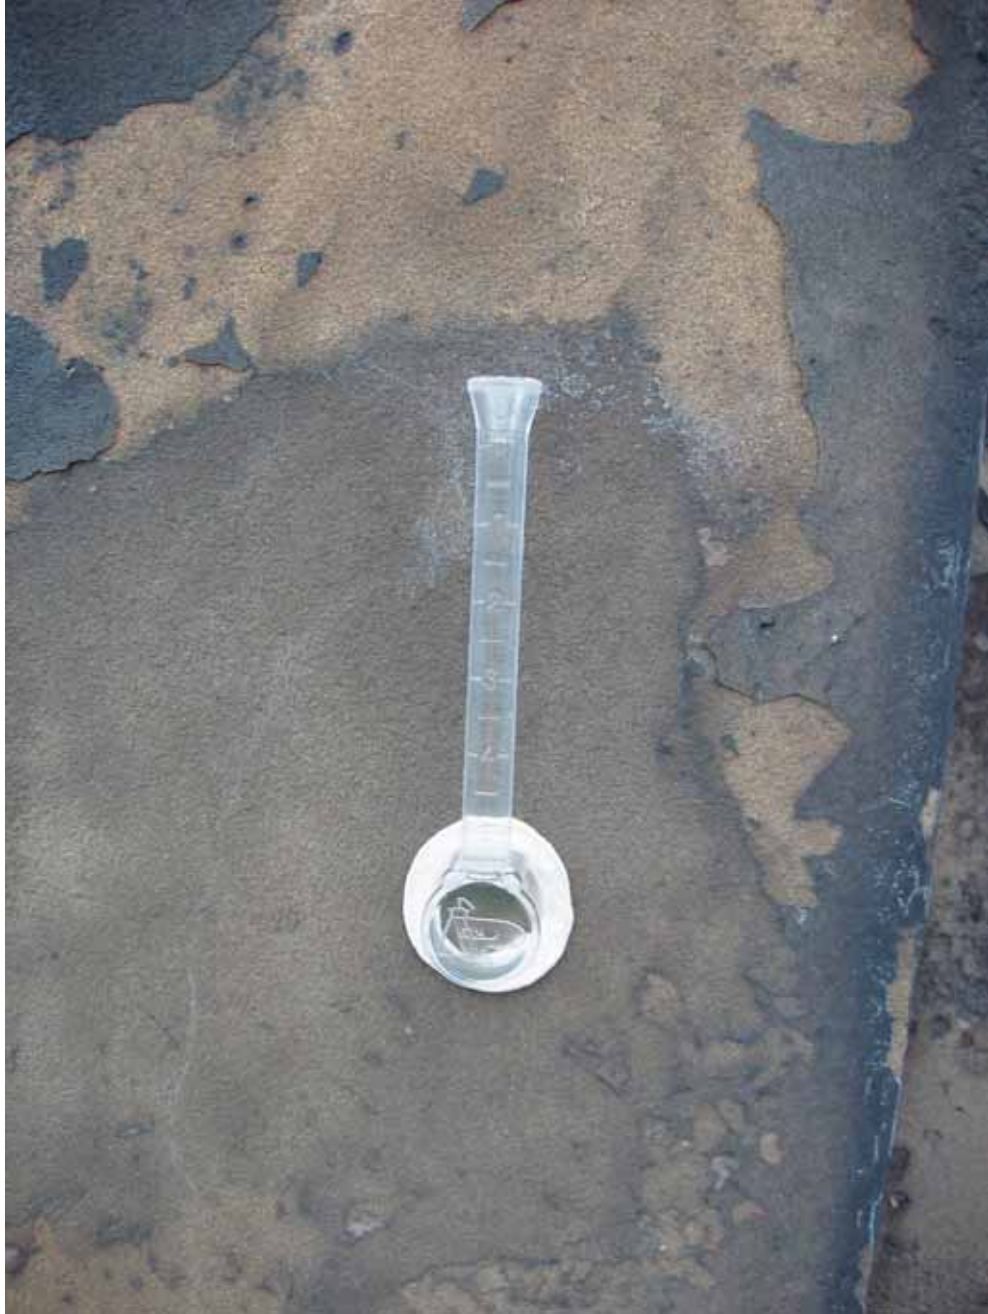
surface and on a case-hardened and soiled surface of the Suddards-Manuel-Clark façade in situ (Figure 4.11). In the laboratory, the same process was carried out on the interior face of the large sample from the monument (Figure 4.12).⁸⁰ This sample had been kept in a desiccator at 23% humidity prior to the experiment and was used as the control. Two other materials were chosen to compare with the Suddards-Manuel-Clark sandstone, a brownstone and a quartzite. These materials were chosen because it was conjectured that the brownstone would have a similar permeability to the sandstone and that the quartzite would have a much lower permeability than the sandstone.

Figure 4.11 RILEM tube testing in situ on a case-hardened surface (Source: E. Kemery, 2009)

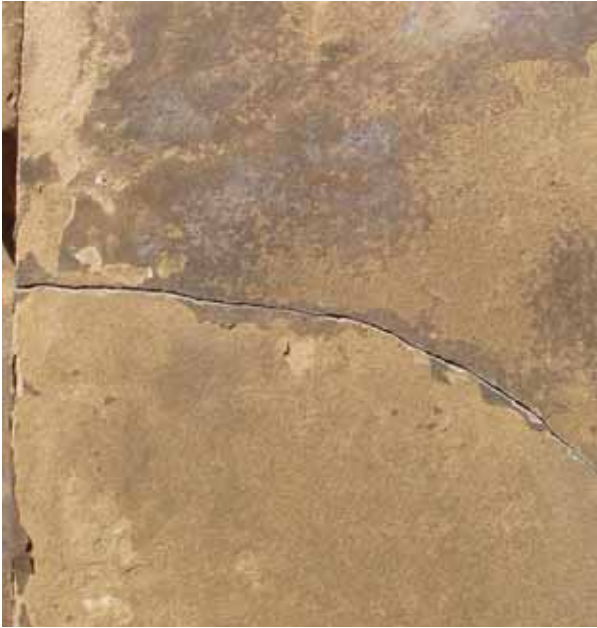
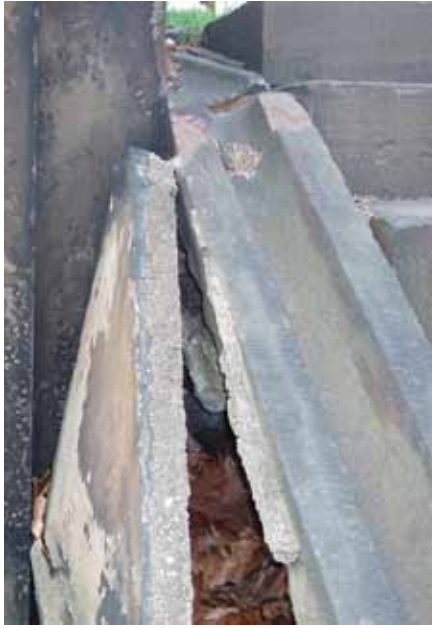
(a)	(b)

DEFINITION	
An individual fissure, generally 0.5 to 2 millimeters in width but clearly visible to the naked eye, resulting in partial (a) or full (b) separation of the masonry unit

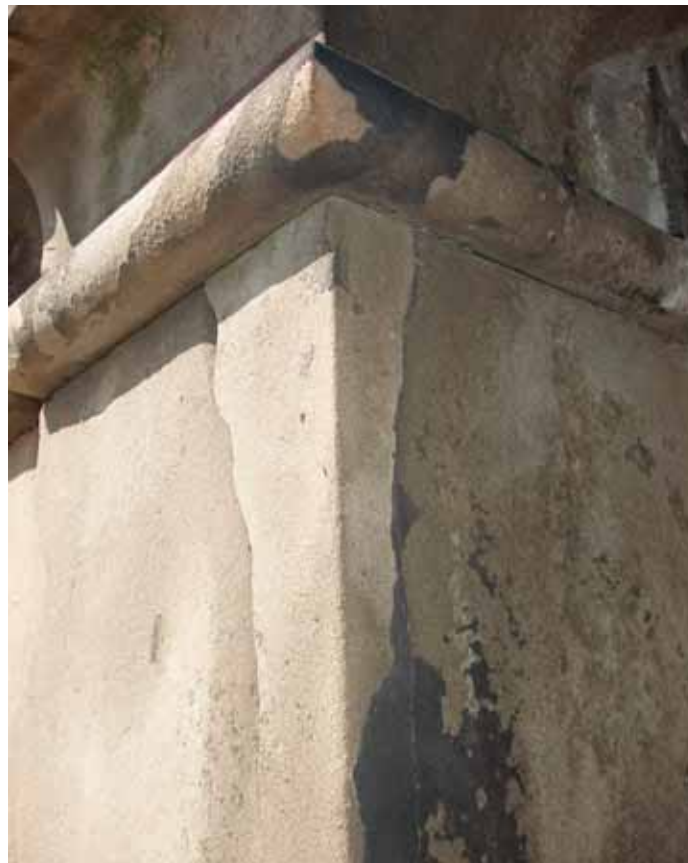
Planar or lens shaped detachments
that have become partially separated
from the stone unit

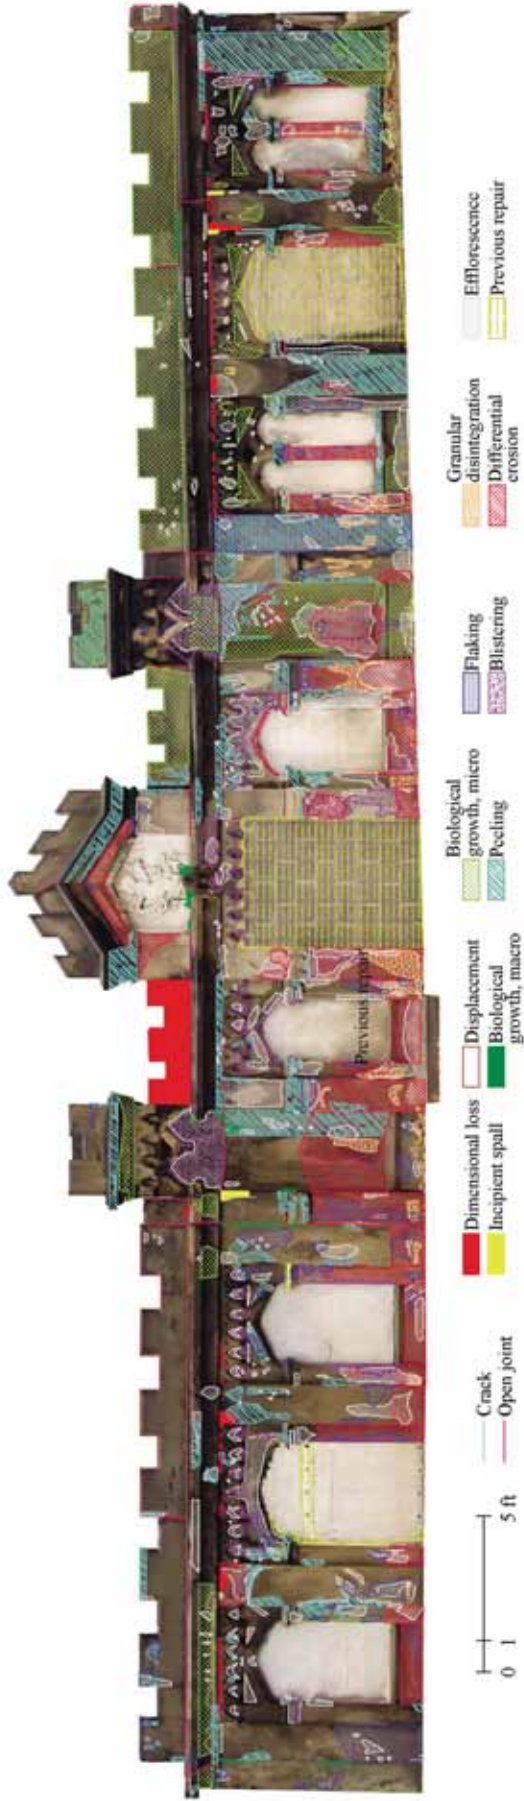
Figure 6.1 All conditions of the Suddards-Manuel-Clark monument

Conditions of the façade of the vault are discussed in detail below; the interior is inaccessible, and through limited visual examination, a few conclusions can be made about the conditions within the vault that may have some effect on the façade. Photographs of the Clark section of the monument taken through what were likely designed as vents give some degree of view of the vault interior. The brick structure of the vault can be seen as well as a render covering the brick on some surfaces. This render is cracked in areas and has been lost and exposes the brick backer wall in other areas. The walls and the ceiling of the vault display what appears to be black microbiological

colonization, indicating that conditions of moisture and temperature are hospitable to biological growth. Efflorescence is also present on the walls and the ceiling and is especially concentrated at joints.

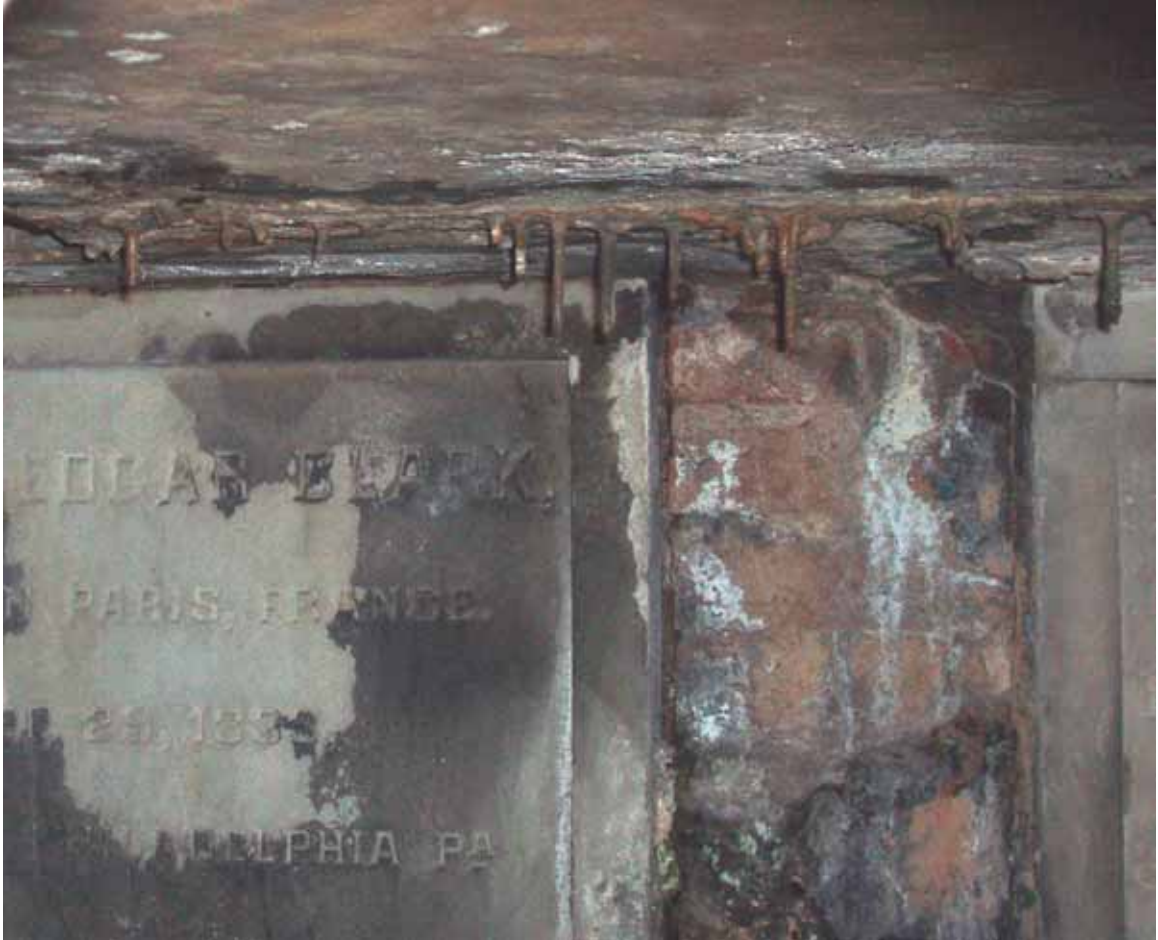
Figure 6.3 Interior of Suddards-Manuel-Clark vault showing black biological colonization (Source: E. Kemery, 2009)

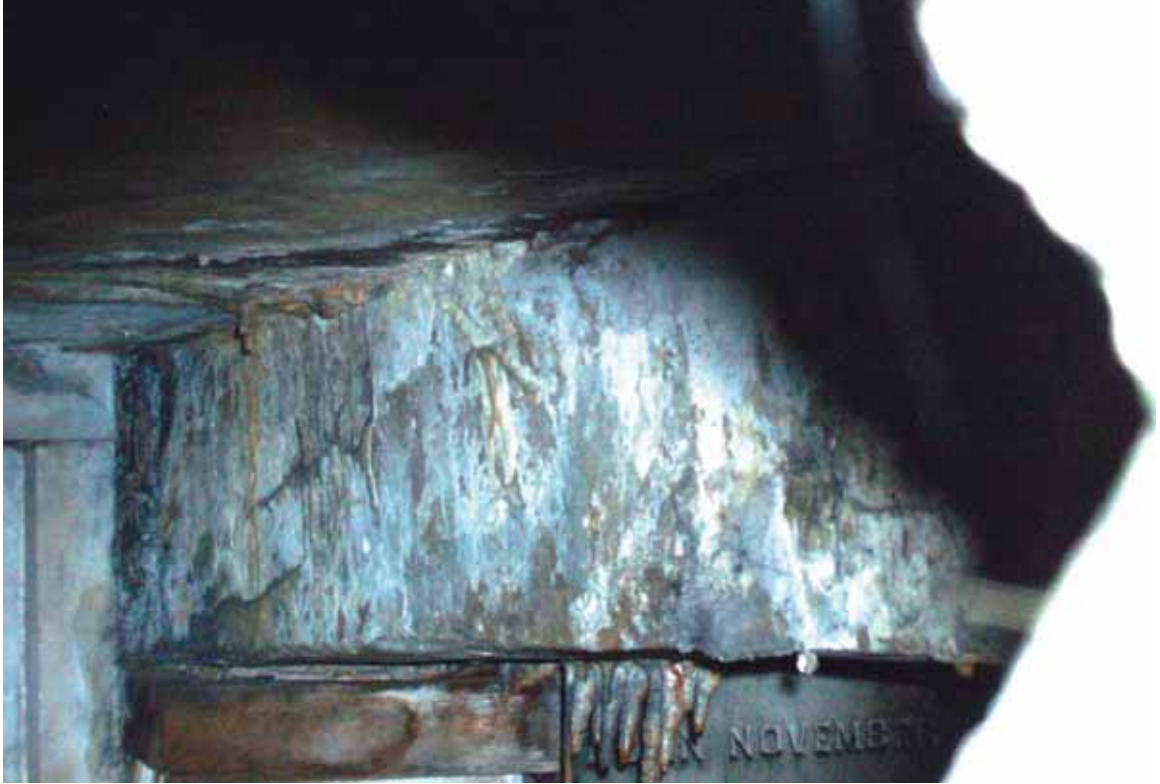
Figure 6.4 Interior of Suddards-Manuel-Clark vault showing stalactites and calcite buildup (Source: E. Kemery, 2009)

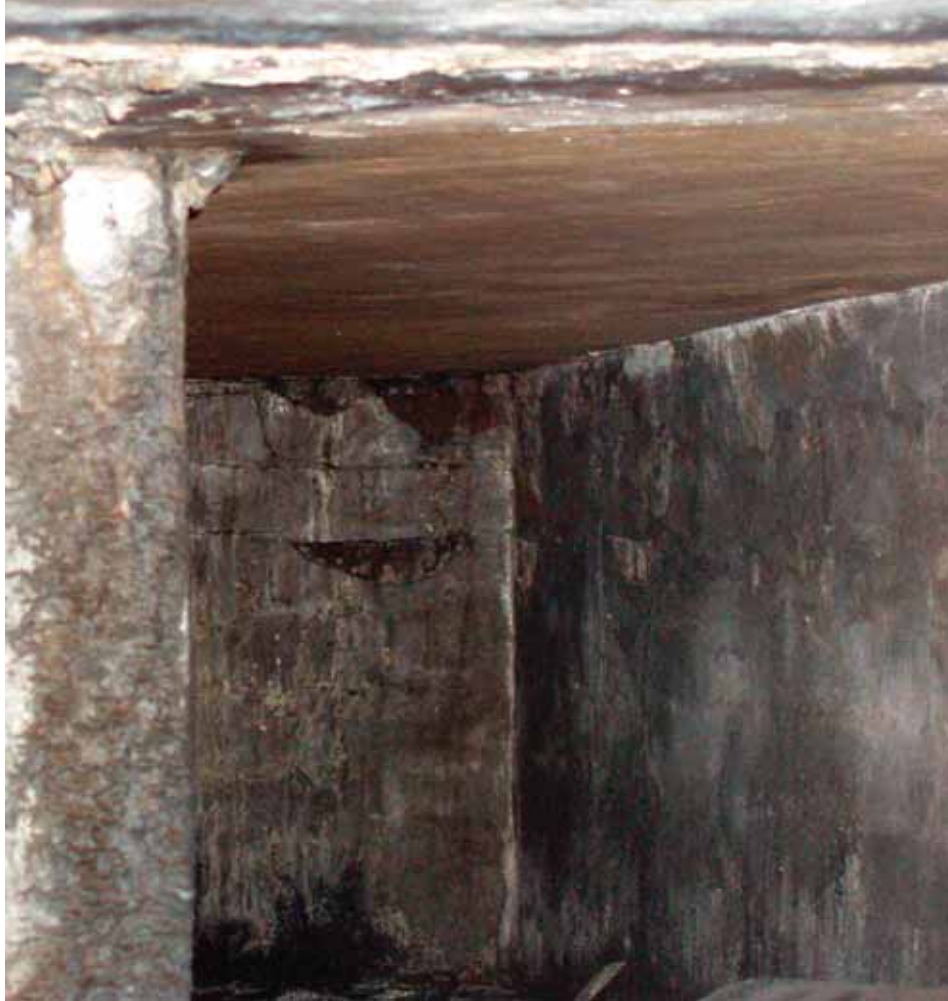
Photographs taken both when liquid water was present on the walls and ceiling of the monument and when no liquid water was visible show both soluble salts and insoluble salts. When liquid water is present either due to groundwater entering into the monument or vapor condensation, soluble salts go into solution, and heavy deposits of insoluble salts remain. Also prominent in photographs are stalactites that have formed from horizontal areas within the vault. These stalactites range in length, width and concentration. The calcium carbonate in these formations may come from the sandstone, brick, mortar or render; not enough is known about the construction of the interior to rule out any of those sources.

Figure 6.5 Interior of Suddards-Manuel-Clark vault showing efflorescence (Source: E. Kemery, 2009)

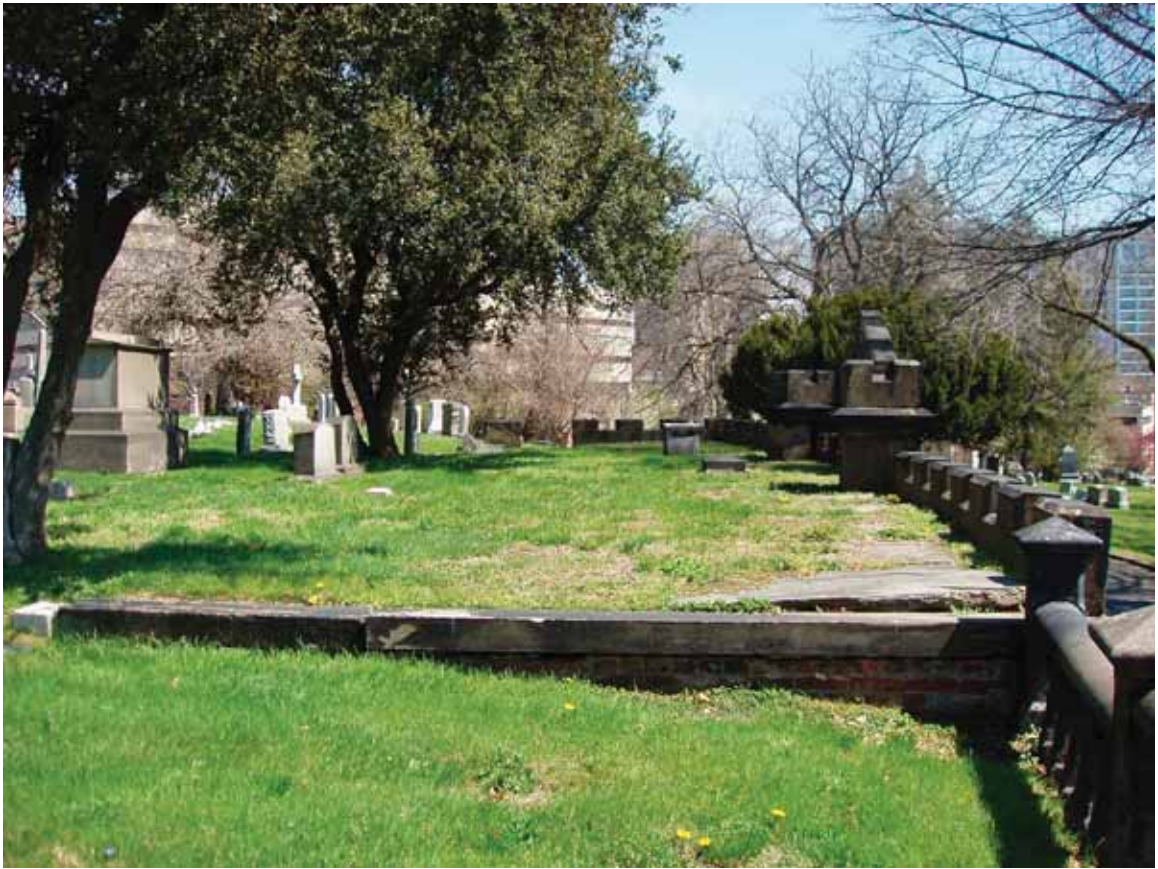
Figure 6.6 Top of the Suddards-Manuel-Clark monument, note slate paving stones in foreground and ventilation sources at center (Source: E. Kemery, 2009)

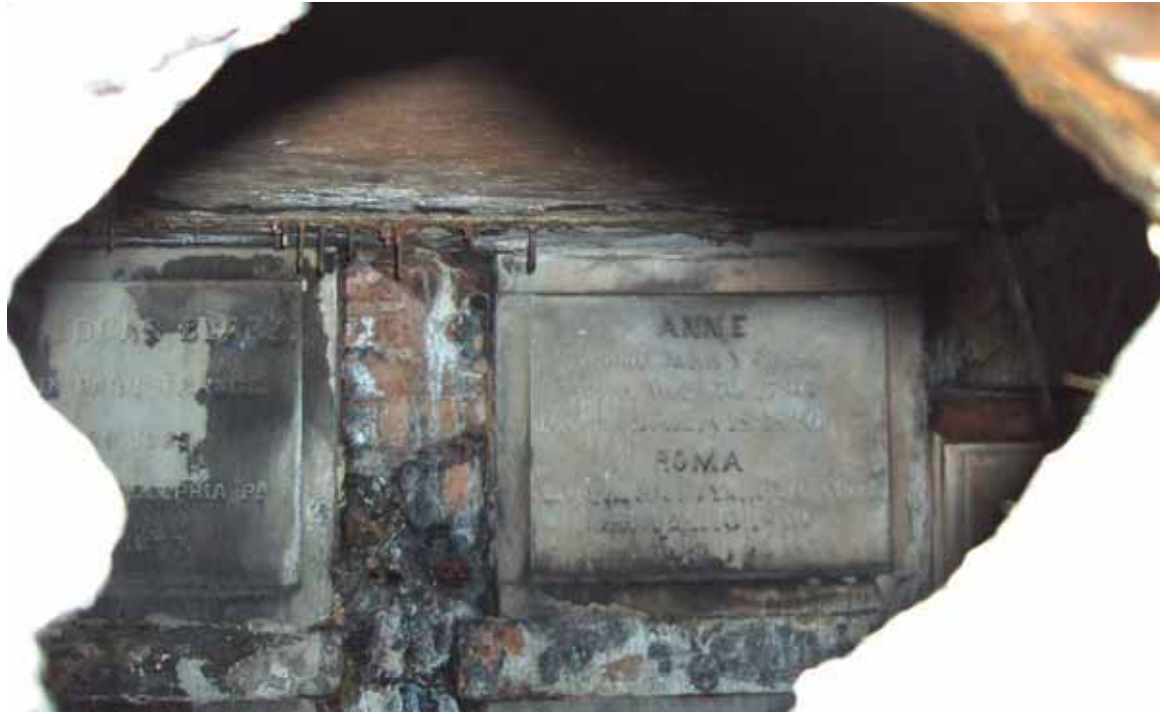
Figure 6.8 Interior of Suddards-Manuel-Clark vault under dry conditions (Source: E. Kemery, 2009)

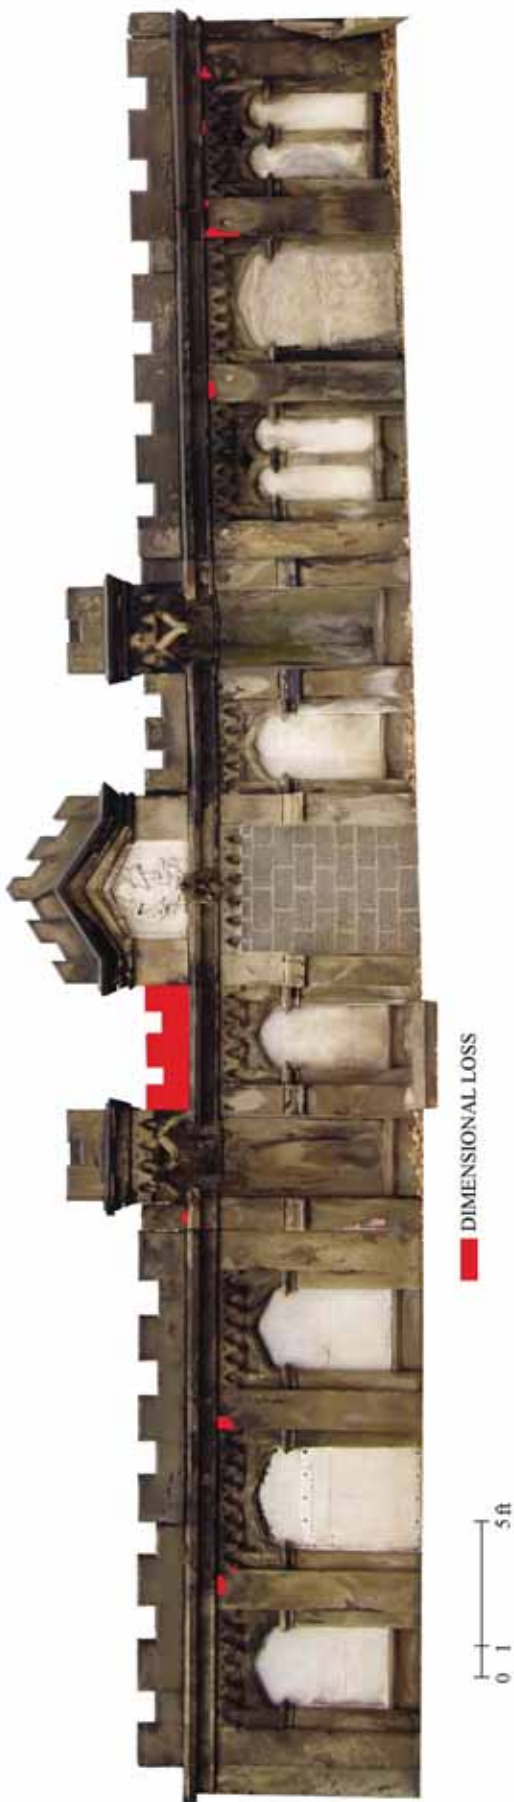
Figure 6.12 Dimensional Loss

Dimensional loss is complete or partial absence of masonry units resulting in significant incompleteness of form. In only one area is an entire masonry unit absent, which is where a crenellation is missing between the west tower and central pedimented segment of the Manuel section. This crenellation and its pair are the smallest unit blocks of crenellations. The Suddards-Manuel-Clark monument has a history of vandalism, and this loss is certainly a product of human force rather than natural forces.⁸⁵ The missing crenellation block remains at the base of the façade where it fell from the parapet.

The other areas of dimensional loss are only partial absence of masonry units. Like the cracks and incipient spall of the monument, dimensional losses are relatively few and small in size, and they exhibit the same pattern of occurring below the joint at the base of the simplified entablature. Some but not all losses abut incipient spalls and cracks; in most case, dimensional losses would follow cracks and incipient spalls. Like the incipient spalls, dimensional losses are often located at the corners of the wide flat piers of the monument's façade. In two areas, there are dimensional losses of projecting features. At least four if not more of the dimensional losses of the monument are related to the weathering of the joint under the entablature that runs the length of the façade. In the two areas where there are mid-entablature breaks in the masonry units, differential erosion has occurred from water running down the joint between the two stone blocks. The combination of differential erosion, dissolution of cementing material and the locus of water carving its way down the face of the flat pier beneath has led to dimensional loss

as well as erosion. Other areas of dimensional loss appear to be related to inherent flaws in the stone.

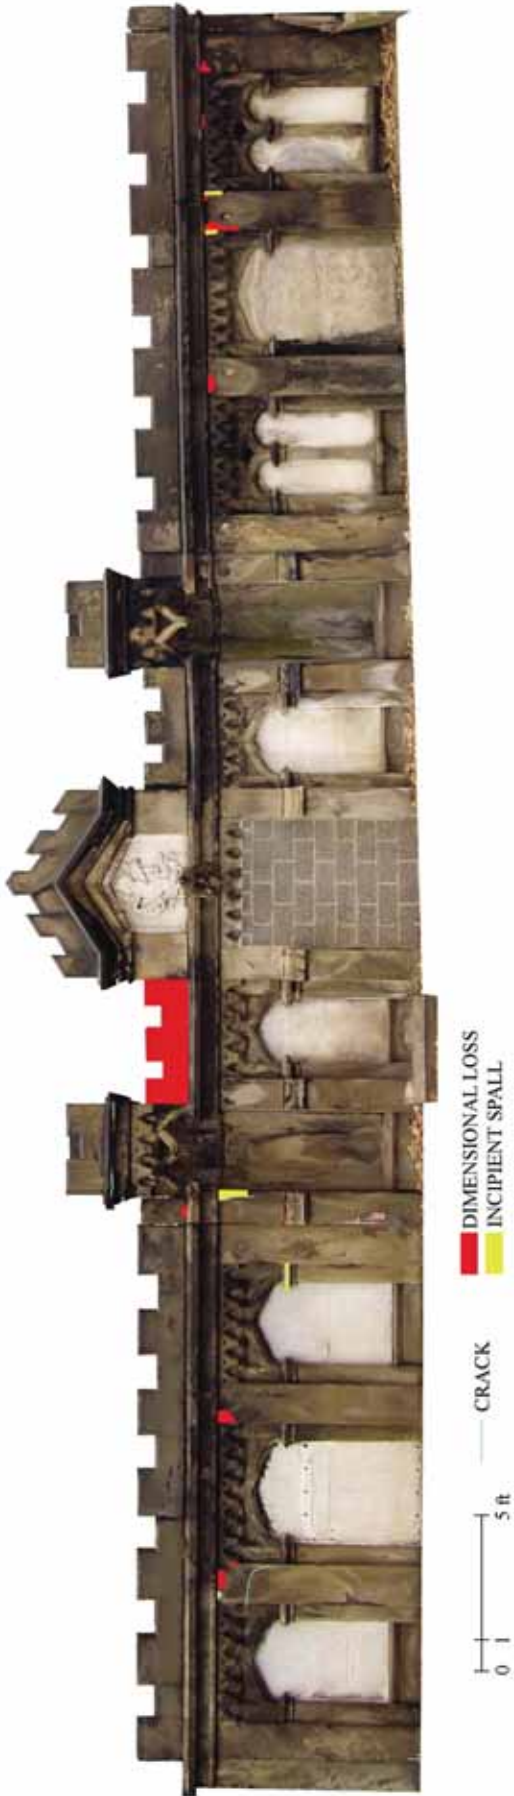
The largest of the cracks of the vault's façade is located on the wide flat face of the second pier of the Suddards section. Unlike the other cracks in the piers it is neither vertical nor parallel to the length of the pier. This crack cuts across almost the entire face of the pier and curves downward becoming narrower from west to east (left to right). While the structural reason behind this crack is unclear, it may be an inherent flaw in this particular masonry unit or from quarrying, salts in and at the edges of the crack are visible. The presence of salts also indicates that water has entered into the crack; both moisture and salts can aggravate and deteriorate this crack over time, which could lead to

The largest of these incipient spalls is about 10-3/4 inches long by 3-1/2 inches wide. This area of cracking and incipient spall is located directly under one of the masonry blocks that supports the west tower. The line of the bounding crack can be followed almost directly from the outer edge of this tower, and because it is a very narrow area that supports the tower, it can be assumed that a combination of compression

Figure 6.13 Crack, incipient spall and dimensional loss

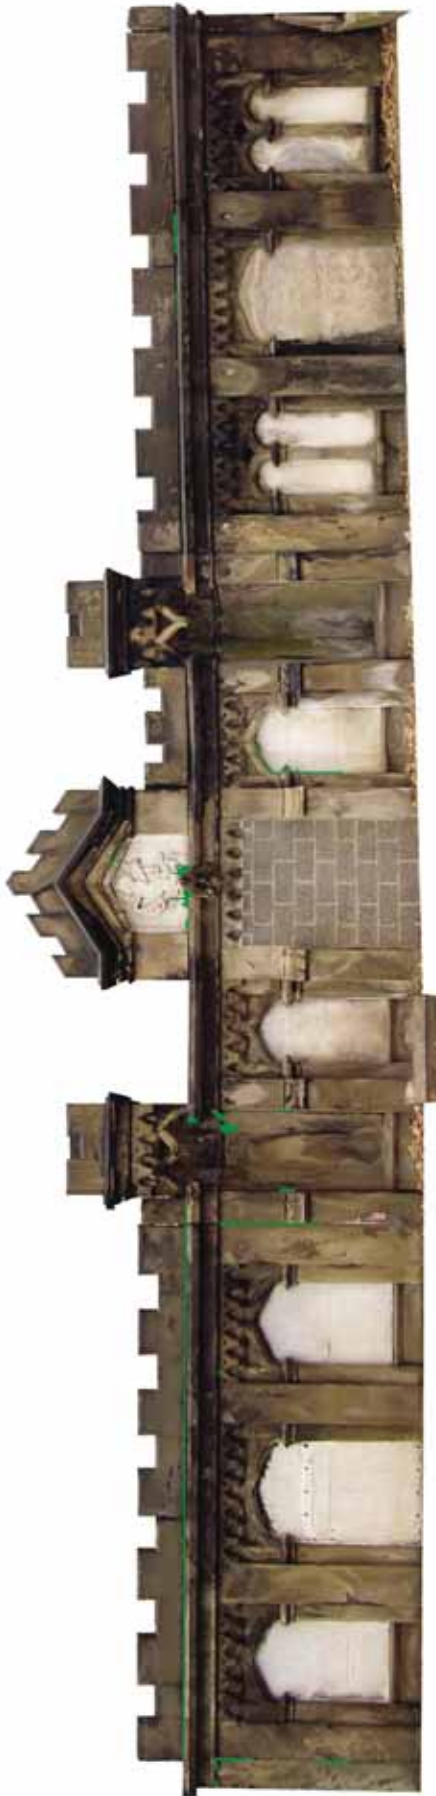
■ BIOLOGICAL GROWTH, MACRO

The condition of macrobiological growth is the presence of higher plant forms, including their root remnants. Every incidence of macrobiological growth on the monument is in a joint. In some, but not all areas, this joint can be an open joint. Macrobiological growth can be sustained by “nutrients from simple plants, like bacteria and algae, on and between stone blocks” and take root “especially in areas of ample moisture supply.”⁸⁷ Macrobiological growth has caused open joints in some cases, and in other cases, open joints have allowed for macrobiological growth. Areas of large macrobiological growth are usually in the form of woody stems and roots, which can be living or root remnants. “The pressure of a growing plant root...is surprisingly high,” and this type of growth is what has widened joints.⁸⁸ Areas of individual macrobiological growth are usually in the form of thick areas of moss growth and small green plants. Colonization of biological growth is concentrated along the joint under the crenellations of the Suddards section of the monument and in areas under the crenellations of the Clark section of the monument. This joint is at grade, providing macrobiological growth in these areas with moisture and nutrients from the soil.

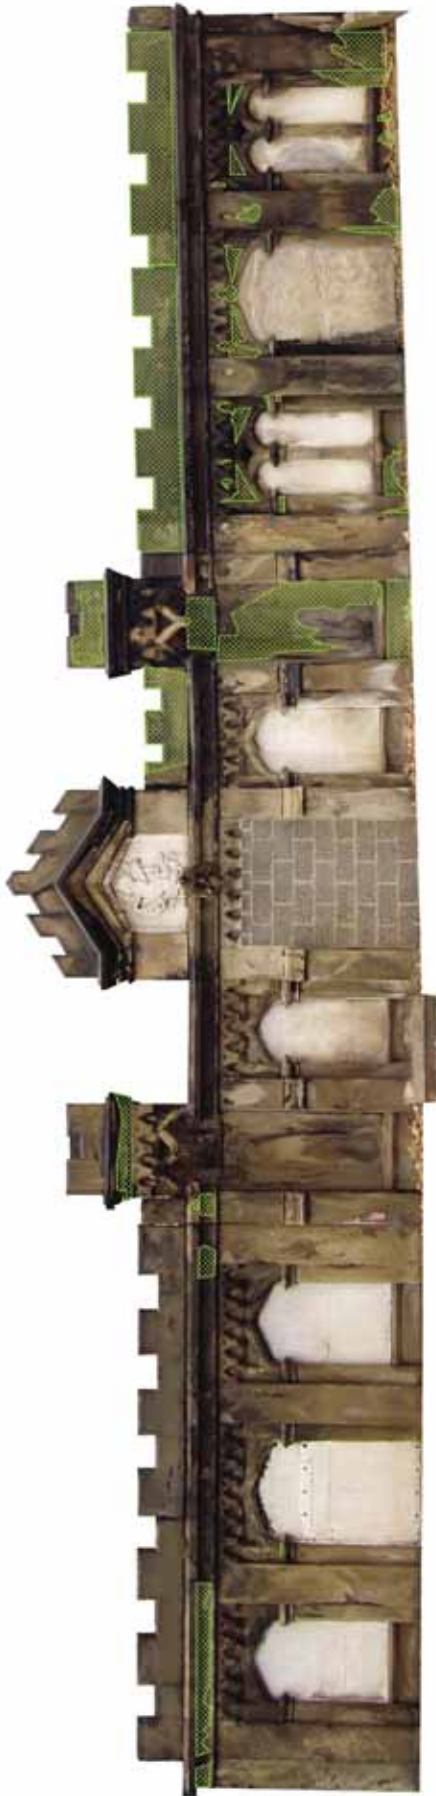
Figure 6.18 Biological growth, micro

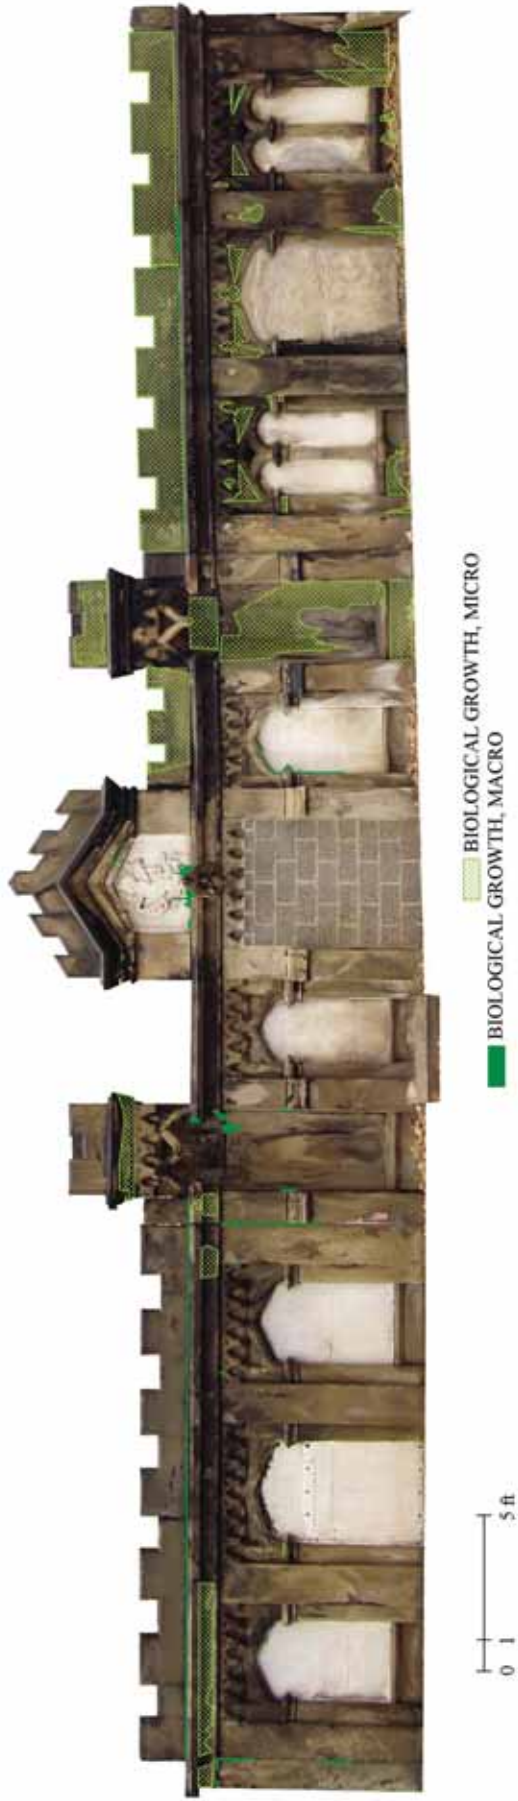
Figure 6.19 Macrobiological and microbiological growth

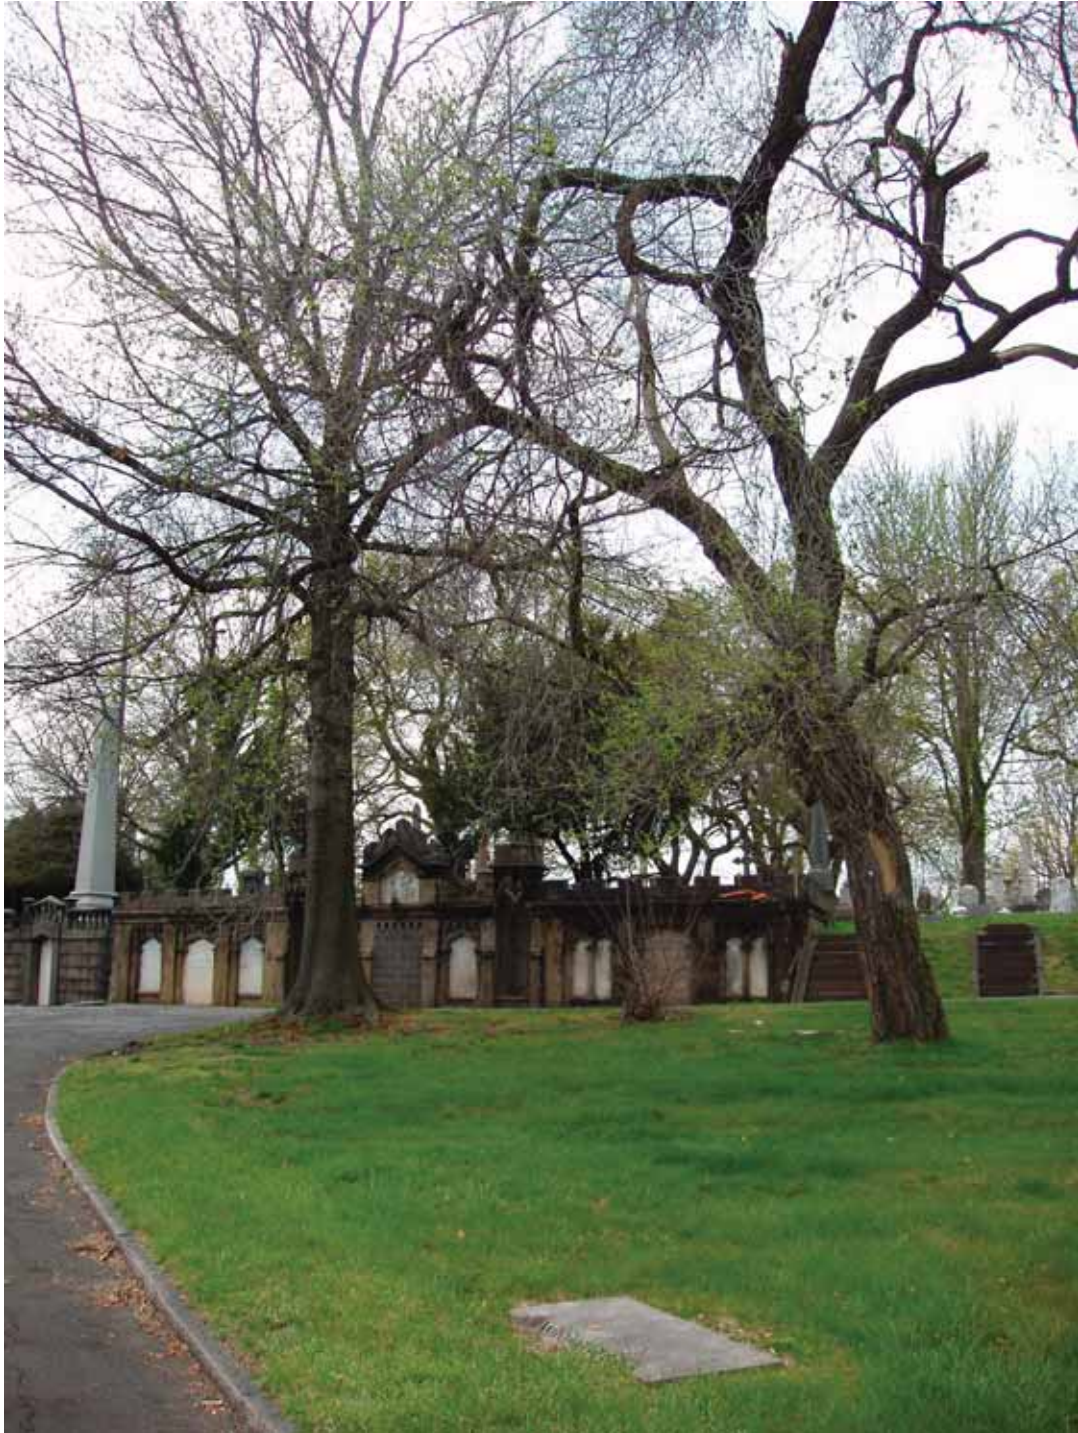
Figure 6.20 View from south of the monument; note overhanging trees (Source: E. Kemery, 2009)

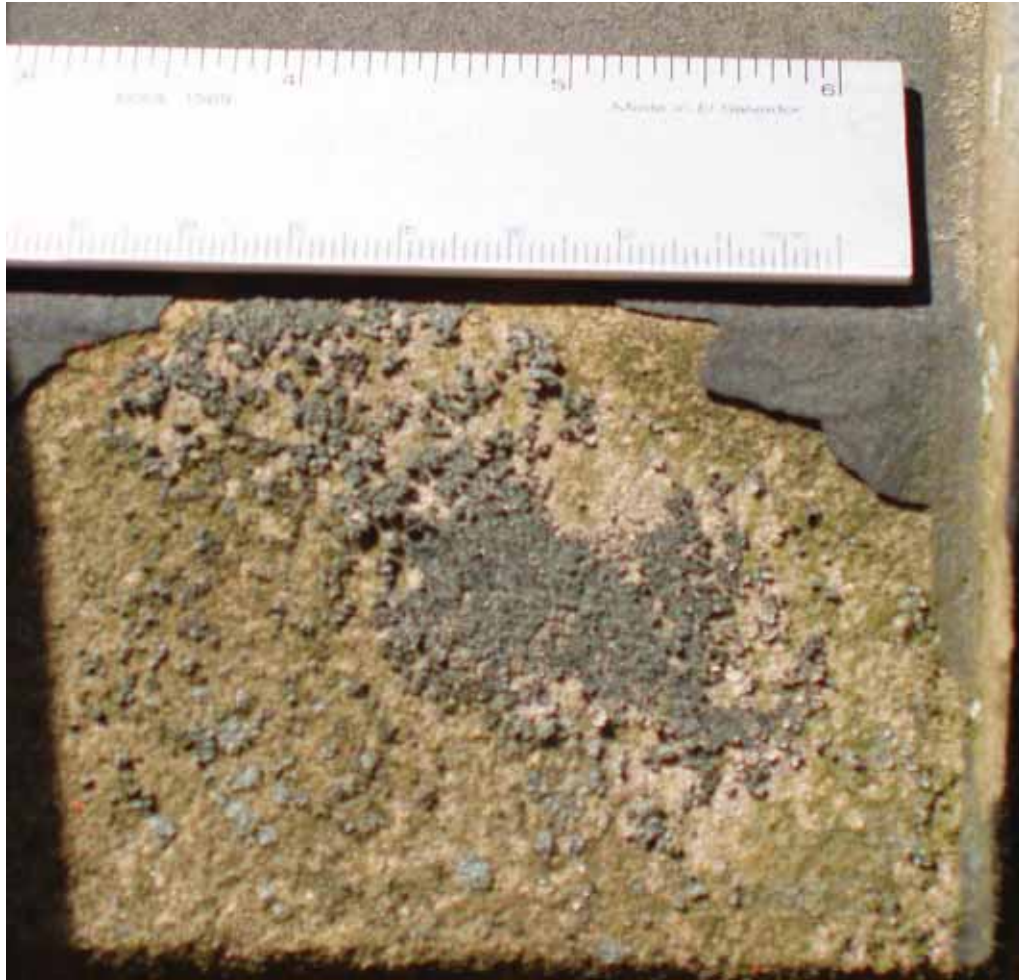
Figure 6.22 Microbiological colonization beneath peeling on crenellations (Source: E. Kemery, 2009)

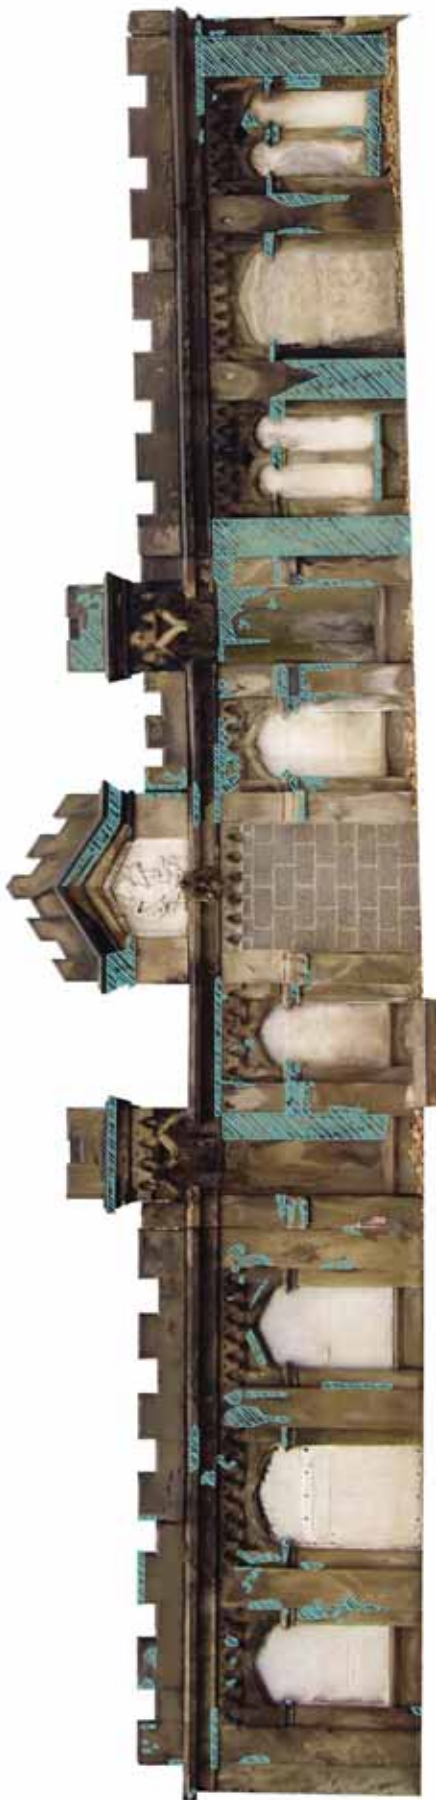
Figure 6.23 Peeling

also found on carved elements like many of the small pilaster capitals and projecting mouldings of the Manuel section but not on the carved arcades. Thicker detachments on water-protected areas such as pilasters under mouldings may be due to slow gypsum formation while thinner black peeling can be found in exposed areas. Where peeling has already been largely lost, if case hardening is left, it remains at the outer edges and on corners. On long rounded and projecting areas like the mouldings of the entablature, the thin detaching crusts have split lengthwise. While peeling is occurring in larger areas on the east half of the monument, it is occurring in more small patches on the west half of the monument. In a few areas, removed peeling shows subflorescence beneath the peeling surface and in other areas, removal of peeling reveals colonization of microflora. Insects also create habitats between the stone surface and the areas of peeling and leave behind organic byproducts.
