Conservation Plan for the Suddards-Manuel-Clark Funerary Monument, The Woodlands Cemetery, Philadelphia, PA

A thesis in Historic Preservation Presented to the Faculties of the University of Pennsylvania in Partial Fulfillment of the Requirements for the Degree of MASTER OF SCIENCE IN HISTORIC PRESERVATION, 2009.

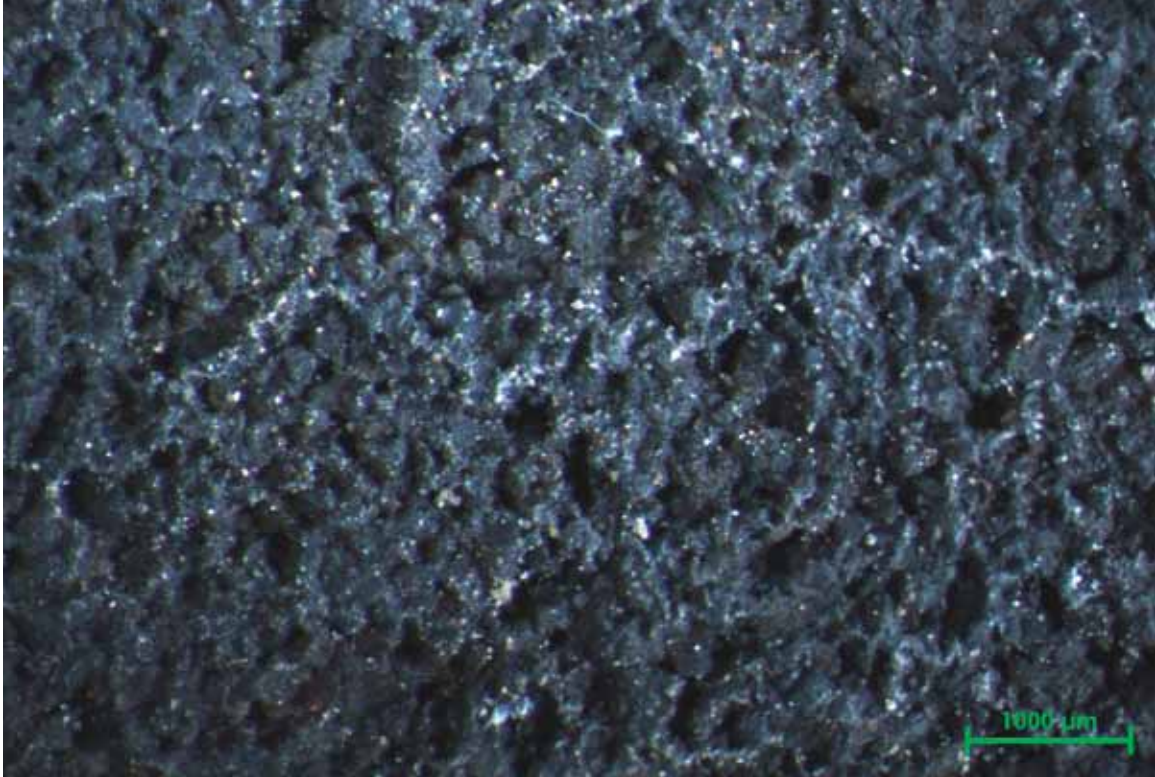
Figure 6.24 Surface detail of peeling surface, 50x, Leica MZ16 stereomicroscope, reflected light (Source: E. Kemery, 2009)

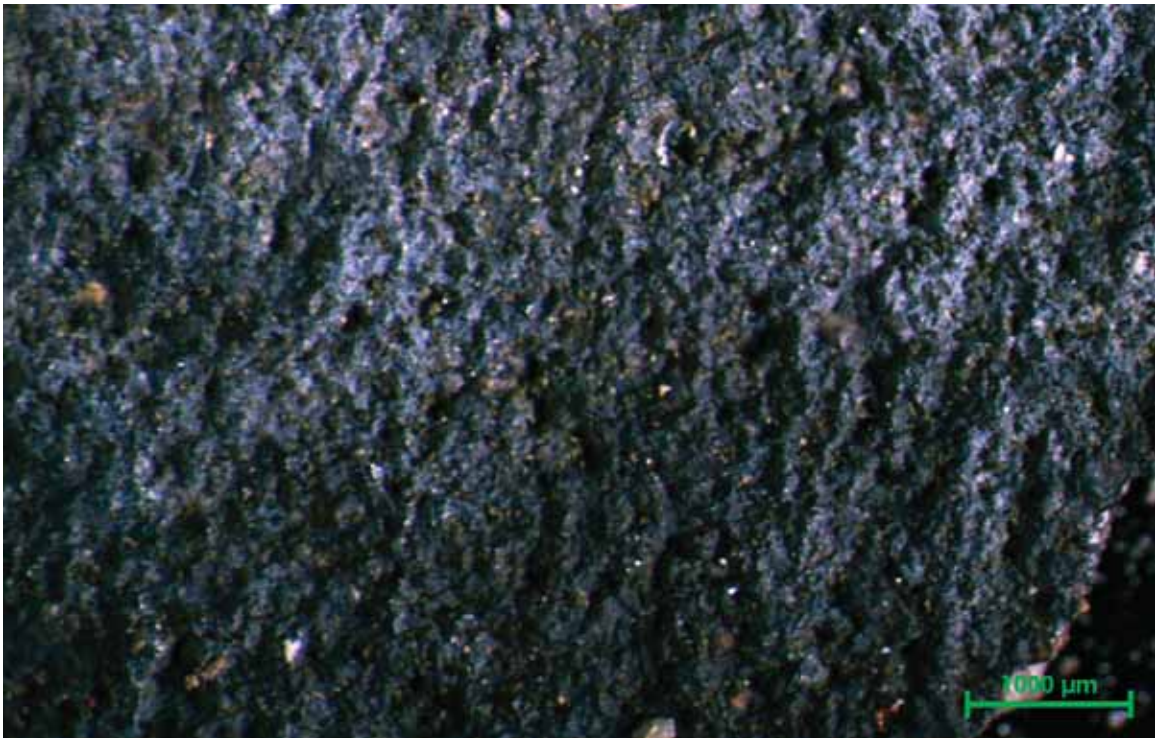
Figure 6.25 Surface detail of opaque peeling, 50x, Leica MZ16 stereomicroscope, reflected light (Source: E. Kemery, 2009)

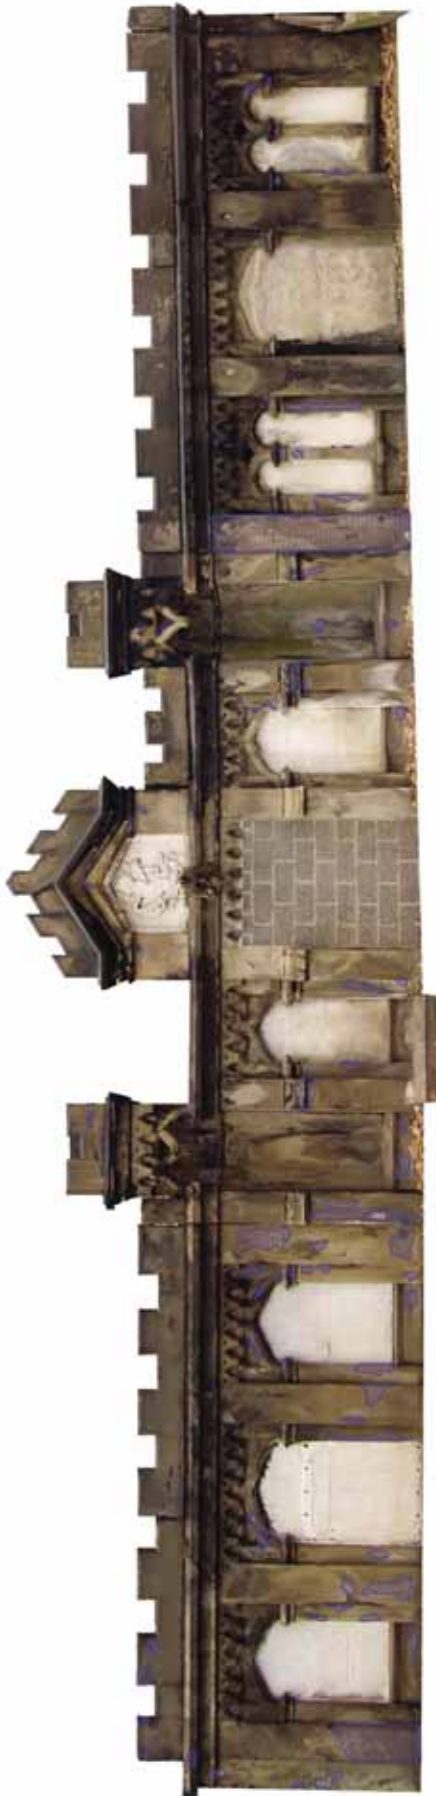
Figure 6.26 Flaking

Flaking consists of areas of thin, irregular detachments from the surface of the stone that are roughly of uniform thickness. While flaking and peeling are very similar conditions, peeling is the detachment of original surface, and flaking is the detachment of the surface that is left after peeling has occurred. Flaking is not nearly as extensive of a condition as peeling, and it is more concentrated on the west half of the monument, as the east half of the monument retains more of its original surface. Flaking and peeling occur together in a few areas where both original and new stone surface are detaching concurrently. Flaking can occur both as areas of multiple small flakes or as areas of single large detachments. Although the stone does not have discernable bedding, flakes come off in laminar units, and in a few areas, areas are visible where flakes that have spalled are actively re-flaking. Flaking can also be the result of newly formed gypsum on freshly exposed stone after peeling.

In many instances, efflorescence also accompanies flaking, and removal of flakes sometimes reveals subflorescence. Salt weathering is the cause of flaking in these areas. Almost all occurrences of flaking are on flat, vertical surfaces of the façade. These flat, vertical surfaces have moderate drying rates, and salt solutions will remain in “the surface zone, so that the liquid front will not withdraw into the stone.”⁹⁵ Salt cycling, when salts alternate recrystallization and return to solution, on the surface of the stone in areas of moderate drying rates will create flakes of detachment. In areas of low drying rates, salt cycling instead causes granular disintegration.

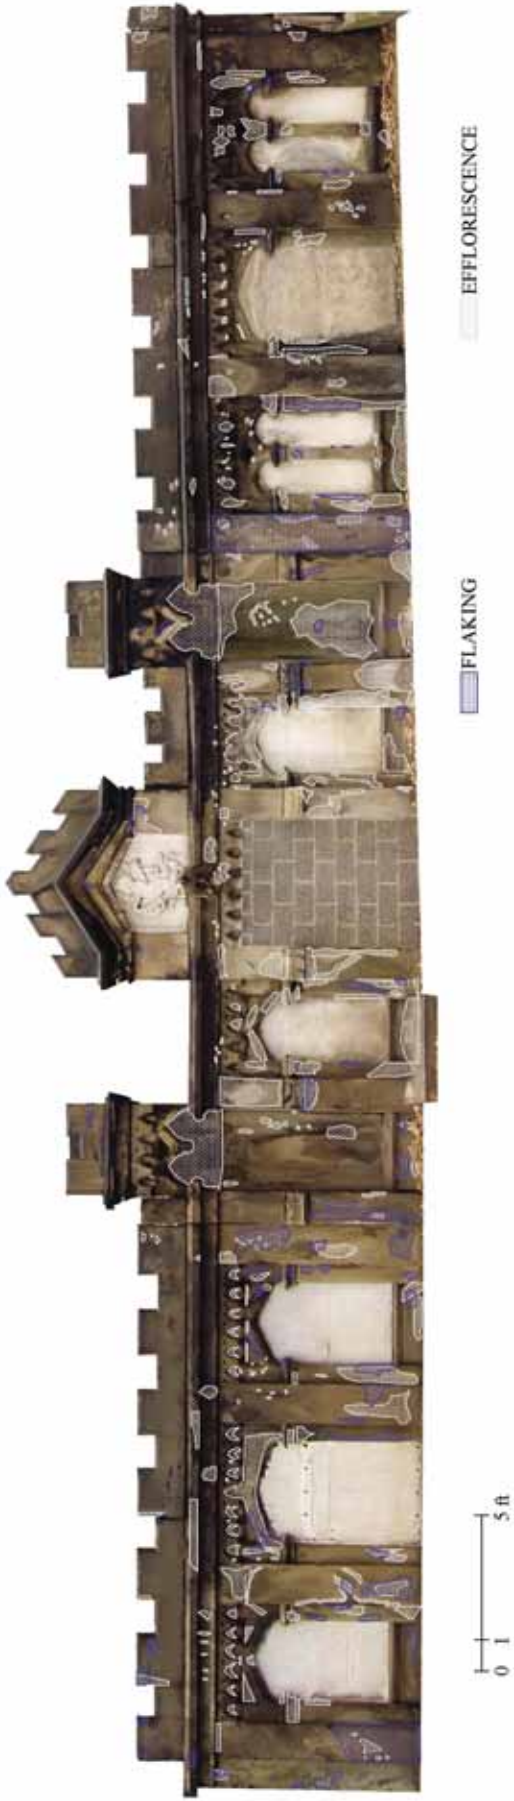
Figure 6.27 Flaking and efflorescence

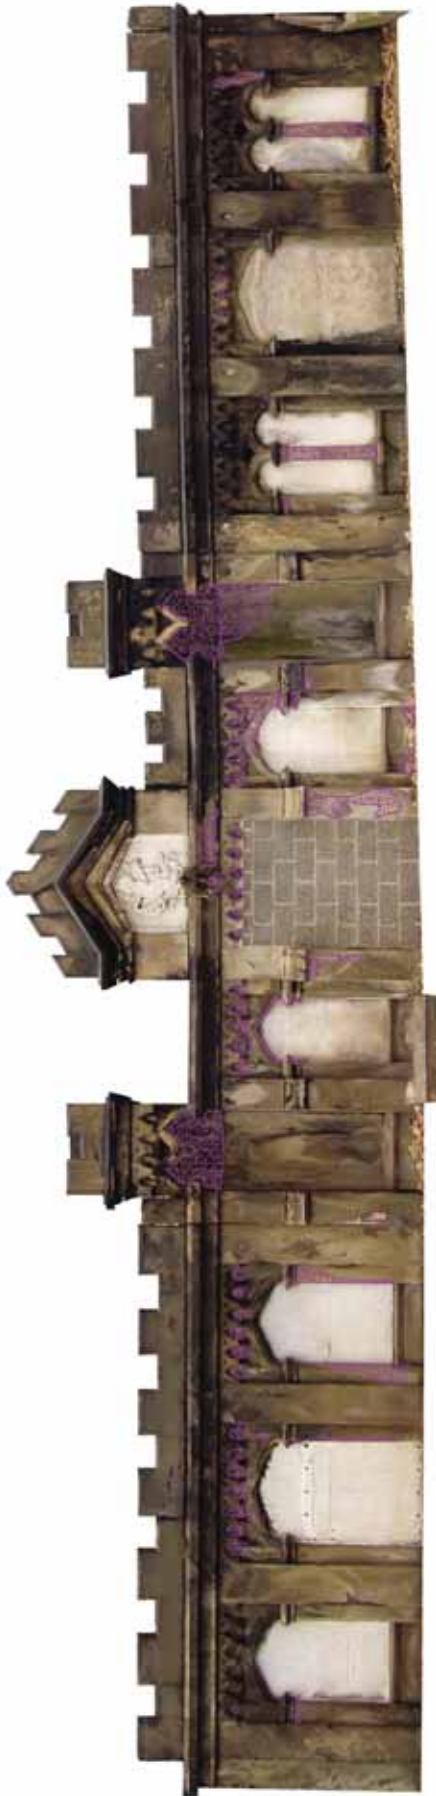
BLISTERING

Blistering is localized areas of separated, raised hemispherical elevations resulting from the partial detachment and deformation of the surface of the stone. Like the condition of flaking, blistering does not apply, nor does it occur, on the original surface of the stone. Blisters can be thin, friable and flake-like or dense and crust-like; blisters range in color from the color of the stone to darkened tones similar to those of peeling. Individual blisters can range in size from a few millimeters to three or four inches. Blistering is only located in protected or recessed areas, and it almost always accompanied by efflorescence. The most severe areas of blistering appear inside the upper coved areas of the two towers of the Manuel section. Other blisters have formed in recessed bays between piers, especially in the areas under the arches of the blind arcades. Blisters in the areas under the arches of the blind arcades are the most dense and hemispherical and some of the darkest in color.

A sample of blisters had a moisture content much higher than other samples taken from the monument (spall, flakes, opaque peeling and common peeling). Testing for presence of ions also showed the highest concentrations of both NO_3^- and SO_4^{2-} as compared to the other samples taken. These levels of SO_4^{2-} as well as the location of blisters in sheltered areas suggest the presence of $\text{CaSO}_4 \cdot 2\text{H}_2\text{O}$, gypsum. The sandstone of the Suddards-Manuel-Clark monument is slightly calcareous, and the calcite in the sandstone reacts with the SO_2 air pollutants to form gypsum. Because gypsum is soluble in water, “rain-washed...surfaces rarely accumulate” gypsum crusts, which explains why blisters are only located in covered areas of the stone.⁹⁶ Darkened areas are gypsum

The spalling of blisters from the Suddards-Manuel-Clark stone often reveals both subflorescence and biological colonization, which may also contribute to the very elevated levels of NO_3^- and SO_4^{2-} ions. Salts and microflora contribute to the loss of blisters and likely contribute to the buildup of blister crusting as well.

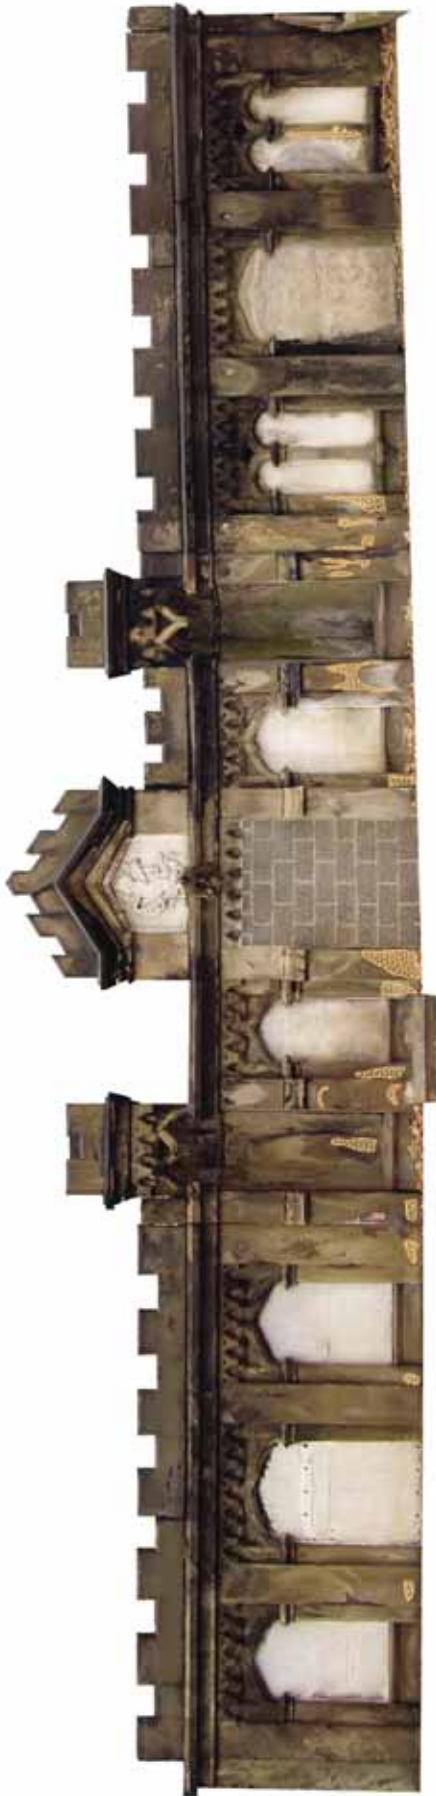
GRANULAR DISINTEGRATION

Granular disintegration is the detachment of single grains or aggregates of grains, producing a sugar-like debris. Like the conditions of flaking and blistering, granular disintegration does not occur on areas of original surface. While granular disintegration occurs infrequently on the façade of the Suddards-Manuel-Clark monument, it develops in specific areas and is related to other conditions that are manifest. Granular disintegration is often accompanied by efflorescence and/or differential erosion. Just as efflorescence can be named as a cause of granular disintegration, granular disintegration can be named as a source of differential erosion. Granular disintegration on the monument's façade occurs in areas with low drying rates. These "zone[s] of maximum moisture content, which [are] necessarily the zone[s] of the salt precipitation" are generally located in the lower half of the monument and in many cases very close to the ground.⁹⁸ These areas remain moist due to capillary rise and are sometimes even visibly and tactilely wet. Where salt precipitation is "located on the surface, the damage type that forms will be sanding off," or granular disintegration.⁹⁹ Crystallization of salts in pores of the sandstone cause individual grains to push off or loosen from the face of the stone. When liquid moisture or moisture vapor become present again, and salts return into solution, loose grains are left as debris. While some of this debris is left positioned precariously on the surface of the stone, other loose grains can be washed away by liquid water or blown from the face of the stone. Accordingly, relatively little granular disintegration can be seen on the façade of the Suddards-Manuel-Clark monument, when compared with other surficial conditions. While the presence of loose grains is what has

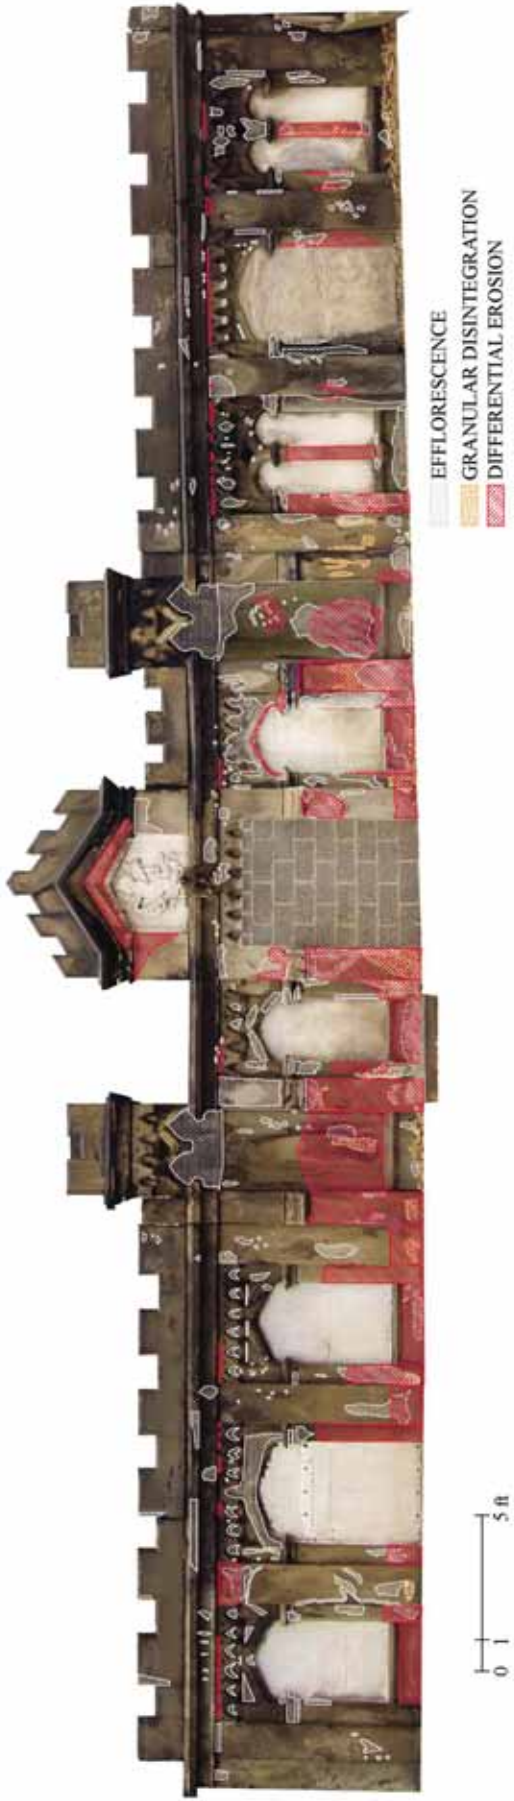
Figure 6.32 Granular disintegration, differential erosion and efflorescence

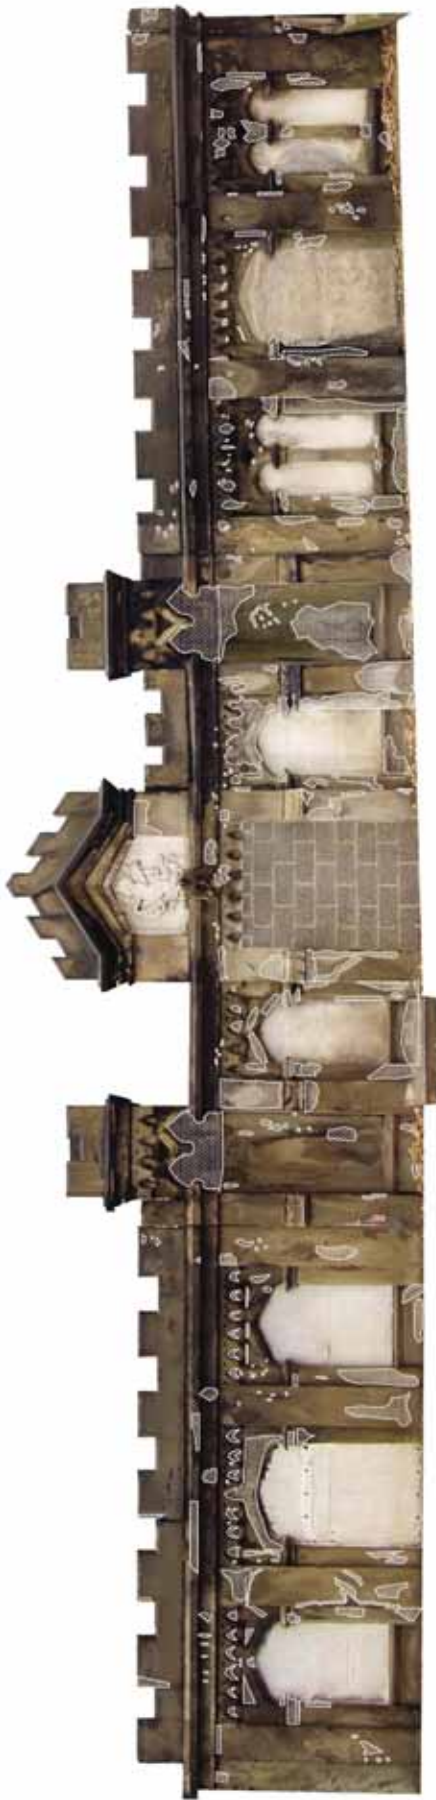
EFFLORESCENCE

Efflorescence as recorded on the façade of the Suddards-Manuel-Clark monument does not occur in any specific pattern. Salts are present on all three sections of the monument, and it must be remembered that only those salts that had crystallized on the surface of the stone the day the condition of efflorescence was recorded are documented herein. Not only does salt cycling greatly affect the weathering of stone, but presence of salts can also encourage chemical weathering. When salt solutions have high pH levels, from pH of 9 up to pH of more than 11, “silica mobility tends to be greatly increased” because the “solubility of silica increases exponentially above pH 9.”¹⁰⁷ Microbiological growth can also “precipitate sulphates and oxalates, and thus may be active in creating

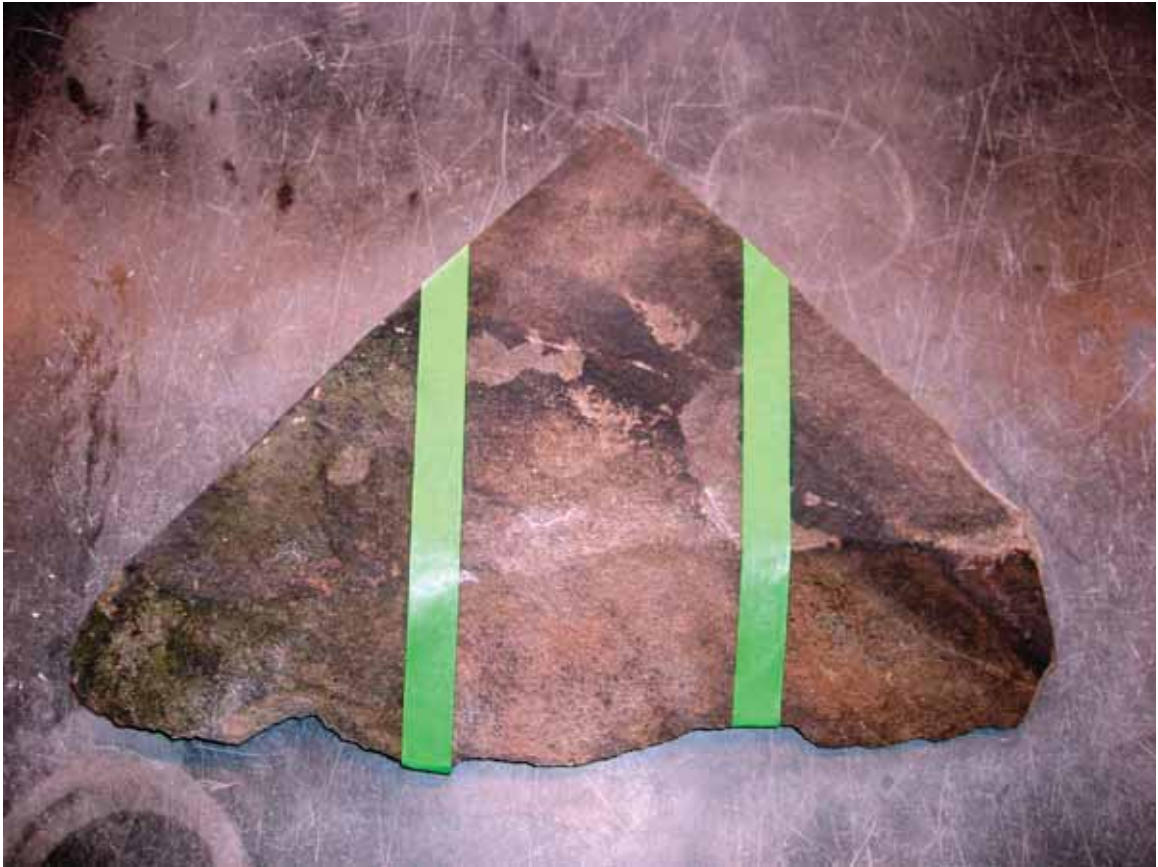
Figure 7.1 Pilot cleaning tests with PROSOCO, Inc. Sure Klean® Heavy Duty Restoration Cleaner; control (left), 1:3 cleaner to water solution (middle), 1:6 cleaner to water solution (right) (Source: E. Kemery, 2009)

As cleaning is the first step to be taken before any conservation treatment is begun, pilot cleaning tests were carried out first on the large sandstone sample in the laboratory and then in situ on the monument. PROSOCO, Inc. Sure Klean® Heavy Duty Restoration Cleaner, a hydrofluoric acid based cleaner, was diluted 1 part cleaner to 3 parts water and 1 part cleaner to 6 parts water. After pre-wetting, the cleaner was applied, left for a three minute dwell time, scrubbed gently with a brush and then rinsed off. This cycle was repeated three times. After three cycles, the 1:6 cleaner had lightened soiling and cleared much biological growth, and the 1:3 cleaner had lightened the soiling greatly and cleared all biological growth from its test area.

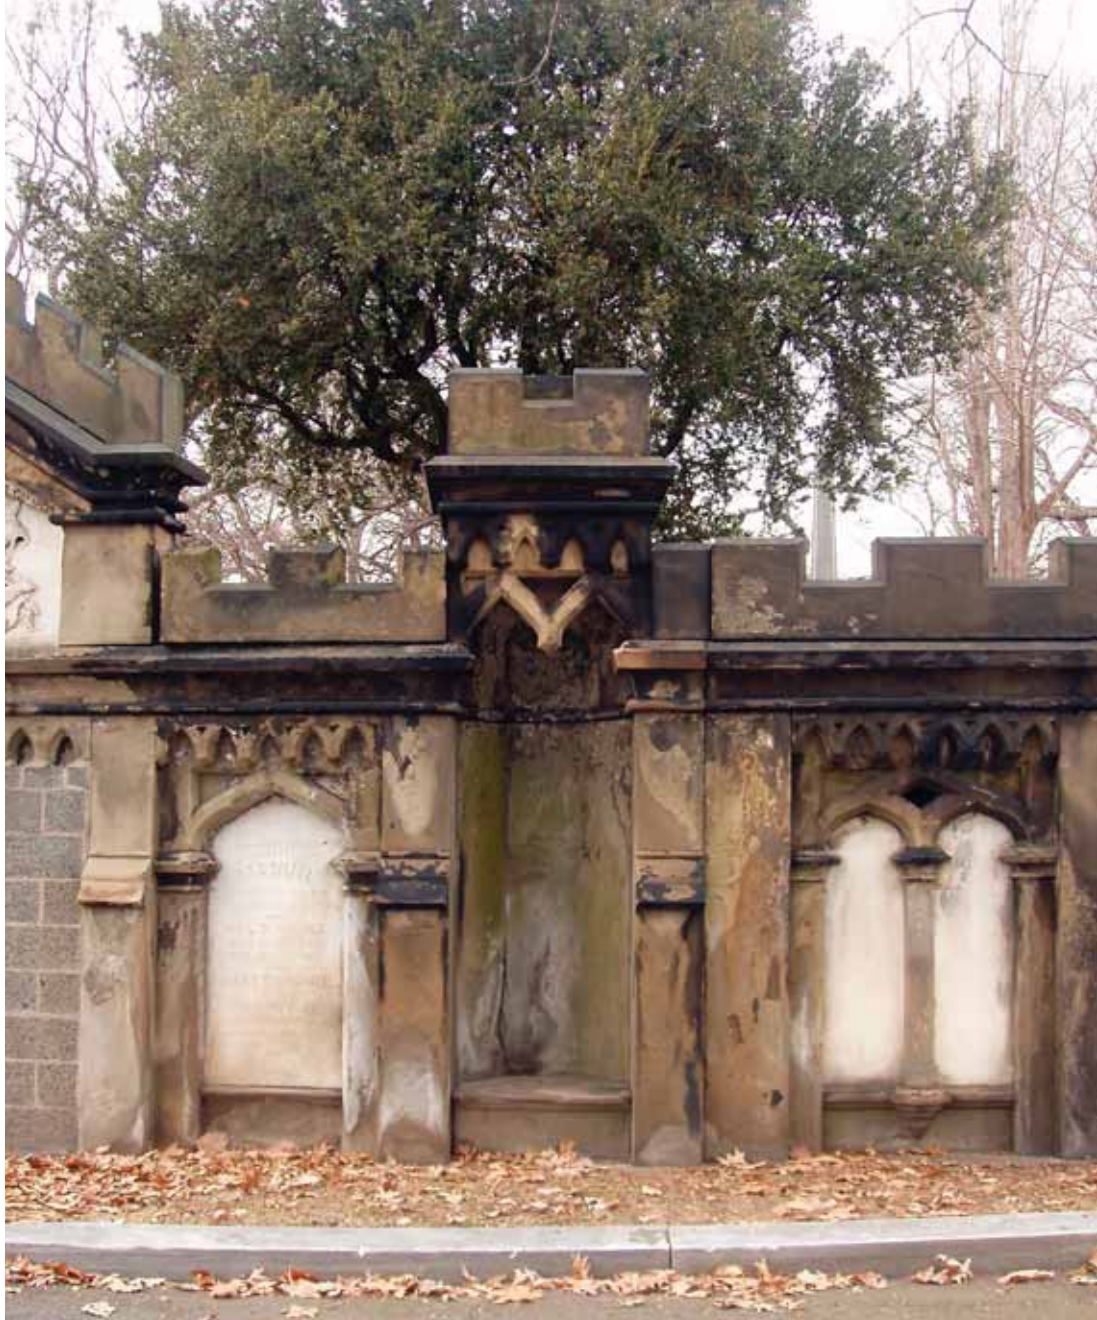
Figure 7.3 Section of the Suddards-Manuel-Clark monument to be cleaned, before cleaning with Cathedral Stone® Products D/2 Biological Solution (Source: E. Kemery, 2009)

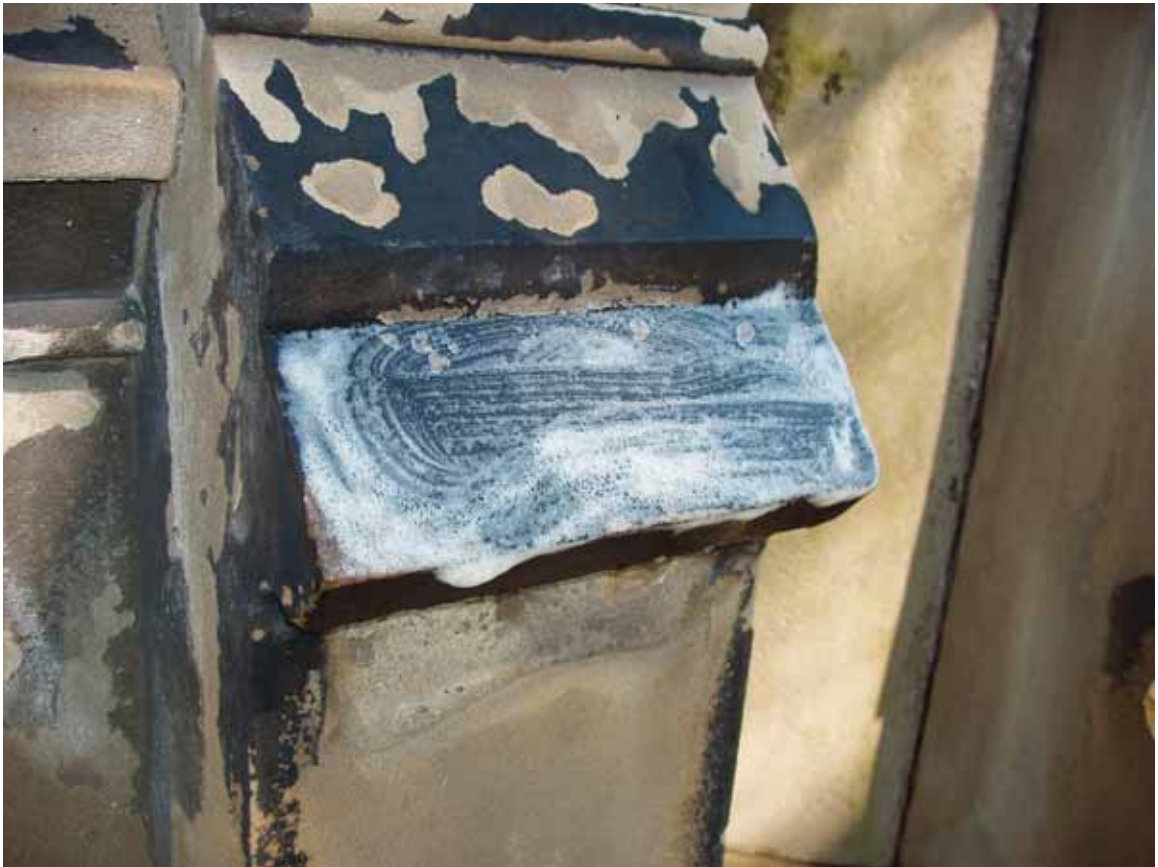
Figure 7.5 Section of opaque peeling/case-hardened crust during cleaning with Cathedral Stone® Products D/2 Biological Solution; D/2 Solution had no effect on case-hardened surfaces (Source: E. Kemery, 2009)

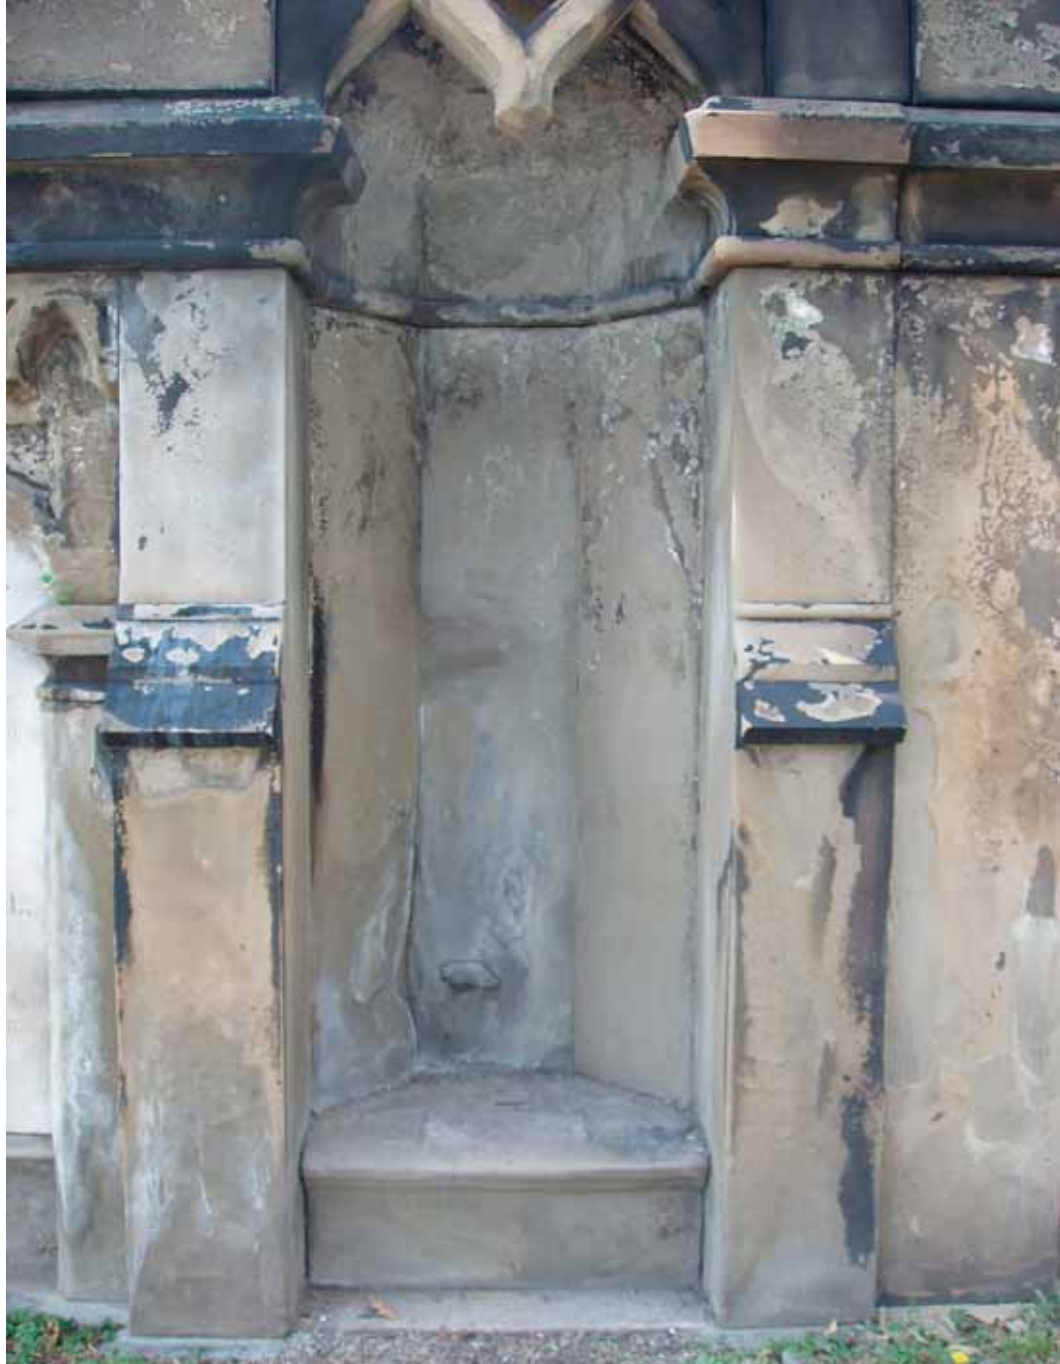
Figure 7.6 Cove area after cleaning with Cathedral Stone® Products D/2 Biological Solution
(Source: E. Kemery, 2009)

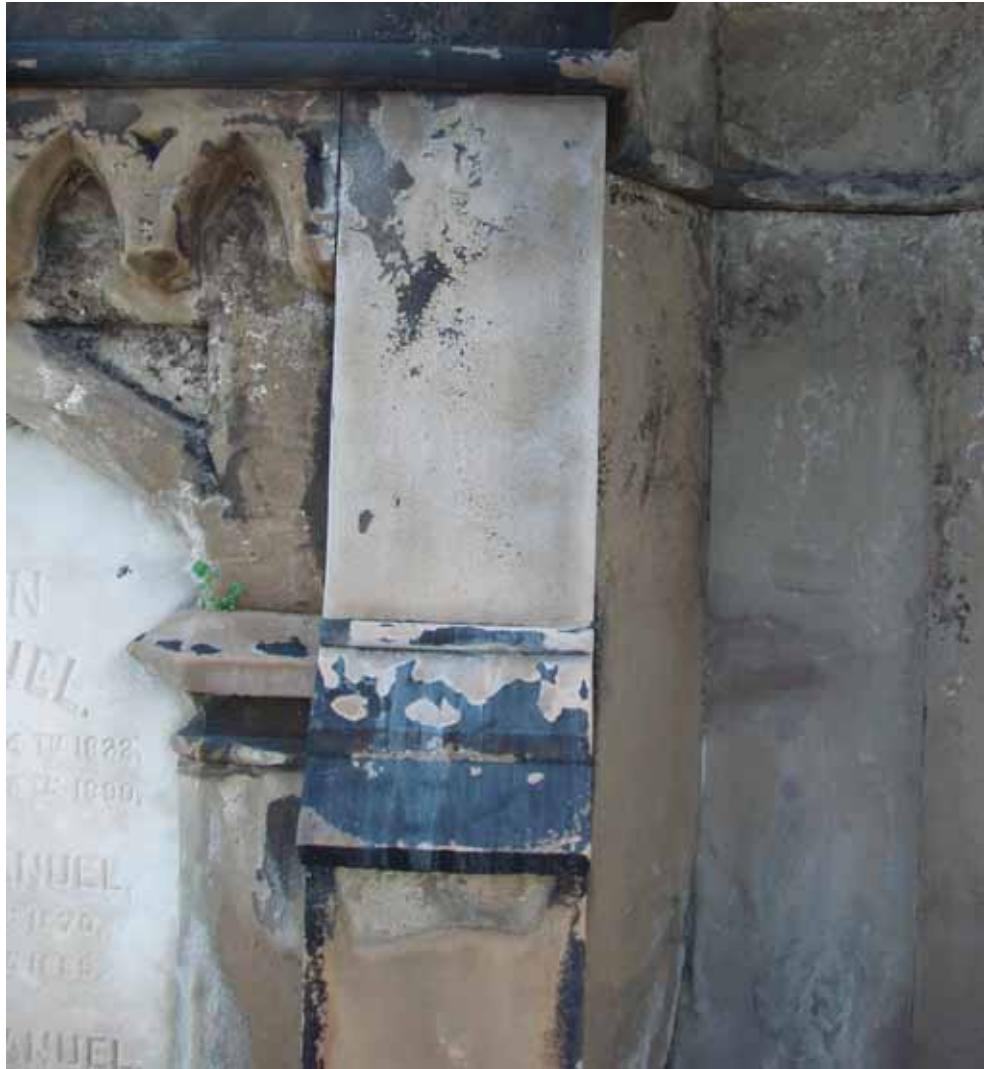
Figure 7.7 D/2 Solution did not remove soiling from case-hardened areas; note efflorescence post-cleaning (Source: E. Kemery, 2009)

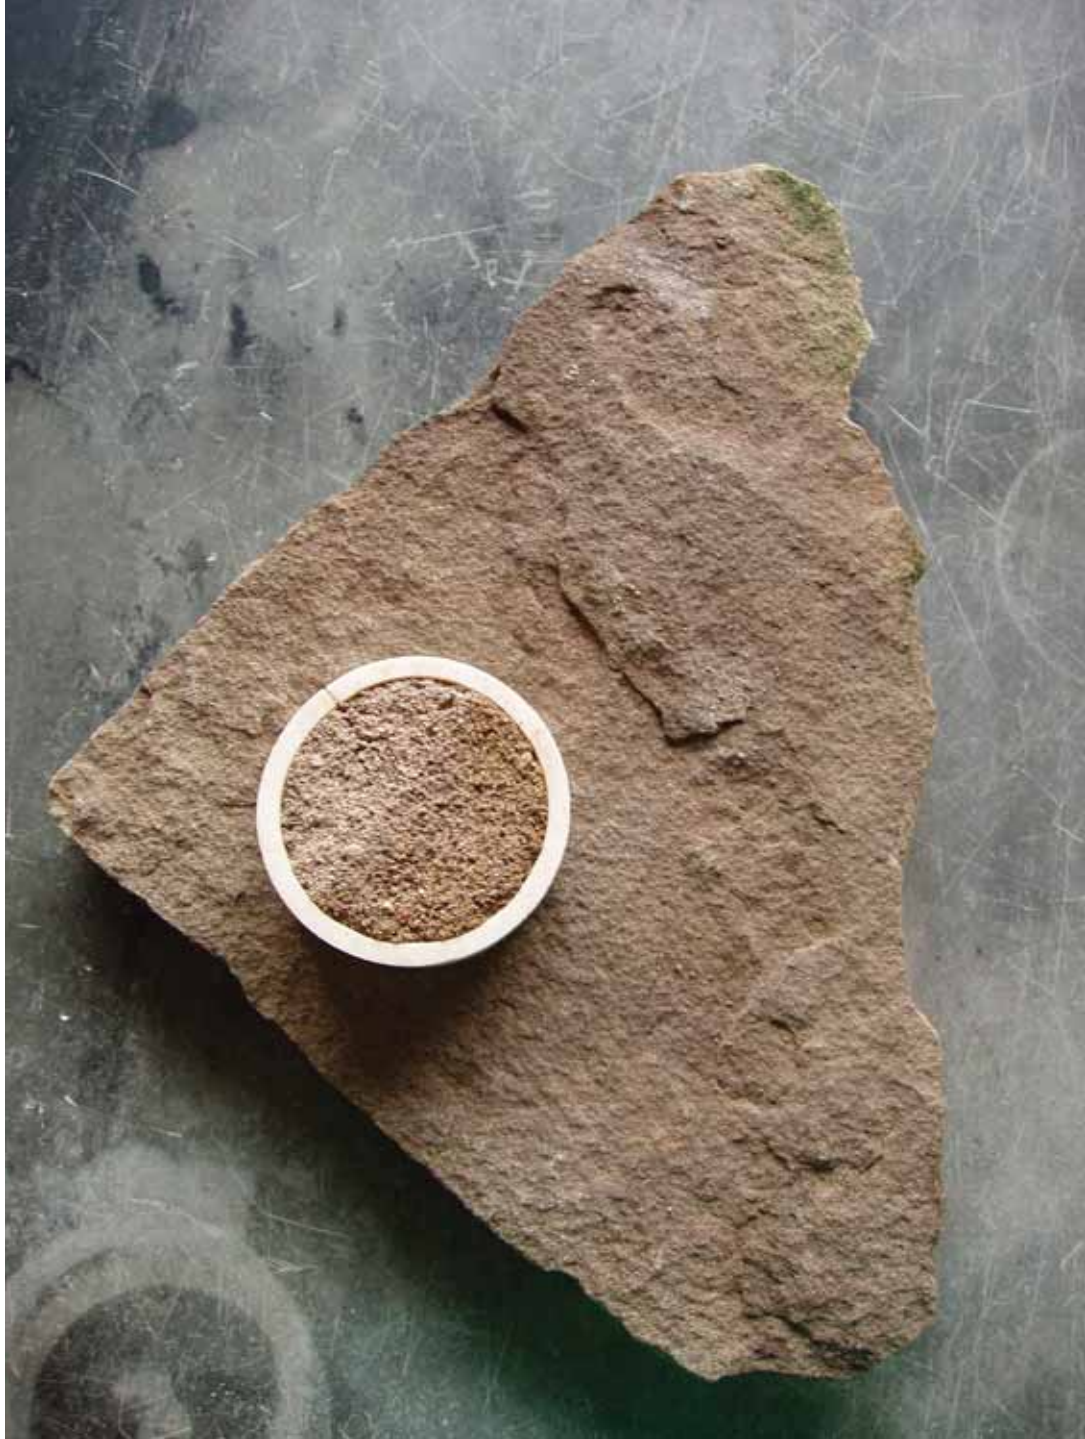
Figure 7.11 Repair mortar formulation 1 NHL 3.5 + 3 Sand + 1.00 g Van Dyke Brown (Source: E. Kemery, 2009)

After drying overnight, the mortar samples were compared in northern daylight to the clean sandstone sample, and while several of the samples were close in color to the stone, the formulation of 1 NHL 3.5 + 3 Sand + 1.00 g Van Dyke Brown was the closest match.
