A Technical Study and Conservation Proposal for the Glass Mosaic Decoration of Villa Caparra in Guaynabo, Puerto Rico

Yaritza Hernández
University of Pennsylvania

A THESIS

Historic Preservation

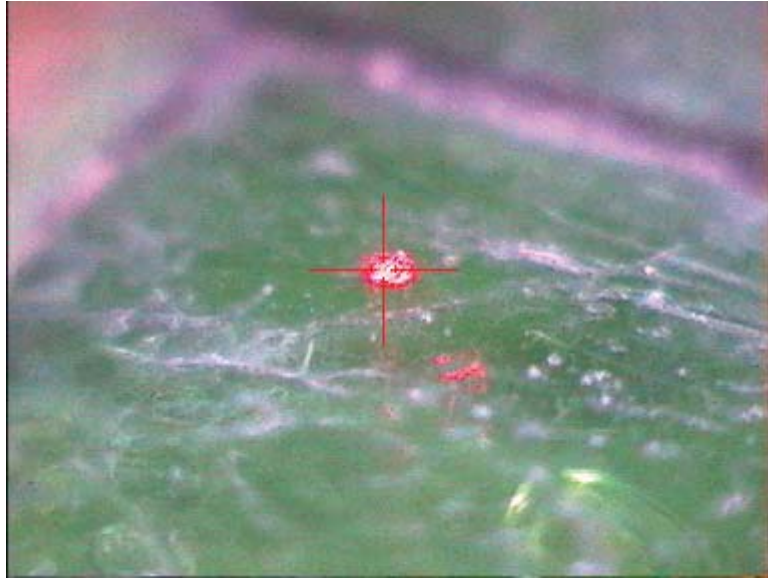
Figure 19: XRF analysis on Sample CL_B Opaque Green (source: Winterthur Museum, April, 2010).

A total of twelve flat glass tessera samples from Villa Caparra in a variety of colors and deterioration were analyzed. Sample CL_B was taken from one of the porte-cochere columns and is still embedded in the bedding mortar. It underwent a full analysis of all of its glass tesserae since it had 9 different colors of glass: gray, amber, green, beige, black, slag pink, red and gold leaf. All of the tesserae measured had a maximum thickness of 1/8" with the exception of the gold tesserae which was 1/4" thick. (see Appendix F)

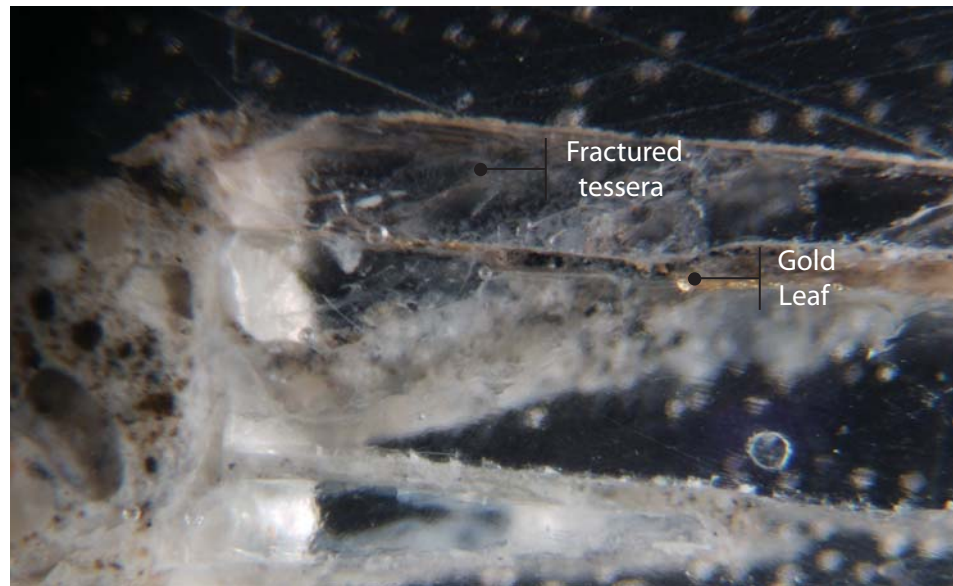
A gold tessera sample was collected for cross section analysis at the University of Pennsylvania's Architectural Conservation Laboratory. The gold leaf tessera was removed from the main entrance exterior surround. In general, gold tesserae on site were observed to perform poorly and even more so in areas that were exposed to the elements.

Figure 21: Cross Section Gold Tessera from Main Entrance Door (source: by author, January,2010.)

The prepared sample revealed that the tessera had several cracks on the thin layer that covers the gold leaf. The glass used as the base tessera had weakened and broken off from the bedding mortar. It's clear from the cross section that the failure of this particular type of tesserae comes from both the top glass layer and the bottom glass layer by the cement bedding mortar. (see figure 21) Additional tests would be required to determine which of the two glass layers deteriorates faster, or if one them triggers the other condition. To be determined is whether a suitable conservation scheme can be developed to save what is left of the original material or if replacement is more appropriate in this particular case.

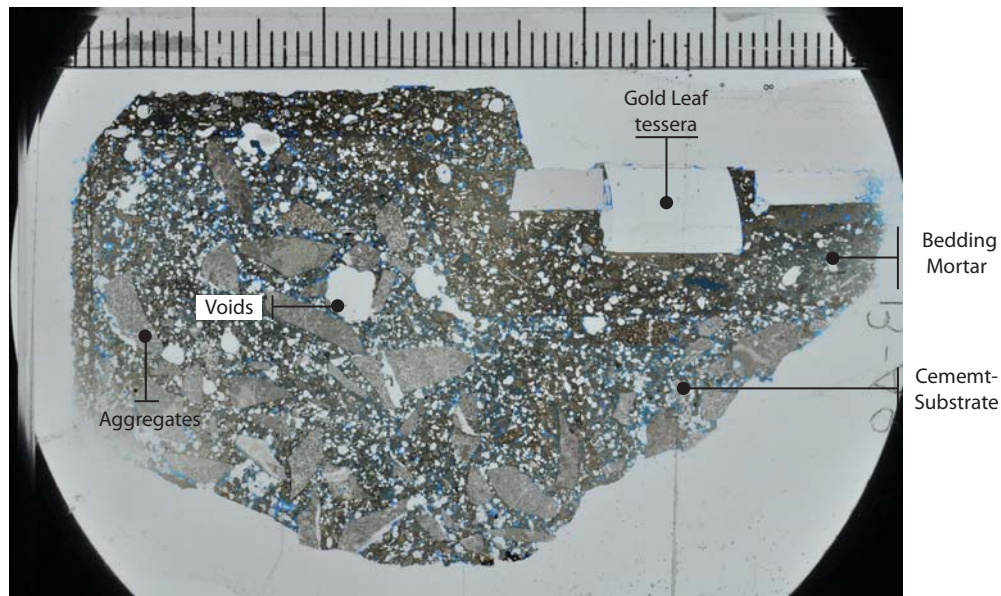
The sample for thin section was chosen from the column of the porte-cochere. This sample contains four of the main layers involved in the mosaic laying. (Starting from the bottom, the first layer is the concrete substrate; then the bedding mortar; followed by the glass tesserae; and, the decorative cement border constitutes the fourth layer. The selected area was mounted in an oversized slide 2"x 3". Observed through a polarized light microscope at 10x magnification, the support shows calcareous aggregates and reveals a high porosity, represented by large pores. At the same magnification, the bedding mortar also showed similar calcareous aggregates but had smaller pores and less quantity of voids. By the size of pores it can be assumed that the permeability of the support is higher than that of the bedding mortar. The sample also shows that the glass tessera in section has a network of tiny cracks that go through from the surface to bottom. The thin section analysis has proven valuable in viewing the differences between the mortars used. (*see figure 22*)

Figure 22: Sample CL_B petrography slide [2"x 3"] . (source: Jamie Hayden May, 2010)

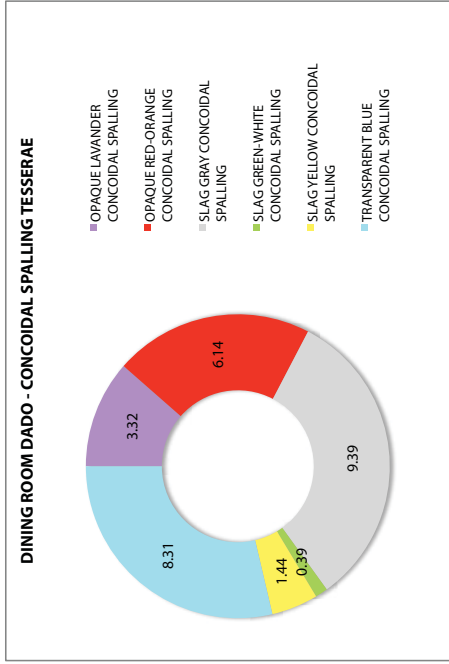
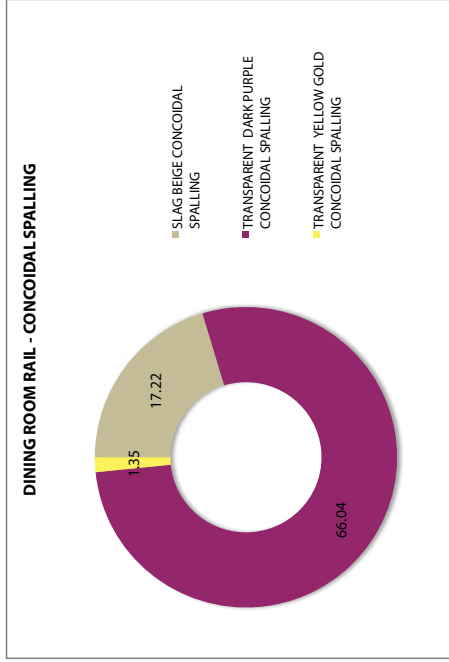
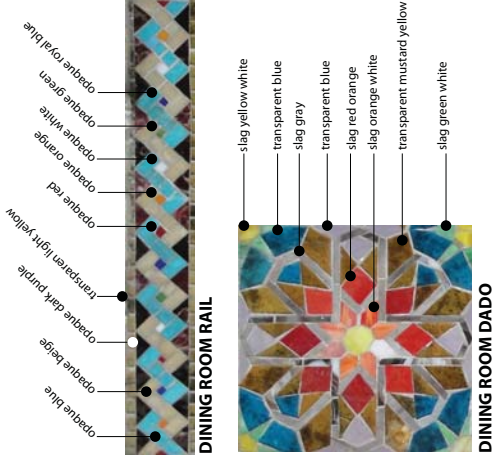
Dining Room Rail & Dado - Wall B

DINING ROOM DADO_CONCOIDAL SPALLING				
CHARACTERISTIC	COLOR	CONDITION	AREA	%
OPAQUE	LAVANDER	CONCOIDAL SPALLING	1.9184	3.32
OPAQUE	RED-ORANGE	CONCOIDAL SPALLING	3.5464	6.14
SLAG	GRAY	CONCOIDAL SPALLING	5.4217	9.39
SLAG	GREEN-WHITE	CONCOIDAL SPALLING	0.2230	0.39
SLAG	YELLOW	CONCOIDAL SPALLING	0.8298	1.44
TRANSPARENT	BLUE	CONCOIDAL SPALLING	4.7968	8.31
TOTAL			16.7361	28.9821

DINING ROOM RAIL_CONCOIDAL SPALLING				
CHARACTERISTIC	COLOR	CONDITION	AREA	%
SLAG	BABY BLUE	CONCOIDAL SPALLING	6.3110	15.39
SLAG	BEIGE	CONCOIDAL SPALLING	7.0626	17.22
TRANSPARENT	DARK PURPLE	CONCOIDAL SPALLING	27.0846	66.04
TRANSPARENT	YELLOW GOLD	CONCOIDAL SPALLING	0.5522	1.35
TOTAL			41.0104	100.00

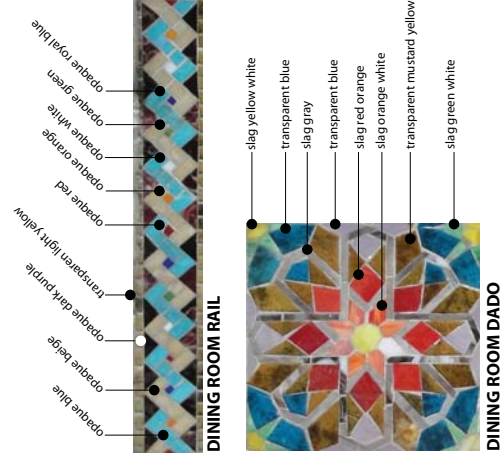
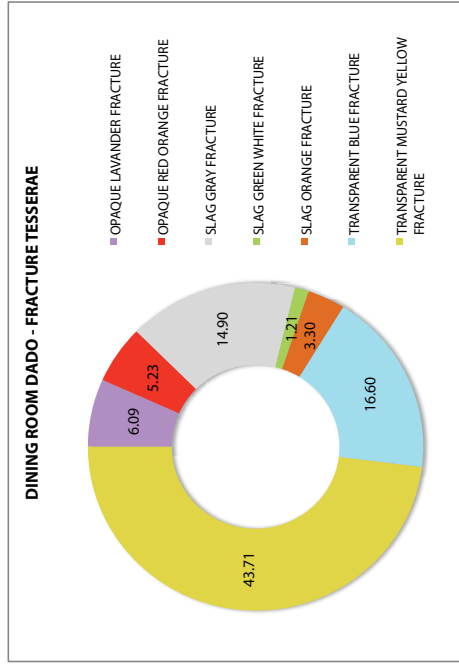
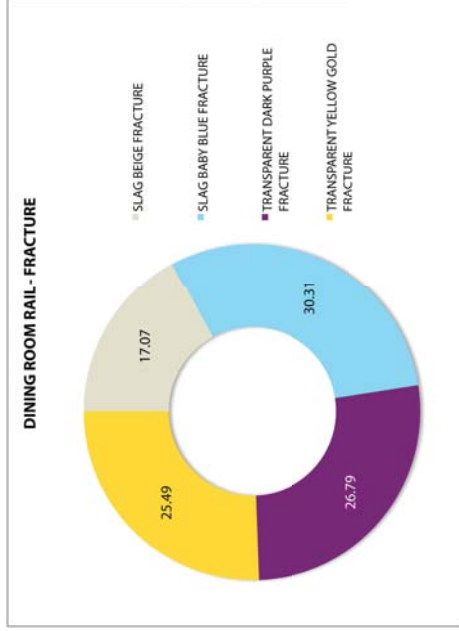
Dining Room Rail & Dado - Wall B

DINING ROOM RAIL - FRACTURE			
CHARACTERISTIC	COLOR	CONDITION	AREA
OPAQUE	LAVANDER	FRACTURE	49.37
OPAQUE	RED ORANGE	FRACTURE	42.44
SLAG	GRAY	FRACTURE	120.93
SLAG	GREEN WHITE	FRACTURE	9.84
SLAG	ORANGE	FRACTURE	26.81
TRANSPARENT	BLUE	FRACTURE	134.66
TRANSPARENT	MUSTARD YELLOW	FRACTURE	354.66
TOTAL AREA			738.73
			%
			6.09
			5.23
			14.90
			1.21
			3.30
			16.60
			43.71
			91.05

DINING ROOM RAIL - FRACTURE			
CHARACTERISTIC	COLOR	CONDITION	AREA
OPAQUE	ORANGE	FRACTURE	0.12
OPAQUE	WHITE	FRACTURE	0.13
SLAG	BABY BLUE	FRACTURE	22.02
SLAG	BEIGE	FRACTURE	12.40
TRANSPARENT	DARK PURPLE	FRACTURE	19.46
TRANSPARENT	YELLOW GOLD	FRACTURE	18.52
TOTAL AREA			72.65
			%
			0.01
			0.02
			2.71
			1.53
			2.40
			2.28
			8.95

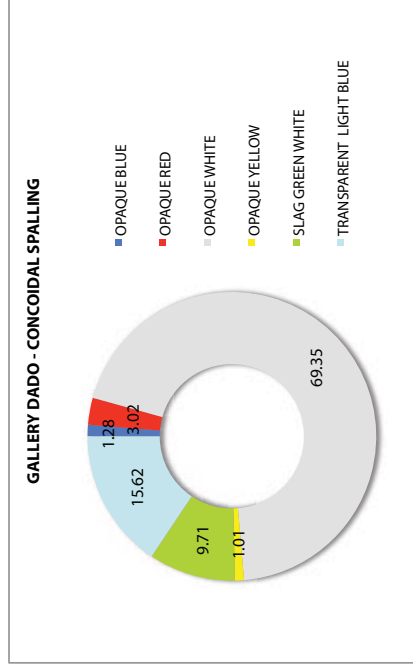
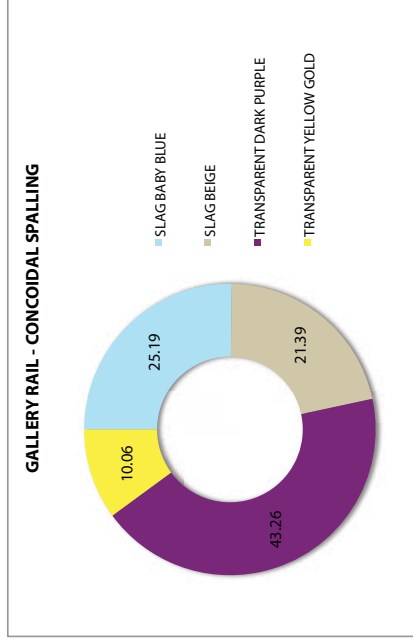
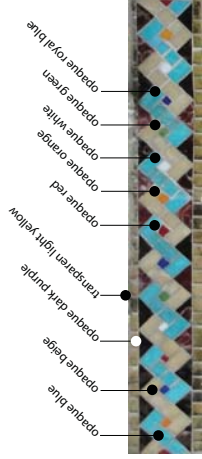
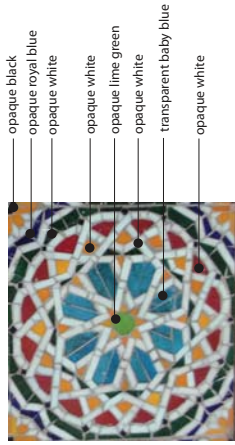
Gallery Dado & Rail

GALLERY DADO - CONCOIDAL SPALLING			
CHARACTERISTICS	COLOR	CONDITION	AREA
OPAQUE	BLUE	CONCOIDAL SPALLING	0.47
OPAQUE	RED	CONCOIDAL SPALLING	1.11
OPAQUE	WHITE	CONCOIDAL SPALLING	25.49
OPAQUE	YELLOW	CONCOIDAL SPALLING	0.37
SLAG	GREEN WHITE	CONCOIDAL SPALLING	3.57
TRANSPARENT	LIGHT BLUE	CONCOIDAL SPALLING	5.74
TOTAL AREA			36.76
			99.99

GALLERY RAIL - CONCOIDAL SPALLING			
CHARACTERISTICS	COLOR	CONDITION	AREA
OPAQUE	LIME GREEN	CONCOIDAL SPALLING	0.17
SLAG	BABY BLUE	CONCOIDAL SPALLING	43.17
SLAG	BEIGE	CONCOIDAL SPALLING	36.67
TRANSPARENT	DARK PURPLE	CONCOIDAL SPALLING	74.15
TRANSPARENT	YELLOW GOLD	CONCOIDAL SPALLING	17.23
TOTAL AREA			171.39
			100.00

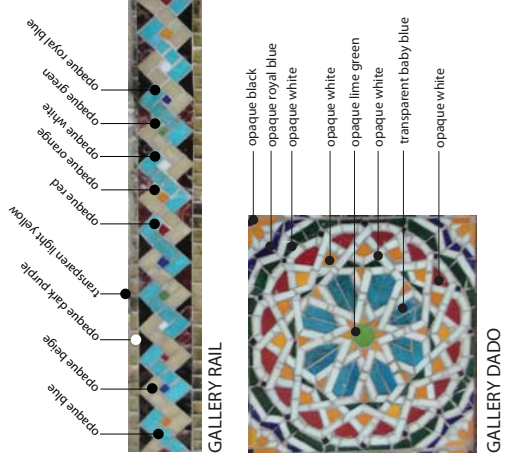
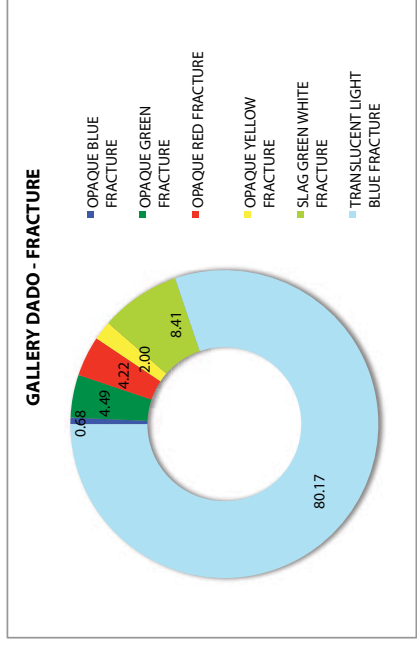
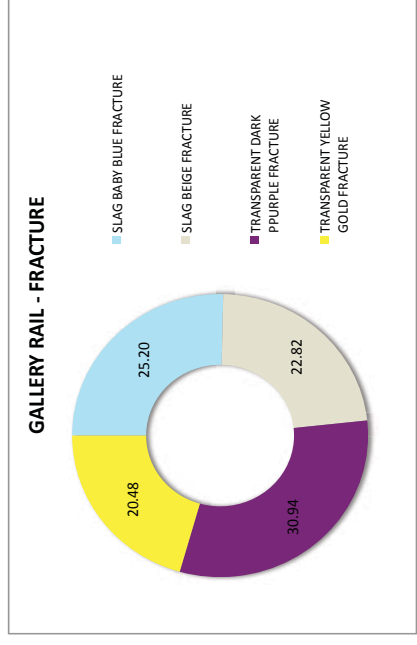
Gallery Dado & Rail

GALLERY DADO - FRACTURE			
CHARACTERISTIC	COLOR	CONDITION	AREA
OPAQUE	BLACK	FRACTURE	0.08
OPAQUE	BLUE	FRACTURE	0.68
OPAQUE	GREEN	FRACTURE	3.14
OPAQUE	RED	FRACTURE	20.74
OPAQUE	YELLOW	FRACTURE	19.48
SLAG	GREEN WHITE	FRACTURE	9.23
TRANSLUCENT	LIGHT BLUE	FRACTURE	38.81
TOTAL AREA			461.35
			19.83

GALLERY RAIL - FRACTURE			
CHARACTERISTIC	COLOR	CONDITION	AREA
OPAQUE	BLUE	FRACTURE	0.16
OPAQUE	LIME GREEN	FRACTURE	0.61
OPAQUE	WHITE	FRACTURE	0.92
SLAG	BABY BLUE	FRACTURE	76.15
SLAG	BEIGE	FRACTURE	68.97
TRANSPARENT	DARK PURPLE	FRACTURE	93.49
TRANSPARENT	YELLOW GOLD	FRACTURE	61.89
TOTAL AREA			302.17
			100.00

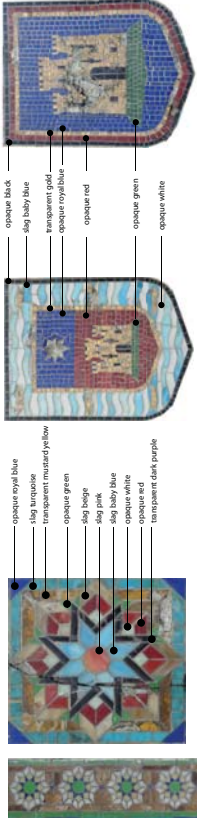
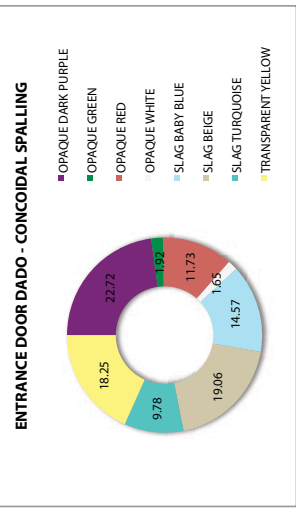
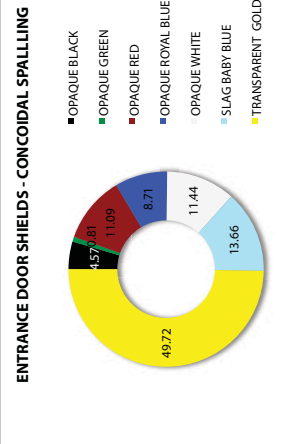
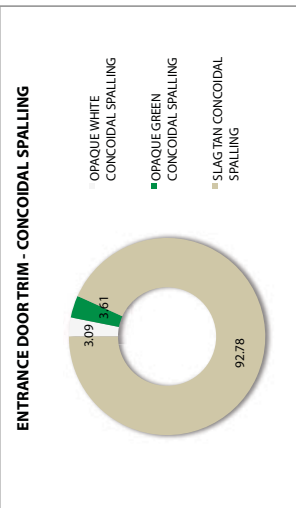
Elevation Key
Entrance Door

ENTRANCE DOOR DADO - CONCOIDAL SPALLING			
CHARACTERISTICS	COLOR	CONDITION	AREA
OPAQUE	DARK PURPLE	CONCOIDAL SPALLING	69.67
OPAQUE	GREEN	CONCOIDAL SPALLING	5.90
OPAQUE	RED	CONCOIDAL SPALLING	35.96
OPAQUE	ROYAL BLUE	CONCOIDAL SPALLING	1.01
OPAQUE	WHITE	CONCOIDAL SPALLING	5.05
SLAG	BABY BLUE	CONCOIDAL SPALLING	44.67
SLAG	BEIGE	CONCOIDAL SPALLING	58.46
SLAG	TURQUOISE	CONCOIDAL SPALLING	29.99
TRANSPARENT	YELLOW	CONCOIDAL SPALLING	55.98
TOTAL AREA			306.69

ENTRANCE DOOR DADO - CONCOIDAL SPALLING			
CHARACTERISTICS	COLOR	CONDITION	AREA
OPAQUE	GREEN	CONCOIDAL SPALLING	6.33
OPAQUE	LIGHT YELLOW	CONCOIDAL SPALLING	0.66
OPAQUE	ROYAL BLUE	CONCOIDAL SPALLING	0.24
OPAQUE	WHITE	CONCOIDAL SPALLING	5.42
SLAG	TAN	CONCOIDAL SPALLING	162.60
TOTAL AREA			175.26

ENTRANCE DOOR SHIELD - CONCOIDAL SPALLING			
CHARACTERISTICS	COLOR	CONDITION	AREA
OPAQUE	BLACK	CONCOIDAL SPALLING	4.54
OPAQUE	GREEN	CONCOIDAL SPALLING	0.81
OPAQUE	RED	CONCOIDAL SPALLING	11.01
OPAQUE	ROYAL BLUE	CONCOIDAL SPALLING	8.66
OPAQUE	WHITE	CONCOIDAL SPALLING	11.36
SLAG	BABY BLUE	CONCOIDAL SPALLING	13.57
TRANSPARENT	GOLD	CONCOIDAL SPALLING	49.40
TOTAL AREA			99.35

ENTRANCE DOOR DADO - FRACTURE			
CHARACTERISTICS	COLOR	CONDITION	AREA
SLAG	BEIGE	FRACTURE	164.64
OPAQUE	DARK PURPLE	FRACTURE	164.64
OPAQUE	GREEN	FRACTURE	4.11
OPAQUE	RED	FRACTURE	25.59
OPAQUE	ROYAL BLUE	FRACTURE	4.60
OPAQUE	WHITE	FRACTURE	4.94
SLAG	PINK WHITE	FRACTURE	21.07
SLAG	BABY BLUE	FRACTURE	93.88
SLAG	TURQUOISE	FRACTURE	229.39
TRANSPARENT	YELLOW	FRACTURE	72.72
TOTAL AREA			785.60

ENTRANCE DOOR SHIELD - FRACTURE			
CHARACTERISTICS	COLOR	CONDITION	AREA
OPAQUE	BLACK	FRACTURE	1.40
OPAQUE	GREEN	FRACTURE	0.56
OPAQUE	RED	FRACTURE	7.30
OPAQUE	ROYAL BLUE	FRACTURE	3.25
OPAQUE	WHITE	FRACTURE	4.53
SLAG	BABY BLUE	FRACTURE	17.95
TRANSPARENT	GOLD	FRACTURE	16.37
TOTAL AREA			51.37

ENTRANCE DOOR TRIM - FRACTURE			
CHARACTERISTICS	COLOR	CONDITION	AREA
OPAQUE	ROYAL BLUE	FRACTURE	0.05
OPAQUE	WHITE	FRACTURE	4.57
OPAQUE	LIGHT YELLOW	FRACTURE	1.79
SLAG	TAN	FRACTURE	259.43
TOTAL AREA			265.84

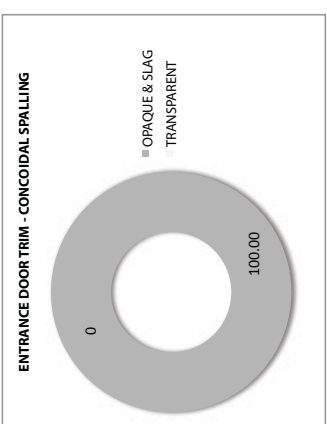
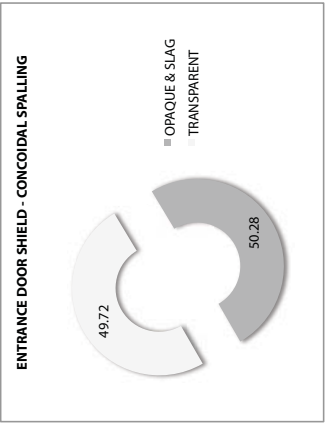
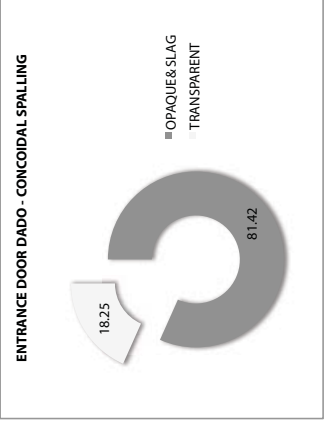
ENTRANCE DOOR DADO - CONCOIDAL SPALLING		ENTRANCE DOOR SHIELD - CONCOIDAL SPALLING		ENTRANCE DOOR TRIM - CONCOIDAL SPALLING	
CHARACTERISTIC		CHARACTERISTIC		CHARACTERISTIC	
OPAQUE & SLAG	AREA %	OPAQUE & SLAG	AREA %	OPAQUE & SLAG	AREA %
18.25	81.42	49.72	50.28	0	100.00
TRANSPARENT	18.25	TRANSPARENT	49.72	TRANSPARENT	0
TOTAL AREA	99.67	TOTAL AREA	100.00	TOTAL AREA	100.00

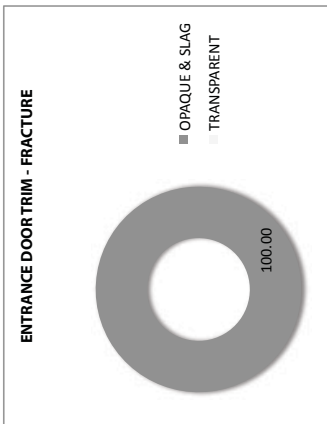
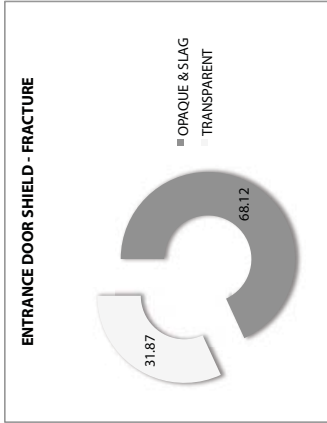
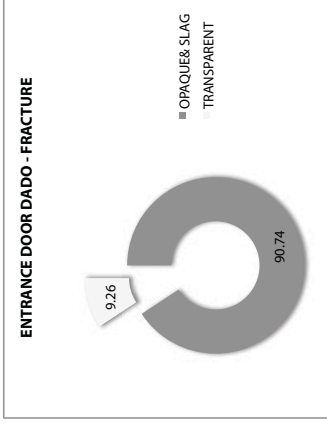
ENTRANCE DOOR DADO - FRACTURE		ENTRANCE DOOR SHIELD - FRACTURE		ENTRANCE DOOR TRIM - FRACTURE	
CHARACTERISTIC		CHARACTERISTIC		CHARACTERISTIC	
OPAQUE & SLAG	AREA %	OPAQUE & SLAG	AREA %	OPAQUE & SLAG	AREA %
9.26	90.74	31.87	68.12	0	100.00
TRANSPARENT	9.26	TRANSPARENT	31.87	TRANSPARENT	0
TOTAL AREA	100.00	TOTAL AREA	99.99	TOTAL AREA	100.00

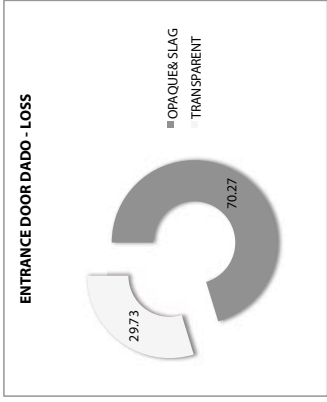
ENTRANCE DOOR DADO - LOSS	
CHARACTERISTIC	AREA %
OPAQUE & SLAG	70.27
TRANSPARENT	29.73
TOTAL AREA	100.00

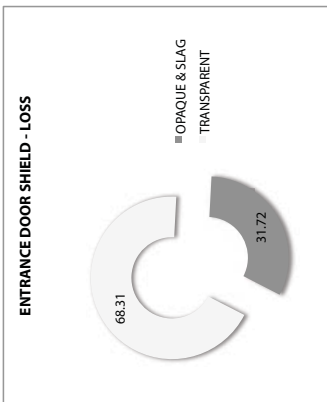
ENTRANCE DOOR SHIELD - LOSS	
CHARACTERISTIC	AREA %
OPAQUE & SLAG	31.72
TRANSPARENT	68.31
TOTAL AREA	68.31

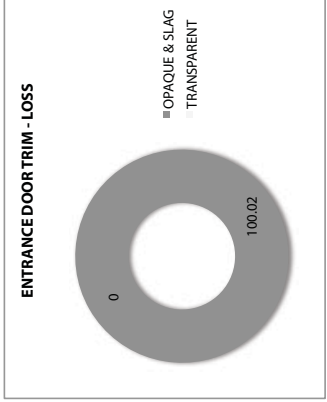
ENTRANCE DOOR TRIM - LOSS	
CHARACTERISTIC	AREA %
OPAQUE & SLAG	100.02
TRANSPARENT	0
TOTAL AREA	100.02
