A Thesis in Historic Preservation Presented to the Faculties of the University of Pennsylvania in Partial Fulfillment of the Requirements for the Degree of Master of Science in Historic Preservation 2007.

GRANDMA PRISBREY'S BOTTLE VILLAGE:
A VALUES BASED CONDITIONS ASSESSMENT OF AN
AMERICAN FOLK ART ENVIRONMENT

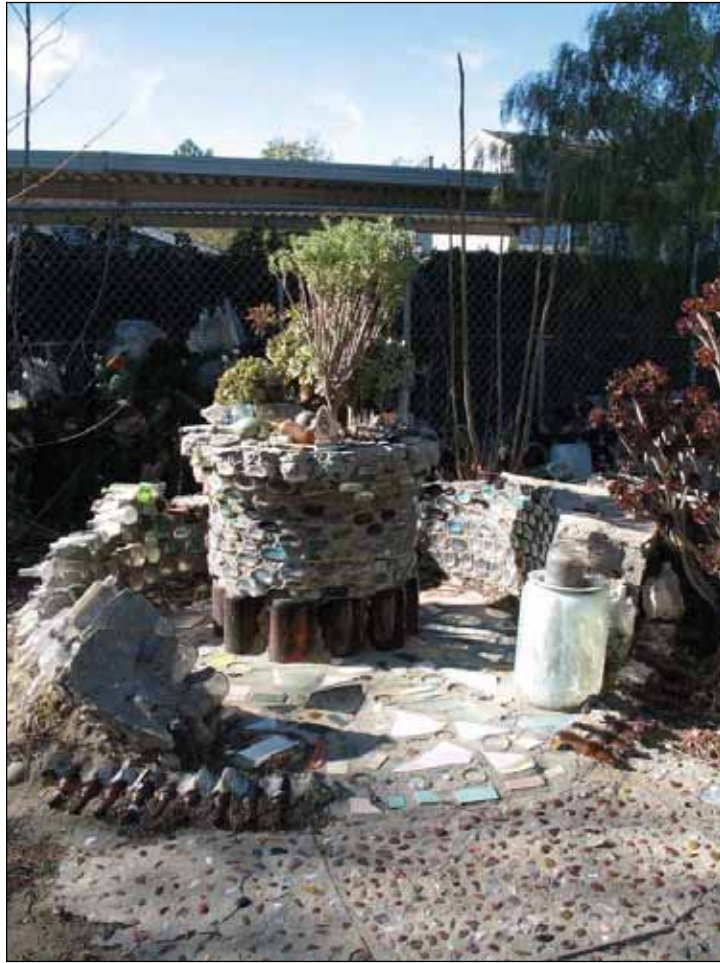
Figure 1.7: The Cabana (b. 1956),
load bearing bottle masonry ruin. (TSD 2007)

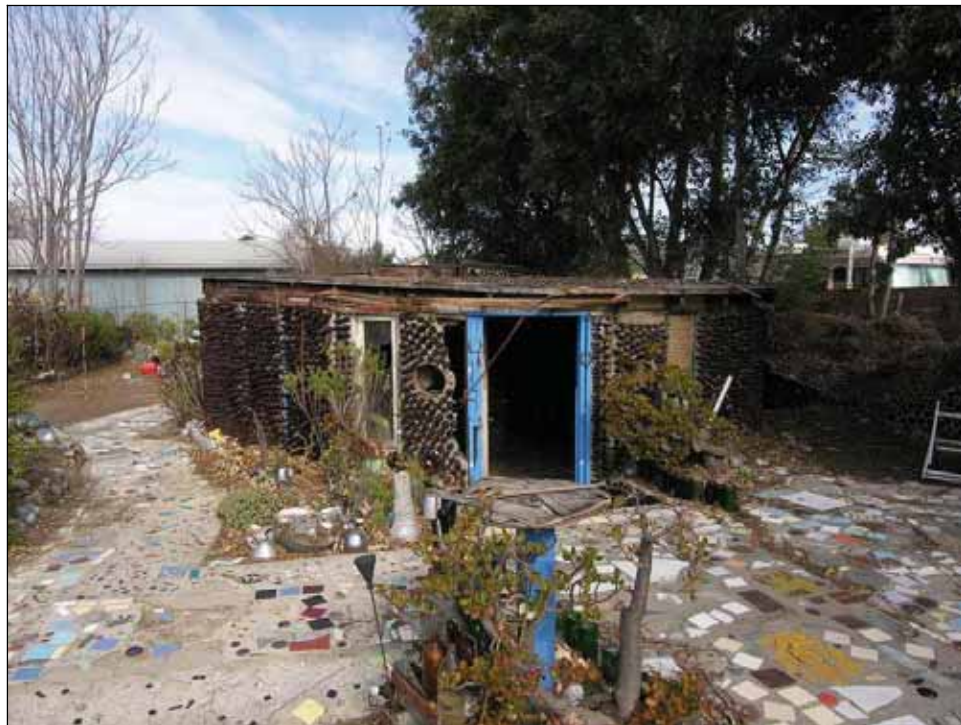
Figure 1.16: The Round House, built c. 1957 (R. Eppich 2007)

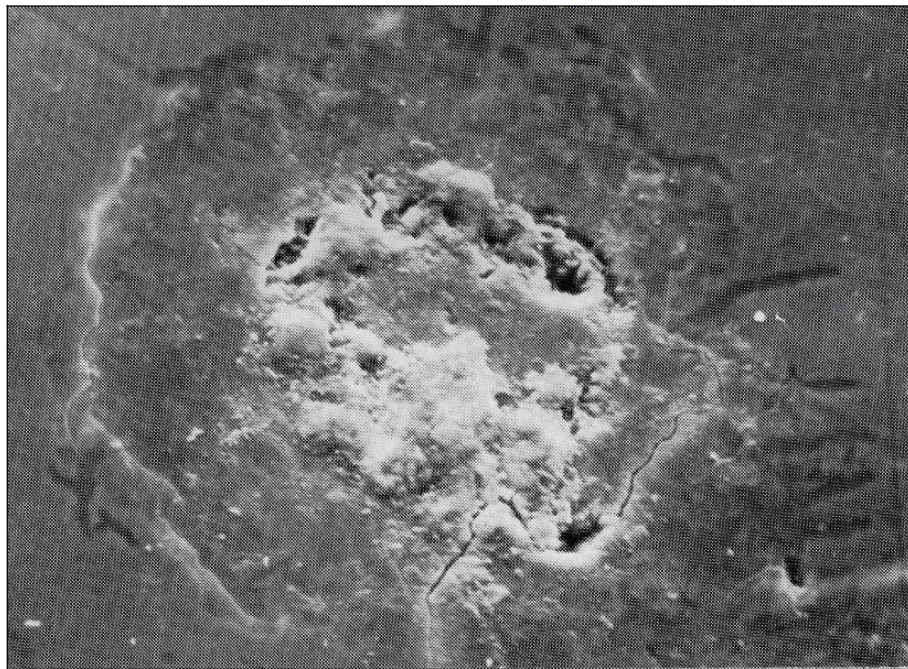
Corrosion of glass by water is a direct ion exchange. Alkali ions from the soda cannot leave the glass unless protons replace them to maintain electrical neutrality in the microstructure. Ions such as potassium and sodium are able to move around in the network, being continuously replaced by other cations when corrosion occurs. Protons are smaller than alkali ions (especially potassium ion) and thus the alkali-depleted surface layer has a smaller volume; potash glasses have about half the durability of the corresponding soda glasses because the potassium ion takes up more space in the network. This ion exchange may lead to a decrease in volume causing microporosity of the surface layer, one result being the formation of pits (Fig. 7.7). These pits collect dirt, allow water to accumulate, and can be the source of further deterioration.

Figure 7.7: Pitting on surface of glass (400x). (Newton 89)

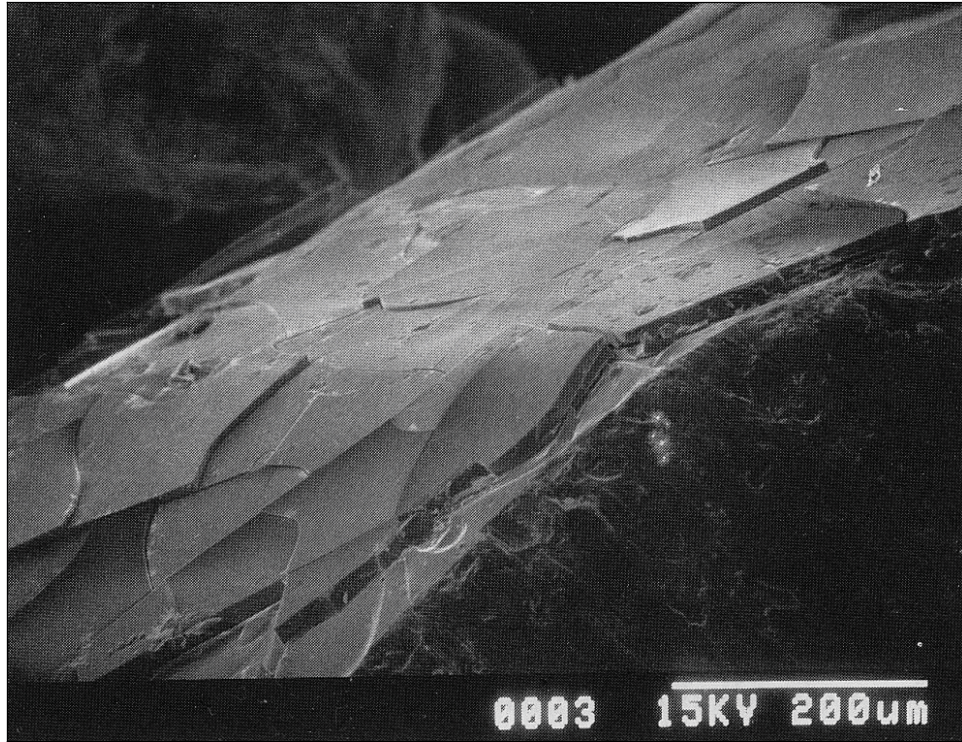
Crizzling occurs when there is a reduction in volume of the leached layer causing shrinkage (Fig. 7.8). At the molecular level, crizzling is a chemical instability due to an excess of alkali or deficiency in stabilizer. When a pH of 9 or more is reached, the silica network and the divalent network modifiers (calcium, magnesium, lead, etc.) can be leached out of the glass molecular structure. This causes a break down of the glassy network, and crystallization, or dissolution, ensues (Fig. 7.9). Chemically, the glass has entered a new phase, or solid state, one of an ordered molecular structure, ceasing to be amorphous or highly viscous. It can no longer be defined as a glass (ASTM C162-94C) when complete crystallization has occurred. This level of pH can be reached by several factors; when the alkali is not renewed by aqueous solutions, i.e. precipitation; if there is a high pH level due to acid rain or ambient atmospheric conditions; or, if the glass is

Figure 7.8: Crizzling of glass surface. (Tennent, 1999)

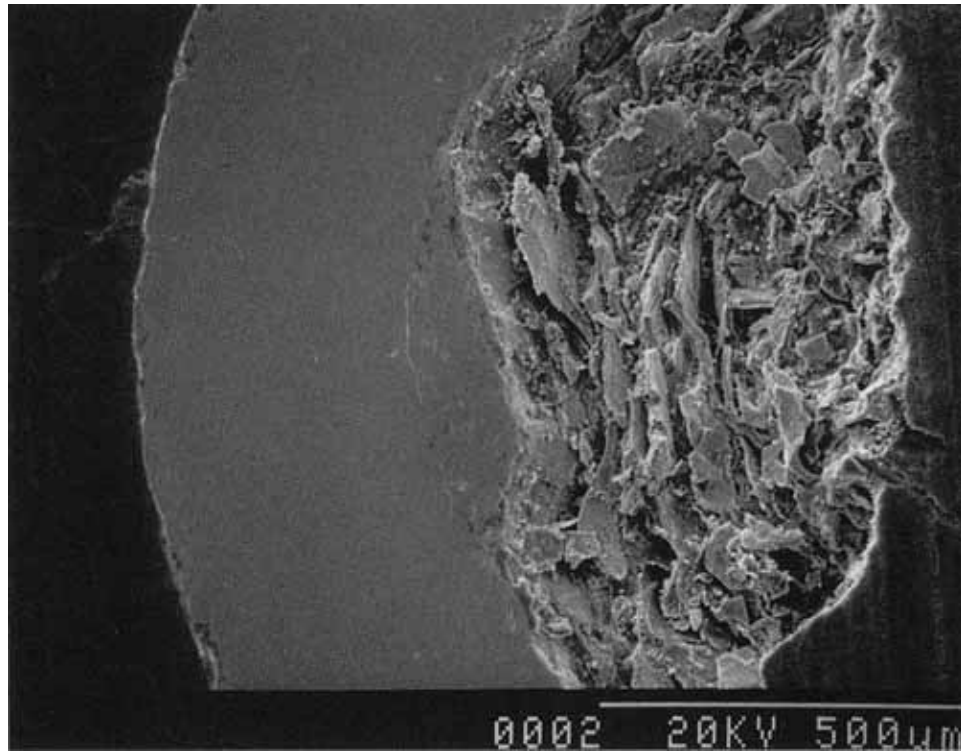
Figure 7.9: Crystallization of glass network. (Tennet 1999)

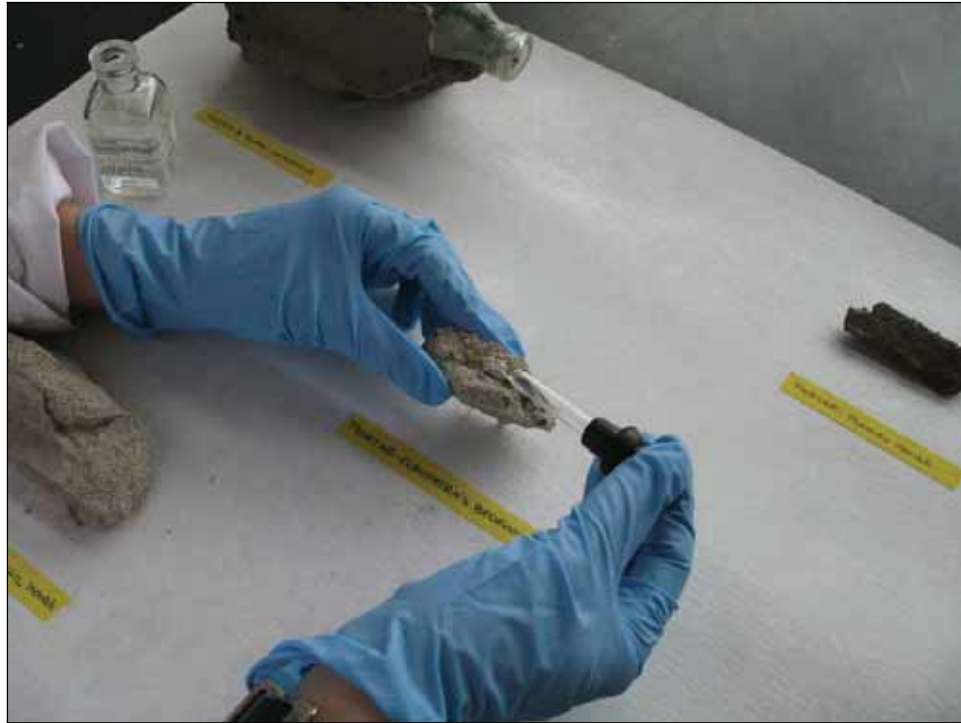
Quantitative analysis is conducted to determine the abundance of a particular substance in a sample. To determine if the constituents of the mortar are a possible source of alkalinity which may be inciting attack on the silica network of the container glass, a phenolphthalein test was conducted on four separate samples from Bottle Village. Phenolphthalein ($C_{20}H_{14}O_4$) is a pH indicator which denotes the level of carbonation, or state of curing, of a mortar. Wet and newly cured mortar may exhibit a pH of 12 (Fig. 7.10). During carbonation of the mortar, the pH will decrease due to contact with carbon dioxide in the air, as well as a minimum presence of humidity. Administering one drop of phenolphthalein on a mortar sample which is still curing will elicit a bright pink reaction, indicating a possible source of alkalinity from the presence of calcium hydroxide. If the reaction is pale pink, the mortar is close to a completely cured, carbonated state. The reaction of the Bottle Village mortar to the phenolphthalein tests was neutral, exhibiting no pink shade on the applied area (Fig. 7.11). Therefore, it is possible to surmise that calcium hydroxide does not play an active role in the molecular deterioration between the interfaces of the glass bottles and cement mortar.

Figure 7.11: Phenolphthalein test for carbonation of mortar. (L. Hall 2007)

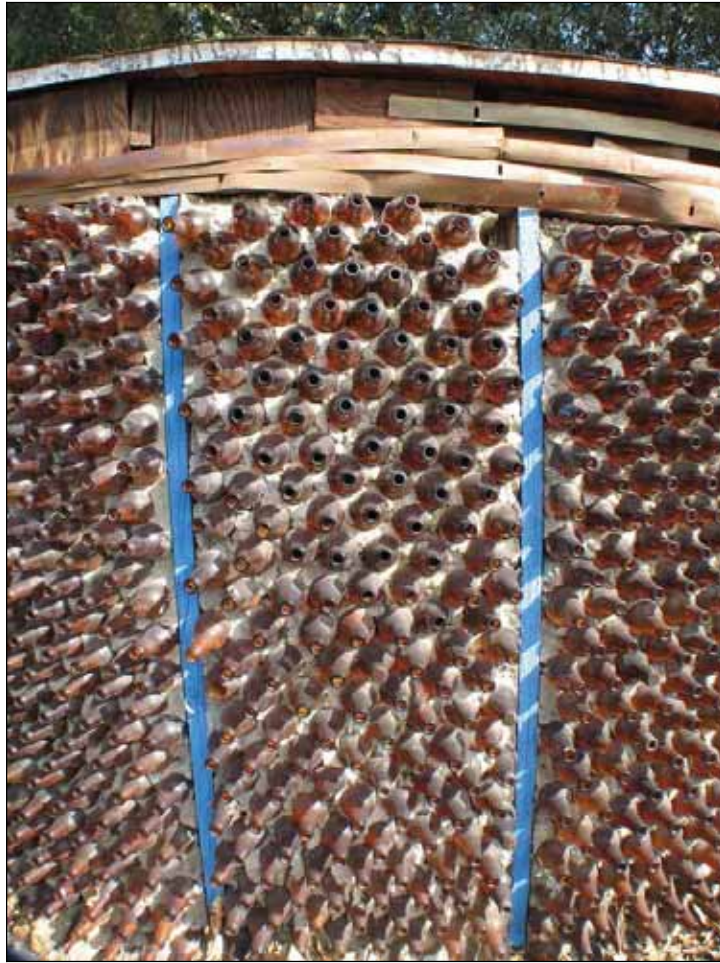
at approximately 16" o.c. provide some of the vertical load bearing performance on the periphery of the circular structure (fig. 7.13). These wood studs are directly in contact with the earth, specifically 3' below grade, making these components susceptible to damp, rot and termite damage (fig. 7.14). The Level II rapid conditions survey indicates rot and termite damage is prevalent on 80% of these components. Biological deterioration of wood affects the load bearing capability and long-term performance. Level III designates a fair to poor roof condition for the Round House. Visible deformation and settling of the roof is present, indicating this component may be exceeding the load bearing capabilities of the deteriorating 2" by 4" wood studs. Though the Round House is ranked as the highest priority structure on site (or lowest financial investment for stabilization), the conditions analysis ranks framing and roof in a more severe state of decay than the Rumpus Room, Cleopatra's Bedroom or the Viewing Room.

Figure 7.13: Round House load bearing studs and walls (TSD 2007)

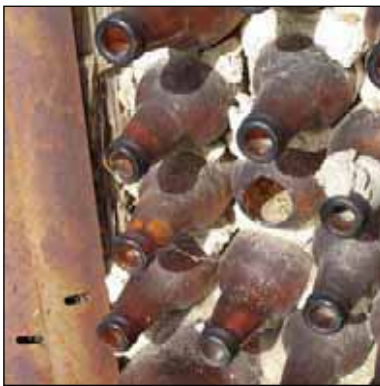
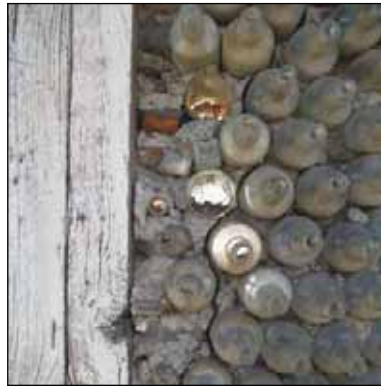
Broken

Partial loss of 60% or less, or damage of the container. Discontinuous form and lacking in completeness from fragmentation.

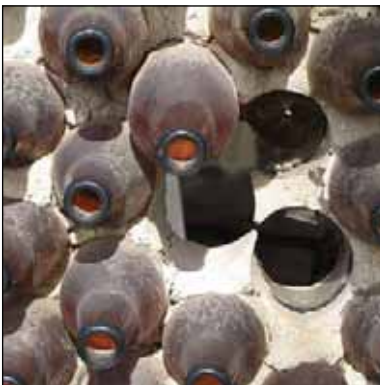
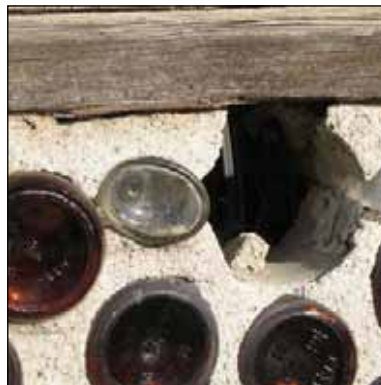
Missing

At least 59% loss or more, or total absence of the container.

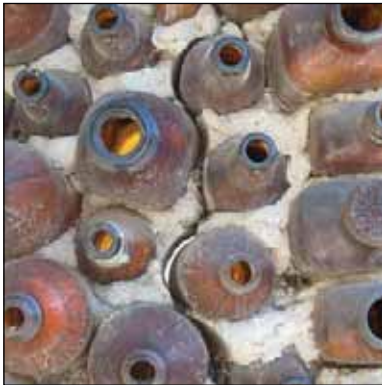
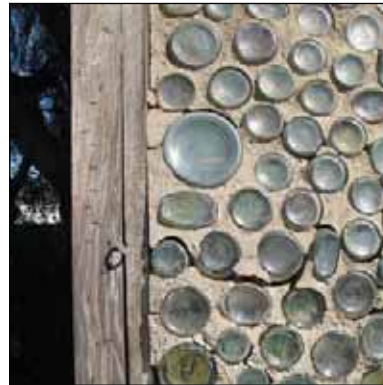
Cracking

Partial or complete fractures of varying width, depth and orientation. Fractures may be minor (network cracking), moderate or severe (deformation-displacement) in regards to structural performance

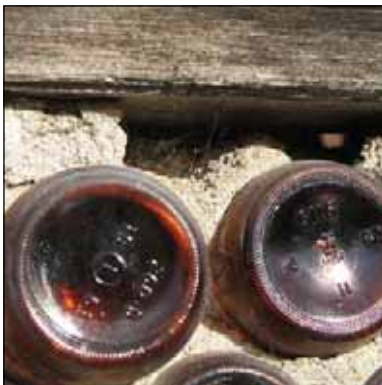
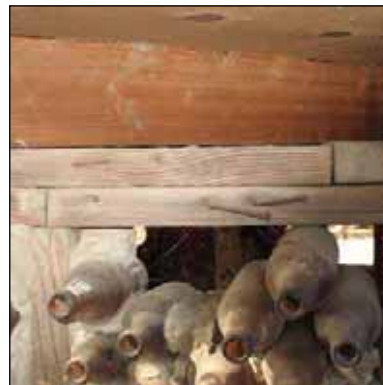
Missing

Complete or partial loss of at least 60% or more of the mortar matrix.

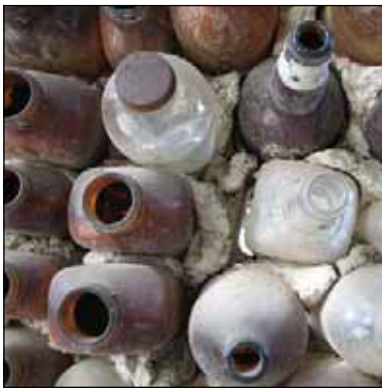
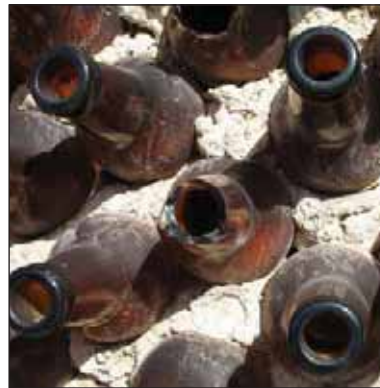
Friability

Loss of mortar cohesion between binder and aggregates resulting in granular disintegration. The material is easily reduced to a powder to the touch.

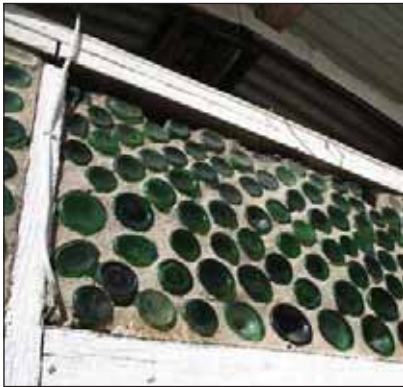
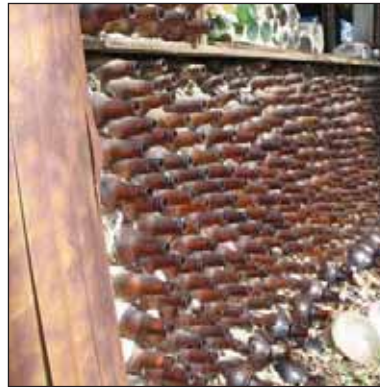
Deformation

Curve-like deviation from the original form of the masonry wall due material interface detachment from compression stress over time, or shear/lateral stress due to seismic activity.

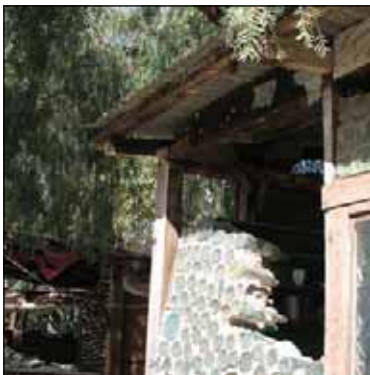
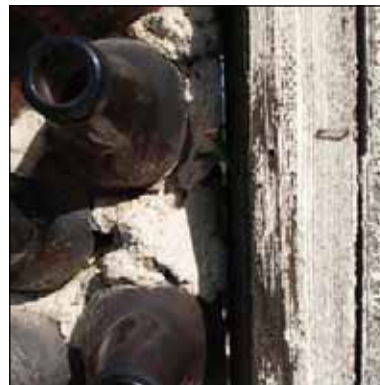
Detachment

Partial or complete loss of bond between the glass and mortar matrix, or between the mortar and frame.

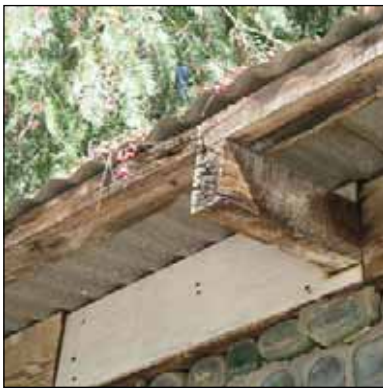
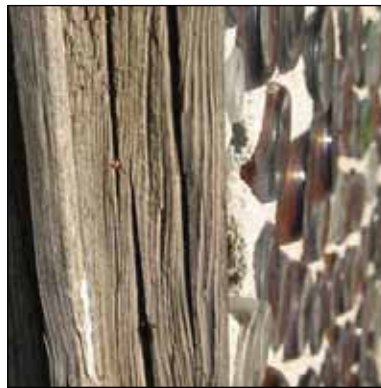
Checking

Lengthwise splits and cracks in the wood members due to expansion and contraction from heat and humidity during seasonal fluxuations.

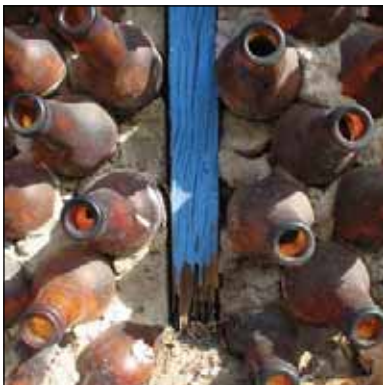
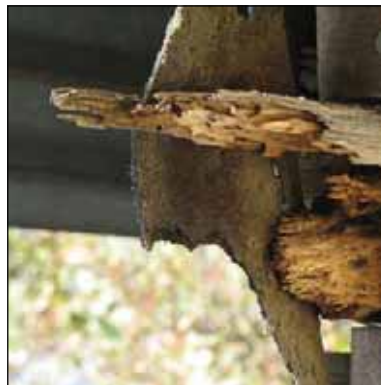
Rot/Termite

The decomposition of the wood from biological agents resuting in discoloration, softening and loss of structural integrity.

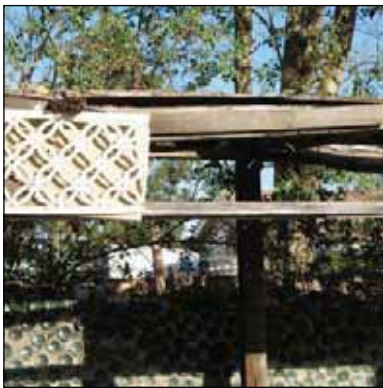
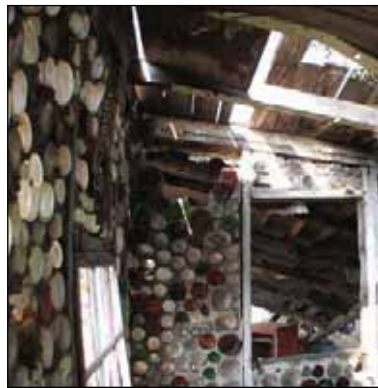
Missing

Full or partial loss of 60% or or more of the wood frame resulting in structural instability.

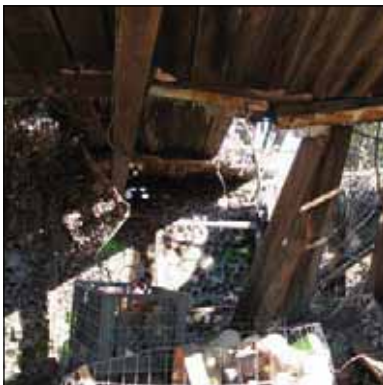
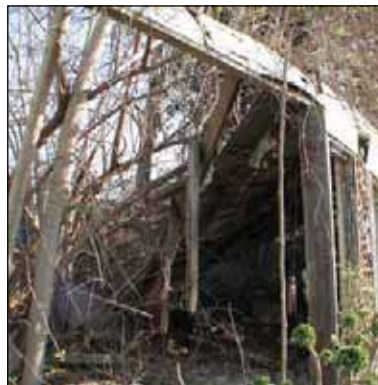
Collapse

Complete failure of a framing system.

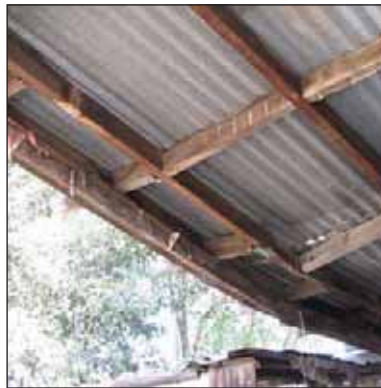
Deformation

Movement of structural members or assemblies resulting in bending, warping, and dislocation.

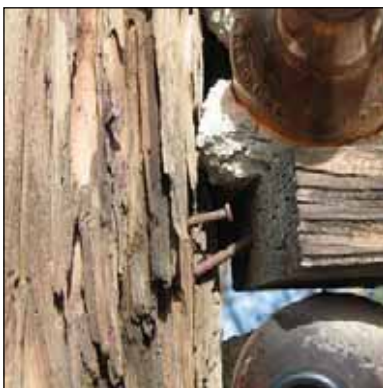
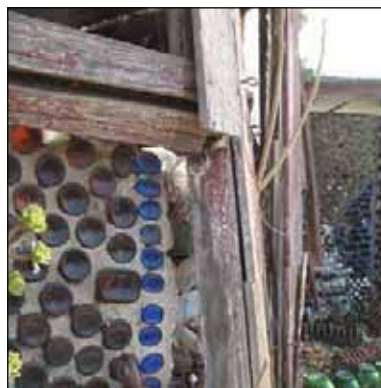
Detachment

The partial or complete release of a framing connection from the original placement resulting in inadequate and uneven displacement of load, loosening of the frame, and structural instability.

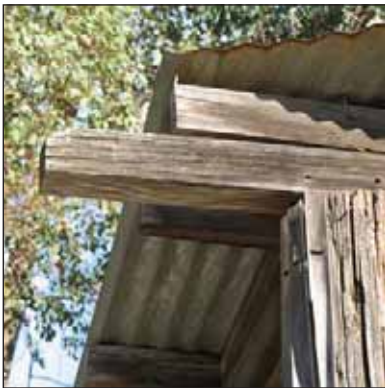
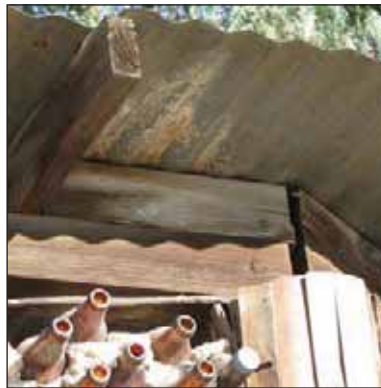
Corrosion

The chemical and eletrochemial reaction between the metal and the surrounding environment which produces deterioration of the metal and it's inherent properties.

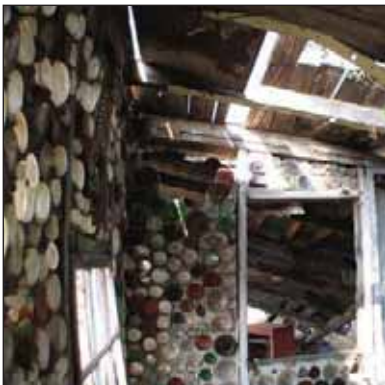
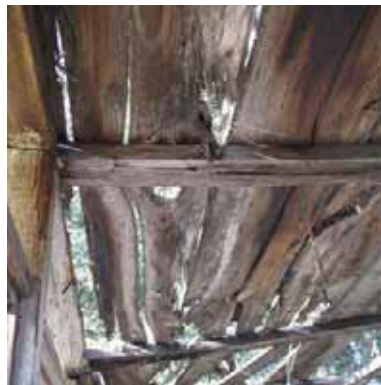
Missing

Absence of 59% or less of the roofing material. Characteristics include discontinuous form and lacking in completeness. Some areas exhibit total absence of the roof.

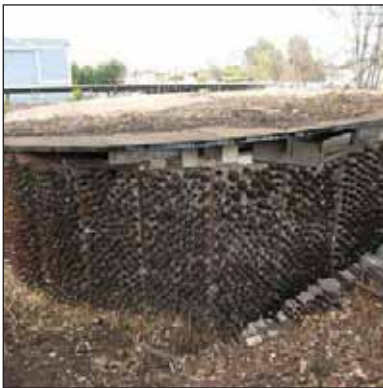
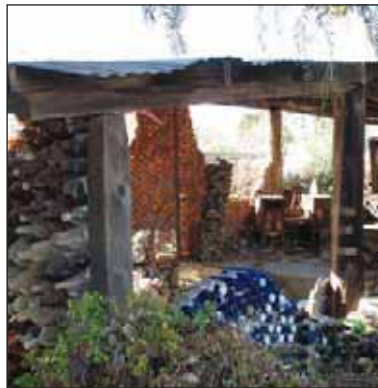
Deformation

Deviation from the original form of the roof due to material live load or exceedence of material performance resulting in structural stability.

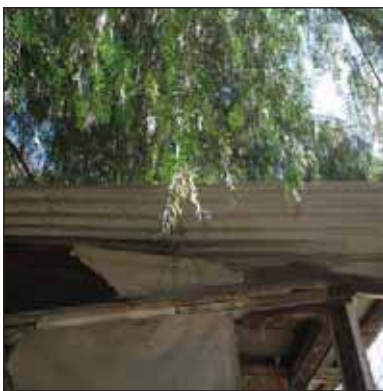
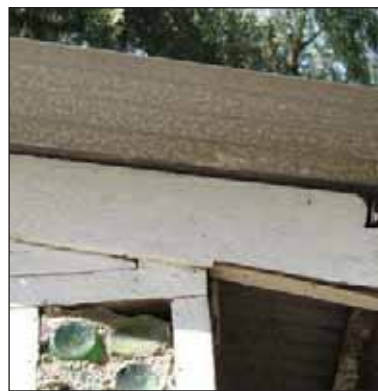
Detachment

Partial or total release of any roof component resulting in a disconnect from the frame.

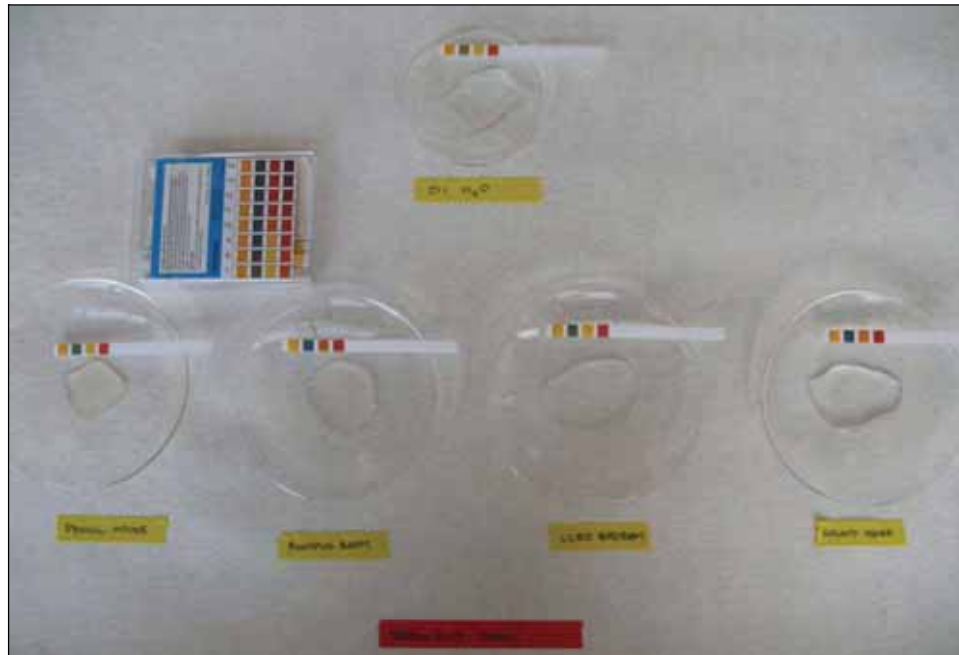
Sample	pH
DI H ₂ O	7
Pencil House	6.9 -7.2
Rumpus Room	9.5
Cleopatra's Bedroom	6.9 – 7.2
Round House	9.5

pH test with mortar solution

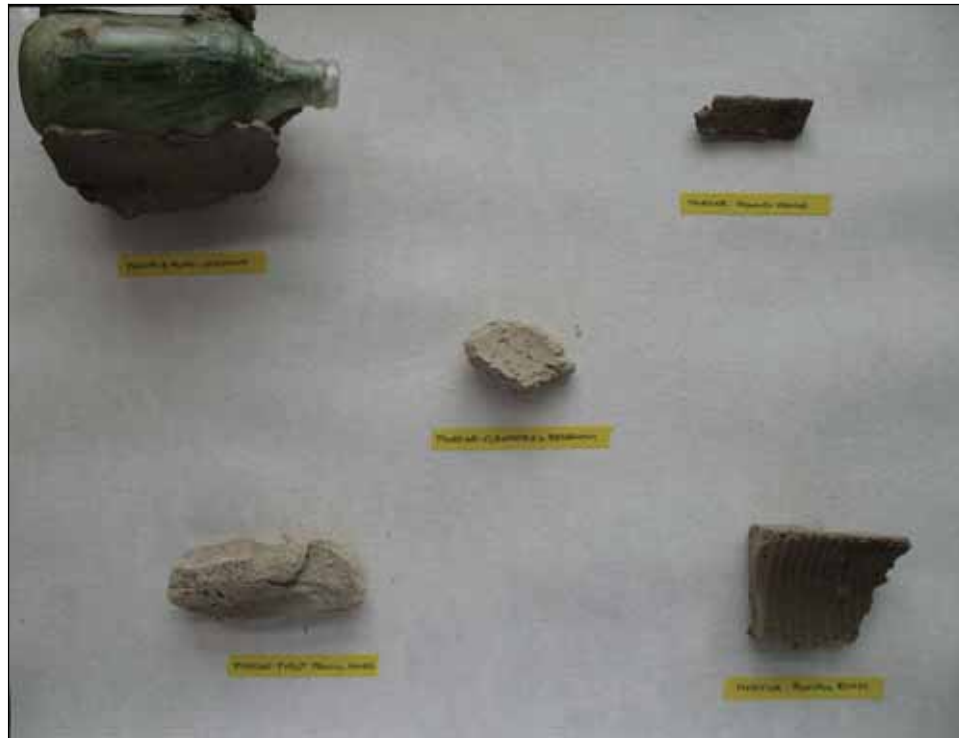
Whatman pH strip test & DI H₂O mortar solution.

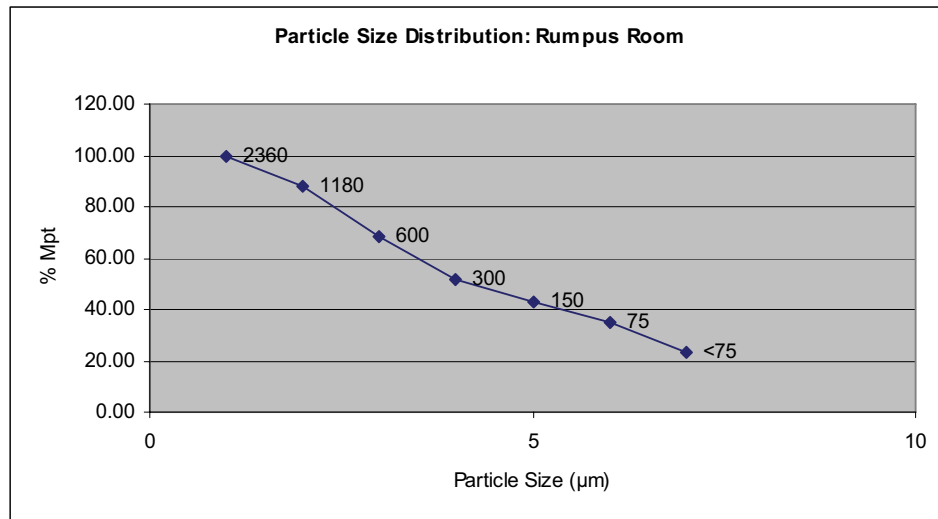
Grain Shape : sub-angular to sub-rounded		
	Mineralogy : Predominately quartz		
	Sieve analysis :	<u>Screen</u>	<u>% Retained</u>
		8	1.7
		16	10.06
		30	19.75
		50	16.74
		100	8.91
		200	1.74
		pan	5.27

Grandma Prisbrey's Bottle Village University of Pennsylvania, M.S. Historic Preservation: Thesis			
<u>MORTAR ANALYSIS</u>			
Project/Site :	Grandma Prisbrey's Bottle Village		
Location :	Simi Valley, CA	Date Sampled :	6-Mar-07
Analysis Performed By :	Teresa S. Duff	Date Analyzed:	29-Mar-07 to 4-April -07
DESCRIPTION OF SAMPLE			
Type/Location :	Rumpus Room, W façade	Sample No.	N/A
Surface Appearance :	Dark gray, some small voids, rough, large, lumpy particles, large inclusion of green & white		
Cross Section :	No visible layers, no inclusions		
Color :	dark gray	Texture:	Rough (80 grit)
Hardness :	5	Gross Wgt.:	30.53g
COMPONENTS			
Fines :	Color : light gray/pinkish	Wgt.:3.7g	Wgt. %: 12%
	Organic Matter : None noted		
	Composition :		
Acid Soluble Fraction :	Wgt : 7.12g		Wgt. %: 24%
	Desc. of reaction : moderate reaction to HCl, some effervescence with small bubbles		Filtrate Color : greenish yellow
	Composition :

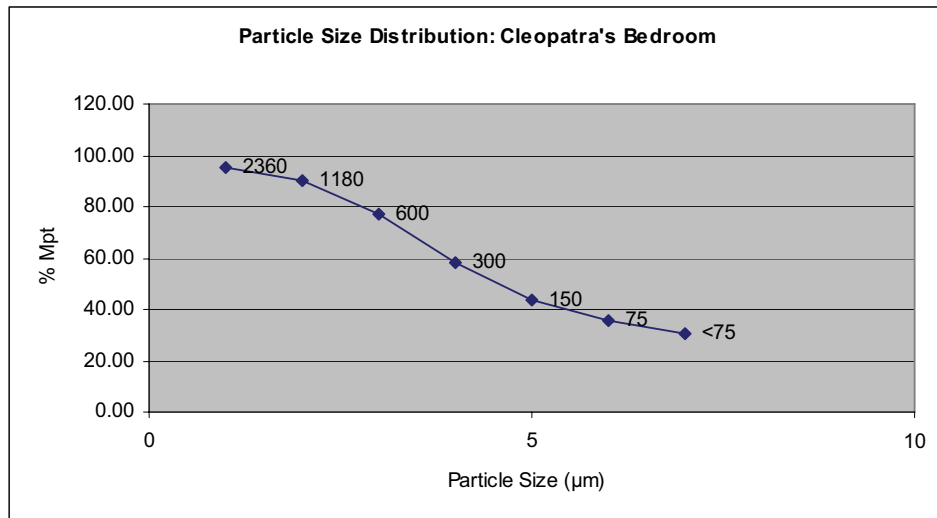
Grandma Prisbrey's Bottle Village University of Pennsylvania, M.S. Historic Preservation: Thesis			
<u>MORTAR ANALYSIS</u>			
Project/Site :	Grandma Prisbrey's Bottle Village		
Location :	Simi Valley, CA	Date Sampled	6-Mar-07
Analysis Performed By :	Teresa S. Duff	Date Analyzed:	29-Mar-07 to 4-April -07
DESCRIPTION OF SAMPLE			
Type/Location :	Cleopatra's Bedroom, S façade	Sample No.	N/A
Surface Appearance :	very small voids, small particles, extremely friable to the touch		
Cross Section :	No visible layers, no inclusions		
Color :	dark white/light gray	Texture:	Friable (220 grit)
Hardness :	2	Gross Wgt.:	22.89g
COMPONENTS			
Fines :	Color : white/off-white	Wgt.:3.26g	Wgt. %: 14%
	Organic Matter : None noted		
	Composition :		
Acid Soluble Fraction :	Wgt : 3.8g		Wgt. %: 17%
	Desc. of reaction : moderate reaction to HCl, some effervescence with small bubbles		Filtrate Color : greenish yellow
	Composition :

Aggregate :	Color :5Y-8/2, 5Y-7/2	Wgt.:15.83g	Wgt. %: 69%
	Grain Shape : sub-angular (small) to sub-rounded (large)		
	Mineralogy : Predominately quartz		
	Sieve analysis :	Screen	% Retained
		8	4.63
		16	5.55
		30	13.02
		50	18.48
		100	14.94
		200	7.73
		pan	4.81

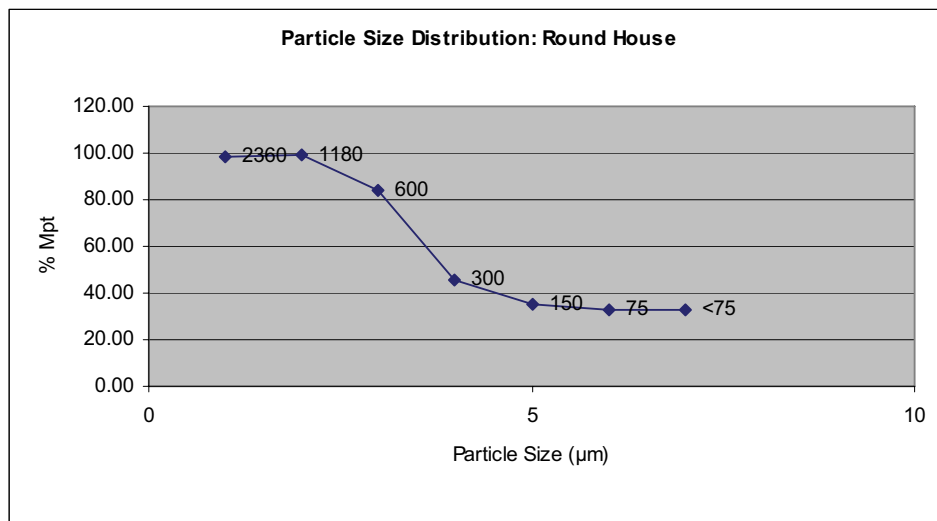
University of Pennsylvania, M.S. Historic Preservation: Thesis			
<u>MORTAR ANALYSIS</u>			
Project/Site :	Grandma Prisbrey's Bottle Village		
Location :	Simi Valley, CA	Date Sampled:	6-Mar-07
Analysis Performed By :	Teresa S. Duff	Date Analyzed:	29-Mar-07 to 4-April -07
DESCRIPTION OF SAMPLE			
Type/Location :	Round House, SW façade	Sample No.	N/A
Surface Appearance :	very dark gray, small inclusions		
Cross Section :	No visible layers, small voids prevalent		
Color :	dark grayish sand, white sand, quartz particles	Texture:	semi-smooth (120 grit)
Hardness :	unknown	Gross Wgt.:	18.12g
COMPONENTS			
Fines :	Color : very light gray	Wgt.:1.22g	Wgt. %: 6%
	Organic Matter : None noted		
	Composition :		
Acid Soluble Fraction :	Wgt : 4.64g	Wgt. %: 25%	
	Desc. of reaction : moderate reaction to HCl, some effervescence with small bubbles	Filtrate Color : greenish/yellow	
	Composition :		
Aggregate :	Color :5Y-8/2, 5Y-7/1	Wgt.:12.26g	Wgt. %: 67%, Vol% N/A

Grain Shape : sub-angular to sub-rounded		
	Mineralogy : Predominately white & smokey quartz, citrine		
	Sieve analysis :	<u>Screen</u>	<u>% Retained</u>
		8	0.28
		16	1.21
		30	14.74
		50	39.02
		100	10.1
		200	1.6
		pan	0.33
