Bethesda Terrace: Conditions Assessment and Evaluation of Previous Stone Conservation Treatments

Christopher John Gembinski
University of Pennsylvania

Historic Preservation

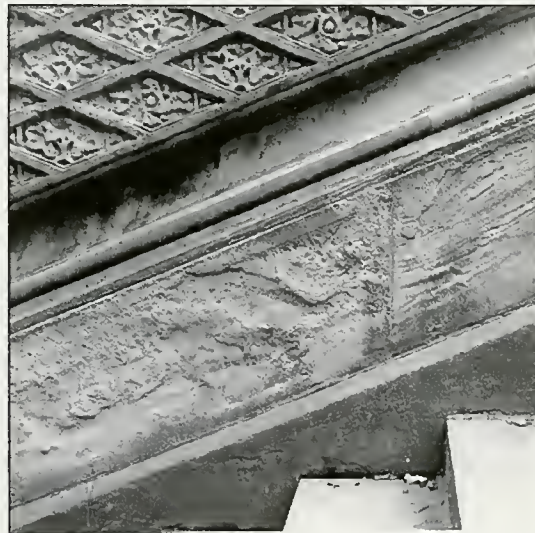
Fig. 6 - Retroweathering - retroweathering on wall panel base of north arcade stair.

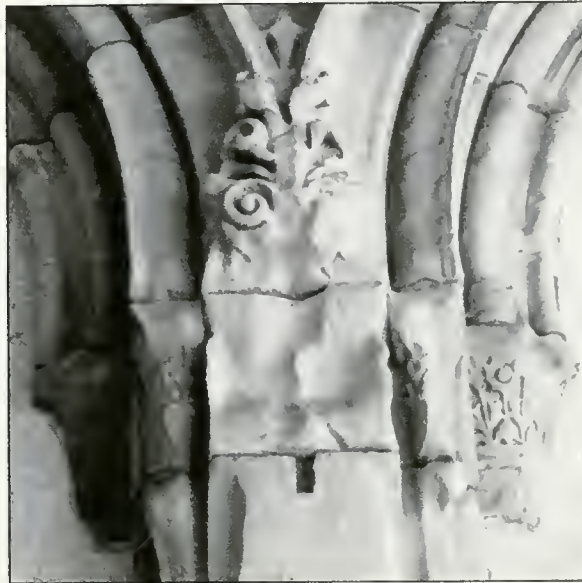
Fig. 7 - (1b.a) Rounding/notching - concave/convex weathering forming soft edges and hollowed areas.

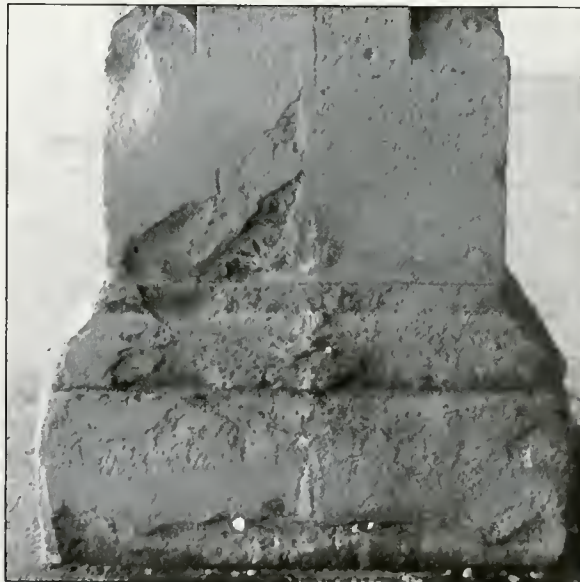
Fig. 10 - (1b.e) Roughening – alteration of original stone surface causing loss of smoothness, gloss or original tooling marks.

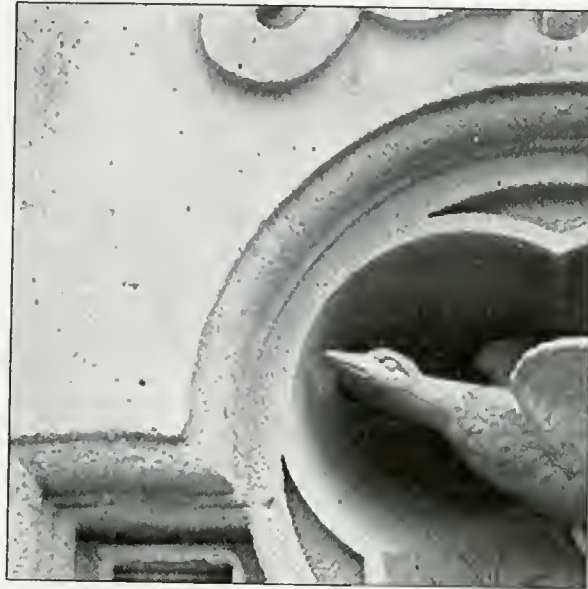
Fig. 11 - (1b.g) Pitting – alteration of stone surface resulting in pitted areas where less stable components weather out of the stone.

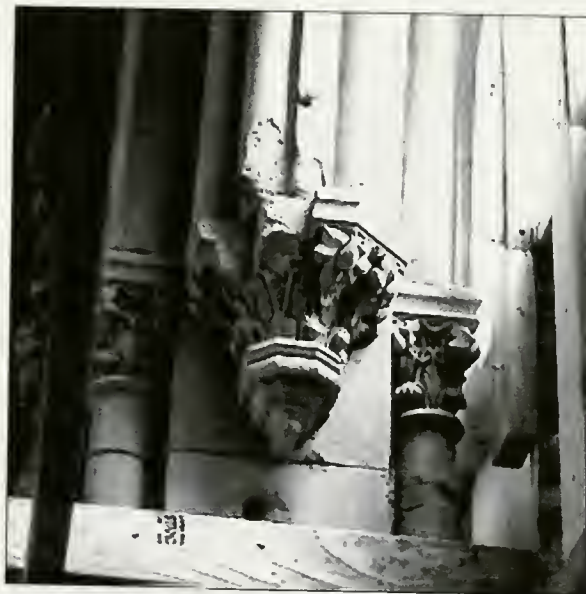
Fig. 12 - (1c) Breakage due to direct anthropogenic influence.

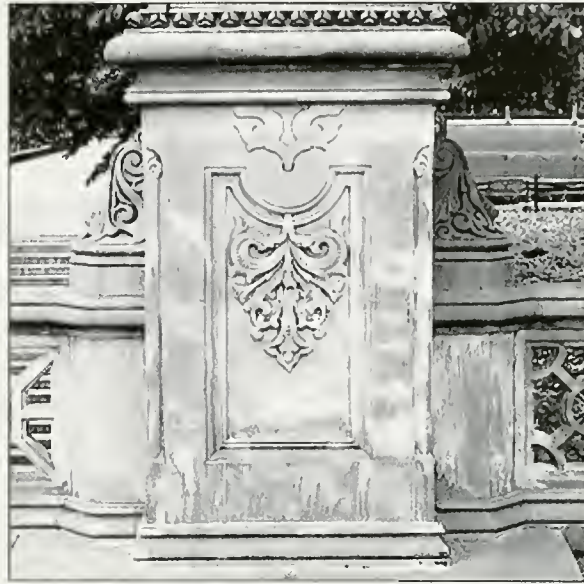
Fig. 15 - (2a.b) Bleaching - chromatic alteration of original stone surface resulting from extraction of coloring matter through natural weathering or chemical treatments.

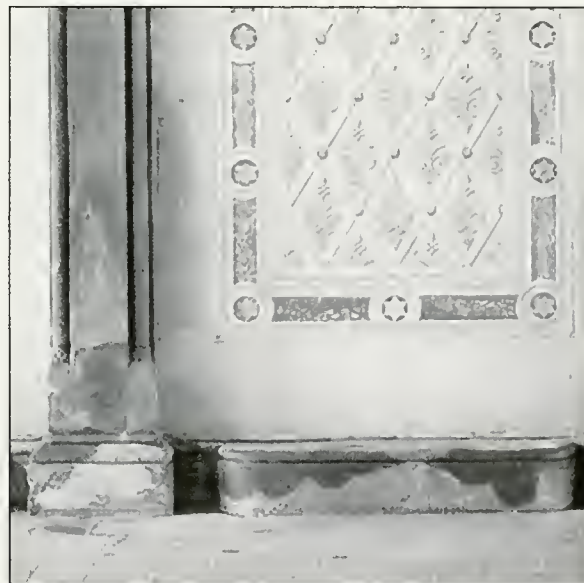
Fig. 16 - (2b.b) Soiling from ground water - often the result of rising damp and water penetration.

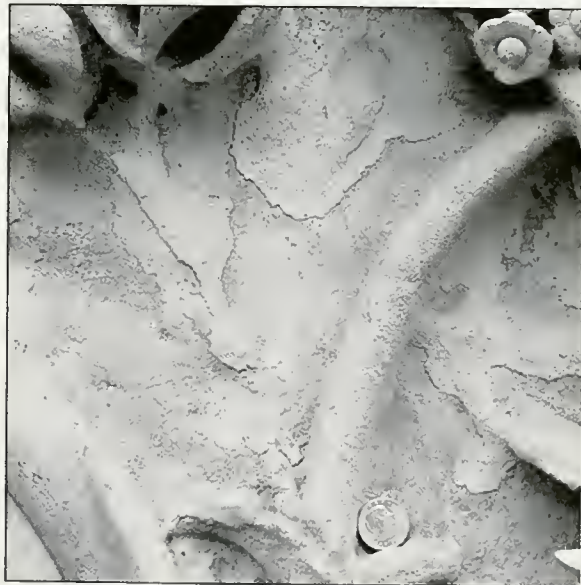
Fig. 22 - (3d.b) Flaking resulting in multiple flakes - detachment of multiple layers of flaking parallel to the stone surface.

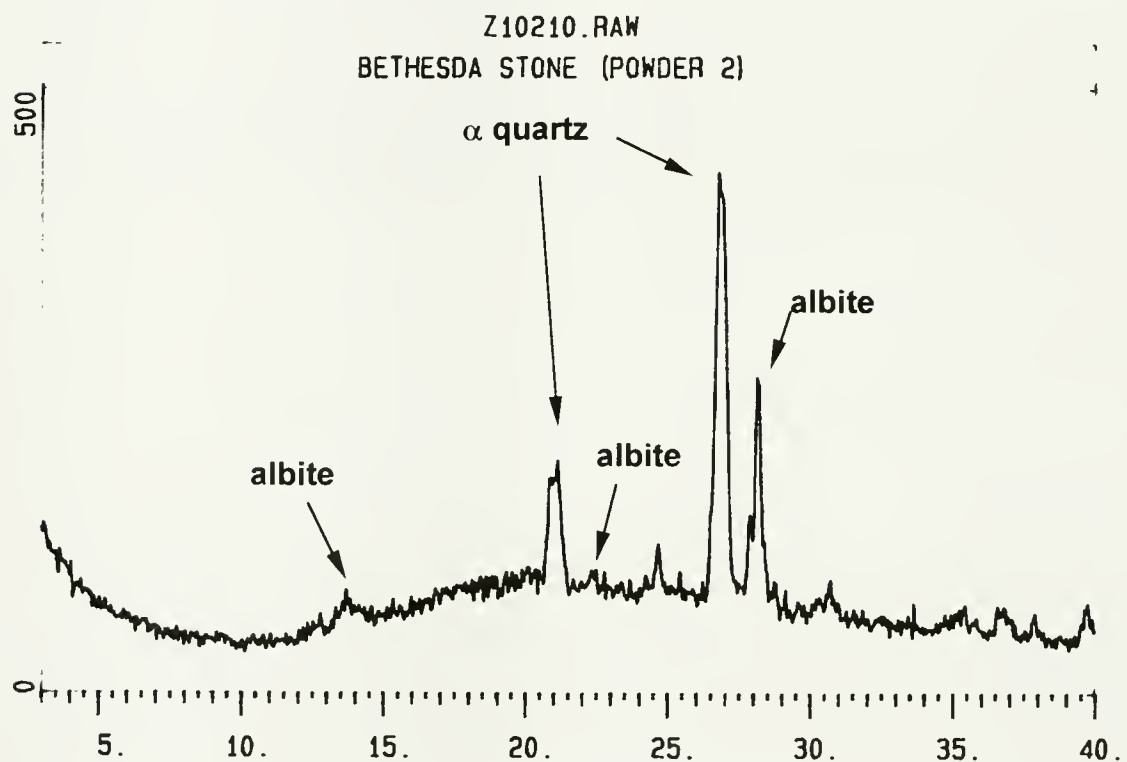
Fig. 37 - XRD for Bethesda Terrace Sandstone.

Powder x-ray diffraction is an analytical technique that measures the amount and type of x-rays reflected from a material when bombarded by x-rays. This technique is capable of matching unknown x-ray diffraction patterns with known patterns logged in a database. A sample from the interior section of an untreated sandstone core (sample H) was powdered and mounted on orange cellophane tape. The sample was scanned at 1°/min. from 3° to 40°. The tape accounts for the high interference pattern at the lower angles of the recorded x-ray pattern. The pattern illustrated below indicates the majority of the sample is α quartz as

expected. It is possible to identify other compounds by matching the pattern of silicon oxide and removing those peaks from the graphic pattern. Other trace compounds were tentatively identified as albite, possibly from disintegrating plagioclase feldspars.

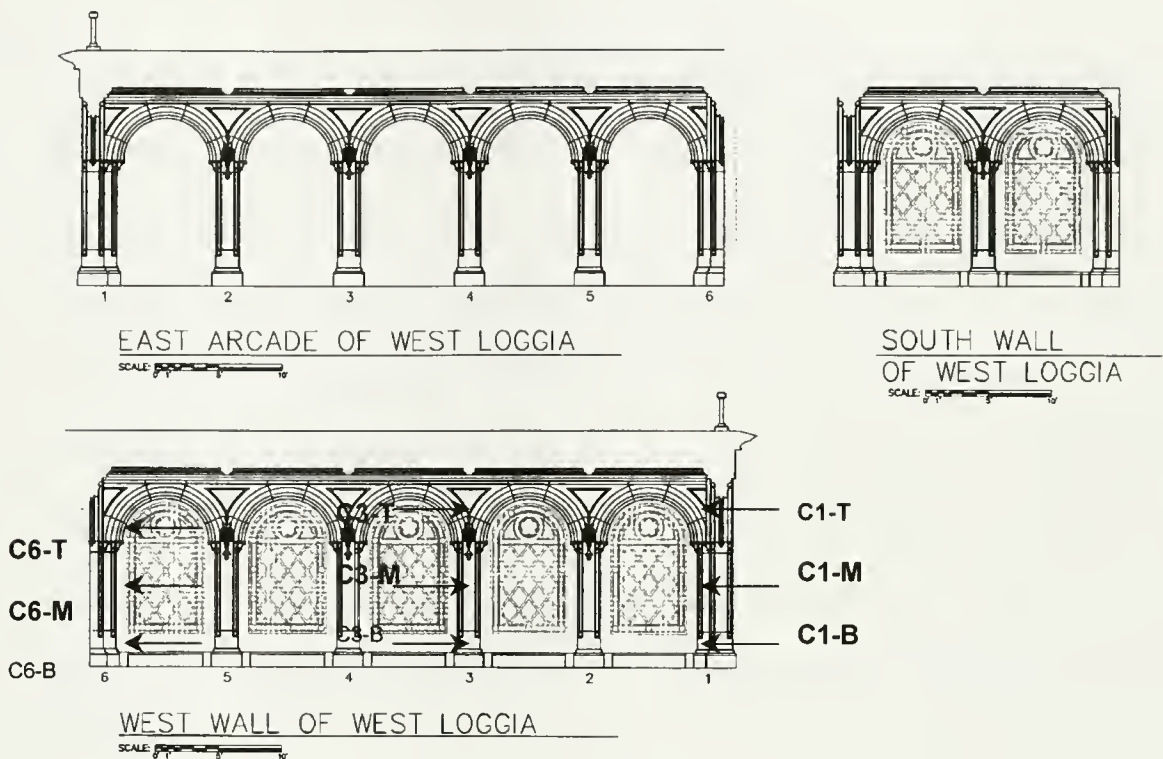
Fig. 38 - Soluble salt sample locations, west loggia.

Qualitative analysis of soluble salts followed standard chemical procedures utilized for salt ion identification.⁴⁶ Samples were obtained from the pilasters of the west loggia of the arcade. This is the area where the heaviest efflorescence occurs at this time. The samples were lightly brushed off the surface with a palette knife. Where a large amount of crust formation was available, this was carefully removed so as not to disturb the surface below the crust. Nine samples were removed from three heights on three columns as illustrated below.

The majority of the identifiable ions were chlorides and sulfates (see table 14). The chlorides as mentioned above are undoubtedly from sodium chloride de-icing salts used on the terrace in the past. Phosphates were identified on the northwest arcade column of the west loggia of the arcade. It is possible that these salts are deposits from water run-off from the urns above which contain fertilizers. It was suspected that nitrates or nitrites were present in the column bases of the arcade due to human and animal urine. No nitrates or nitrites were identified with this method. Some carbonates, probably from mortars, were detected. Further testing was conducted on four of the samples using x-ray diffraction.

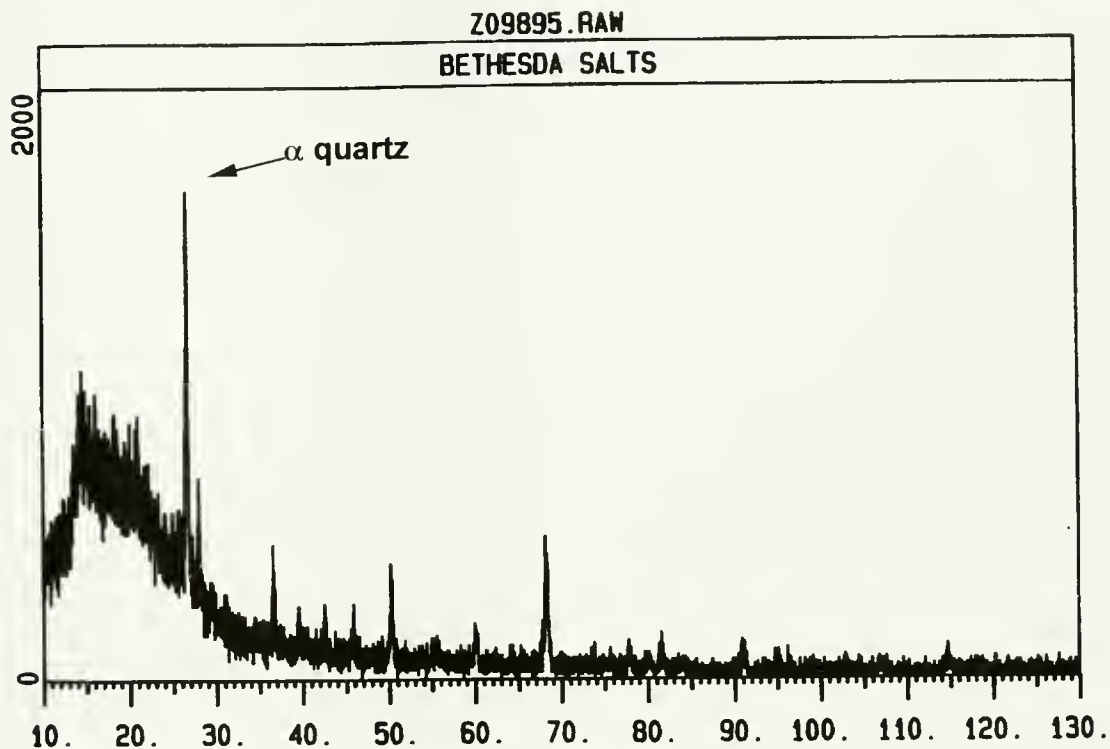
Fig. 39 - XRD sample no. 1 of arcade salts

A sample of efflorescence was removed from the southwest corner pilaster of the west loggia to attempt to determine the exact composition of the soluble salts found in this area. The sample was powdered and scanned at 5°/min. from 10° to 70°. This sample also exhibits the high interference at the lower angles from the mounting tape. The presence of α quartz from disintegrating sandstone in the sample interfered with the proper identification of the salts (see figure 39).

This sample shows the presence of α quartz however, the small amounts of salts could not be detected.

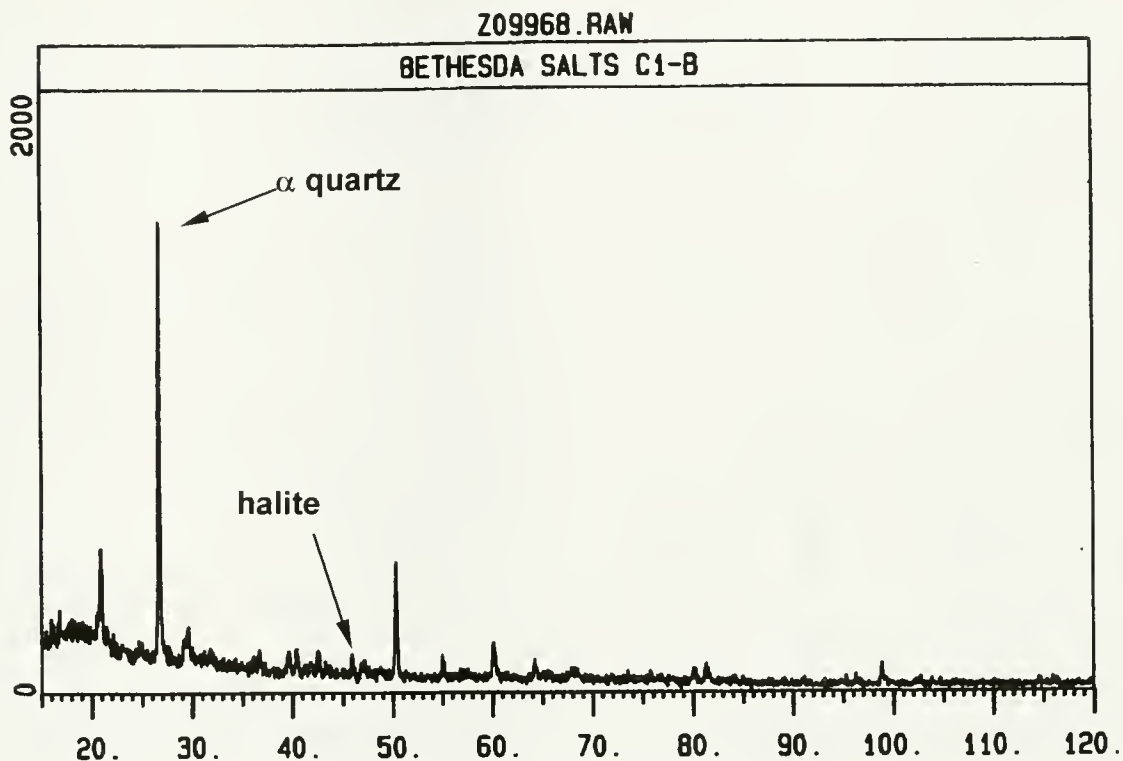
An additional sample of the same salt crust was mounted with petroleum jelly in a well slide to further investigate the possibility of reducing the interference created by the tape used in the previous scans. This mounting technique reduced the interference, but the results again showed that the primary component of the sample was α quartz (see figure 40).

Fig. 40 - XRD sample no. 2 of arcade salts
This sample detected halite, but no other compounds.

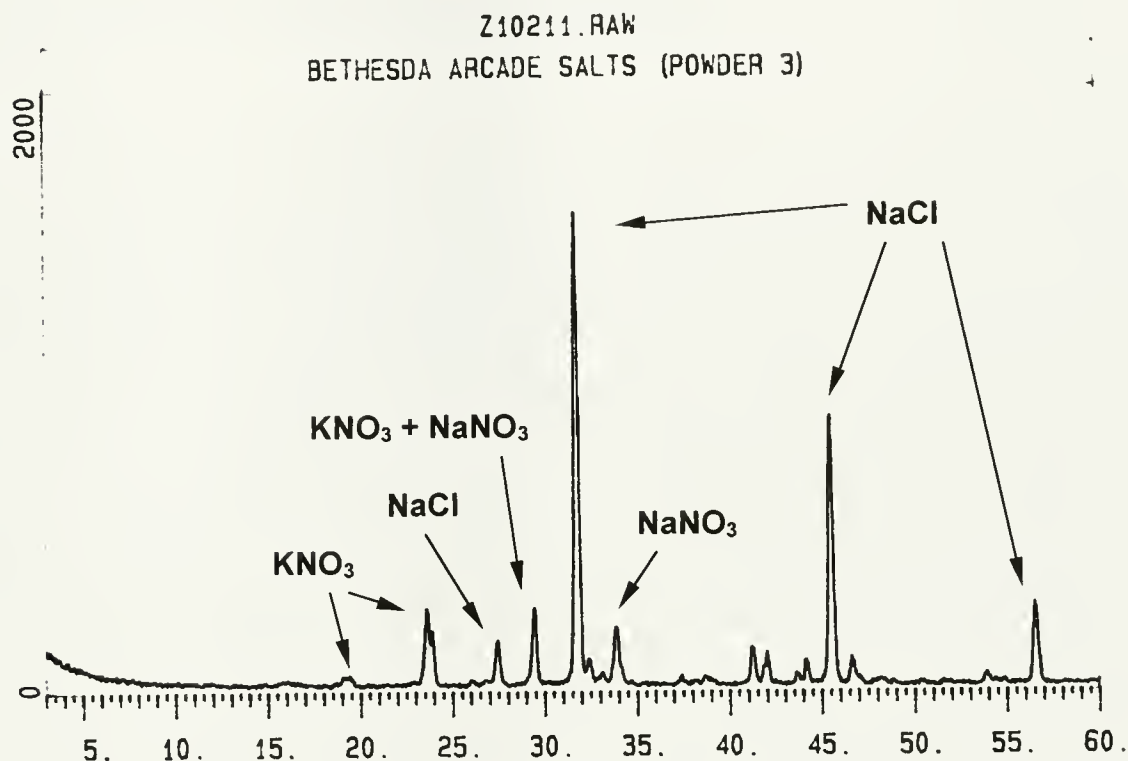
Fig. 41 - XRD sample no. 3 of arcade salts.

A new sample from the arcade was taken a few weeks later when efflorescence was dense on the arcade stone. It was also mounted on a glass slide with petroleum jelly and scanned at $1^\circ/\text{min}$. from 3° to 60° . The pattern identified halite (NaCl) as the main component with trace amounts of niter (KNO_3) and nitratite (NaNO_3) (see figure 41).

Sample no. 3 was mounted with petroleum jelly on a glass slide. The XRD pattern shows less interference at lower angles. The XRD pattern shows halite peaks with trace amounts of niter.

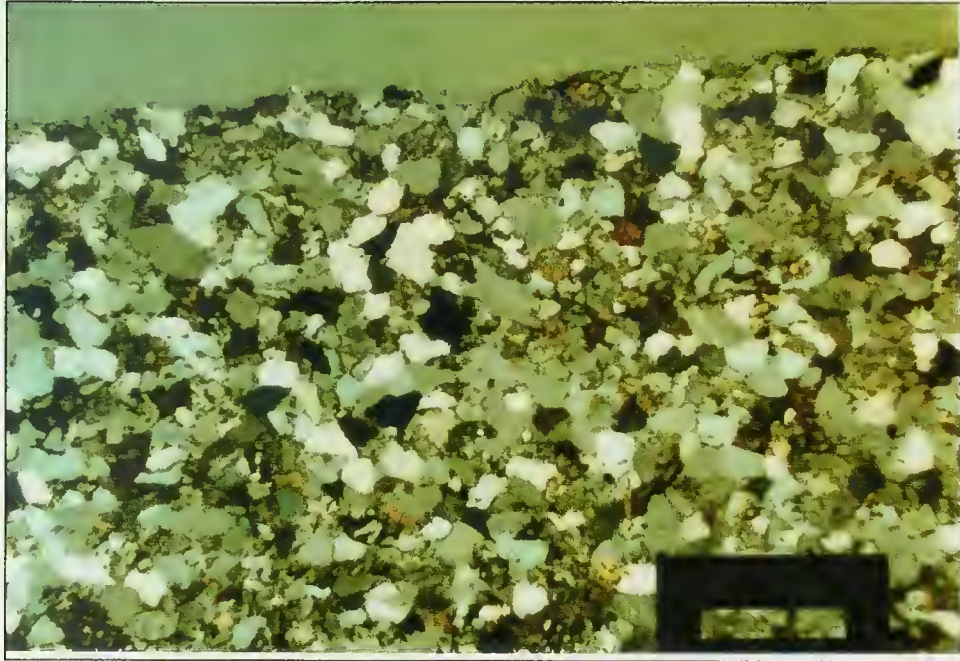
surface of the stone (see figure 43). This visible layer may be a build up of fine debris from either the treatment or weathering. No fractured or compacted crystals were observed in the thin sections (see figure 42).

Fig. 42 - Honed Surface (50X - plane-polarized light).
Note no alteration is visible near the surface of the sample.

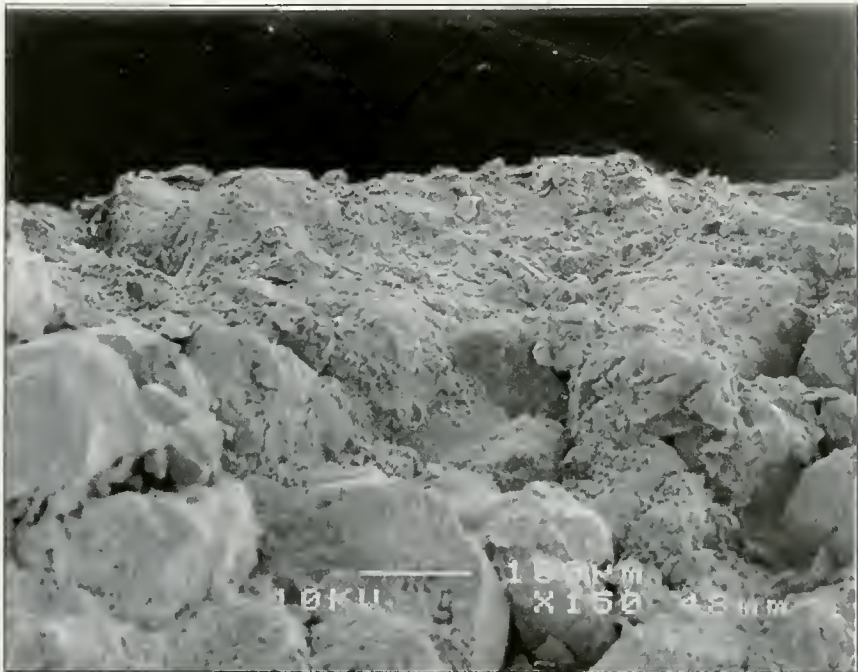
Fig. 43 - Honed surface (150X - JEOL SEM).

This treatment resulted in a visual unification of the stone surface by removing unstable stone and creating a faceted surface as a function of hand variability during the honing process. Examination with plain light microscopy at 100X and with a scanning electron microscope revealed that a 100 μm thick exists at the

Visible 100- μ m layer may be alteration to the surface of the sandstone from honing or it may be dirt deposit.

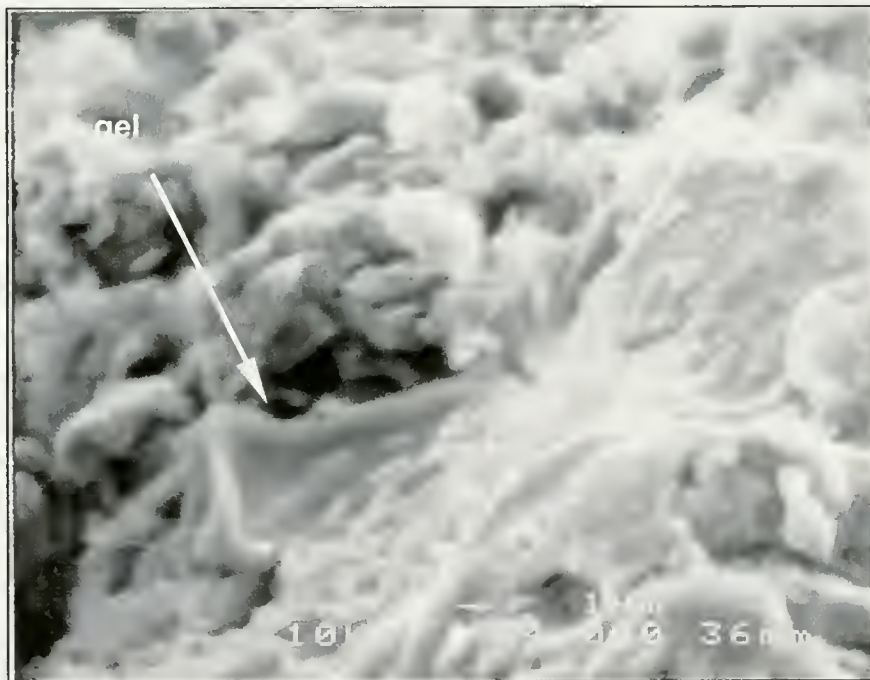
Consolidants applied as experimental treatments in the 1980s still remain in the sandstone of the exterior terrace based on scanning electron microscopy examination. Documentation of the formulation and application of these treatments is vague, however laboratory testing showed that both consolidants are still present and currently reduce capillarity in the areas tested. The application of consolidants did not alter the color of the stone.

Fig. 44 - Wacker OH™ in Bethesda Terrace sandstone (4,000X - JEOL SEM). Characteristic gel of Wacker OH™ is visible on quartz grains.

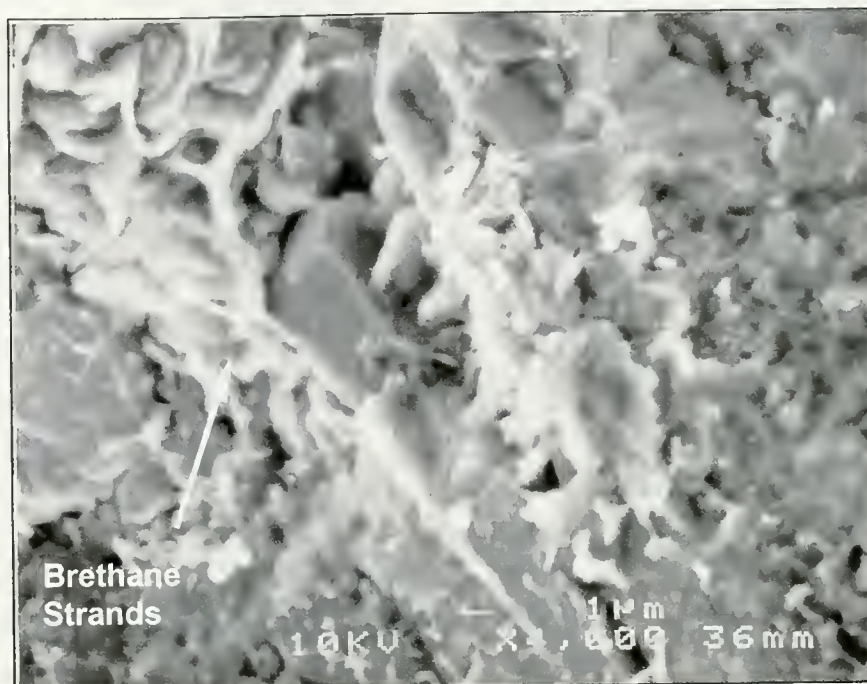
Fig. 45 - Brethane in Bethesda Terrace sandstone (4,000X - JEOL SEM).
Strands of Brethane appear stringy between crystals.

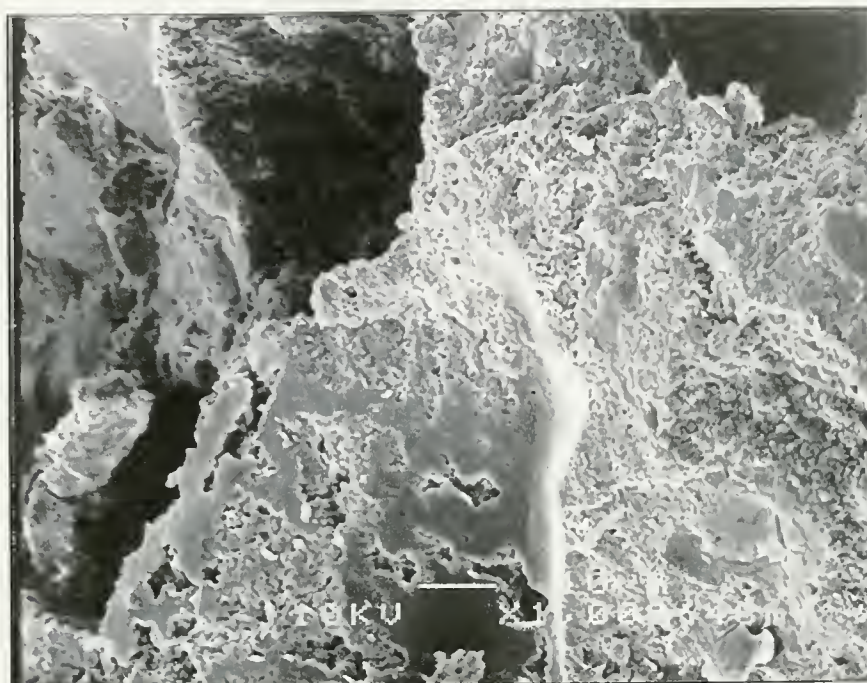
Fig. 48 - Patching material – (1,000X - JEOL SEM).

Images of the patching material with SEM confirmed the addition of a non-crystalline substance (see figure 48).

No evidence of biological growth in pores of the stone or on the glassy surfaces, attributed to the presence of an organic component, is visible.

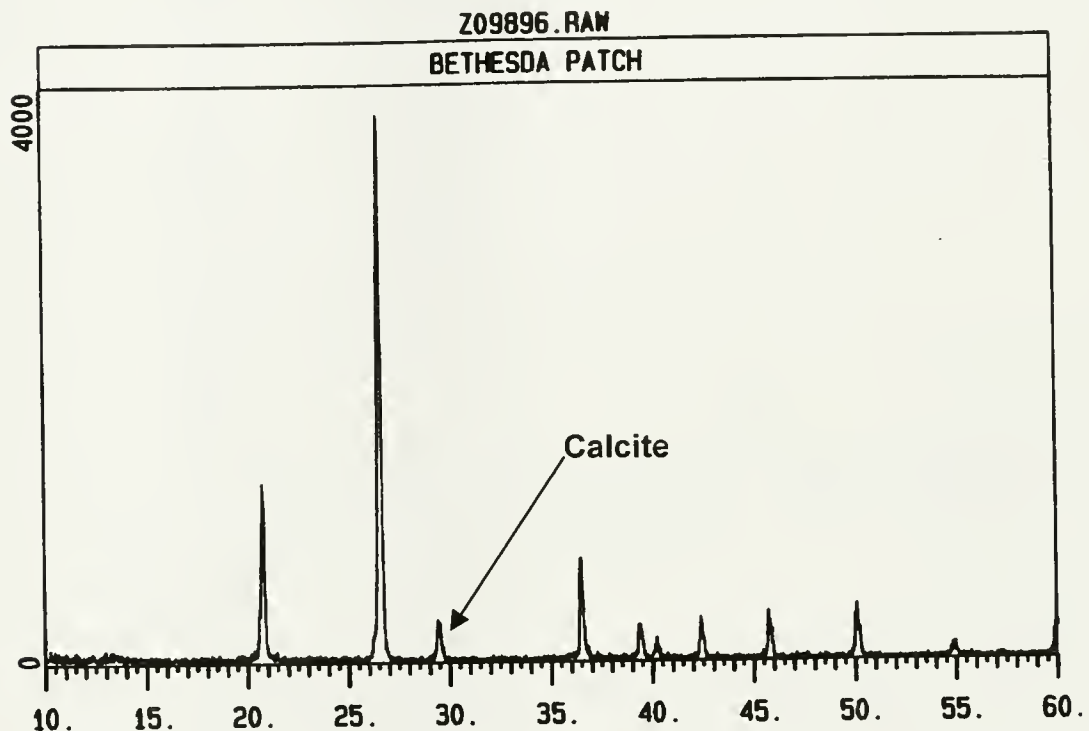
Fig. 48 - XRD Pattern for core sample - P

A sample of composite patching material was removed for XRD analysis from a discolored patch on the north west balustrade of the middle terrace. This sample was flat mounted whole with sculpting putty and scanned at 5°/min. from 10° to 70°. ⁴⁹ The pattern detected from this sample clearly indicates that the crystalline composed detectable with this technique is α quartz. A peak for calcite was also identified, confirming the presence of the lime binder in the patching material. This confirms previous information regarding the composition of the composite patching material used in the 1980s restoration as containing sand and lime.

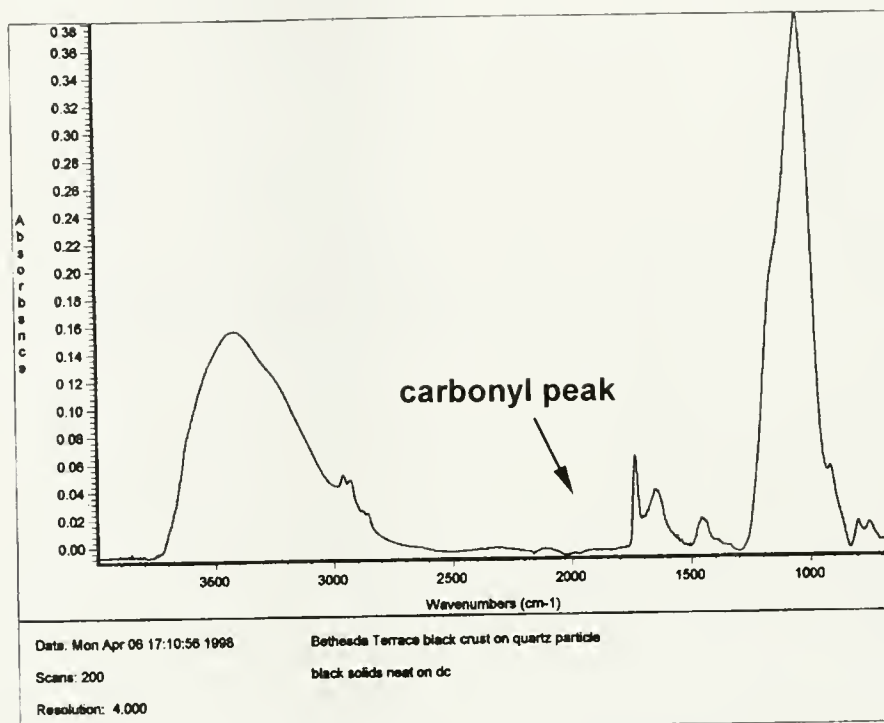
Fig. 48 - FTIR spectrum (isolated black stain).

It was suspected that an organic additive was causing the black staining. FTIR analysis of the black crust was conducted.⁵⁰ The results showed a high concentration of hydroxides and a high carbonyl peak indicating the presence of organic materials. This peak was isolated and compared to spectra of known organic materials. The closest matches were the Acryloid™ or Rhoplex™ acrylate groups.

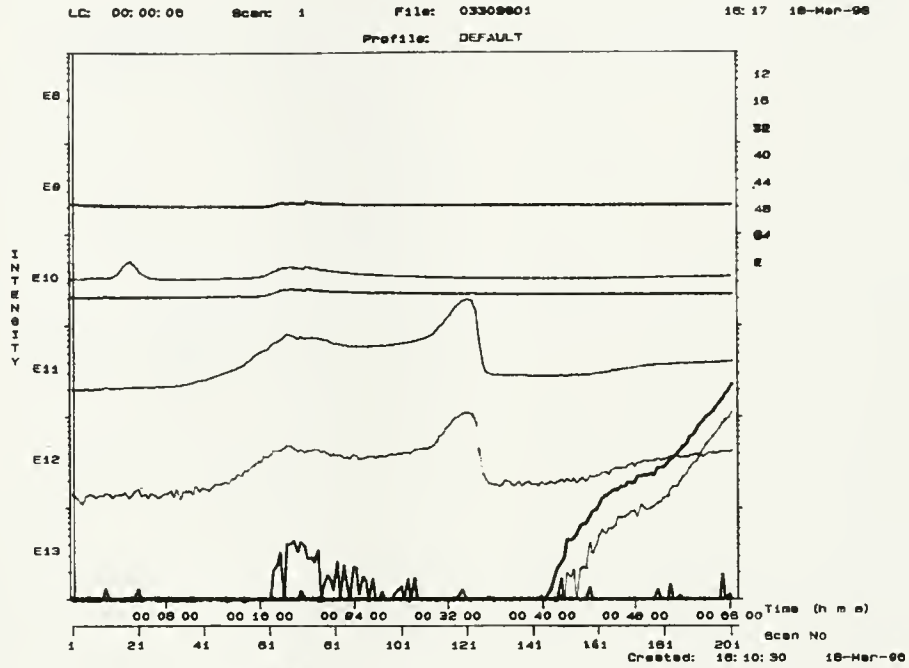
Fig. 53 - MS analysis of powdered patching mortar.
SPECTRUM AT MAX. OF ORGANIC EVOLUTION

Thermal analyses in combination with mass spectrometry were also used to compliment the FTIR analysis of the organic additives in the patching mortar. Two distinct peaks were obtained in the thermal gravimetric analysis (TGA) and were compared to a sample of methyl methacrylate analyzed with the same methods. One of the peaks resembled the methyl methacrylate, however the second did not. This suggests that the acrylic admixture in the patching material was a combination of two substances.

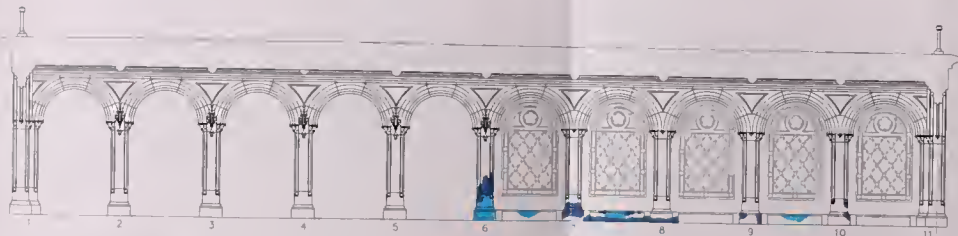
EAST WALL OF CENTRAL ARCADE

PENETRATION DURING RAIN

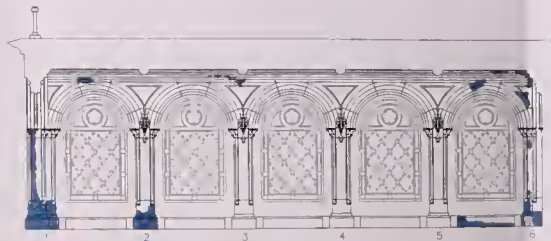
EAST WALL OF EAST LOGGIA

PENETRATION DURING RAIN

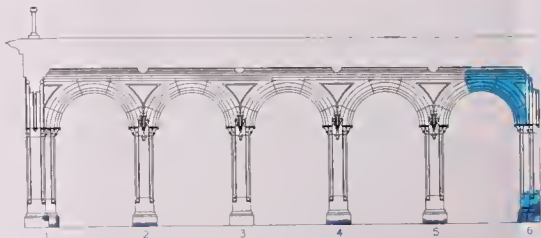
EAST ARCADE OF WEST LOGGIA

PENETRATION DURING RAIN

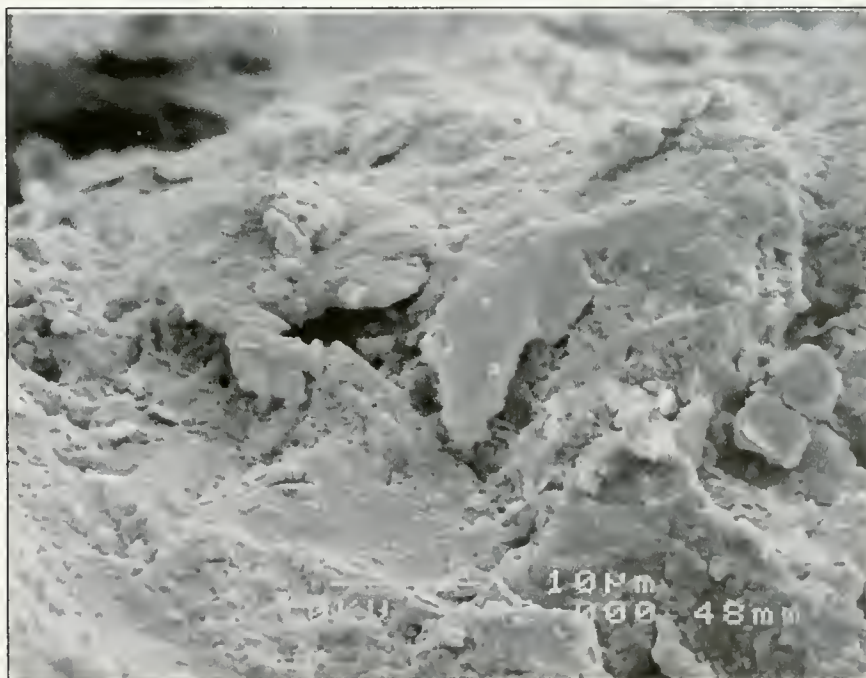
Fig. 61 - Honed Bethesda Terrace sandstone (2,000X – JEOL SEM).
Smooth flakes on honed surface.

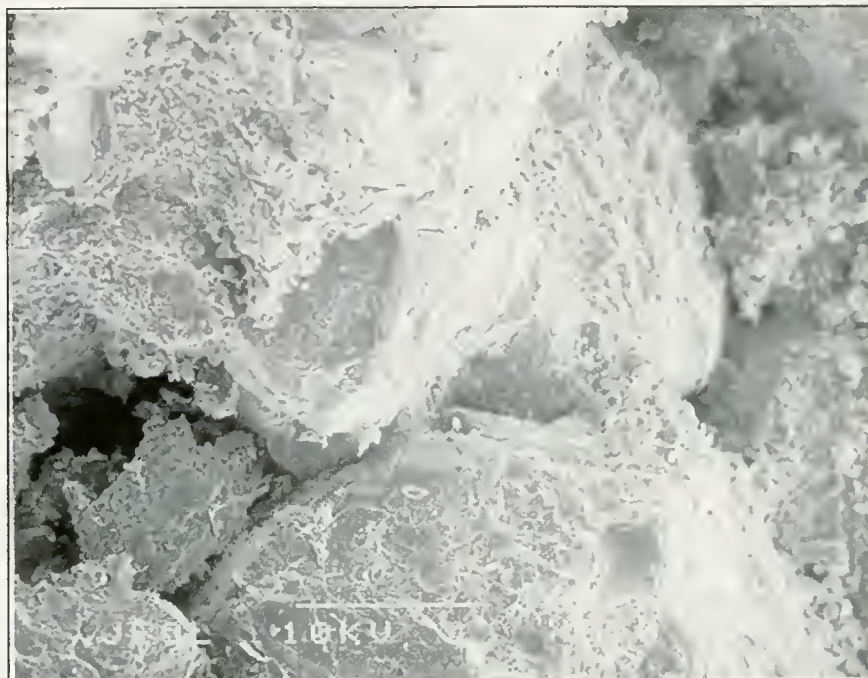
Fig. 62 - Bethesda Terrace sandstone treated with Wacker OH™ (250X – JEOL SEM).
Wacker OH™ appears as a film on the quartz grains of the Bethesda Terrace sandstone

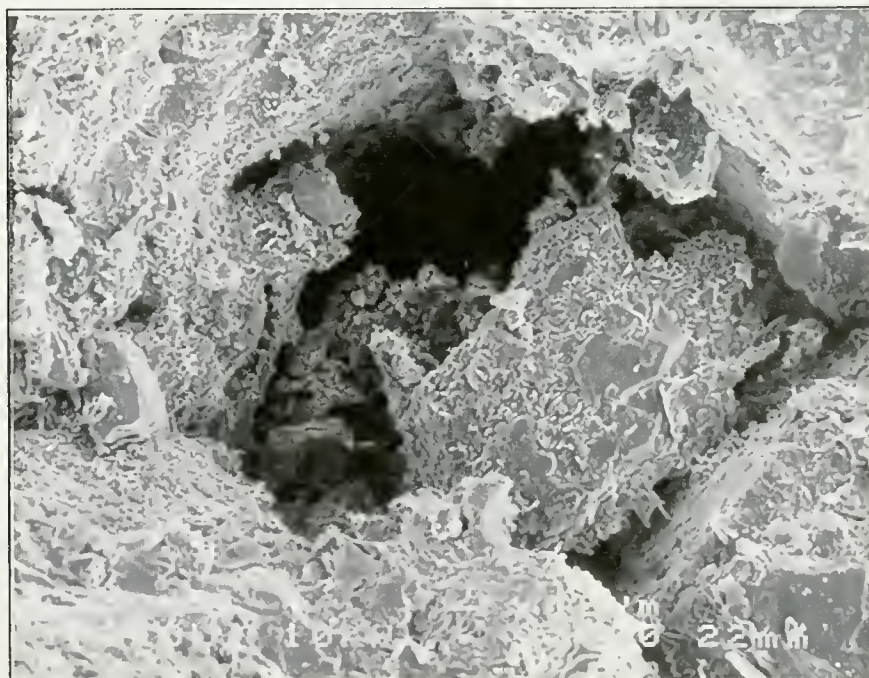
Fig. 63 - Bethesda Terrace sandstone treated with Wacker OH™ (500X – JEOL SEM).
Wacker OH™ is observed in the pores of the Bethesda Terrace sandstone.

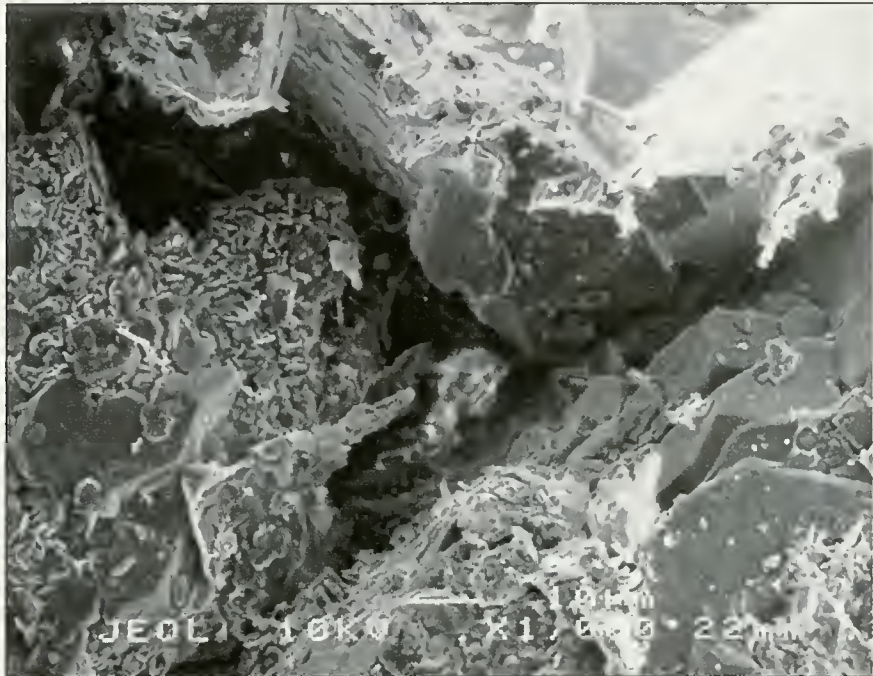
Fig. 64 - Bethesda Terrace sandstone treated with Wacker OH™ (1,000X – JEOL SEM).
Clay particles are coated with Wacker OH™.

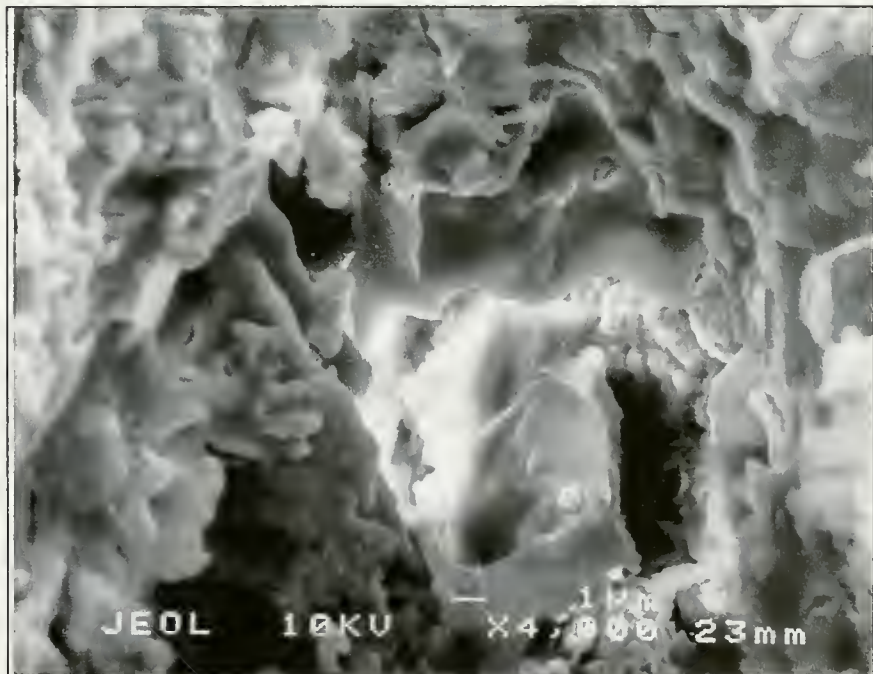
Fig. 65 - Bethesda Terrace sandstone treated with Wacker OH™ (4,000X – JEOL SEM).
Wacker OH™ is observed as a gel coating the surface of the Bethesda Terrace sandstone grains.

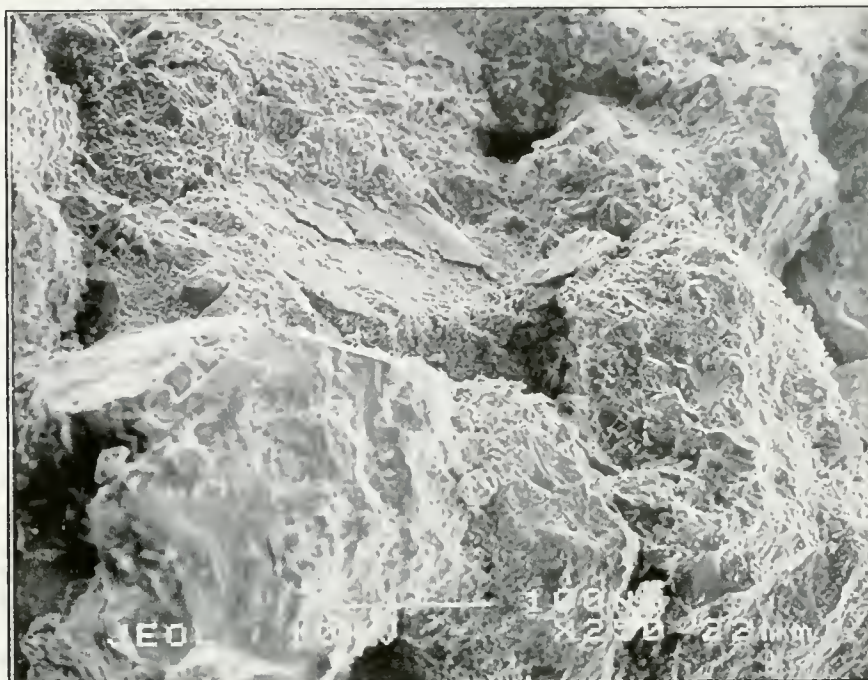
Fig. 66 - Bethesda Terrace sandstone treated with Brethane (250X – JEOL SEM).
Brethane observed as a rough coating over the grains of the Bethesda Terrace sandstone.

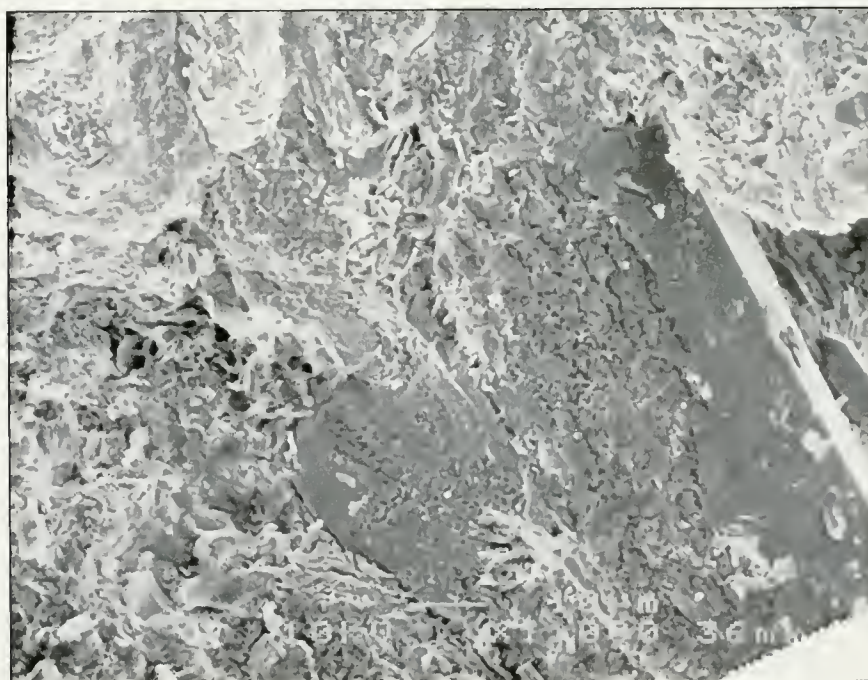
Fig. 67 - Bethesda Terrace sandstone treated with Brethane (1,000X – JEOL SEM).
Brethane is observed as stringy masses adhering to the Bethesda Terrace sandstone grains.

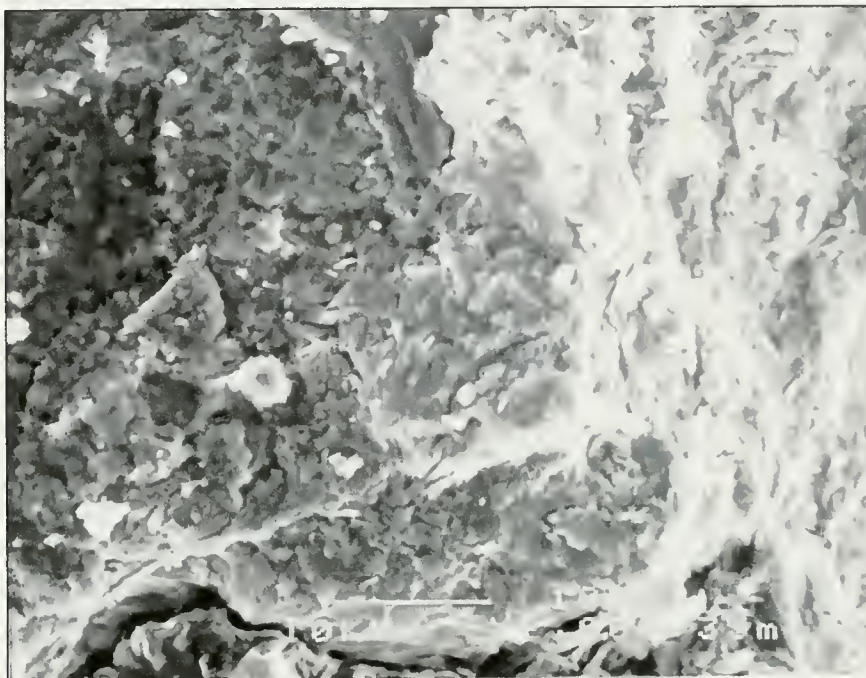
Fig. 68 - Bethesda Terrace sandstone treated with Brethane (2,000X - JEOL SEM).
Rough, stringy appearance of Brethane in the Bethesda Terrace sandstone.

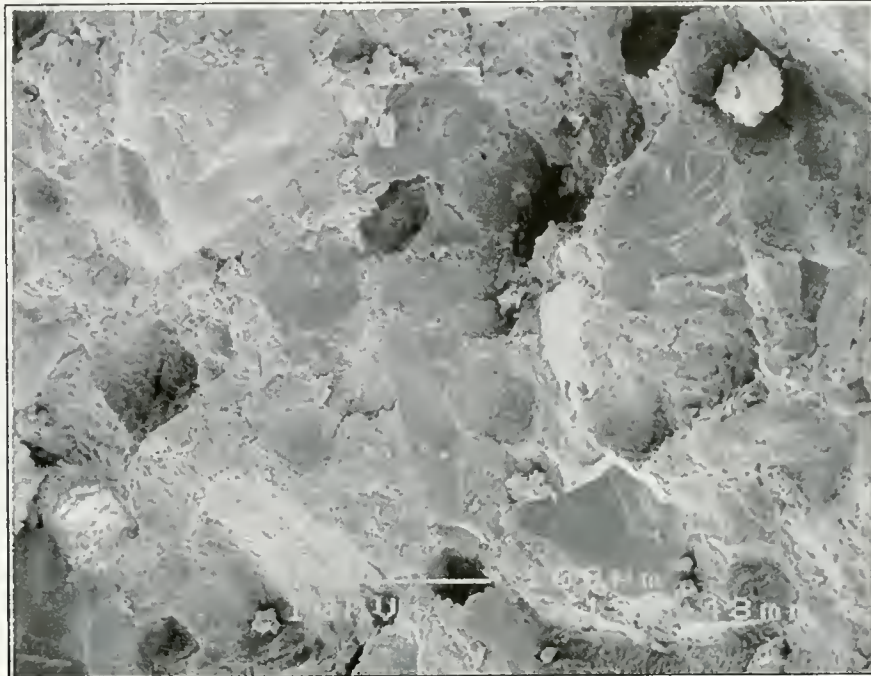
Fig. 69 - Composite Patching material from Bethesda Terrace (150X – JEOL SEM).
Composite patching material showing glassy consistency of mortar matrix.

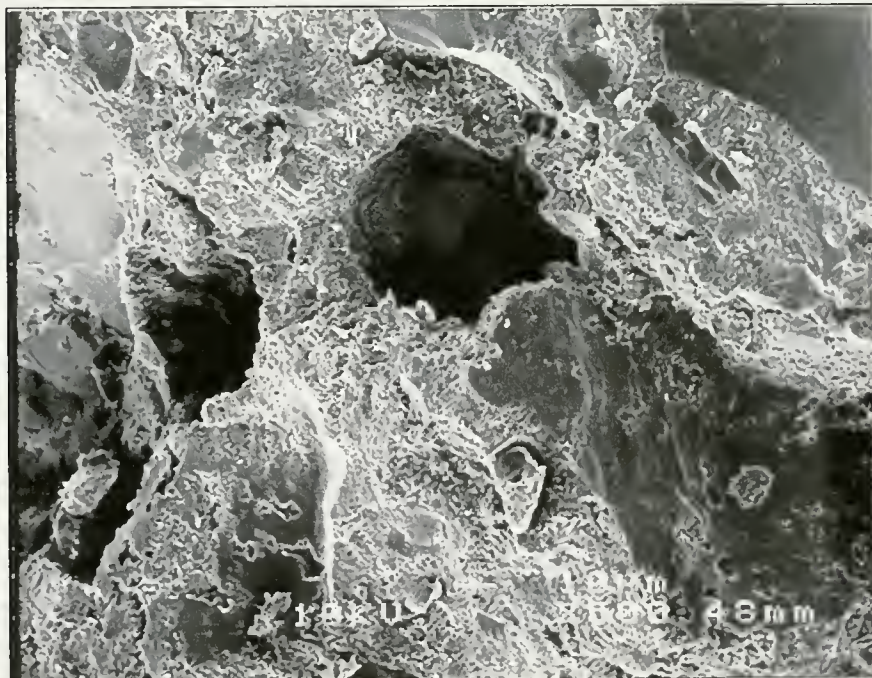
Fig. 70 - Composite Patching material from Bethesda Terrace (500X – JEOL SEM).
Matrix of composite patching material contains low amounts mineral components. The smooth, glassy texture of the matrix appears to be an organic admixture.
