Documentation and Architectural Analysis of Little Manor Plantation House

William Luby Ferguson
University of Pennsylvania

A THESIS

Historic Preservation

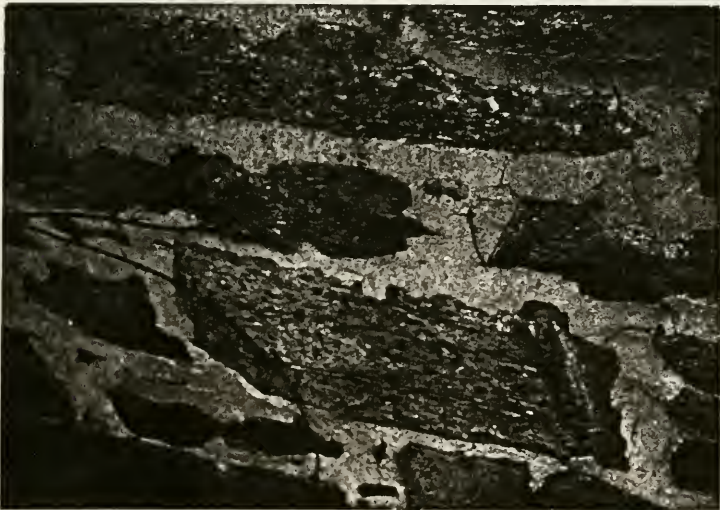
Figure 10: Gneiss Foundation Below Main Door of North Elevation

In both the Federal and Georgian period sections, the foundation is made of wet laid rubble and some cut stone. The stone appears to be a type of tan colored gneiss and was also used for the base of the Georgian chimney and most of the components of the Federal chimneys. The foundation walls rise about four feet above grade on the exterior. The walls in the basement areas vary in height from about seven feet in the Georgian section, to four feet under the cross hall. Lime mortars were used in the joints, and were struck to form a crude ribbon design. The photograph below shows a section of the foundation below the main portico. The spots in the middle of the picture are some type of oxidized ferrous material.

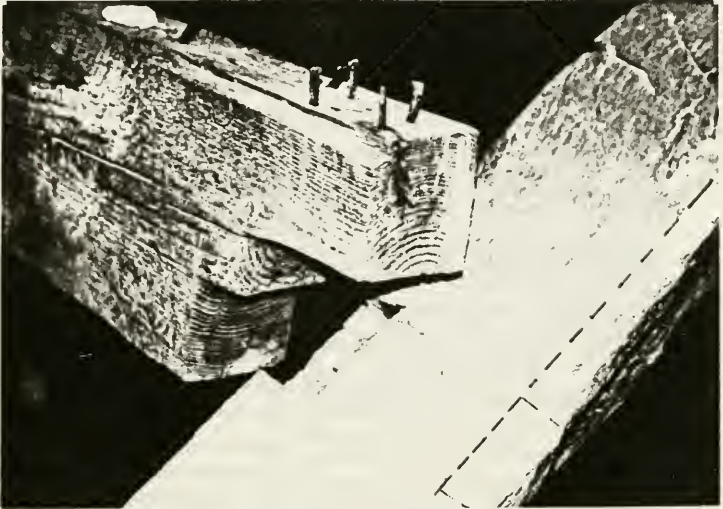
Figure 12: Federal Section Joist and Sill

It is a variation of a shouldered tusk and tenon joint, where the joist laps onto the sill. When the joint is connected, there is a four to five inch gap between the outside of the sill and the joist end, illustrated by the dotted line. Unfortunately, this sill is brown rotted, and normally is twelve inches wide rather than the eight inch width seen. The dotted area represents a band on the outer edge of the sills and plates on which all of the vertical framing members are placed, connected by mortise and tenon joints, and in some cases, nails for secondary studs. The joist is four inches thick and nine inches high. For the purpose of identifying the location of photographed framing details, the Figure Numbers of the photographs match the circled numbers on the framing drawings.

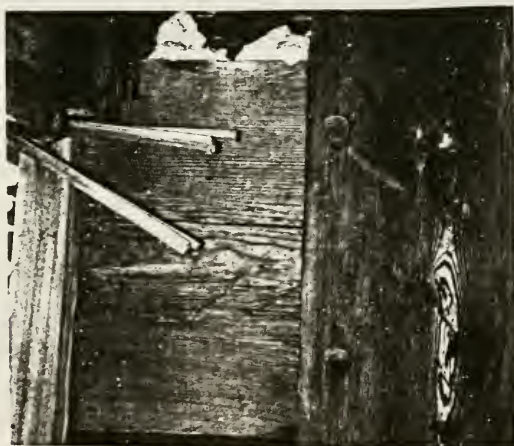
Figure 22: Federal Section Second Floor Plate and Corner Post.

Mortise and tenon joints vary widely in size and in the depth of the tenons, but never penetrate all the way through the adjoining members. The deepest mortises stop within one-and-a-half inches of full penetration. The largest joints occur where plates meet corner posts in the Federal section. Shown below, the tenon is short but wide and is secured with two pins.

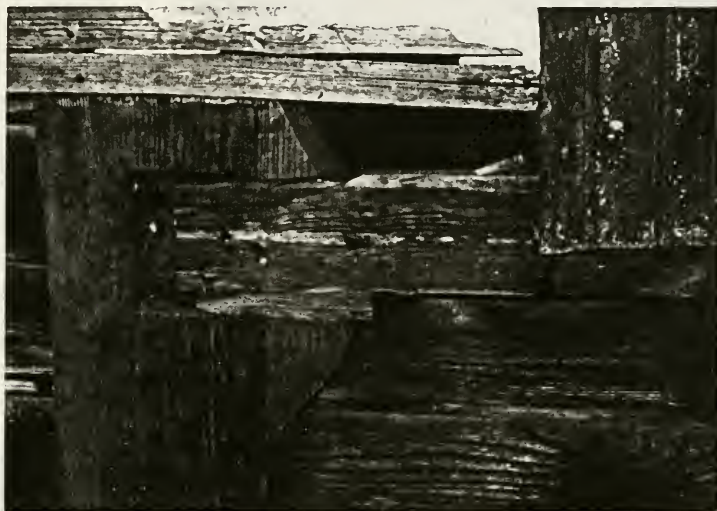
Figure 23: Georgian Hall East Window Cleat

Framing members of door and window surrounds of the Georgian and Federal sections differ in that those in the Georgian section have lighter components and more commonly utilize cleats below window sills. Shown below, from the Georgian hall, the cleat is notched into the nearest primary stud, then secured with a triangular block and wrought nails. In the Federal section, there are cleats used on some of the secondary windows, but generally the window sills are not notched into the adjoining vertical members. Instead, the sills are secured to cripple studs between the main studs, similar to the procedure used in modern platform framing.

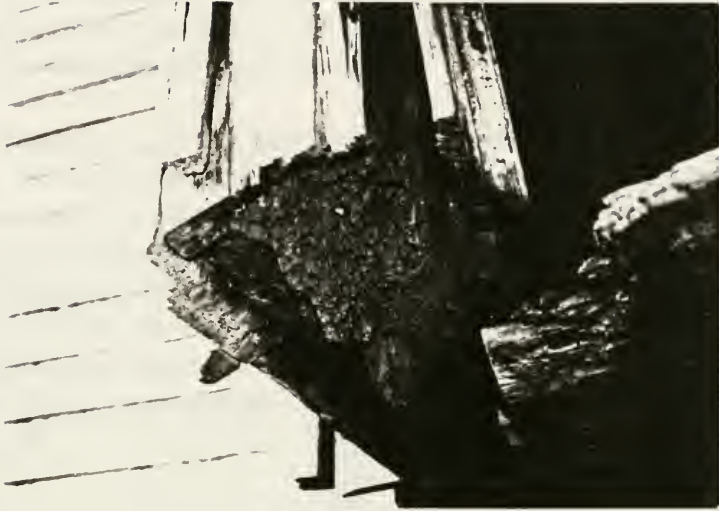
Figure 24: Federal Cross Hall East Door Jamb

In both the Georgian and Federal Sections, most of the doors and windows have jambs, sills and headers that are molded on one edge in order to receive the sashes and doors. On doors, the jamb is molded to form stops. The photograph at the top of the next page shows the jamb of the Federal cross hall west door. The rotted area is a tenon which was secured to the sill. The molded area of the jamb is cut from the same piece of wood as the tenon, although the photograph makes it appear they are separate. Note the applied casings and band moldings inside and outside the jamb. An applied strip molding is seen on the left side of the jamb, probably to provide a stop for a storm door. Applied wood moldings are used extensively in both the Georgian and Federal sections for casings, band moldings, baseboards, cornices (Georgian only), and exterior trim elements.

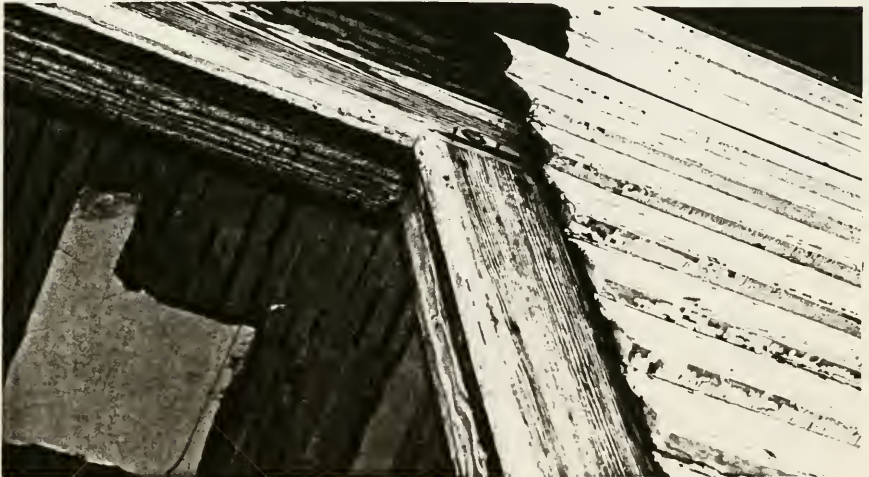
Figure 25: Federal Section First Floor Window Frame

As the photograph shows, the six inch members are mortised and tenoned at the top corners. Channels and stops are molded on the inside edges to receive sashes. Note the unmolded weatherboard to the right of the missing outside casing. As will be discussed later, there is a hierarchy of weatherboards involving four distinct types.

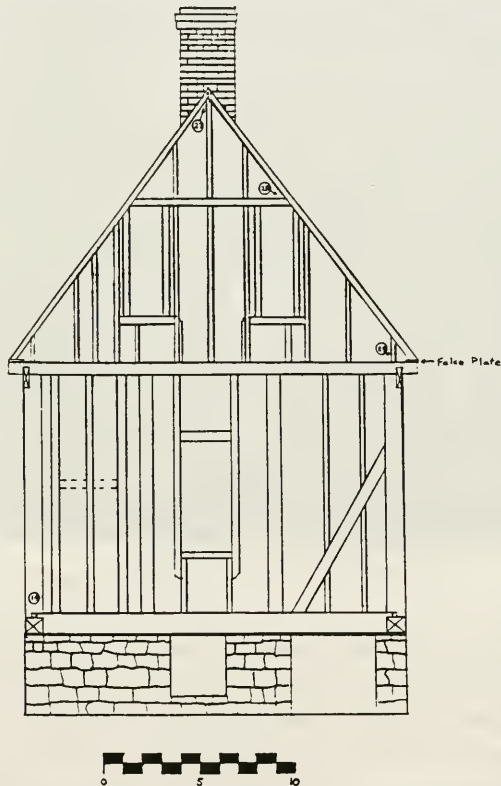
Figure 26: South Elevation of Georgian Section

The drawing shows how the Georgian framing system is similar to that in the Federal section below the eaves. Like the north elevation of the Federal section, the east and west plates, seen in cross section, are notched into the corner posts and south plate. In the Georgian section, the east/west plates project below the north/south plates, whereas the opposite occurs in the Federal main massing. Otherwise the heavy joints are identical below the eaves, including the connection of corner posts to the sills and the mortise and tenon joints of braces and primary studs.

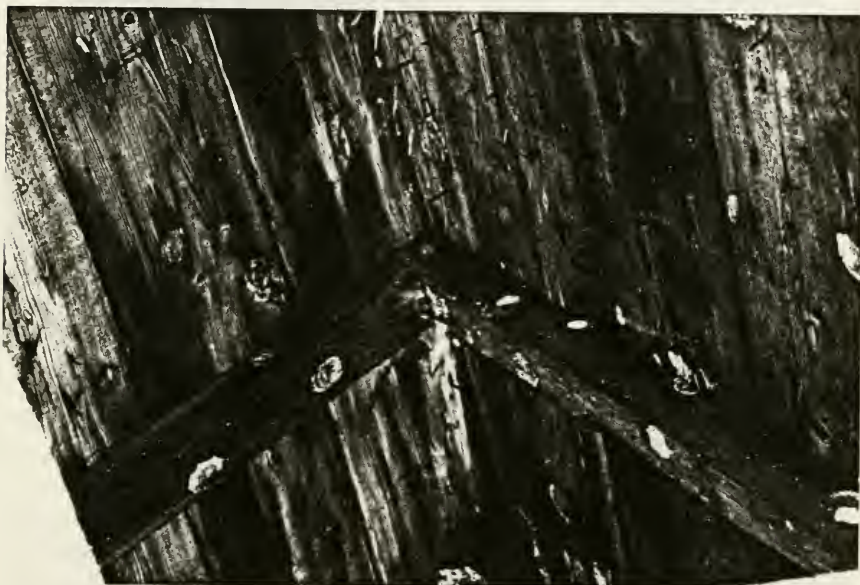
Figure 27: Georgian Section Rafters at Ridge

The roof structures differ dramatically. As seen in the Georgian Section elevation, the roof is steep, with a fifty-three degree roof pitch. The rafters are half lapped and pinned at the ridge as viewed in Figure 27.

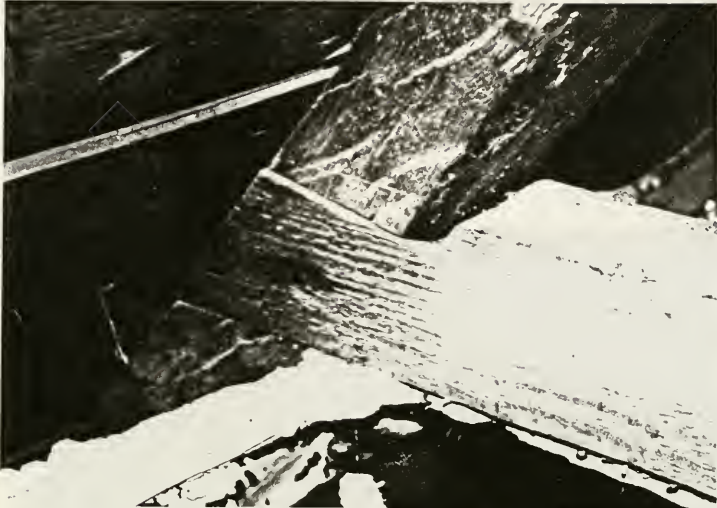
Figure 28: Georgian Section Half Dovetail Lap of Collar Tie

The rafters are generally three-by-fours, but vary slightly in size. They are spaced one to two feet on center. About five feet below the ridge, they are interrupted by collar ties which are connected to the rafters by half dovetail lap joints as seen in Figure 28. The dovetail joints are secured with wrought nails, the most common framing nail used in the Georgian section. At the gable ends, studs are mortised and tenoned into the plate, then are toenailed into the end rafters or are mortised and tenoned into the end collar tie.

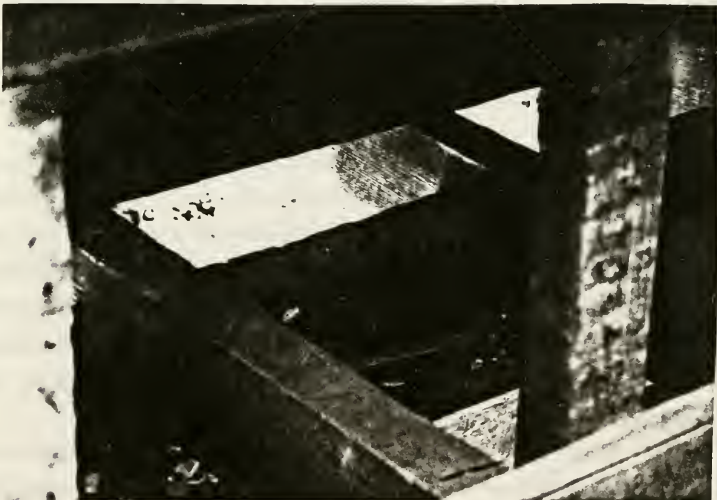
Figure 29: Georgian Section False Plate Detail

The rafters run down onto a false plate at the ends of the main plate and joists. Figure 29 shows this design feature. Note how the rafters are centered on the first floor ceiling joists. In the foreground is a knee wall stud and baseboard.

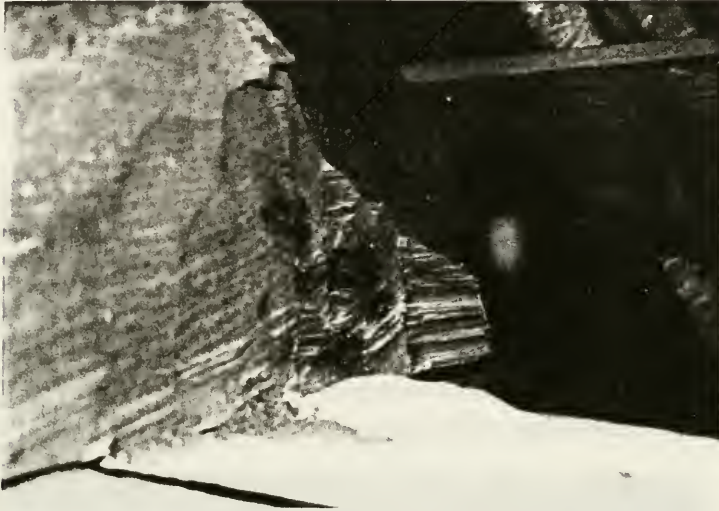
Figure 30: Federal Cross Hall Collar Tie End

The roof frame of the Federal Section cross hall is similar to the Georgian section, because it is basically a continuation of an existing roof structure. They differ in that the false plates of the cross hall are wider and thicker, its rafters are not always centered on the ceiling joists, and the cross hall collar ties are not notched into the rafters. Figure 30 shows a typical cross hall collar tie where it meets a rafter. The end is hacked so that the shafts of the nails can penetrate into the rafter.

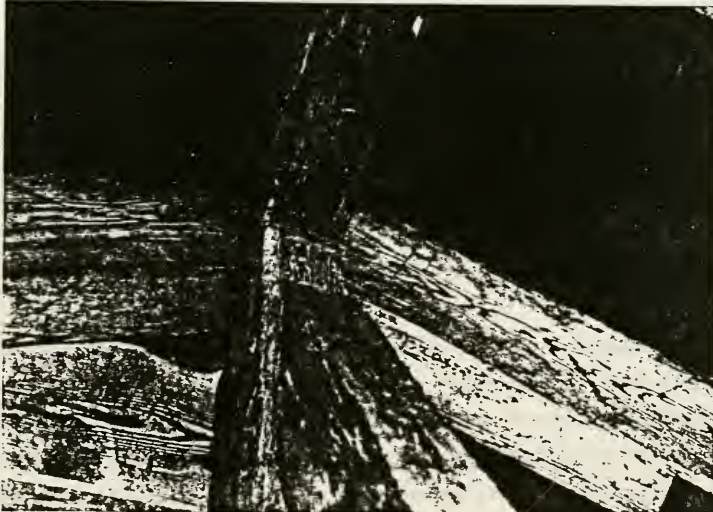
Figure 32: Federal Ridge Board Detail

In Figure 32, the ridge board is seen at the top of the picture. It is a four by eight, and receives the tenon of a four by seven gable center post. The band rafters on either side of the post are also four by sevens notched into the post and ridge board but the exact nature of the connection could not be examined. The brace at the bottom is a three by twelve, and is also notched into the post.

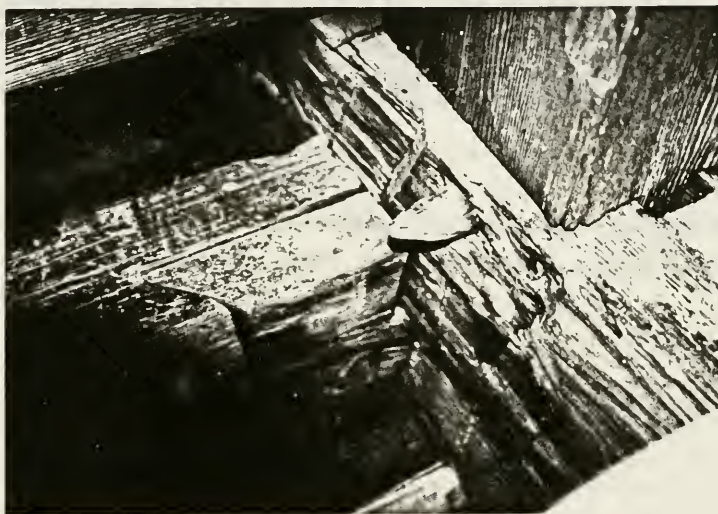
Figure 33: Joinery at the Base of the Federal Section Gable Center Post

At the base of the gable center post is the most complex joint in the building, seen in Figure 33. At the upper right, the post is notched into a five-by-eight center beam. The pointed pin of the mortise and tenon joint of this connection is clearly visible in the middle of the photograph. The beam is in turn double-notched into the massive upper plate, as seen below the pin. Double-notching refers to the beam and plate being cut so that the notches do not remove too much of the wood mass of one of the two members, thus providing a stronger joint. A third joint is seen in the lower left, near the shaded area. This is the center bevel scarf joint of the second floor top plate and extends the full eighteen inches through the height of the plate. One of the four pins of the scarf joint is barely visible in the lower center part of the picture. The double-notch joint is used throughout the Federal and Georgian sections, wherever joists and beams meet plates.

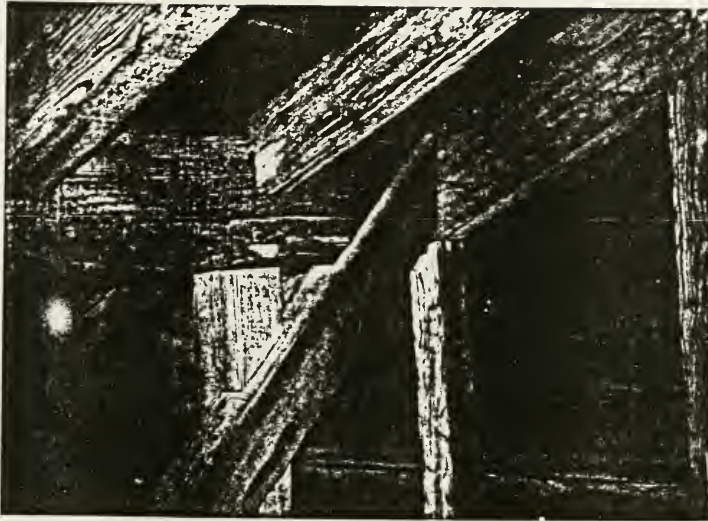
Figure 34: Structural Purlin of Federal Main Gable Roof

The four structural purlins which support the large gable roof are four-by-sevens. Figure 34 shows one of the upper purlins, as well as the rafters, posts and braces connected to it. The rafters in the foreground are double-notched into the purlin. The rafters on the other side of the purlin are not notched, but have beveled ends and are simply toenailed into the purlin with cut nails. Below and to the right of the center rafter are a pinned mortise and tenon joint of a post, and a lap joints of a brace over the post and purlin.

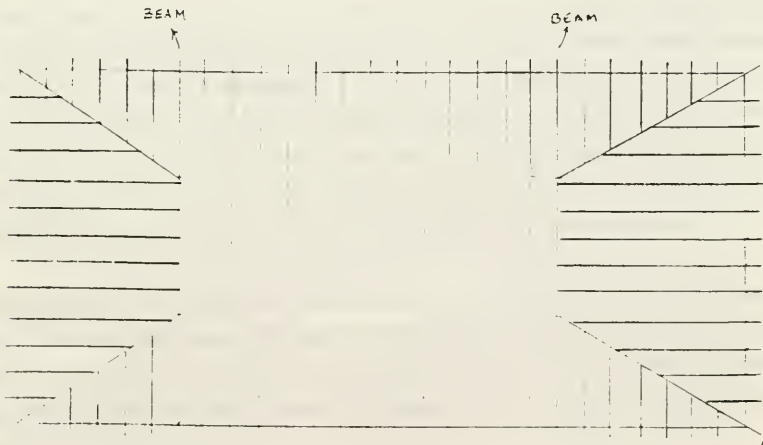
Figure 35: Attic Joist Plan of Federal Main Massing

Perhaps the most unusual feature of the roof framing of the Federal main mass is the existence of diagonal framing of the attic joists near the east and west elevations. A sketch of this joist plan is provided below. This framing anomaly is also marked on Figure 13.

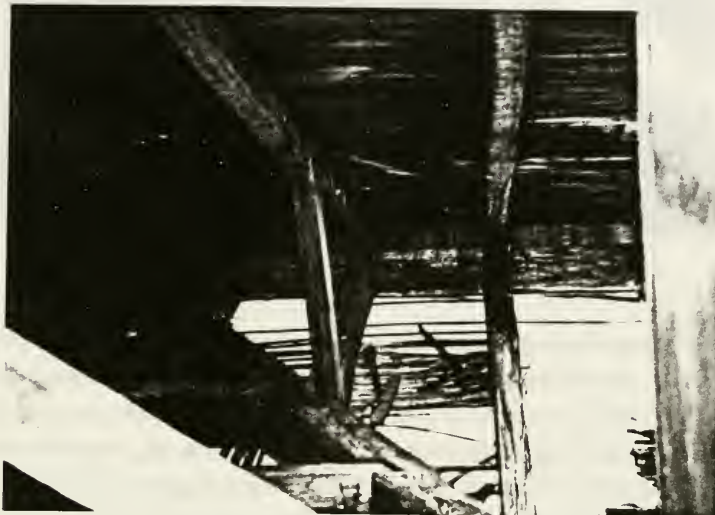
Figure 36: Federal Main Mass Diagonal Framing of Attic Joists

Figure 36 shows the southeast section of the attic joist plan. A diagonal member, called a dragon beam, is seen in the lower left, a seven-by-ten, and joists are double notched into it. Rafters are seen running onto a thick false plate. They have V-shaped notches which meet the top and inside edges of the false plate and are toenailed with cut nails.

At first, the author was at a loss as to why such diagonal framing elements were used for the attic joists, but it became apparent that this design was necessary in order to have projecting joists serve as the framing component of the cornices on all four sides of the building. The dragon beam shown in Figure 36 runs through the corners of the building and is cut in the shape of a V at the end. The diagonal layout allows joists to run through the east and west elevations. As will be seen in the roof frames of the wing rooms and the main portico, there is another method by which eaves can be created, but they are considerably less sturdy.

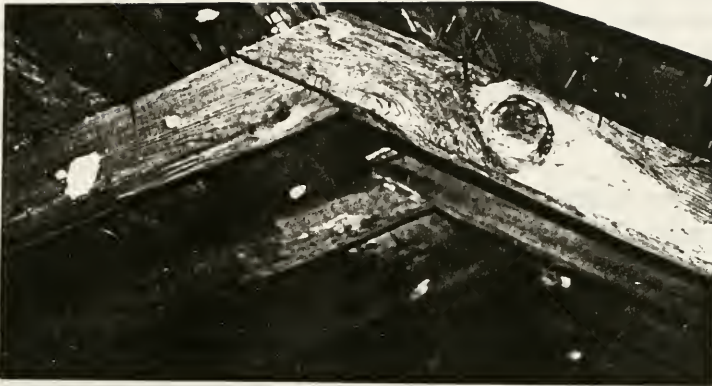
Figure 37: Federal Main Portico Roof Rafters

The roof framing of the wing chambers and main portico have half lap joints for the rafter pairs and have no ridge board. The roofs slope at a twenty-five degree pitch like that of the Federal section main massing. The rafters are slender, being primarily two-by-fours instead of three-by-fours used in the main massing and Georgian section. The next photograph shows typical rafter pairs.

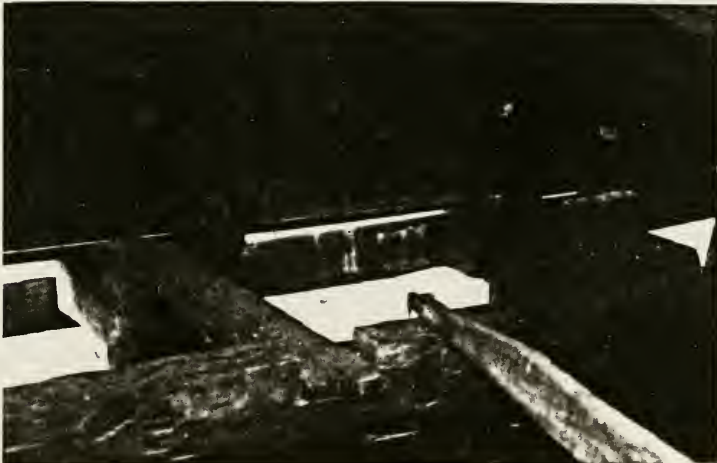
Figure 38: Federal Main Portico Attic Joist Framing

The attic joist plans of the wing rooms and portico are similar to the main massing roof, with one major exception: instead of diagonal framing elements, there are a series of small joists acting as outriggers placed perpendicular to the band joist near the gable. Shown below, two of the small outriggers are seen projecting through the gable, providing a nailer for the fascia. Note how the outriggers have a thin lap joint over the band joist. The band joist and its parallel joists project through the east and west elevations of the portico, creating nailers for soffit and fascia on the sides. This method is not as structurally strong as that of the diagonal framing of the principal elevation, but is an adequate design for small structures.

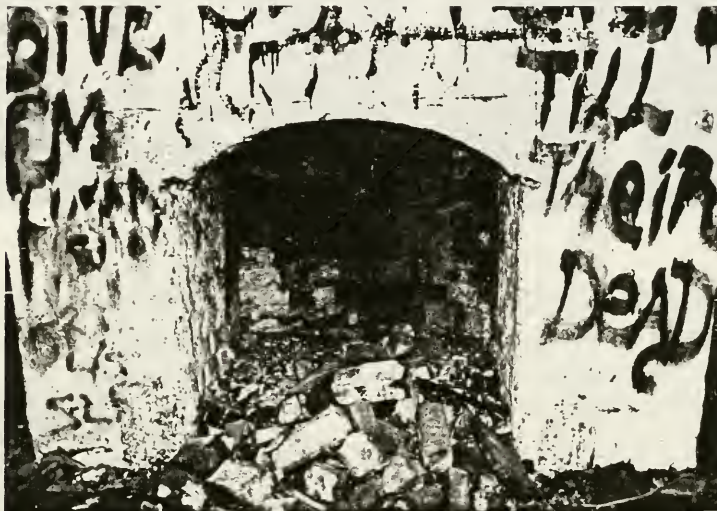
Figure 40: Georgian North Chamber Fireplace

The fireplace in the Georgian north chamber, the most intact in the building, is deeply recessed and features an elliptical arch. The exterior and interior surfaces are lime plaster parget and the cheeks angle slightly toward the back.

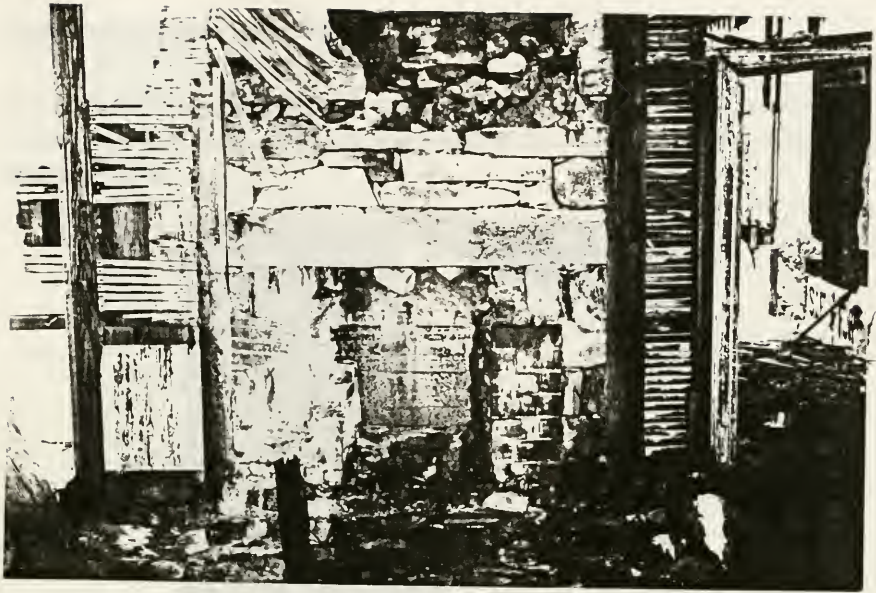
Figure 41: Federal West Parlor Firebox

The two Federal double chimneys service the east and west parlors, the second floor east and west chambers and the two wing chambers. In terms of design, they are similar to the Georgian English basement fireplace, but the Federal parlor fireplaces have taller openings and a course of finished brick in the firebox and on the surround. The west parlor fireplace, shown at the top of the next page, also features a back made of iron straps. Mitch Wilds, Senior Restoration Specialist for the North Carolina SHPO, speculates that the installation of an iron back might of been a response to use of coal as a fuel. The iron back would be more resistant to the higher temperatures achieved by coal-burning fires as compared to other materials designed for wood. The firebox was also reduced in size for coal burning use.

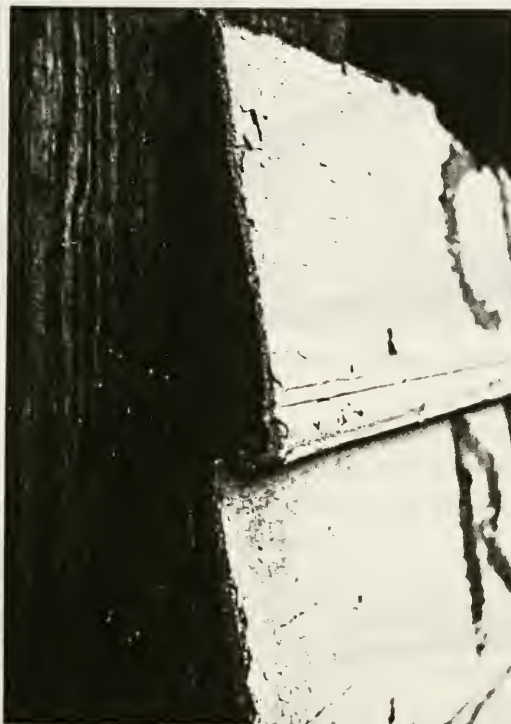
Figure 43: Weatherboard Detail of North Elevation

The vertical envelope of Little Manor is clad in four types of weatherboard. The principal elevation has the most elaborate weatherboard molding, featuring a small and large bead over a fillet as shown below.

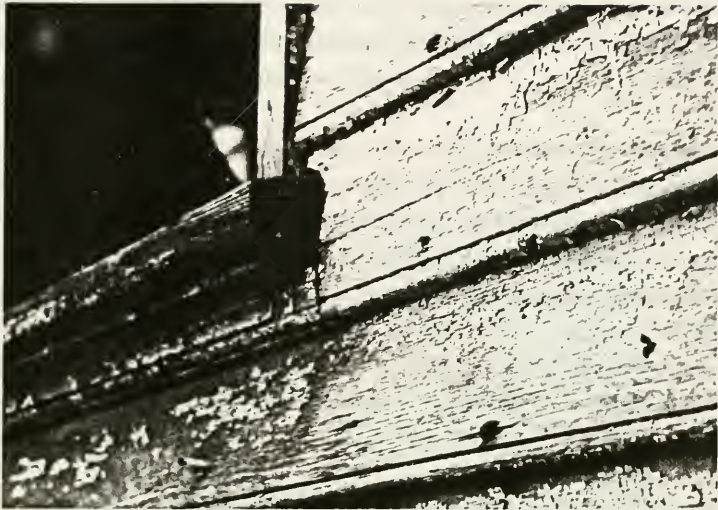
Figure 44: Federal West Parlor South Window and Siding

The Federal east, west, and cross hall elevations have molded weatherboards with one fillet and one bead, as seen on the top of the next page. Note the window, with its beveled sill over a fillet and small cyma recta molding.

The weatherboard throughout the building bevels from a quarter inch at the top to a half inch at the molded edge, and overlaps one to two inches. The exposure varies, but the average weather for the Federal section is five inches. For the Georgian section, it is about five-and-one-half inches.

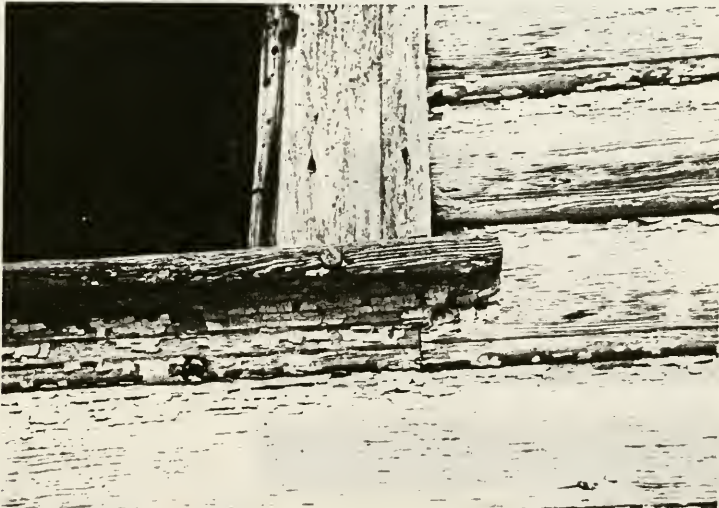
Figure 45: Georgian West Parlor Window and Weatherboard

The Georgian section weatherboard also has a fillet with a single bead, but the bead is less rounded than that of the Federal section. The Georgian section window sills are thinner, and they form a variation of a cavetto molding under which is a wide fillet and matching bead. A peg is clearly visible in the center of the photograph.

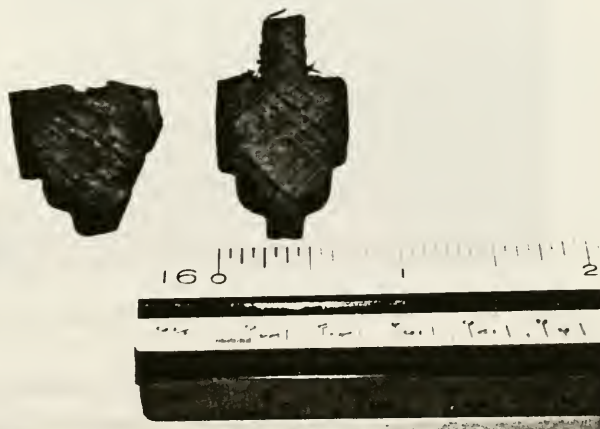
Figure 46: Federal Section Muntins; Cross Hall Transom and East Parlor

Although whole window sashes are missing, two Federal muntin profiles were obtained, one from the cross hall east door transom and one from the southeast window of the Federal parlor. They are shown below. The muntin on the left is from the cross hall transom.

These muntins were compared to other muntin profiles gathered by the North Carolina SHPO. They closely resemble, in form, several North Carolina Georgian structures from the 1780s and 90s, but are considerably smaller and therefore are likely to be from the Federal period.

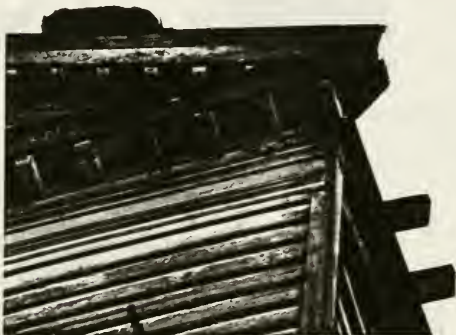
Figure 48: North Elevation; Trim Elements of Federal Main Gable

drawings of these features, but the modillion profiles as shown are incorrect. Figure 48 shows the northwest corner of the main massing. As the modillions project from the building, there is a plain block that is interrupted by a fillet, then the profile curves upward in a quarter round configuration. The picture shows a cyma reversa molding below the modillions interrupted by a fillet. Also shown are a small rake board molding and corner boards, which have a roundel molding at the corner. The silhouettes of a dragon beam and projecting attic joists are visible to the right.

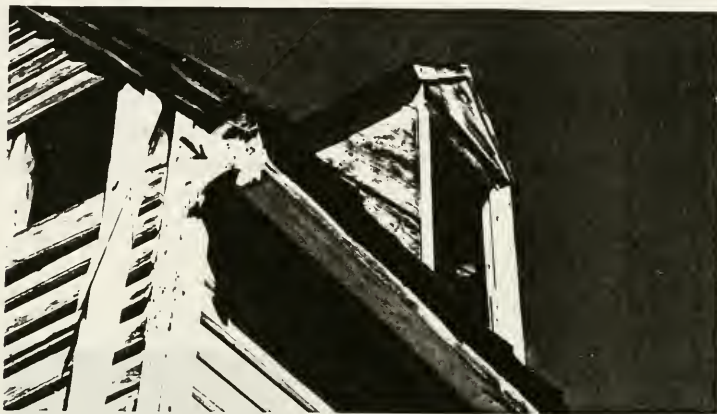
Figure 51: Pattern Board at Southeast Corner of Georgian Section

The Georgian section ornamental details and overall form are strikingly similar to the Bracken House, an eighteenth century dwelling in Williamsburg. The eaves details match, especially the pattern boards, which are nearly identical. The pattern board is shown in middle left of the next photograph. The dentils of the Georgian section are missing, but their small sizes were determined from ghost marks.

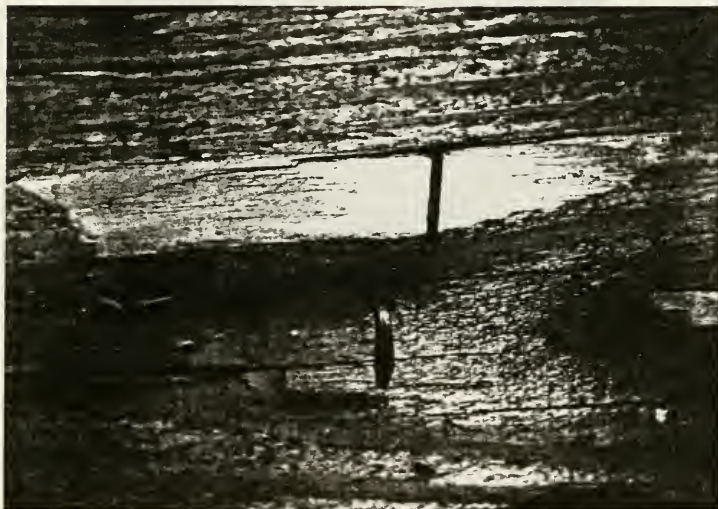
Figure 53: Wrought and Cut Nails in Georgian South Chamber Roof Sheathing

The sheathing boards for the roofs of both sections are wide planks with one inch thicknesses, except in the cross hall, where the sheathing has been replaced with sheathing lath. Nail patterns in the sheathing indicate multiple campaigns of roofing. The next figure shows nails protruding from sheathing in the Georgian south chamber. A wrought nail with a spoon-tipped shank is seen in the lower middle part of the picture, with a cut nail above it. The sheathing of the Federal main roof has early cut nails with handmade heads. In both cases, the sheathing is likely original material.

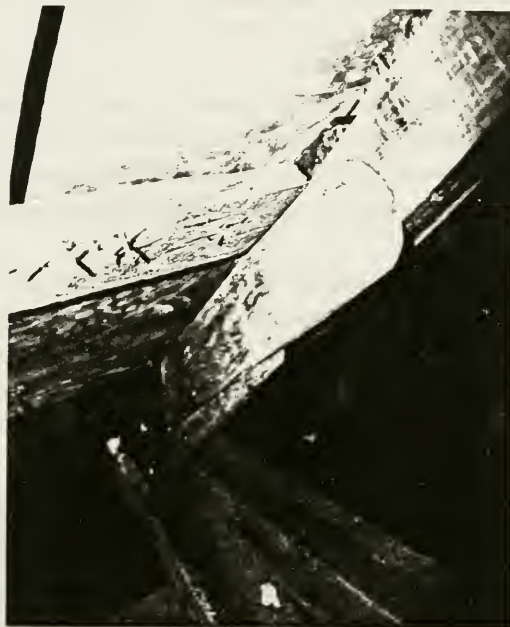
Figure 54: Oak Roof Shingles in Cross Hall Attic Space

In the process of removing roof sheathing boards from the cross hall, the carpenters decided to use old wood shingles as nailers for the purlins. Seen in Figure 54, the shingles are made of oak, are about five inches wide and a one-half inch thick at the exposed ends. The ends are

scalloped, a common feature of shingles in the eighteenth and early nineteenth centuries, designed to prevent warping. When these shingles were installed for roofing purposes is unknown, because of the absence of embedded historic nails. Wood shingles rarely last beyond forty years, but it is possible these were leftover from the original construction date and had fallen into the attic space. In the Federal section, scalloped pine shingles were discovered in the main gable roof structure but when they were originally used is also unknown.

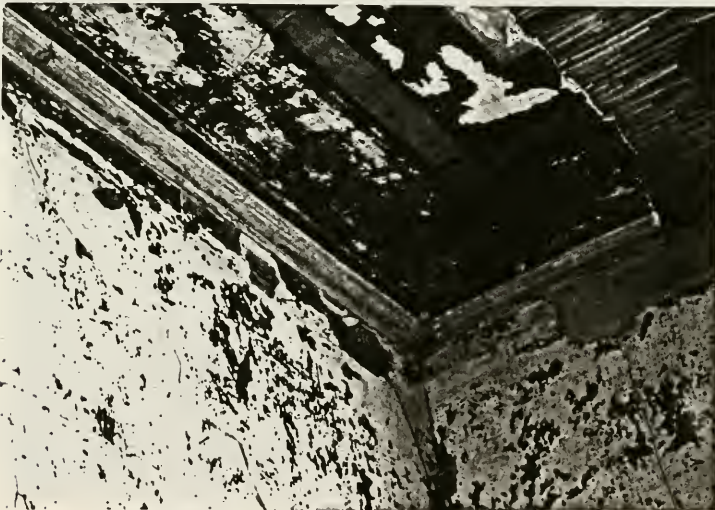
Figure 55: Paint Finishes in Federal East Parlor

A good example of this is provided by the Federal east parlor, the only room in the building other than the Georgian parlor with nonwhite paint on the plaster surfaces. Figure 55 shows the ceiling area at the northwest corner of the room. Part of the elaborately painted ceiling is still intact, but most of the paint has flaked off the wall surfaces. As will later be seen the Frances Benjamin Johnson photographs, the paint finishes in this room were the most elaborate in the building.

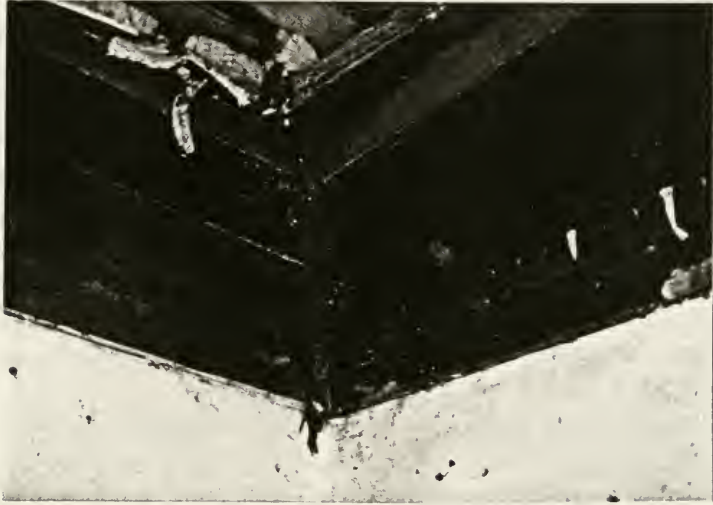
Figure 69: Ceiling Cornice Detail of Georgian Hall

The wooden ceiling cornices of the cross hall and Georgian hall are missing some of their components, but the dentils are still intact as seen in Figure 69. The cornice is eight inches in height and project about five inches into the room. They involve at least three separate applied pieces, to form the full profile.

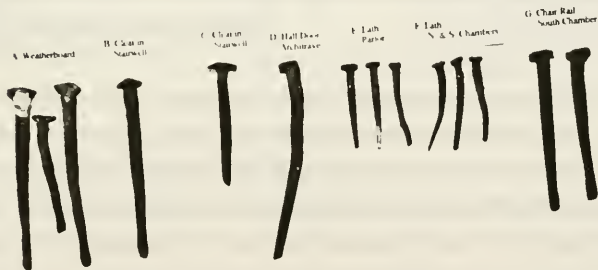
Figure 71: Representative Nail Types of Georgian Section

The dominant nail type used in the Georgian section of the building is the hand wrought nail. Shown in Figure 71, these nails were used for framing elements, weatherboard, exterior trim, second floor interior trim, and flooring. These are represented by labels A, B, C, and G.

In terms of chronology, the most interesting nails are the lath nails used in the Georgian section. The lath nails shown as labels E and F in Figure 71 are either Type IIC or Type IV, (early machine-cut nails with handmade heads and early machine-headed cut nails). Most of these are Type IIC nails, produced from 1790 to 1810. This indicates that the lath and plaster in the Georgian section was installed several years after the original construction date of 1781, the time the property was transferred to Thomas Person. It could also indicate that the Georgian section was built in the 1790s. In the deed and will research literature, it is constantly assumed that individuals would immediately build on their newly acquired properties, but there is no actual evidence to support this. Person may have decided to build the structure many years after inheriting the property, bearing in mind he already had a residence in Granville County. In regard to the existence of Type IV nails (1815 to 1830), it is likely they were used for minor alterations or repairs. The absence of completely hand forged nails for lath continues to surprise the author despite the theory just put forward. In the analysis of nails of Little Manor, this is one area that needs further investigation. It does, however, indicate that technology transferred quickly to Little Manor from the more heavily populated coastal settlements.

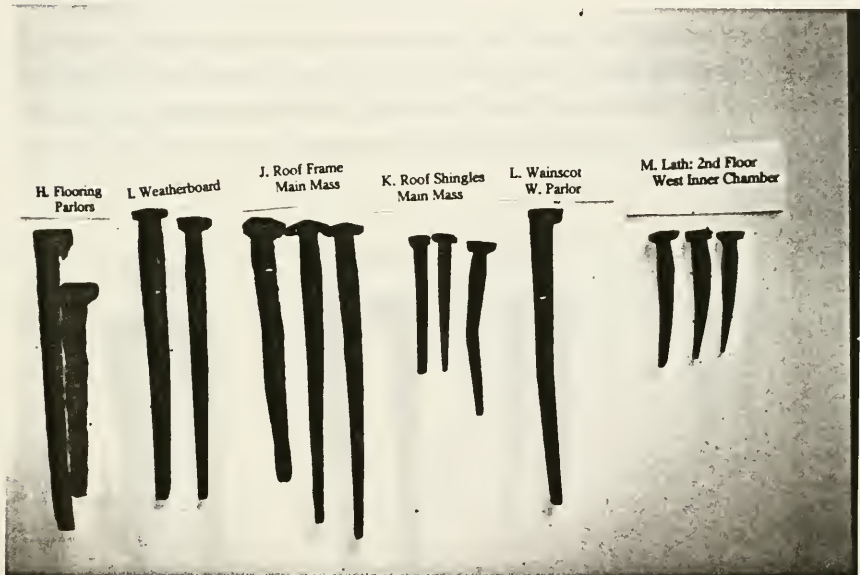
Figure 72: Nails of Federal Main Massing

Analysis of nails in the other sections of the building are less complicated. In the Federal main massing, the nails used in the weatherboard and roof frame are Type IIA nails, early machine-cut nails with handmade heads. Shown under labels I and J (the two to the right) in Figure 72, they were produced between 1790 and the mid-1820s, which fits the time frame of the construction of the main massing sometime after 1804.

The fourth main nail type in the Federal main massing is Type III, completely machine-cut brads, produced between 1805 and 1820. These nails match the trim nails used in the Georgian section and are seen under label L in Figure 72. The flooring nails of the main massing are identical to the trim nails and are seen under label H. They appear slightly oversized because of their corroded condition.

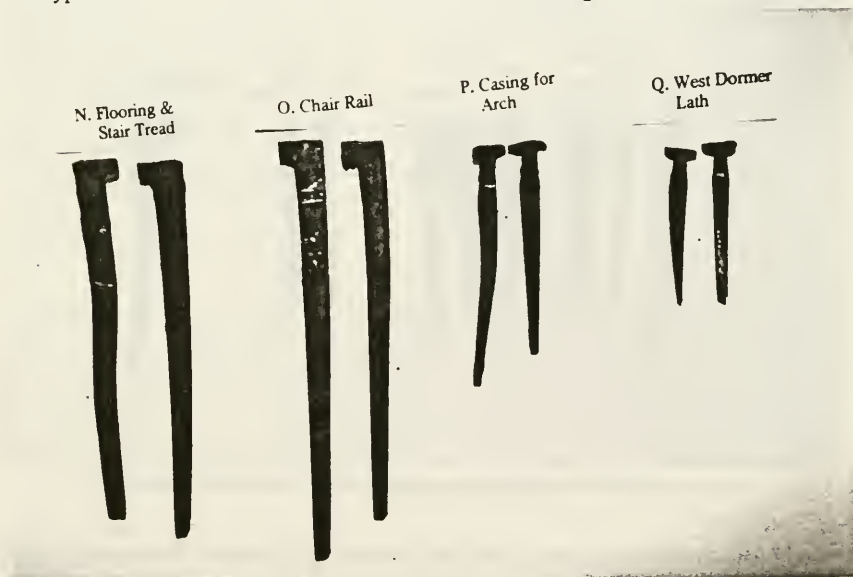
Figure 73: Nail Samples From Cross Hall

Nails taken from the cross hall area match those of the Federal main massing, which indicates the cross hall was built at the same time as the main massing. Shown in Figure 73, they are Type III nails (labels N and O) and Type IIA and Type IIC nails (labels P and Q). The Type III nails are used in all first floor sections of the building.

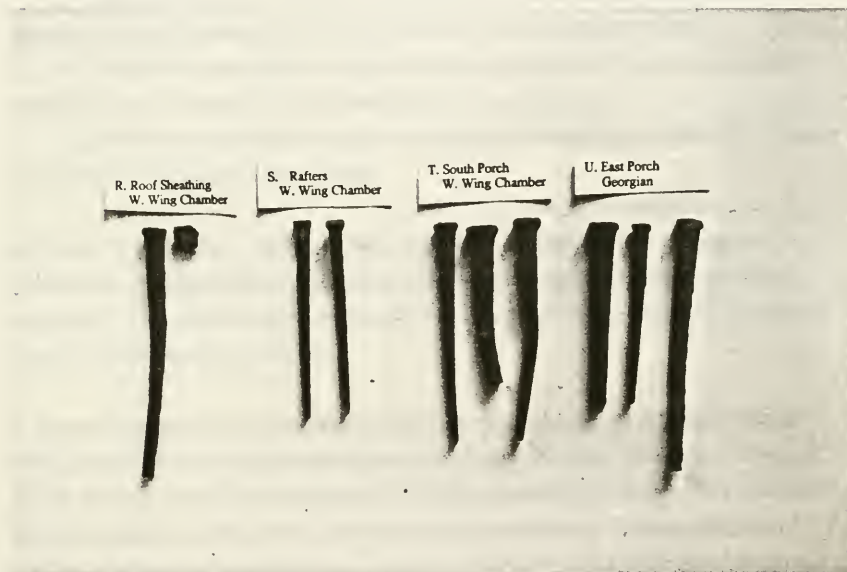
Figure 74: Nails of Rear Porch Structures and Federal West Chamber Roof

All of the porches other than that of the Federal main portico are in a state of collapse, but sections of these structures are still intact, lying on the ground. About 75% of the surviving nails of the framing elements and weatherboard for the fallen porches off the south elevation of the Federal section and east/west elevations of the Georgian section are built with Type IV nails and there are no earlier cut nails. It is likely that these porches and the Federal wing chamber roofs were constructed at some point after the introduction date of these nails after 1815. A few of these nails are shown in Figure 74.

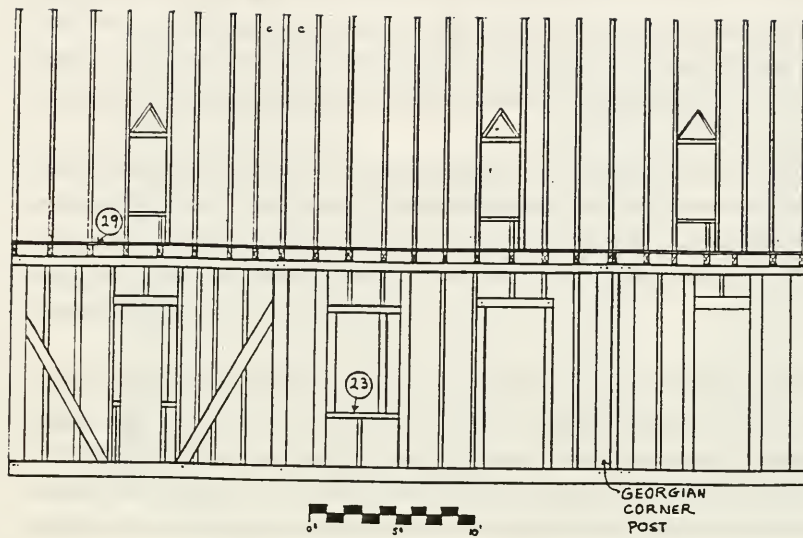
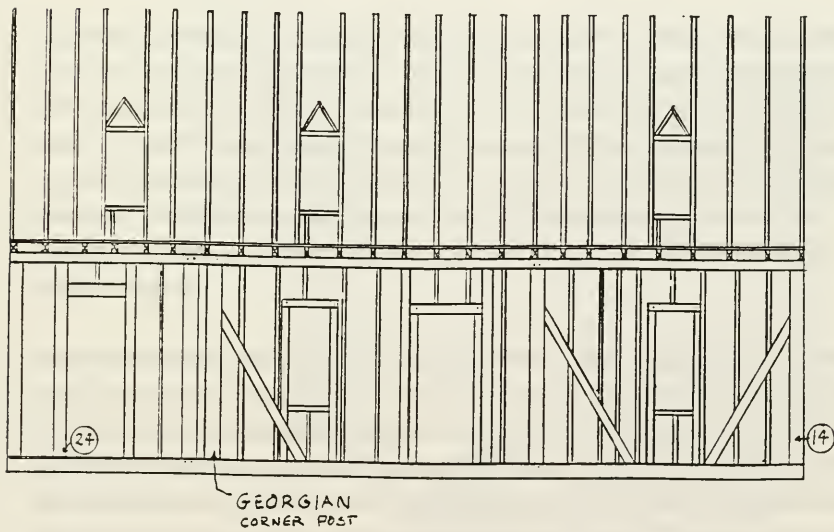
Figure 77: East (top) and West (bottom) Elevations of Georgian/Cross Hall Section

far left of the east elevation, it can be seen that the opening was converted from a window to a door. The surviving framing elements of a window match the framing elements of the opening on the other side, seen at the far right of the west elevation. Hence, the original openings of this room consisted of two windows, typical of a Georgian parlor.

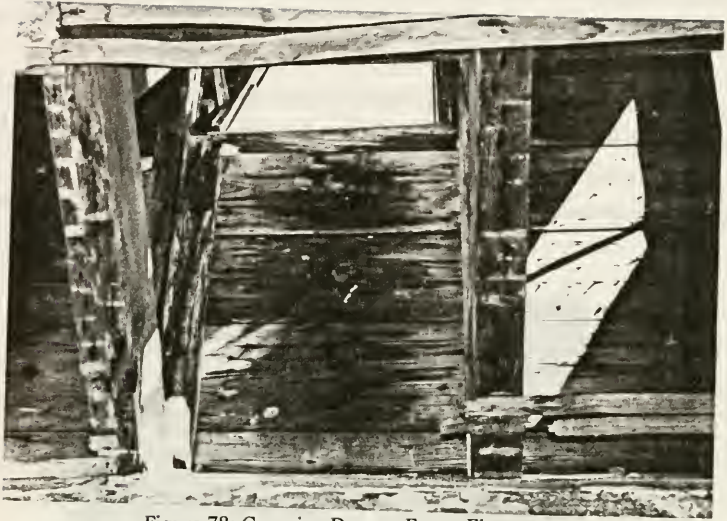
Figure 78: Georgian Dormer Frame Elements

Early alterations were also performed on the second floor of the Georgian section. As seen in both Georgian section elevations, the dormers do not directly line up with the openings below. This is because the carpenters were restricted by the roof frame already in place. They had to cut through one rafter as seen below the sills of the dormers, then installed a companion rafter for structural support. Figures 78 and 79 illustrate this process. Figure 78 shows the original rafter (on the left) cut to make way for the dormer structure. Figure 79 shows a wind brace cut for the same reason, seen on the middle left. Ordinarily, the wind brace would end at the rafter with a half lap joint cut into the rafter rather than the brace being completely sawed off.

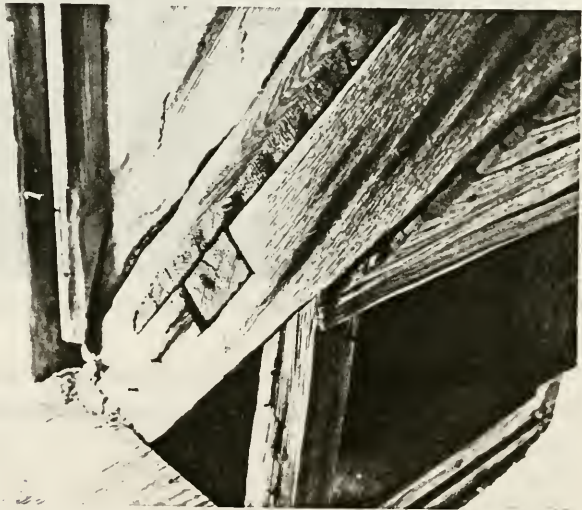
Figure 79: Wind Brace in Georgian Dormer Frame

When the dormers were installed could not be ascertained, but it likely occurred before the construction of the Federal section because of the lack of Type IIA cut nails in the framing elements. The occupants may have lived on the first floor, then decided to expand into the half story space.

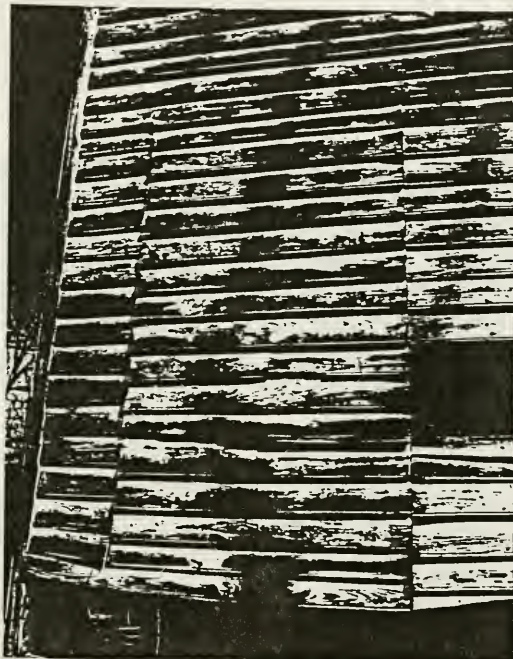
Figure 80: Covered Doorway on Georgian South Elevation

A final alteration in the Georgian parlor occurred late in the building's history. Shown in Figure 80, a door was sided over with weatherboard at the southwest corner of the Georgian south elevation. This door is shown in the L. Scott Garner floor plans of 1964 and was covered at some point afterward. The frame inside is still intact and matches the other jambs in the Georgian/cross hall section.

The date when this doorway was covered is a mystery. In the Garner plans, the door is shown, but is covered in a 1925 photograph seen in Figure 84.

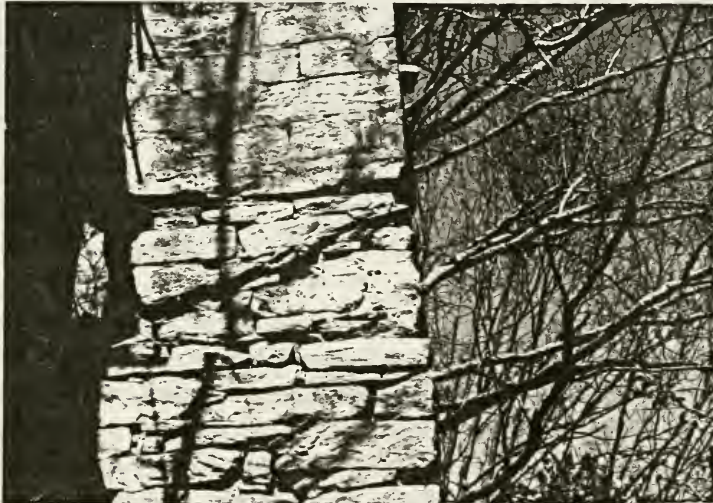
Figure 82: Ghost Mark of Front Gable Roof on South Elevation of Federal East Chimney

The most significant early alteration that occurred at Little Manor, and one that impacts the architectural history of tripartite North Carolina structures, occurred with changes to the Federal wing chamber roofs. In 1998, restoration contractor Dean Ruedrich, with Mitch Wilds, discovered the ghost marks of front gable roofs on the chimneys near the wing chambers. Shown in Figure 82, the mark of a twenty-five degree gable roof is clearly visible.

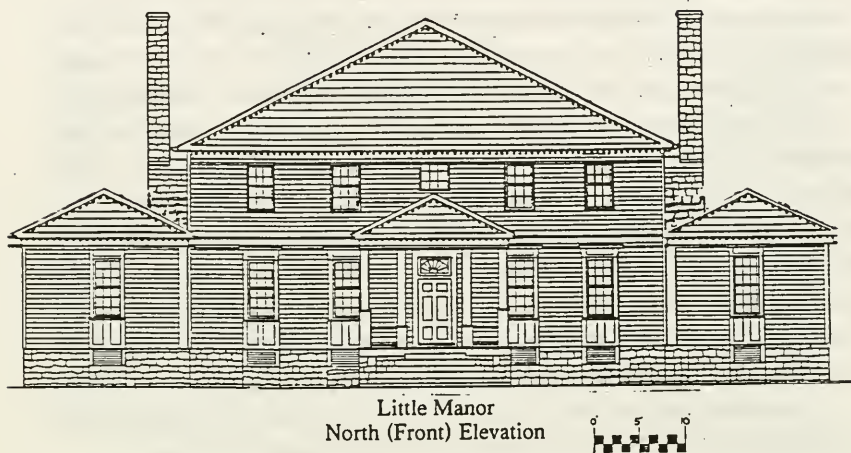
Figure 83: Original Design of Federal North Elevation

Ruedrich and Wilds theorized that the original front gable roofs were at some point rotated ninety degrees to give the roof structures their current side gable configuration. The thesis investigation confirms this theory. It begins with a major design flaw during the original Federal construction campaign. The builders were trying to create a tripartite principal elevation with three matching ornamented small front gables beneath one large main front gable. The front gables of the wing rooms were designed to be the same height, roof pitch

and approximate width of the main portico as seen in Figure 83. This would provide an elegant and unique symmetry to the structure lacking in all other North Carolina tripartite structures.

Although visually pleasing, the problem with the design is that during rain storms heads of water rush down the roof surfaces of the gables directly onto the chimney and weatherboard of the side elevations of the main massing. Unless very large valley gutters or wide metal flashing materials are used, there is no way the water is prevented from splashing onto the weatherboard and into its overlapping seams. Heads of water can also penetrate into the mortar joints of the chimneys. The result is that these vulnerable areas began to deteriorate rapidly, and the owners were forced to solve the problem by rotating the roof structure to its current form so the flow of water ran off the eaves down onto the ground or into a gutter.
