Documentation and Architectural Analysis of Little Manor Plantation House

William Luby Ferguson
University of Pennsylvania

A THESIS

Historic Preservation

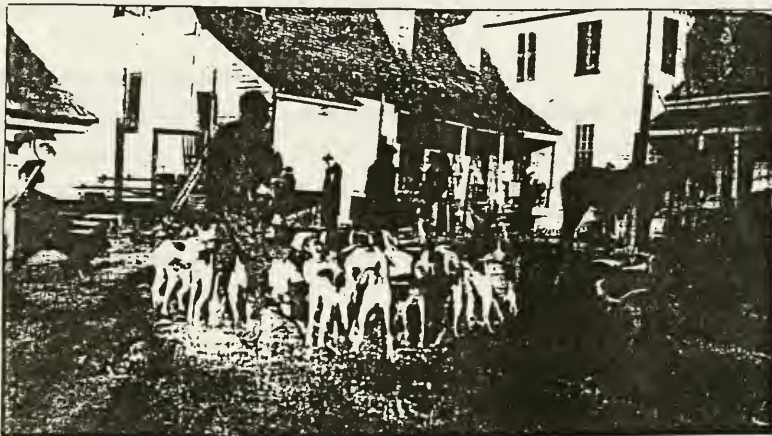
Figure 84: 1925 Photograph of Little Manor

In the analysis of nails, it was determined that the porch structures on the rear of the building were constructed sometime between 1815 and the 1850s. Two of these are seen in Figure 84, which shows a view of Little Manor taken from the southeast in 1925, during a fox hunt. One porch kicks out from the Georgian roof in the center of the photograph and the other projects from underneath the eaves of the Federal east wing chamber roof. The fact that the wing porch is not a continuation of the main wing roof indicates it was probably built

separately, sometime after the wing side gable roof. All of the roofs in the photograph have wood shingles with square butt ends, likely the roofing material before the installation of the standing seam metal roof. Wooden shutters are visible on some of the windows and there is an outbuilding to the far left.
