Structural Failures of Single Wall Construction in a Western Mining Town: Bodie, California

Andrea Sue Morrison
University of Pennsylvania

A THESIS

Historic Preservation

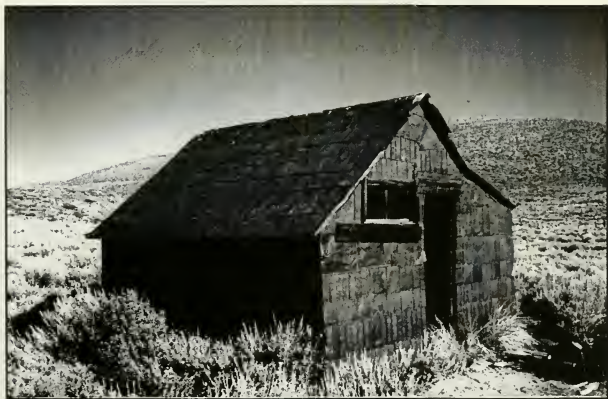
Figure 2.10b. Photograph showing use of tin can shingles. South-East elevation of Tin Cabin. Photo taken 12 Aug., 1997 by P.D. Schulz.

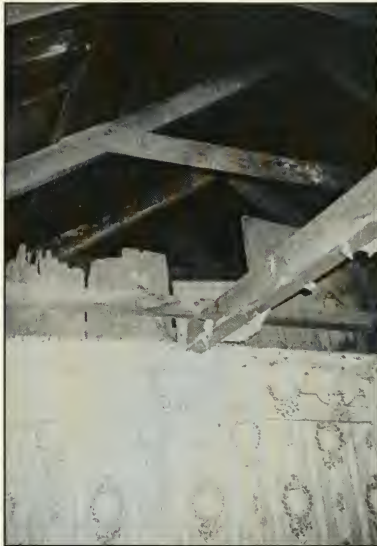
Figure 2.11a. Photo of interior wall showing tops untrimmed & use of wallpaper.

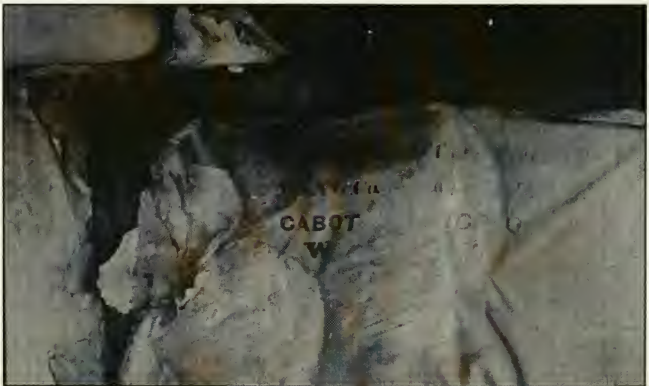
Figure 2.11b. Photo showing insulation techniques; canvas, muslin , and newspaper.

cloth, again covered with wallpaper. Because single-wall construction has no interior structural frame, there is no room for the service of insulation. Once again, the miners used what they could find to exclude inclement weather. The insertion of builder's paper, scraps of cloth, newspaper, or rags made from clothes stuffed between boards or in open joints or cracks was common. There is a plethora of tin can lids nailed over knot holes as well. The use of recycled materials is prevalent at Bodie, which is illustrative of a frugal and resourceful lifestyle [Figures 2.12a].

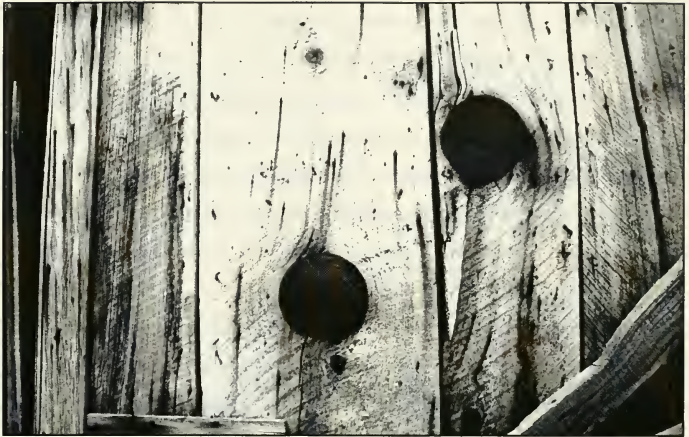
Figure 2.12a. Photo showing use of recycled materials. Building O, Rm. 5, East wall; tin can seal over knot holes. Photo taken 13 June, 1996 by P.D. Schulz.

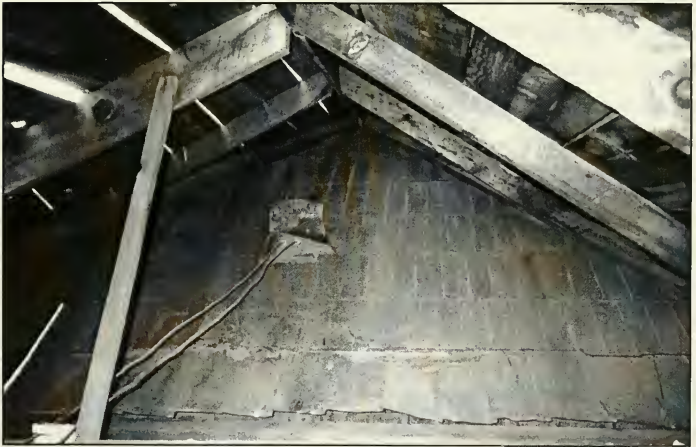
As the inhabitants remained, certain alterations were made to the original structures. "L" shaped-additions were common of the more elaborate buildings, where a separate gabled room would be added off one side of the original Hall/Parlor structure. In this case, the framing for the new roof addition would be laid directly on top of the sheathing of the original building, a term coined as "California addition" [Figure 2.12b]. With an "L" addition, the walls of the new room are butt-up against the exterior of the old, and no effort is made to tie the

Figure 2.12b. Photo showing "California Addition;" new roof is constructed directly on top of the original without removing shingles. Selhorn building over Rm. 2 looking North. Photo taken 29 July, 1997 by P.D. Schulz.

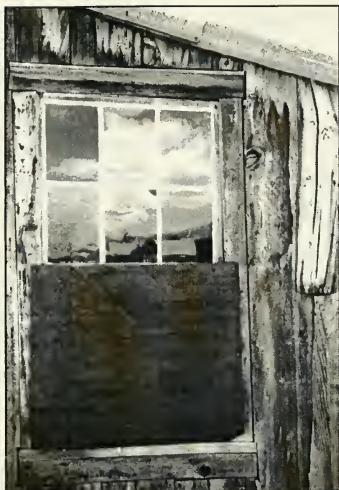
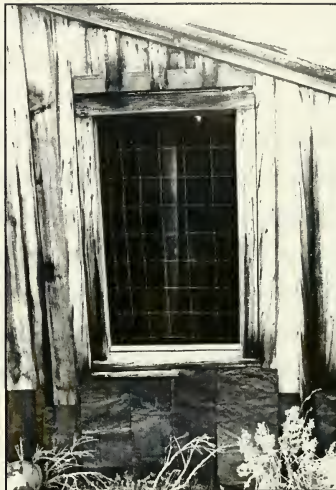
Figure 2.15a & 2.15b. McMillan West, Window 4, exterior. Photo taken 8 July, 1997; Andrews, Window 6, exterior. Photo taken 22 May, 1997 by P.D. Schulz.

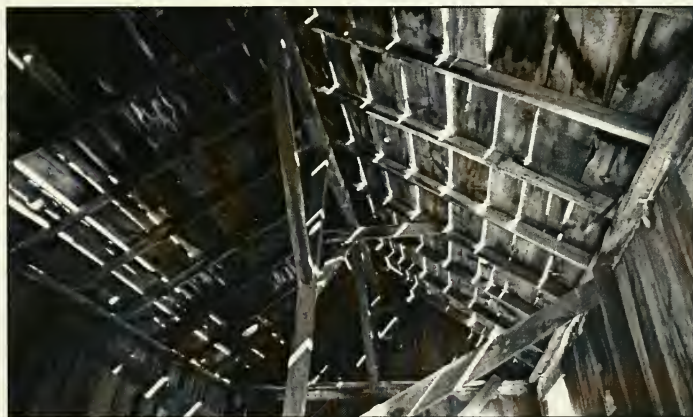
Figure 2.15c. Tong Sing Wo, Room 1, looking North with Nelson's shoring. Photo taken 16 August, 1996 by D.H. Chang.

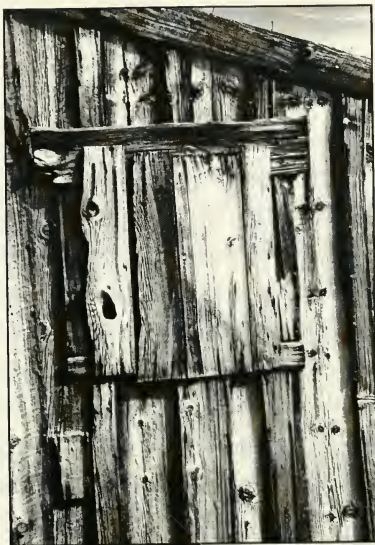
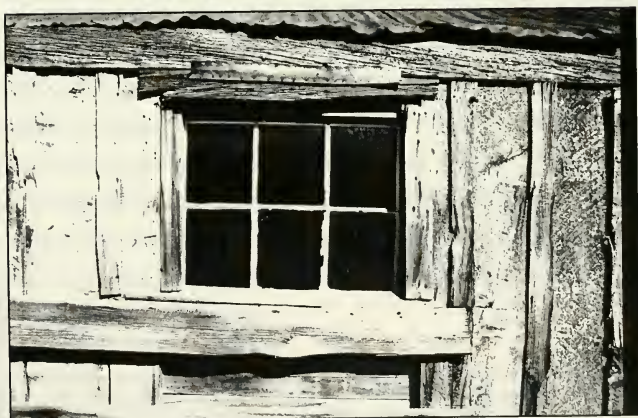
Another form of deterioration of the wood on a chemical level is the natural “weathering” of the wood, triggered by the breakdown of its materials. This breakdown, when left to proceed un-interrupted will lead to the failure of the materials, and hence the structural system of the single-wall buildings. “Weathering” is a combination of alternating swelling and shrinking of the material (thermal expansion and contraction), combined with photodegradation of the wood surfaces from exposure to sunlight and ultraviolet radiation. One advantage to the structures in Bodie is that the park encourages the natural weathering of the materials. The erosion of the surface exposes newer surfaces of the wood at its depth which adds color and enhances the appearance of the picturesque mining landscape. The weathered appearance of the buildings marks the passage of time, evoking a romantic appreciation of the aged ghost town [Figures 3.13a & 3.13b].

Figures 3.13a & 3.13b. The weathered appearance of the buildings marks the passage of time.

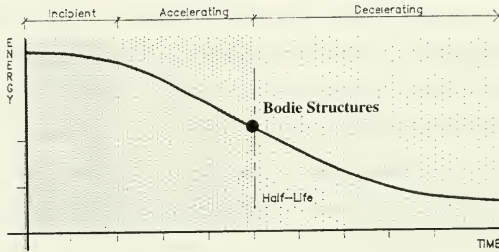
Deterioration Curve

Considering that the failures of the structural system of the single-wall buildings fall into a specific profile, the performance and duration of the system can be predicted based on that profile and an understanding of the environment. According to S. Y. Harris, the deterioration of a building is a measure of the capacity of a system to undergo spontaneous change, and can be charted over time as a declining *S* curve. The mathematical characteristics of the *S* curve are that the curve accelerates to a point of contraflexure then decelerates, with the lower range of the curve asymptotic to the ordinate. In terms of building history, Harris subdivides the *S* curve into three phases of deterioration: the incipient, accelerating and decelerating deterioration [Figure 4.1a].

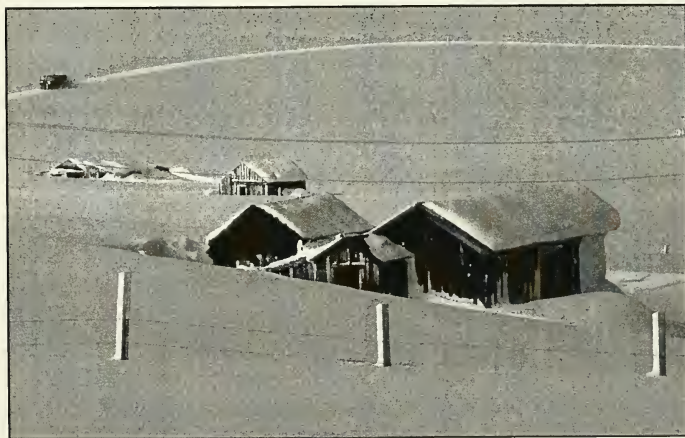
Figure 4.4b. Photograph of Andrews looking North-West showing extreme weather conditions. Photo taken 1988 by J. Brad Sturdivant.

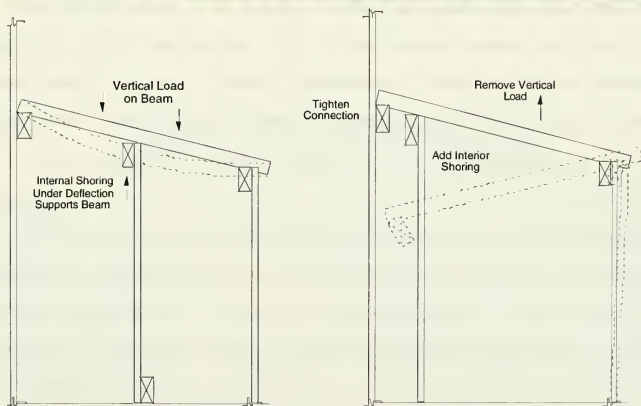
When the roof members bend under load and do not regain their initial state, the horizontal closure of the structure is compromised. Gaps formed from the bent, twisted, or cracked sheathing allow water to penetrate to the interior, which causes additional damage to the structure. Considering that bending (creep) is caused by excessive load to the elastic material, the most rational means to mitigate deflection is to remove the excessive load. This would require removing the snow from the roofs of the Bodie buildings; a task that would no doubt require a significant reallocation of manpower at times of the year when extra staff is least available and Bodie is least accessible [figures 4.4a & 4.4b]. Rafters that have already deflected to the point of plasticity could be reconstituted with sister rafters that would share the work of transmitting the load to the ground. The most costly approach, and perhaps the least aesthetically pleasing solution is to construct an internal shoring system under the deflected rafter members. The shoring would substitute for the rafters and walls in holding the building up, acting much like a skeletal system [Figures 4.5a & 4.5b].

Figure 4.5b. Diagram illustrating intervention strategies for deflected roof members and roof collapse.

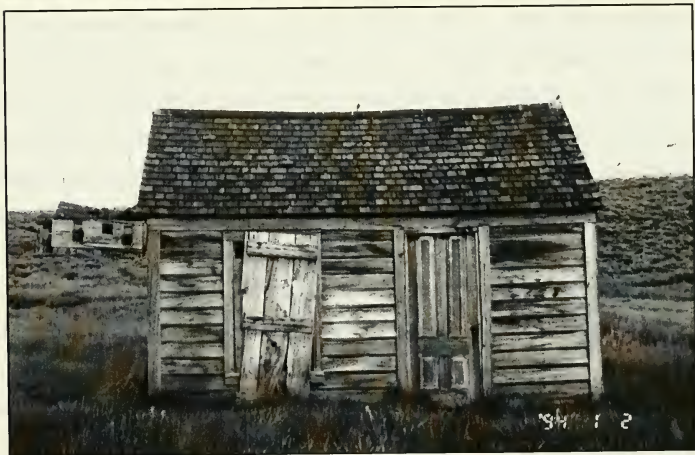
Figure 4.6b. Replaced roof with new material protects the interior of the structure, but compromises the integrity of the park and leads to creeping reconstruction. West elevation, Building "E1" taken 2 Sept., 1998 by A.S. Morrison.

existing fabric and installation of new sheathing and shingles. Several Bodie buildings have already undergone this treatment. One advantage of such intervention is that it replaces a failing system with a sound one and so protects the interior from accelerating deterioration. Also, the new roof can be expected to remain functional without attention for several years. The visual downside of this approach is that- at least for the first year or two- the replacement roof (even though made in kind) is readily discernible as new and so detracts from the atmosphere of arrested decay. The other disadvantage of this intervention strategy is the wholesale loss of historic fabric, a practice that has been criticized as leading to creeping reconstruction [Figure 4.6b].

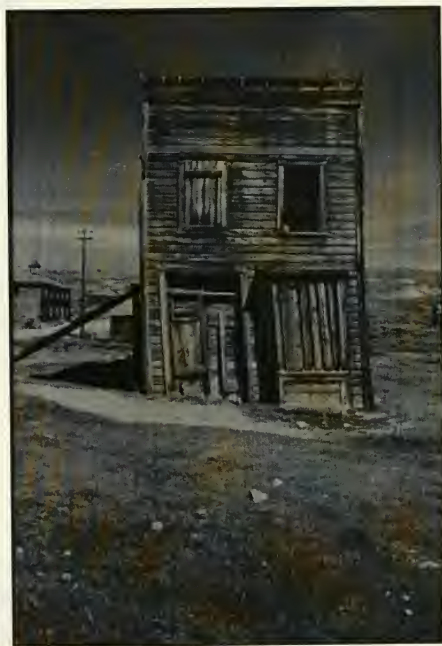
Figure 4.8b. Photograph of Swazey Hotel on Main Street showing pole propped up against outside of structure on the leeward side to resist racking. Taken 2 Sept., 1998 by A.S. Morrison.

the joint, or a combination plate can be used for joints under both tension and compression [Figure 4.8a]. The stabilization of these joints will counteract the lateral forces imposing stress onto the structure, thereby mitigating further shearing of the building. The park personnel have in the past braced the structures externally by propping a pole against the leeward side to the wind. This is a functional alternative and in a small way adds to the intrigue of the “arrested” town. This is a very economical option [Figure 4.8b].

Figure 4.8a. Diagram of combination plate and "T" plates to be used to stiffen joints from Nash, 122.

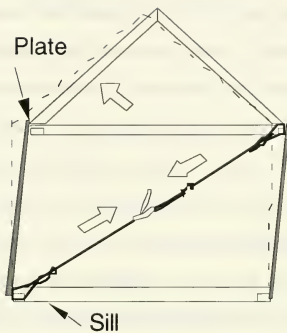
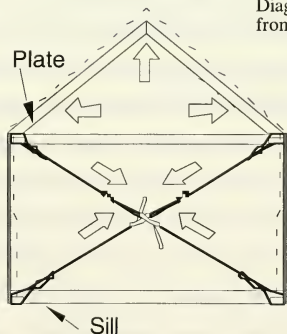
Figure 4.9. Diagrams showing use of come-along, and cable & turnbuckles to stiffen box.

In structures that already exhibit pronounced racking, the substitution of a different system may be necessary to keep the structure from further deformation. When rafters and joists shear under stress, the ends become disconnected, causing the walls to lean outward as the house pulls apart under the weight of the roof. In the case of the Bodie, it is not necessary to pull the skewed walls back into true alignment because much of the appeal of the abandoned town comes from its deformed and odd-shaped buildings. However, the mechanics utilized in correcting leaning walls and swayback roofs can be utilized as an efficient stabilization method for racked structures. Instead of expecting the fragile buildings to continue to carry their own weight under compression, the substitution of a turnbuckle and cable system can stabilize the structure by transferring the weight to tension cables. The cables should be attached diagonally from the top plate to the opposite bottom plate to resist lateral forces. A turnbuckle can also be left in permanently as a wall tie where collar ties and knee braces are needed.¹¹ The advantage to using a turnbuckle and cable system in the single-wall buildings is that they effectively stabilize the structures against racking and sagging roofs, but they are also distinct in appearance as not to be confused with original construction [Figure 4.9]. This form of intervention is in keeping with the Secretary of Interior’s Standards for rehabilitation of historic structures.

Use of a Come-along to pull the structure together.

Cable & turnbuckles
left in permanently to
stiffen box. Resists
vertical and lateral
loads

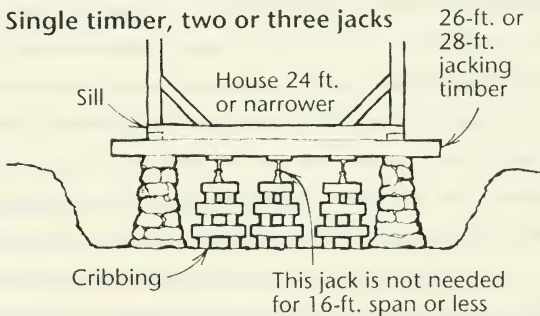
Figure 4.10. Diagram showing method for jacking up a house if excavation is needed to prevent heaving, replace foundations, etc. Nash, 85.

The second failure that compromises the structural system is differential settlement. The best way to mitigate uneven settlement is to infill dirt and build up the foundation area under the areas that have settled to bring the structure back to plumb. As with other structural deformations, an alternative intervention is to reconstitute the connections. Stiffening the joints with steel plates, sistered rafters, or inserted collar ties will allow less movement of the structural system if a section of the building begins to settle. This intervention would most effectively preclude deformation if used in conjunction with a built-up subsoil to prevent the possibility of uneven settlement. The most comprehensive stabilization measure is to substitute an entirely new foundation under the buildings. To conceal the new foundation system, it would be necessary to excavate beneath the existing floor, supporting the structure with temporary jacks while new piles are placed.¹² The piles could be made out of wood piers or concrete. Any new foundation that was inserted would have to be properly concealed from public view [Figure 4.10].
