Pressing Forward: A Technical Study of the Mancos Times-Tribune Building With Recommendations for Conservation

Samuel Loos
University of Pennsylvania

PRESSING FORWARD: A TECHNICAL STUDY OF THE MANCOS TIMES-
TRIBUNE BUILDING WITH RECOMMENDATIONS FOR CONSERVATION

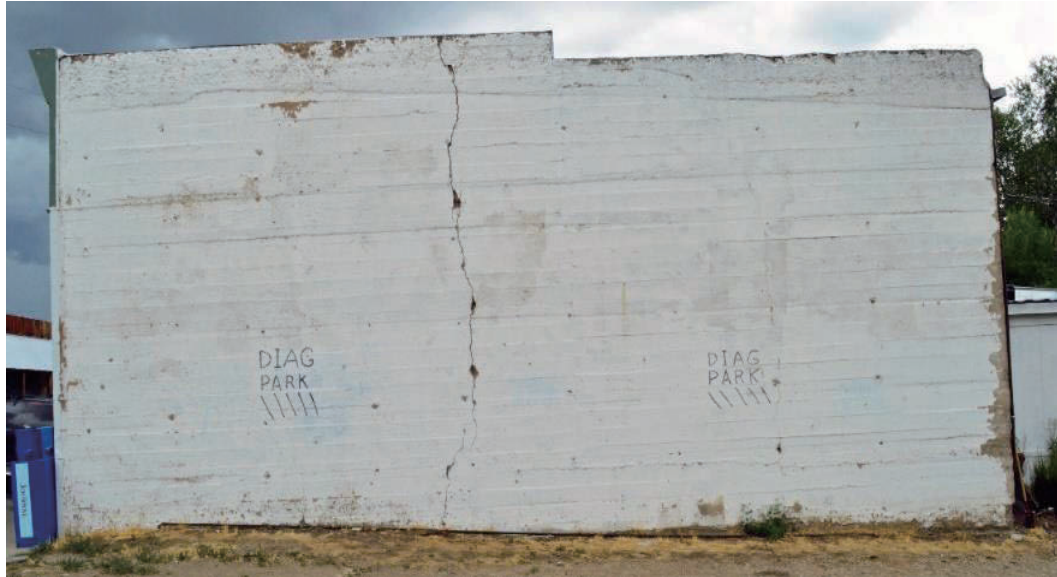
Figure 3.5 Exposed west wall (Author 2014).

The supporting walls are in overall good condition. The concrete itself is of good composition, with minor conditions which are natural to the material. No freeze/thaw damage is present. There has been some weathering along the topmost portion of the parapets and on the very southern edge of the west wall (Figure 3.6), removing mostly cement binder along with some aggregate and the paint finish, creating a rough appearance. The weathering is caused by the abrasion of rainwater and its slightly acidic nature from the presence of carbonic acid. Small holes are present in a regular pattern are present on the west wall, formed from the removal of iron ties after the formwork was removed.

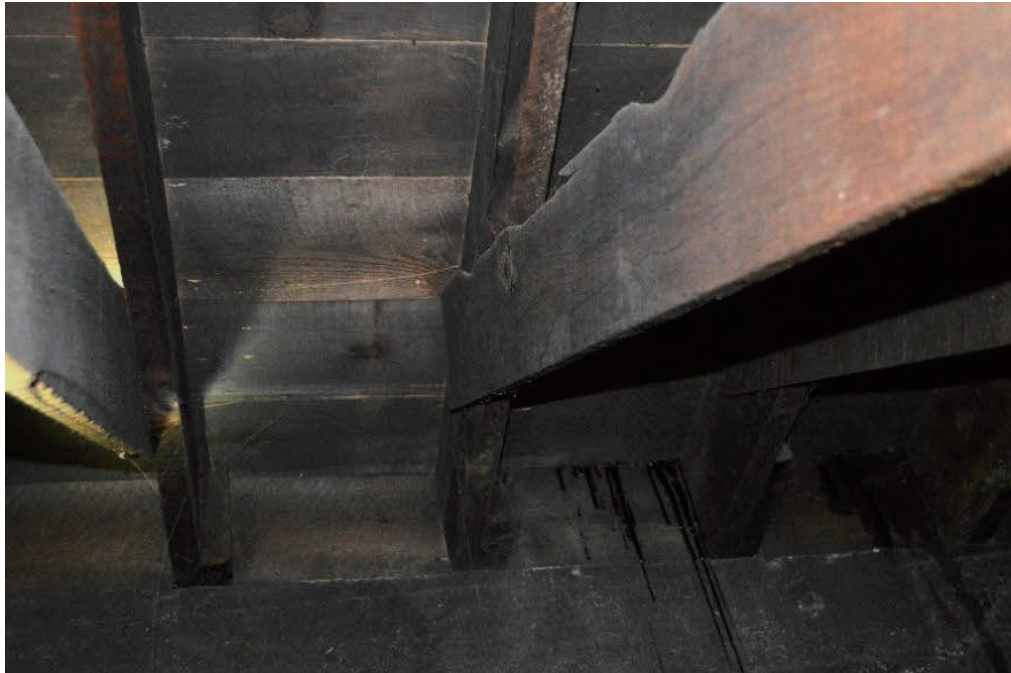
Figure 3.11 View of the roofing system showing rafters and decking boards (Author 2014).⁴

The entire roofing system is overall in very good condition. The roof framing is structurally sound and bears no evidence of rot or active water penetration. Superficial charring, likely from an early stove fire, is evident near the south wall where it was originally placed. The fire did not compromise the load-bearing capacity of the framing. The outer roofing surface is also in very good with no tears, bubbles, or serious defects in the membrane allowing water infiltration. The flashing appears tight.

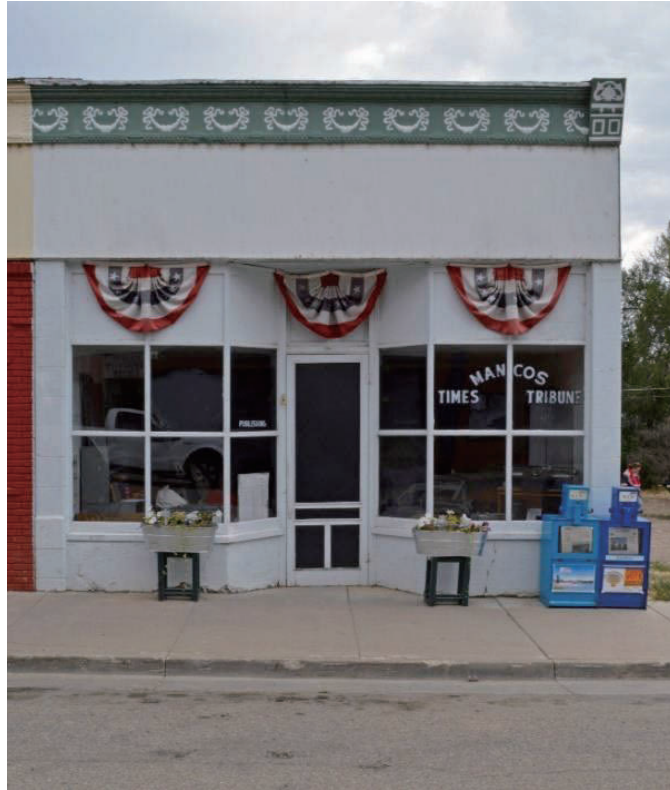
Figure 3.13 Façade of the Mancos Times-Tribune Building (Author 2014).

The façade is in overall excellent condition and has its original elements retained in their entirety. The windows are in very good condition with the only observed damage being two cracked panes in the upper row, but the woodwork is structurally sound with no indications of rot. The bottom part of the concrete base has begun to deteriorate, likely caused by de-icing salts (Figure 3.15). The salts enter into pores of the concrete when dissolved in water and then when they dry, they expand, creating pressure against the pore, causing the concrete to crack and erode.

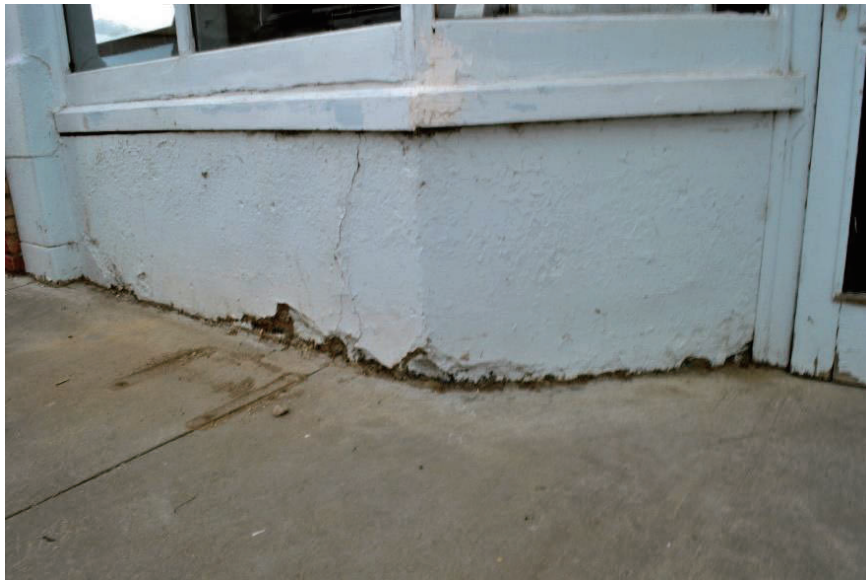
Figure 3.15 Concrete base of display windows (Author 2014).

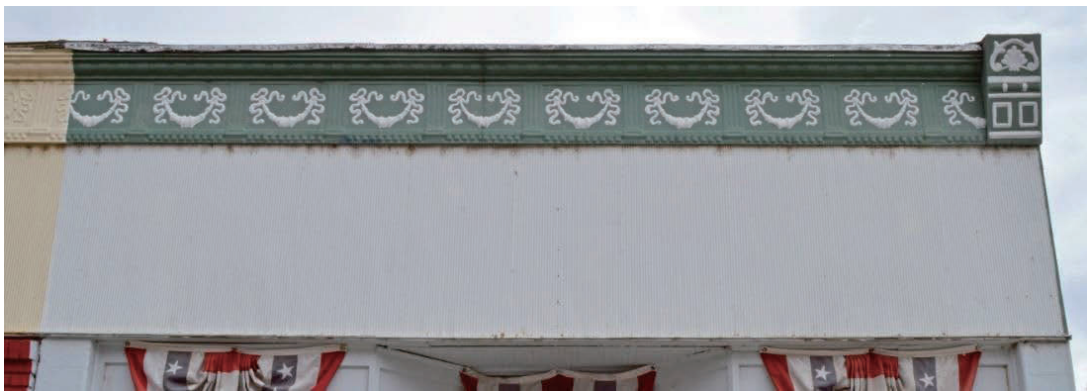
Figure 3.18 Decorative pressed metal cornice and architrave (Author 2014).

The architrave and cornice are also in excellent condition. All joints appear tight and there are no signs of rust.

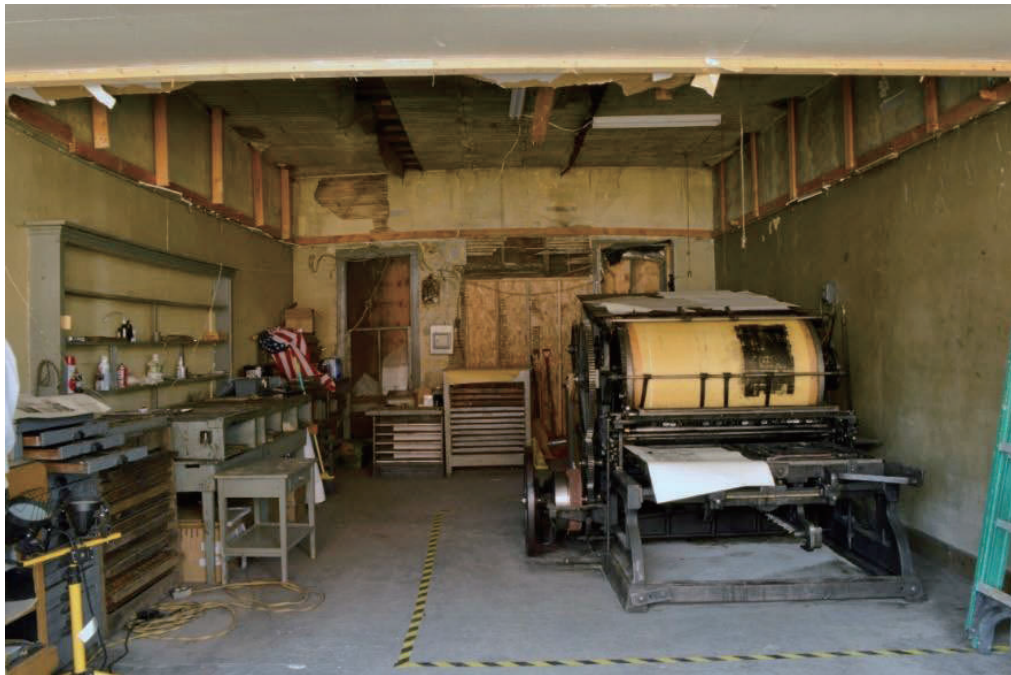
Figure 3.19 Southern view of the building's interior (Author 2014).

The interior is in overall good condition with specific elements in fair to poor condition. The pressed metal ceiling has accumulated a significant layer of dirt on both of its sides and its most recent finish is deteriorating and losing adhesion with the underlying layers. These two conditions are not isolated, but occurring across the entire ceiling. The ceiling has been cut and pulled back in numerous places, as detailed above, but in most instances, the metal is retained and can be repaired. The east and west plaster walls are in very good conditions, with the loss of some finishes being the only visible pathology. The plaster is not cracking, losing adhesion with the concrete substrate or becoming friable. The plaster and finishes on the south wall are in poor condition. The south wall in general has been under heavy distress throughout its recent history which is reflected on the state of the plaster. The rear entryway appears to have only recently been stabilized with wood framers, before which, heavy loads were exerted on the central wall. The sashes also appear to have been damaged for quite some time allowing for water infiltration. The plywood board were only added within the last two years to help weatherize the wall. There is a section of lost plaster above the eastern window (Figure 3.28) and expanded entryway (Figure 3.29). A number of cracks have formed on the central portion and the most recent finish is losing adhesion with its underlying layer. Much of the plaster on the south wall is loose and easily removable. The concrete floor has formed a few large cracks and a network of smaller ones across the majority of its surface, typically associated with alkali-aggregate reactivity and shrinkage from hydration. The cracks are an aesthetical issue only.⁶ Tree root activity has caused cracking and displacement in an area of the interior from the southwest corner to the front of the original back door.

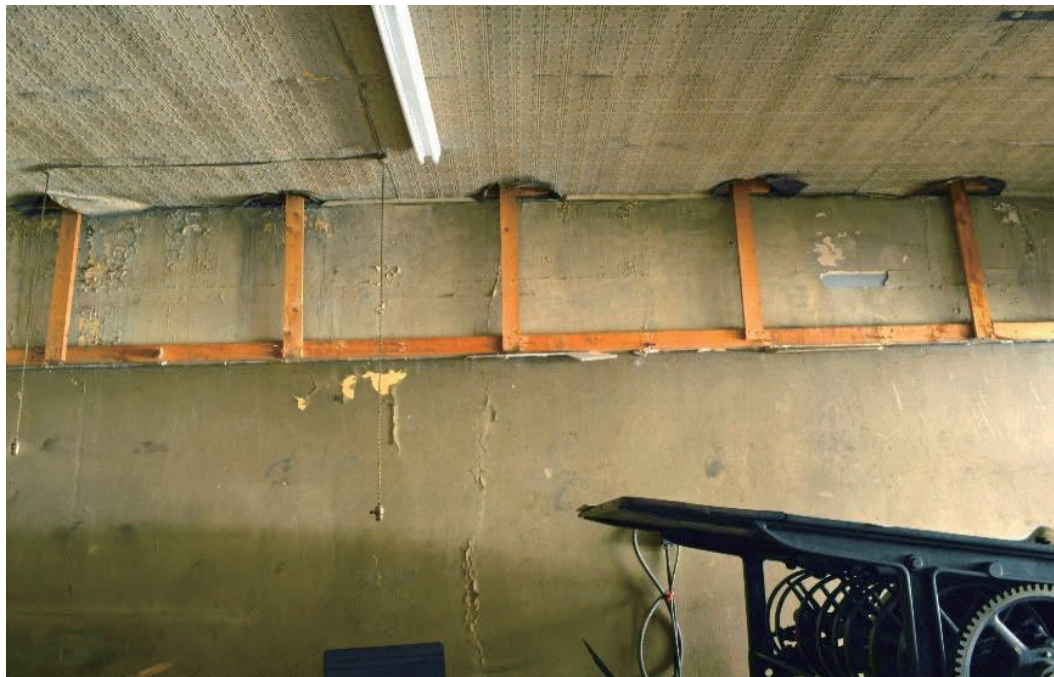
Figure 3.24 Remaining drop ceiling framing showing the cut pressed metal ceiling (Author 2014).

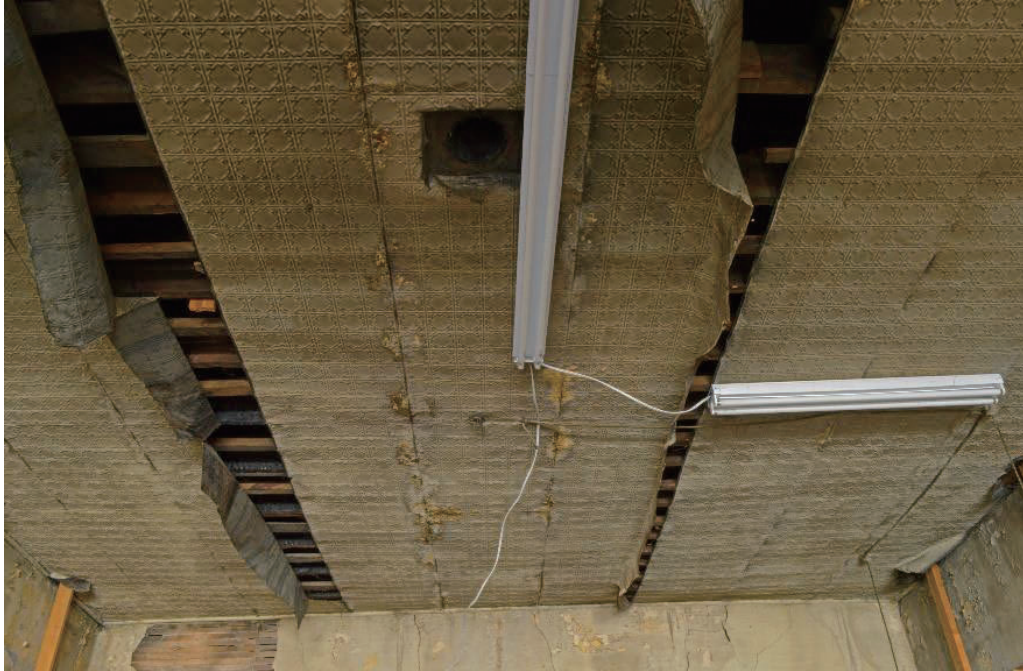
Figure 3.25 Peeled back pressed metal ceiling for removed drop ceiling supports and cut rectangle for removed stove (Author 2014).

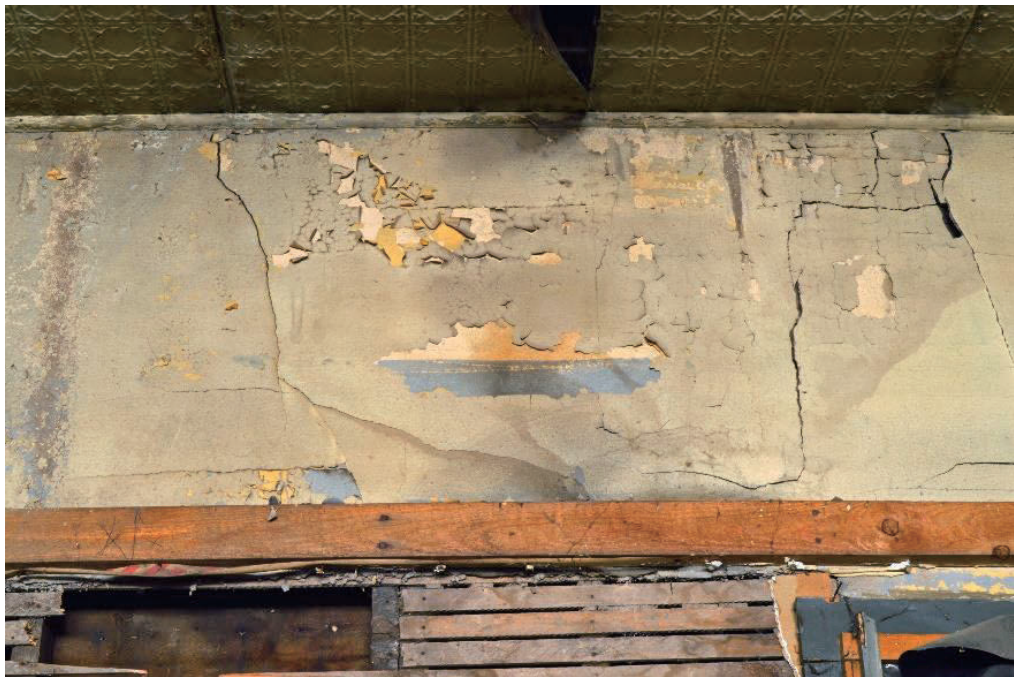
Figure 3.29 Loss of plaster and most recent finish on middle section of south wall (Author 2014).

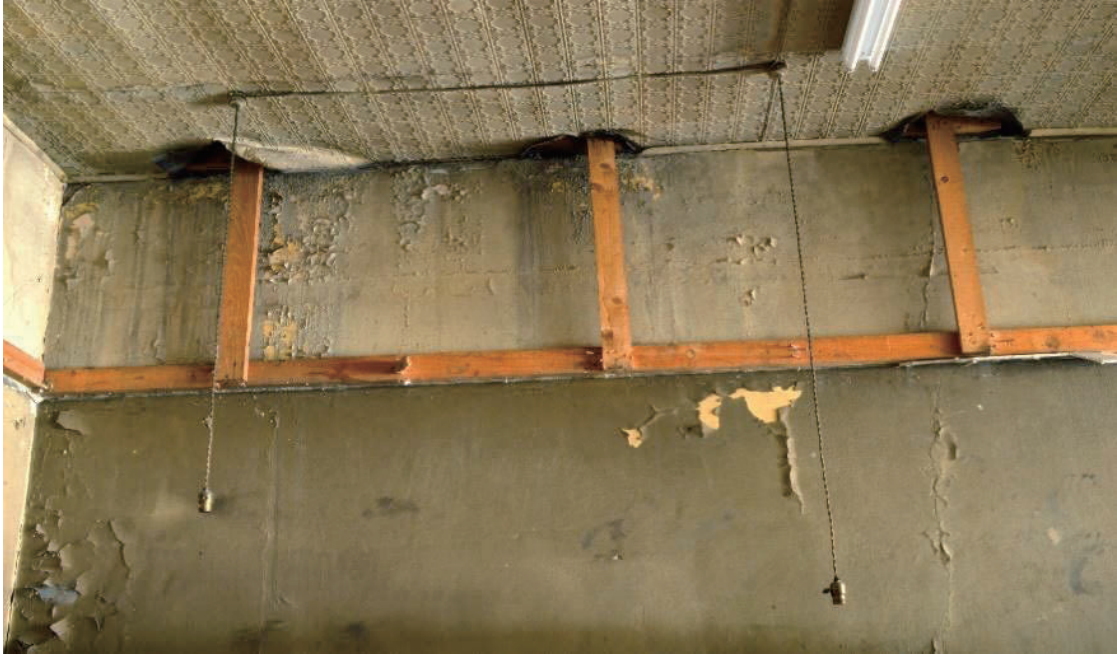
The mechanical systems in the building are in rather poor condition. As mentioned above, the building currently lacks any kind of climate control systems, either air conditioning or heating. It also lacks plumbing or any kind of water systems. The building does contain an electrical system, one being a modern addition, but the other is quite outdated.

Figure 3.30 Historic wiring for single suspended bulbs (Author 2014).

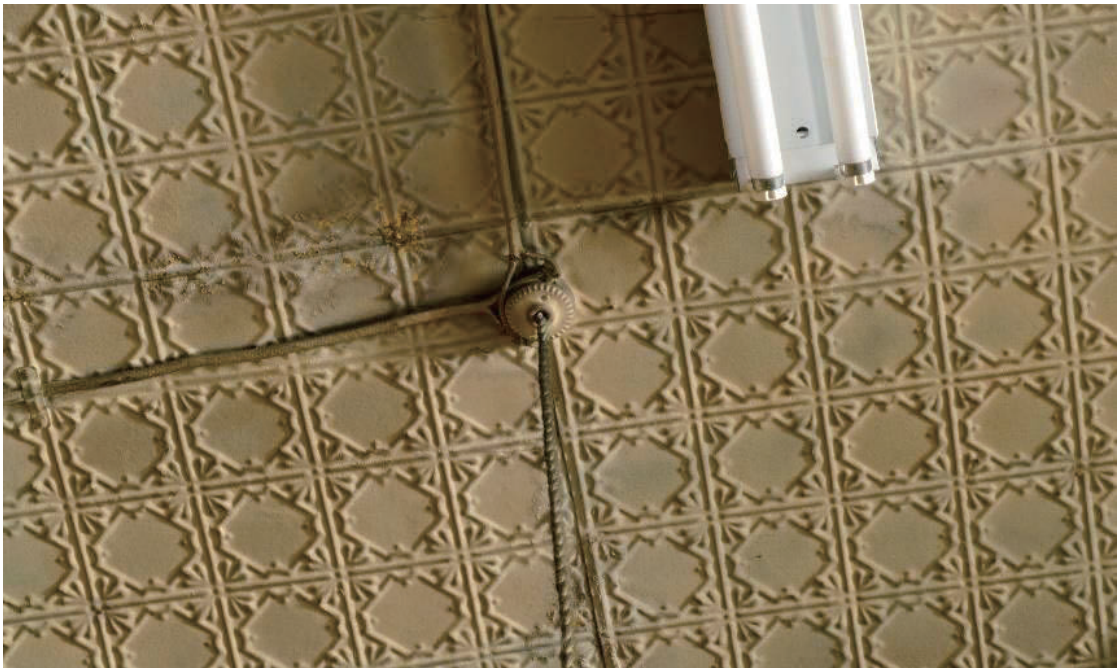
Figure 3.31 Detail of historic wiring (Author 2014).

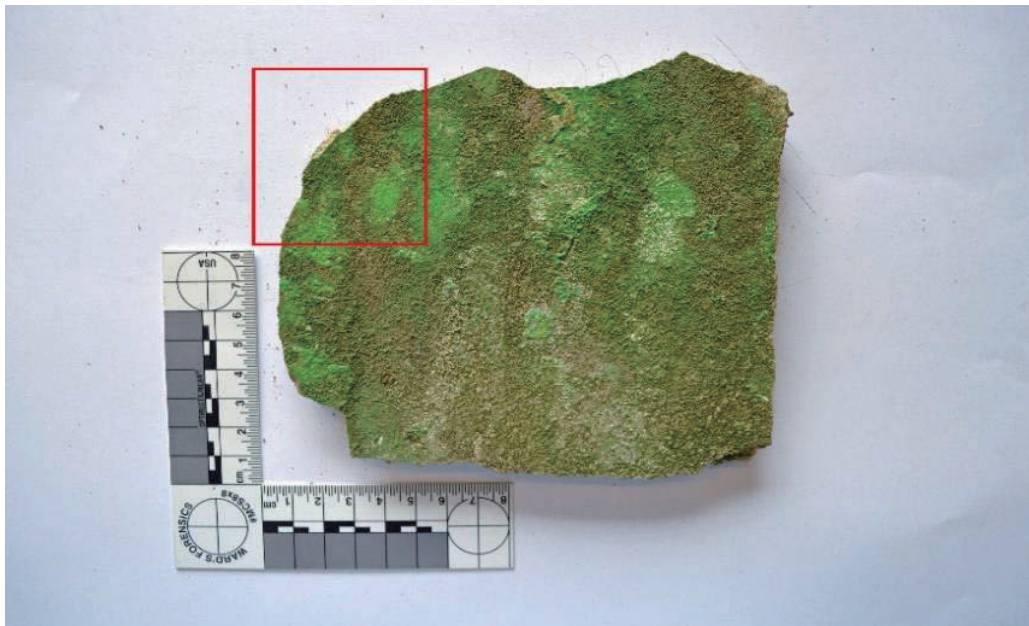
A sample for analysis was removed from the bulk sample with a chisel and hammer, with the post-extraction location noted in Figure 6.4. Two pieces were removed to have a combined sample of at least thirty grams for the chemical digestion. An additional sample was taken for observation under a Leica MZ16 stereoscope with illumination by a Leica KL 2500 LCD source at 3050K.

Figure 5.4 Location of removed plaster sample used for analysis (Author 2015).

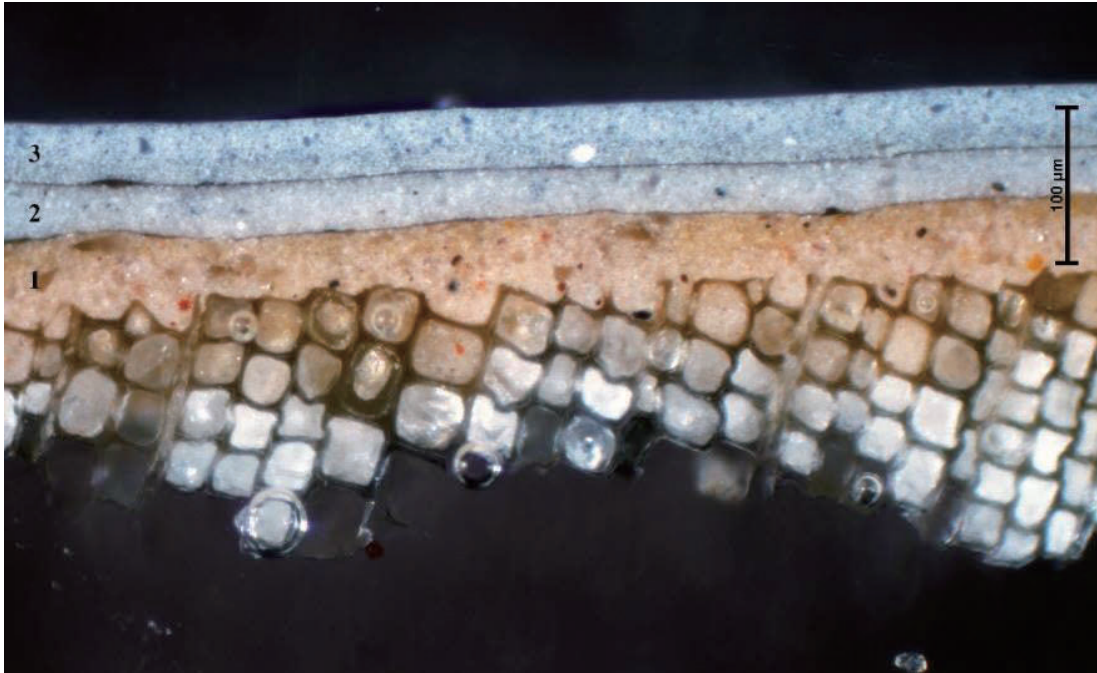
The door has had a uniform color scheme throughout most of its life. The panel molding is an outlier and does not display the stratigraphies of any other component. Because of its cream color, the first layer could easily be characterized as a prime coat, but given its large width and overlying dirt layer indicative of long exposure, it was determined to be a finish layer instead (Figure 6.1). Some layers of the bead board were lost between extraction and embedding, as the component's current green finish is not present. The more modern layers must have had very low adhesion, as there are no remnants of any layers above the third. The three layers that are present still reveal its stratigraphy to be different than that of the other components. It also has more distinct dirt layers than other components, indicating that it was exposed longer and painted less frequently than other areas.

Figure 6.1 Sample MTT 04 showing its original cream orange finish (Author 2015).

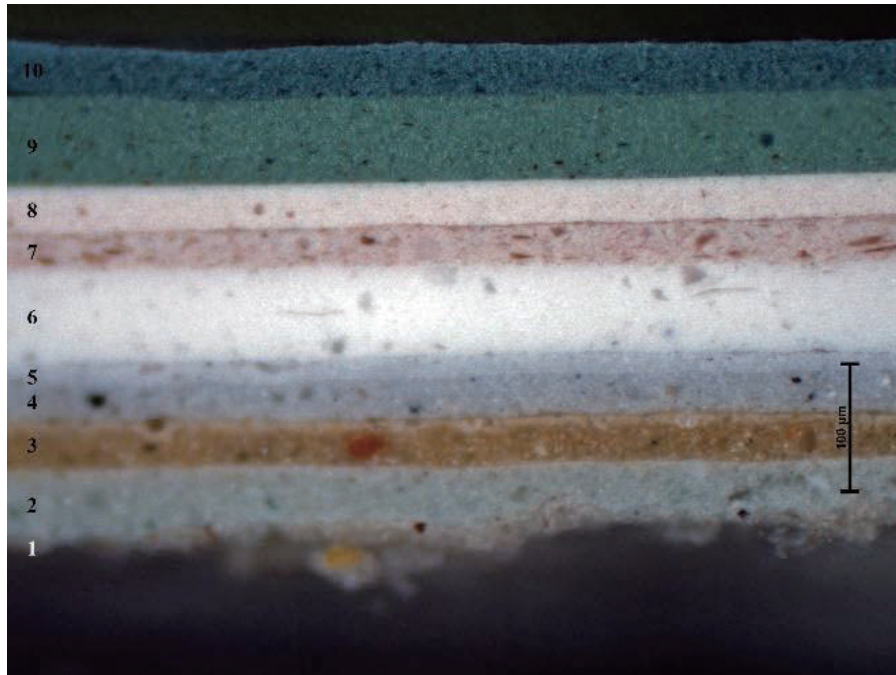
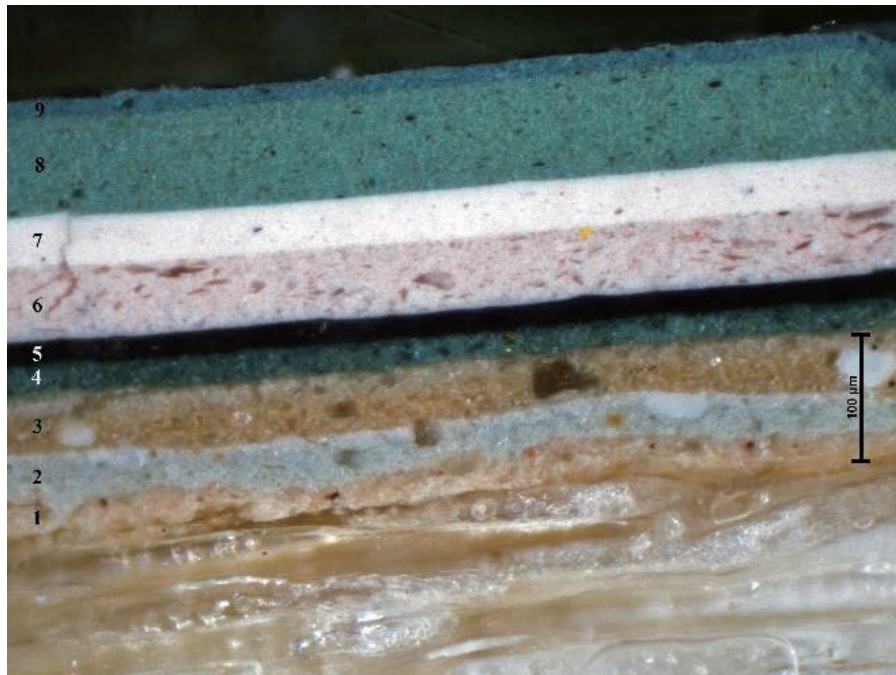
The stile and rail components of the door have followed identical paint schemes throughout the life of the building, but the panel and its bead board schemes are divergent; the bead board from the beginning and the panel beginning with its third finish (Figures 6.1 and 6.2). The stiles, rails and panel share identical grey and brown first and second layers, but with the third repainting, the stiles and rails are painted a dark green while the panel is painted a grey very similar to the original finish. There is a period of bichromy on the door before the schemes of the three components follow the same sequence after the application of a light pink layer. Currently, all components of the door are finished with a dark green paint.

Figure 6.2 Comparison between the finish stratigraphies of the panel (MTT 03, top) middle rail (MTT 02, bottom) and of the front door (Author 2015).

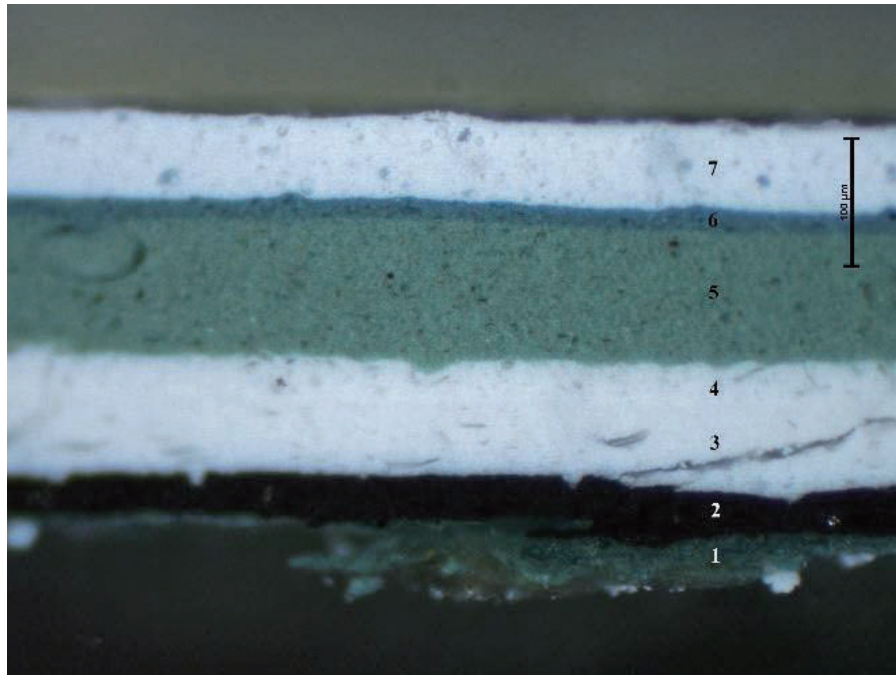
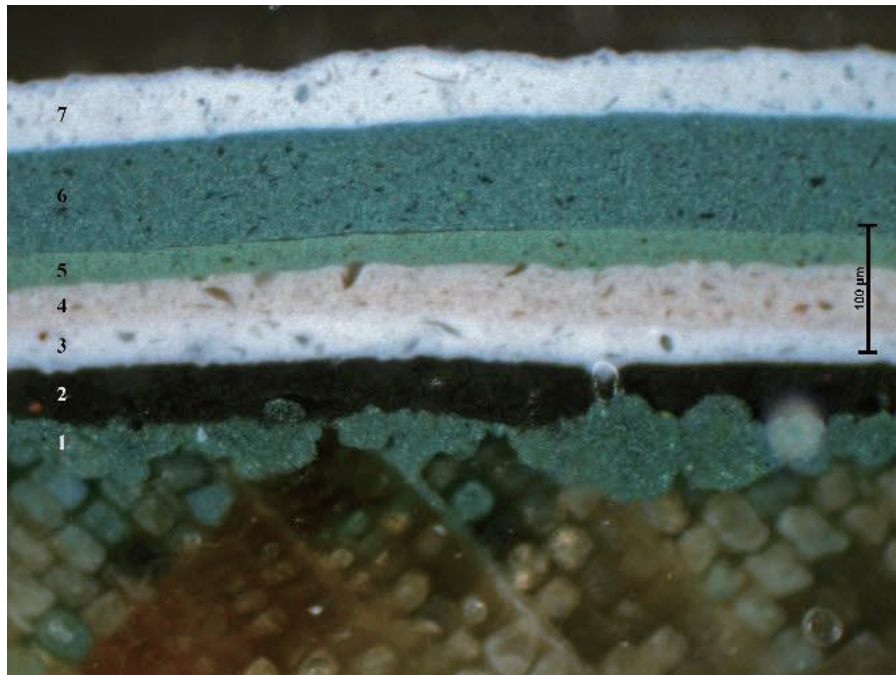
Both the mullions and muntins which make up the windows have very similar stratigraphies and follow a similar sequence as that found on the door (Figures 6.2 and 6.3). The vertical and horizontal elements follow somewhat different stratigraphies, with the observed layers on the mullion being identical to those on the stiles and rails of the door, with the current finish being the only difference (Figures 6.2 and 6.3). Older layers on the mullion sample (MTT 16) were removed before the application of its first layer, as there is no prime coat present and the layer is a dark green finish identical to that seen on the door samples (MTT 01 and 02). Since the observed layers on this sample correspond so well to those seen on the door, it can be assumed that its first three layers, now removed, matched those seen on the door samples (MTT 01 and 02). Its original finish then was a grey paint above a tan cream prime coat. The two vertical samples have identical stratigraphies, but similar to what happened with the horizontal sample, sample MTT 14 had its original layers removed before the application of its first layer, a dark green paint. The same assumptions made about MTT 16 can be applied here. The other vertical element sample (MTT 17) has retained a complete stratigraphy and has a tan cream prime and grey paint as its original finish. Currently, all components of the windows are finished with a white paint.

Figure 6.3 Comparison between the finish stratigraphies of a horizontal element (MTT 14, top) with a vertical element (MTT 16, bottom) on the façade windows (Author 2015).

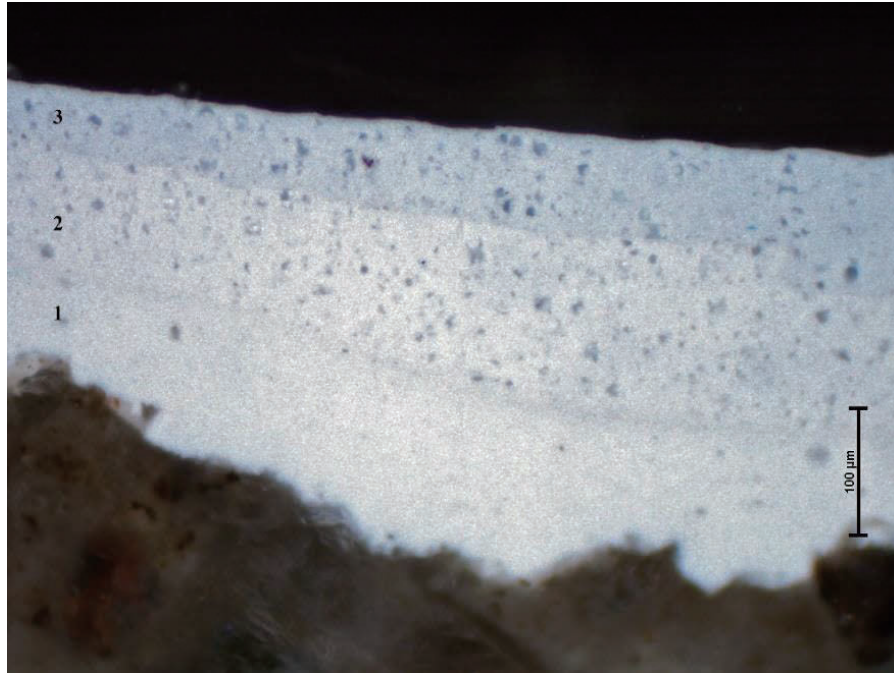
The concrete base below the windows has three layers of white paint on it, but they all appear to be of a more recent application because of their wide widths (Figure 6.4). Therefore, it is concluded that the concrete base was originally unfinished.

Figure 6.4 Cross section of concrete base finishes (MTT 18) showing modern paints (Author 2015).

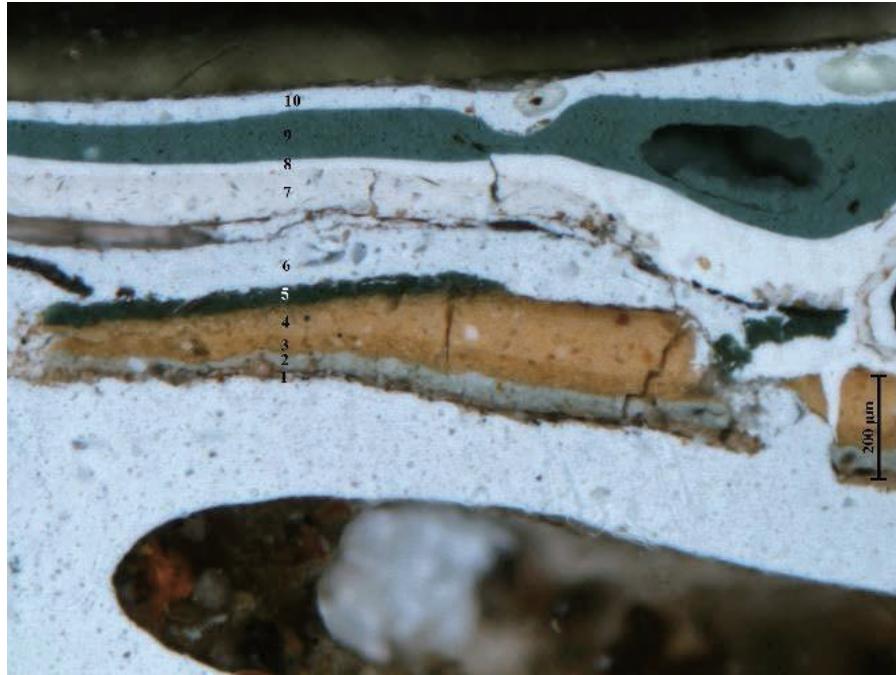
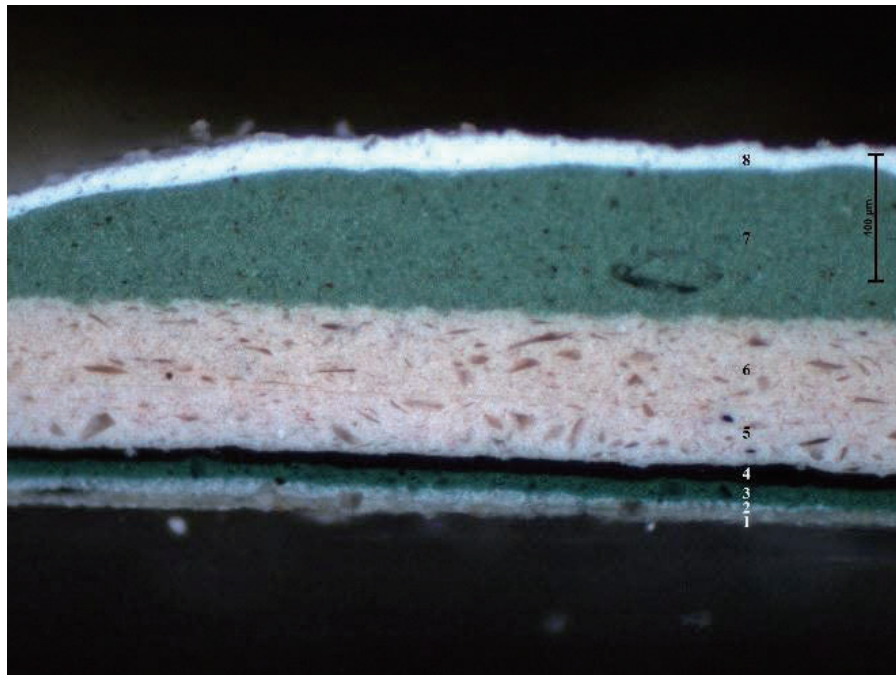
The chronology of the architrave sample stratigraphy is completely illegible and didn't retain a substrate. Only white paints were observed, but is in no discernable order, along with an unknown gritty substance, possibly bronzing powder. In samples taken of the frieze (MTT 13) and the ornamental relief (MTT 15), the metal substrate was not retained, but their stratigraphies are legible and in a chronological order. In both samples, it appears that the original finish was a grey prime coat, applied by the

manufacturer, finished with a grey paint applied later (Figure 6.5). After this similar first layer, their stratigraphies diverge, with the frieze following a similar paint scheme to that found on the stiles and rails of the front door and the relief following a completely different scheme. Therefore, it was very likely that the cornice was polychromed with the ornaments in relief painted a different color than the rest of the piece.

Figures 6.5 Comparison between the finish stratigraphies of the relief ornamentation (MTT 15, top) and the cornice frieze (MTT 13, bottom) (Author 2015).

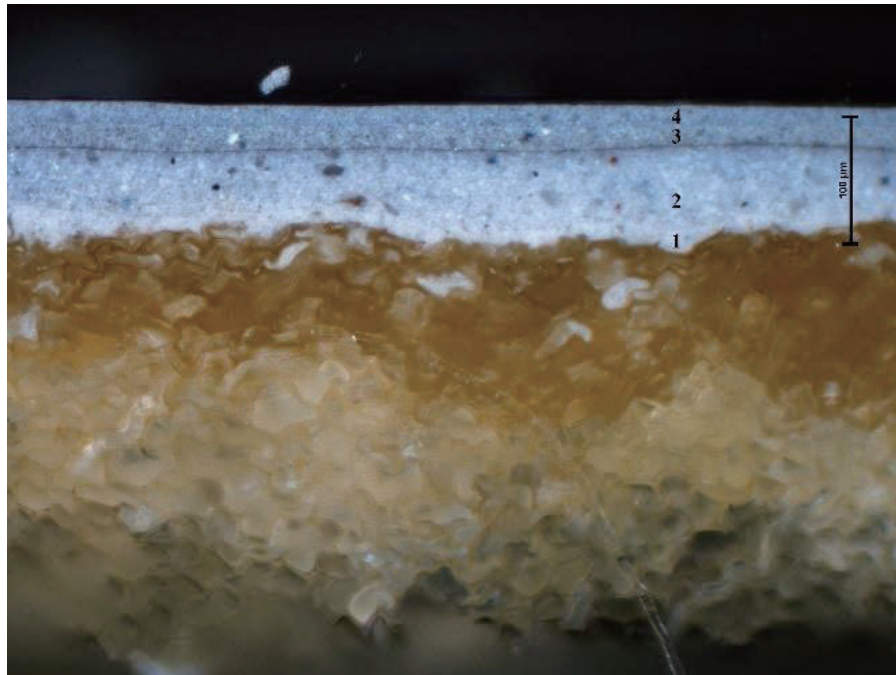
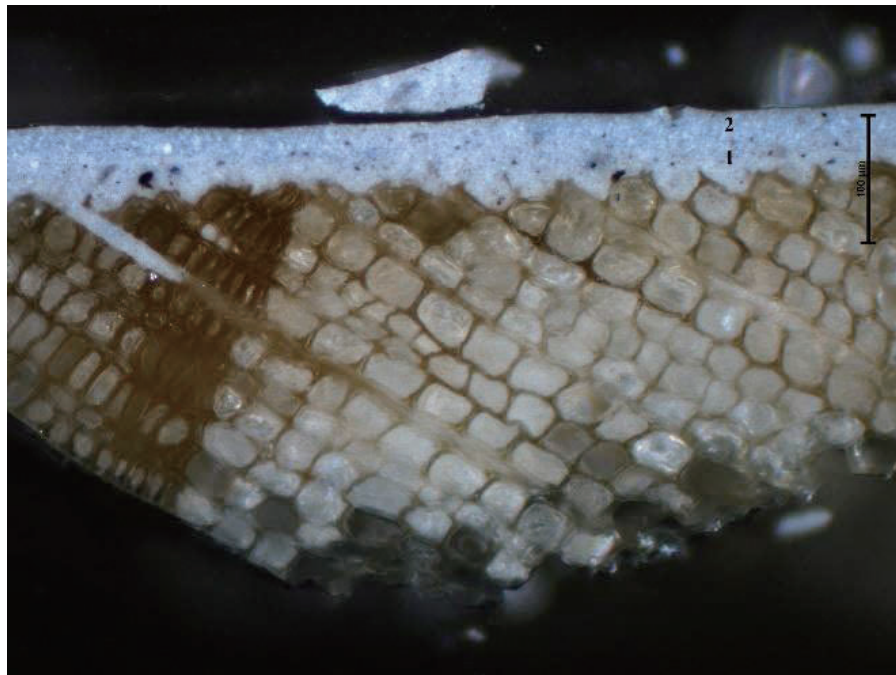
The original finishes on the interior of the shop front windows and rear sash windows were likely a grey paint similar to that used on the façade features, but cannot be unequivocally concluded though, as their low number of layers is suspect (Figure 6.6). Both samples have very similar stratigraphies of a prime coat and grey paint finishes. The prime coats are not the same tan cream as that seen on the front door and windows. The two oldest layers of each appear identical, with two additional layers on the shop front window.

Figures 6.6 Comparison between the finish stratigraphies of the interior east shop front window (MTT 05, top) and the interior sash of the rear east window (MTT 07, bottom) (Author 2015).

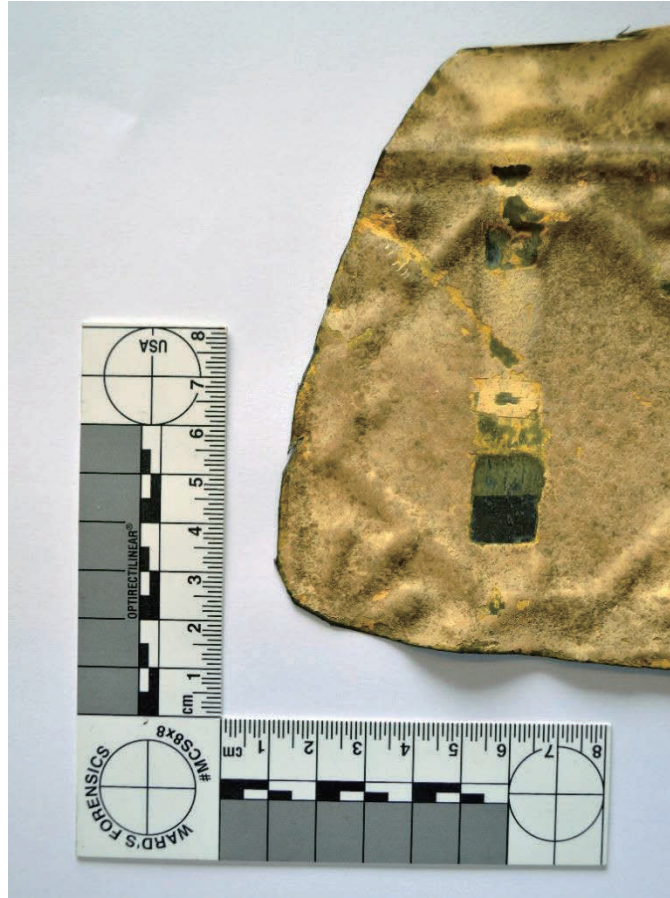
An exposure of the finishes layers on the presses metal ceiling was conducted and each layer color matched using the Munsell system (Figure 6.8). The top of the original finish was colored by the following finish, so it was slightly scraped to reveal its true color. It was matched as 10GY 5/1. The second finish was matched as 2.5Y 8.5/6. The third, most recent finish, was matched as 2.5Y 8.5/4.

Figure 6.8 Exposure of pressed metal ceiling finishes stratigraphy (Author 2015).

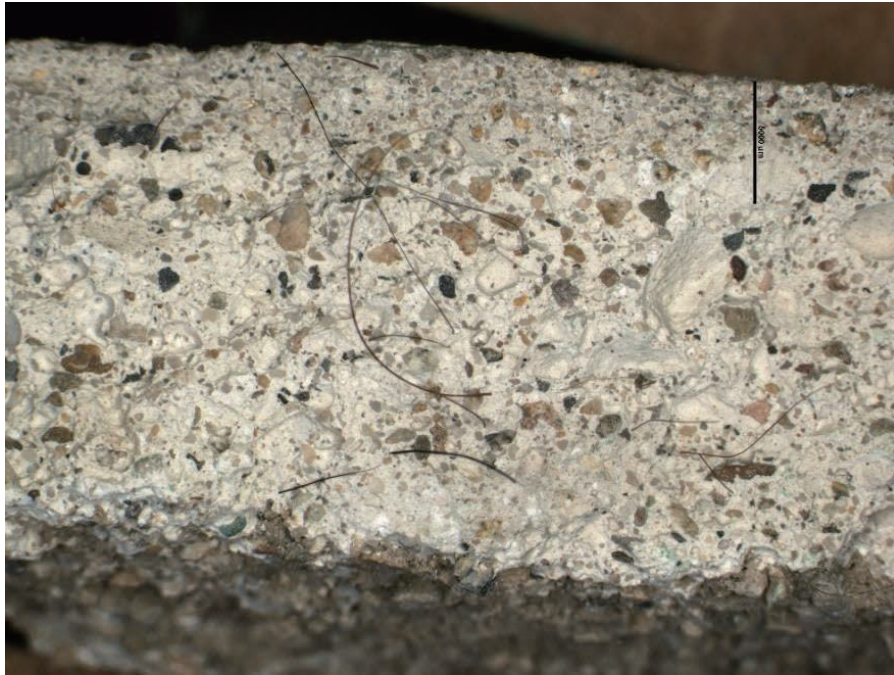
The plaster used in the interior was determined to have a natural hydraulic lime binder and a very high amount of aggregate (Figure 6.9). Black hair, likely horse hair was also abundant and used to increase the strength of the plaster. Visual examination indicated that the plaster was installed using the traditional three coat process of a scratch coat, brown coat and finish coat. Aggregate at the top of the sample is a smaller and better sorted than that of the main body and the lower portion has a rough texture of exposed aggregate.

Figure 6.9 Photograph of bulk sample at 12.5x zoom showing multiple layers, colored aggregate and black hair (Author 2015).

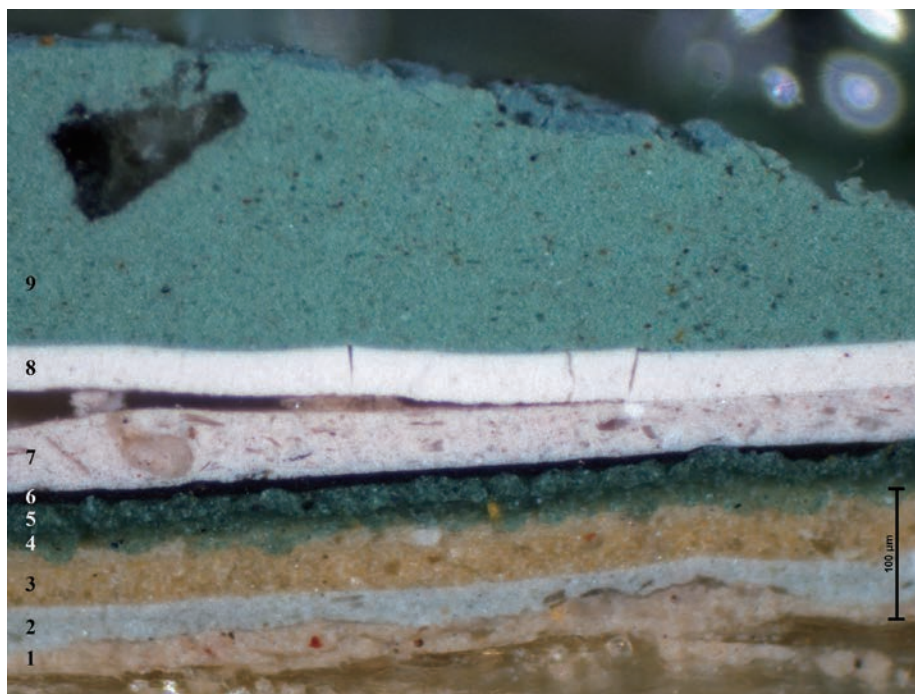
Notes: Layer 1 is likely a prime coat for layer 2. At the sample's right edge, layer 1 is distressed, splitting in two and layer 8 is detaching from layer 7. The lighter tops of layer 2 and layer 3 indicate surface deterioration, possibly from UV radiation. Similarly observed in MTT 02, 03 and 17. Layers 3 and 4 appear to be two applications of the same finish. No additional layers were revealed or known layers made more distinct under UV.

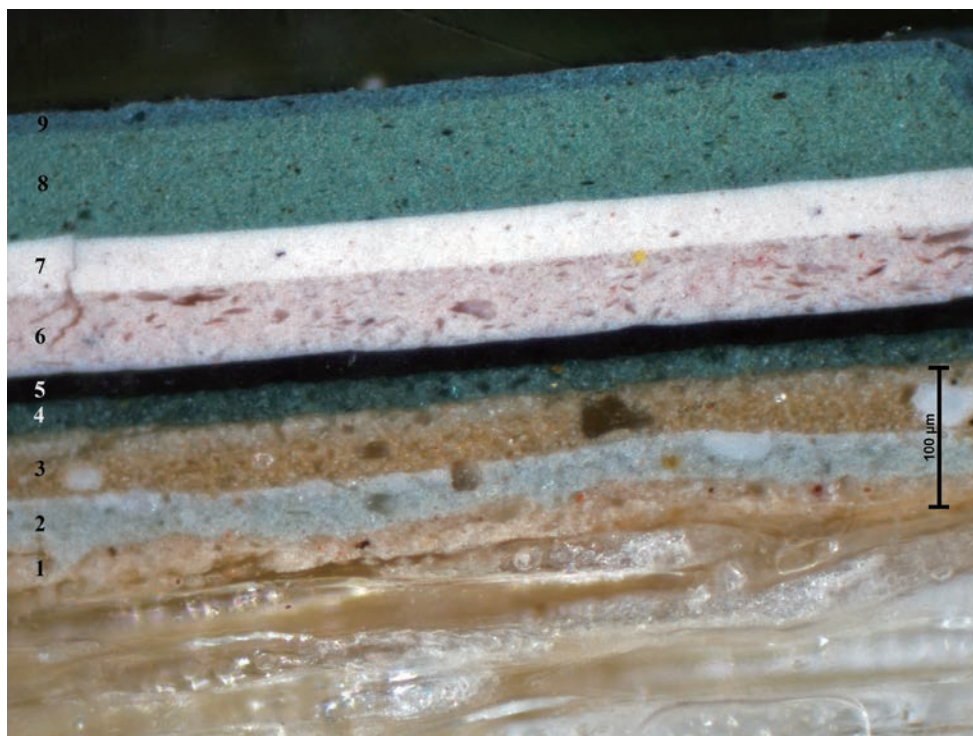
Notes: Layer 1 is likely a prime coat for layer 2. The lighter tops of layers 3 and 4 indicate surface deterioration, possibly from UV radiation. Similarly observed in MTT 01, 03 and 17. No additional layers were revealed or known layers made more distinct under UV.

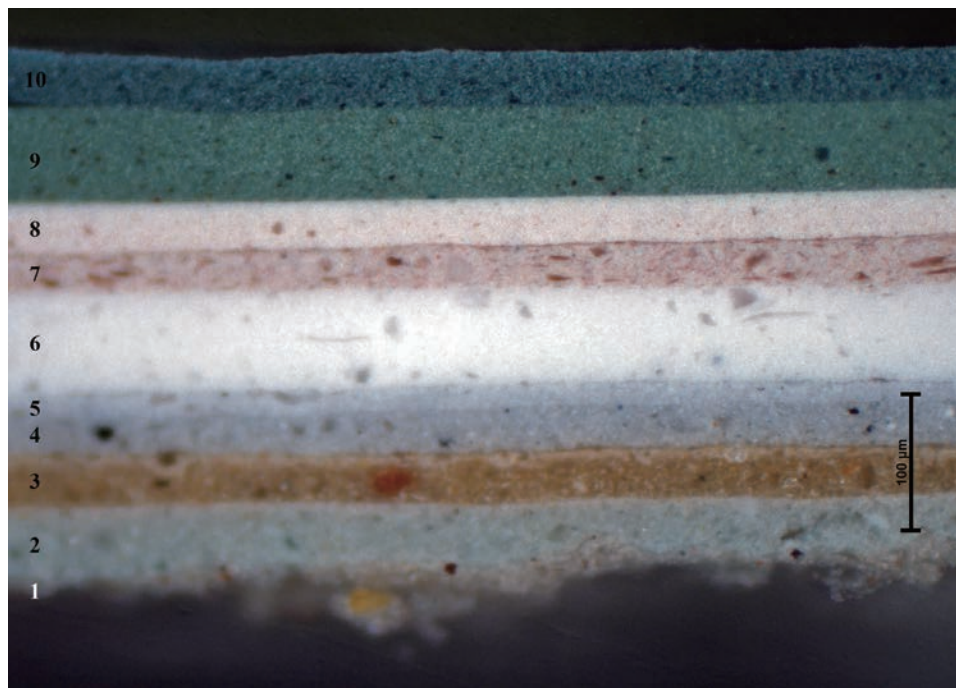
Sample No.: MTT 03		Substrate: Absent	
Location: Exterior. Front door, center of panel.			
Camera: Nikon DS-Fi1		Illumination: Intralux 5000-1 Reflected Quartz Halogen	
Microscope: Nikon ALPHASHOT-2 YS2			Magnification: 100x
Date analyzed: 4 April 2015		Analyzed by: Samuel Loos

Notes: Layer 1 is likely a prime coat for layer 2. Layer 1 is only a fragment, therefore measurements were not taken. The lighter tops of Layers 2 and 3 indicate surface deterioration, possibly from UV radiation. Similarly observed in MTT 01, 02 and 17. No additional layers were revealed or known layers made more distinct under UV.

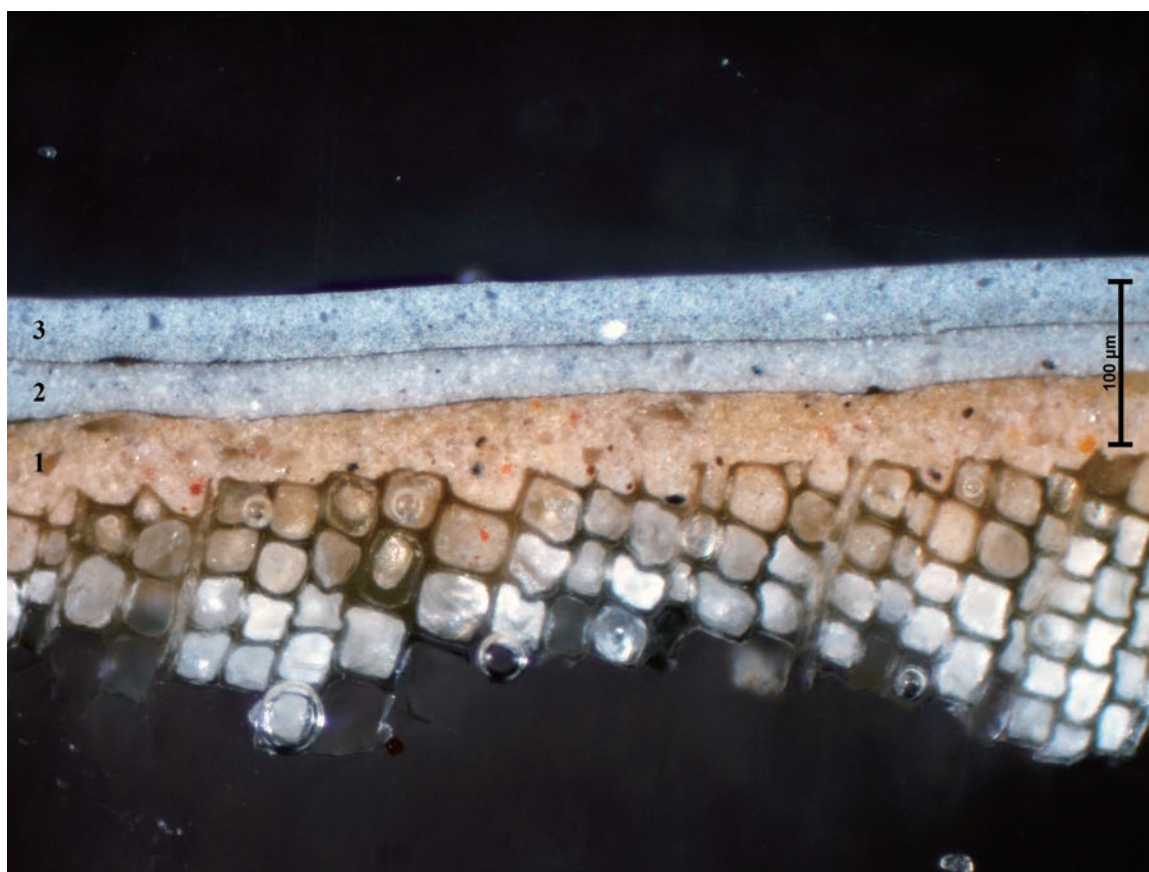
Sample No.: MTT 04	Substrate: Wood
Location: Exterior. Front door, molding of panel.	
Camera: Nikon DS-Fi1	Illumination: Intralux 5000-1 Reflected Quartz Haloge
Microscope: Nikon ALPHASHOT-2 YS2	Magnification: 100x
Date analyzed: 4 April 2015	Analyzed by: Samuel Loos

Notes: Layer 1 is likely a prime coat for layer 2. Layer 1 darkens along its interface with layer 2. The three layers are not strongly adhered to each other. There are dirt layers atop layers 1 and 2. No additional layers were revealed or known layers made more distinct under UV.
