Pressing Forward: A Technical Study of the Mancos Times-Tribune Building With Recommendations for Conservation

Samuel Loos
University of Pennsylvania

PRESSING FORWARD: A TECHNICAL STUDY OF THE MANCOS TIMES-
TRIBUNE BUILDING WITH RECOMMENDATIONS FOR CONSERVATION

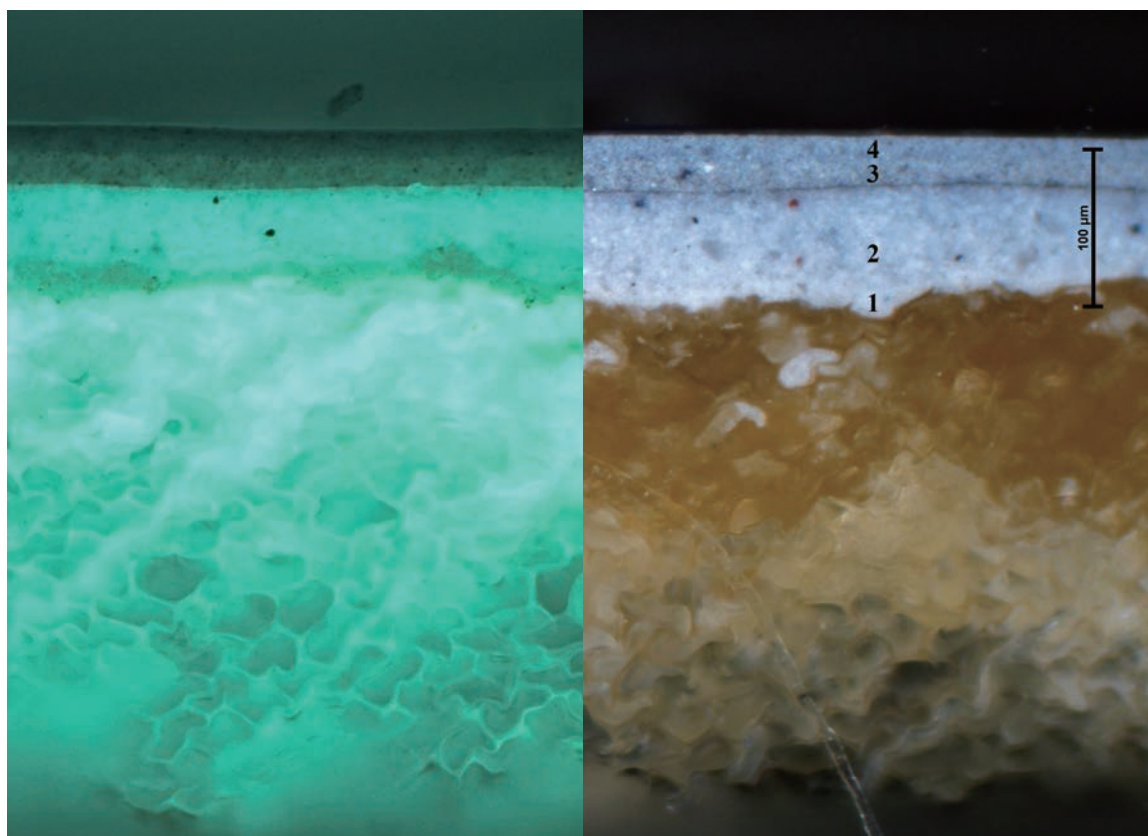
Sample No.: MTT 05		Substrate: Wood	
Location: Interior. Stile of east shop front window.			
Camera: Nikon DS-Fi1		Illumination: Reflected Quartz Halogen, Ultraviolet B 1A	
Microscope: Nikon ALPHASHOT-2 YS2			Magnification: 100x
Date analyzed: 4 April 2015		Analyzed by: Samuel Loos

Notes: Layer 1 is likely a prime coat for layer 2. All three finishes are very similar in hue, but get progressively darker. The apparent prime is also very similar in hue. Layer 1 is a lighter hue and has larger pigment inclusions than layers 2 or 3. All layers were made more distinct under UV.

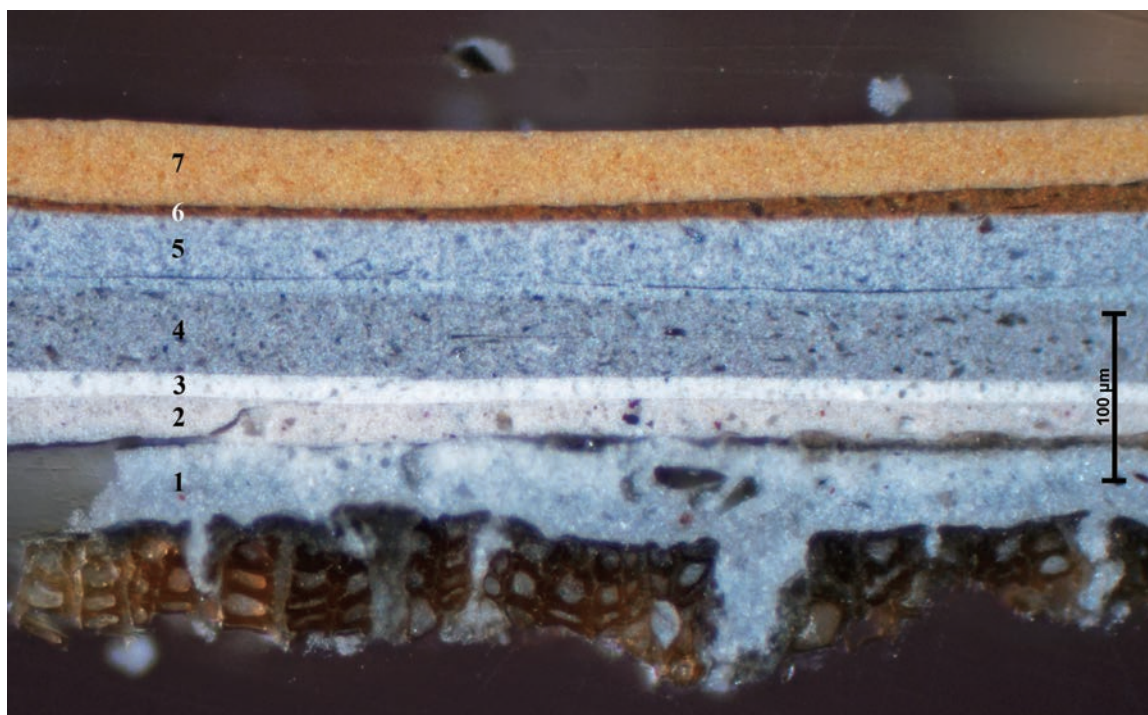
Sample No.: MTT 09	Substrate: Wood
Location: Interior. Typesetting bench, east side.	
Camera: Nikon DS-Fi1	Illumination: Intralux 5000-1 Reflected Quartz Haloge
Microscope: Nikon ALPHASHOT-2 YS2	Magnification: 100x
Date analyzed: 4 April 2015	Analyzed by: Samuel Loos

Notes: F1 appears to either be two coats of the same paint or its outer surface has been greatly discolored. The pigment in the lower section makes it unlikely that its a prime coat. Also, the pigment inclusions of the two sections overlap and mesh. Large dirt layer between F1 and F2. No additional layers were revealed or known layers made more distinct under UV.

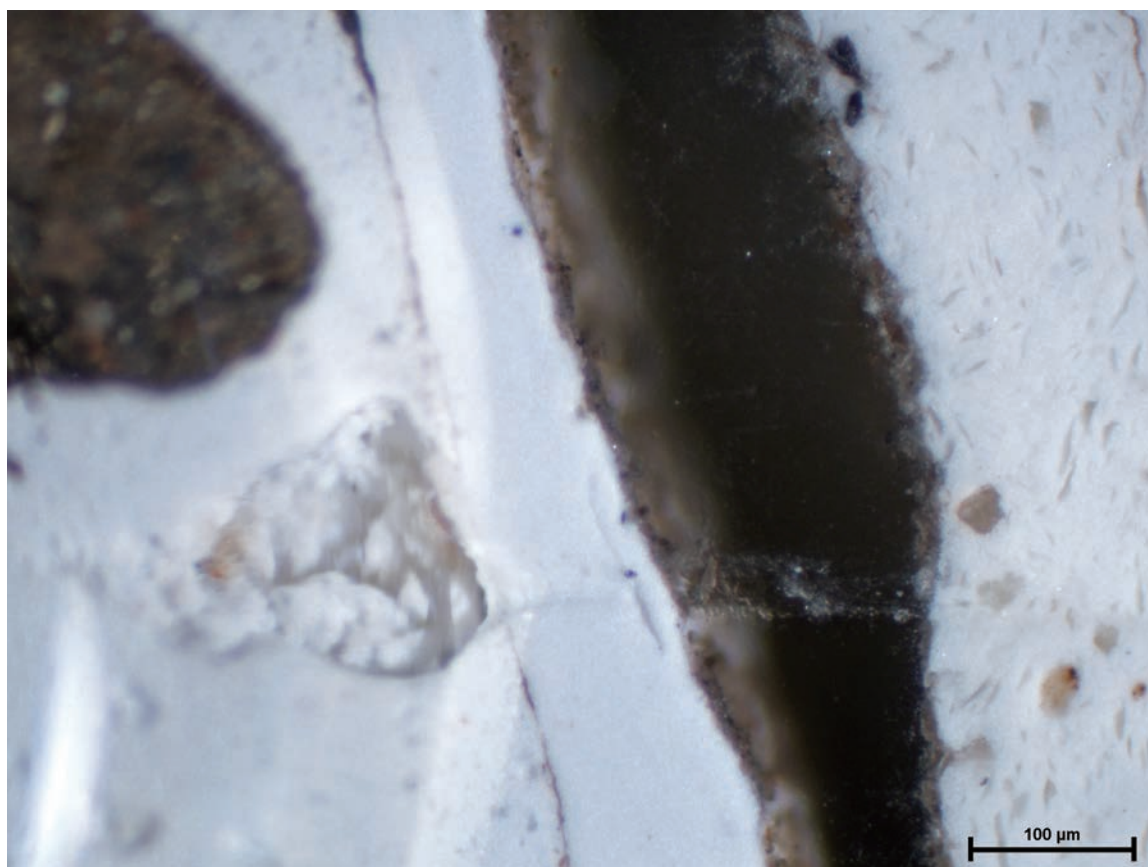
Sample No.: MTT 11		Substrate: Absent	
Location: Exterior. Architrave, west side.			
Camera: Nikon DS-Fi1		Illumination: Intralux 5000-1 Reflected Quartz Haloge	
Microscope: Nikon ALPHASHOT-2 YS2		Magnification: 100x	
Date analyzed: 4 April 2015		Analyzed by: Samuel Loos

Notes: There appear to be at least two, if not three white finishes, along with a grey-blue and light brown finish. Due to the extraction method used of scraping from a metal substrate, the sample is difficult to interpret as the stratigraphy has been disrupted. Because of this, the stratigraphy was not annotated. No additional layers were revealed or known layers made more distinct under UV.

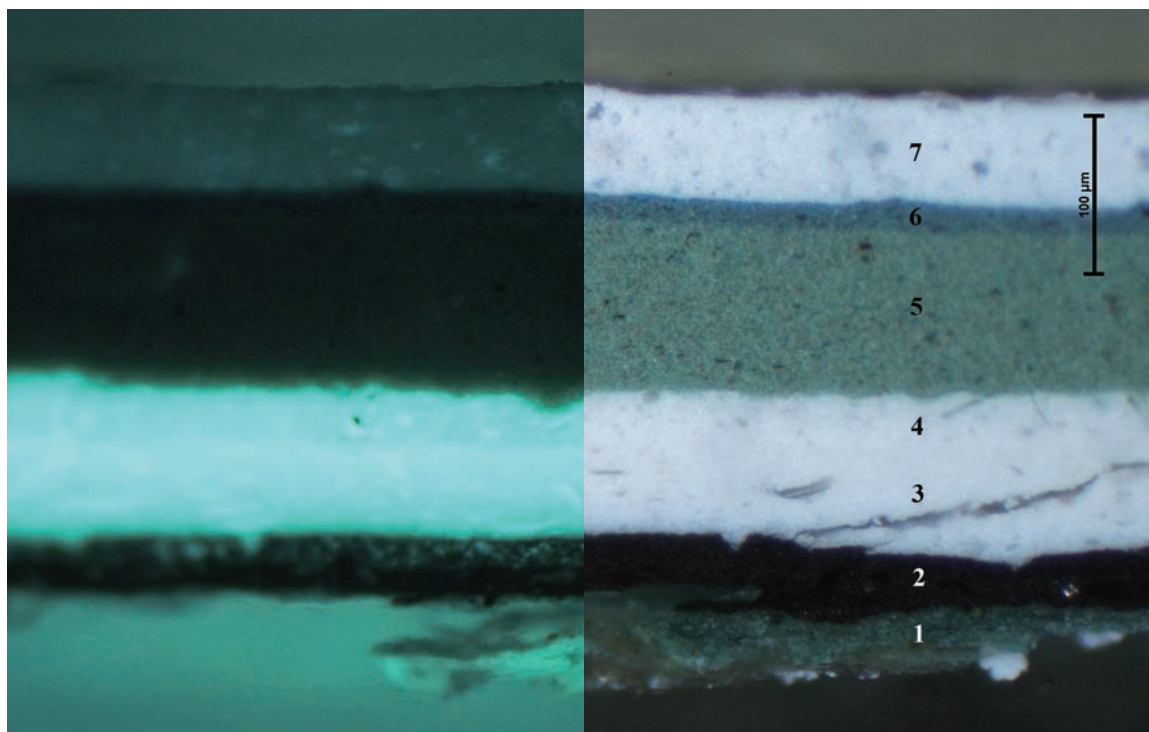
Sample No.: MTT 14	Substrate: Wood fragment
Location: Exterior. Bay window rail.	
Camera: Nikon DS-Fi1	Illumination: Reflected Quartz Halogen, Ultraviolet B 1A
Microscope: Nikon ALPHASHOT-2 YS2	Magnification: 100x
Date analyzed: 4 April 2015	Analyzed by: Samuel Loos

Notes: Very small fragment of wood substrate retained in middle of sample. Much of the original finish was lost, so an accurate measurement could not be taken. Layers 3 and 4 are almost identical, appearing to be two coats of the same paint, or the same paint applied at different times. Both are made more distinct under UV.

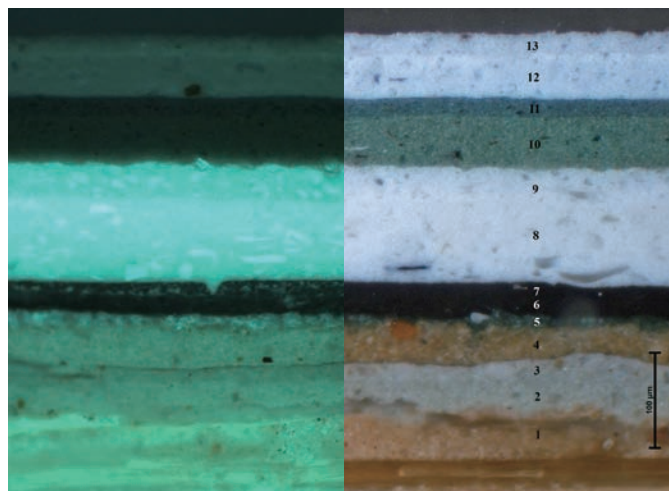
Sample No.: MTT 17		Substrate: Wood	
Location: Exterior. Bay window muntin.			
Camera: Nikon DS-Fi1		Illumination: Reflected Quartz Halogen, Ultraviolet B 1A	
Microscope: Nikon ALPHASHOT-2 YS2		Magnification: 100x	
Date analyzed: 5 April 2015		Analyzed by: Samuel Loos

Notes: Layer 1 is deteriorating, losing its adhesion with layer 2. The lighter topsof layer 4 indicates surface deterioration, possibly from UV radiation. Similarly observed in MTT 01, 02 and 03. Layers 6 and 7 are indistinguishable under visible light. Layers 2, 3, 8 and 9 are made more distinct and layer 7 was revealed under UV.

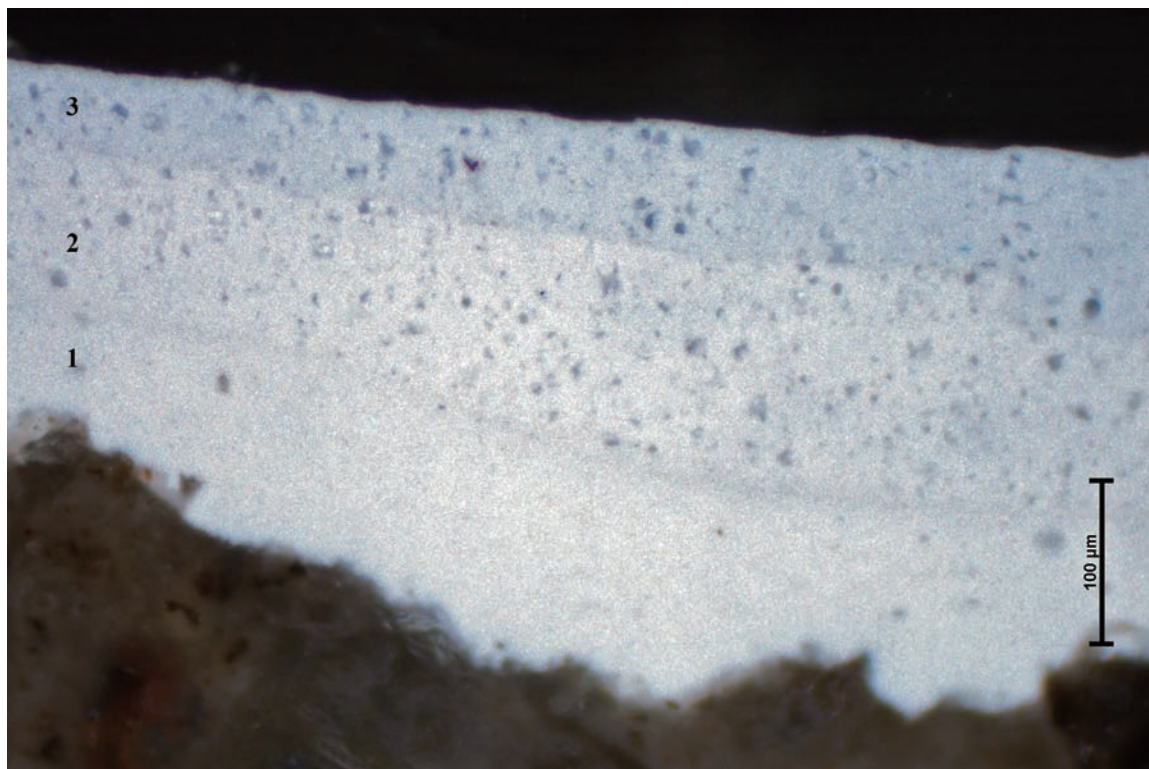
Sample No.: MTT 18	Substrate: Concrete
Location: Exterior. Concrete base below window.	
Camera: Nikon DS-Fi1	Illumination: Intralux 5000-1 Reflected Quartz Haloge
Microscope: Nikon ALPHASHOT-2 YS2	Magnification: 100x
Date analyzed: 5 April 2015	Analyzed by: Samuel Loos

Notes: All three finishes are almost indistinct from each other, being very similar in color. The boundaries between the three layers are difficult to perceive. Layers 2 and 3 contain air bubbles where layer 1 does not. No additional layers were revealed or known layers made more distinct under UV.

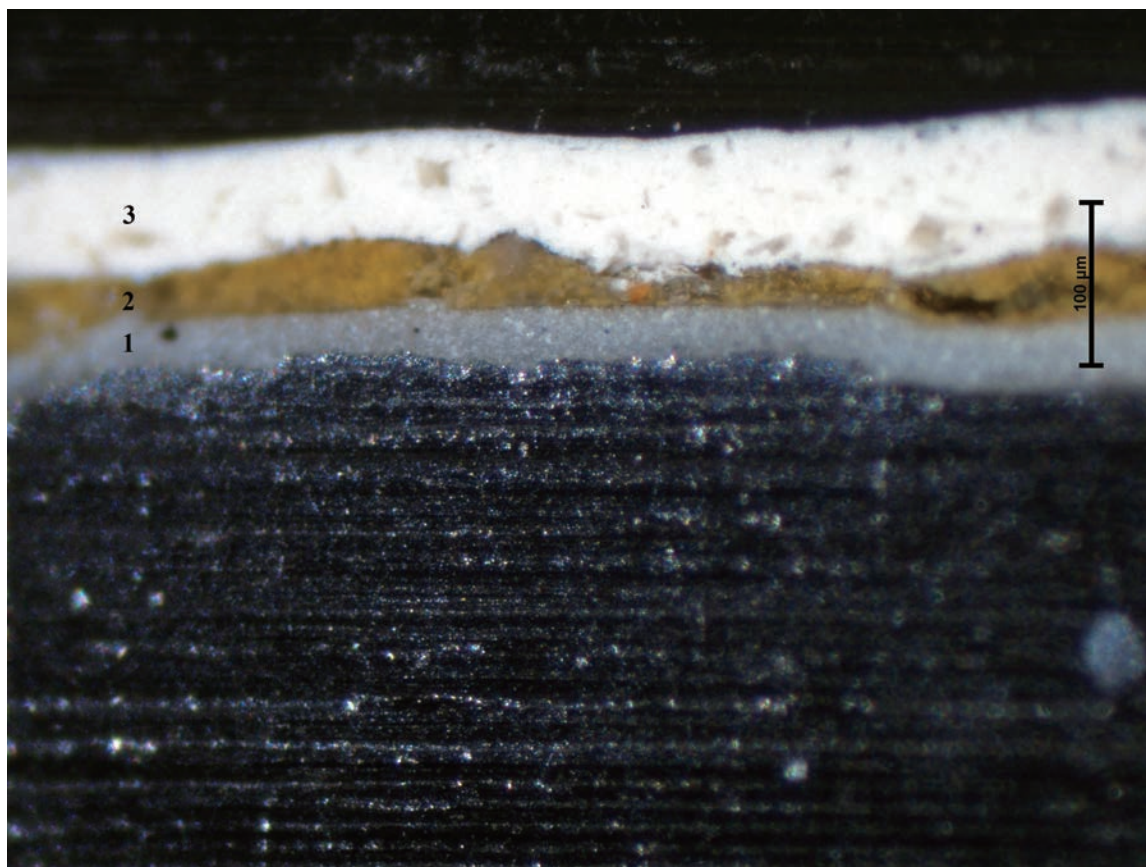
Sample No.: MTT 19	Substrate: Mild steel
Location: Interior. Ceiling.	
Camera: Nikon DS-Fi1	Illumination: Intralux 5000-1 Reflected Quartz Haloge
Microscope: Nikon ALPHASHOT-2 YS2	Magnification: 100x
Date analyzed: 5 April 2015	Analyzed by: Samuel Loos

Notes: Layer 1 is likely a shop prime. Layer 2 was exposed for a long time and shows deterioration and fracturing. No additional layers were revealed or known layers made more distinct under UV.

The steel ceiling needs two repairs: first, the areas which have been distorted should be reset and then the entire ceiling should be repainted.

Once the metal sheets have been reformed, they, along with the rest of the ceiling, need to be repainted. The ceiling sheets need to be adequately prepped to provide a clean surface to which the new paint can adhere. All loose, flaking and damaged paint should be removed following the recommendations outlined for the sheet metal cornice. Since the two finish layers of the ceiling are highly deteriorated, there is less concern for retaining its historic stratigraphy,

and so a chemical paint stripper may be used. The recommendations for repainting the metal ceiling are less stringent than those for the cornice since this metal is protected indoors. Iron or zinc oxide paints should be used and the original paint scheme restored.

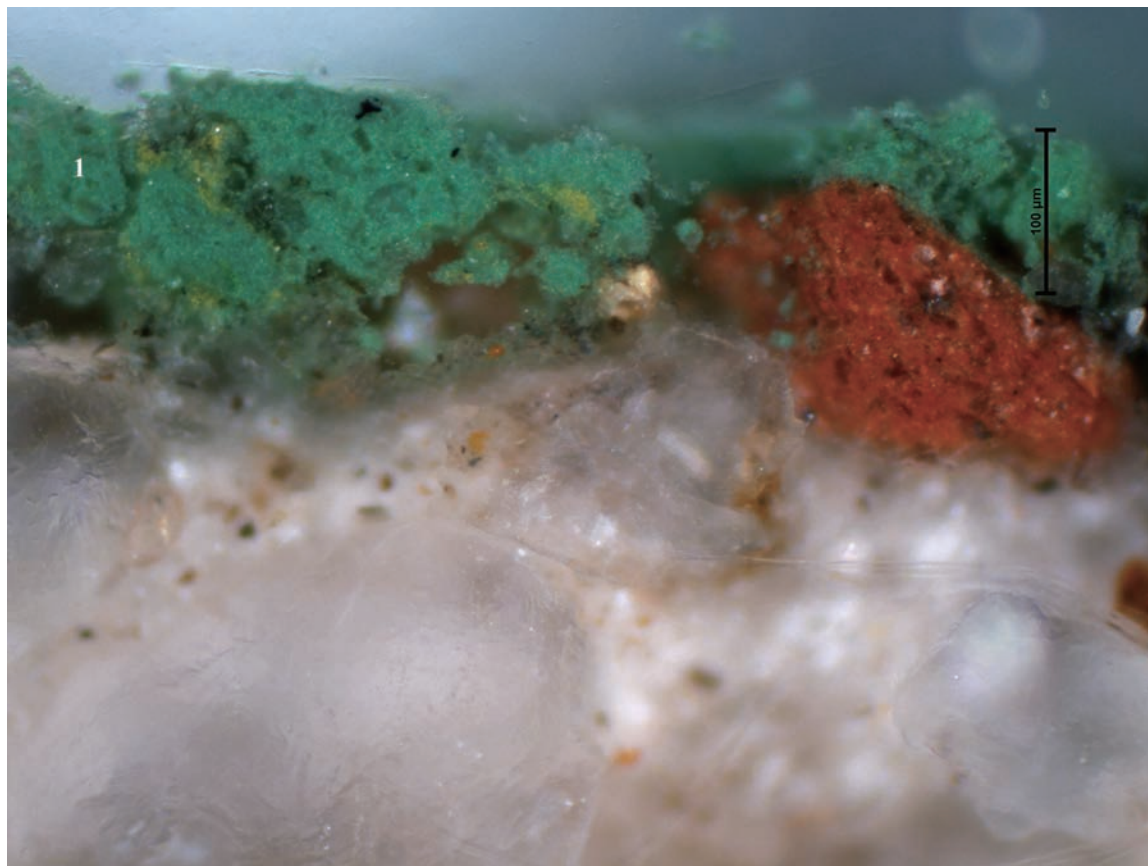
Sample No.: MTT 21	Substrate: Plaster
Location: Interior. South wall, bottom section above baseboard.	
Camera: Nikon DS-Fi1	Illumination: Intralux 5000-1 Reflected Quartz Haloge
Microscope: Nikon ALPHASHOT-2 YS2	Magnification: 100x
Date analyzed: 5 April 2015	Analyzed by: Samuel Loos

Notes: Given the date of the building and location on the interior, more layers were expected to be observed. One explanation could be the use of distemper paints, which could have washed away. Additional layers were observed on the bulk sample. No additional layers were revealed or known layers made more distinct under UV.

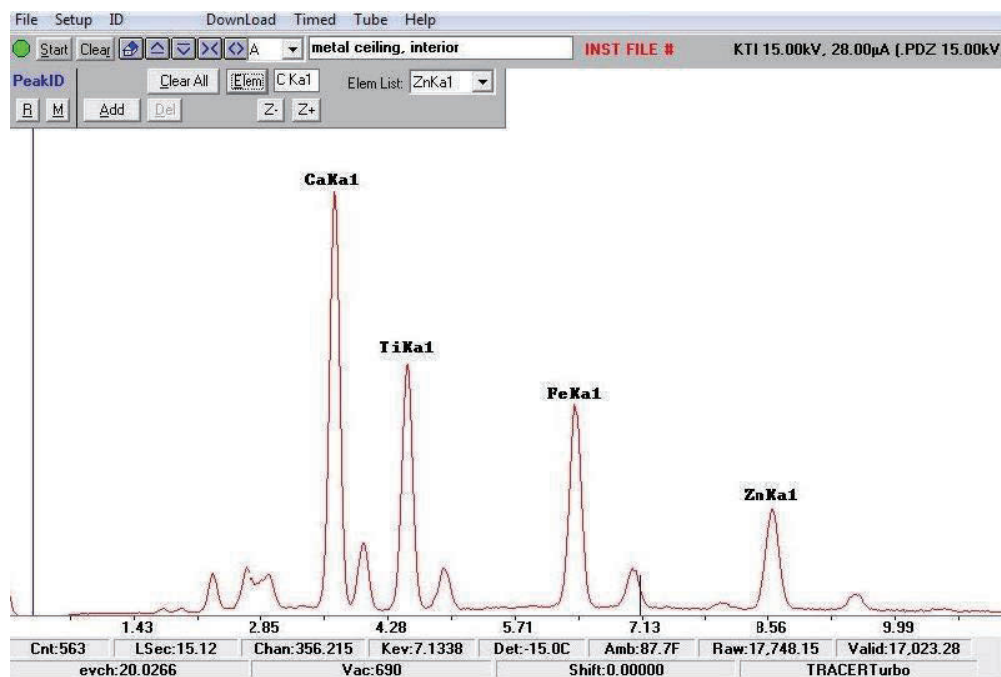
Figure B.8 Graph of XRF data from test on finished side of pressed metal ceiling sample (MTT 19), showing peaks for calcium, titanium, iron and zinc (from left to right).

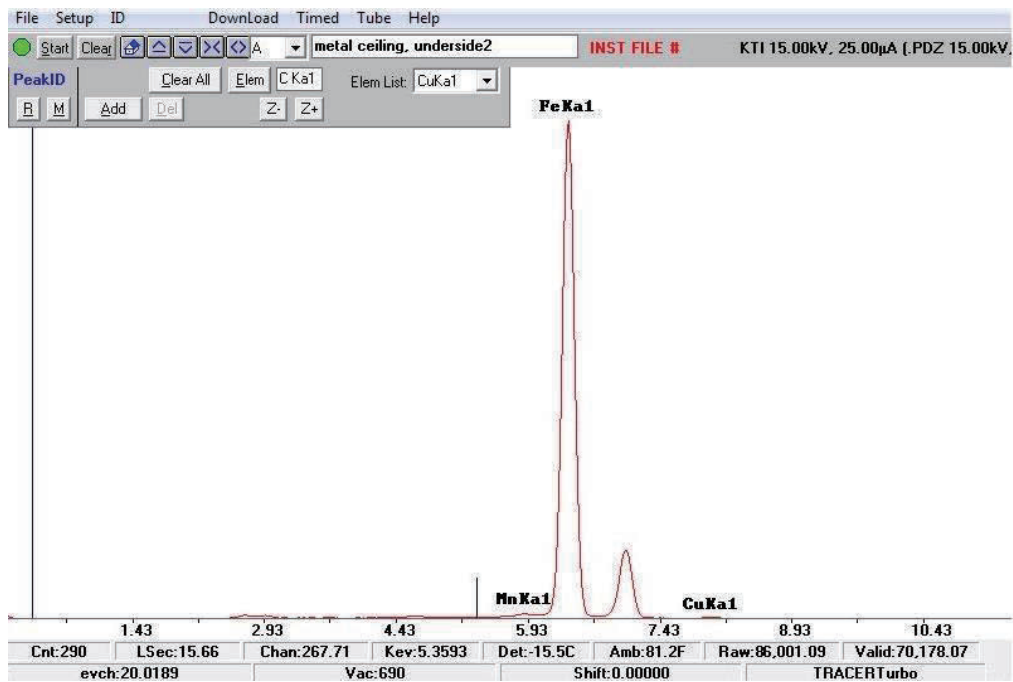
Figure B.9 Graph of XRF data from test on unfinished side of pressed metal ceiling sample (MTT 19), showing peaks for iron.
