SLOPE INSTABILITY ON THE JORDANIAN HIGHWAYS

Thesis submitted to the University of London
for the degree of Doctor of Philosophy in
Engineering Geology.

October, 1974.

Engineering Geology Division,
Imperial College of Science and
Technology,
London S.W.7.

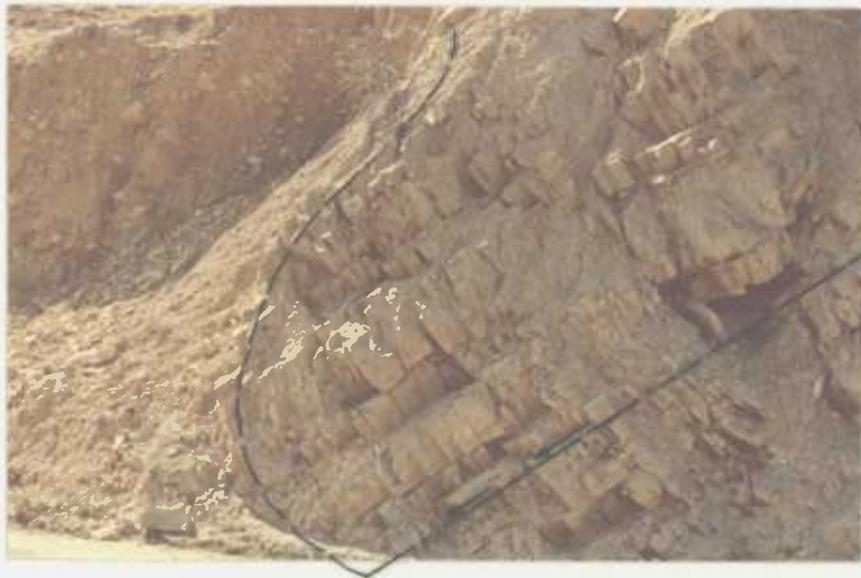
Plate 1.1 Slabslide with internal toppling of a limestone along a bedding plane - geologic plane of weakness.

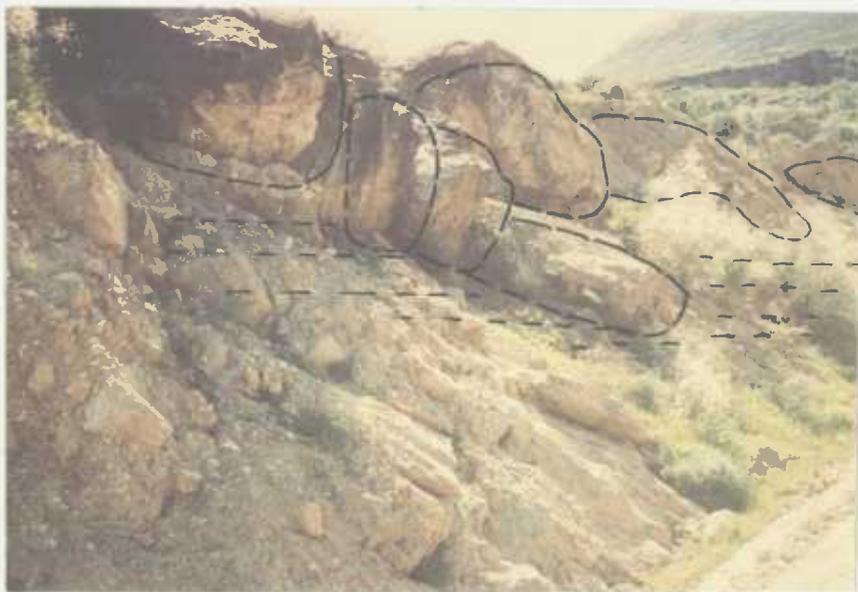
Plate 1.2 Block flow into the underlying soft clay.

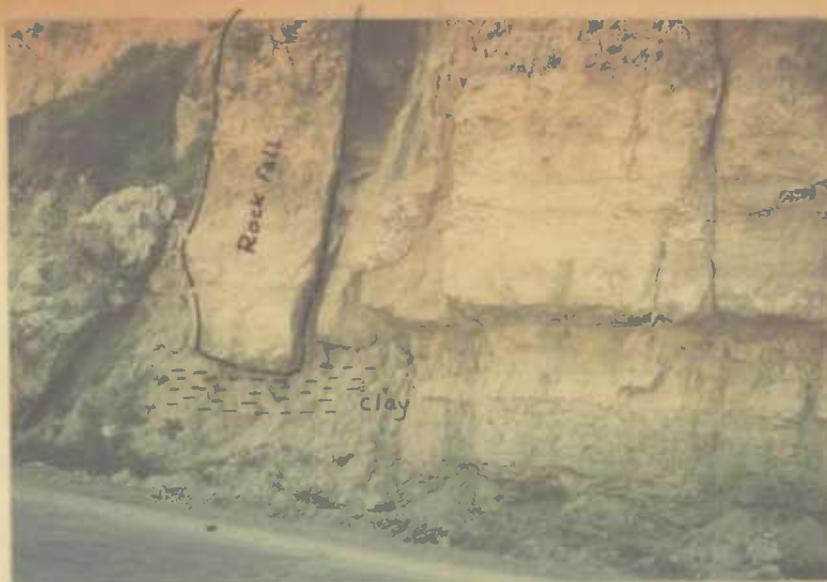
plate 1.3 Rockfall due to the erosion of the underlying soft clay.

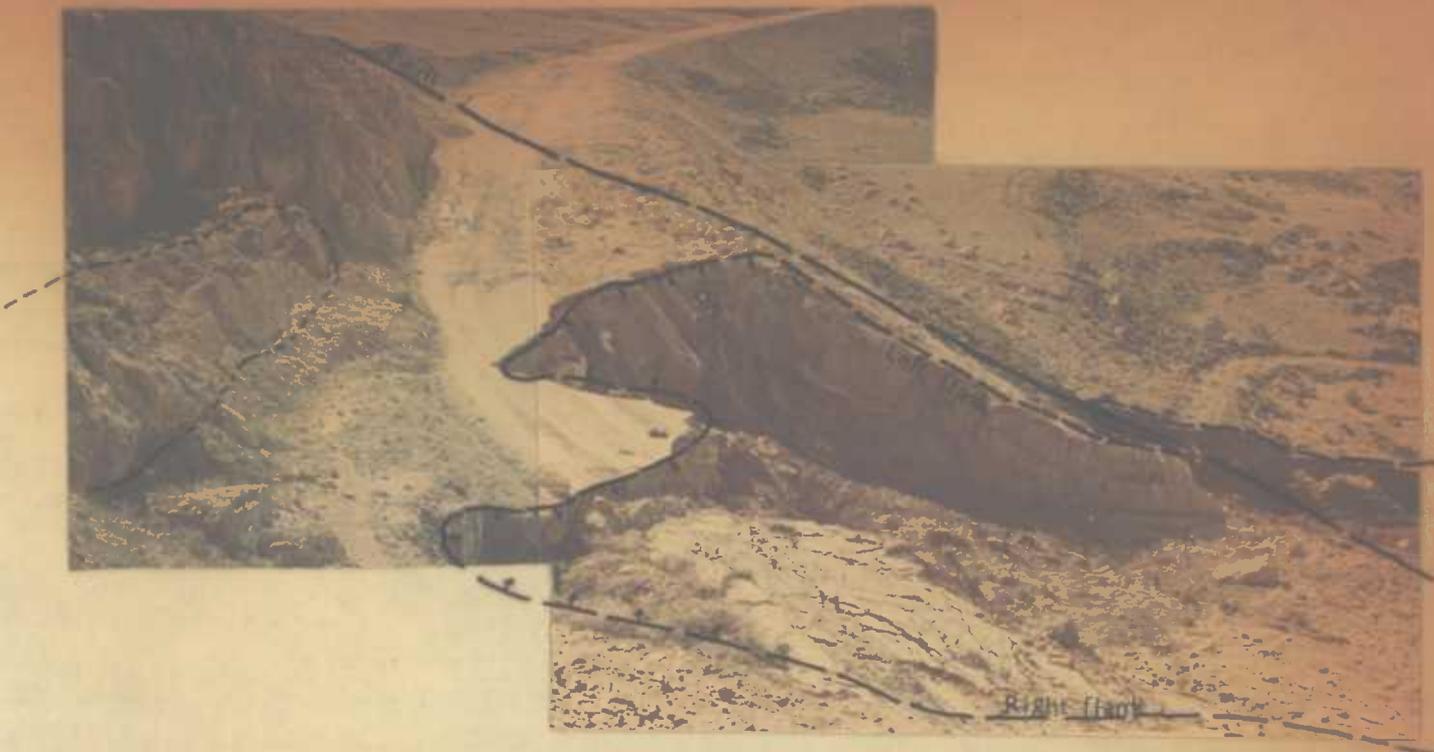
Plate 4.2 The main features of the movement of landslide V - 1971 (the main scarp), (Observation point 5.)

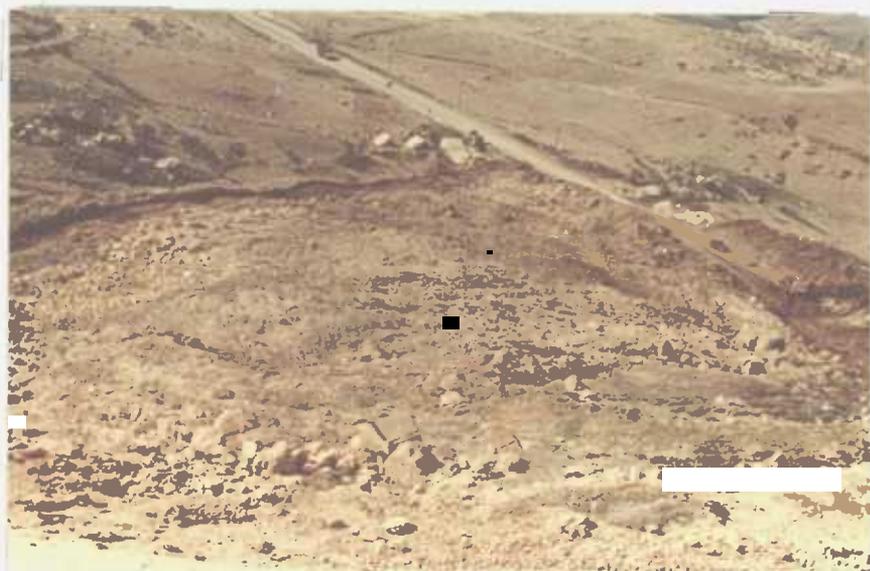
Observation point 1: The toe of the recent landslide V within an old landslide area. The main scarp of this landslide is located at the contact between A2 and A3 of the Lower Ajlun Group and affects the upper highway, while the toe of the landslide has over-ridden the lower highway with the sliding material (Plate 4.1).

Plate 4.1 General view of landslide V - 1971 (looking down the slope). The sliding material near the toe is covering the lower road (observation point 1).

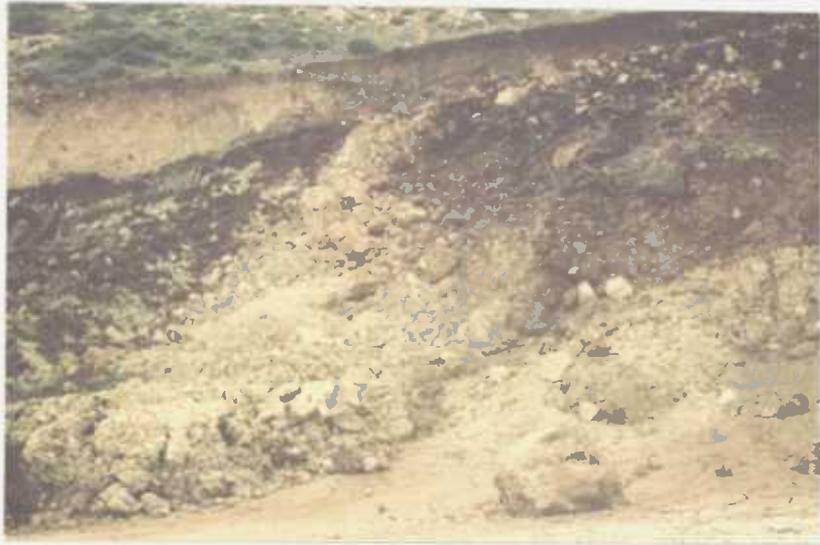
Plate 4.3 A mudflow consisting of brown silty clay, yellowish clay and marl (observation point 6).

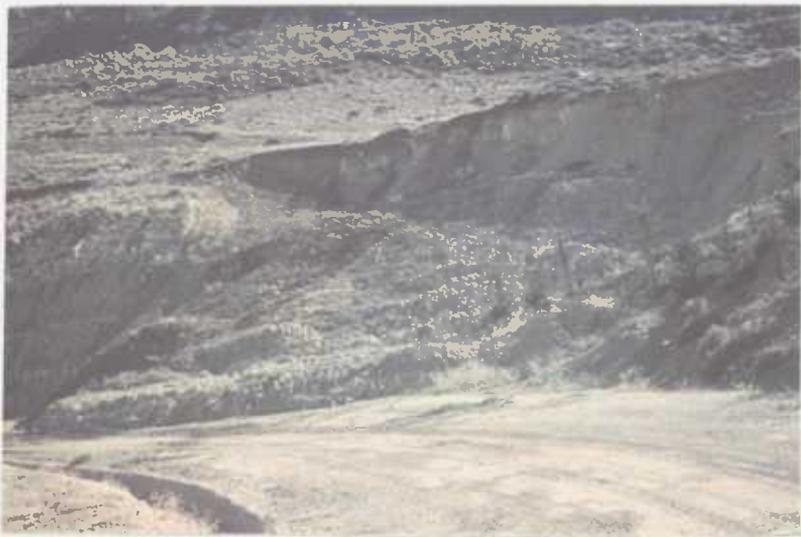
Observation point 7: a mudflow. The material involved is mainly yellow marl and green clay. Trees have recently been planted at this site (Plate 4.4).

Plate 4.4 A mudflow, consisting of yellowish marl and clay (observation point 7).

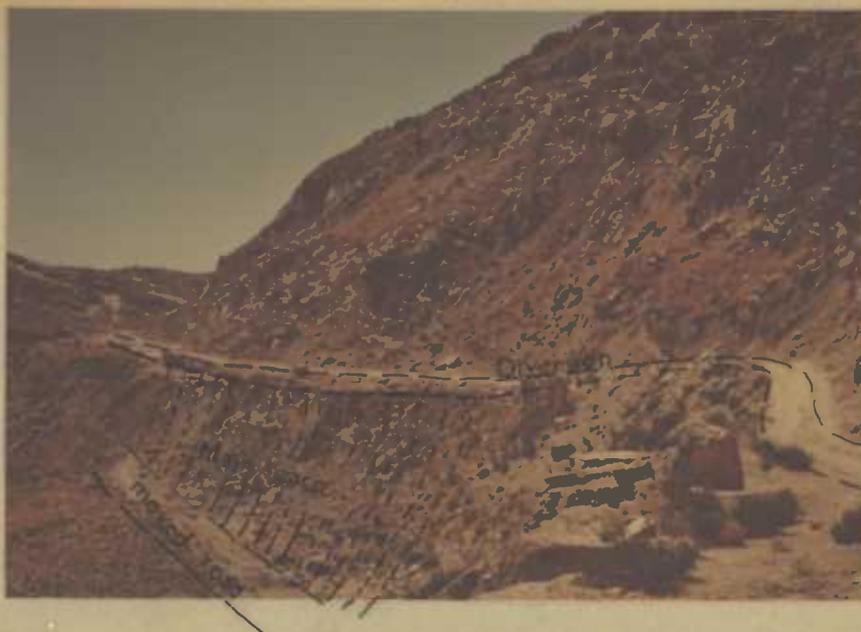
Observation point 13: landslide VI (Section 4.4 and Plate 4.11).

Plate 4.11 The main features of landslide VI. The main scarp and the moved road (Observation Point 13).

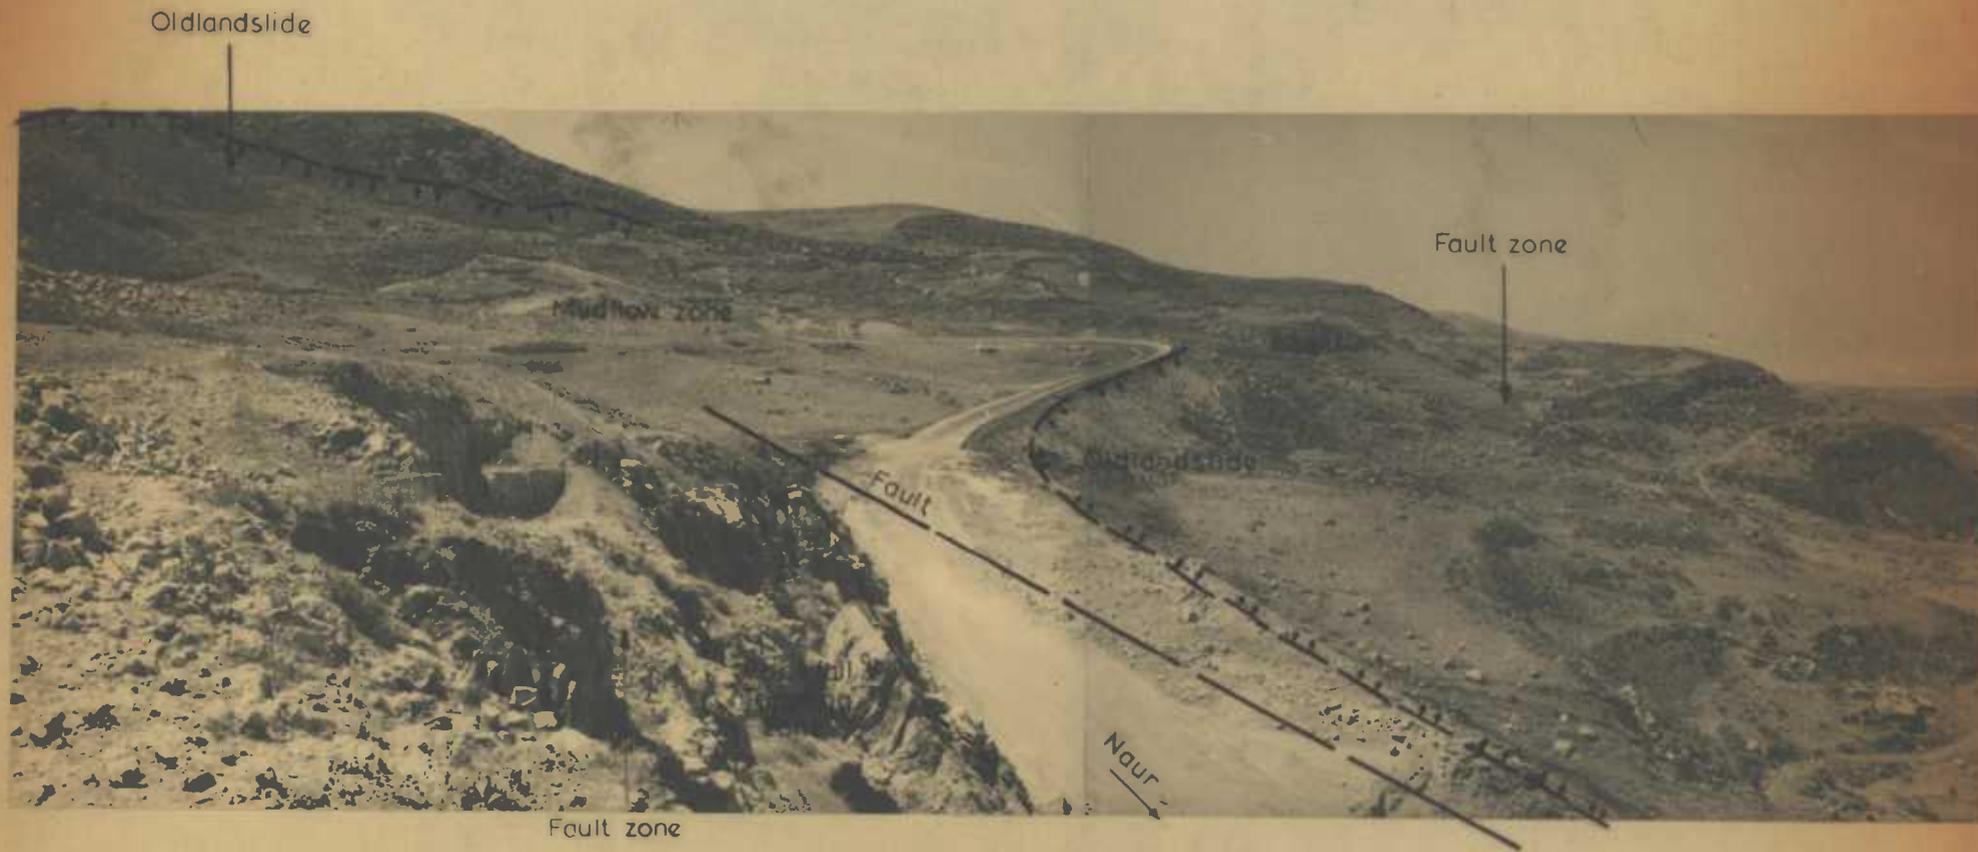
Plate 4.13

The morphology of the area in the region of landslide V shows a hummocky terrain arising from the old landslide movements in the area (Plate 4.13).

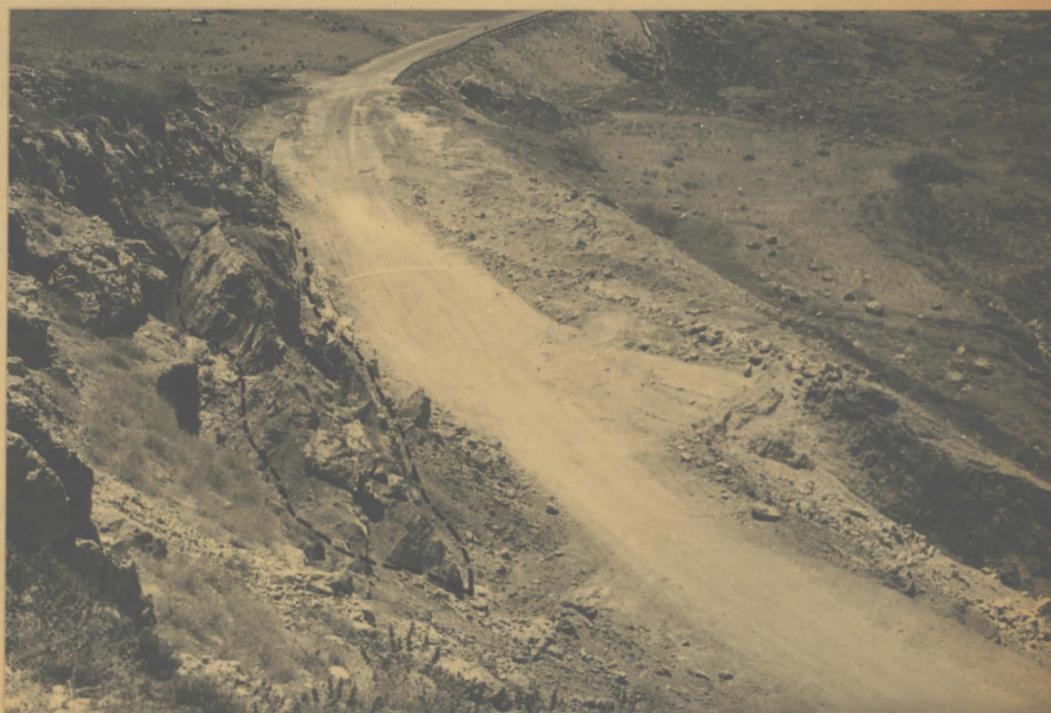
Plate 4.15 Toppling and rockfall at the crown of landslide V.

It can be seen from the joint surveys that joint set no. I combined with the other sets divide the strata into many blocks which contribute to an overall potential instability and weakness of this hillside (Plate 4.16 and 4.17). Any undercutting of the underlying soft marls and clays would cause rockfalls and other rock instability (Plate 4.15).

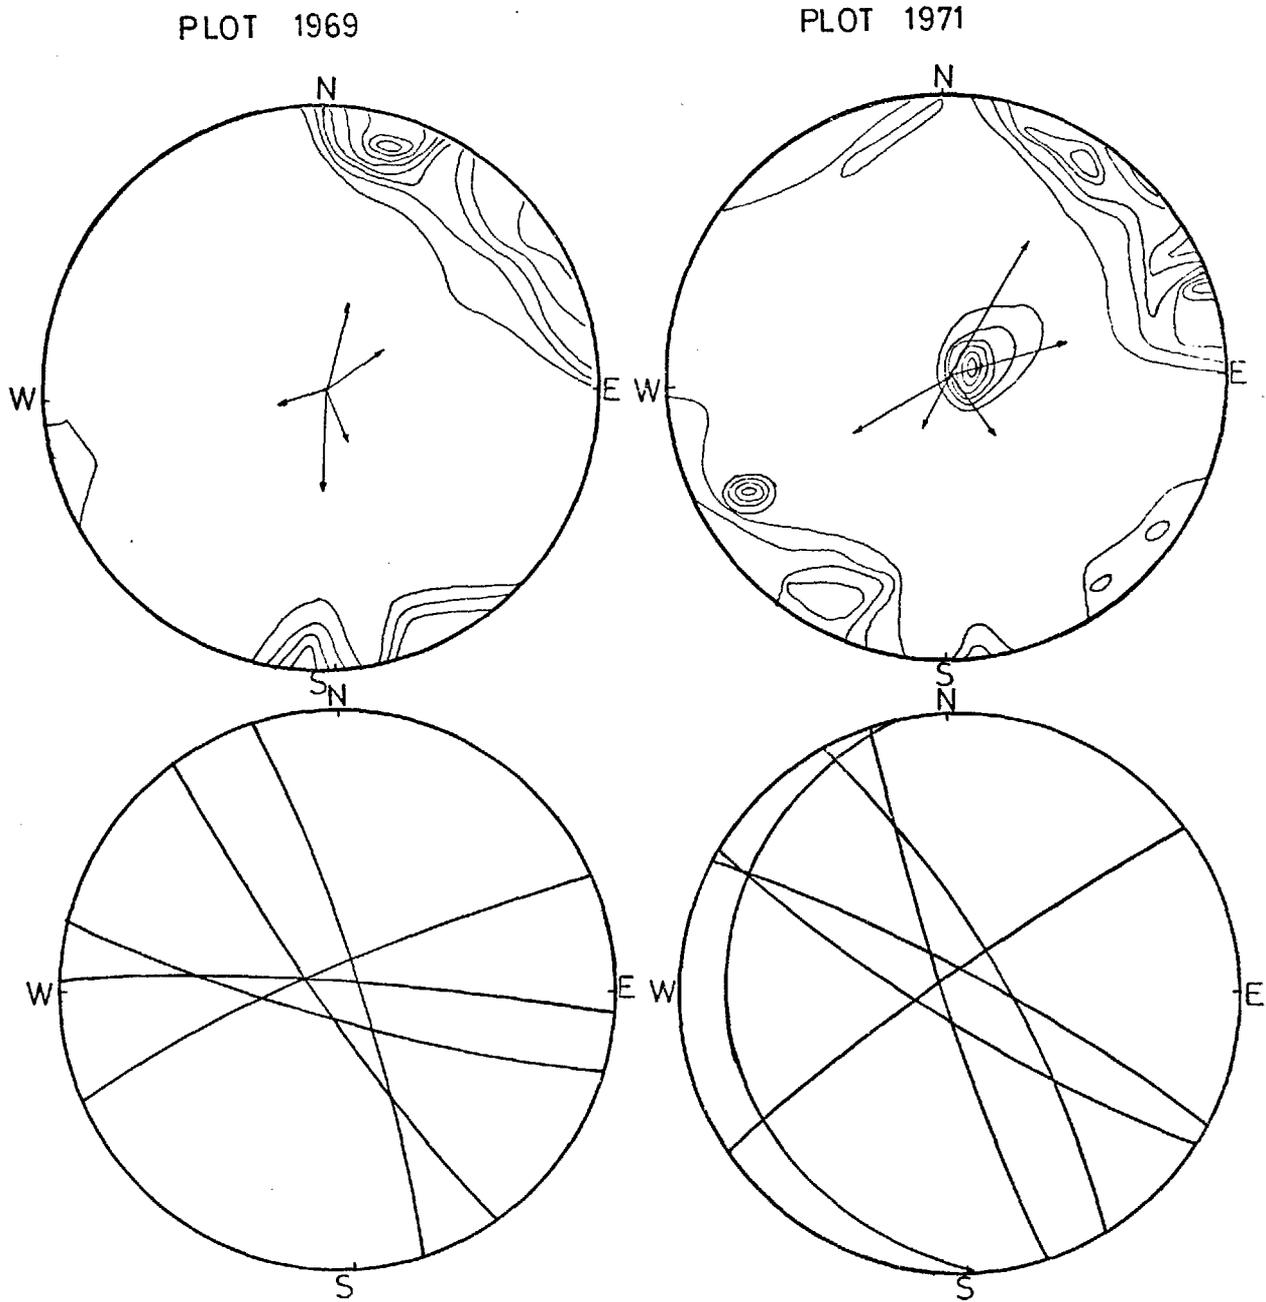
Fig(4.8)

STEREOGRAPHIC PLOT OF JOINTS OF THE STRATA AT THE CREST OF LANDSLIDE V AFTER THE MOVEMENTS OF 1969 & 1971 .

Set No. I is the one most strongly developed (circumferential) and might contribute to the most unstable slope conditions when these joints combined with the stratification and the other joint sets. In this situation, outwardly leaning blocks may become separated from the main mass by development of the backing joints. Se. No. I represents about 88% out of a total of 96 joints measured in this strata near the crest of the landslide (Fig. 4.8).

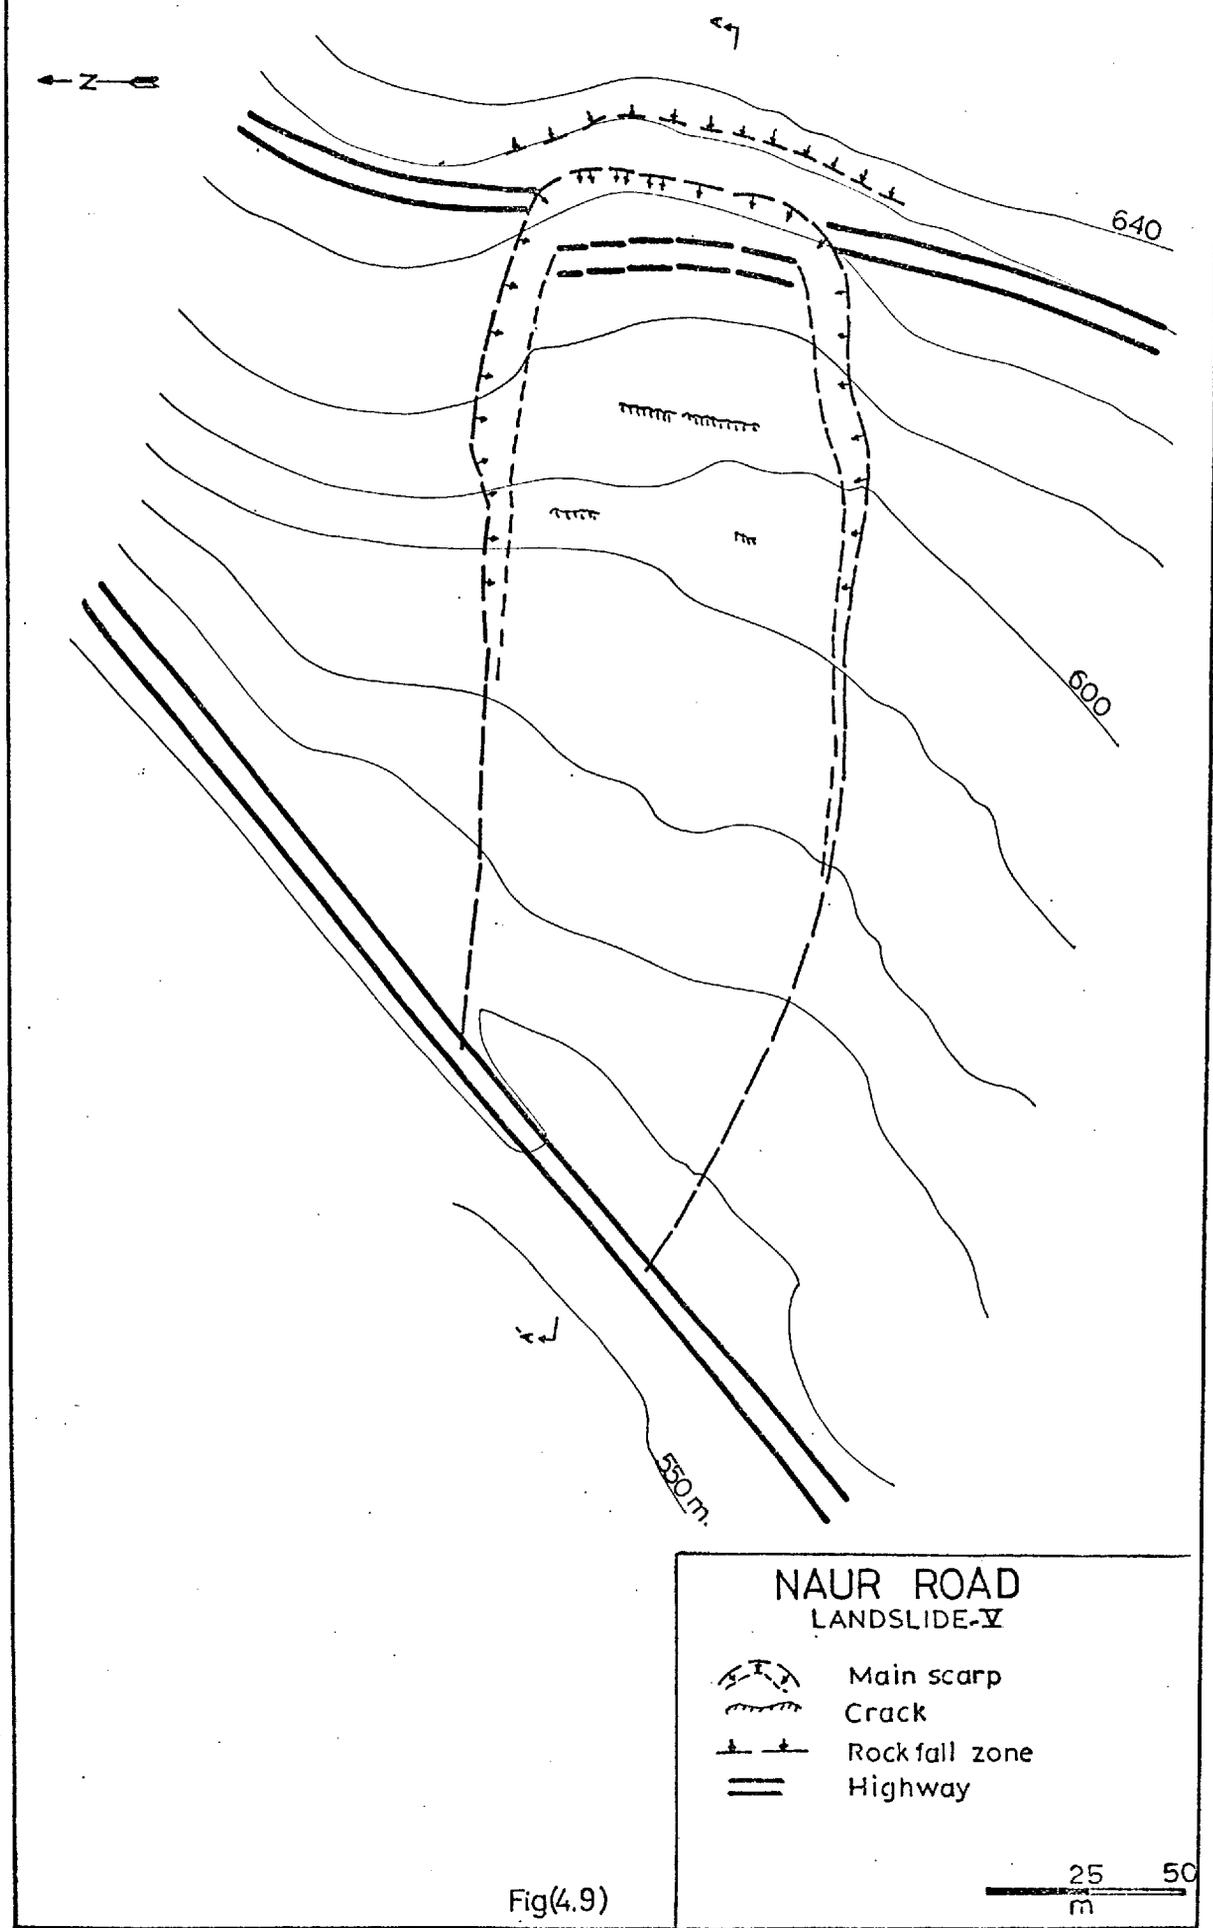
In January 1967, there was 238 mm of rainfall after which a sudden landslide movement occurred. No investigations were made at the time of the movement. In March 1969, after periods of exceptionally heavy rainfall, a circular type of landslide occurred at 25 Km along the Naur-Adasiye highway. The landslide covers an area of about 25,000 m². The sliding mass moved as an almost monolithic body sinking about 10 m in the upper part (crown) of the slope where a steep clay wall marked as the main back scarp. At the main back scarp and on the flanks the slide had a clear-cut boundary, on which the rotation movement was clearly observed (Fig. 4.9 and Plates 4.2 and 4.20).

NAUR- ADASIYE ROAD MAP OF LANDSLIDE .V (1969)

The breadth of the landslide was about 90 m, and its length approximately 250 m. The slide mass comprised an estimated total volume of approximately 500,000 m³. The slide mass sank at the rear, affecting the upper highway but causing little disturbance on the bedrock. The toe material overridden the lower highway (Fig. 4.9 and Plate 4.20). The movement was mainly towards the west. Immediately after the occurrence of this landslide, the Ministry of Public Works began excavating the toe part to open up the lower highway. In this way part of the resisting force was decreased. In April 1971, after a previous dry year and after 252 mm of heavy rainfall, a shallow debris slide occurred with a downward and outward movement. The near vertical main scarp 9.5 m high formed near the edge of the upper highway affecting approximately 3 m of its width, where also a steep clay wall was exposed. A spring discharging from the main scarp was observed (Plate 4.18). The total length of this second movement was about 225 m with a width ranging between 70 and 155m; the affected part of the upper highway was approximately 95 m and the moved material covered about 160 m of the lower highway (Fig. 4.10). The landslide mass was totally disturbed, and was probably in a saturated slurried state at the time movement was renewed. In an attempt to control the renewed movement, the Ministry of Public Works constructed a retaining wall at the edge of the lower highway and excavated the whole toe part of the present landslide. Fig. 4.11 shows three cross sections before and

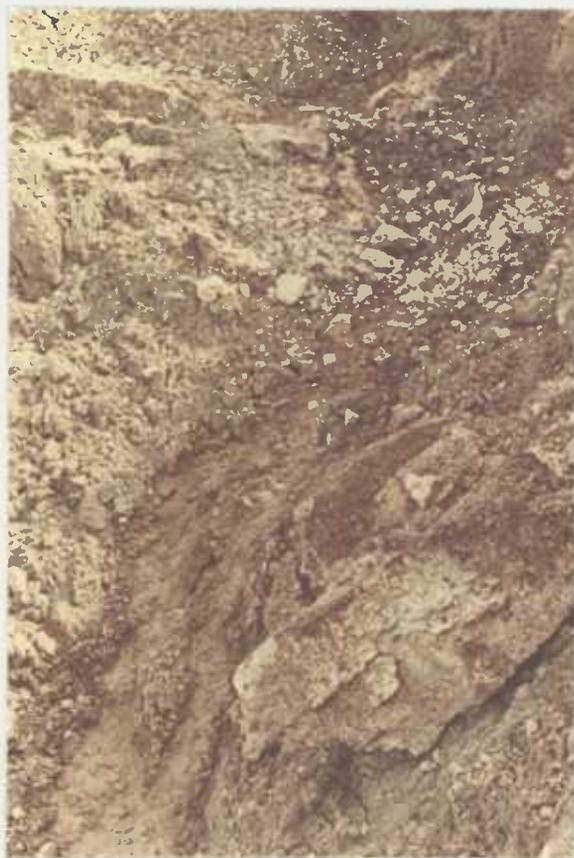
Plate 4.19 Flow of the material near the main scarp.

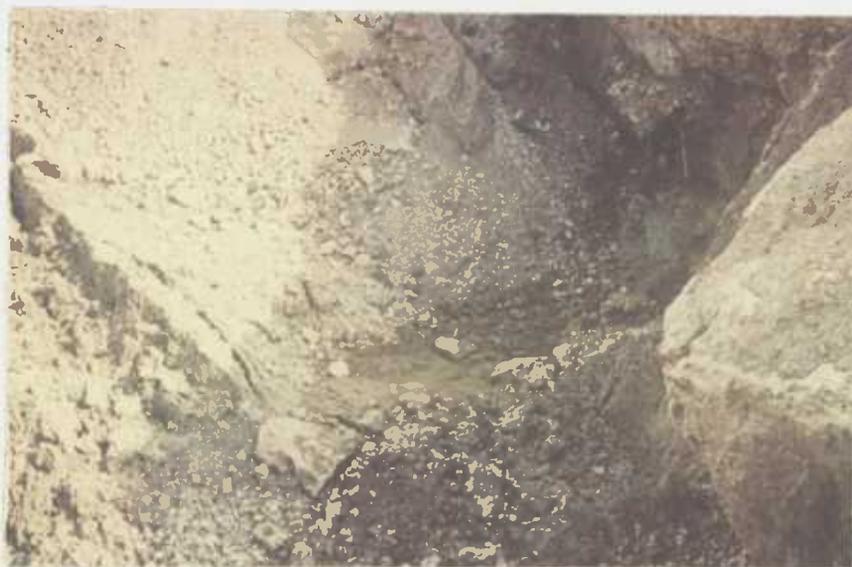
Plate 4.18 A spring discharging from the bottom of the main scarp.

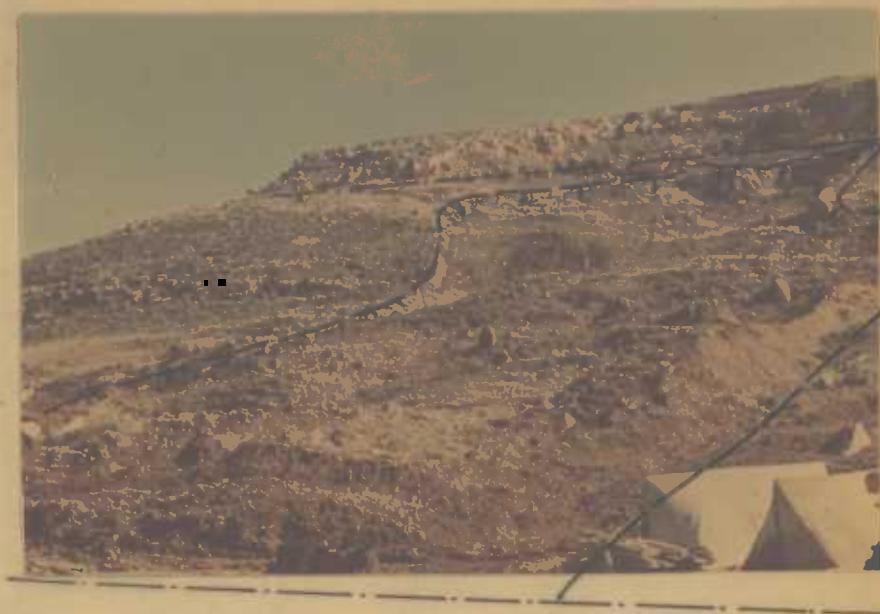
Plate 4.20 General view of landslide V (looking up the slope). The main scarp, left and right flanks, the upper and lower road.

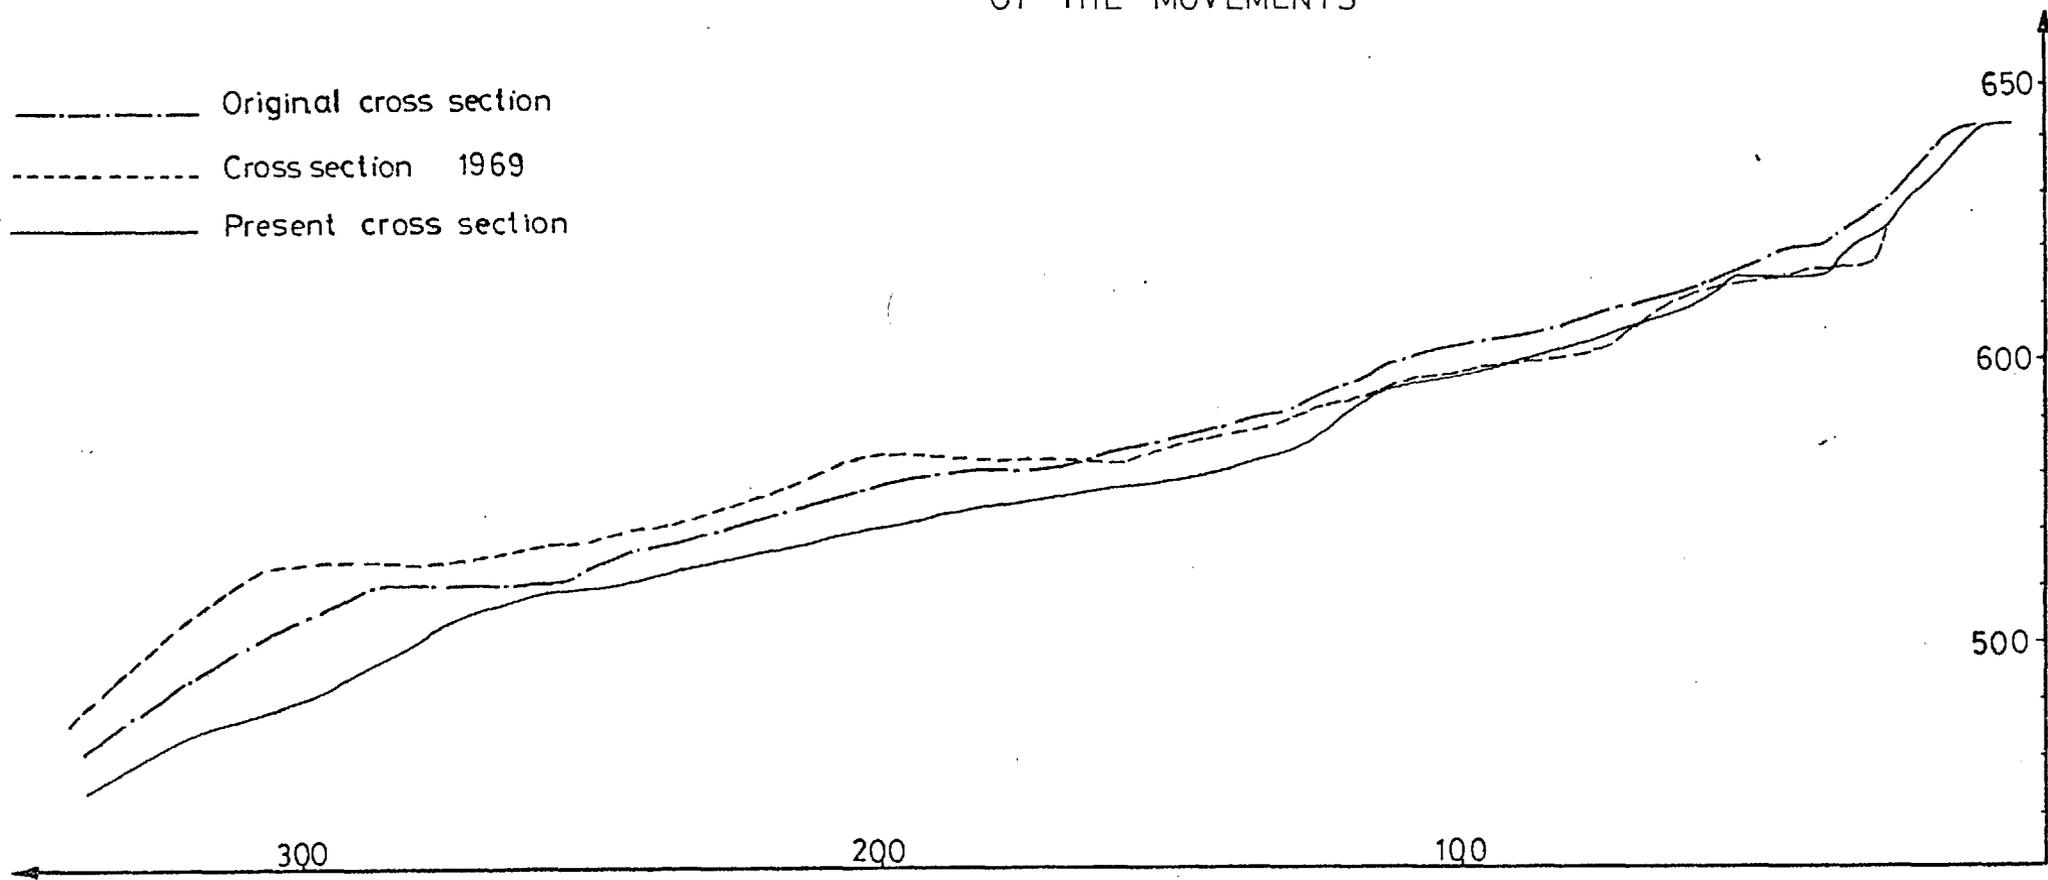
LANDSLIDE .V
CROSS SECTIONS SHOWING THE EVOLUTION
OF THE MOVEMENTS

after the first movement of 1969 and the present cross section of 1971 after the final excavation.

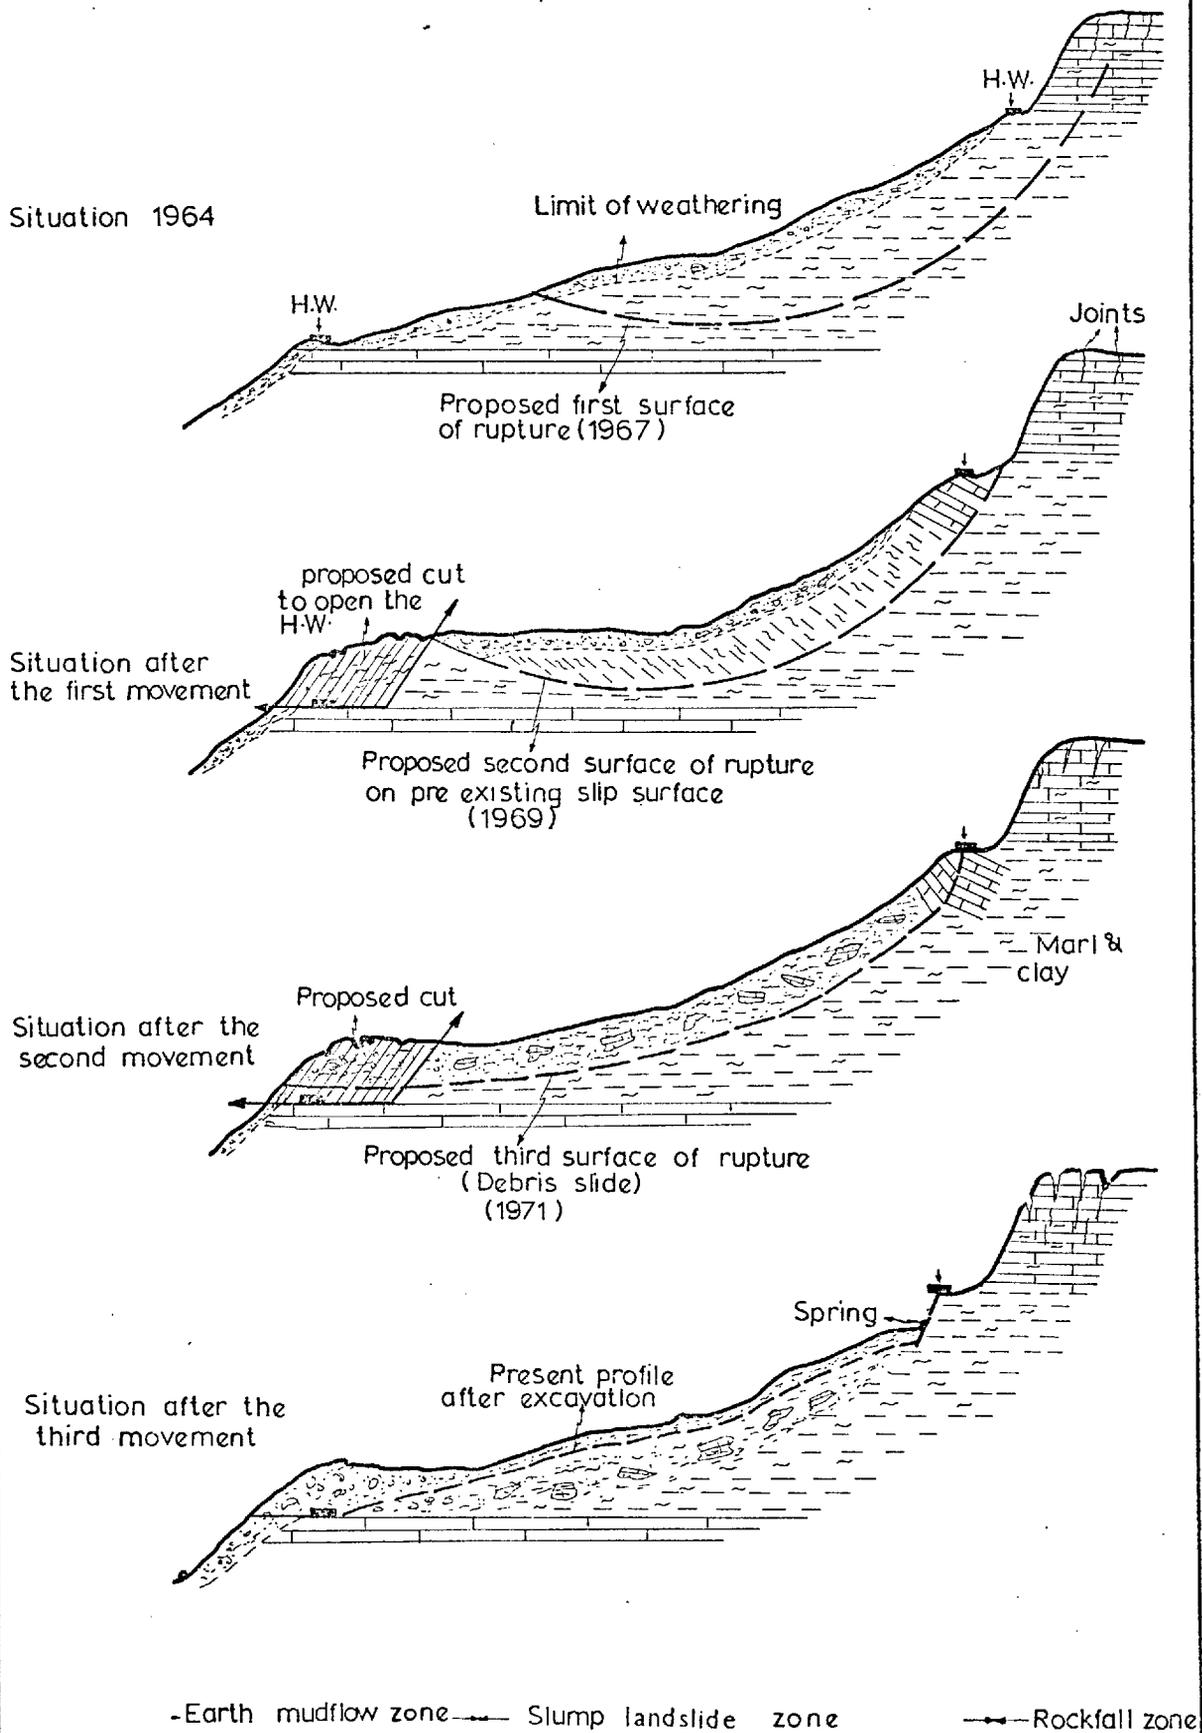
Fig(4.12)

Fig. 4.12 shows the proposed instability zones and the movements in this area. Fig. 4.13 is a schematic block diagram showing the main features of the movements in the area.

NAUR- ADASIYE ROAD LANDSLIDE V PROPOSED EVOLUTION OF MOVEMENTS (PRINCIPAL SKETCHES)

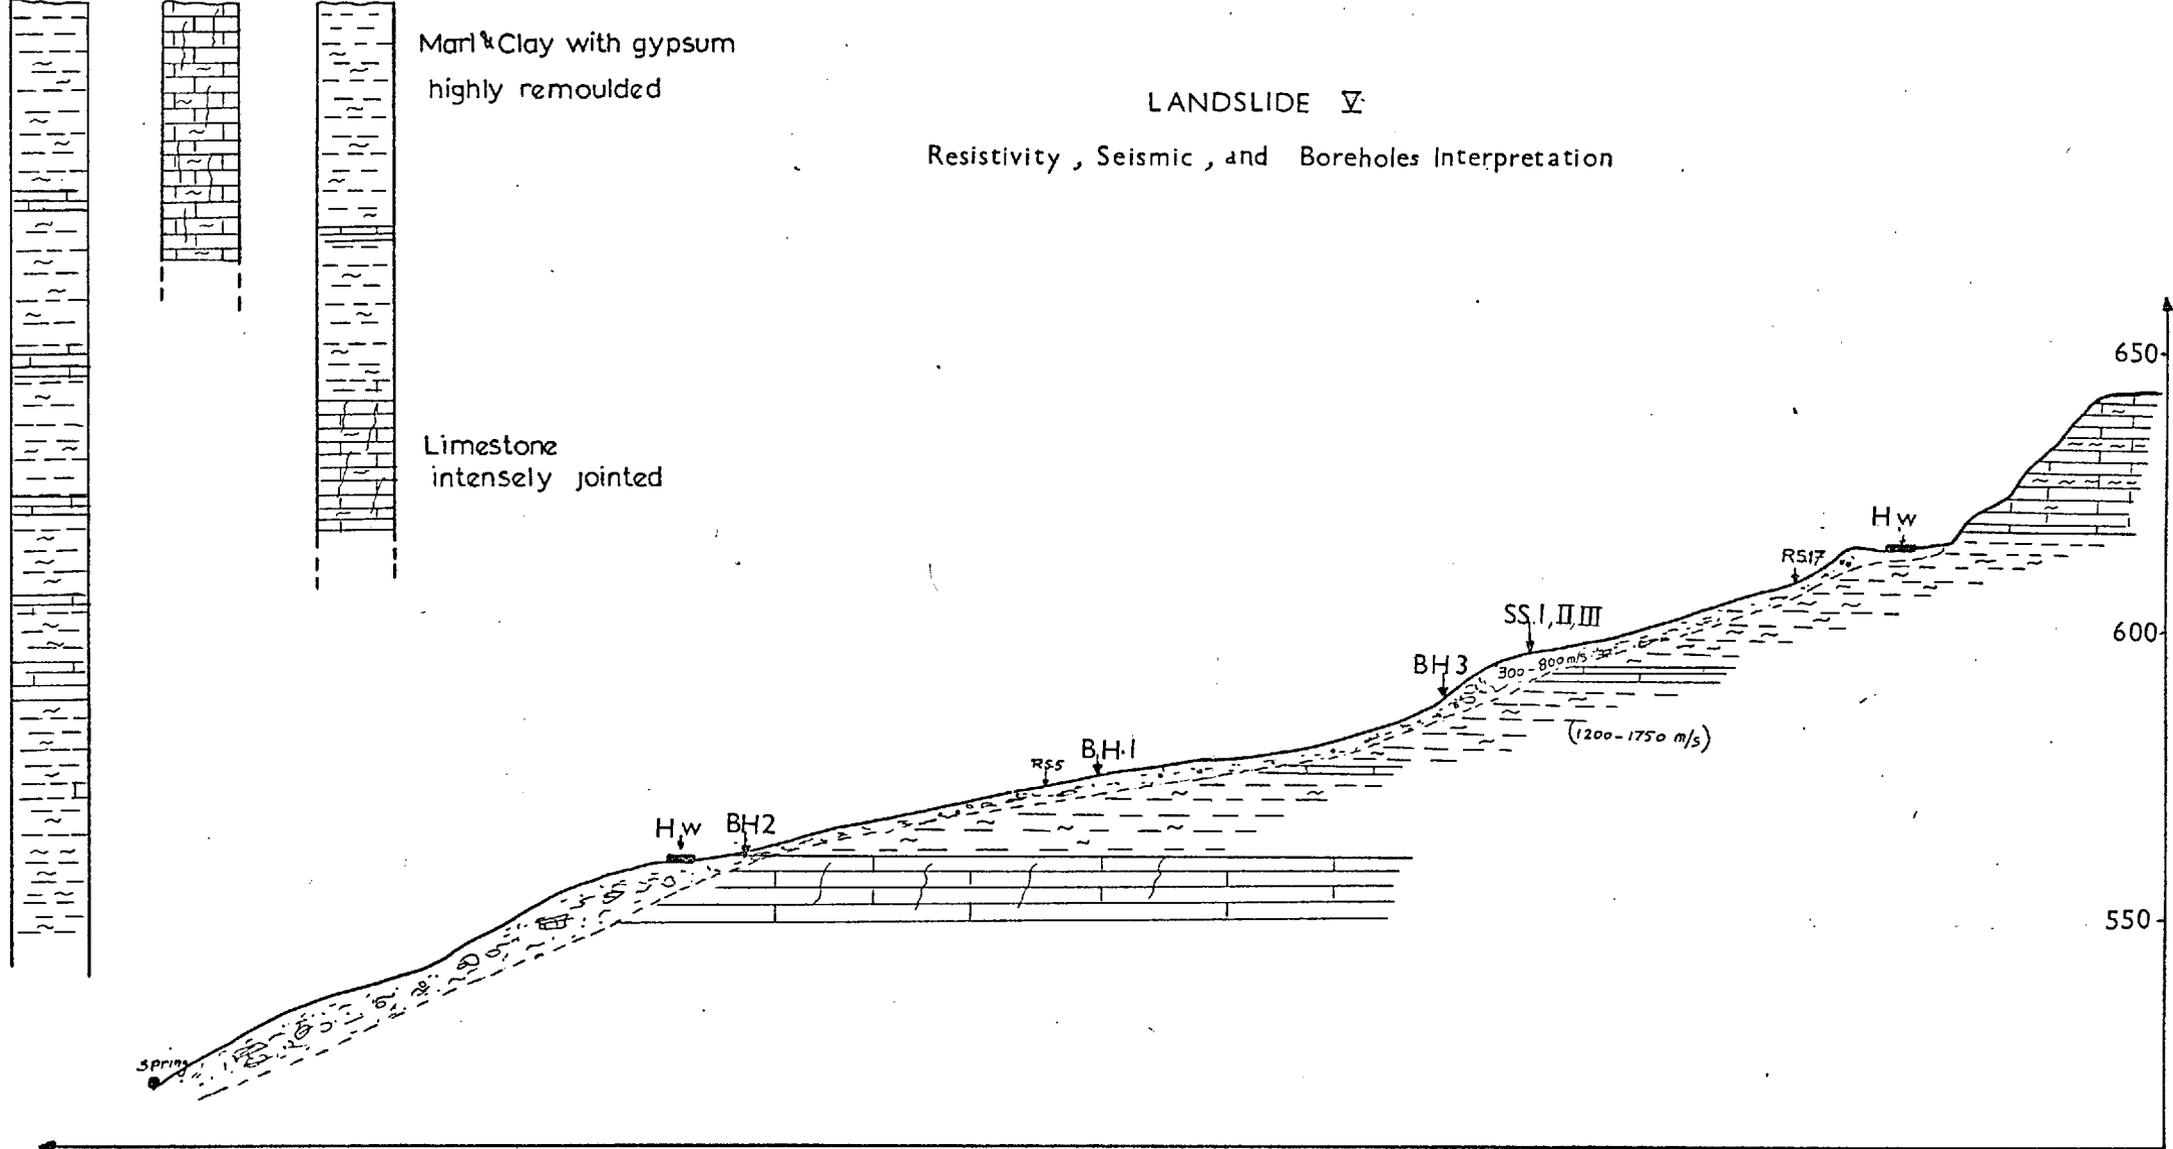
Fig(4.14)

Resistivity, Seismic, and Boreholes Interpretation

was influenced by one major fault, crossing the left flank and going through the toe part of the landslide. This was verified by the surface geological mapping and study of the aerial photographs.

A lithological cross section of the site of the landslide was prepared based on all the information obtained, i.e. exploratory drilling, geophysical surveys and surface geological mapping. This cross section is shown in Fig. 4.14.

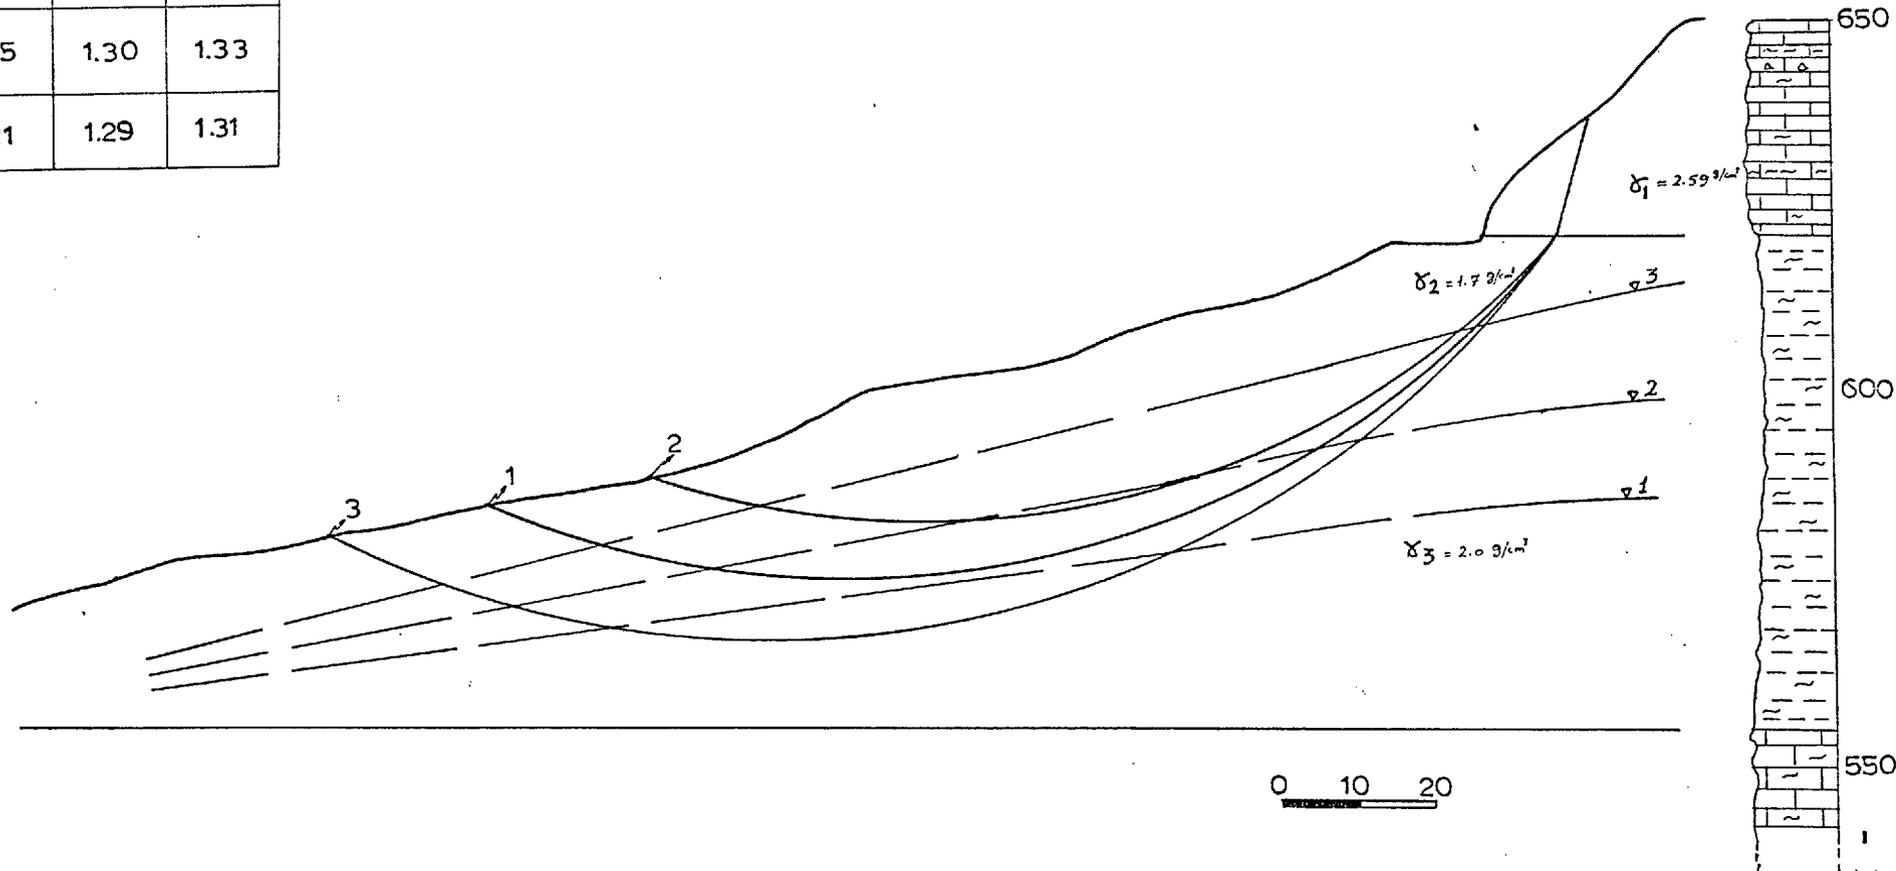
Fig(4.16)

CIRCLE No.	FACTOR OF SAFETY			
	W.T. 3	W.T. 2	W.T. 1	NO W.T.
1	1.10	1.28	1.32	1.34
2	1.07	1.25	1.30	1.33
3	1.02	1.21	1.29	1.31

LANDSLIDE.V
ORIGINAL CROSS SECTION
(BEFORE SLIDING)
