SLOPE INSTABILITY ON THE JORDANIAN HIGHWAYS

Thesis submitted to the University of London
for the degree of Doctor of Philosophy in
Engineering Geology.

October, 1974.

Engineering Geology Division,
Imperial College of Science and
Technology,
London S.W.7.

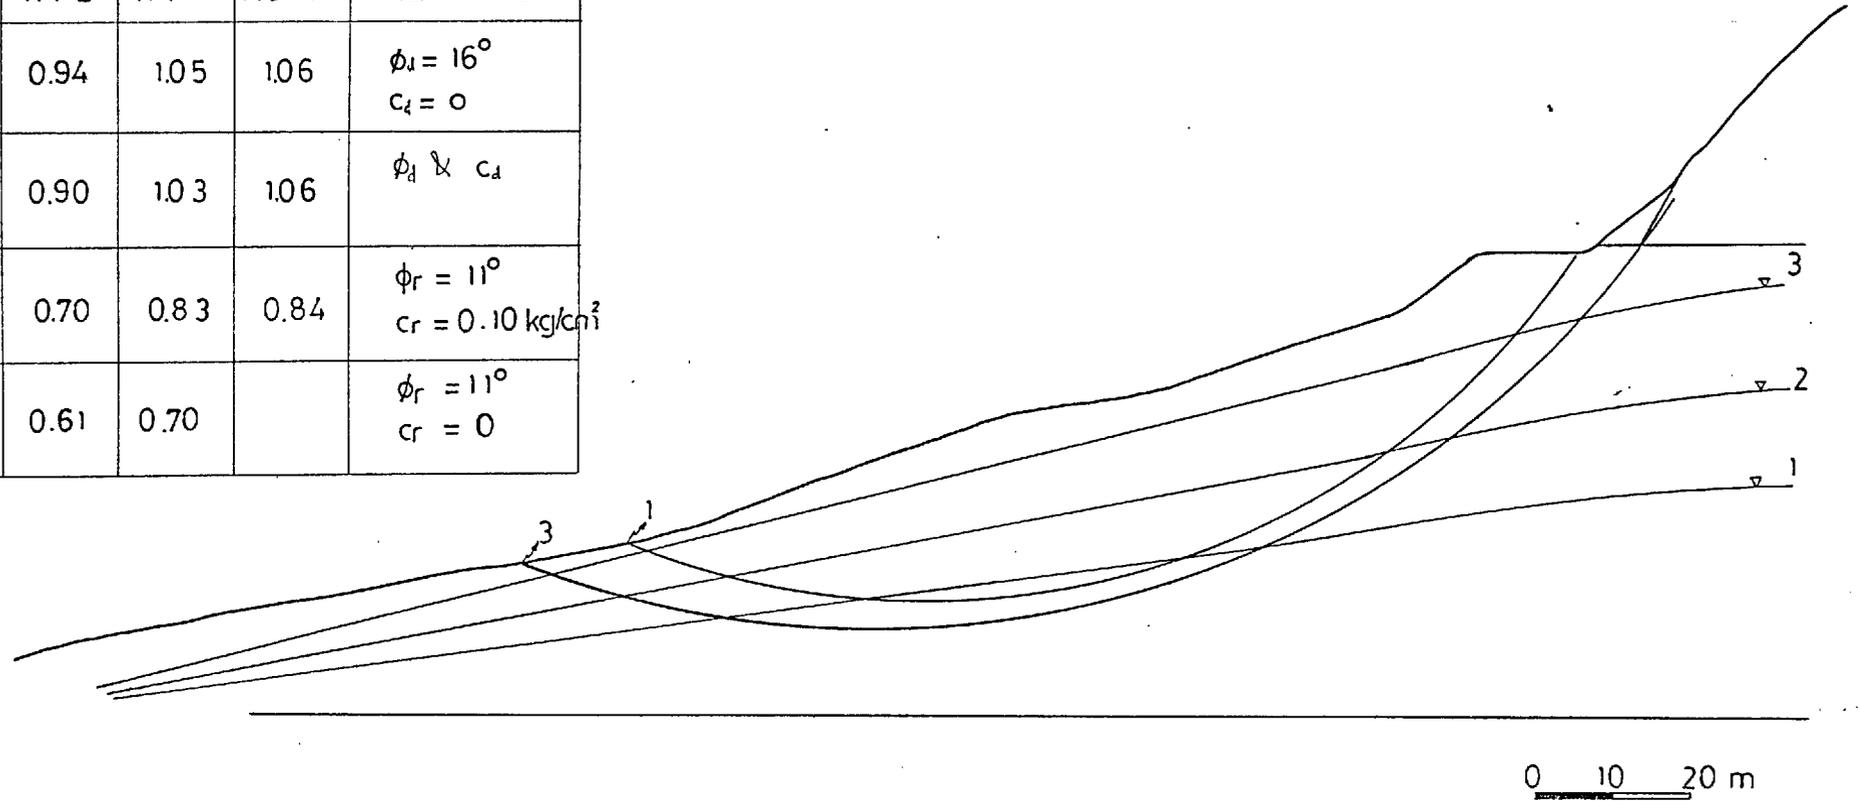
Fig(4.17)

LANDSLIDE. V
PRESENT CROSS SECTION
(AFTER SLIDING)

CIRCLE No.	FACTOR OF SAFETY				REMARKS
	W.T. 3	W.T. 2	W.T. 1	NO W.T.	
1	0.73	0.94	1.05	1.06	$\phi_d = 16^\circ$ $c_d = 0$
3	0.71	0.90	1.03	1.06	$\phi_d \ \& \ c_d$
	0.57	0.70	0.83	0.84	$\phi_r = 11^\circ$ $c_r = 0.10 \text{ kg/cm}^2$
	0.48	0.61	0.70		$\phi_r = 11^\circ$ $c_r = 0$

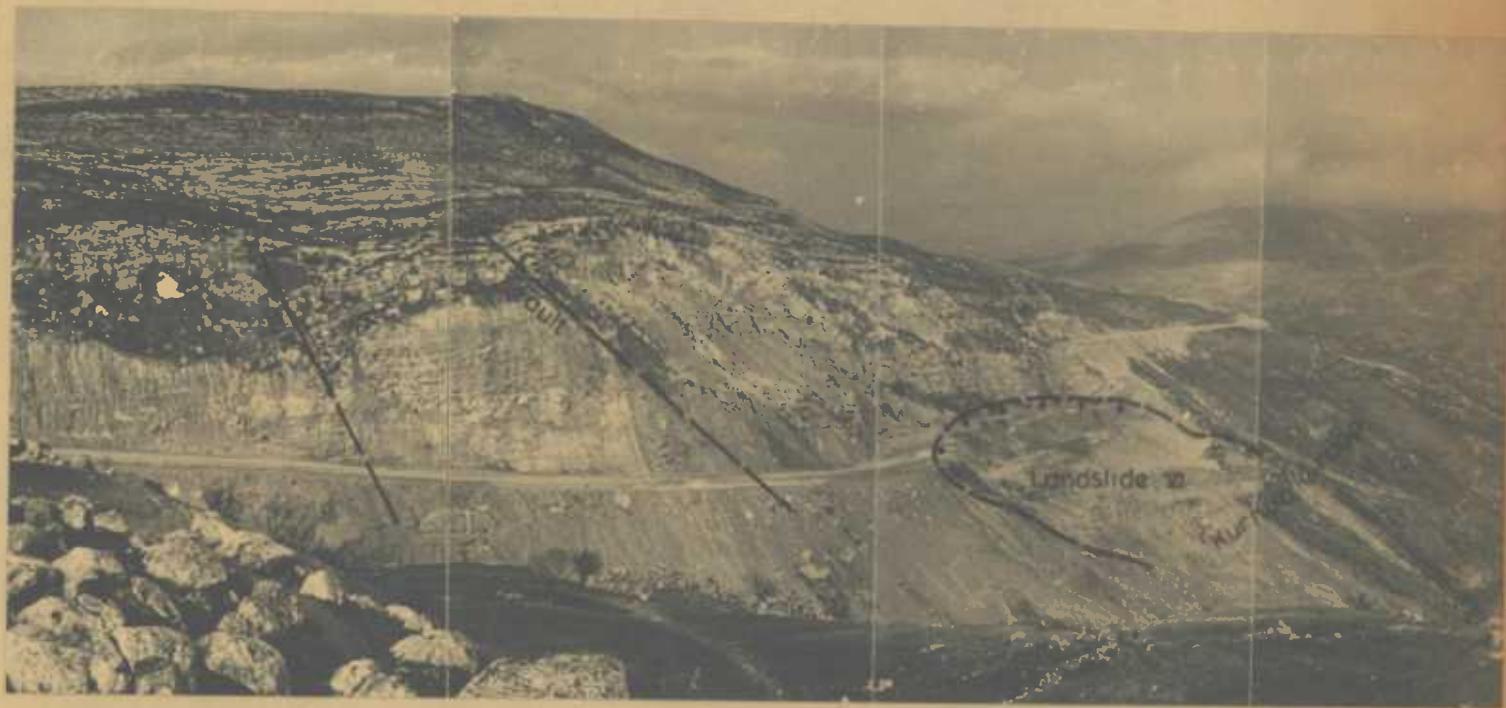
Plate 4.21 General view of the study area of landslide VI.

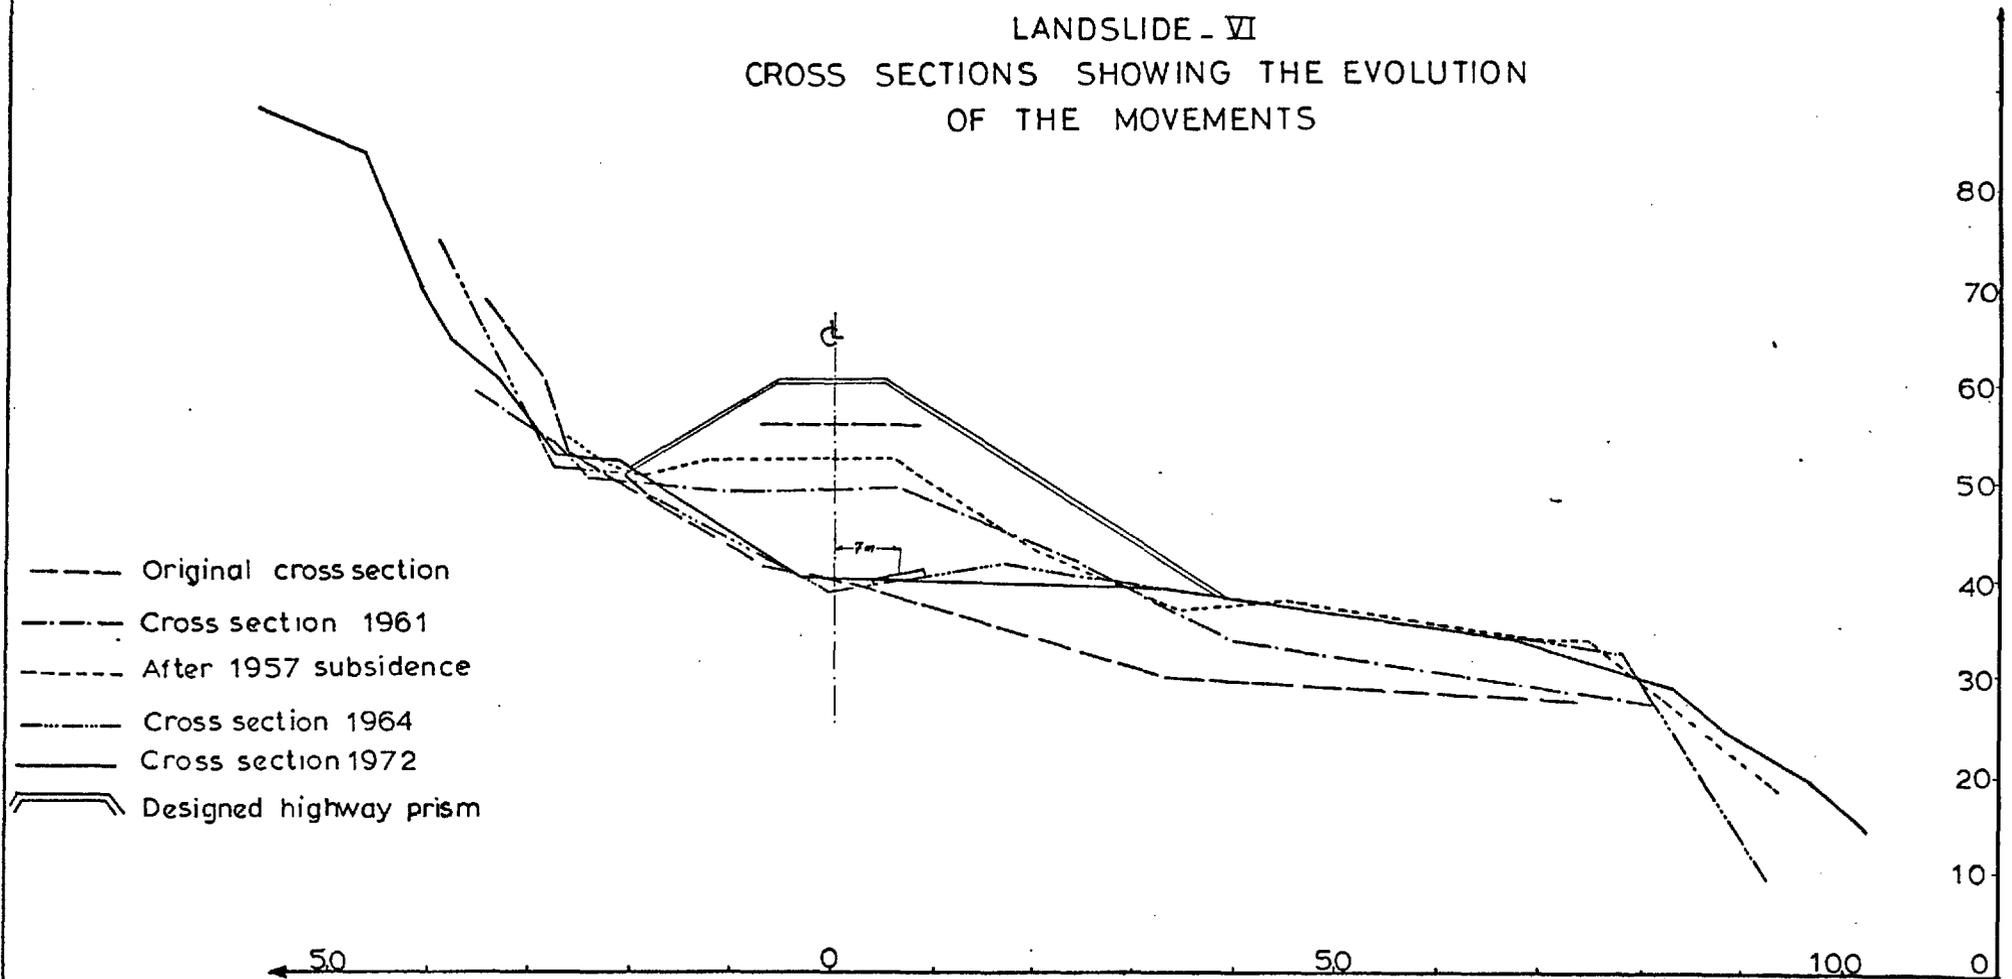
Fig(4.21)

construction of the highway in 1956 a subsidence of approximately 7.5 m vertical displacement occurred. Construction continued after repairs to the damaged section were completed. New fill was placed, but the required design height of the highway could not be reached, owing to the progressive nature of the movement. In 1957 a new movement of apparently 5.5 m vertical displacement commenced (Fig. 4.21). After the subsidence of 1957 numerous boreholes were made in the vicinity of the moved mass, but they were not deep enough to reach the undisturbed bedrock. In February 1964, following a month of 141 mm continuous heavy rainfall and 610 mm total rainfall in the winter season, the major landslide movement occurred. As a result of the translational movement the slide mass sank about 12 m at the main scarp with an outward horizontal displacement of 7 m northeast direction. The main scarp of the movement is at an elevation of 625 m, affecting all the width of the highway. The breadth of the landslide was about 245 m, and the length along the long axis is about 125 m, the axis approximately trending N74E on the west slope of Wadi Umariye. The slide mass covers an area of approximately 40,000 m². After the occurrence of the 1964 landslide, no direct indication of the progressive nature of this movement was apparent. As a result of the movement, internal disturbance in the strata and in the moved mass was

LANDSLIDE - VI
 CROSS SECTIONS SHOWING THE EVOLUTION
 OF THE MOVEMENTS

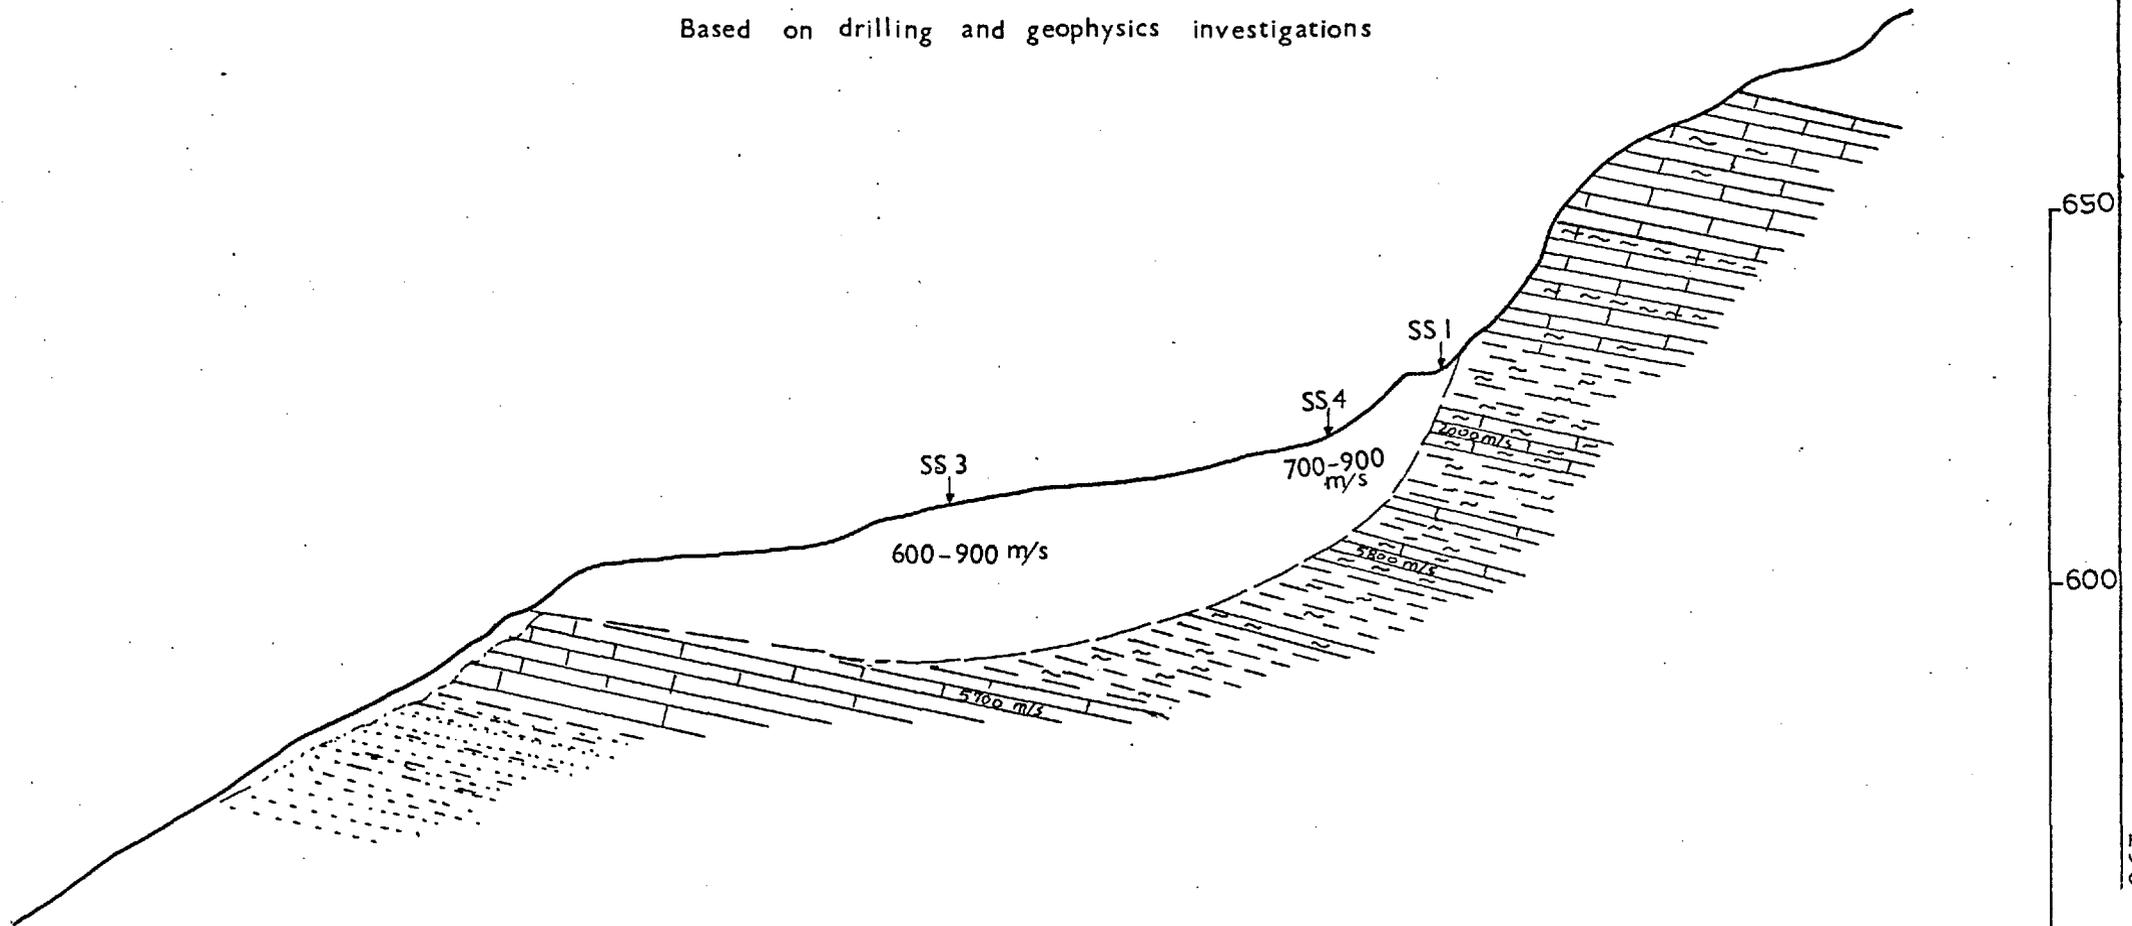
Fig(4.22)

observed, which can be a good indication of a non-circular movement. The first two-thirds of the failure surface of the landslide is in the plastic clay layers, while the last section was mainly tangential to the limestone bedrock (Fig. 4.22).

LANDSLIDE. VI
GEOLOGICAL CROSS SECTION

The simplifying assumptions, especially in respect to the geology of the site, that have been made for the purpose of stability analysis, are indicated in Fig. 4.25. The sole of the slip surface is assumed to be a curvature through the marly, clayey material and plane tangential to the limestone bedrock (Fig. 4.22).

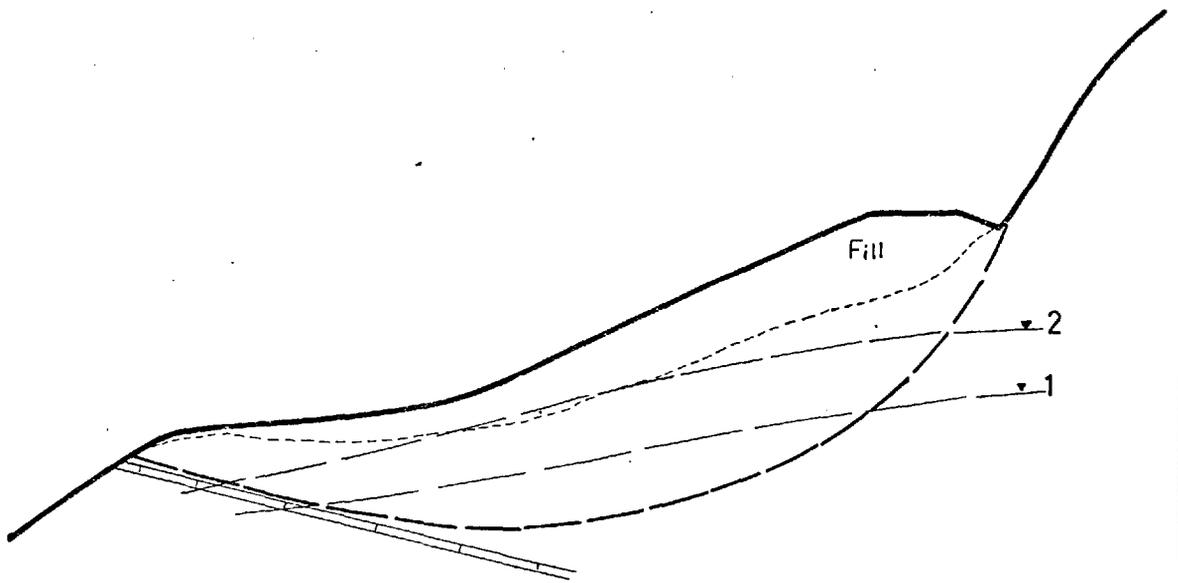
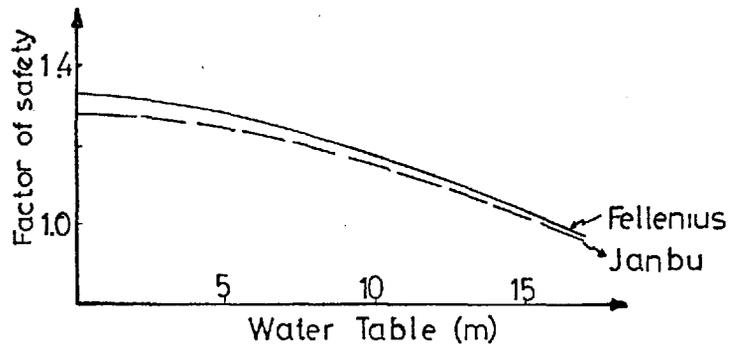
Fig(4.25)

The main stability calculations were carried out for two different assumed positions of the water table in the slope corresponding to water tables 1 and 2 (Fig. 4.25).

LANDSLIDE - VI
 CROSS SECTION PRIOR TO THE
 MOVEMENT OF 1964

Water table	Factor of safety		Remarks
	Fellenius	Janbu	
NO w.t.	1.33	1.28	Peak
1	1.23	1.21	Strength
2	1.04	1.04	Parameters

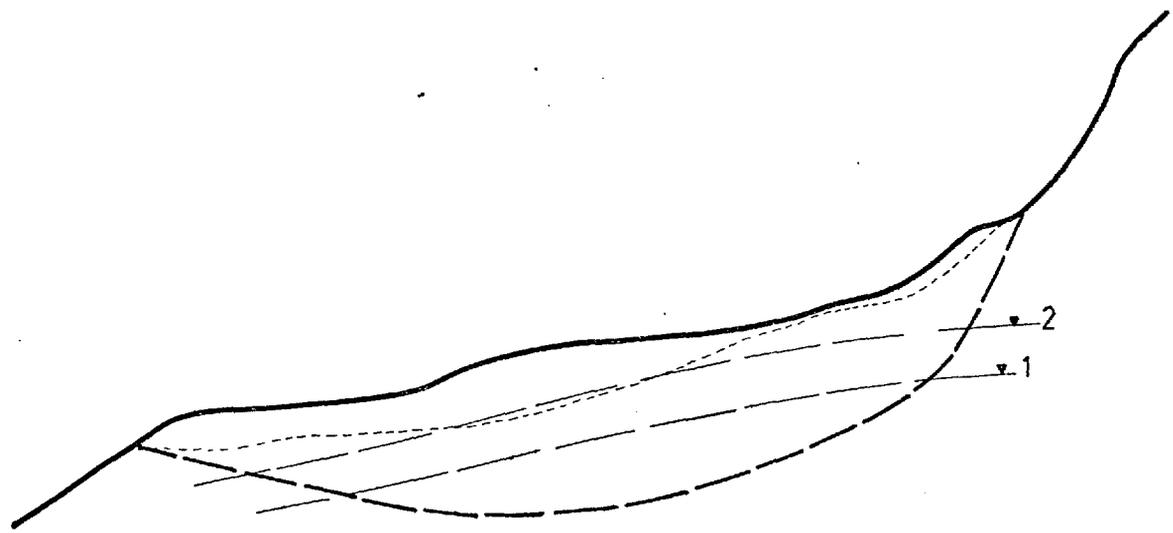
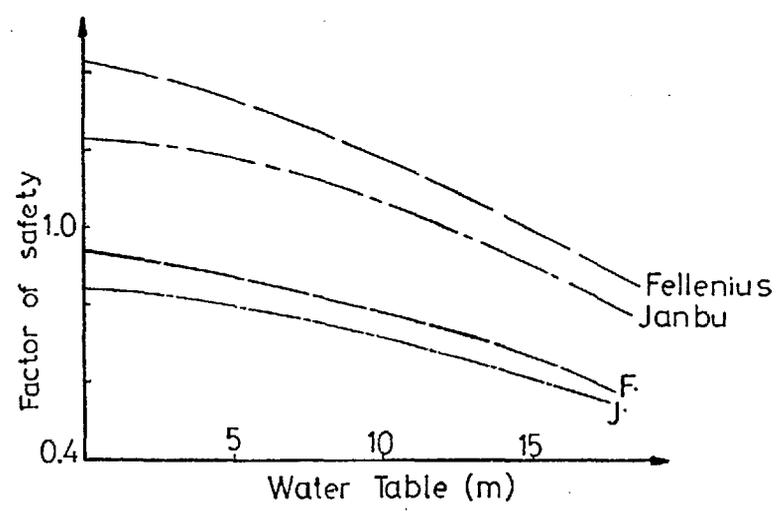
Fig(4.26)

The stability analyses of the slope in its present state (Fig. 4.26) on pre-existing failure surface, and the residual strength parameters represented by $C'_r = 0$ and $\phi'_r = 10^\circ$ show that these parameters under-estimate the factor of safety. Therefore the fully softened strength parameters represented by $C'_d = 0$ and $\phi'_p = 15^\circ$ were used in the analyses of this

LANDSLIDE VI
PRESENT CROSS SECTION
(AFTER SLIDING)

W.T.	Factor of safety		Remarks
	Fellenius	Janbu	
NO w.t.	0.95	0.85	Residual Fully soft.
1	0.82	0.77	R.
	1.23	1.12	F. S.
2	0.64	0.60	R.
	0.96	0.85	F. S.

section, again assuming no water table in the slip mass and water tables in positions 1 and 2 respectively. It was found that the factor of safety was between 1.43 and 0.85 using Janbu's method.

- (i) Increasing the resisting forces by excavating the low strength materials at the toe part and replacing them by constructing a free drainage retaining buttress founded on the underlying bedrock. This construction will also probably increase the disturbing forces of the lower part, if there are many joints in the underlying bedrock, so it may be necessary to examine the bedrock in more detail and if the bedrock proves to be highly jointed, the retaining buttress should be replaced by sheet piling.

- (ii) Stabilizing the subgrade by densifying the materials beneath the embankment.
- (iii) Grouting the area above and below the failure zone to increase the cohesion and thus the resisting forces.
- (iv) Improving surface drainage by constructing culverts and canals to divert the rainwater from the landslide area.

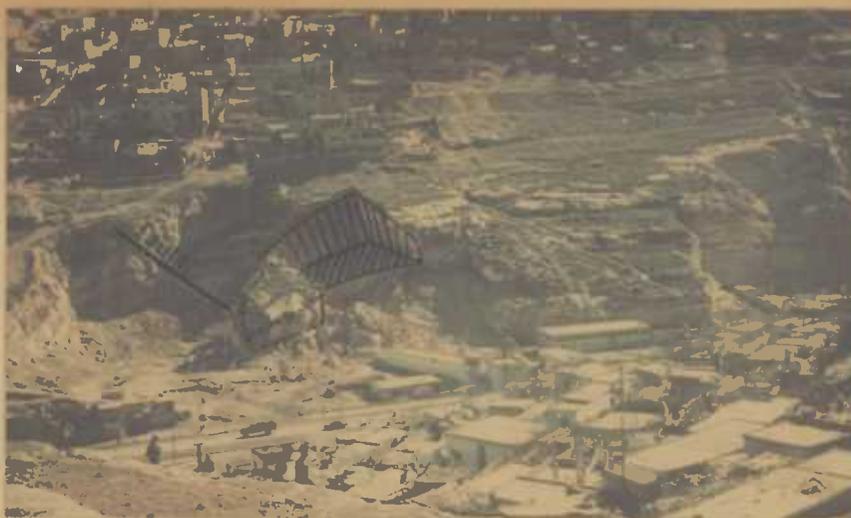
This landslide is located at Ras-El-Ain in the central part of old Amman city, along the main road to Jerusalem. The site is an old quarry for building materials. A lack of experience in blasting techniques and the undesigned cutting slopes caused disturbance of the rock mass for some extent near the surface and contributed to instability in the slopes (Plates 4.22, 4.23, 4.24 and 4.25).

Plate 4.22 Shows a general view of the study area of the landslide VII.

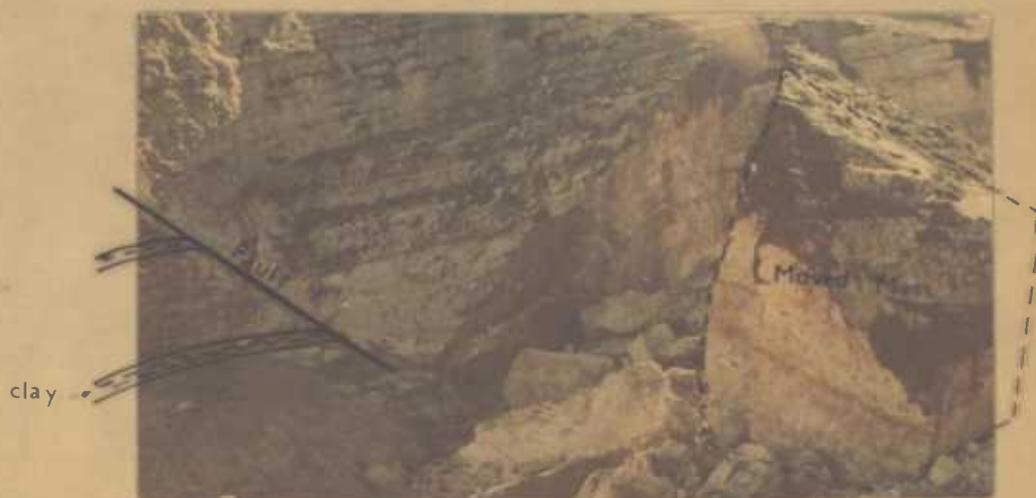
The strata in this region are mainly horizontal but they dip at 29° out of the slope in the vicinity of the failure. The change in dip is caused by the presence of a fault (Plates 4.22 and 4.23). The fault trends $N85^{\circ}E$ and dips 44° in a south easterly direction.

Plate 4.23 Shows the main features of landslide VII, (the moved mass, the faults and the clay bands).

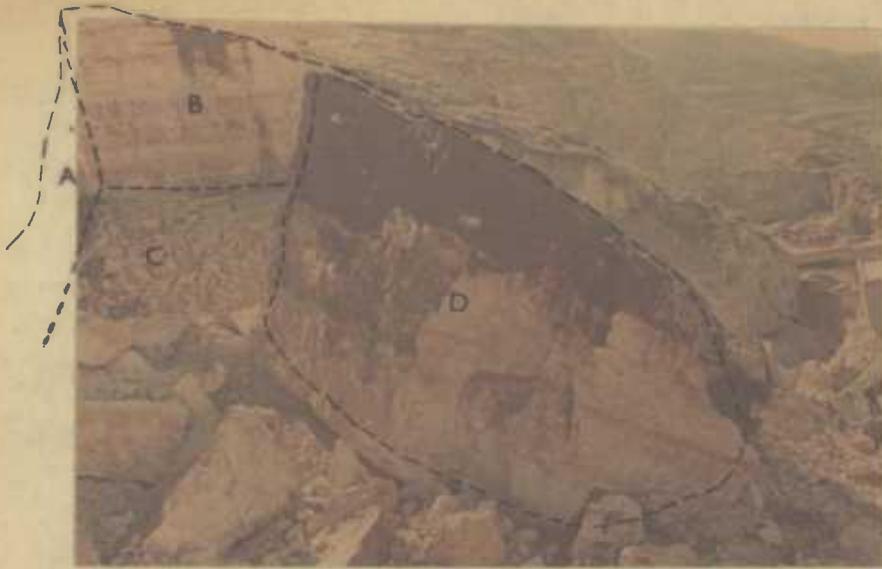
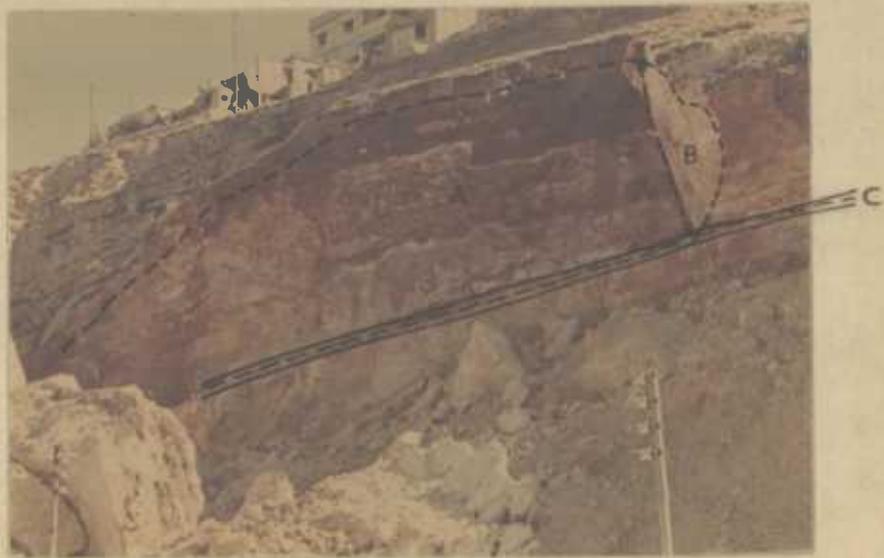
Plates 4.24 and 4.25

The bedrock in the vicinity of the landslide is limestone and marly limestones alternating with thin bands of clay and marl. The thickness of the clay bands is between 10-30 cm. The exposed face of the bedrock is highly jointed. Two joints were observed, one trending parallel to the slope dipping nearly vertical (circumferential); and other intersects the slope vertically (Plate 4.24).

Shows the old existing joint (A), the tension joint (B), then the failure surface (C) and the slipped mass (D).

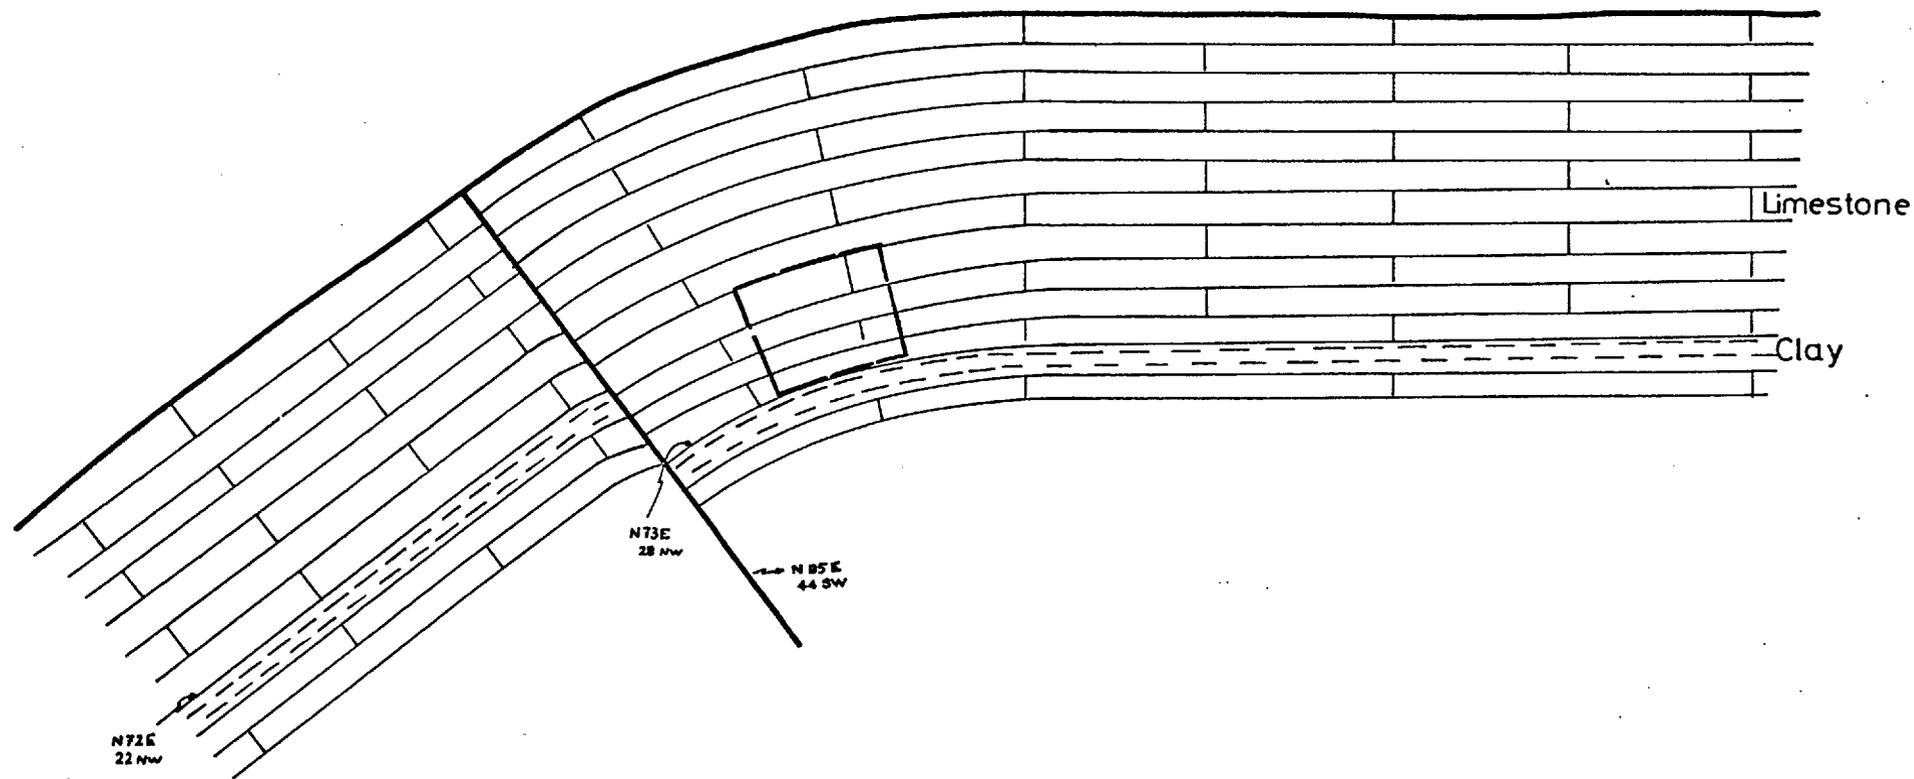
Fig(4.28)

From the plan view of the area (Fig. 4.28) it can be seen that the failure is located on the west limb of an anticline intersected by a normal fault. The hillside cutting is approximately vertical, with an average height near the face of the cutting of about 18 m. The slope is made up of five large blocks which are bounded by master joints J1, J2, J3, J4 of circumferential type and another three discontinuous joints J5, J6, J7 intersecting the slope vertically (Fig. 4.29). The bedding surface on which the block rests dips at 29° out of the slope in the direction of the movement.

SCHMATIC PLAN VIEW OF THE STUDY AREA OF
LANDSLIDE VII

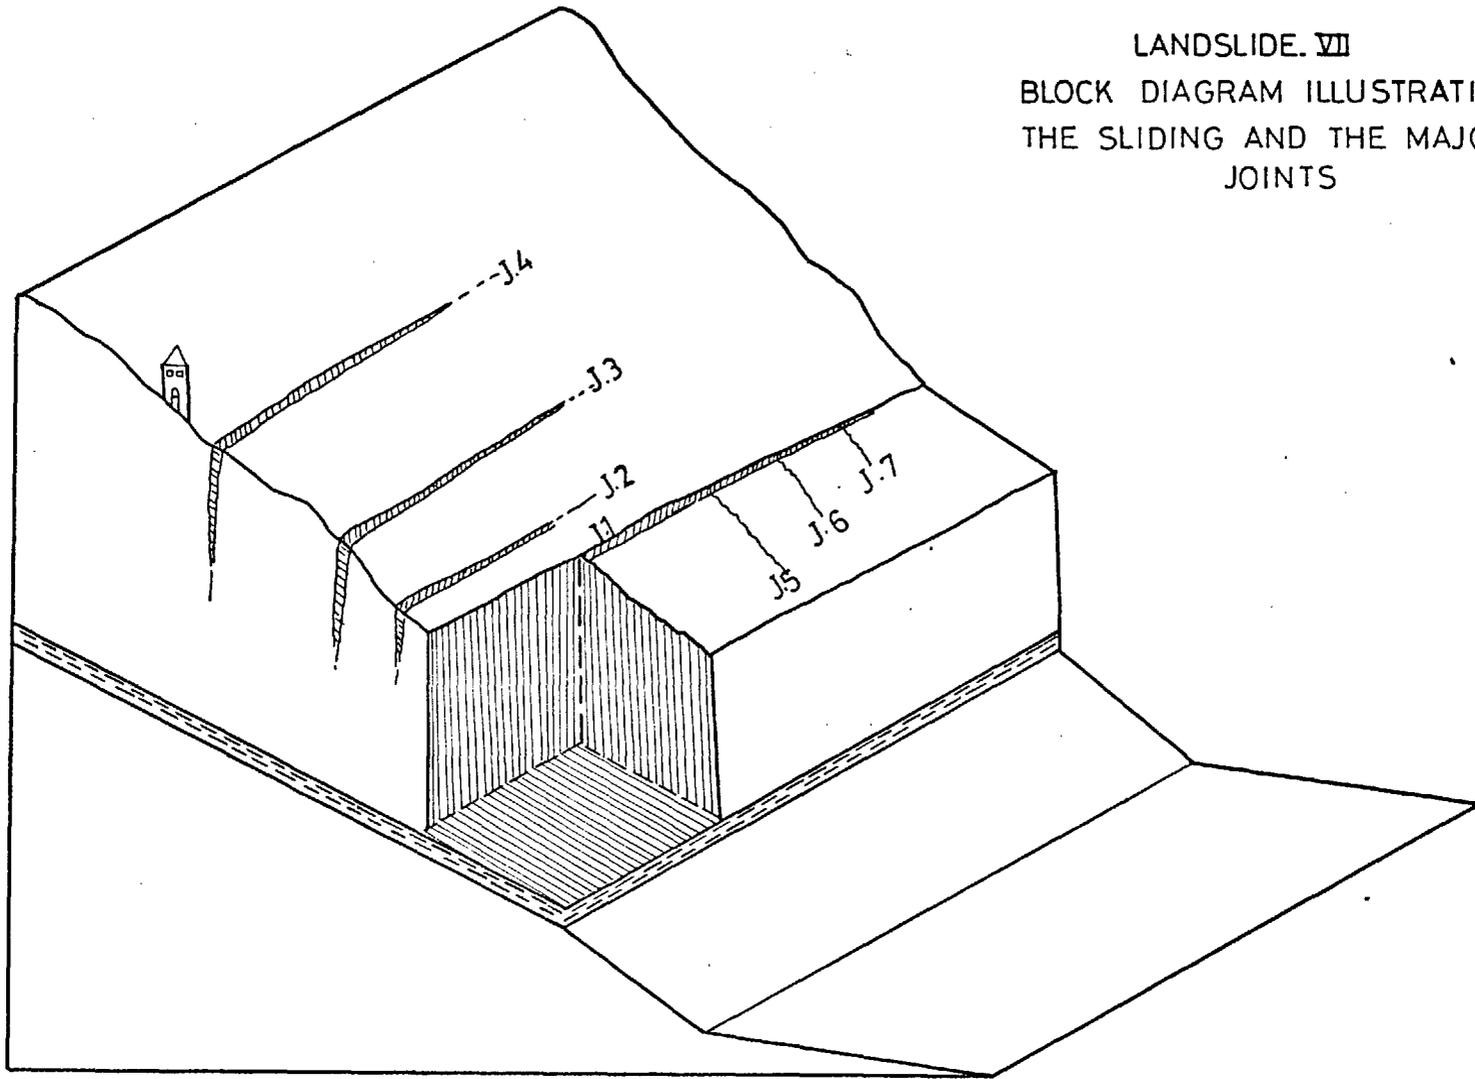
Fig(4.29)

(i) The geometry of the slope, (ii) the orientation and strength of the major faults within the rock mass, and (iii) the tensile strength of the discontinuous joints (J5, 6, 7). The most critical situation would exist when the two joint sets combined. In such circumstances the seven blocks may become separated from the main mass by a progressive opening of the backing joint owing to the lateral stress release caused by the first failure. These blocks will move along the steep inclined bedding plane on the clay band. The angle of

LANDSLIDE. VII
BLOCK DIAGRAM ILLUSTRATING
THE SLIDING AND THE MAJOR
JOINTS

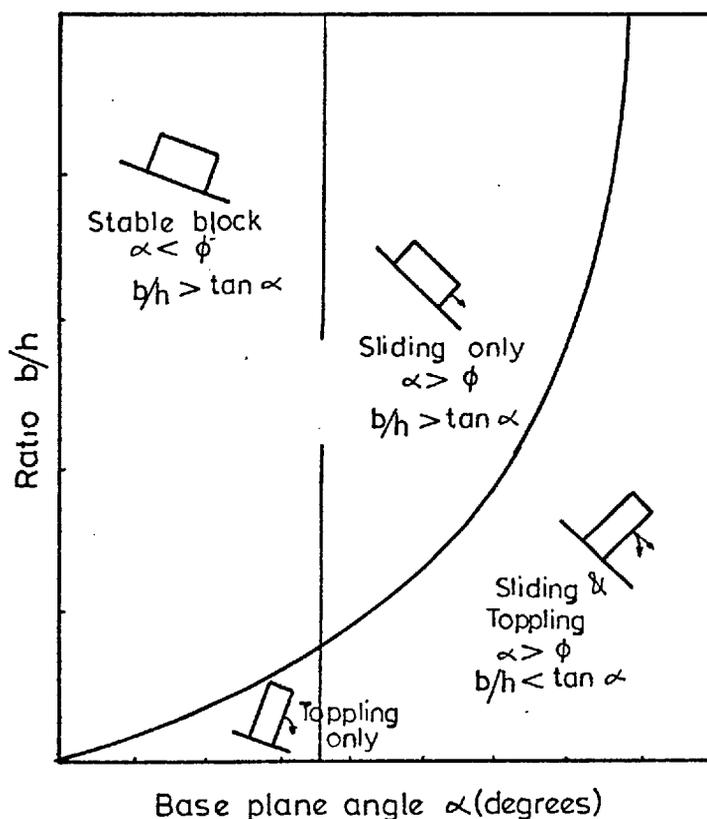
Figure 4.31

Considering the stability of the blocks ABCD and AEFB, $b/h < \tan \alpha$ and $\alpha > \phi$, thus the failure mechanism is by sliding and toppling, and also when considering the stability of the block AGHD, $b/h > \tan \alpha$ and $\tan \alpha > \phi$; sliding only can be expected (Figs. 4.31 and 4.32).

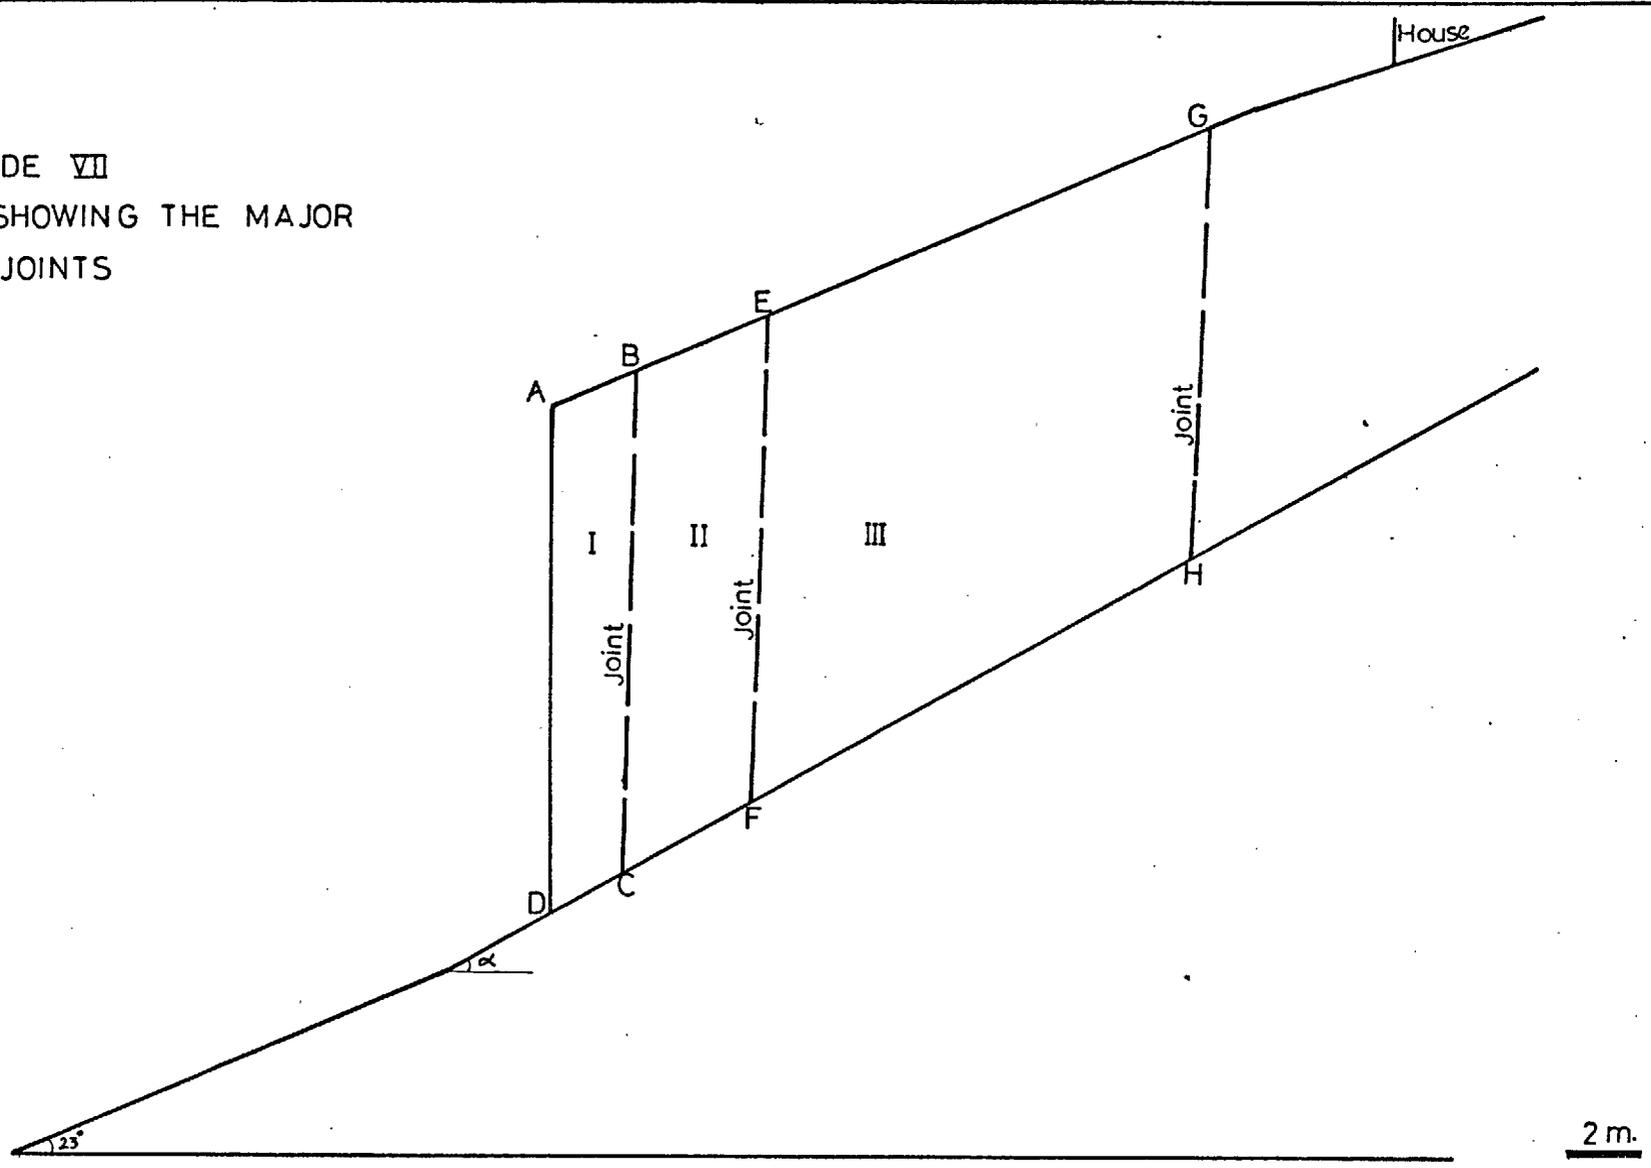
Fig (4.32)

Both equations were solved for an assumed factor of safety of 1.5, with no excess water pressures on the slide mass. The minimum bolt tensions required to stabilize the blocks ABCD, AEFD and AGHD with respect to the angle ϕ for optimum bolt inclination are 24, 192 and 352 tons respectively.

LANDSLIDE VII
CROSS SECTION SHOWING THE MAJOR
JOINTS

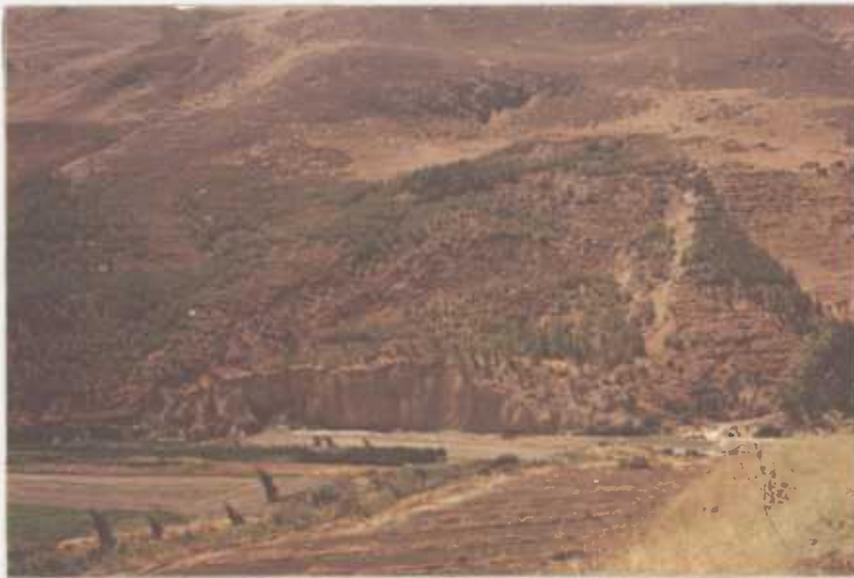
Plate 5.1 Landslide activated by the undercutting of the river near the Zerqa River bridge.

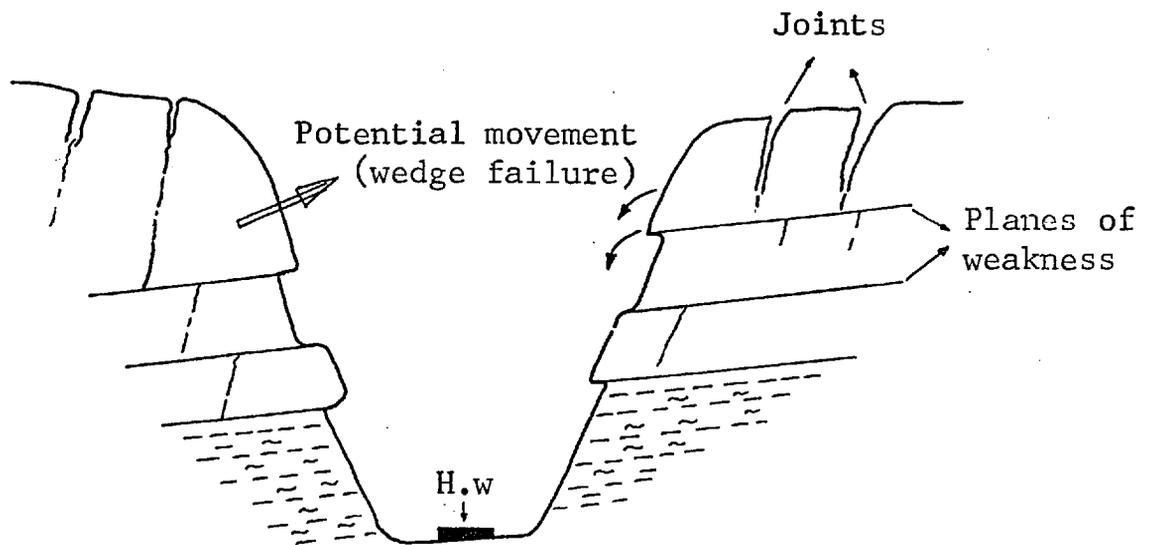
Figure 5.3

Observation point no. 4 shows a small mudflow area planted by trees. The material involved is mainly a brown soil with yellow silty clays. The average liquid and plastic limits of this soil are 50% and 25% respectively. The grain size distribution indicates that the clay percentage is as high as 60% with 20% silt, 10% sand and 10% gravel. The hillside cuttings along this section, at about 3 km from Sweileh city, show 10 metres of limestone and marly limestone underlain by an average of 5 metres of marl and clay. The dip of the strata is about 25-35 degrees out of the slope towards the highway on the right side and into the hill on the left side of the highway (Figure 5.3).

The representative joint sets dip between $60-80^{\circ}$ with a strike of N20E, N85W and N55W (Figure 5.4). The inclination of the slope is between $70-80^{\circ}$ E. The unfavourable condition regarding the dip of the strata as well as the dip of the jointing together with the steep inclination of the slope renders block sliding and toppling probable, thus endangering the traffic. These probable types of failures might occur due to the stress release after the removal of lateral support by cutting the roadway, causing successive opening of the joints.

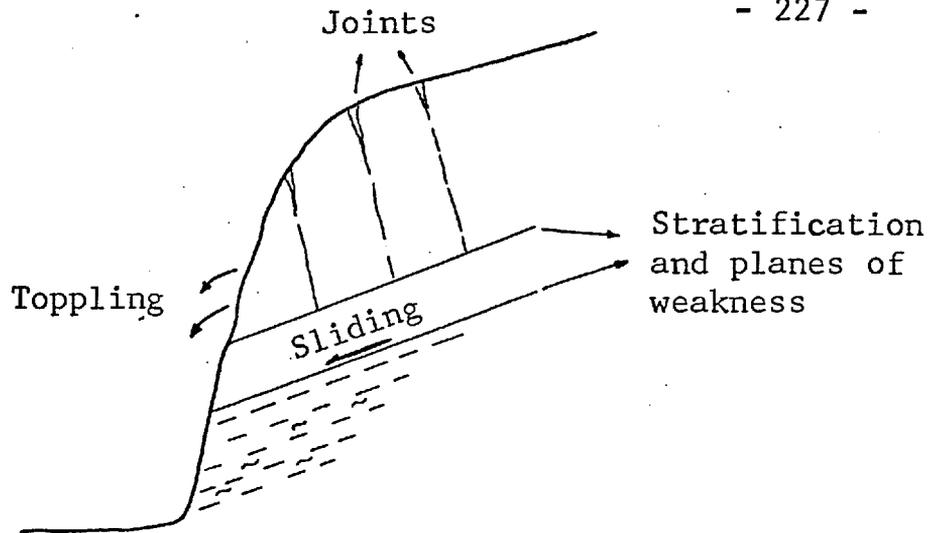
Figure 5.5

Two types of failures have been observed: (a) block sliding, and (b) toppling. The stability of this type of slope is mainly controlled by orientation and inclination of the planes of weakness relative to the slope face and the shear resistance along the discontinuities. These planes of weakness are represented by stratifications and joints within the rock mass. When the inclination of the stratification is greater than the friction angle between the block and the plane, sliding occurs, and when the vertical line passing through the centre of gravity of the block falls outside the base of the block, toppling occurs (following the idea of Hoek and Boyd), Figure 5.5.

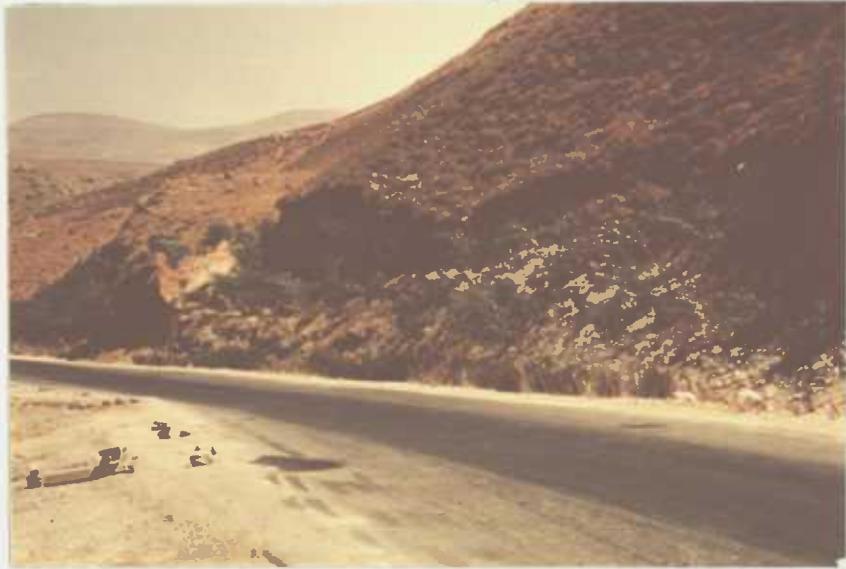
The last portion of the highway, extending from two kilometres north of Mastaba village to Jarash city, between key points D and E, is mainly in a steep hillside cutting within the Upper Kurnub group. Many different types of instability including cracking and subsidence in the pavement, earth and mudflows, in addition to major progressive landslide movements. Observation point 14:- Earth and mudflow within the silty clayey material. Plate 5.2.

Plate 5.2 Earth and mudflow within the silty clayey materials along the Sweileh-Jarash road (observation point 14).

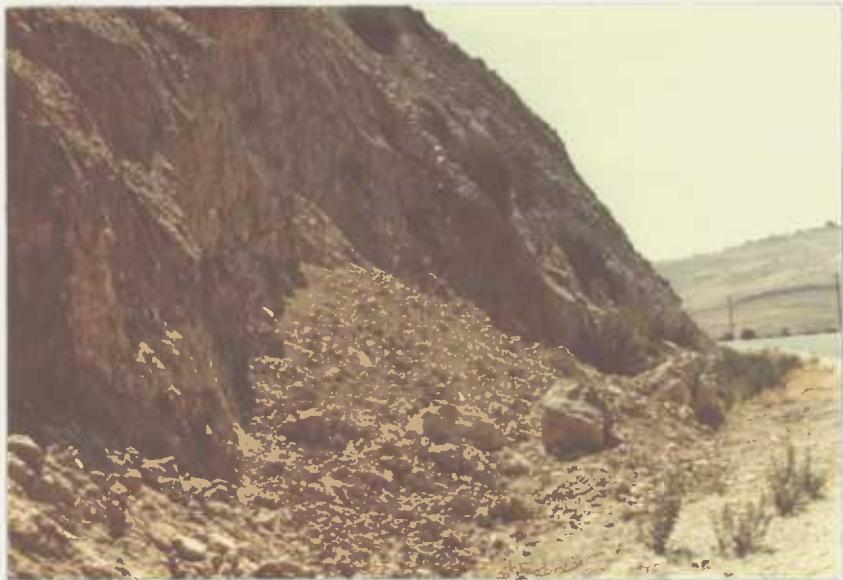
Plate 5.3 Earth fall along the Sweileh-Jarash road.
