SLOPE INSTABILITY ON THE JORDANIAN HIGHWAYS

Thesis submitted to the University of London
for the degree of Doctor of Philosophy in
Engineering Geology.

October, 1974.

Engineering Geology Division,
Imperial College of Science and
Technology,
London S.W.7.

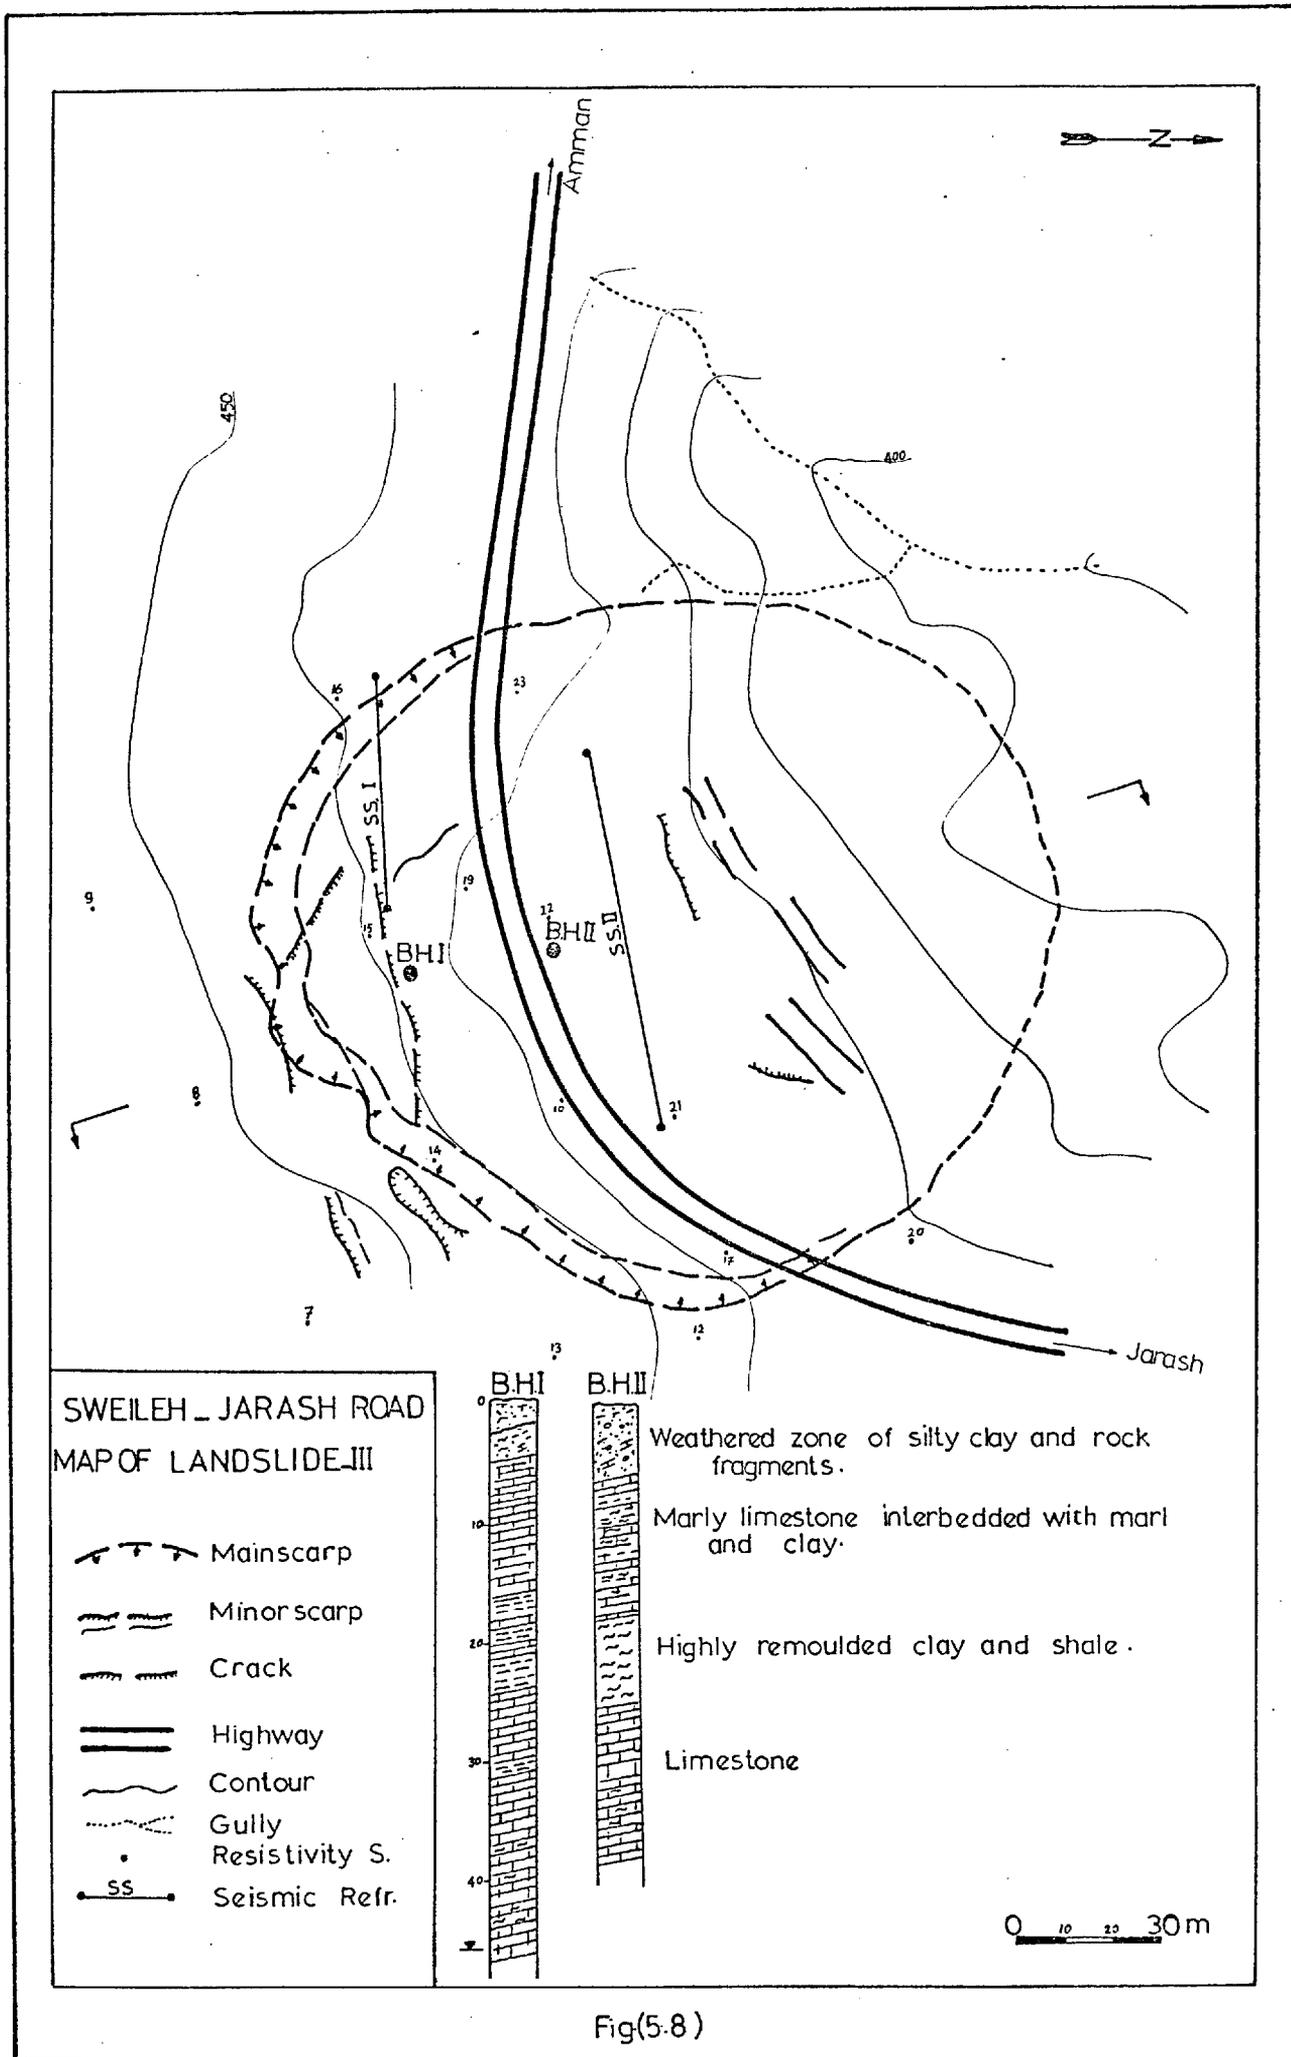
Fig(5-8)

The recent landslide III occurred in an area of an old landslide which covers a total area of about 370,000 m². The main scarp of the new landslide is at an elevation of 445 m, about 25 to 45 m from the existing highway which is here at an elevation of 428 m (Plate 5.4 & Figure 5.8).

The core samples obtained from the first 20 m of these boreholes were intensely jointed marly limestone with slickensides and polished surfaces, together with remoulded marl and clay. The water content of materials in this zone increases with depth from 22% to 30%. The strata between 20-21.7 m are highly disturbed, being composed of marly limestone and marls with a 25% water content. 3 m below this level the strata are remoulded to very soft marl and clay with cavities observed during the drilling. Hard limestone was located at a depth of about 24 m interbedded with thin bands of marl and clay; the natural water content of these bands is as low as 12%. A typical profile of the boreholes in the slide area is shown in Figure 5.8.

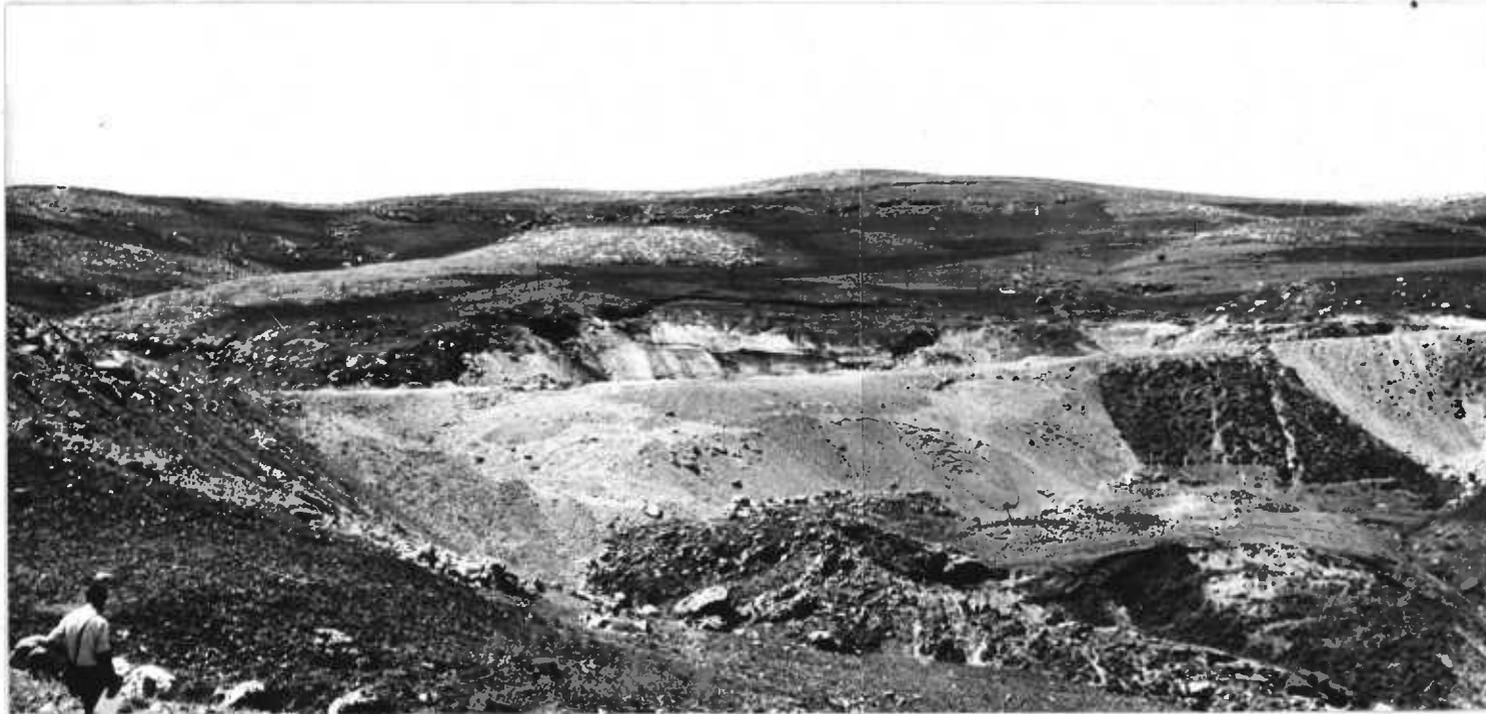
Plate 5.4 General view of the landslide III in 1969.

The breadth of the slide was about 160 m measured along the highway, and the length along the long axis about 170 m, the axis trends about N 20° W. The slide mass comprised a total volume of about 400,000 m³, and covers an area of about 15,000 m², which is 1/20th of the ancient landslide area. The surface of slide mass was relatively wet during the movement, the mass consisting of clay and weathered rock fragments ranging in size from clay to boulders. The soil is yellowish-brown, with large included marlstone and marly limestone boulders.

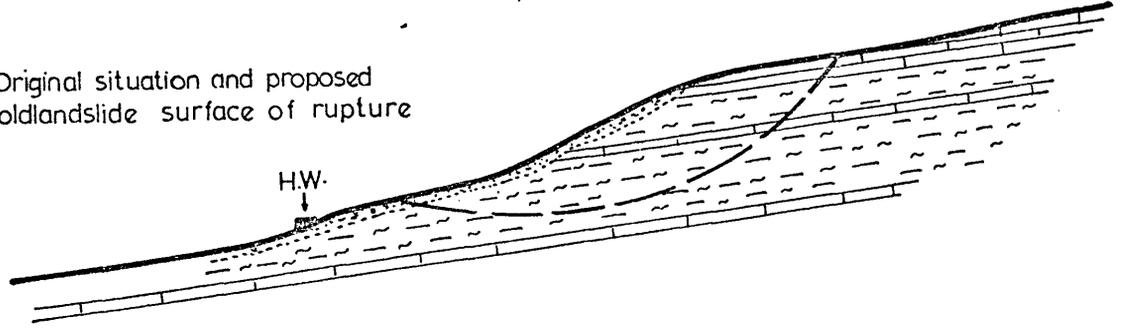
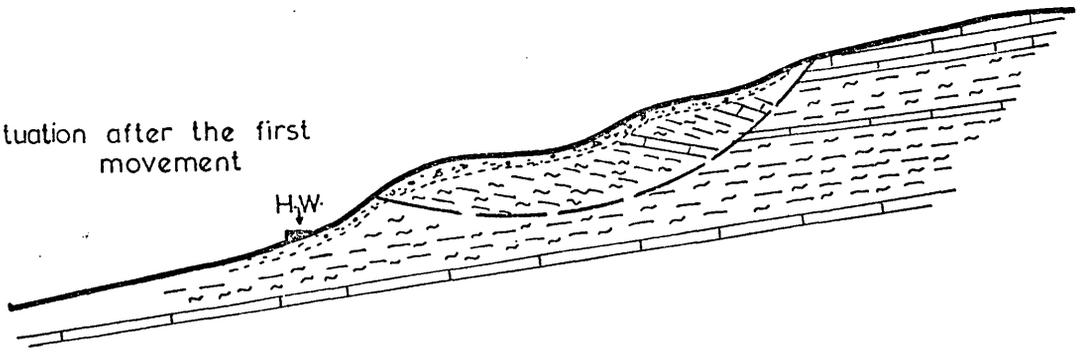
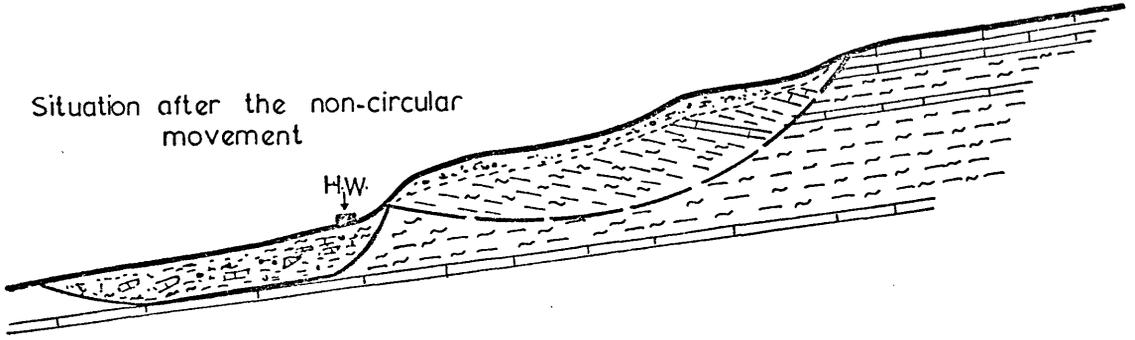
SWEILEH - JARASH ROAD LANDSLIDE III PROPOSED EVOLUTION OF MOVEMENTS (PRINCIPAL SKETCHES)

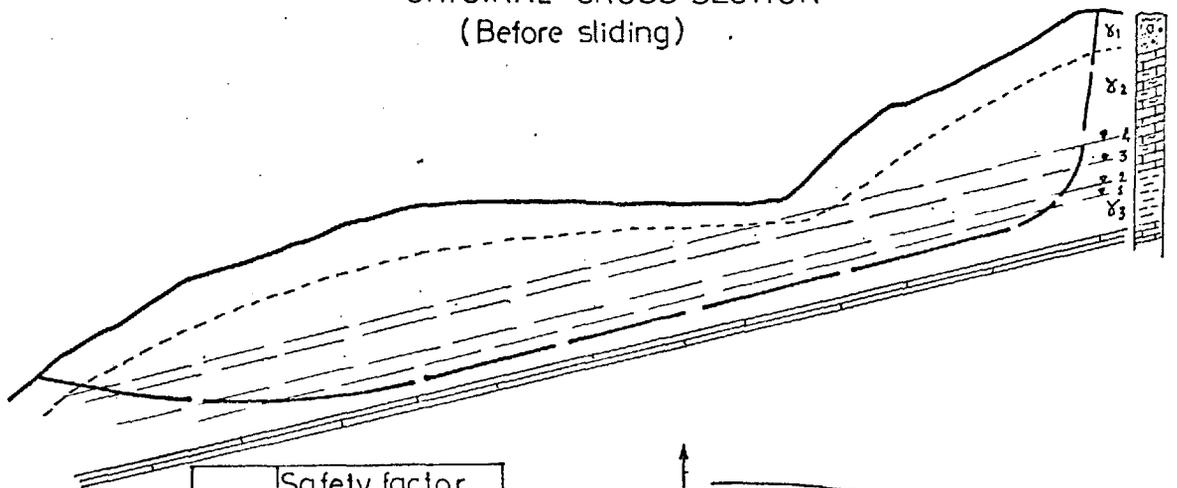
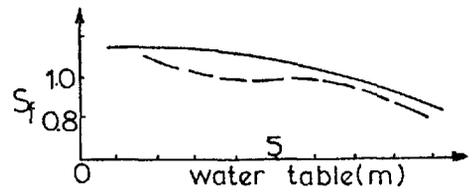
Fig(5.17)

Stability analyses for the original cross sections (prior to the movement) were carried out using peak strength parameters in terms of effective stresses, and assuming transient perched water tables in positions 1, 2, 3, 4 respectively at the time of failure during a heavy rainfall

(Fig. 5.17). It was found that the safety factor using Janbu's method ranged between 0.89 and 1.155 and by Fellenius's method between 0.89 - 1.15. It can be seen clearly that the movement would have occurred for a transient water table in position 3, when the factor of safety is equal to unity for both methods. The perched water table was found by the drilling at a depth of 46 m.

W.T.	Safety factor	
	Fellenius	Janbu
1	1.15	1.155
2	1.11	1.007
3	1.036	0.996
4	0.89	0.827

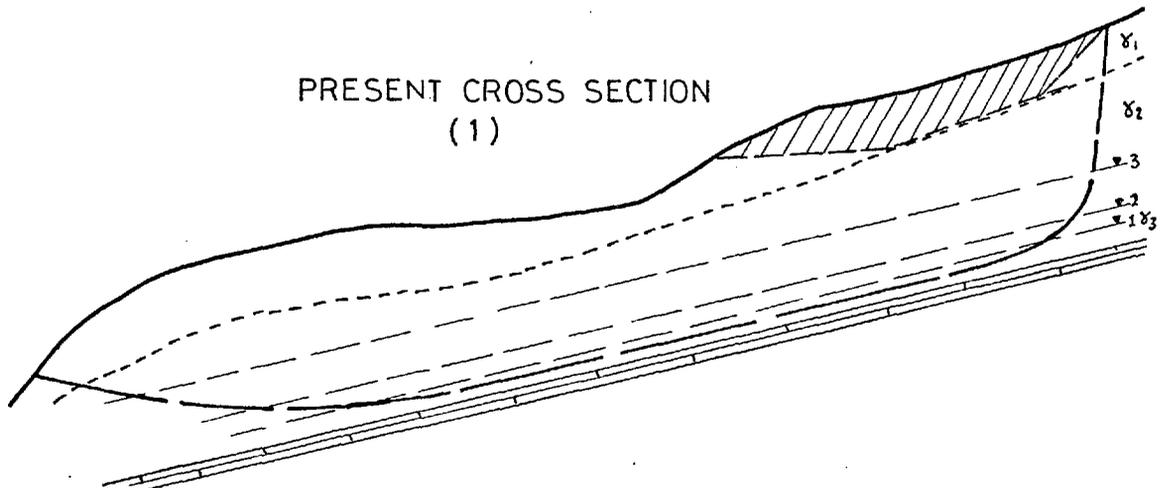
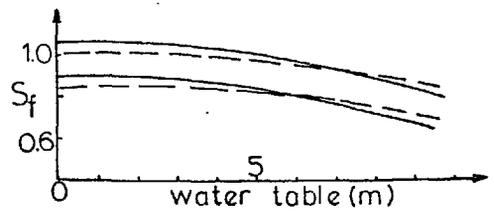
Fig(5.18)

For cross section 1 with a pre-existing slip surface and assuming no excess water pressures on the slip surface and water tables in positions 1, 2, 3 it was found that the factor

W.T.	Safety factor		Remarks
	Fellenius	Janbu	
No	1.08	1.002	c_r & ϕ_r
W.T.	0.92	0.86	$c_r=0, \phi_r$
		1.062	$c=0, \phi_r=13^\circ$
1	1.08	1.001	c_r & ϕ_r
	0.914	0.845	$c_r=0, \phi_r$
2	1.048	0.985	c_r & ϕ_r
	0.878	0.813	$c_r=0, \phi_r$
3	0.85	0.862	c_r & ϕ_r
	0.68	0.695	$c_r=0, \phi_r$

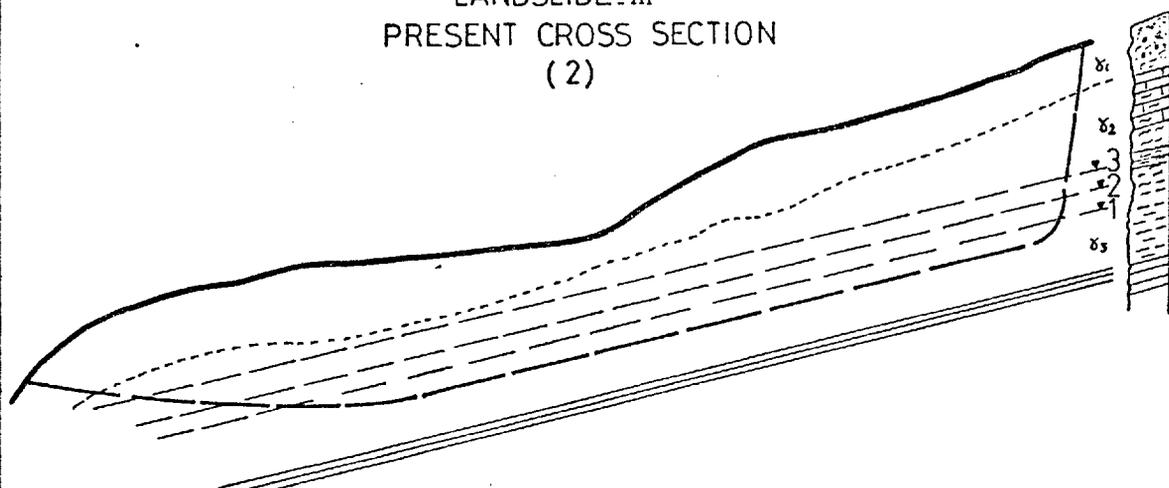
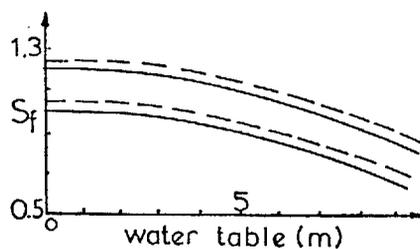
Fig(5.19)

For cross section 2, Fig. 5.19, the failure surface is assumed to be shallower than the original slip surface, and assuming no excess water pressures on the slip surface, and water tables in positions 1, 2, 3 and using the same shear strength parameters, it was found that the factor of safety by Janbu's method ranged between 0.994 - 1.26 for $C'r = 0.12 \text{ Kgf/cm}^2$, and $\phi'r = 10^\circ$, and 0.79 - 1.046 for $C'r = 0$, and $\phi'r = 10^\circ$. These values are 3-4% higher than the factors of safety obtained by the Fellenius method.

The stability analyses clearly show that the slopes remain in a critical state with regard to further movement and

W.T.	Fellenius	Janbu	c_r & ϕ_r
no w.t.	1.22	1.26	$c_r=0$
1	1.176	1.223	c_r & ϕ_r
	0.97	1.12	$c_r=0$
2	1.13	1.17	c_r & ϕ_r
	0.93	0.96	$c_r=0$
3	0.93	0.994	c_r & ϕ_r
	0.73	0.79	$c_r=0$

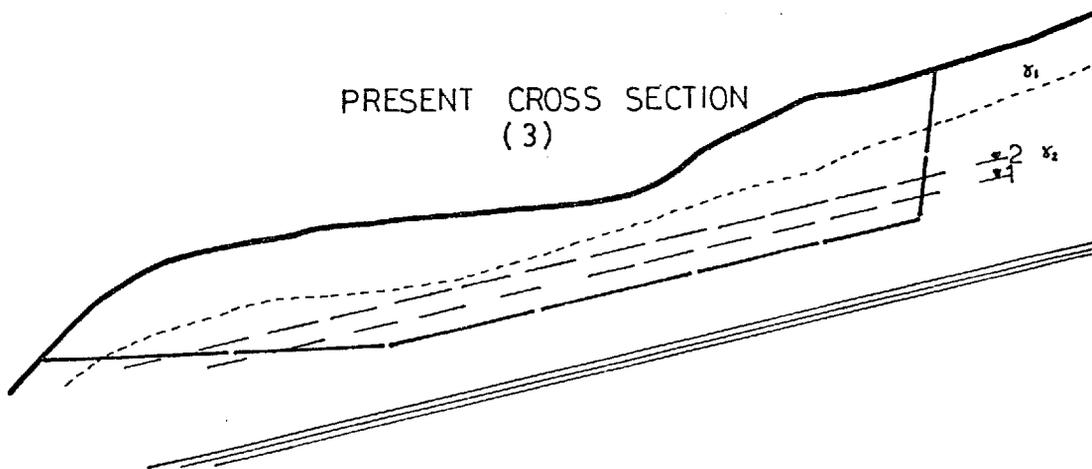
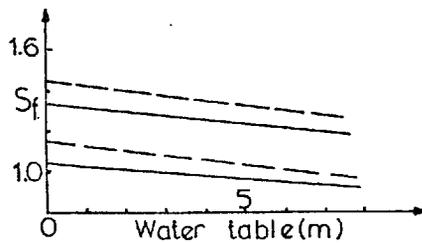
Fig(5.20)

Using cross section 3, Fig. 5.20, assuming an even shallower failure surface with no excess water pressure and water tables in positions 1, 2 it was found that the factor of safety by Janbu's method was in the range of 1.040 to 1.15 using $C'r = 0$ and $\phi'r = 10^\circ$, and 1.334 - 1.45 using $C'r = 0.12 \text{ Kgf/cm}^2$, and $\phi'r = 10^\circ$. These values are about 8-12% higher than the factors of safety obtained by Fellenius method.

W.T.	Fellenius	Janbu	c_r & ϕ_r
No W.T.	1.35	1.45	c_r & ϕ_r
	1.06	1.15	$c_r=0$
1	1.27	1.39	c_r & ϕ_r
	1.0	1.10	$c_r=0$
2	1.246	1.334	c_r & ϕ_r
	0.976	1.04	$c_r=0$

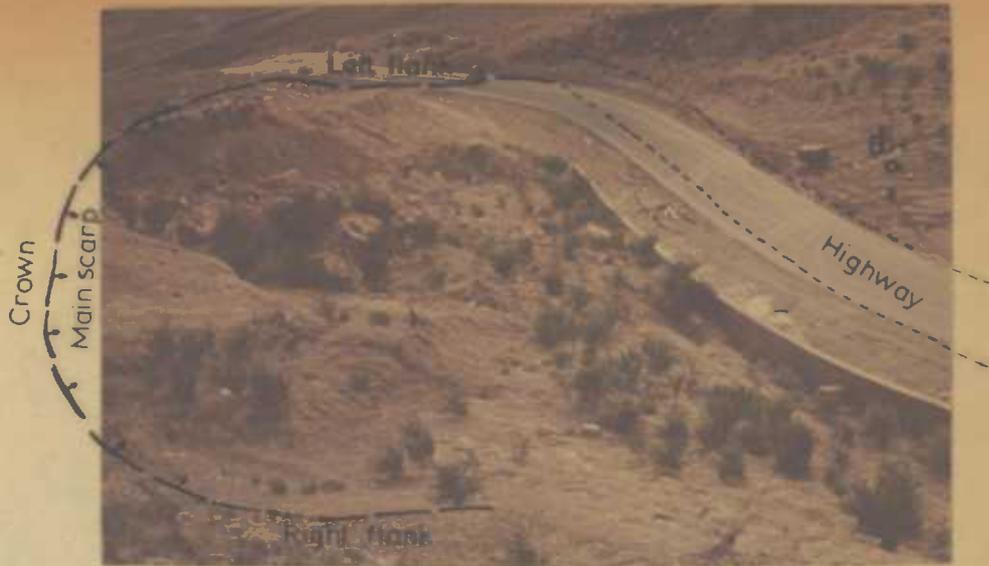
Faulting phenomena are a dominant element in the structural geology of the area. The change of dip and lithology at the south-eastern side of the landslide area (at or near the left flank of the landslide), is the result of the shear fault; in addition the strata in the vicinity of the backslope of the landslide show evidence of structural deformation (Plate 5.7 and 5.8).

Plate 5.8 The main features of the upper part of landslide IV.

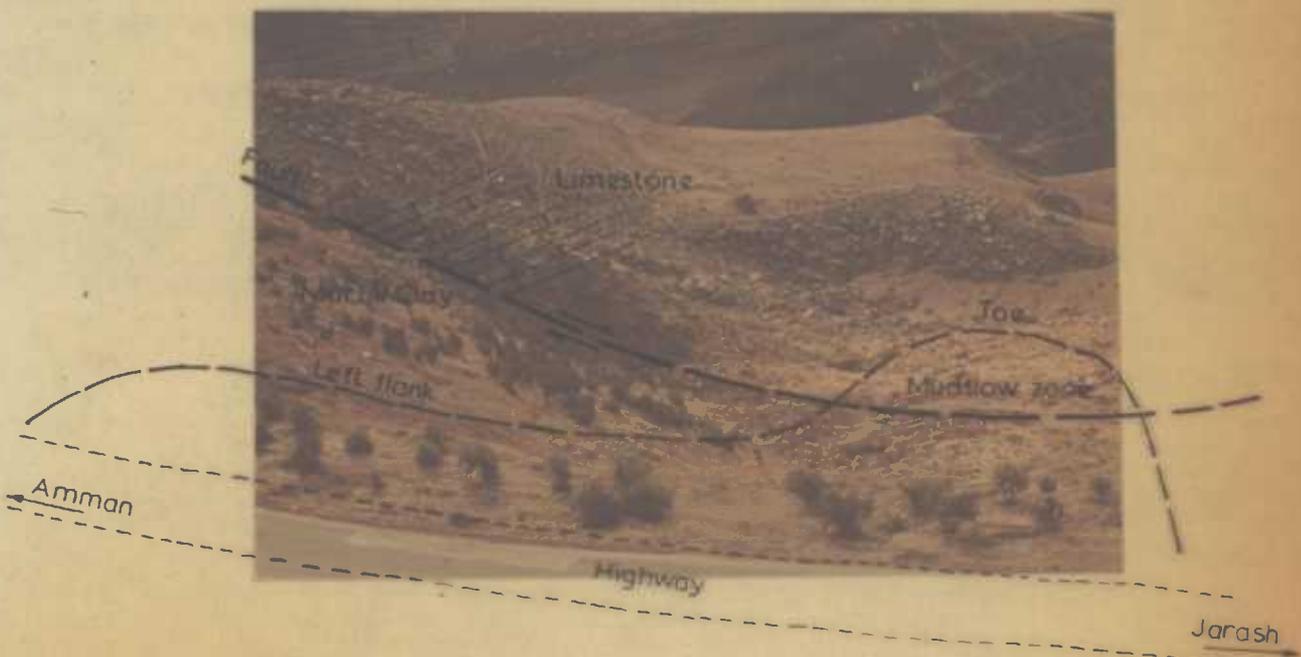
The landslide is on the left flank of a North-South trending anticline, intersected by a NW-SE striking major shear fault, which passes through the landslide zone (Figs. 5.21, 5.1, and Plate 5.7).

Plate 5.7 The main features of the lower part of landslide IV including simplified geology.

The bedrock in the region of the landslide area consists of the marl-clay unit of the lower Ajlun group (A1, 2, 3). The present movement occurred within the A1, 2 formation, near to its contact with A3. The main scarp of the landslide is located in the A2 area. The strata strike almost parallel to the highway. The A3 bedrock is exposed at the southern flank of the present landslide, whilst the north flank is mainly composed of clay and marl (Plate 5.7).

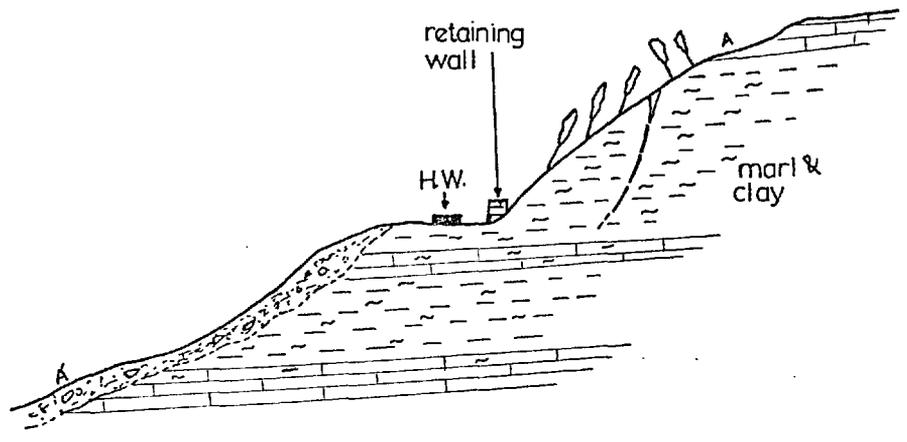
Fig(5.23)

Recently many tension cracks have been observed near the crown of the landslide and in the concrete retaining wall (Plate 5.9). In addition the trees planted behind the retaining wall shifted and curved backward near the crown, indicating that continuation of the movements is occurring (Fig. 5.23, schematic cross section and Plate 5.10).

Schematic cross section showing the trees shifted and curved backward near the crown indicating the movement is in progress.

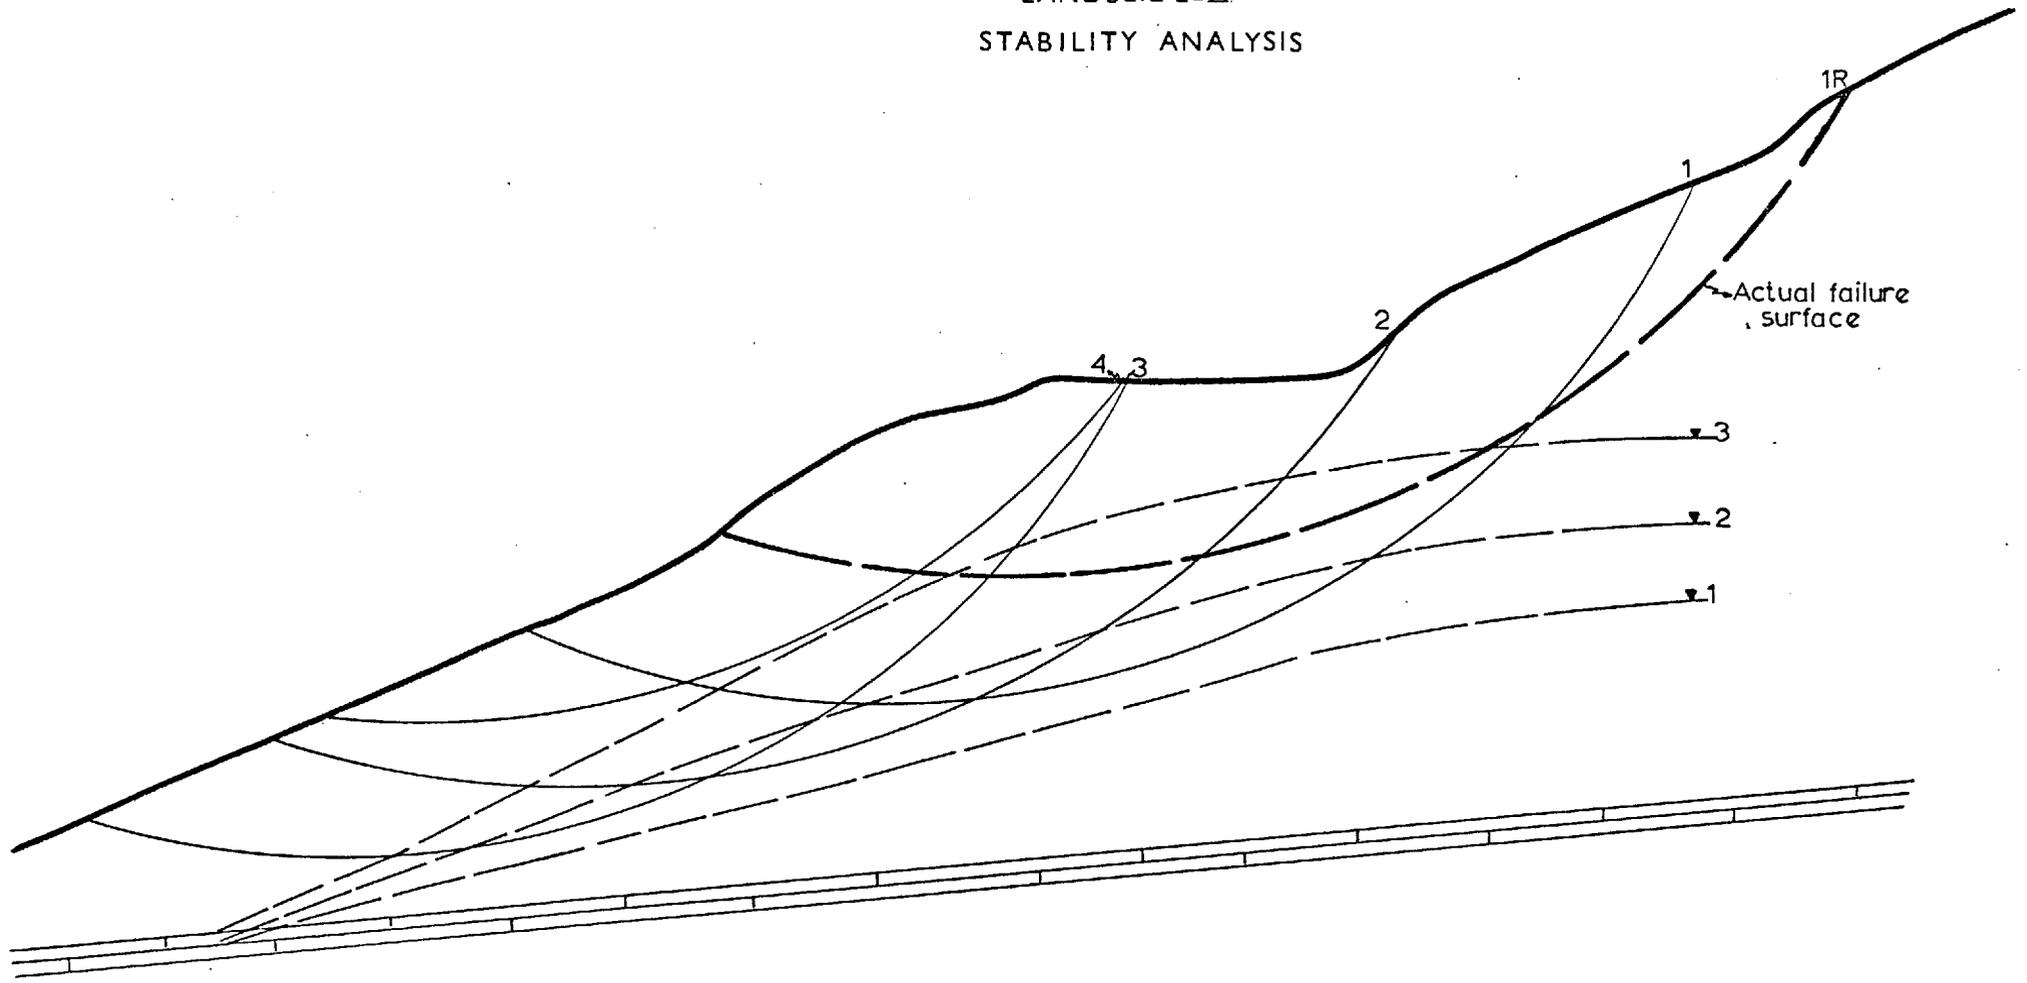
Fig.(5.26)

Stability analysis in terms of effective stresses in the form derived by Bishop (1954) were carried out on the present cross section shown in Fig. 5.26. The calculations were made assuming three positions of transient water tables at the time of failure, during periods of heavy rainfall. Residual strength parameters represented by $C'_r = 0.12 \text{ Kgf/cm}^2$ and $\phi'_r = 9.5^\circ$ were used for the actual slip surface (IR). The factors of safety were found to be 0.94 and 0.88 for

To analyse the stability of the present slope, trial circles 1, 2, 3 and 4 were chosen (Fig. 5.26) and the peak, fully softened, and combination parameters were used. It was found that the peak strength parameters represented by $C'_p = 0.26 \text{ Kgf/cm}^2$ and $\phi'_p = 16^\circ$ overestimate the safety factor (Fig. 5.27). The stability analysis was also carried out using fully softened strength parameters represented by $C'_d = 0.18 \text{ Kgf/cm}^2$ and $\phi'_d = 11.5^\circ$, with the same three positions of the water tables acting on the slip surface. For this case it was found that the factors of safety ranged between 0.83 and 0.93 for the highest positions of water table 2, and was in the range of 0.90 and 1.10 assuming no water pressures on the slip surface.

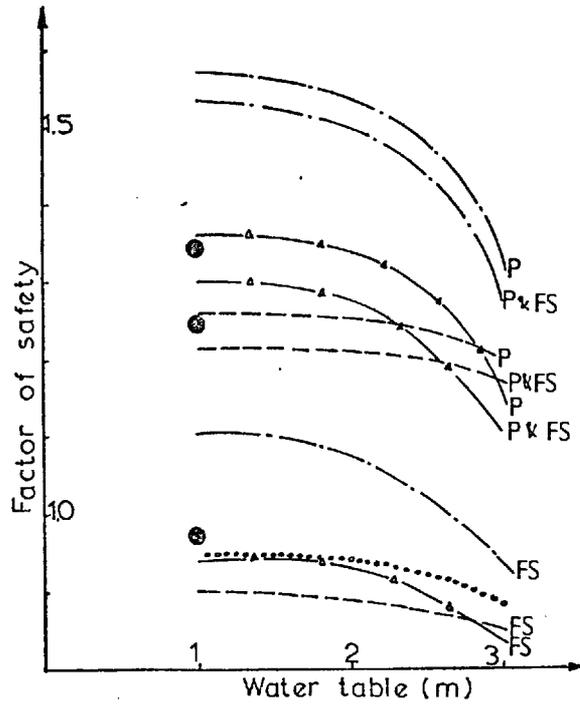
LANDSLIDE-IV RESULTS OF THE STABILITY ANALYSIS

The same analyses were also made using a combination of strength parameters; the fully softened parameters were used along the portion of the trial circle which goes through the landslide mass while peak strength parameters were used along the rest of the trial circles which go through the intact part of the material. It was also found that this type of analysis over-estimated the factor of safety for this particular area. The result of the analysis is shown in Fig. 5.27.

CIRCLE NO.	PARAMETER	NO WATER TABLE	WATER TABLE (2)	WATER TABLE (3)
1R	Residual	0.94	0.94	0.88
1	P	1.57	1.54	1.31
	FS	1.10	1.08	0.93
	P & FS	1.53	1.50	1.27
2	P	1.36	1.34	1.15
	FS	0.94	0.94	0.83
	P & FS	1.30	1.28	1.10
3	P	1.26	1.25	1.20
	FS	0.90	0.89	0.85
	P & FS	1.23	1.21	1.20
4	P	1.35		
	FS	0.97		
	P & FS	1.25

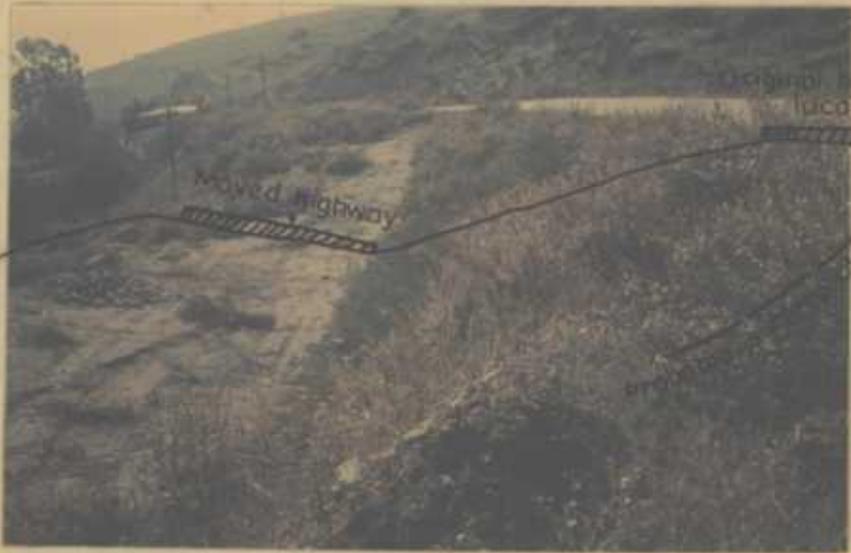
The first movement commenced in December, 1966 (Plate 5.11) after a period of continuous heavy precipitation of 612 mm and 191 mm during December. The total December precipitation was approximately 2.5 times the monthly average for the ten preceding years' record. The month during which the second

Plate 5.11 Showing the moved highway after the movement of 1966 - landslide I.

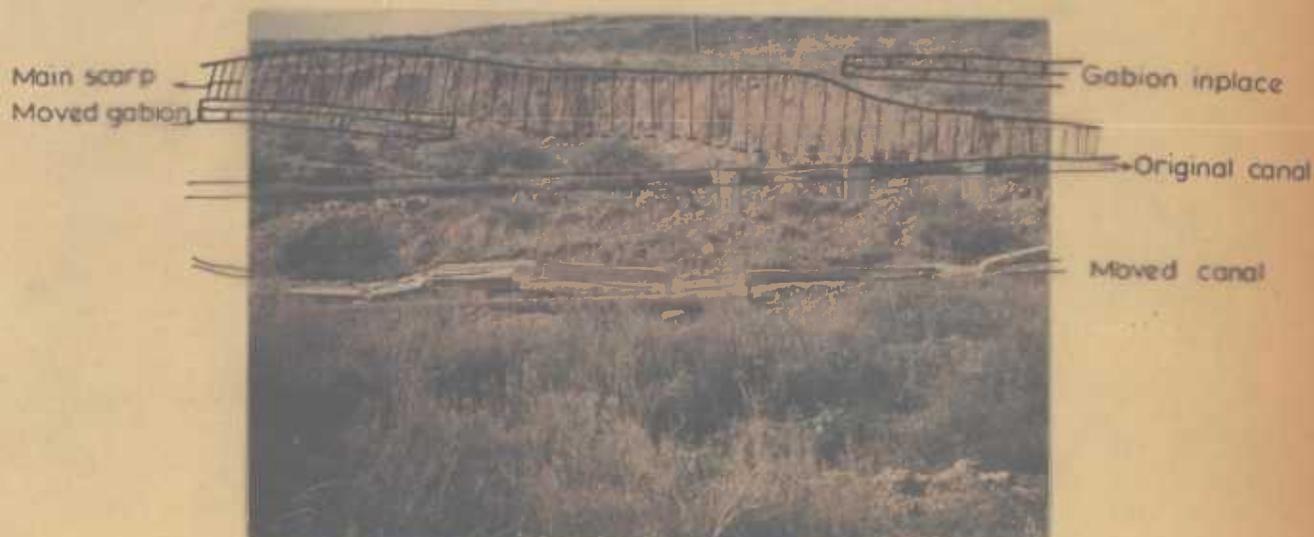
Immediately after the first movement commenced in December 1966, the Ministry of Public Works started reconstruction of the affected section of the highway, but did not undertake an investigation into the main causes and the probable future activation of the movement. Approximately four years later, in April 1971, following a month of 211 mm heavy precipitation a new circular landslide took place, which affected the main irrigation canal which supplies the farms south of the area (Plates 5.12 & 5.13). In the upper part of the landslide there is little disturbance but the toe part shows earth and mudflow. The length of the movement along the long axis was approximately 100 m, with a breadth of 110 m and 3 metres near vertical

Plate 5.12 Main features of the 1971 landslide, showing the moved irrigation canal at the main scarp of landslide I.

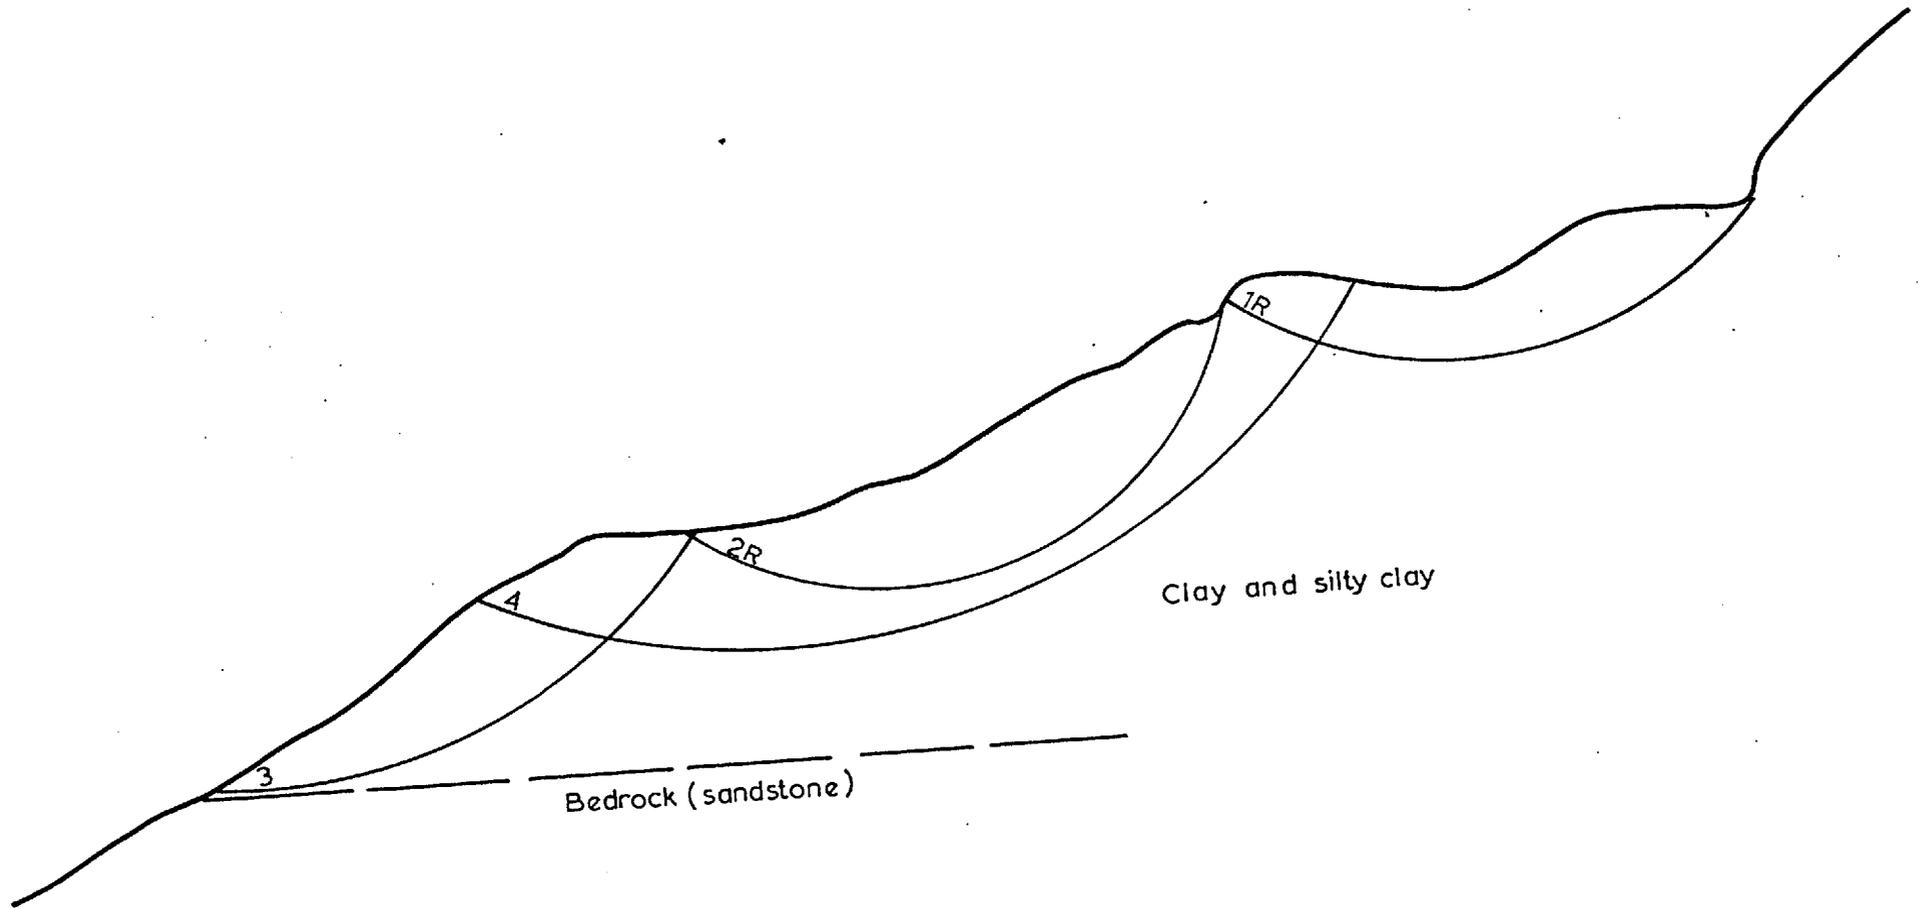
Fig(5.32)

slope. To analyse the stability of the slope in its present state, cross section (Figure 5.32) was chosen; the fully softened strength parameters represented by $C'_d = 0$ and $\phi'_d = 20^\circ$ were used in the form derived by Bishop (1954). The average wet bulk density of the material, 1.89 g/cm^3 , was used in the analysis. Three trial circles were chosen to be analysed. It was found that the factors of safety 1.07, 0.72 and 1.12 for circles 2, 3 and 4 apply respectively.

In the light of the above analysis, it was found that the slope remains unstable with regard to any further softening which may occur arising from the percolation of the precipitation or irrigation water.

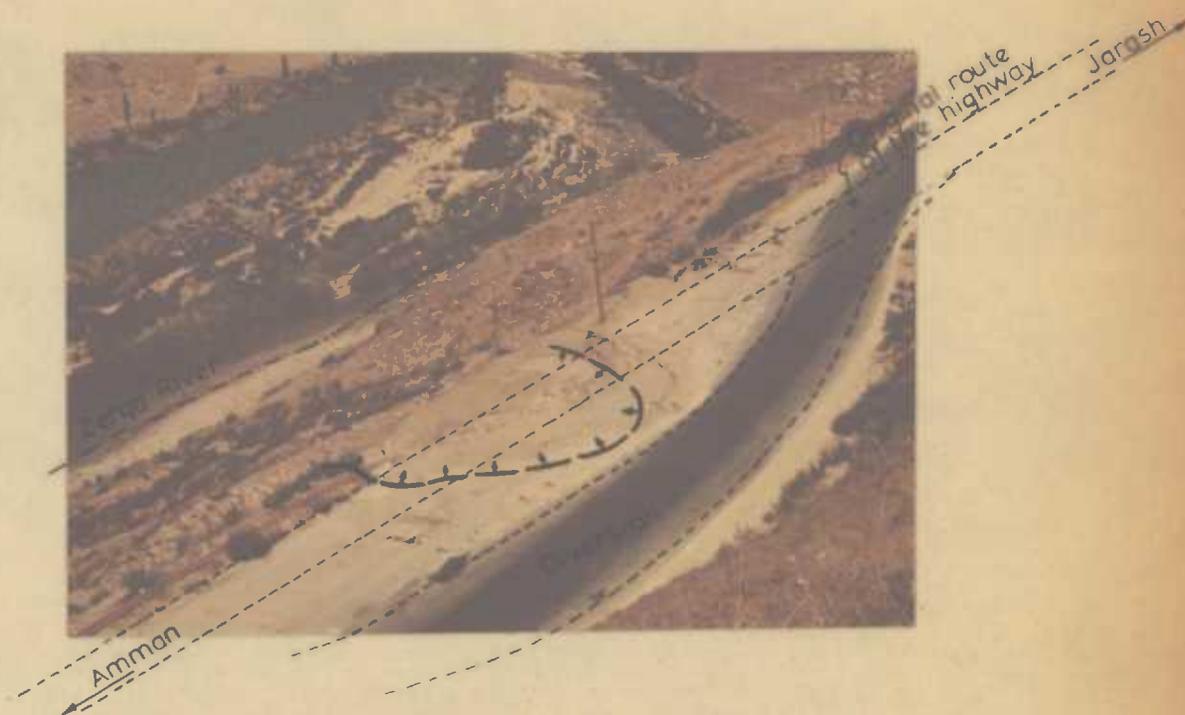
Plate 5.14 General view of landslide II showing the original route of the highway and the diversion.

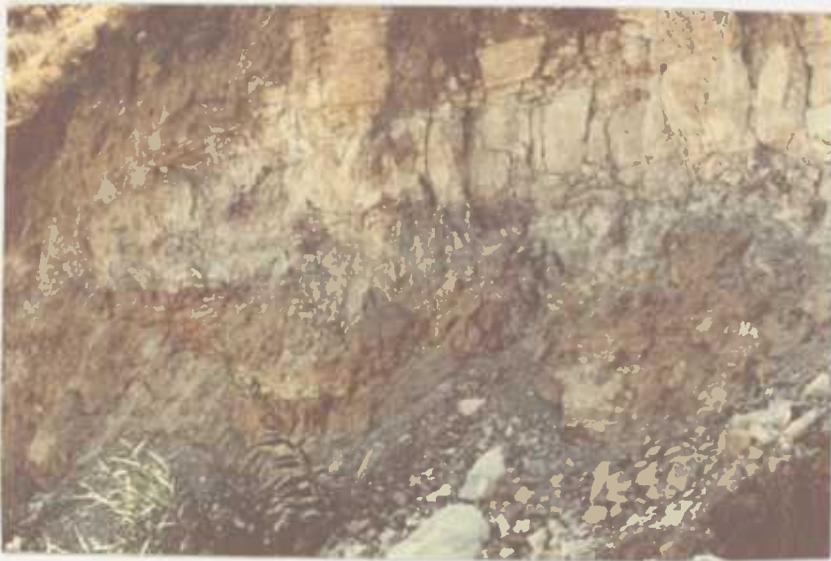
Silty clay is exposed at the road level and is in a highly weathered and intensely jointed condition with small relative displacements on fissures (Plate 5.15).

Plate 5.15 Jointing and weathering of the silty clay at the highway level in the backslope of landslide II.

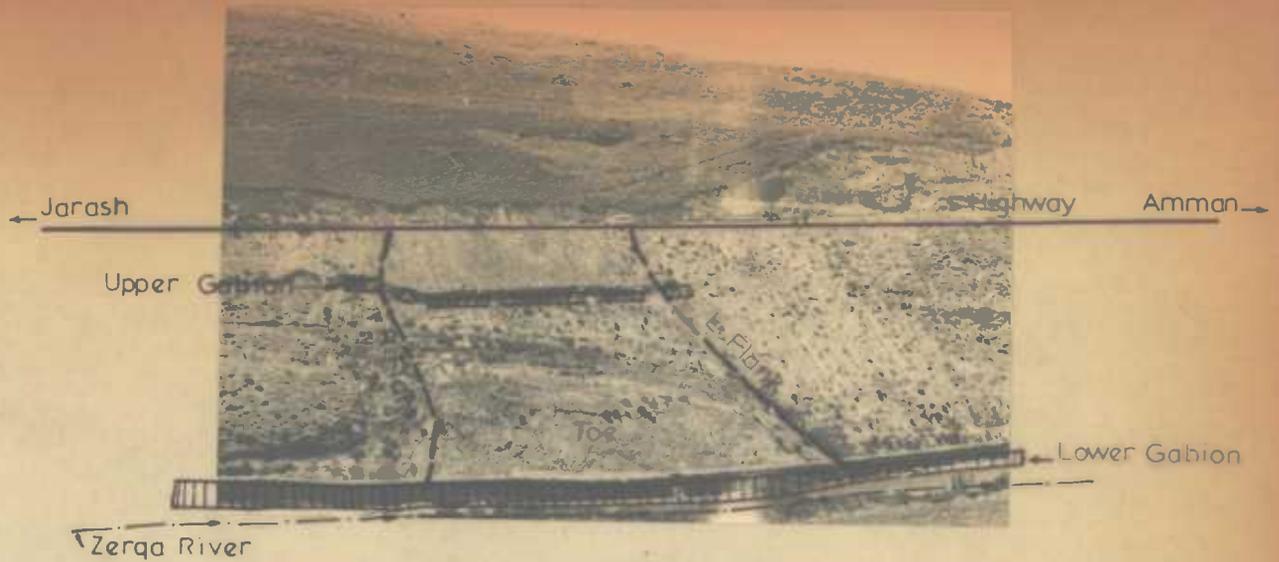
Plate 5.16 General view of landslide II showing the main features of the movement.

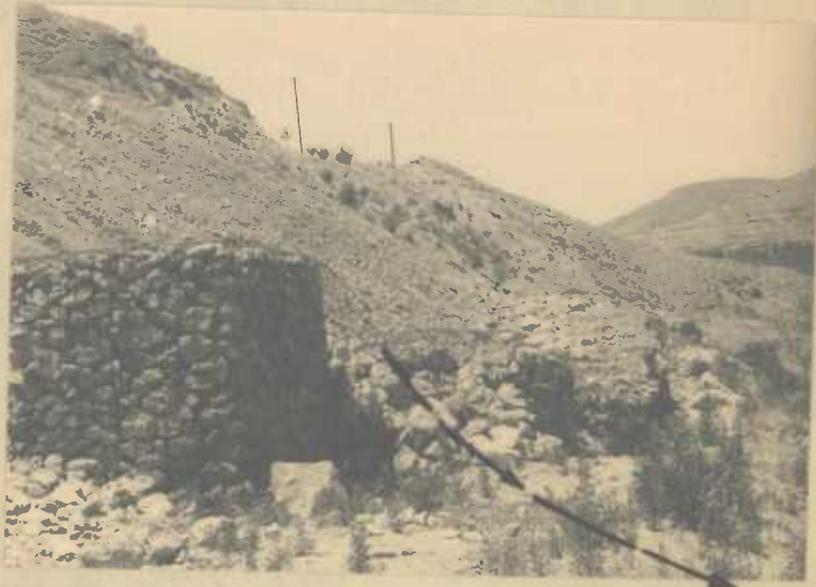
Plate 5.17 Shearing of the upper gabion at the crown of landslide II.

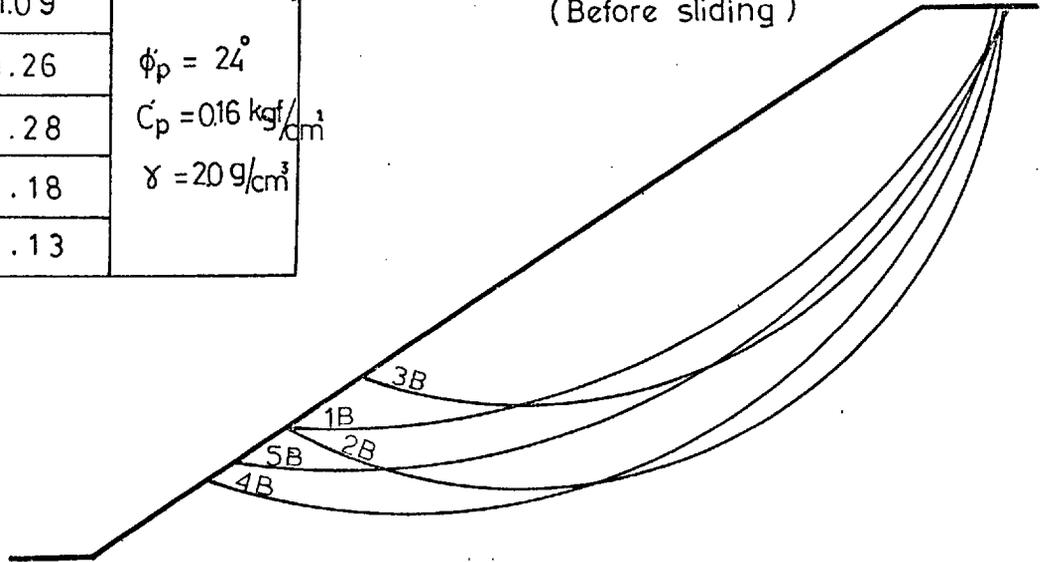
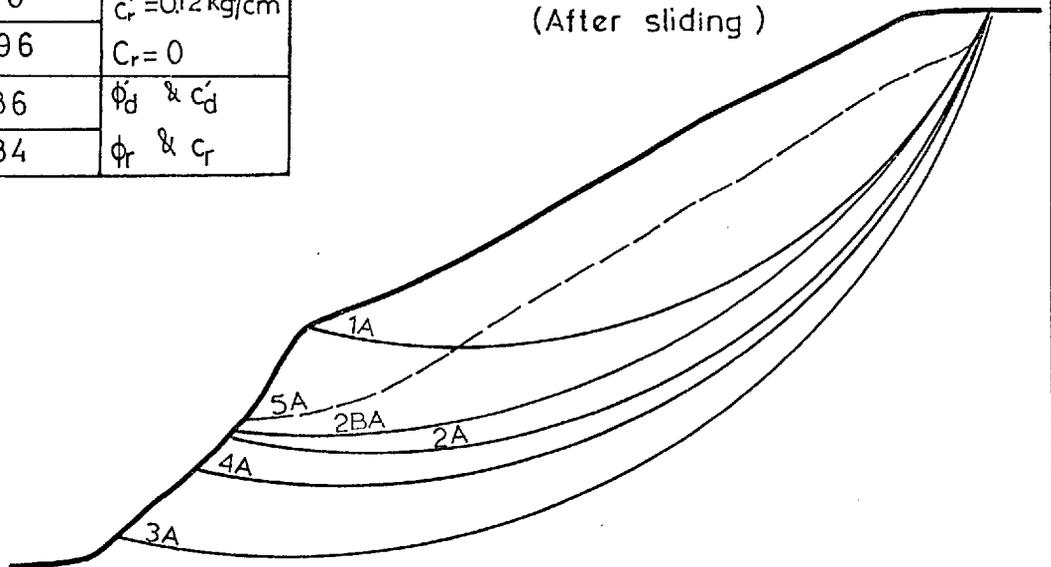
Fig(5.38)

Circle	Factor of safety	Remarks
1 B	1.09	$\phi_p = 24^\circ$ $C_p = 0.16 \text{ kg/cm}^2$ $\gamma = 20 \text{ g/cm}^3$
2 B	1.26	
3 B	1.28	
4 B	1.18	
5 B	1.13

Circle	Factor of safety	Remarks
1 A	1.082	Fully softened
2 A	1.041	$\phi'_d = 22.5^\circ$
3 A	1.005	
4 A	1.040	$\phi_r = 21.5^\circ$ $C_r = 0.12 \text{ kg/cm}^2$
1 BA	0.96	
5 A	0.86	ϕ'_d & C'_d
	0.84	ϕ_r & C_r

ORIGINAL AND PRESENT PROFILES OF
LANDSLIDE.II WITH THE RESULTS OF STABILITY ANALYSIS
