SLOPE INSTABILITY ON THE JORDANIAN HIGHWAYS

Thesis submitted to the University of London
for the degree of Doctor of Philosophy in
Engineering Geology.

October, 1974.

Engineering Geology Division,
Imperial College of Science and
Technology,
London S.W.7.

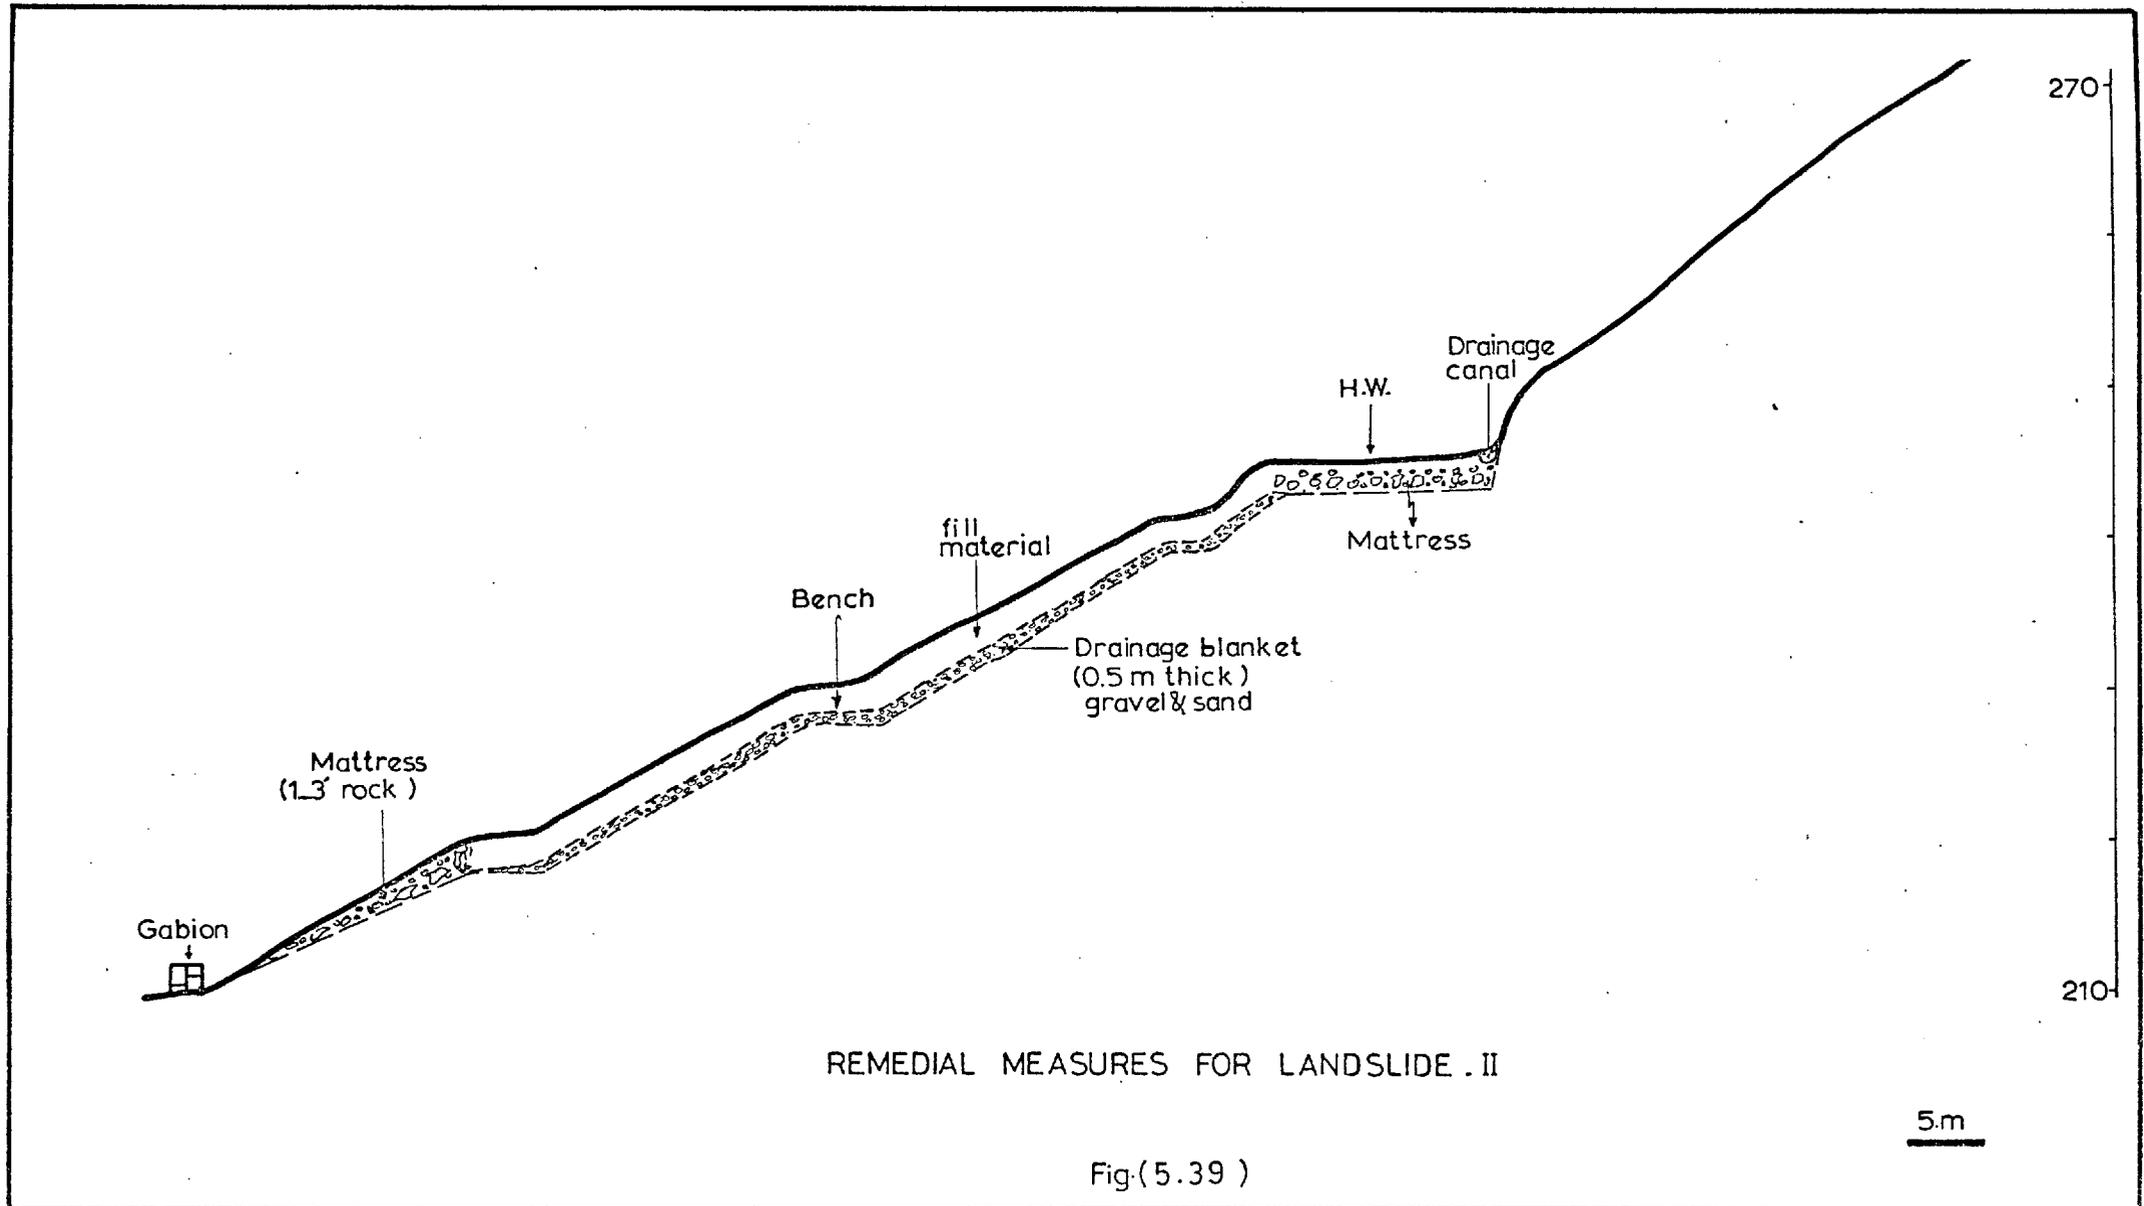
Fig.(5.39)

REMEDIAL MEASURES FOR LANDSLIDE . II

3. Critical slope angle with regard to the height.
4. Lack of the surface and subsurface drainage.
5. Increase of driving forces caused by the construction of gabions at or near the crown of the landslide.
6. Undercutting of the slope by the Zerqa river reducing the resisting forces.

- (iii) Removing the existing upper gabion near the crown of the landslide which has increased the driving forces and has allowed rainwater to percolate into the landslide zone.

- (iv) Flattening the slope and providing benches; benches widths to be 5 m and to dip at 1 in 15, to assist in rapid

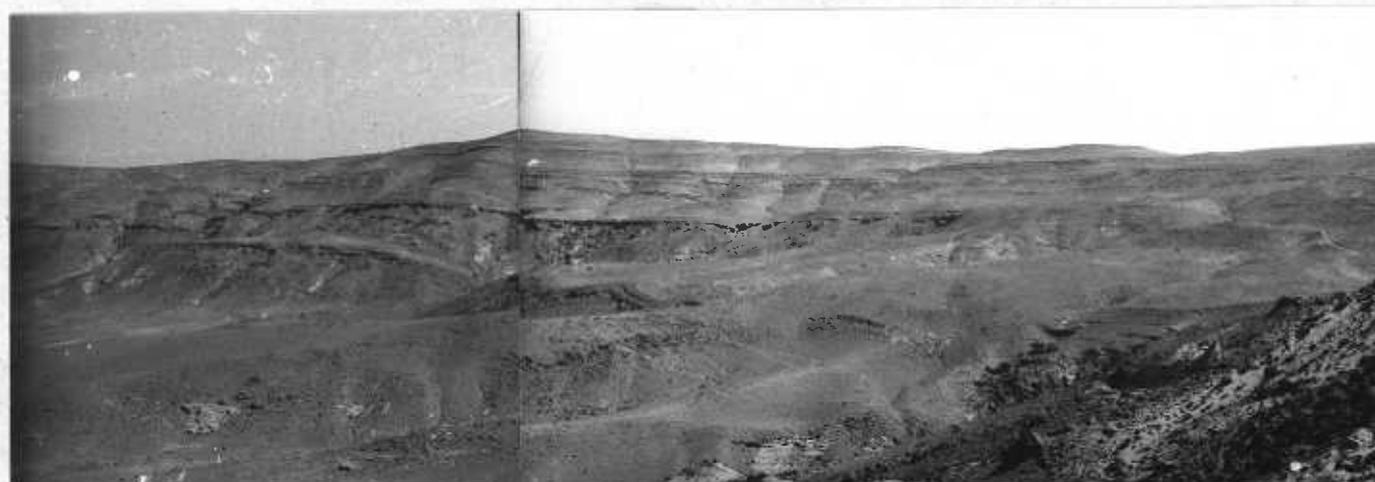
area is characterized by wide steep and deep valleys. The gradients of the proposed highway on the hillside are in the range of 2.5 - 5.5% over a 7 km distance. The morphology of the area shows a hummocky terrain owing to the combined action of weathering, tectonic and old landslide movements in the area (Plate 6.1).

Plate 6.1 General view of the study area of the Ras-en-Naqab escarpment showing a hummocky terrain owing to the combined action of the tectonic, old landsliding and weathering.

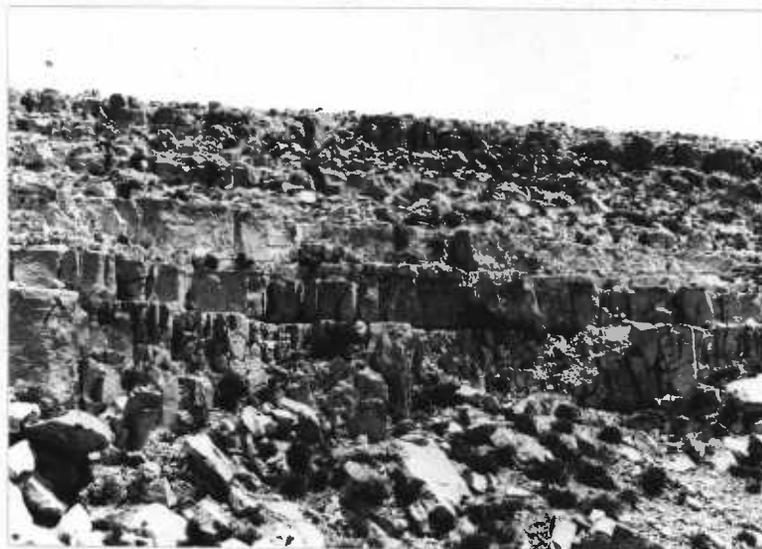
The joint surveys indicate that 76% of all joints are very steep and nearly vertical and parallel to the hillside dipping out of the slope (circumferential). The three sets divide the rock into many cuboidal blocks ranging in size from 0.5 m³ to 2 m³ (Plate 6.4).

Plate 6.4 The intensely jointed bedrock of the Upper Ajlun Formation (joint surveying area 1).

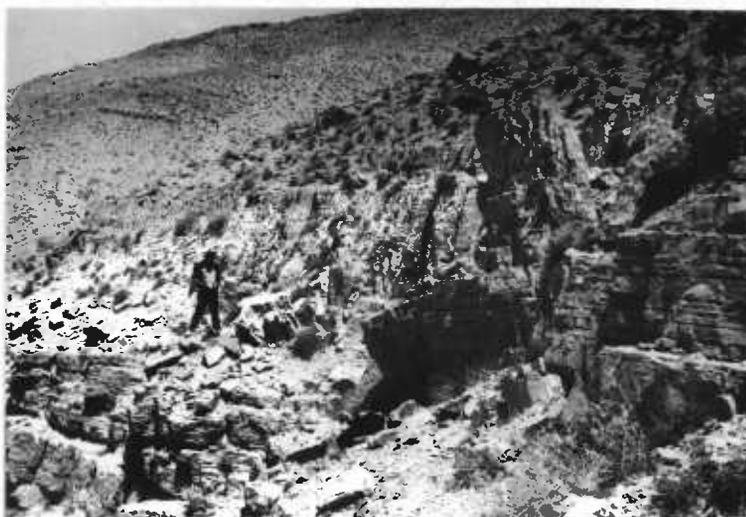
about 60% of these joints are of critical types (circumferential), most of them are open and continuous, Plate 6.5.

Plate 6.5 The upper part of the Lower Ajlun rock unit showing intense jointing and expected toppling (joint surveying area 2).

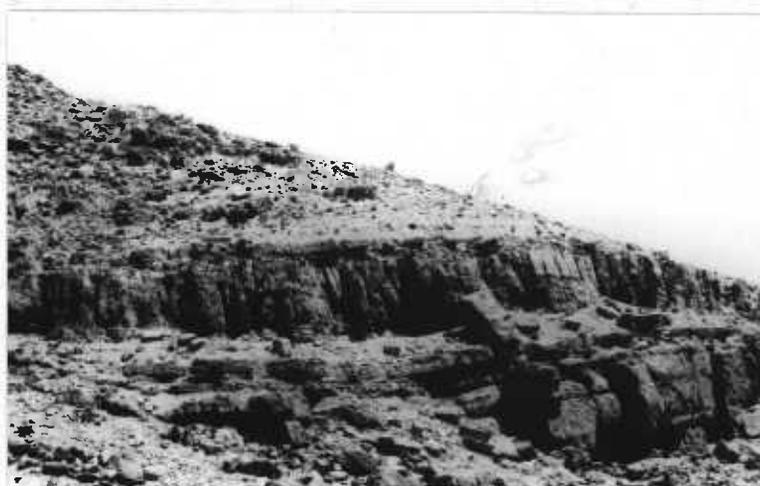
Plate 6.6 The intensely jointed Lower Ajlun rock unit (joint surveying area 3).

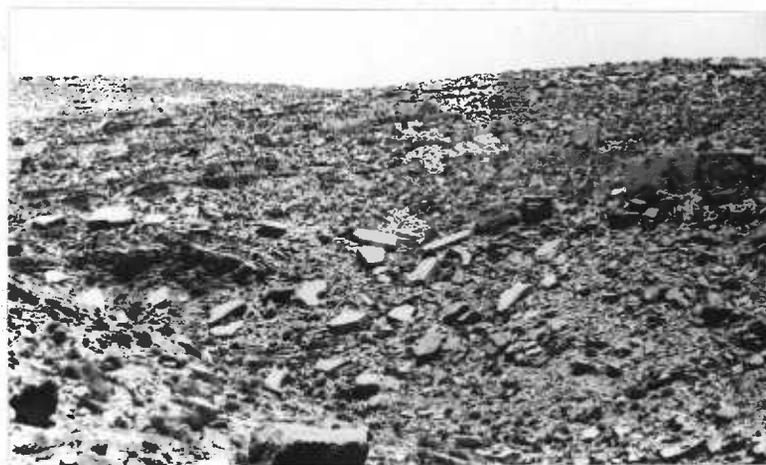
big blocks have slipped forward and fallen into the marl, Plates 6.7 and 6.8 . Slopes cut in this type of bedrock must take into consideration the effect and behaviour of sub-joint systems.

Plate 6.8 Block flow of the Middle Ajlun Formation underlain by the clay-marl unit of the Lower Ajlun Group.

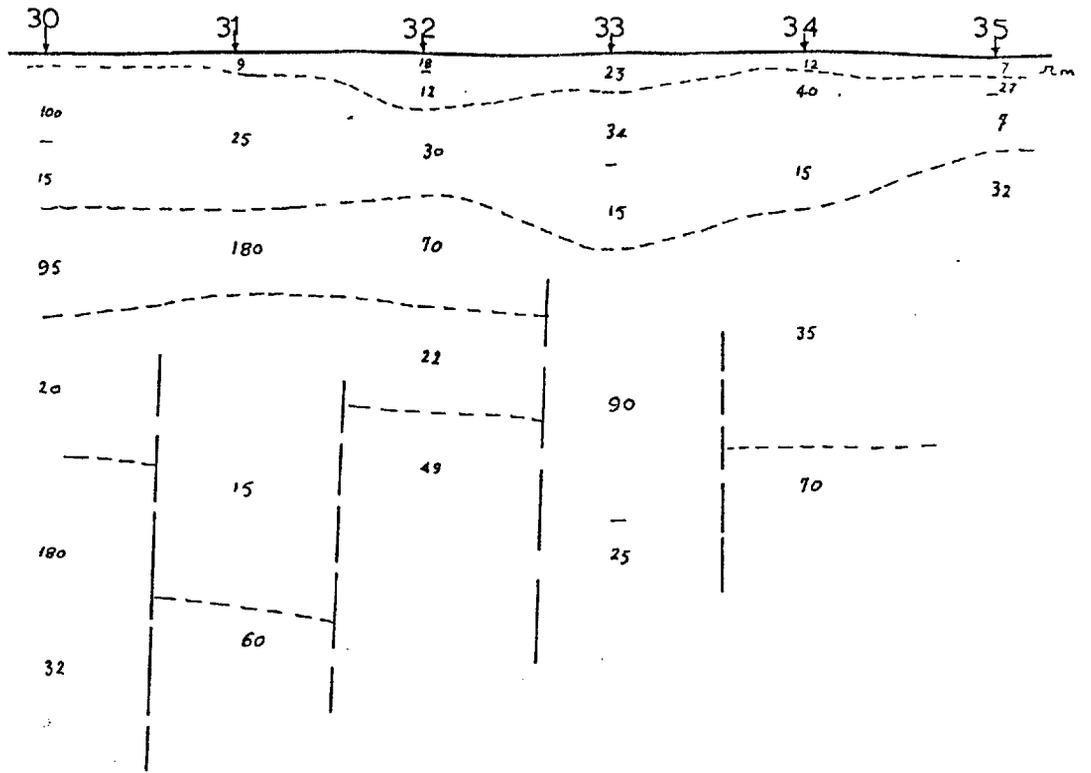
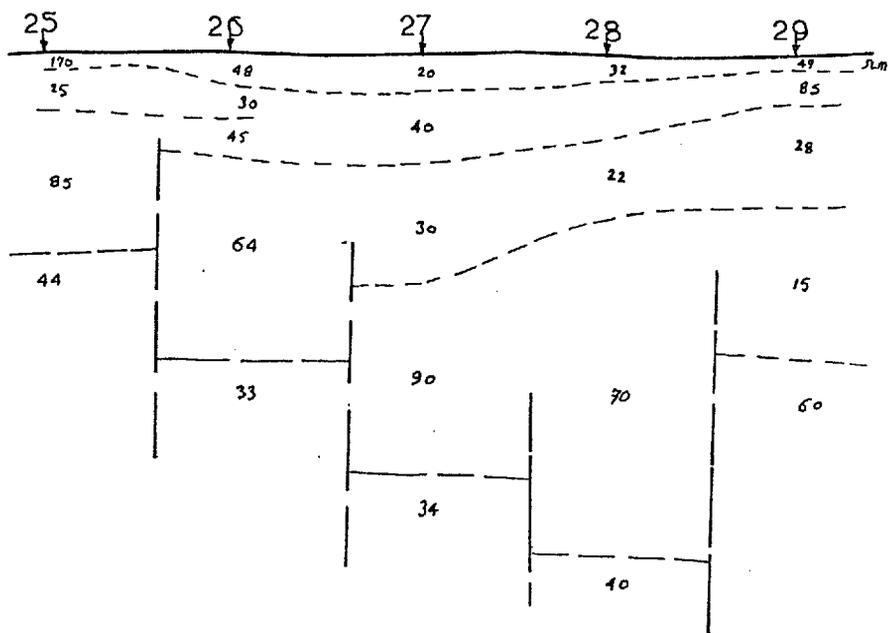
Fig(5.6A)

LANDSLIDE. IV RESISTIVITY SOUNDING PROFILES

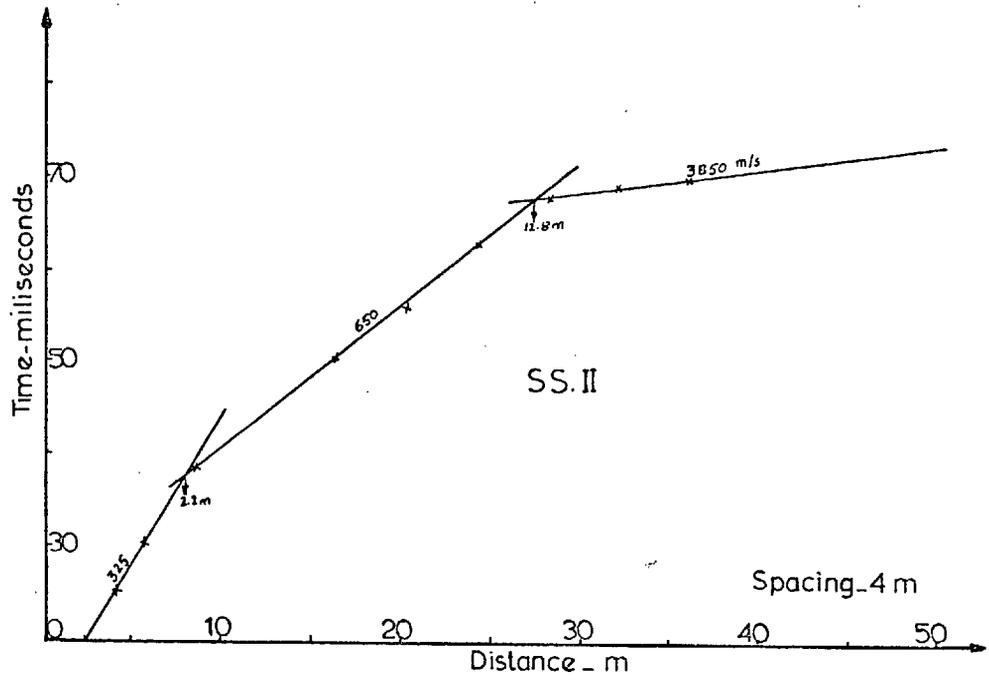
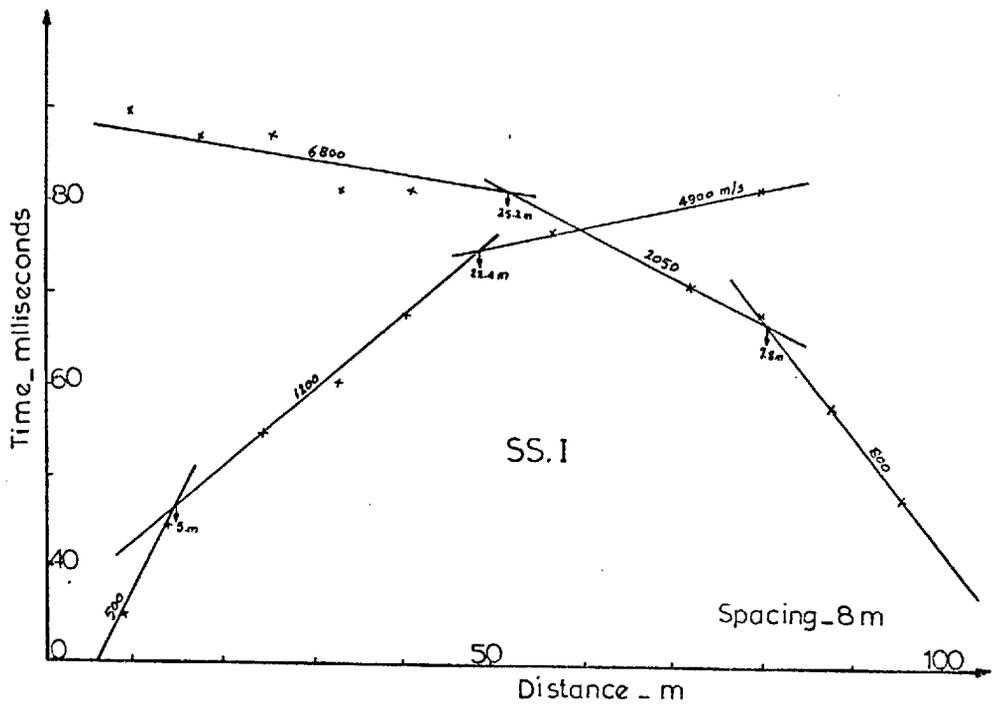
Fig(5.8A)

LANDSLIDE. II SEISMIC REFRACTION PROFILES
