Root Cause Determination of On-orbit Degradation of the VIIRS Rotating Telescope Assembly

M.R. Ciofalo, P.D. Fuqua, J.D. Barrie, M.J. Meshishnek,
C.T. Chu, J.A. Chaney, and R.M. Moision,
The Aerospace Corporation

August 30, 2012

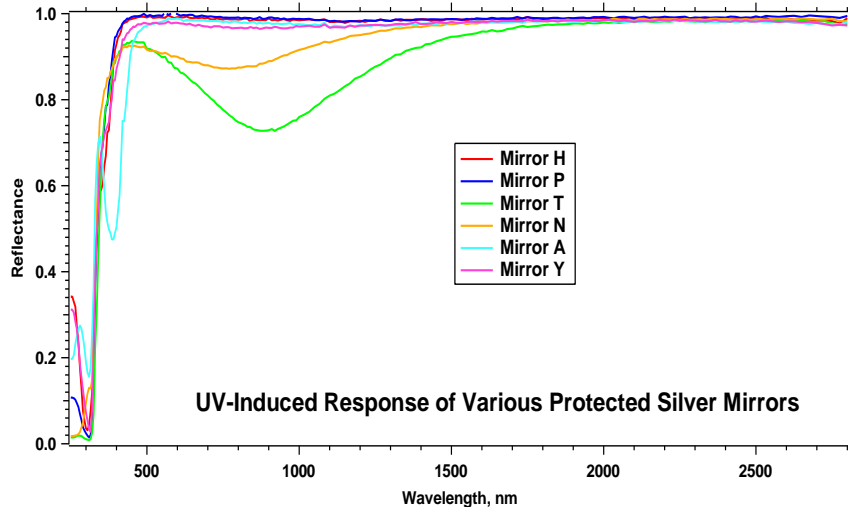
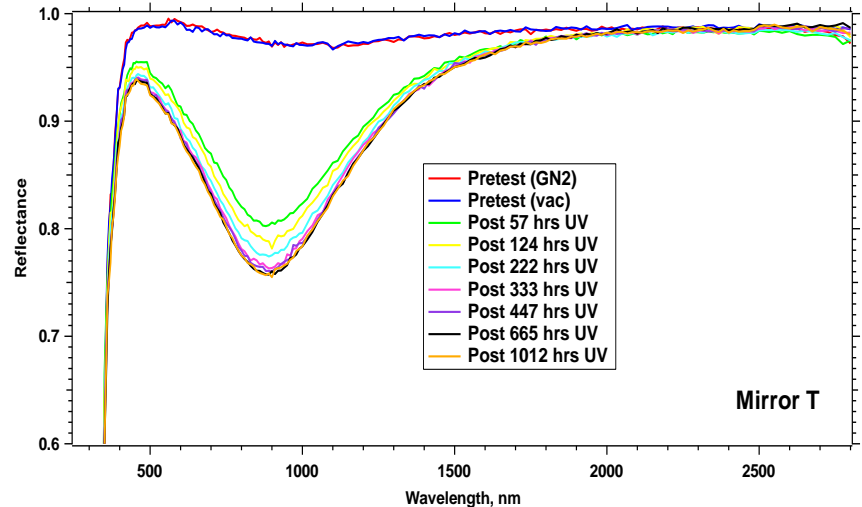
Space Environment Effects (SEE) Testing of Mirror Coatings (2003)

- UV and/or electron radiation can induce absorptions in protected silver mirrors.
- Tests on a variety of mirror types yielded varying results - susceptibility depends upon materials/processes used.
- These results were reported to the VIIRS PO in 2005, but was considered a low risk for their flight-proven coating - *contractors did not pursue testing.*

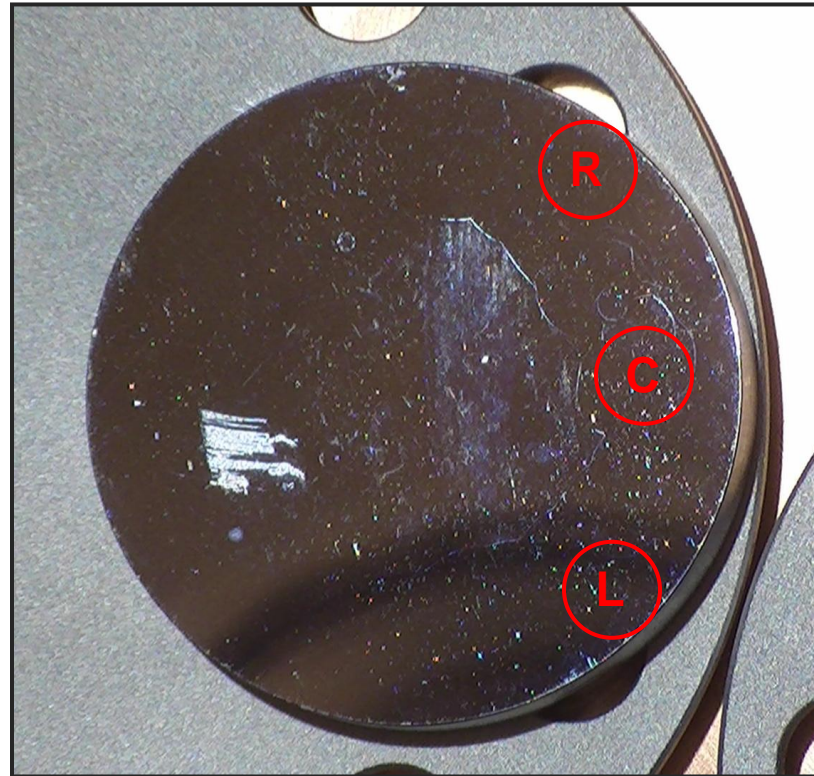
TWM measured in 3 places

R,C, L= right, center, left

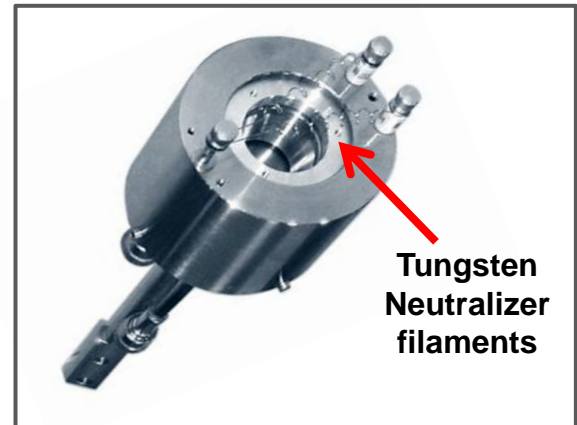
The Smoking Gun

The vendor opted against stripping/recoating

- Proposed using the oxygen ion source to further oxidize top-coating
- Unqualified process - tested once on a single witness sample
- Not discussed with program's subject-matter experts
- Process was hastily implemented (on a Sunday)
- No further testing of witness samples was considered
