Development and Evaluation of the Midwest Guardrail System Placed Adjacent to a 2:1 Fill Slope

*Midwest States Regional Pooled Fund Research Program
Fiscal Year 2004-2005 (Year 15)
Research Project Number SPR-3(017)
NDOR Sponsoring Agency Code RFPF-05-09*

DEVELOPMENT AND EVALUATION OF THE MIDWEST GUARDRAIL SYSTEM (MGS) PLACED ADJACENT TO A 2:1 FILL SLOPE

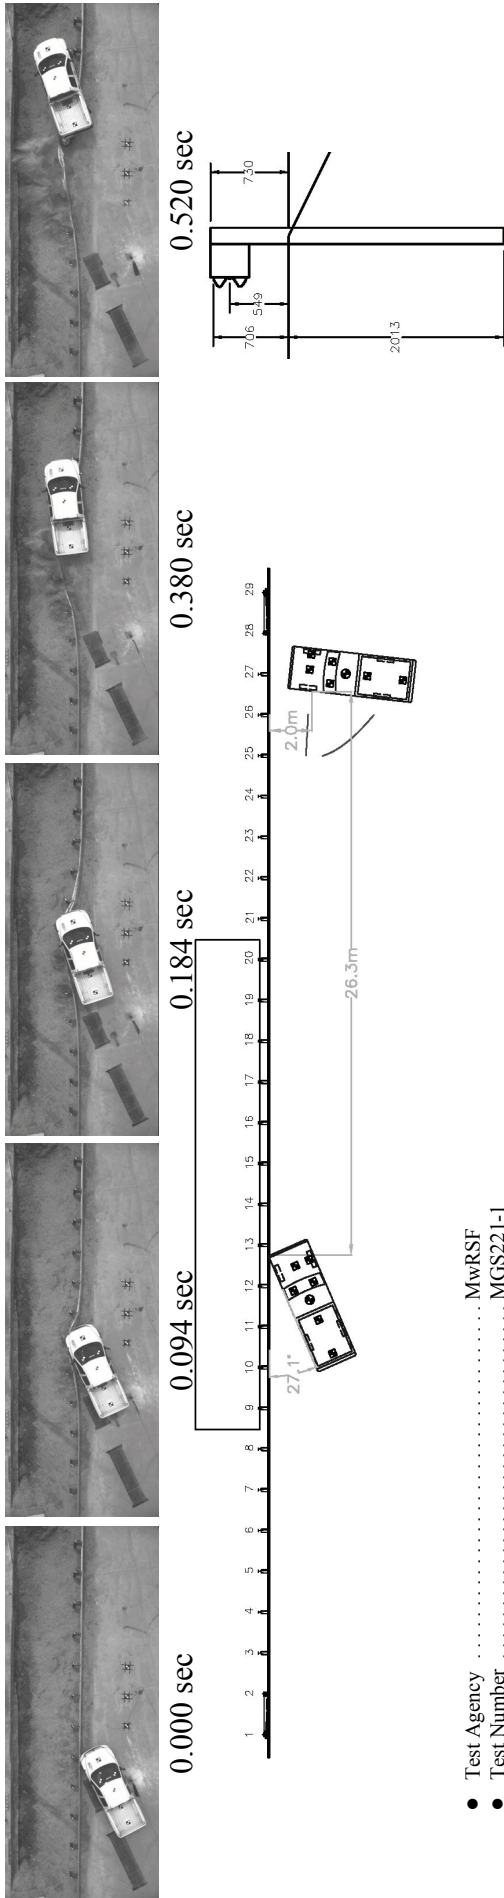
Figure 24. Summary of Test Results and Sequential Photographs, Test No. MGS221-1

The analysis of the test results for test no. MGS221-1 showed that the MGS, with a 706-mm (27³/₄-in.) top mounting height and installed adjacent to a 2:1 fill slope, did not adequately contain nor redirect the 2270P vehicle as the vehicle overrode the top of the system and subsequently landed behind the system. There were no detached elements nor fragments which showed potential for penetrating the occupant compartment nor presented undue hazard to other traffic. Deformations of, or intrusion into, the occupant compartment that could have caused serious injury did not occur. The test vehicle overrode and penetrated the guardrail system. It did remain upright during and after the collision. Vehicle roll, pitch, and yaw angular displacements were noted, but they were deemed acceptable because they did not adversely influence occupant risk safety criteria nor cause rollover. Therefore, test no. MGS221-1 conducted on the MGS installed adjacent to a 2:1 fill slope was determined to be unacceptable according to the TL-3 safety performance criteria found in MASH.

The vehicle override was attributed to the slow release of post no. 15 from the guardrail, thus causing the W-beam to be pulled downward. In addition, the vehicle override was also attributed to the failure of the vehicle's front suspension shortly after impact, thus preventing the guardrail from capturing the pickup truck's left-front tire.

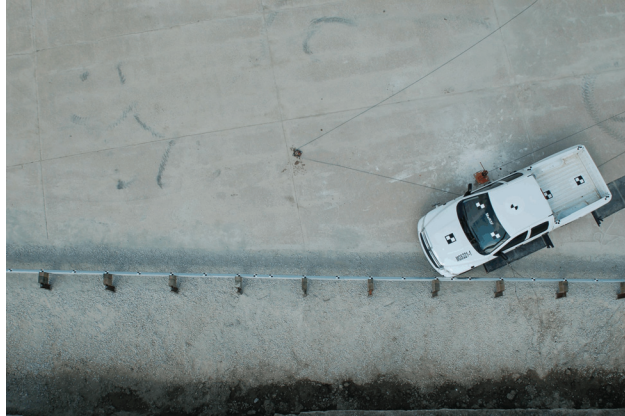
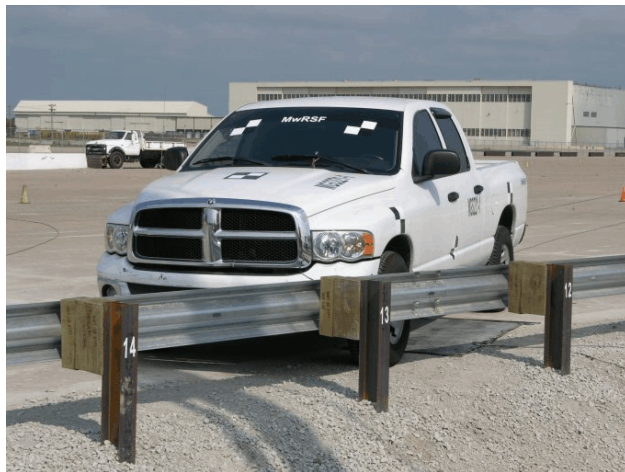
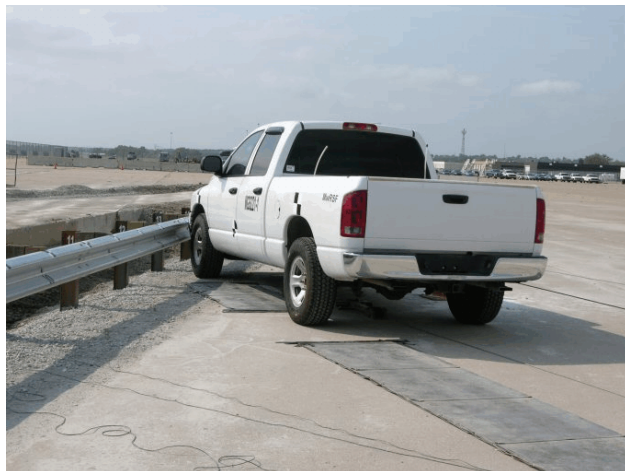
Figure 31. Impact Location, Test No. MGS221-1

Initial vehicle impact was to occur 476 mm (18¾ in.) upstream from the centerline of post no. 13, as shown in Figure 31. Actual vehicle impact occurred 432 mm (17 in.) upstream from the centerline of post no. 13. At 0.010 sec after impact, the left corner of the bumper crushed inward, and post no. 13 deflected. At 0.018 sec, post no. 14 deflected, and the impacted rail flattened. At 0.024 sec, post no. 12 deflected. At 0.036 sec, the rail deformed around post no. 14. At 0.064 sec, post no. 15 deflected, and a buckle point formed at the midspan between post nos. 14 and 15. At 0.074 sec, the left corner of the front bumper was located at post no. 14 which was deflecting. At 0.096 sec, the guardrail released from post no. 14, and post no. 16 deflected. At 0.112 sec, the front of the vehicle was located at the midspan between post nos. 14 and 15. At 0.120 sec, the left-front tire disengaged from the vehicle. At 0.128 sec, buckling occurred at the midspan between post nos. 15 and 16. At this same time, the rail was located under the left corner of the front bumper. At 0.138 sec, the rail deformed around post no. 16, and post no. 17 deflected. At 0.146 sec, the guardrail released from post no. 15, and the right-front tire became airborne. At 0.154 sec, the left corner of the front bumper was located at post no. 15, which was deflecting. At 0.182 sec, the left corner of the bumper protruded over the top of the rail. At 0.206 sec, the front of the vehicle pitched upward. At 0.226 sec, the guardrail released from post no. 15. At this same time, the entire left side of the vehicle was in contact with the rail. At 0.250 sec, the front of the vehicle was located between post nos. 16 and 17. At 0.308 sec, the front of the vehicle was located on top of post no. 17. At 0.324 sec, the right-front tire overrode the rail, the truck stopped redirecting, and the right-rear tire became airborne. At 0.342 sec, the rail began to tear. At this same time, the left-rear tire contacted the rail. At 0.376 sec, the front of the vehicle overrode post no. 18, and the rail at post no. 15 tore. At 0.400

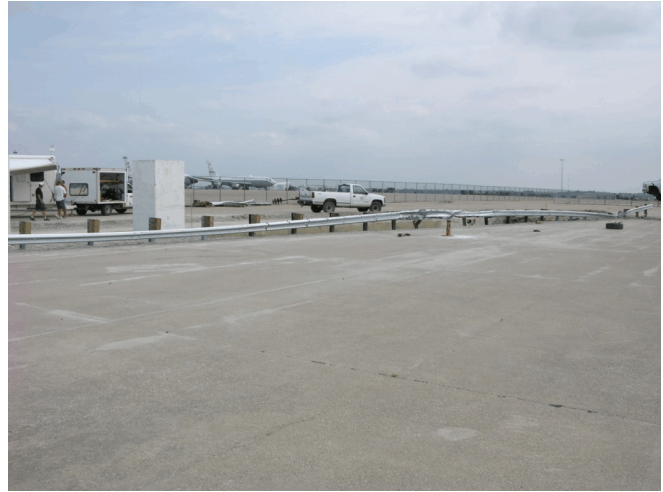
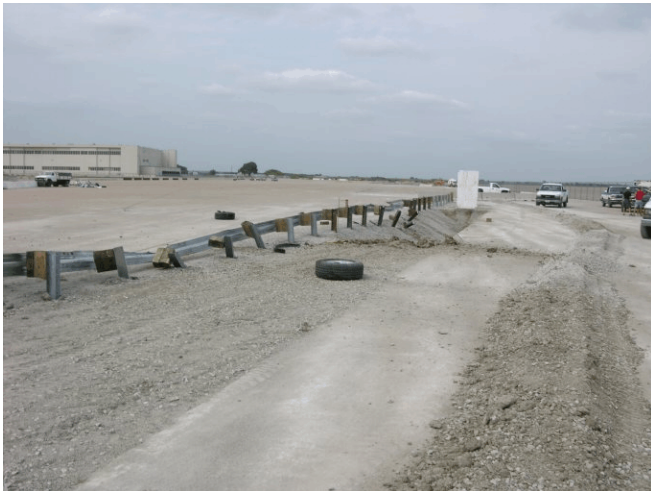
Figure 33. System Damage, Test No. MGS221-1

Damage to the barrier was moderate, as shown in Figures 33 through 41. Barrier damage consisted of deformed guardrail posts, disengaged wooden blockouts, contact marks on a guardrail section and posts, and deformed and fractured W-beam rail. The length of the vehicle contact along the MGS system was approximately 8.8 m (29 ft - 1½ in.), which spanned from 305 mm (12 in.) upstream from the centerline of post no. 13 through the midspan between post nos. 17 and 18.

The permanent set of the barrier system is shown in Figure 33. The maximum lateral permanent set rail and post deflections were 810 mm (31⁷/₈ in.) at the centerline of post no. 16 and 1,086 mm (42³/₄ in.) at post no. 15, respectively, as measured in the field. The maximum lateral dynamic rail and post deflections were 955 mm (37.6 in.) at the centerline of post no. 15 and 1,126 mm (44.3 in.) at post no. 15, respectively, as determined from high-speed digital video analysis.

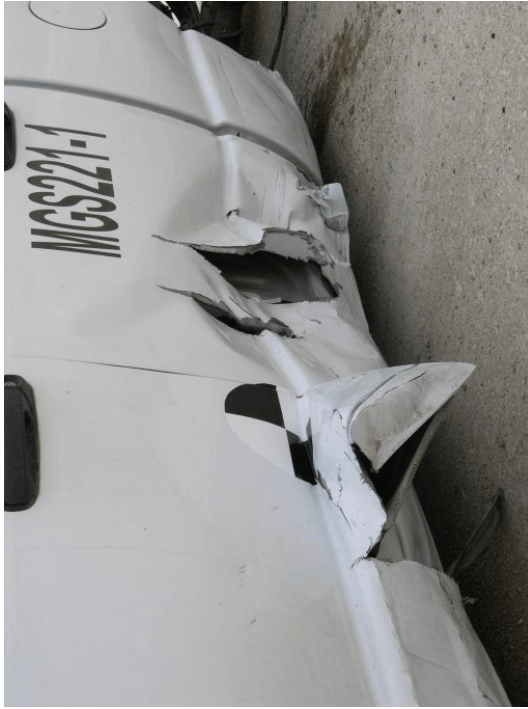
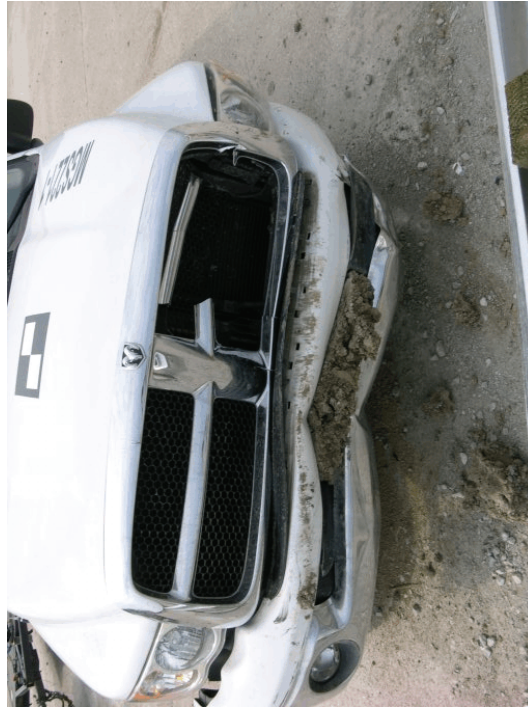
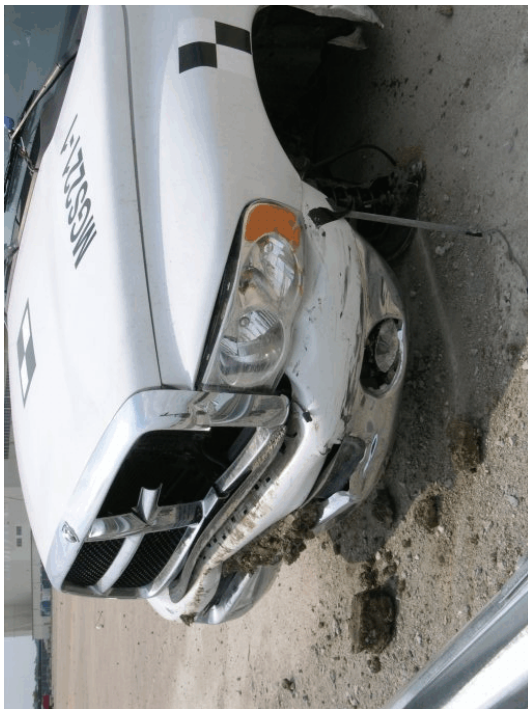
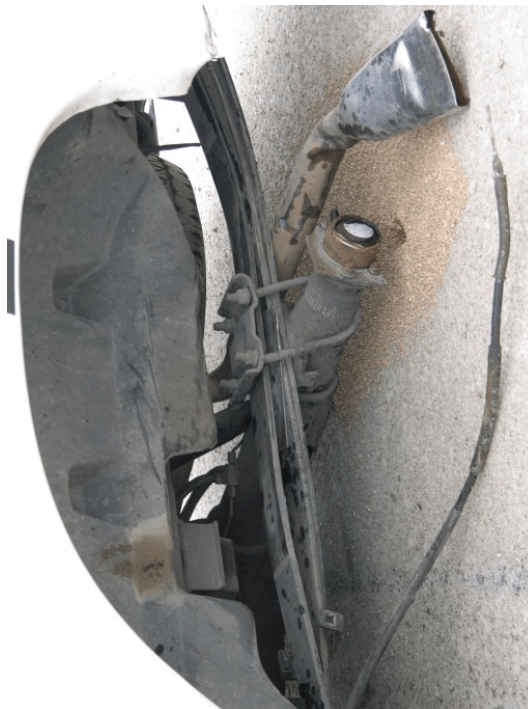
Figure 42. Vehicle Damage, Test No. MGS221-1

Exterior vehicle damage was moderate, as shown in Figures 42 through 44. Occupant compartment deformations to the left side and center of the floor pan were judged insufficient to cause serious injury to the vehicle occupants, as shown in Figure 45. Maximum longitudinal deflections of 6 mm (¹/₄ in.) were located throughout the left-side floor pan. Maximum lateral deflections of 13 mm (¹/₂ in.) were located at the rear-center of the left-side floor pan. Maximum vertical deflections of 13 mm (¹/₂ in.) were located on the floor pan near the left-side door. Complete occupant compartment deformations and the corresponding locations are provided in Appendix E.

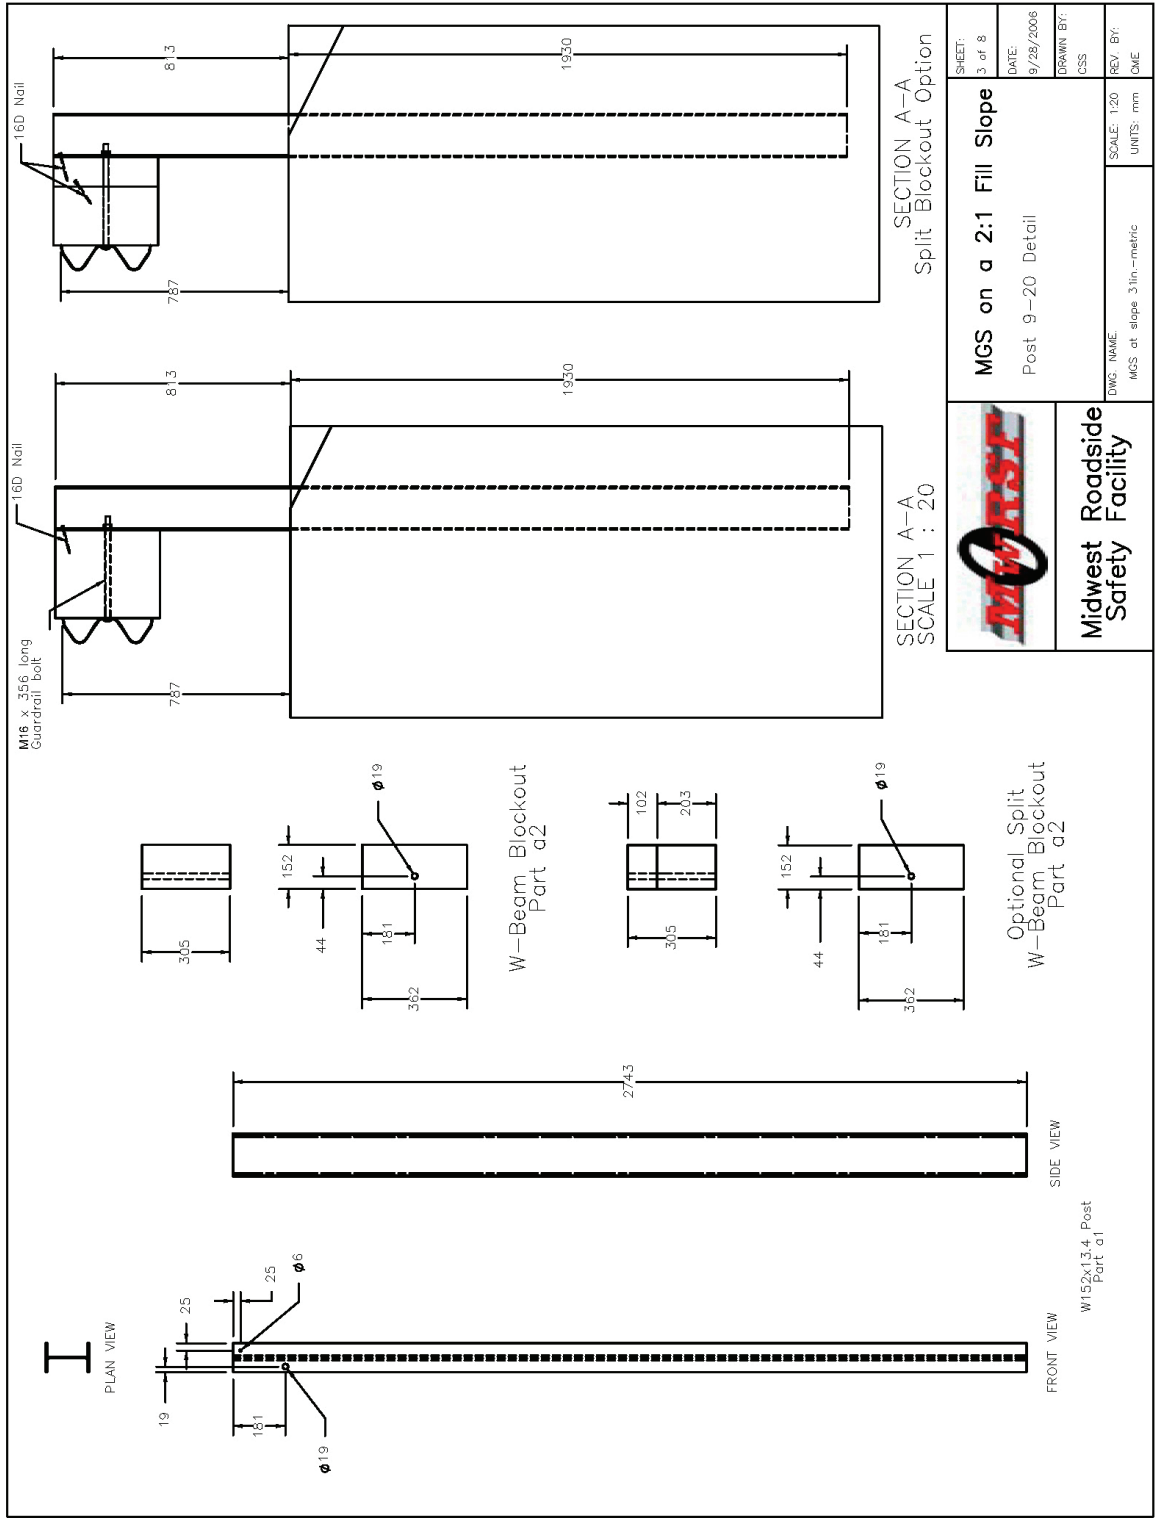
Figure 46. MGS Installed Adjacent to a 2:1 Fill Slope System Modifications, Test No. MGS221-2

Following the unsuccessful performance of the 706-mm (27³/₄ in.) high, MGS installed adjacent to a steep slope, it was believed that raising the rail height to 787 mm (31 in.) would allow for improved engagement between the barrier system and the vehicle. Therefore, the second design of the MGS installed adjacent to a 2:1 fill slope system was identical to the system in test no. MGS221-1 except for the guardrail's top mounting height. The first installation's height was set at the design's anticipated minimum height tolerance of 706 mm (27³/₄ in.). For the second installation, the top W-beam guardrail height was raised to 787 mm (31 in.) with a 632-mm (24⁷/₈-in.) center mounting height. Additionally, post nos. 1 through 29 were still spaced 1,905 mm (75 in.) on center but were embedded to a depth of 1,930 mm (76 in.), as shown in Figures 46 and 47.

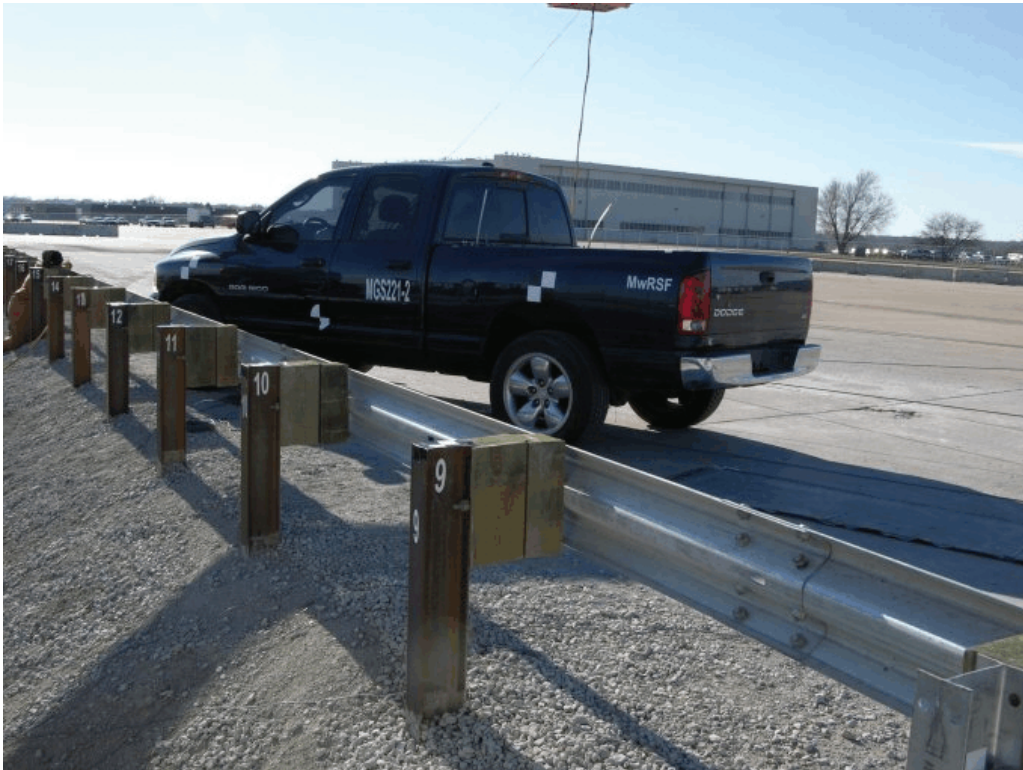
Figure 56. Impact Location, Test No. MGS221-2

Initial vehicle impact was to occur 476 mm (18¾ in.) upstream from the centerline of post no. 13, as shown in Figure 56. Actual vehicle impact occurred 394 mm (15½ in.) upstream from the centerline of post no. 13. At 0.014 sec after impact, post no. 13 deflected. At 0.022 sec, post no. 12 twisted downstream, and the left-front corner of the vehicle crushed inward toward the engine compartment. At this same time, post no. 14 deflected. At 0.030 sec, the soil heaved behind post no. 13. At 0.044 sec, post nos. 14 through 19 twisted downstream. At 0.050 sec, the rail buckled upstream of post no. 5, and the soil heaved behind post no. 14. At 0.076 sec, the left-front tire protruded past the slope break point, and post no. 15 deflected. At this same time, the rail buckled downstream of post no. 15. At 0.084 sec, the left corner of the front bumper was located at post no. 14. At this same time, the left-front corner of the vehicle crushed inward, and the left-side headlight fractured. At 0.090 sec, the rail released from post no. 14 as the post deflected. At this same time, the soil heaved behind post no. 15. At 0.112 sec, the rail buckled at post no. 16. At 0.126 sec, the vehicle began to redirect. At 0.150 sec, the rail released from post no. 15 as the vehicle traversed over it. At this same time, the left-front wheel deformed due to contact with post no. 14. At 0.166 sec, the rail released from post nos. 10 and 11. At 0.208 sec, the deformed left-front wheel contacted post no. 15. At 0.220 sec, the entire left side of the vehicle was in contact with the rail, and both left-side tires protruded past the slope break point. At 0.236 sec, the rail released from post no. 16. At 0.266 sec, post no. 17 deflected. At 0.298 sec, the left-front tire contacted post no. 16. At 0.306 sec, the vehicle became parallel to the system with a resultant velocity of 68.1 km/h (42.3 mph). At 0.322 sec, the left-front corner of the vehicle contacted post no. 17 as the vehicle redirected away from the system. At this same time, the left-rear tire was airborne above the slope. At 0.330 sec, the left-front

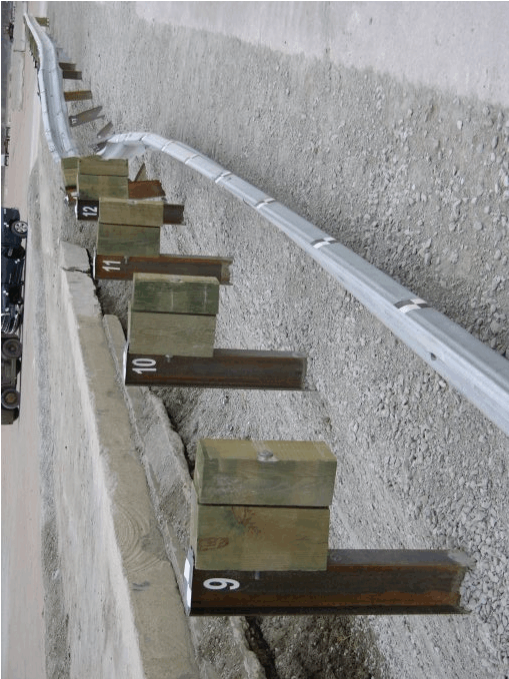
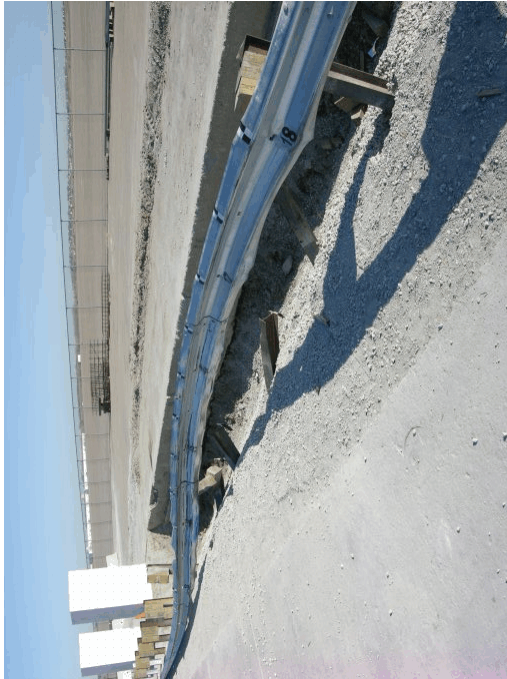
Figure 58. System Damage, Test No. MGS221-2

Damage to the barrier was moderate, as shown in Figures 58 through 64. Barrier damage consisted of deformed W-beam and guardrail posts, disengaged wooden blockouts, and contact marks on a guardrail section and posts. The length of the vehicle contact along the MGS system was approximately 12.42 m (40 ft - 9 in.), which spanned from 394 mm (15½ in.) upstream of the centerline of post no. 13 through 597 mm (23½ in.) downstream from the centerline of post no. 19.

The permanent set of the barrier system is shown in Figure 58. The maximum lateral permanent set rail and post deflections were 1,067 mm (42 in.) at the midspan between post nos. 15 and 16 and 864 mm (34 in.) at post no. 14, respectively, as measured in the field. The maximum lateral dynamic rail and post deflections were 1,463 mm (57.6 in.) at the centerline of post no. 15 and 805 mm (31.7 in.) at post no. 14, respectively, as determined from high-speed digital video analysis. The working width of the system was found to be 1,631 mm (64.2 in.).

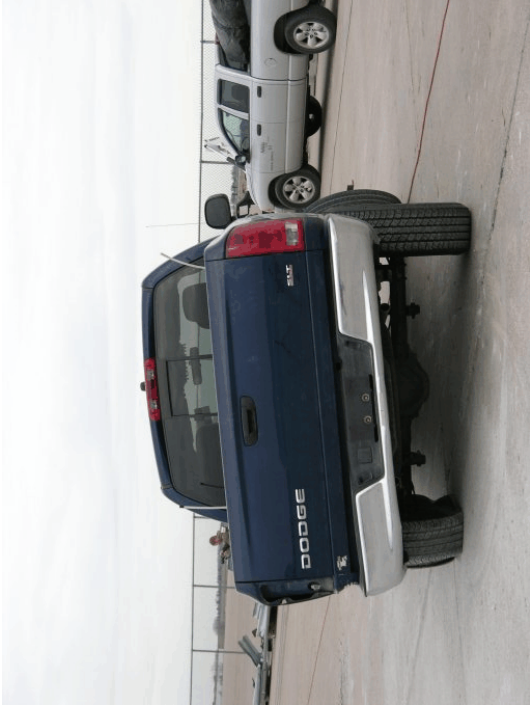
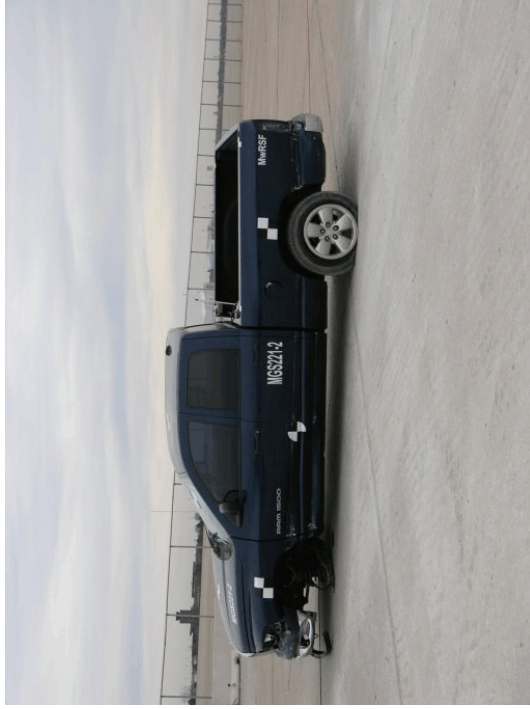
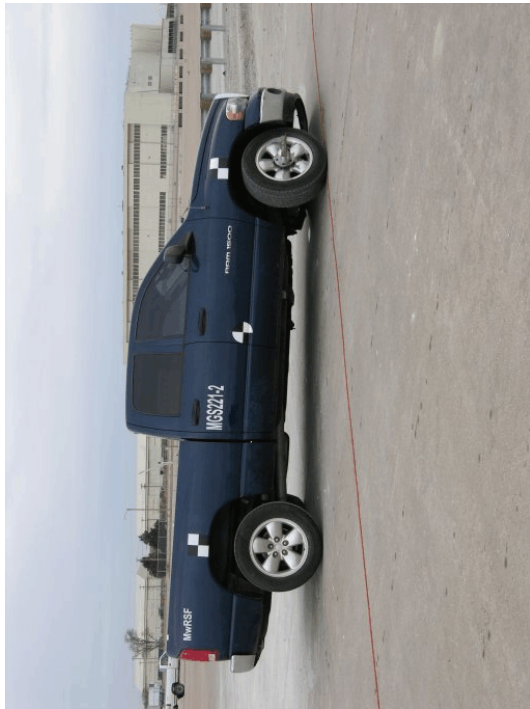
Exterior vehicle damage was moderate, as shown in Figures 65 and 66. Occupant compartment deformations to the left side and center of the floor pan were judged insufficient to cause serious injury to the vehicle occupants. Maximum longitudinal deflections of 6 mm (¼ in.) were located throughout the left-side floor pan. Maximum lateral deflections of 13 mm (½ in.) were

Damage was concentrated on the left-front corner of the vehicle. The left-front corner was deformed inward toward the engine compartment. The left-front tire disengaged from the vehicle. The left-rear tire was deflated. Sheet metal tearing and major deformations were found along the lower portion of the left-side doors and the left-rear fender. The left-side taillight was fractured, while the right-side taillight was slightly dislodged. The roof, hood, and right side of the vehicle and all window glass remained undamaged.

Figure 65. Vehicle Damage, Test No. MGS221-2

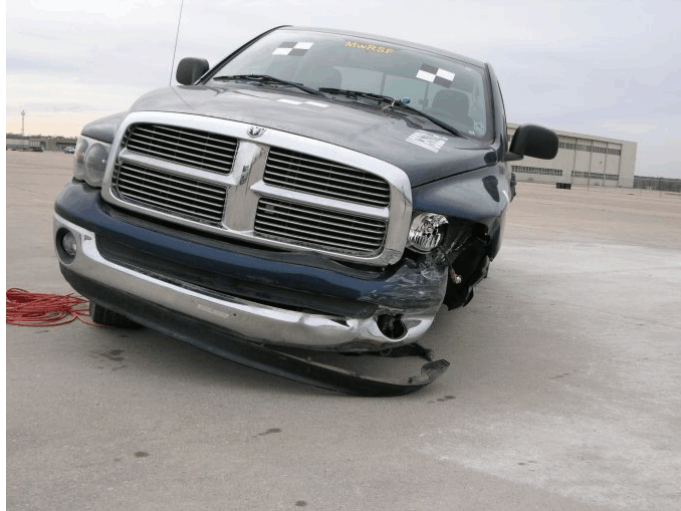
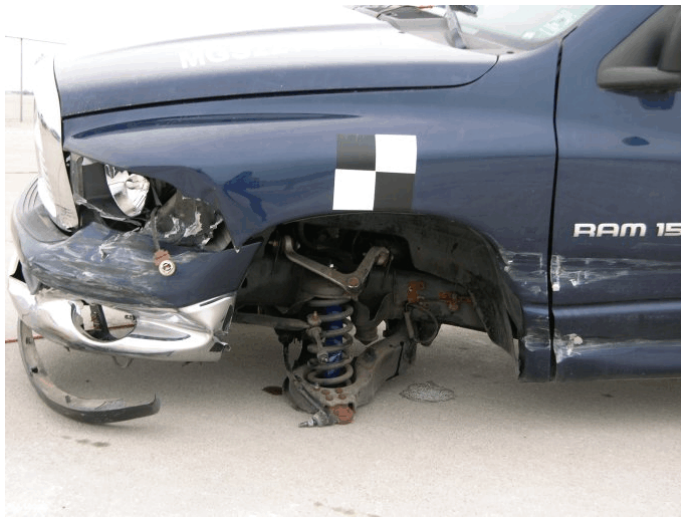
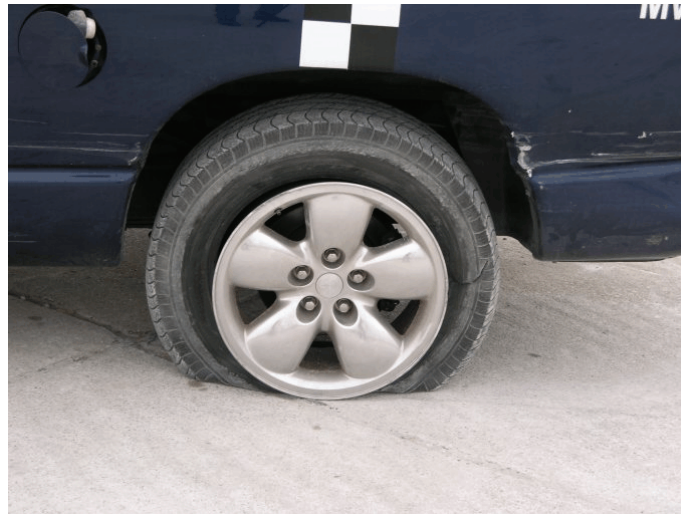
Figure 66. Vehicle Damage, Test No. MGS221-2
