# Midwest Guardrail System With Southern Yellow Pine Posts

TESTING CERT # 2937.01

*Midwest States Regional Pooled Fund Research Program  
Fiscal Year 2011 (Year 21)  
Research Project Number TPF-5(193) Supplemental #31  
NDOR Sponsoring Agency Code RFP-11-MGS-1*

# **MIDWEST GUARDRAIL SYSTEM (MGS) WITH SOUTHERN YELLOW PINE POSTS**

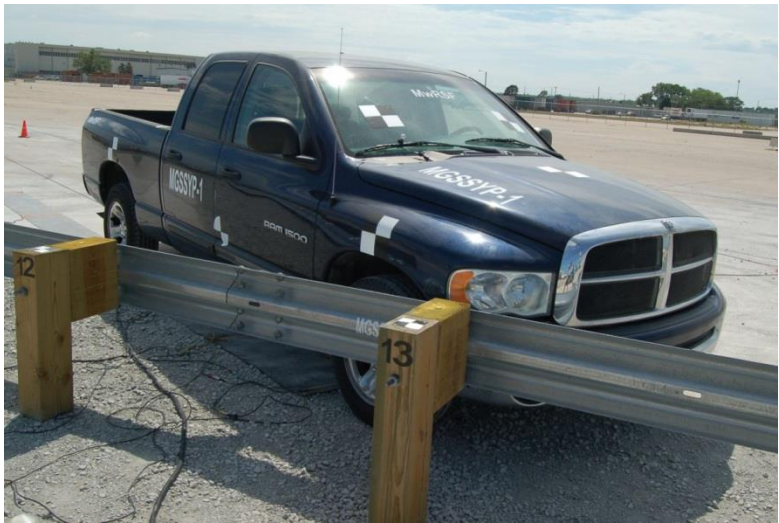
Figure 35. Impact Location, Test No. MGSSYP-1

Initial vehicle impact was to occur 12 ft (3.7 m) upstream of the center line of post no. 15, as shown in Figure 35, which was selected using the CIP plots found in Section 2.3 of MASH to maximize pocketing and the propensity of wheel snag. The actual point of impact was 12 ft – 6 in. (3.8 m) upstream of post no. 15. A sequential description of the impact event is

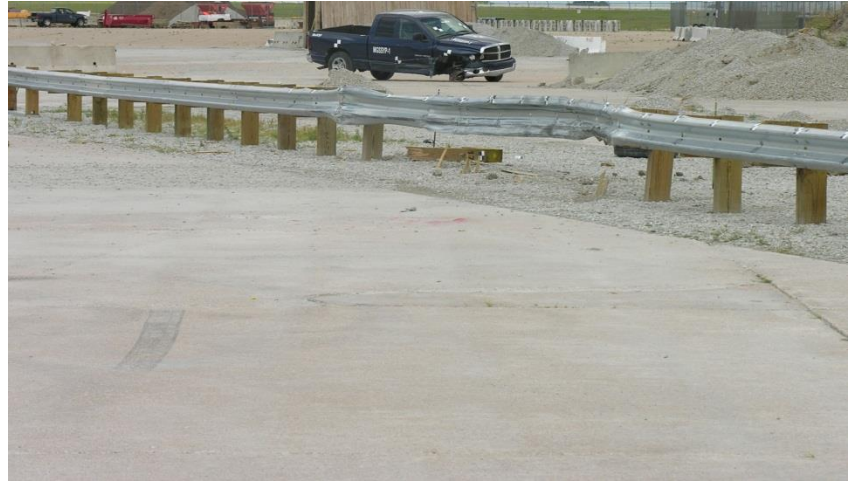
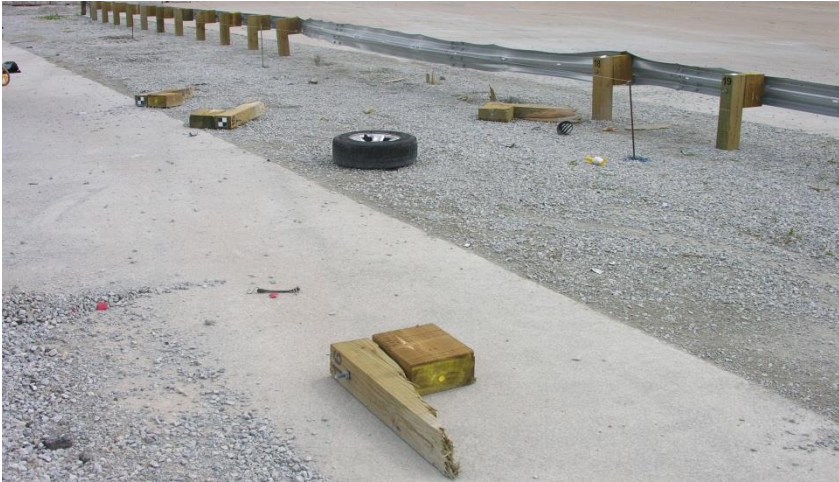
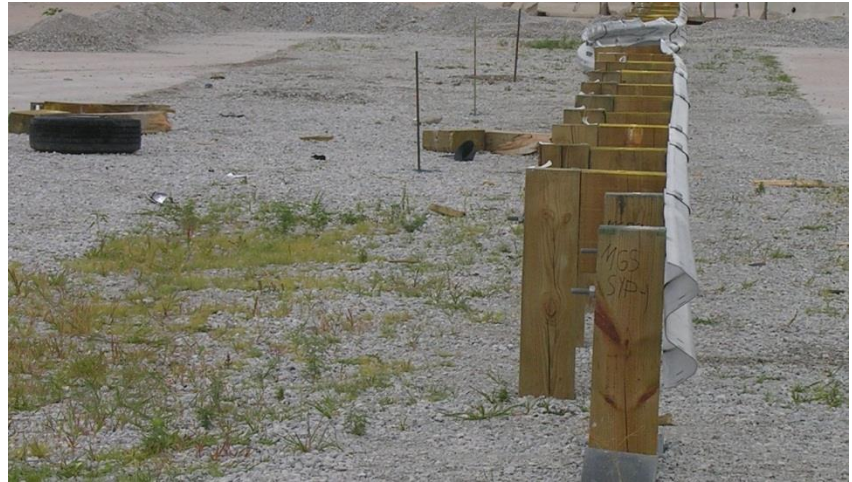
Figure 37. System Damage, Test No. MGSSYP-1

Damage to the barrier was moderate, as shown in Figures 37 through 38 . Barrier damage consisted of deformed guardrail, fractured posts, and contact marks on the front face of the W-beam guardrail. The length of vehicle contact along the barrier was approximately 34 ft – 4 in. (10.5 m) which spanned from 4 in. (102 mm) upstream of the centerline of post no. 13 and extended to 33 in. (838 mm) downstream of post no. 18.

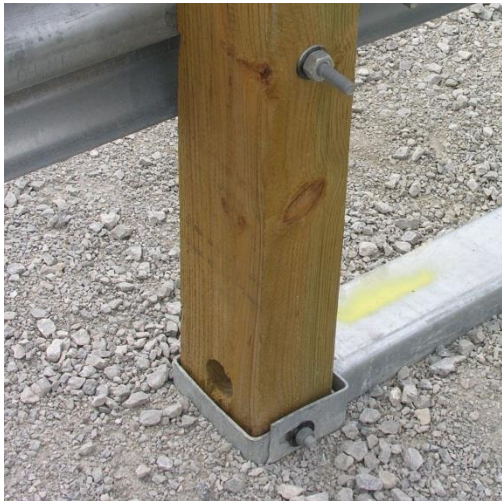
Figure 45. Upstream Anchor Damage, Test No. MGSSYP-1

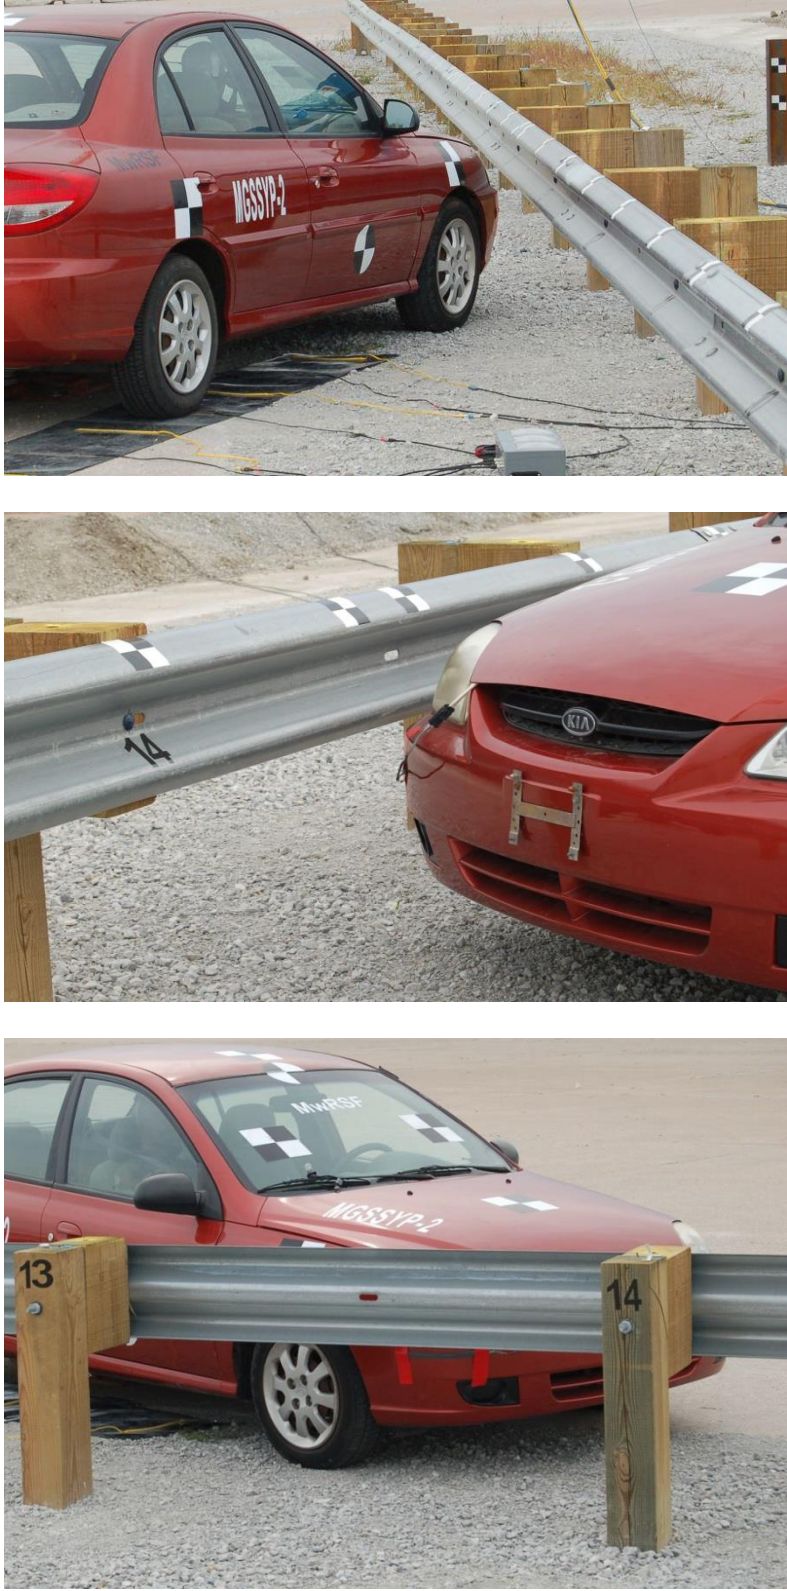
Figure 52. Impact Location, Test No. MGSSYP-2

Initial vehicle impact was to occur 8 ft – 7 in. (2.6 m) upstream of the center line of post no. 15, as shown in Figure 52, which was selected using the CIP plots found in Section 2.3 of MASH to maximize pocketing and the propensity of wheel snag. The actual point of impact was 8 ft – 4 in. (2.5 m) upstream of post no. 15. A sequential description of the impact events is contained in Table 10. The vehicle came to a rest 168 ft – 2 in. (51.3 m) downstream of the impact location and 17 ft – 11 in. (5.5 m) laterally in front of the barrier system, and its trajectory

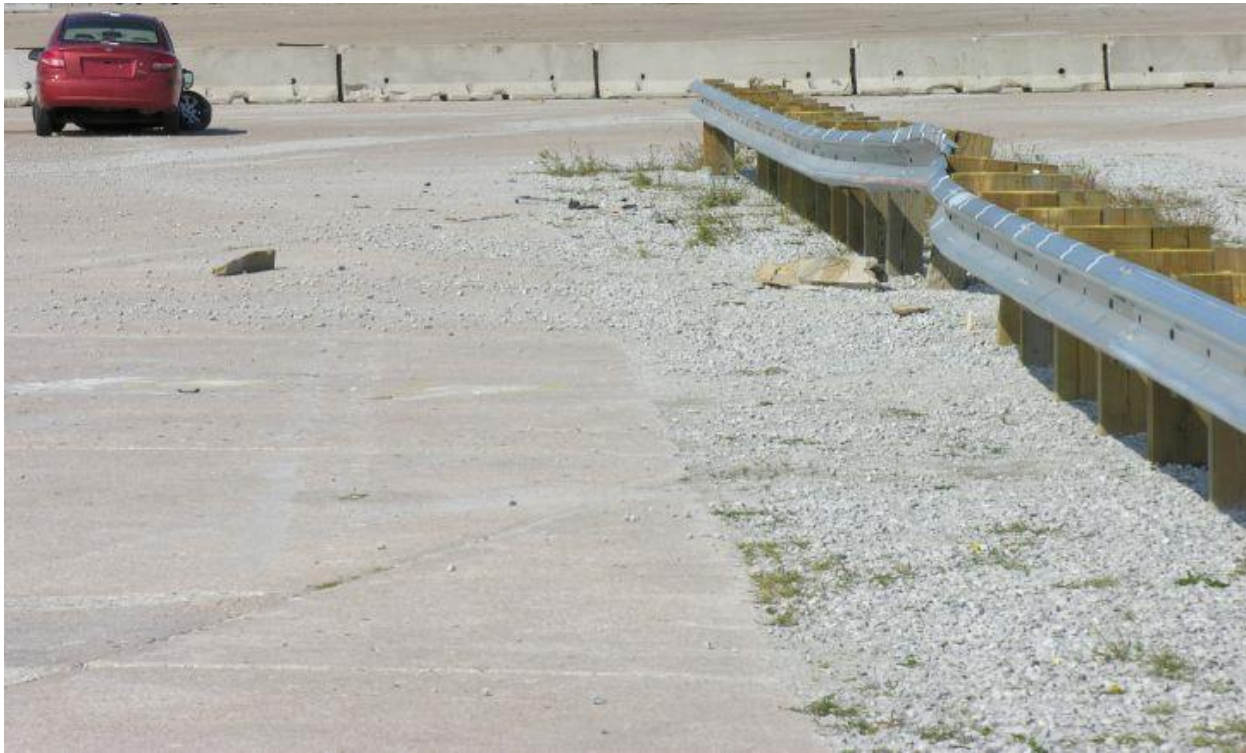
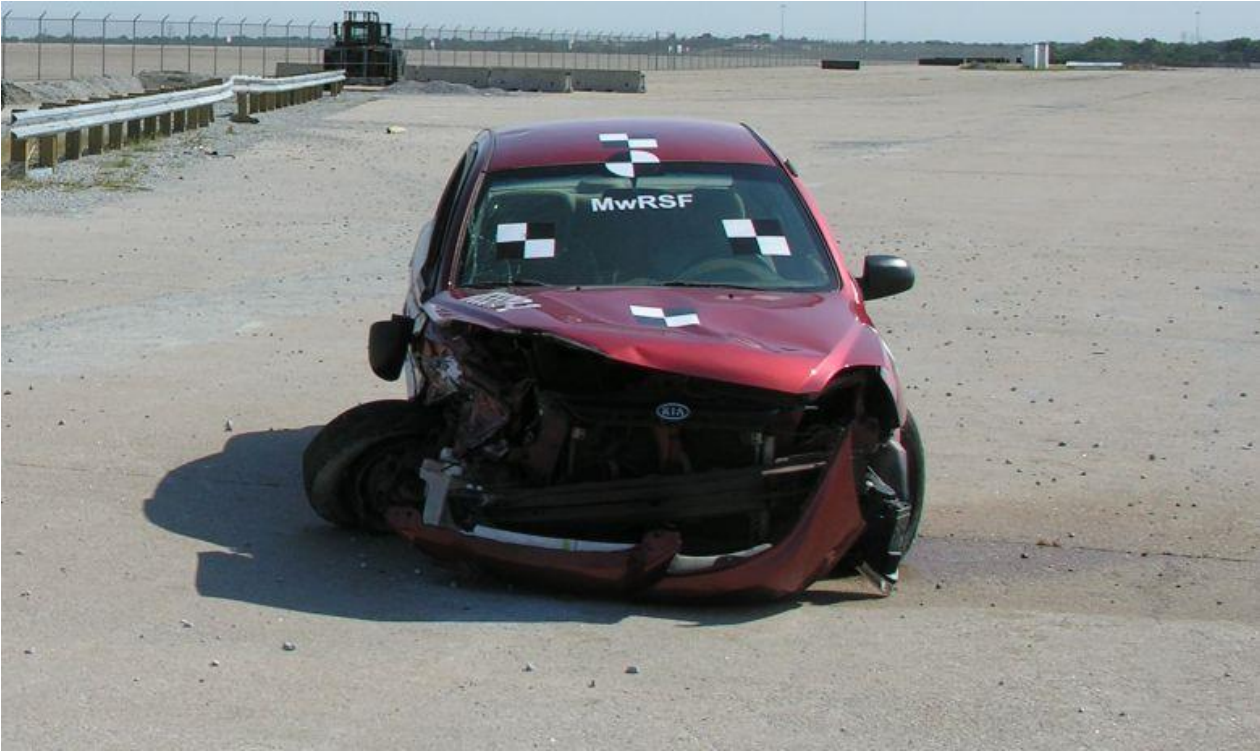
Figure 53. Vehicle Final Position and Trajectory Marks, Test No. MGSSYP-2

did not violate the bounds of the exit box. The vehicle trajectory and final position are shown in Figure 53.

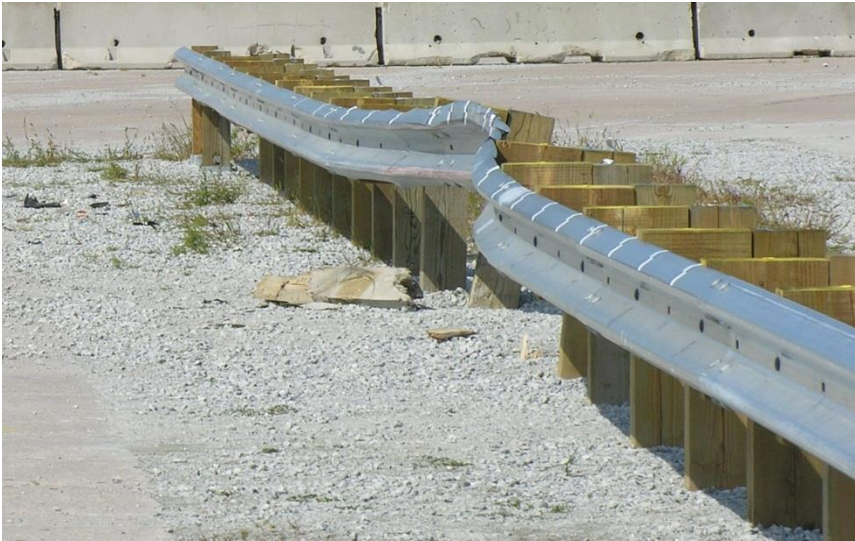
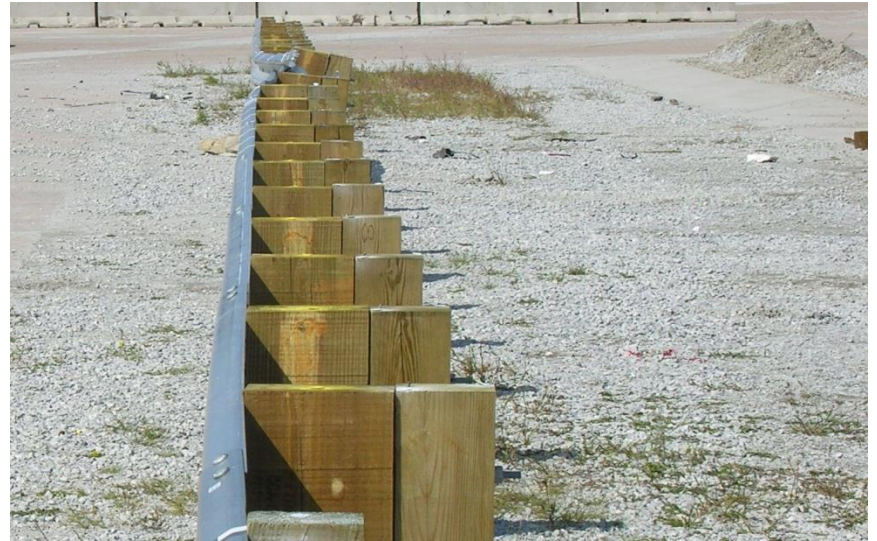
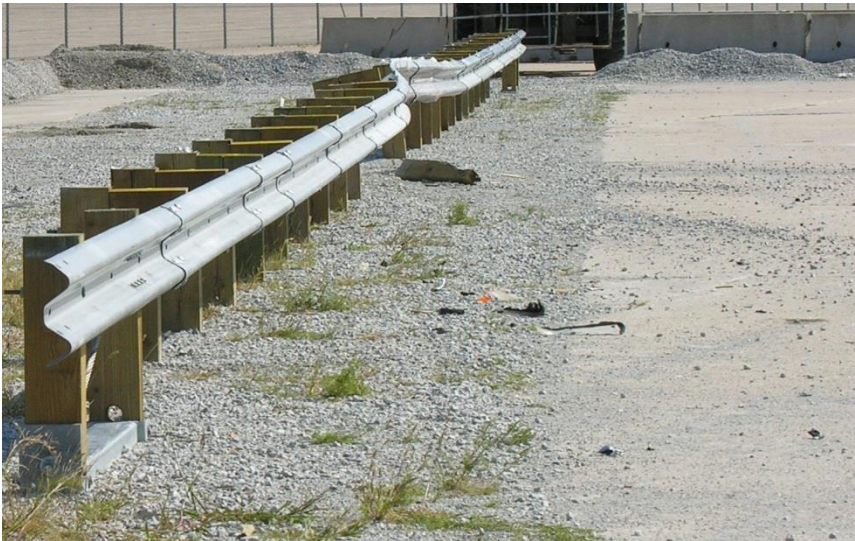
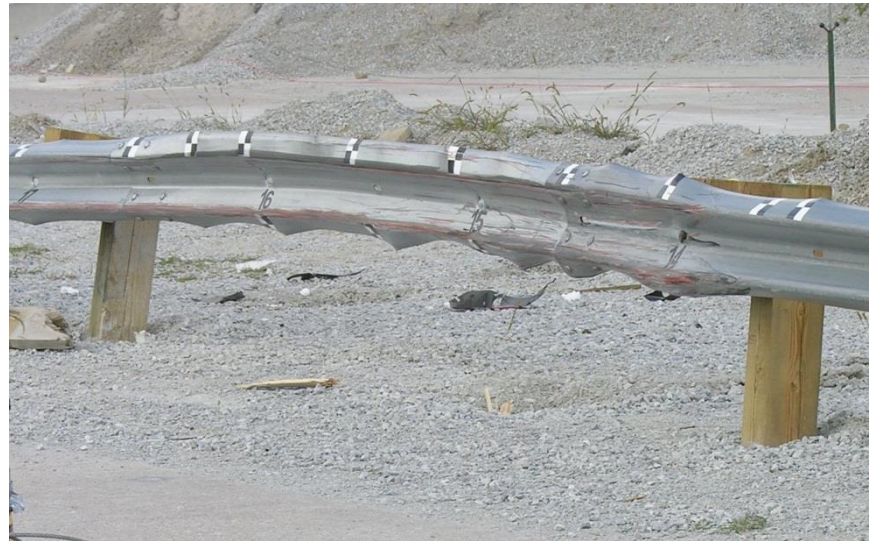
Figure 54. System Damage, Test No. MGSSYP-2

Damage to the barrier was moderate, as shown in Figures 54 through 56. Barrier damage consisted of deformed guardrail, rotated and fractured posts, and contact marks on the guardrail and posts. The length of vehicle contact along the barrier was approximately 23 ft – 1 in. (7.0 m) which spanned from 2 ft – 6½ in. (775 mm) upstream of post no. 14 to 1 ft – 9½ in. (546 mm) downstream of post no. 17.
