Evaluation of a Non-Proprietary, High-Tension, Four-Cable Median Barrier on Level Terrain

TESTING CERT # 2937.01

Midwest States Regional Pooled Fund Research Program

EVALUATION OF A NON-PROPRIETARY, HIGH-TENSION, FOUR-CABLE MEDIAN BARRIER ON LEVEL TERRAIN

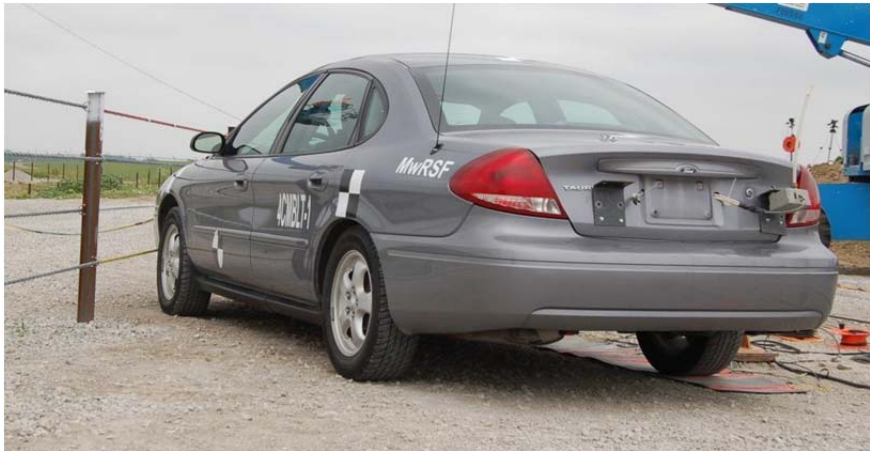
Figure 34. Impact Location, Test No. 4CMBLT-1

Initial vehicle impact was to occur 64 in. (1,626 mm) downstream from post no. 16, as shown in Figure 34, which was selected using an analysis of the vehicle trajectory to maximize the potential for vehicle penetration through the system. A sequential description of the impact events is provided by Table 6. The vehicle came to rest 123 ft (37.5 m) downstream from impact within the system. The vehicle trajectory and final position are shown in Figures 29 and 35.

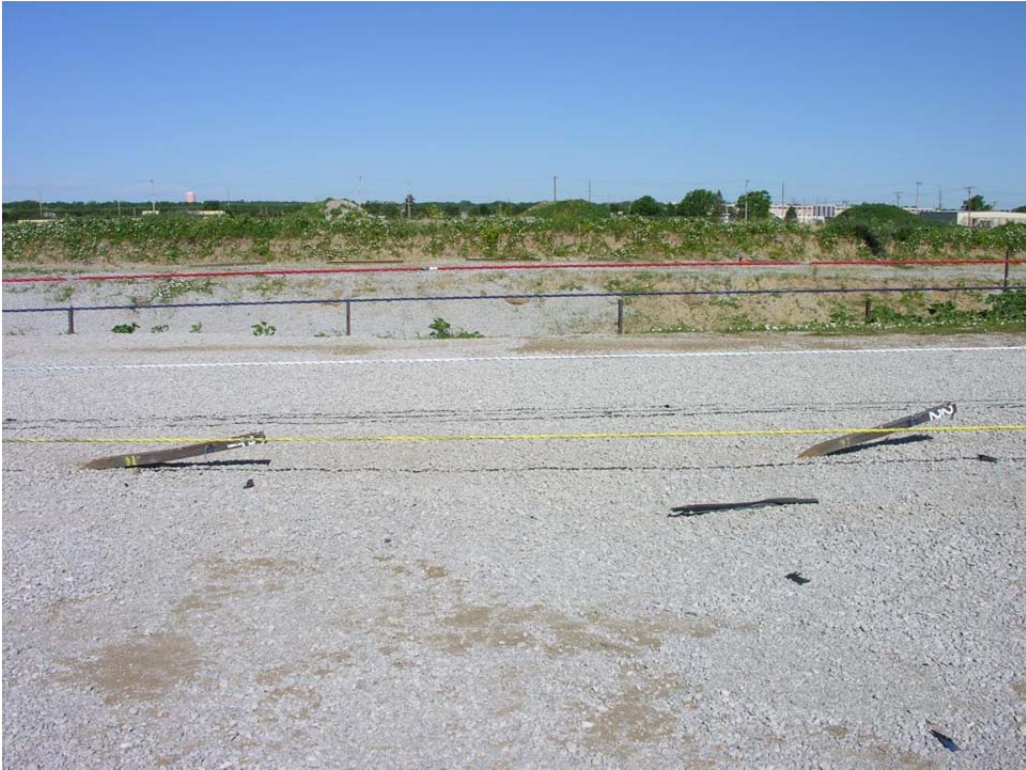
Figure 38. Post Nos. 19 through 22 System Damage, Test No. 4CMBLT-1

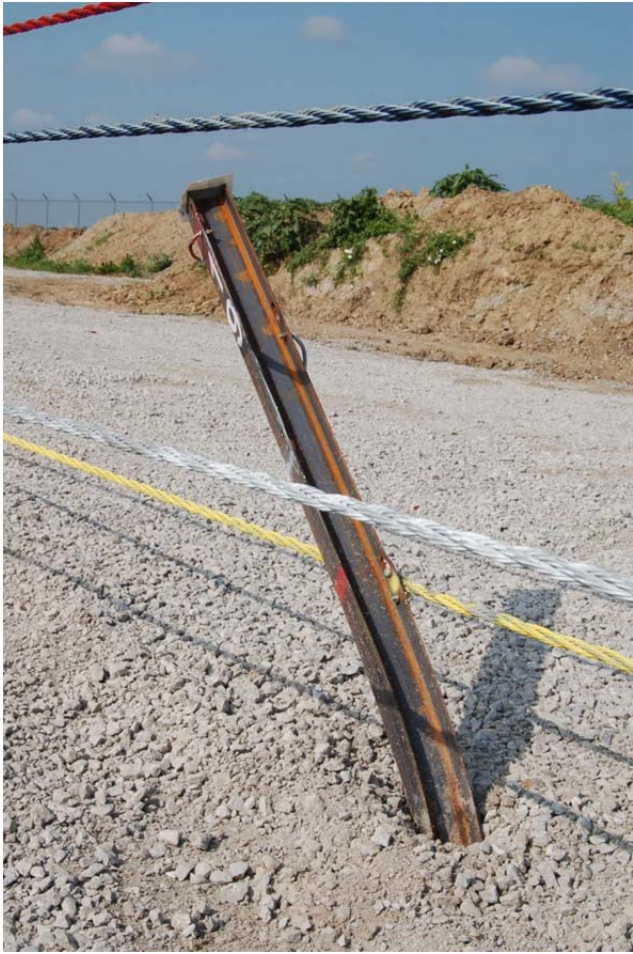
Figure 43. Post No. 19 Damage, Test No. 4CMBLT-1

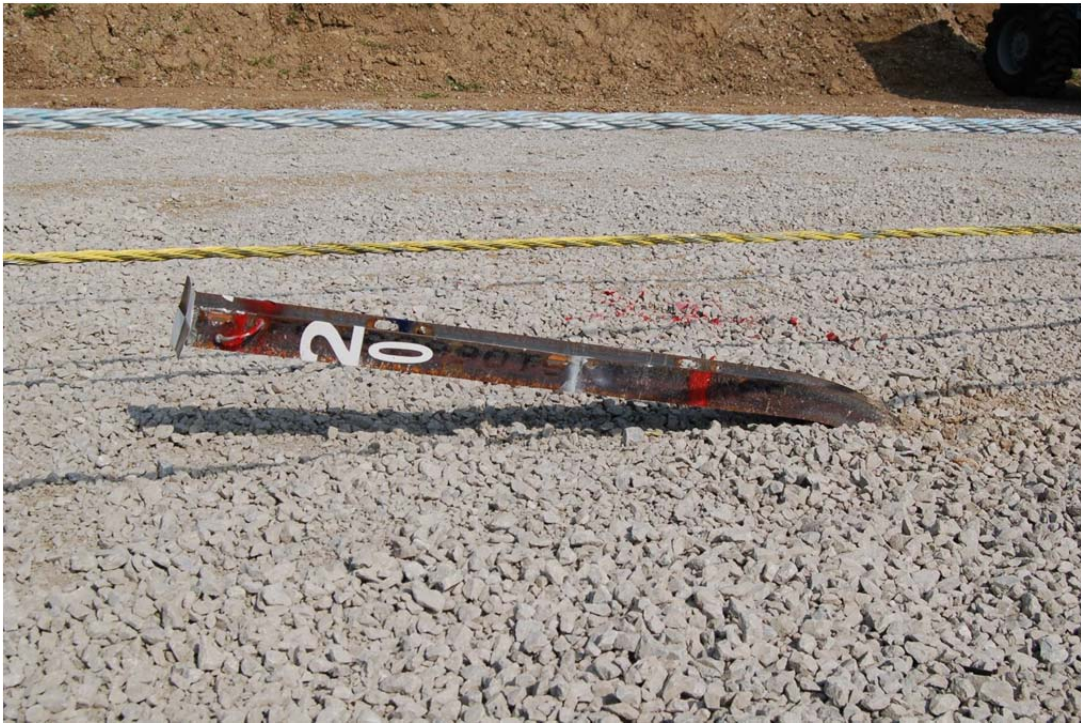
Figure 44. Post No. 20 Damage, Test No. 4CMBLT-1

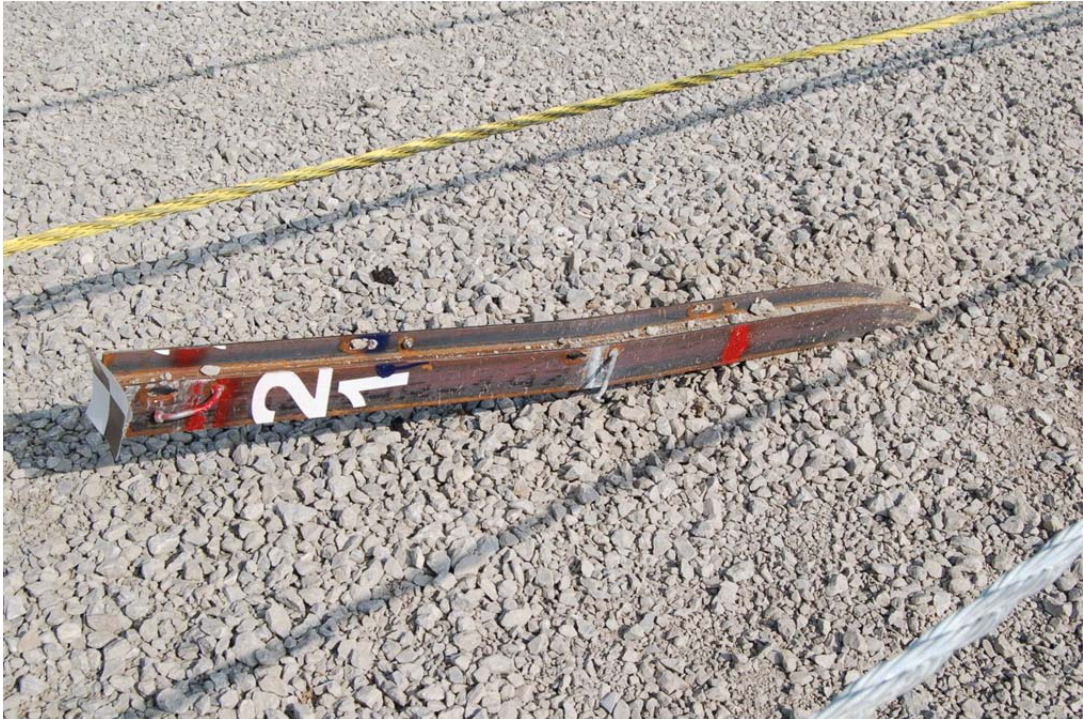
Figure 45. Post No. 21 Damage, Test No. 4CMBLT-1

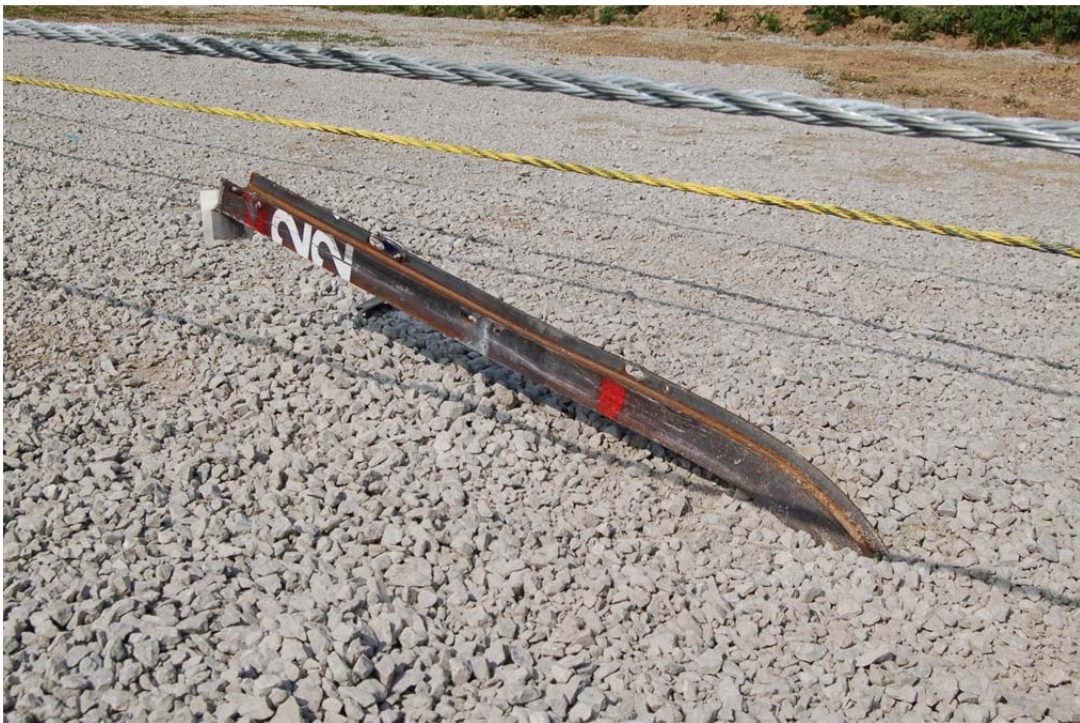
Figure 46. Post No. 22 Damage, Test No. 4CMBLT-1

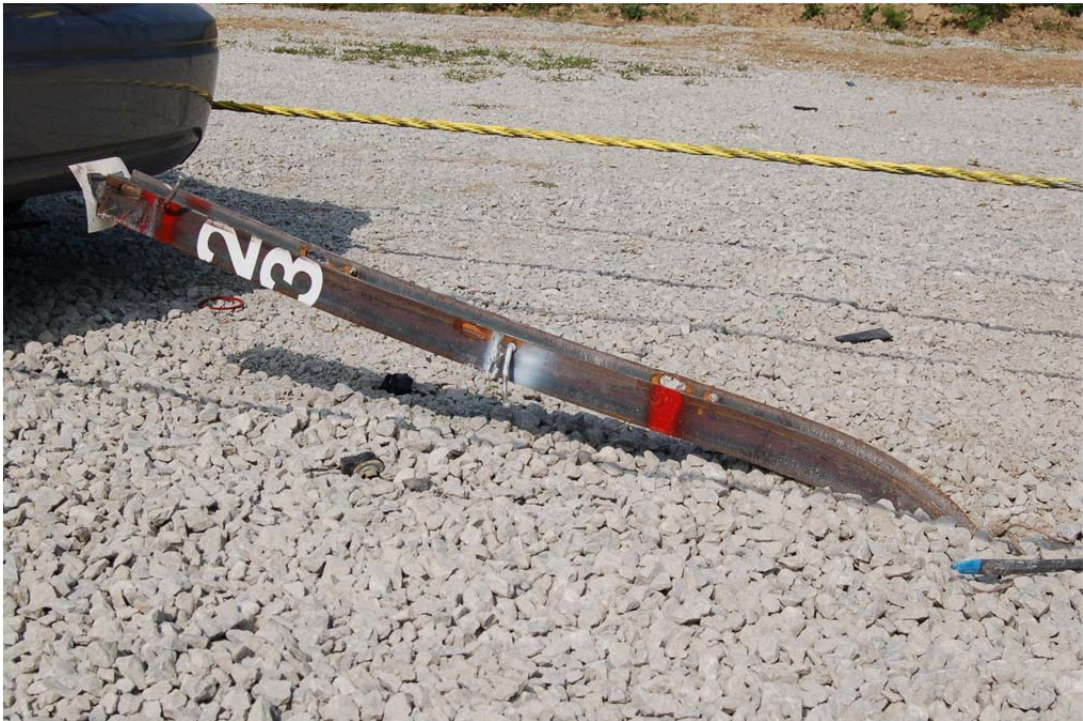
Figure 47. Post No. 23 Damage, Test No. 4CMBLT-1

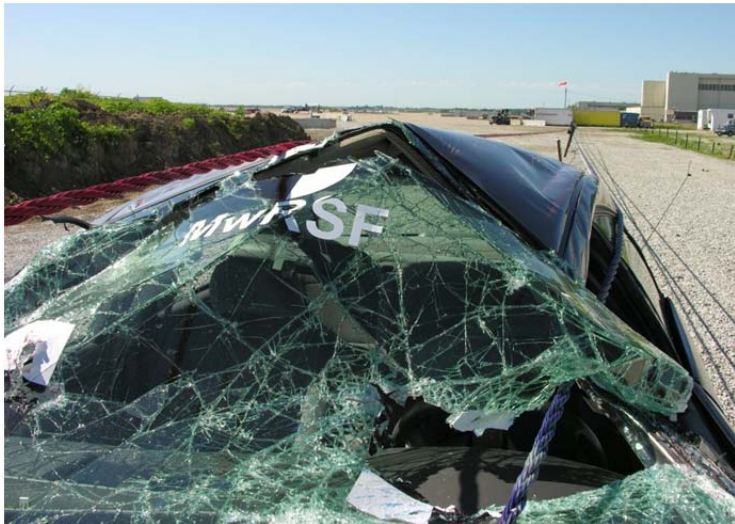
Figure 51. Vehicle Damage, Test No. 4CMBLT-1

After reviewing the high-speed video of test no. 4CMBLT-1, it was determined that the excessive damage to the roof, windshield, and A-pillar was caused by cable no. 2. While the vehicle was redirecting, this cable was in contact with the A-pillar and did not slide up and over the top of the vehicle as anticipated. The cable also did not release away from post no. 18 (the second post downstream from initial impact) as early as predicted. These two phenomena

resulted in a high lateral load being imparted to the vehicle's A-pillar, which eventually caused it to crush along with the windshield and roof.
