# Phase I Development of a Non-Proprietary, Four-Cable, High Tension Median Barrier

TESTING CERT # 2937.01

Midwest States Regional Pooled Fund Research Program  
Fiscal Year 2003-2004 (Year 14), 2005-2006 (Year 16), 2007-2008 (Year 18)  
Research Project Number SPR-3(017)  
NDOR Sponsoring Agency Code RFPF-04-01, RFPF-08-02

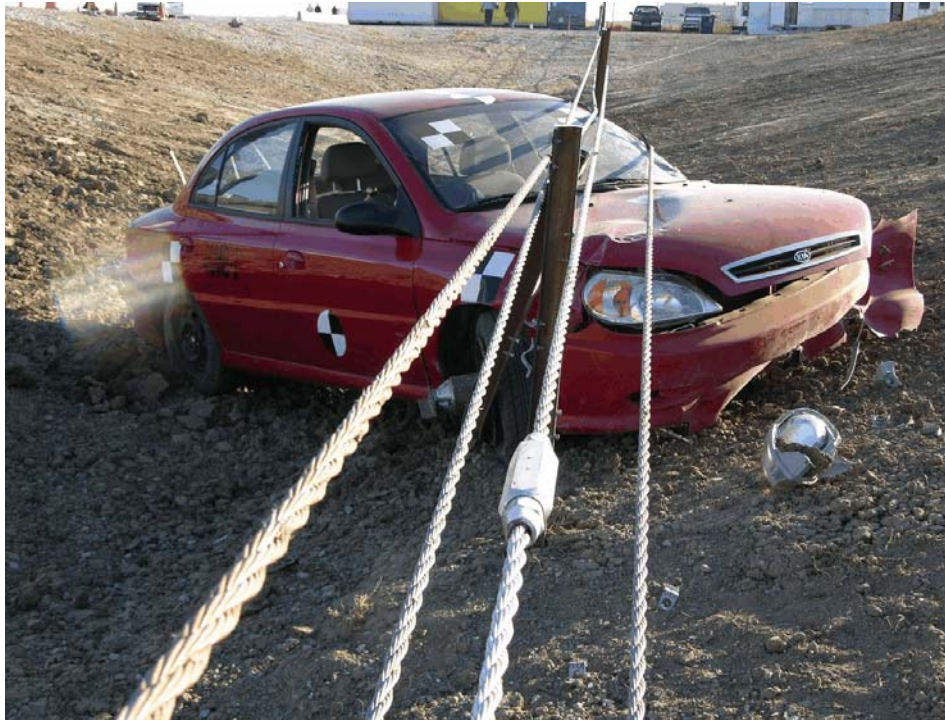
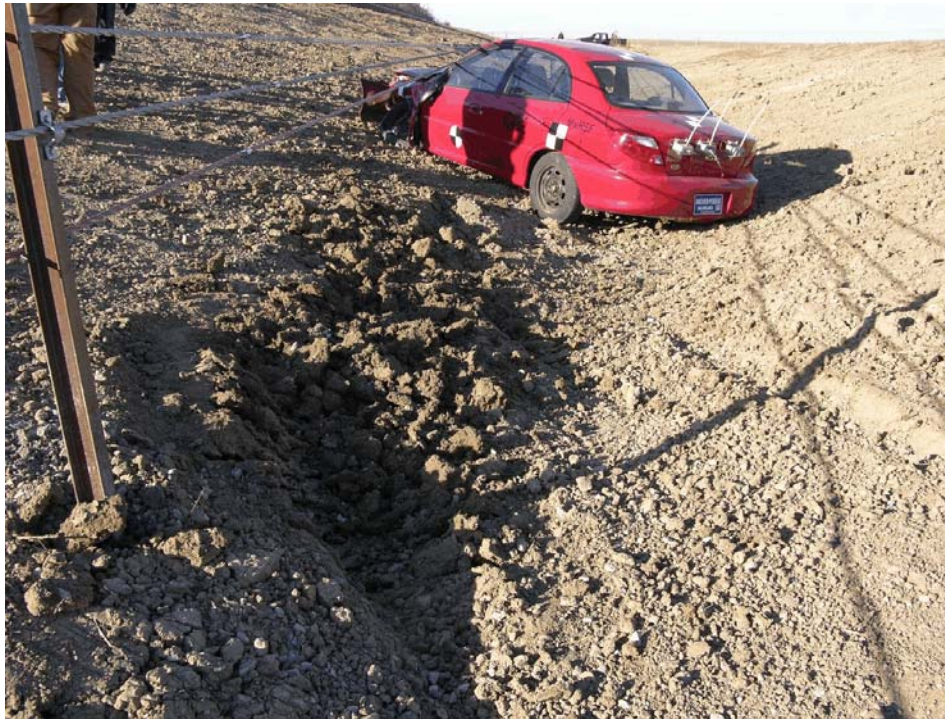
Figure 70. Impact Location, Test No. 4CMB-2

Initial vehicle impact was to occur between post nos. 17 and 18, or 64 in. (1,626 mm) downstream of post no. 17, as shown in Figure 70. Table 9 contains a sequential description of the impact events. The final vehicle position was determined to be 24 ft (7.3 m) downstream and 0.0 ft (0.0 m) laterally from vehicle impact, as shown in Figure 71.

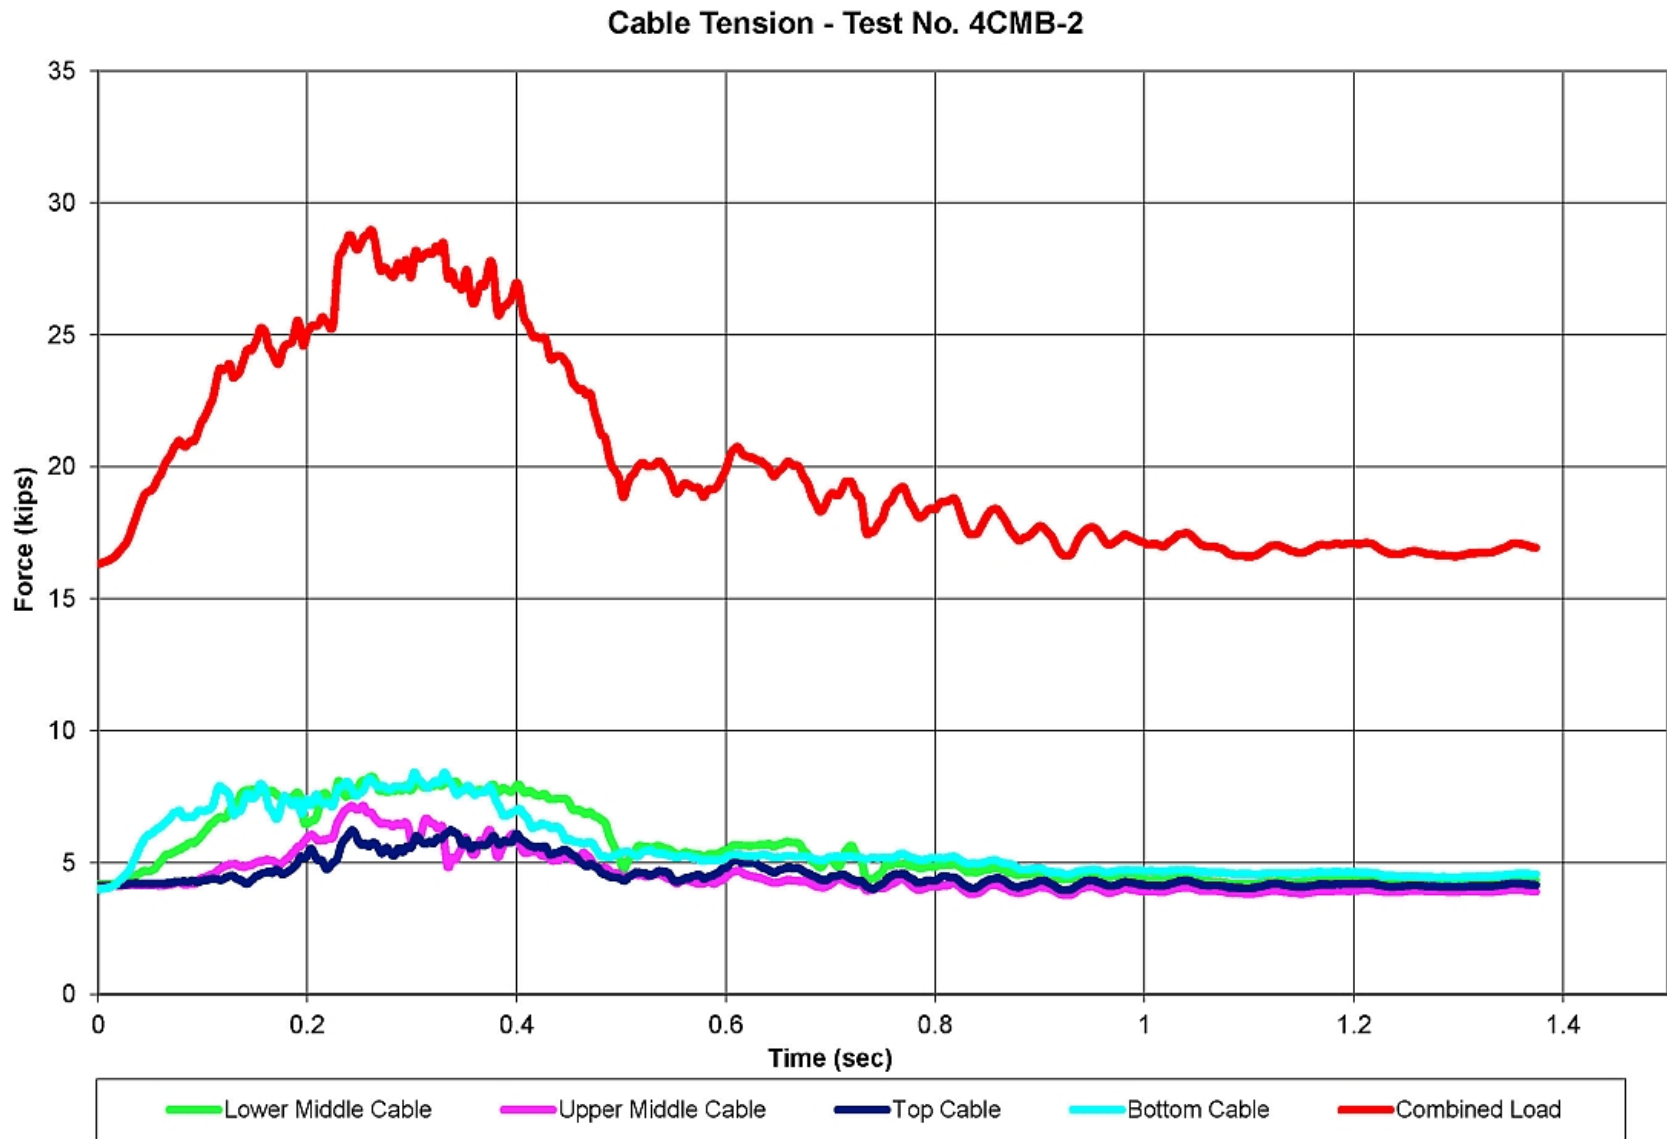
Figure 79. Cable Tensions, Test No. 4CMB-2

The individual cable loads, along with the total combined cable load imparted to the upstream anchor, were determined and are shown graphically in Figure 79. The total axial force imparted to the upstream anchor was 28.97 kips (128.9 kN) and occurring at 0.363 sec after vehicle impact with the barrier system. The maximum force was 8.41 kips (37.4 kN) and occurred in the bottom cable. The upper middle and lower middle cables experienced a maximum load of 7.15 kips
