# Development and Evaluation of the Midwest Guardrail System (MGS) Placed Adjacent to A 2:1 Fill Slope

TESTING CERT # 2937.01

*Midwest States Regional Pooled Fund Research Program  
Fiscal Year 2004-2005 (Year 15)  
Research Project Number SPR-3(017)  
NDOR Sponsoring Agency Code RFPF-05-09*

# **DEVELOPMENT AND EVALUATION OF THE MIDWEST GUARDRAIL SYSTEM (MGS) PLACED ADJACENT TO A 2:1 FILL SLOPE**

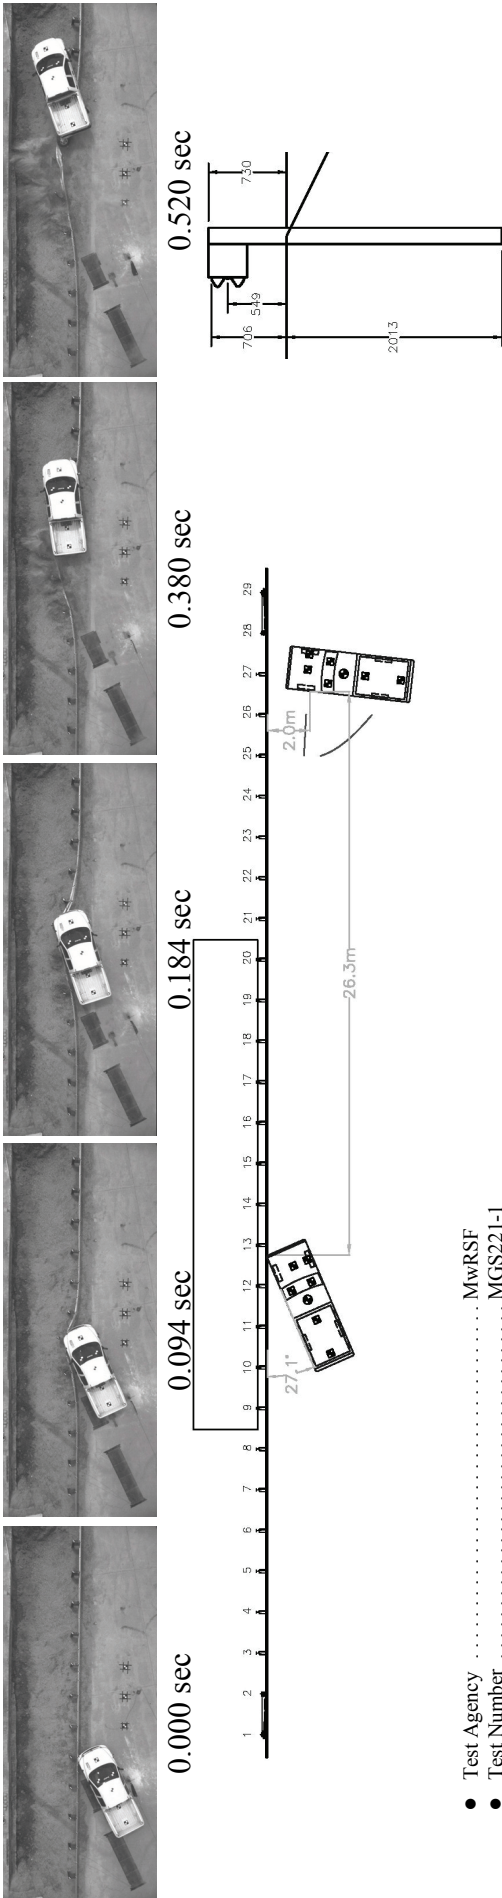
Figure 24. Summary of Test Results and Sequential Photographs, Test No. MGS221-1

The analysis of the test results for test no. MGS221-1 showed that the MGS, with a 706-mm (27<sup>3</sup>/<sub>4</sub>-in.) top mounting height and installed adjacent to a 2:1 fill slope, did not adequately contain nor redirect the 2270P vehicle as the vehicle overrode the top of the system and subsequently landed behind the system. There were no detached elements nor fragments which showed potential for penetrating the occupant compartment nor presented undue hazard to other traffic. Deformations of, or intrusion into, the occupant compartment that could have caused serious injury did not occur. The test vehicle overrode and penetrated the guardrail system. It did remain upright during and after the collision. Vehicle roll, pitch, and yaw angular displacements were noted, but they were deemed acceptable because they did not adversely influence occupant risk safety criteria nor cause rollover. Therefore, test no. MGS221-1 conducted on the MGS installed adjacent to a 2:1 fill slope was determined to be unacceptable according to the TL-3 safety performance criteria found in MASH.

The vehicle override was attributed to the slow release of post no. 15 from the guardrail, thus causing the W-beam to be pulled downward. In addition, the vehicle override was also attributed to the failure of the vehicle's front suspension shortly after impact, thus preventing the guardrail from capturing the pickup truck's left-front tire.

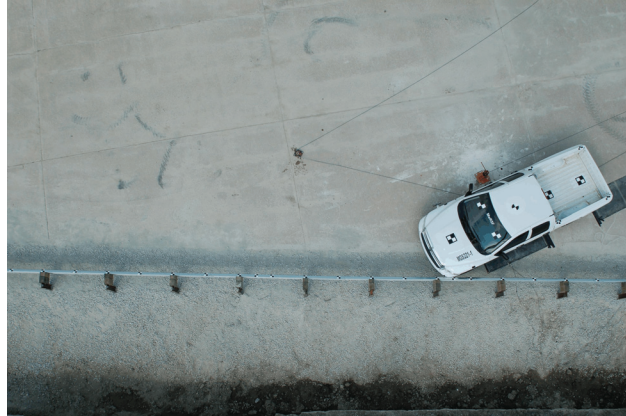
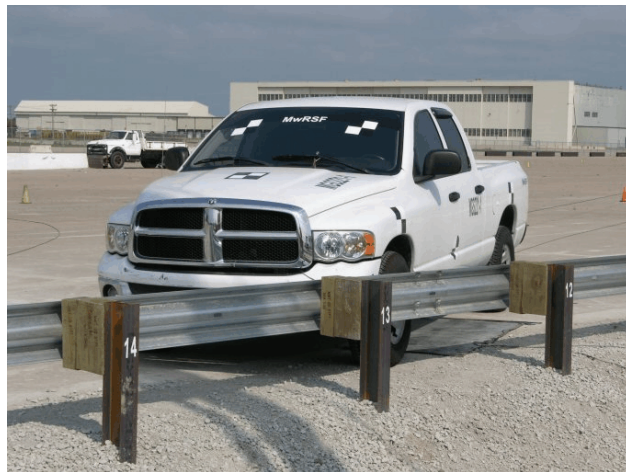
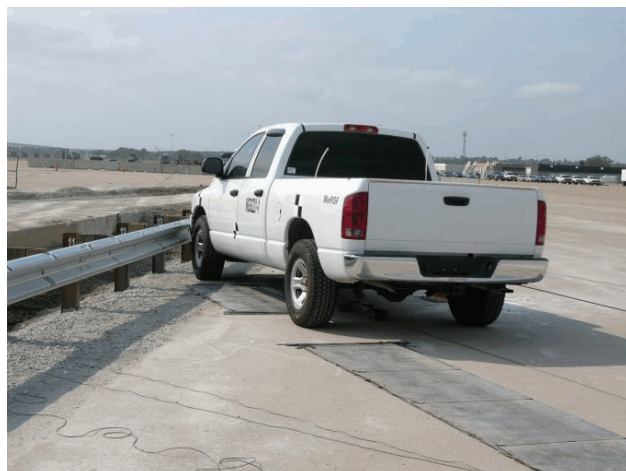
Figure 31. Impact Location, Test No. MGS221-1

Initial vehicle impact was to occur 476 mm (18¾ in.) upstream from the centerline of post no. 13, as shown in Figure 31. Actual vehicle impact occurred 432 mm (17 in.) upstream from the centerline of post no. 13. At 0.010 sec after impact, the left corner of the bumper crushed inward, and post no. 13 deflected. At 0.018 sec, post no. 14 deflected, and the impacted rail flattened. At 0.024 sec, post no. 12 deflected. At 0.036 sec, the rail deformed around post no. 14. At 0.064 sec, post no. 15 deflected, and a buckle point formed at the midspan between post nos. 14 and 15. At 0.074 sec, the left corner of the front bumper was located at post no. 14 which was deflecting. At 0.096 sec, the guardrail released from post no. 14, and post no. 16 deflected. At 0.112 sec, the front of the vehicle was located at the midspan between post nos. 14 and 15. At 0.120 sec, the left-front tire disengaged from the vehicle. At 0.128 sec, buckling occurred at the midspan between post nos. 15 and 16. At this same time, the rail was located under the left corner of the front bumper. At 0.138 sec, the rail deformed around post no. 16, and post no. 17 deflected. At 0.146 sec, the guardrail released from post no. 15, and the right-front tire became airborne. At 0.154 sec, the left corner of the front bumper was located at post no. 15, which was deflecting. At 0.182 sec, the left corner of the bumper protruded over the top of the rail. At 0.206 sec, the front of the vehicle pitched upward. At 0.226 sec, the guardrail released from post no. 15. At this same time, the entire left side of the vehicle was in contact with the rail. At 0.250 sec, the front of the vehicle was located between post nos. 16 and 17. At 0.308 sec, the front of the vehicle was located on top of post no. 17. At 0.324 sec, the right-front tire overrode the rail, the truck stopped redirecting, and the right-rear tire became airborne. At 0.342 sec, the rail began to tear. At this same time, the left-rear tire contacted the rail. At 0.376 sec, the front of the vehicle overrode post no. 18, and the rail at post no. 15 tore. At 0.400

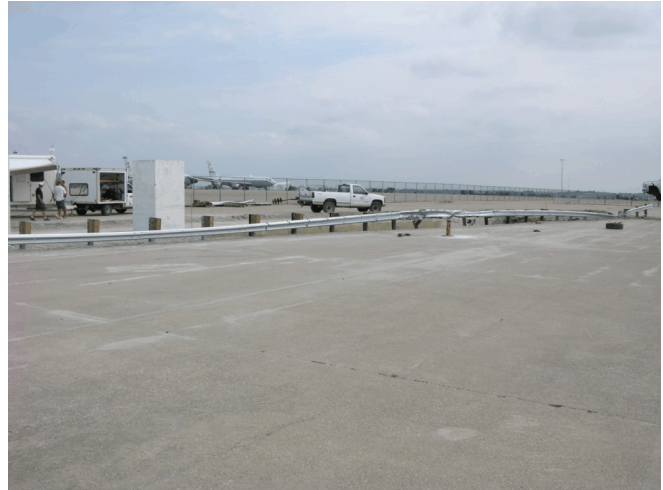
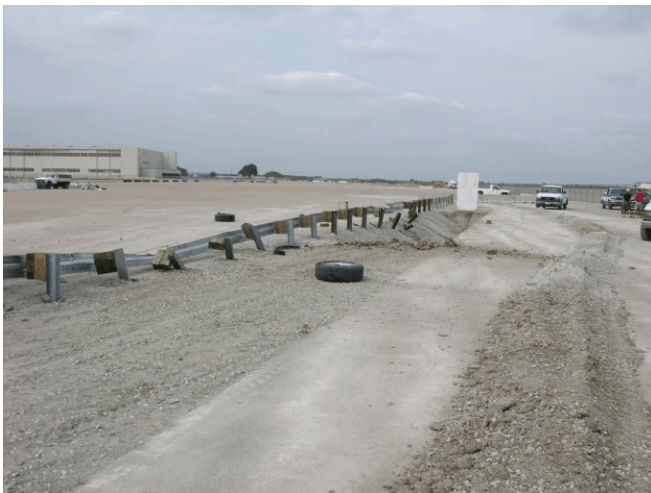
Figure 33. System Damage, Test No. MGS221-1

Damage to the barrier was moderate, as shown in Figures 33 through 41. Barrier damage consisted of deformed guardrail posts, disengaged wooden blockouts, contact marks on a guardrail section and posts, and deformed and fractured W-beam rail. The length of the vehicle contact along the MGS system was approximately 8.8 m (29 ft - 1½ in.), which spanned from 305 mm (12 in.) upstream from the centerline of post no. 13 through the midspan between post nos. 17 and 18.

The permanent set of the barrier system is shown in Figure 33. The maximum lateral permanent set rail and post deflections were 810 mm (31<sup>7</sup>/<sub>8</sub> in.) at the centerline of post no. 16 and 1,086 mm (42<sup>3</sup>/<sub>4</sub> in.) at post no. 15, respectively, as measured in the field. The maximum lateral dynamic rail and post deflections were 955 mm (37.6 in.) at the centerline of post no. 15 and 1,126 mm (44.3 in.) at post no. 15, respectively, as determined from high-speed digital video analysis.

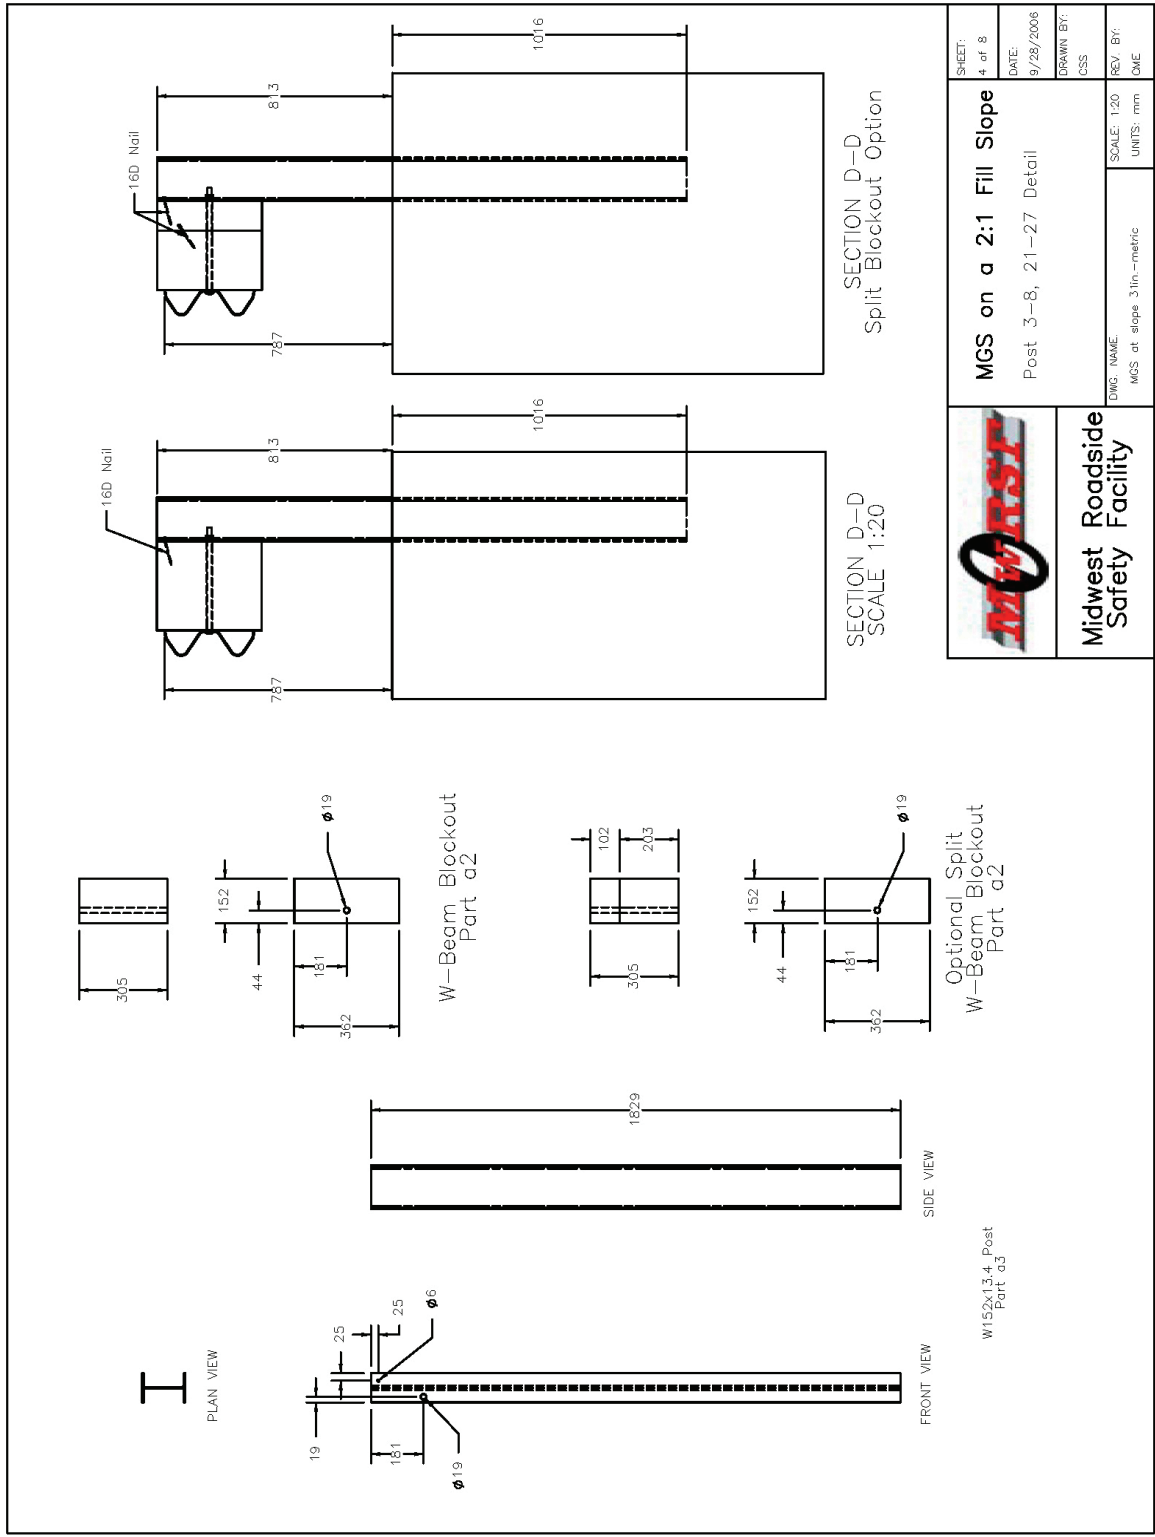
Figure 47. MGS Installed Adjacent to a 2:1 Fill Slope System Modifications, Test No. MGS221-2

Following the unsuccessful performance of the 706-mm (27<sup>3</sup>/<sub>4</sub> in.) high, MGS installed adjacent to a steep slope, it was believed that raising the rail height to 787 mm (31 in.) would allow for improved engagement between the barrier system and the vehicle. Therefore, the second design of the MGS installed adjacent to a 2:1 fill slope system was identical to the system in test no. MGS221-1 except for the guardrail's top mounting height. The first installation's height was set at the design's anticipated minimum height tolerance of 706 mm (27<sup>3</sup>/<sub>4</sub> in.). For the second installation, the top W-beam guardrail height was raised to 787 mm (31 in.) with a 632-mm (24<sup>7</sup>/<sub>8</sub>-in.) center mounting height. Additionally, post nos. 1 through 29 were still spaced 1,905 mm (75 in.) on center but were embedded to a depth of 1,930 mm (76 in.), as shown in Figures 46 and 47.

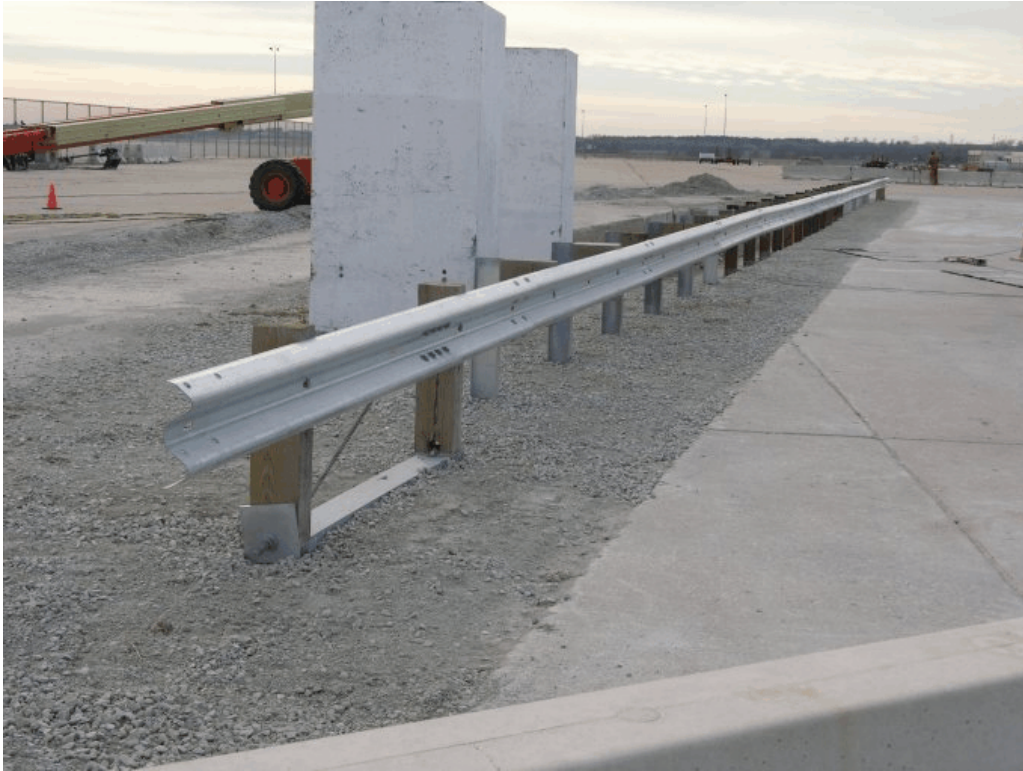
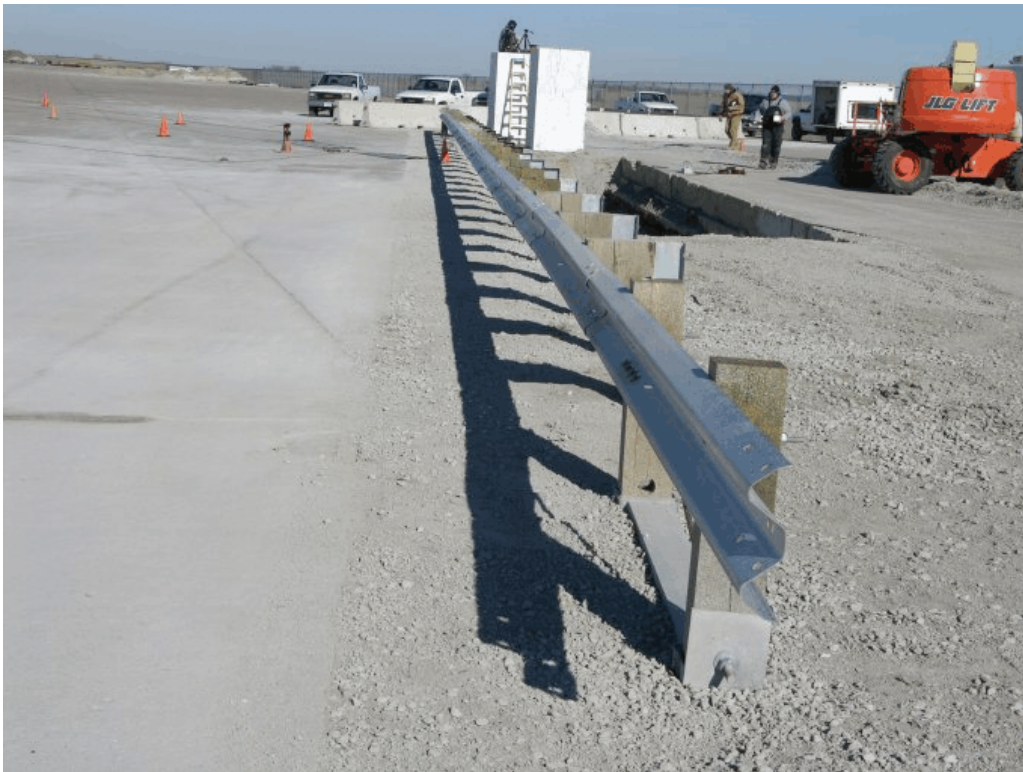
Figure 48. MGS Installed Adjacent to a 2:1 Fill Slope, Test No. MGS221-2

Once again, the posts installed adjacent to the 2:1 foreslope, post nos. 9 through 20, were still ASTM A36 steel W152x13.4 (W6x9) sections measuring 2,743 mm (9 ft) long. As used in the previous system, the rail splices were placed at the center span locations and were configured to reduce vehicle snag at the splice during the crash test. Photographs of the test installation are shown in Figures 48 and 49. The complete system drawings in metric and English units are shown in Appendix G.

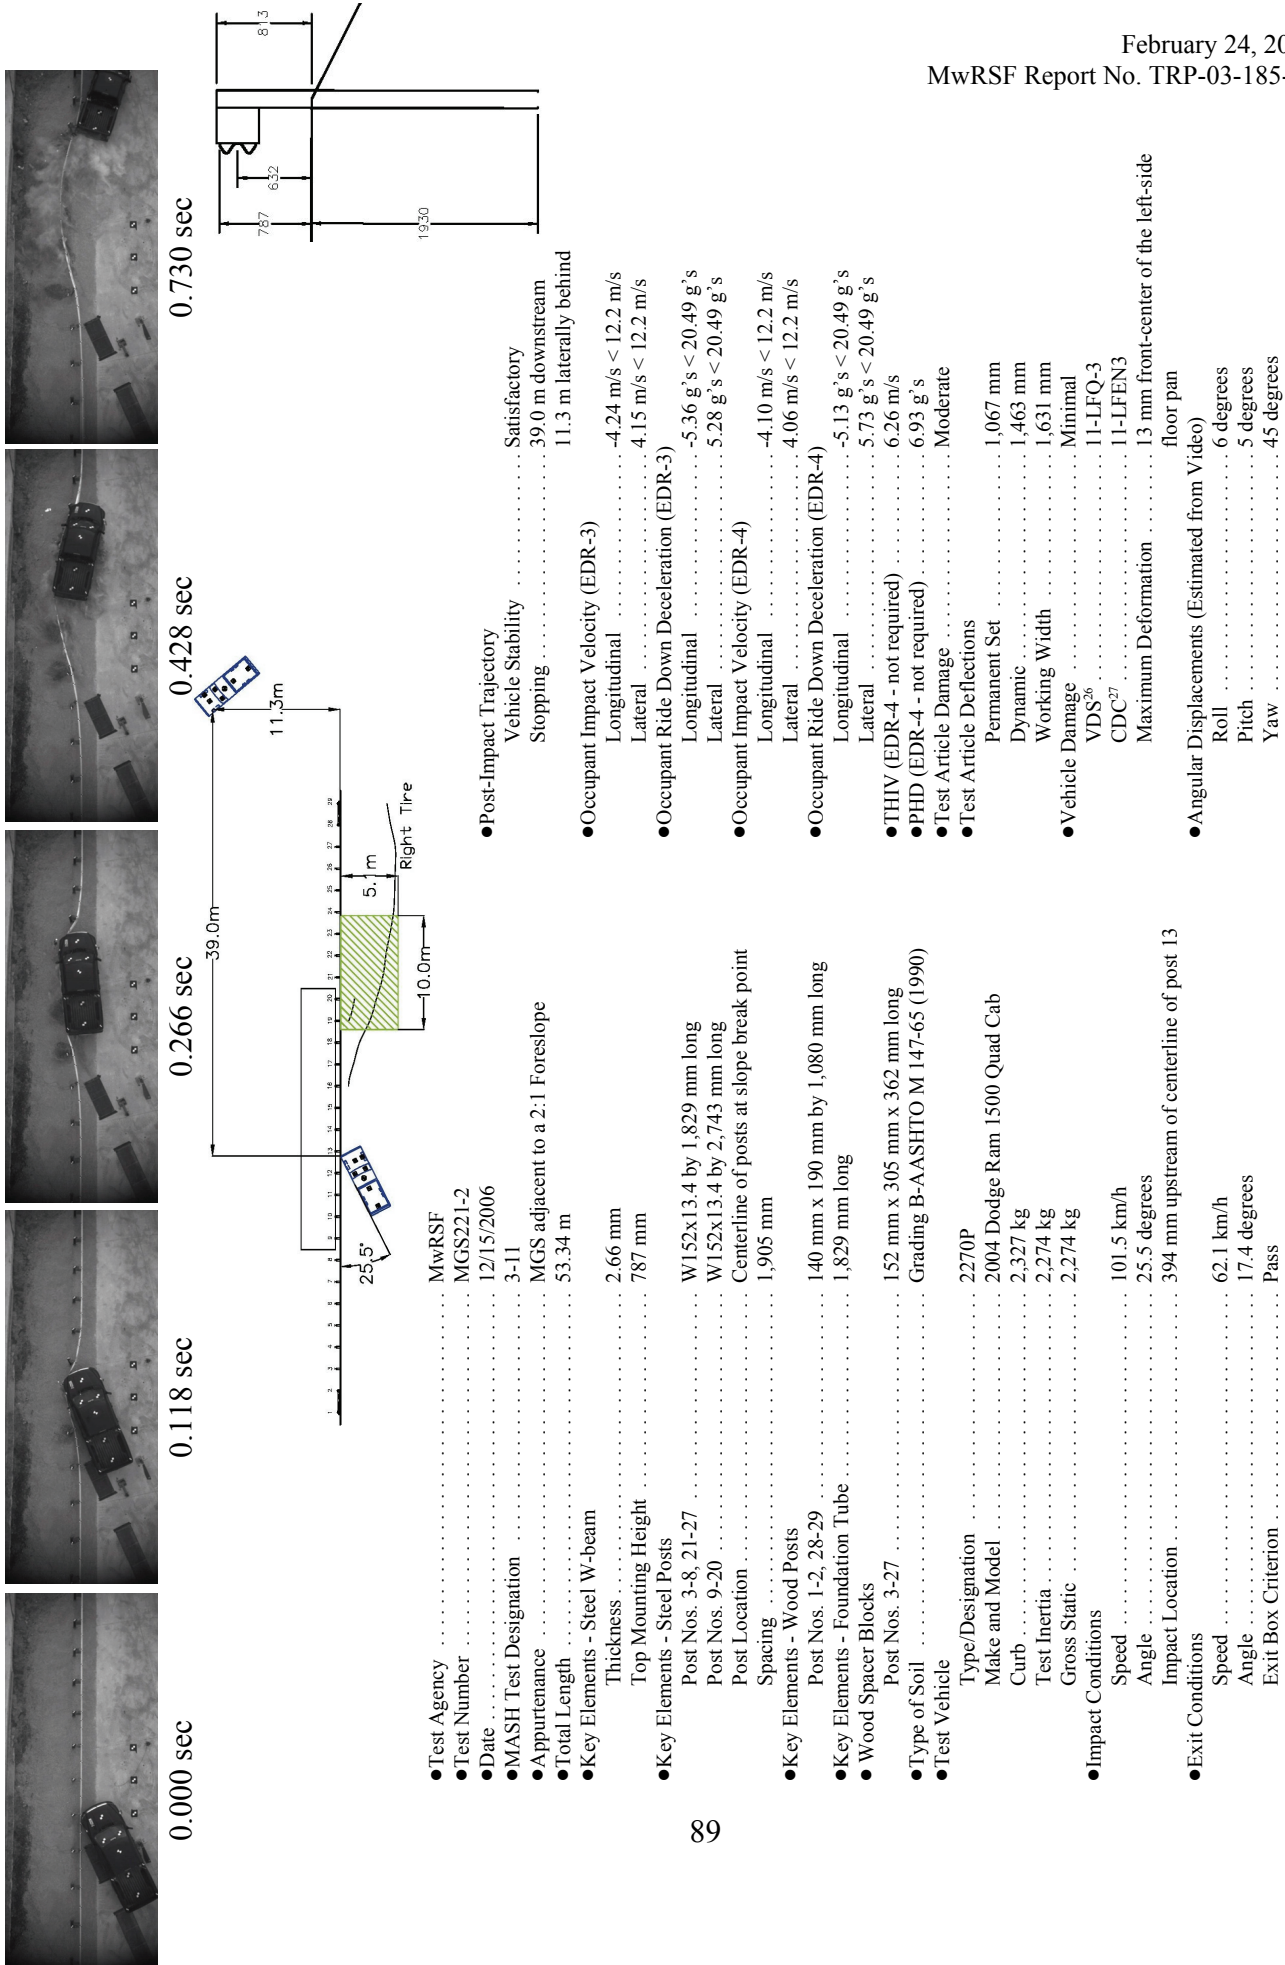
Figure 50. Summary of Test Results and Sequential Photographs, Test No. MGS221-2

The 2,274-kg (5,013-lb) pickup truck impacted the MGS, with a 787-mm (31-in.) top mounting height, installed adjacent to a 2:1 fill slope system at a speed of 101.5 km/h (63.1 mph) and at an angle of 25.5 degrees. A summary of the test results and sequential photographs are shown in Figure 50. A summary of the test results and sequential photographs in English units are shown in Appendix D. Additional sequential photographs are shown in Figures 51 through 54. Documentary photographs of the crash test are shown in Figure 55.
