Development of the Midwest Guardrail System (MGS) W-beam to Thrie Beam Transition Element

*Midwest States' Regional Pooled Fund Research Program
Fiscal Years 2000-2002, 2005-2006 (Years 11-12, 16)
Research Project Number SPR-3(017)
NDOR Sponsoring Agency Codes RFPF-01-04, RFPF-02-05, RFPF-06-04*

DEVELOPMENT OF THE MIDWEST GUARDRAIL SYSTEM (MGS) W-BEAM TO THRIE BEAM TRANSITION ELEMENT

7.1 Test MWT-3	52
7.2 Test Description	52
7.3 Barrier Damage	53
7.4 Vehicle Damage	55
7.5 Occupant Risk Values	56
7.6 Discussion	57
8 ANALYSIS AND DISCUSSION OF TEST NO. MWT-3	77
9 DESIGN MODIFICATIONS (DESIGN NO. 2)	79
10 CRASH TEST NO. 2	94

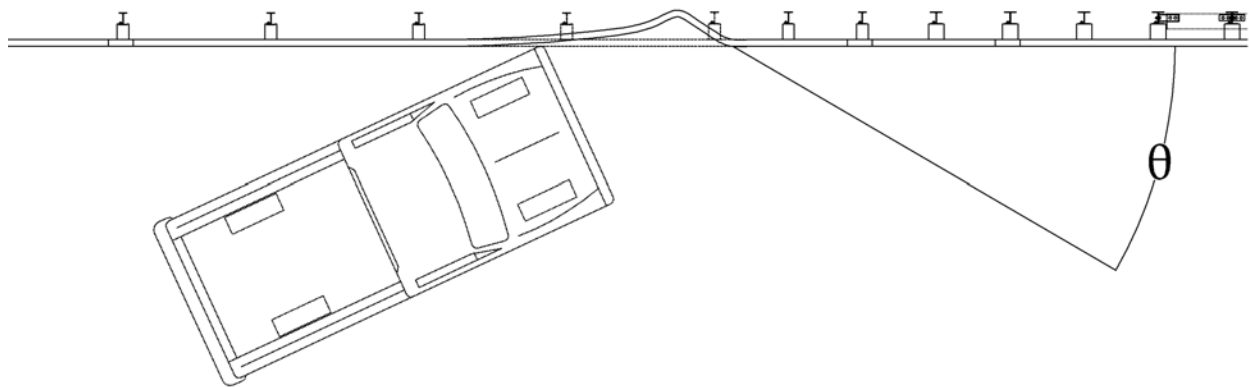
Figure 1. Critical Pocketing Angle

Although BARRIER VII (10) can predict the creation of a sharp bend in a guardrail system that could lead to pocketing, there are no objective criteria with which to measure the risk of serious consequences associated with pocketing. After reviewing crash tests of many guardrail systems, it was theorized that at a critical pocketing angle, θ_p , could be defined such that at angles smaller than θ_p , the bend in the guardrail would not cause serious pocketing. However, at angles more severe than θ_p , where the difference between the guardrail and transition regions was more abrupt, the vehicle

would not be able to escape from the pocket and an undesirable vehicle response could be expected. The critical pocketing angle is defined as the angle between the guardrail region just in front of the impacting vehicle and the downstream section of rail. Note that this definition of θ_p is only applicable where there is a sharp bend in the guardrail, and the pocketing angle is essentially a measure of the magnitude of that angle. It should also be noted that the depth of the pocket may also have a significant impact on the performance of a guardrail system. However, for the purposes of using BARRIER VII to design a guardrail stiffness transition, the authors have assumed that the depth of the pocket will always be sufficient to create a problem, provided the critical pocketing angle is reached, as shown in Figure 1.

Many guardrail and approach guardrail transition tests involving 2000P vehicles were carefully reviewed in order to identify the critical pocketing angle. Based upon this analysis, the critical pocketing angle was estimated to be approximately 23 degrees. Every test that exhibited a pocketing angle of 23 degrees or less resulted in a successful redirection of the 2000P vehicle,

whereas most tests with pocketing angles greater than 23 degrees exhibited significant pocketing and corresponding adverse vehicle behavior. For example, the pocketing angle from test no. MWT-2 was estimated to be 45 degrees. As a result of the pocketing, the rail ruptured and the test vehicle rolled over during the test.

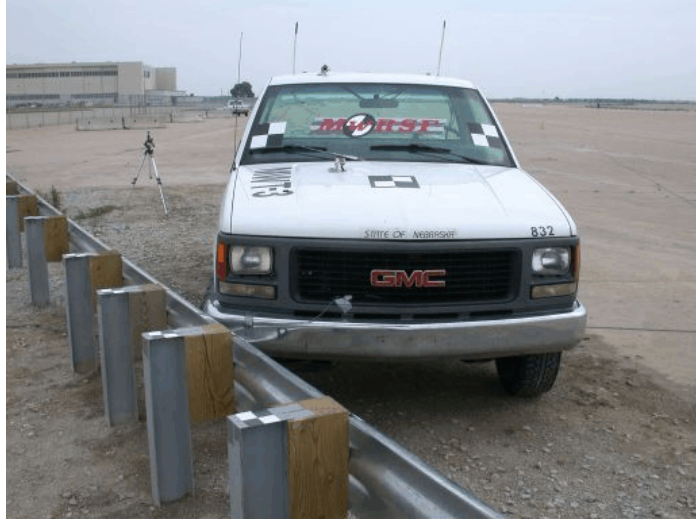
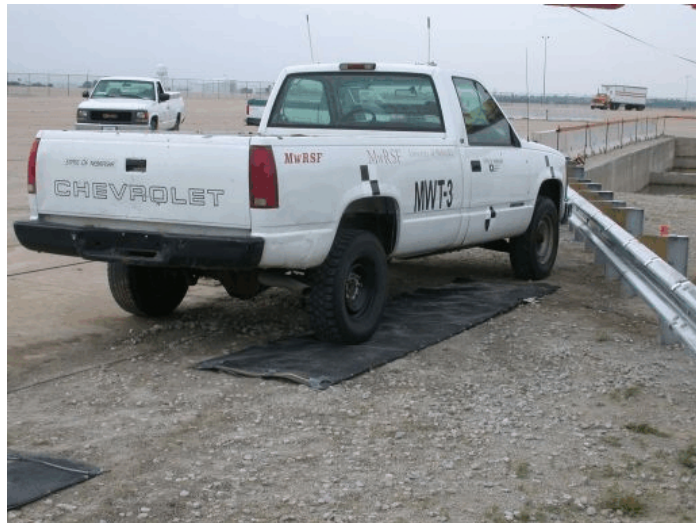
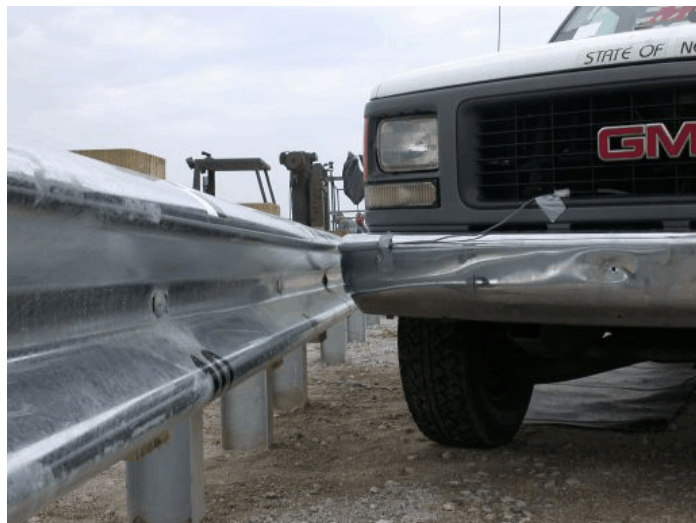
Figure 37. Impact Location, Test MWT-3

Initial vehicle impact was to occur between post nos. 8 and 9, or 330 mm (13 in.) upstream from the centerline of post no. 9, as shown in Figure 37. Actual vehicle impact occurred 203 mm (8 in.) upstream from the centerline of post no. 9. At 0.010 sec after impact, the right-front corner of the vehicle was located at post no. 9 and began to crush inward. At 0.022 sec, the rail deformed at post nos. 8, 9, and 10. At this same time, the soil around post no. 9 began to fail, and the right-front corner of the hood protruded over the rail. At 0.050 sec, the right-front corner of the hood was positioned over post no. 10, rail deflection continued downstream to post no. 11, and large amounts of soil damage were evident. At 0.093 sec, the right-side door became ajar at the top, and the right-front corner of the hood, which was crushed inward to the centerline of the truck with bumper completely under the hood, was positioned over post no. 11. At this same time, post no. 9 rotated clockwise slightly, and post nos. 12 and 13 began to deflect. At 0.097 sec, the body of the truck began to redirect while the truck continued along its same direction and encountered positive roll toward the system. At 0.145 sec, post no. 10 rotated clockwise. At this same time, the left-front edge of the hood separated from the quarter panel, and the front edge of the right-side door crushed into the rail. At

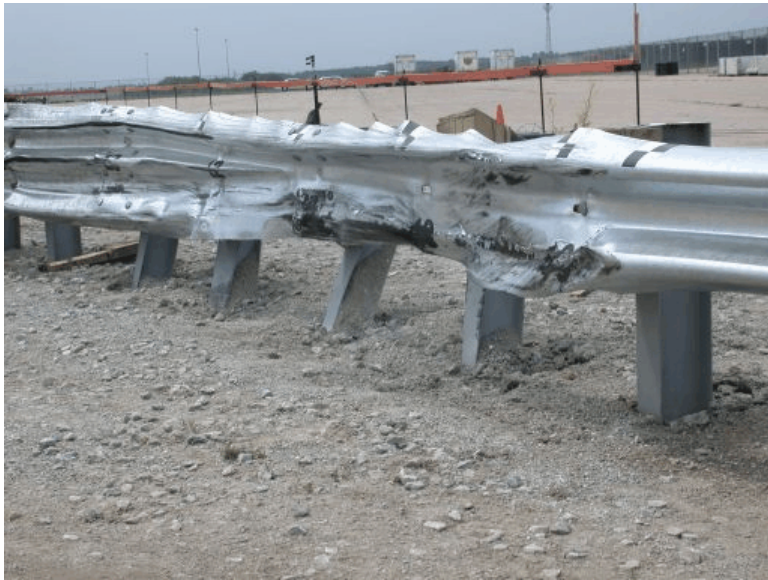
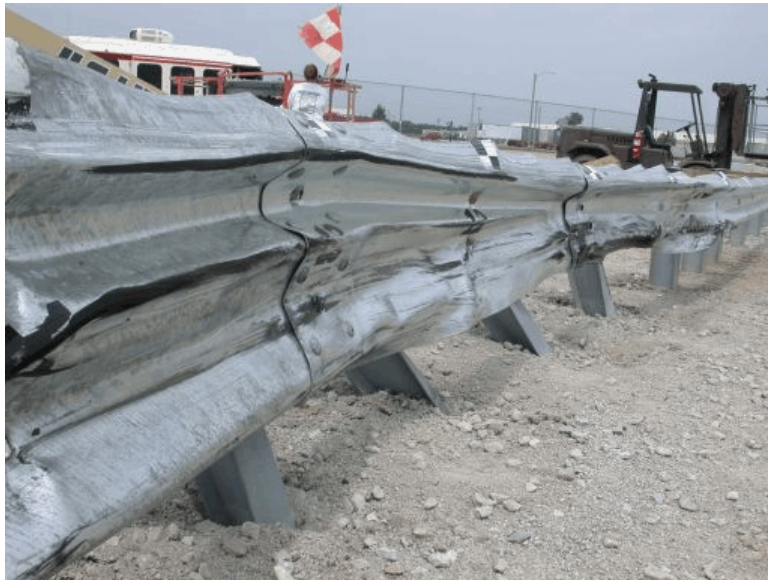
Figure 40. System Damage, Test MWT-3

Damage to the barrier was moderate, as shown in Figures 39 through 45. Barrier damage consisted of deformed guardrail and posts, contact marks on a guardrail section, and fractured wooden spacer blockouts. The length of vehicle contact along the approach guardrail system was approximately 5.7 m (18.75 ft), which spanned from 203 mm (8 in.) upstream from the centerline of post no. 9 through 203 mm (8 in.) upstream from the centerline of post no. 15.

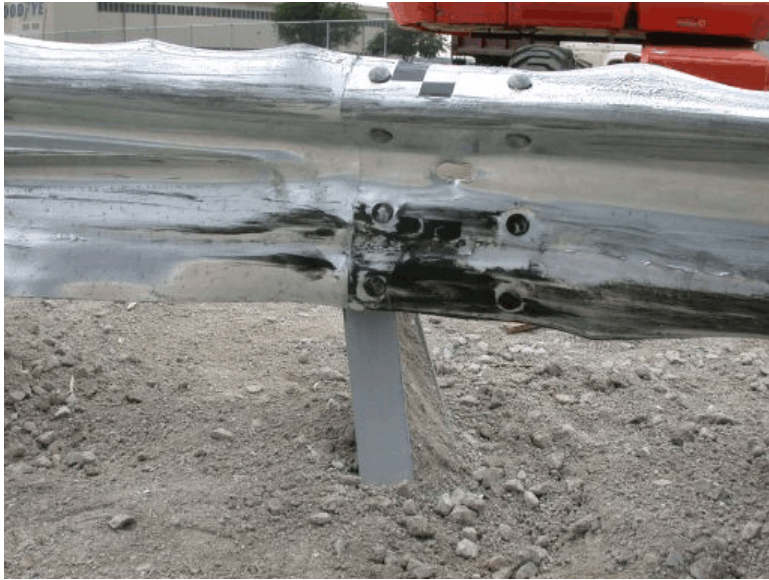
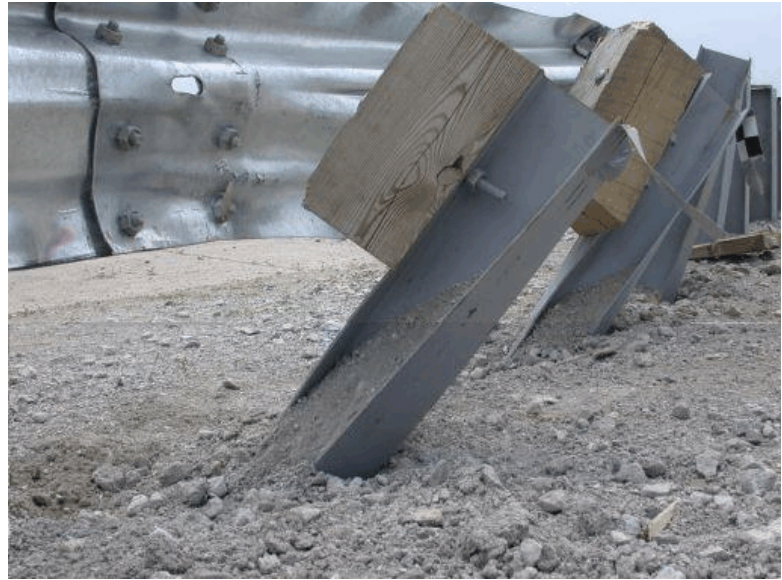
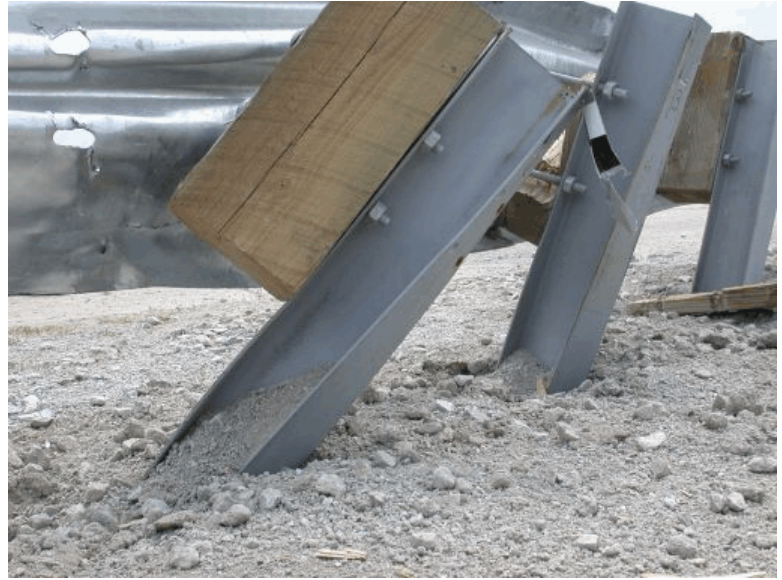
Figure 43. Post Nos. 11 and 12 Damage, Test MWT-3

The permanent set of the barrier system is shown in Figure 39. The maximum lateral permanent set rail and post deflections were 389 mm (15.3 in.) at the centerline of post no. 12 and 556 mm (21.9 in.) at the centerline of post no. 11, respectively, as measured in the field. The maximum lateral dynamic rail and post deflections were 620 mm (24.4 in.) at the centerline of post no. 12 and 649 mm (25.5 in.) at the centerline of post no. 11, respectively, as determined from the high-speed film analysis. The working width of the system was found to be 785 mm (30.9 in.).

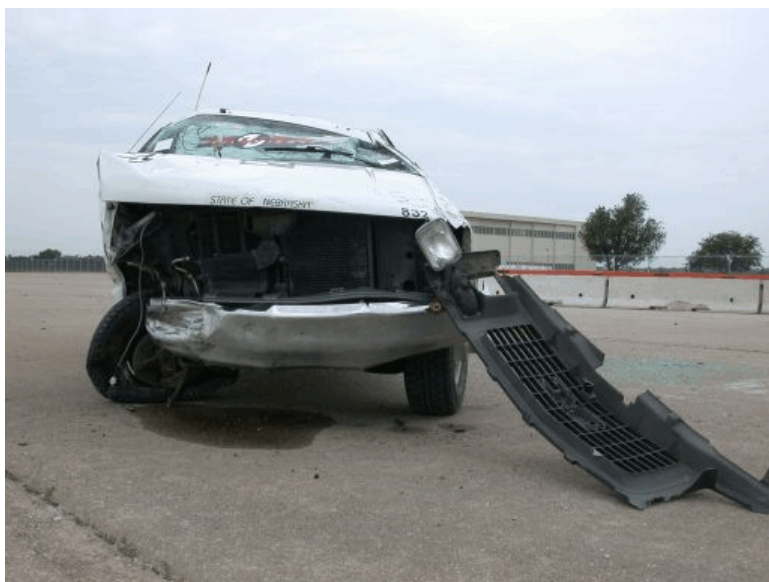
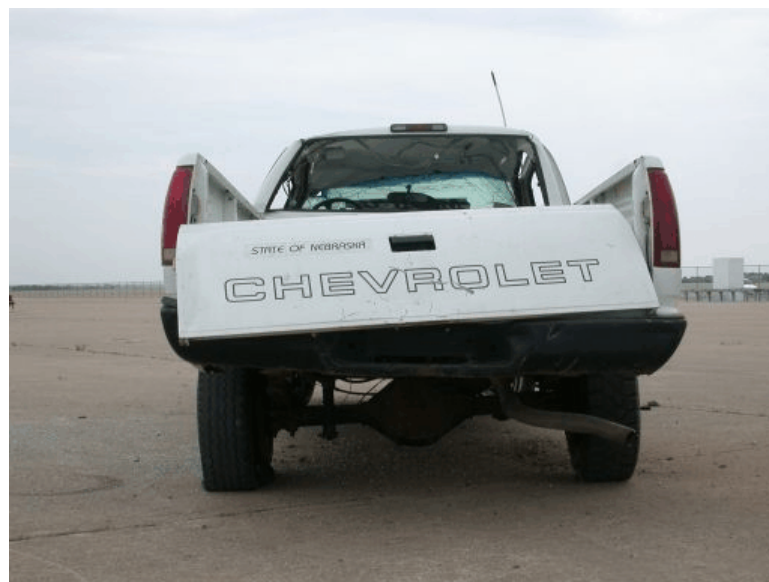
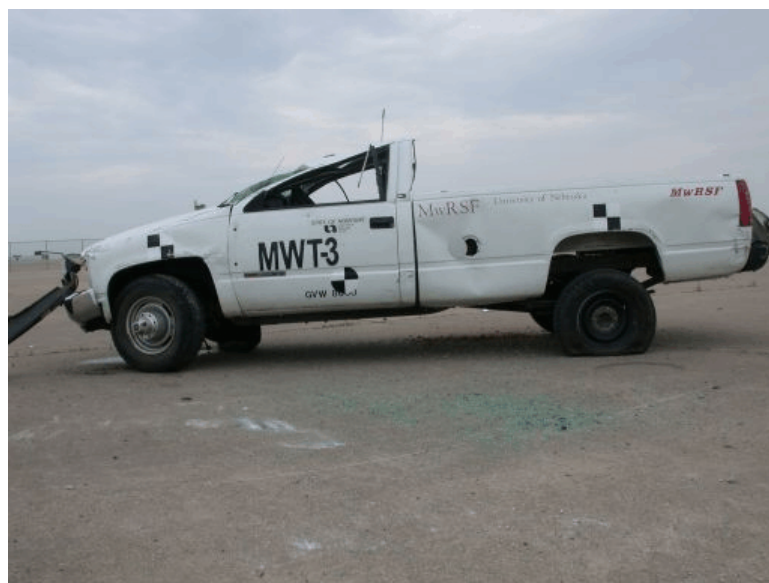
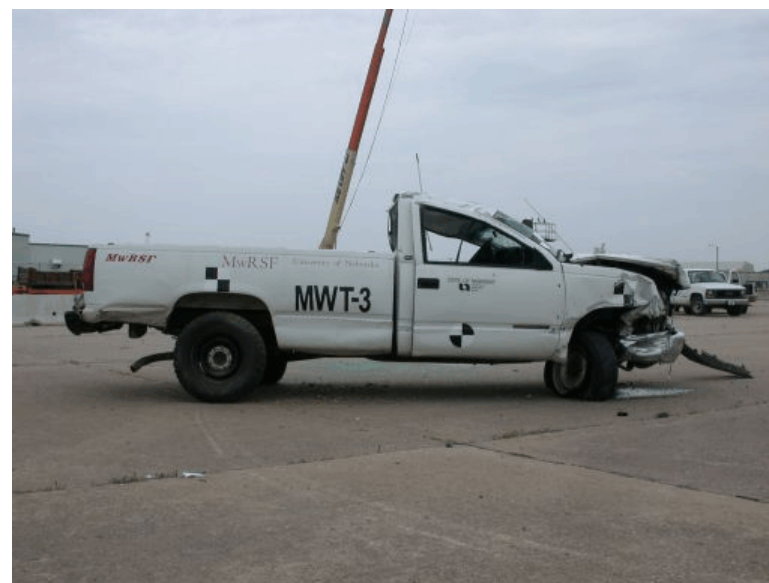
Figure 46. Vehicle Damage, Test MWT-3

Most of the damage was concentrated on the front, both the left and right sides, and the roof of the vehicle due to rollover, as shown in Figure 46. The right-front corner of the vehicle was

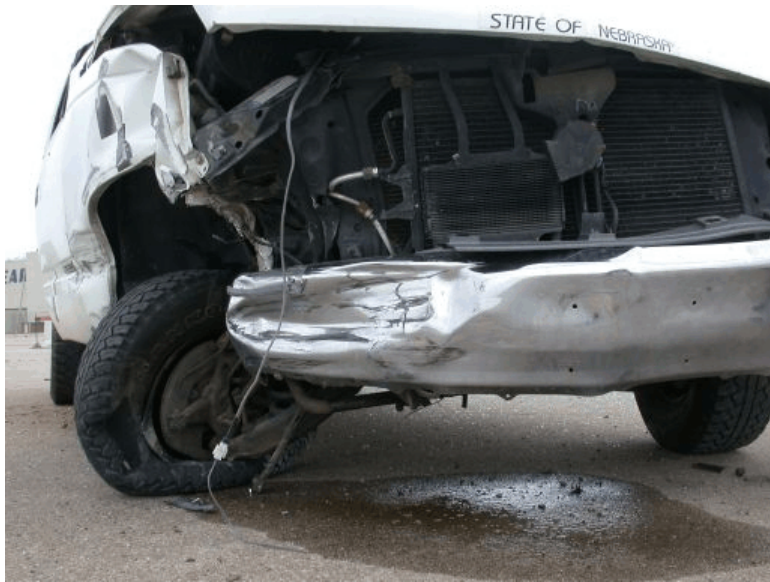
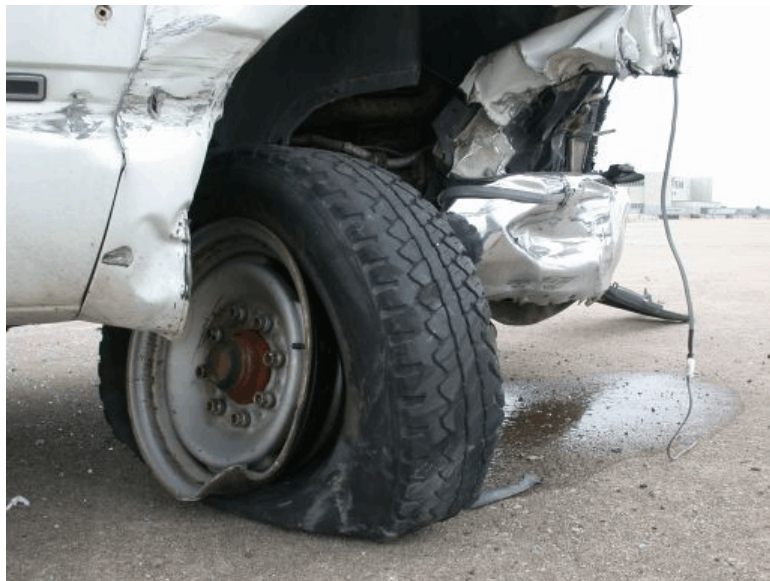
Figure 47. Vehicle Damage, Test MWT-3

Exterior and interior damage to the vehicle was extensive, as shown in Figures 46 through 49. Occupant compartment deformations to the roof were severe due to vehicle rollover. However, the floorboard and firewall deformations were minimal. Complete occupant compartment deformations and the corresponding locations are provided in Appendix C.

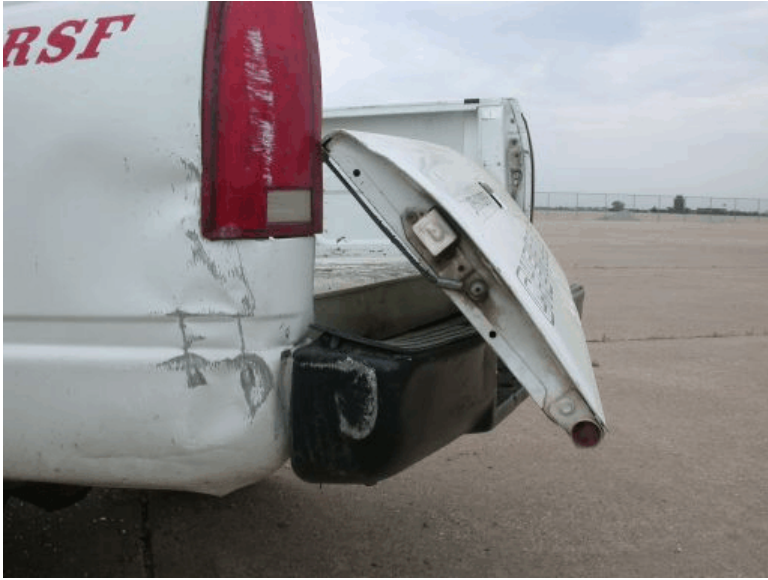
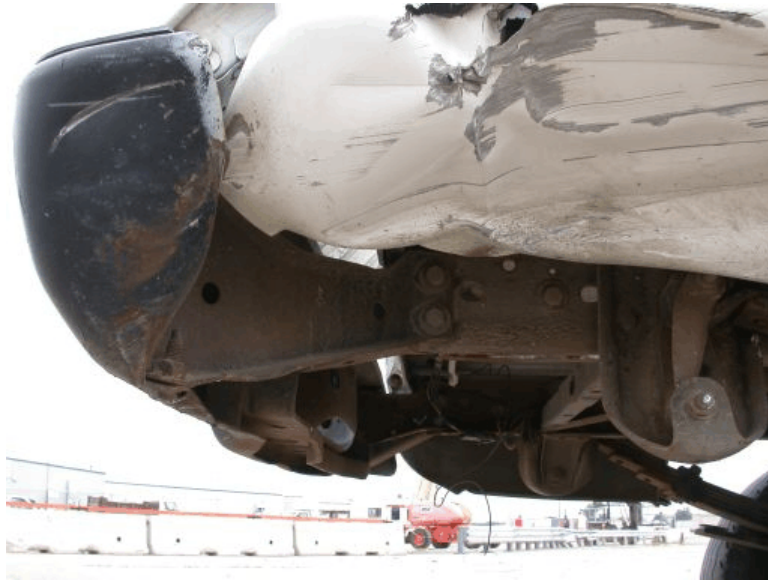
Figure 48. Vehicle Damage, Test MWT-3

The damage to the frame was minimal and focused mainly around the bumper bracket and frame horns. Deformations to the vehicle's body were evident on the right side in the shape of the guardrail. Left-side damage was limited to light scraping and box deformations due to rollover. The windshield was shattered but remained intact due to the safety layer, as shown in Figure 48. All other window glass shattered and was removed from the system.

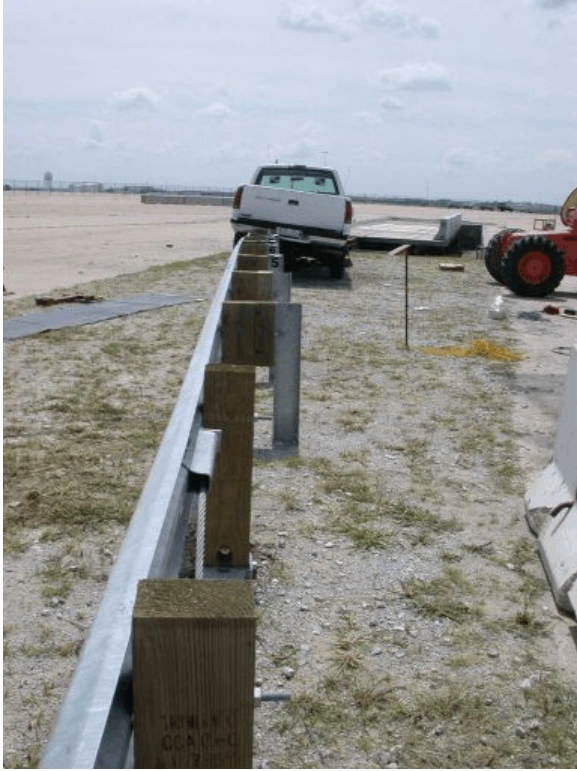
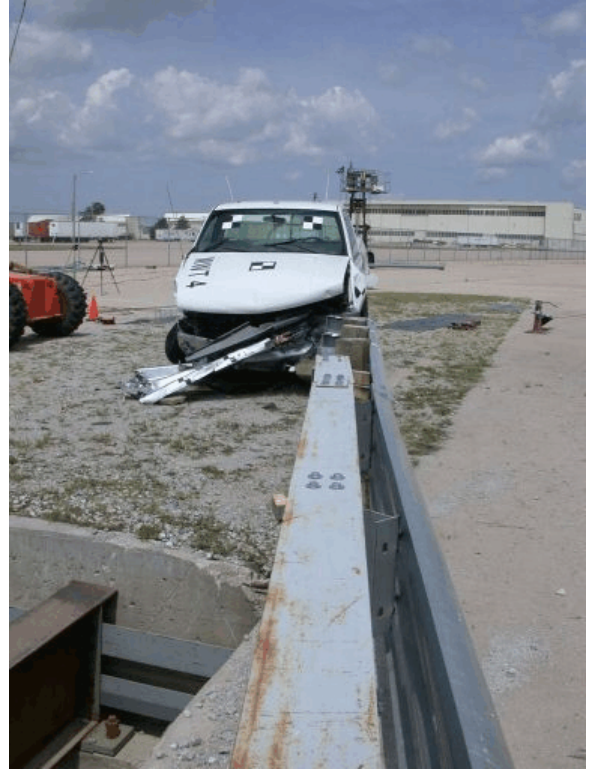
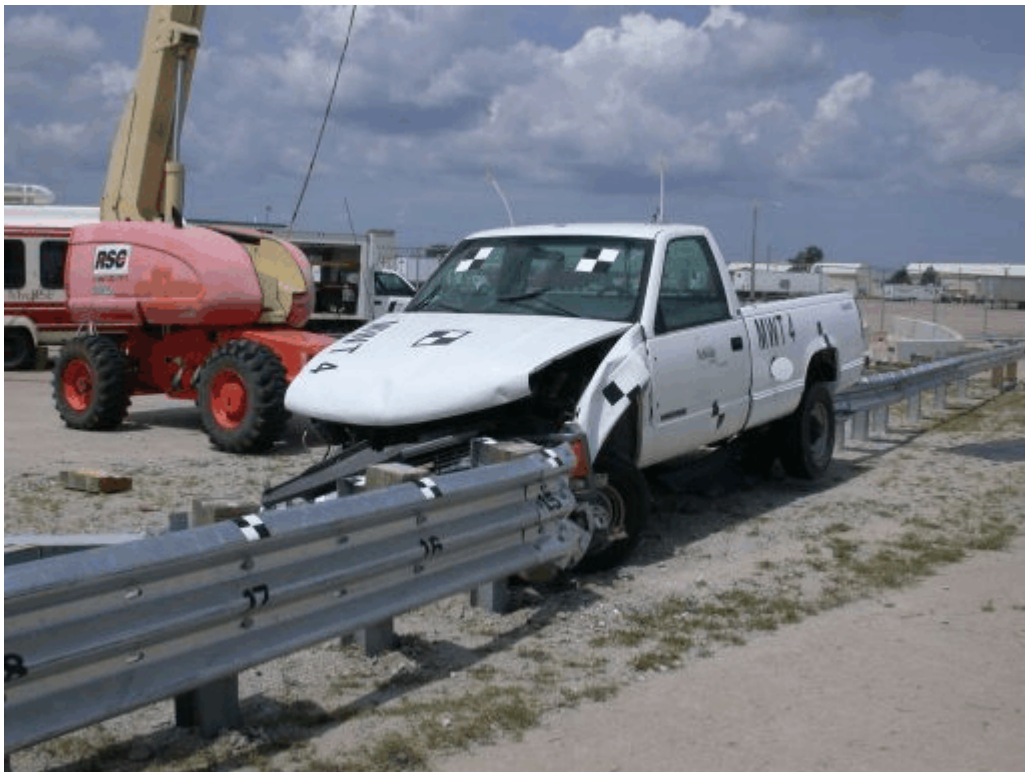
Figure 69. Vehicle Final Position, Test MWT-4

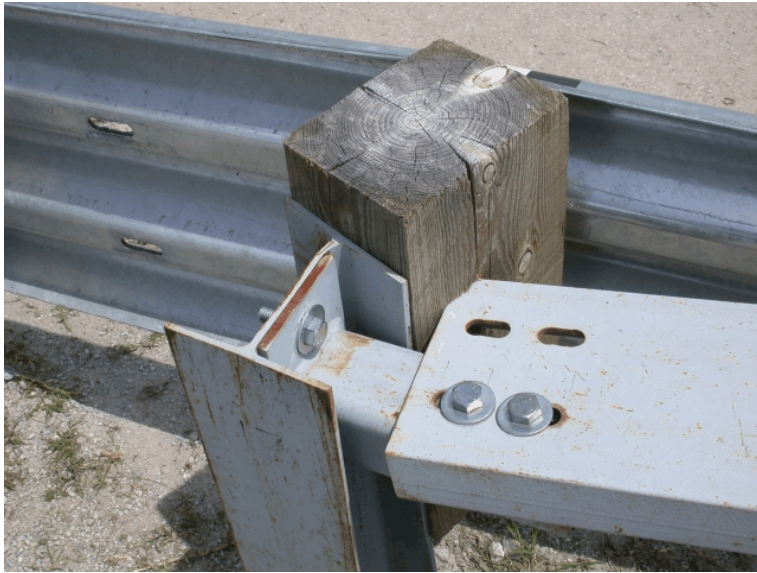
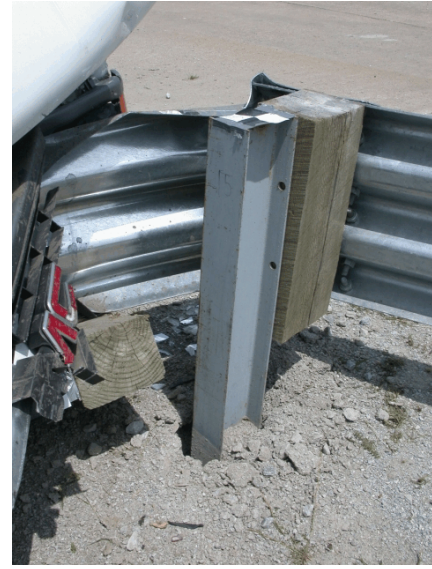
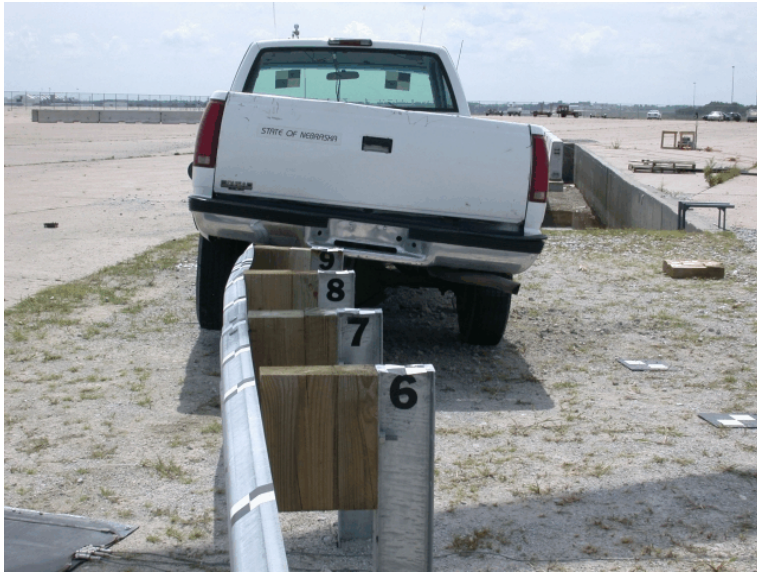
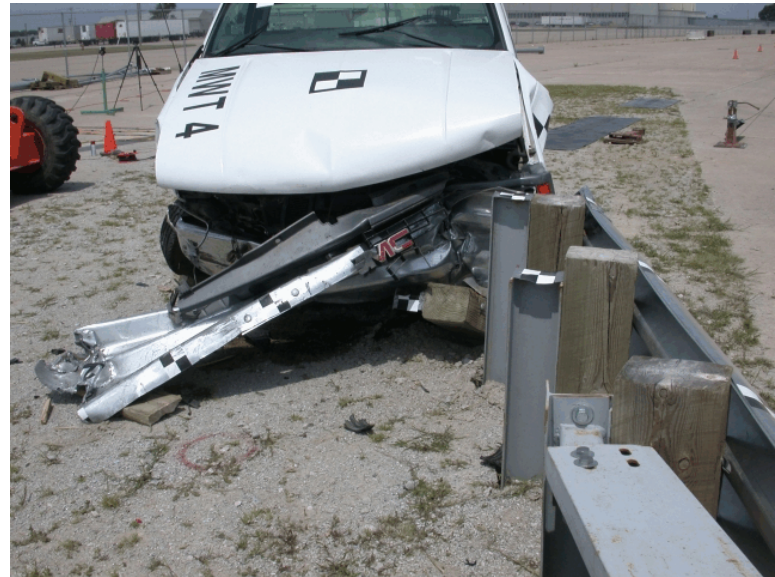
Barrier damage was extensive as shown in Figures 70 through 76. Barrier damage consisted of deformed guardrail and posts, ruptured guardrail, fractured blockouts, and contact marks on a guardrail section. The length of vehicle contact along the approach guardrail system was approximately 5.9 m (19.5 ft), which spanned from 229 mm (9 in.) upstream from the centerline of post no. 9 through the centerline of post no. 15.

Figure 71. System Damage, Test No. MWT-4

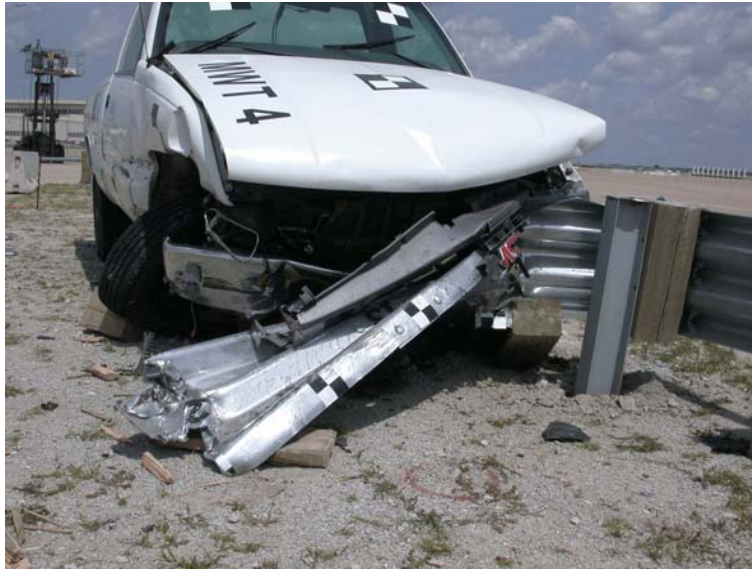
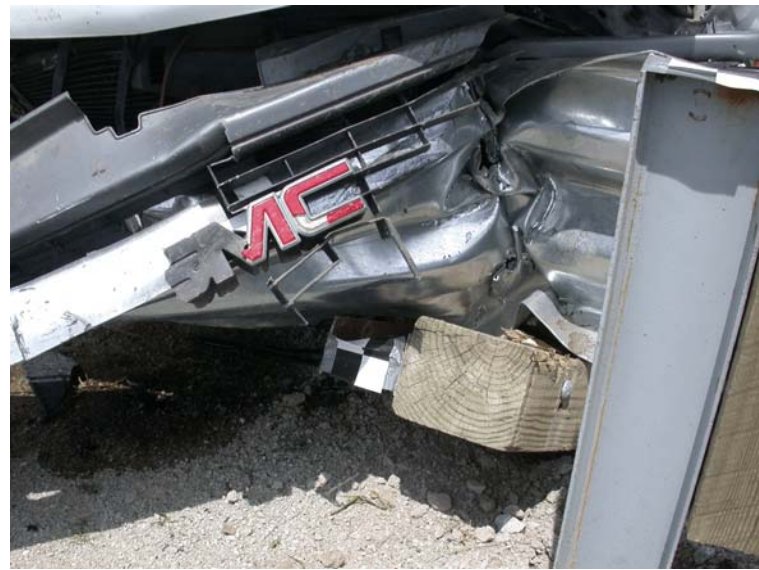
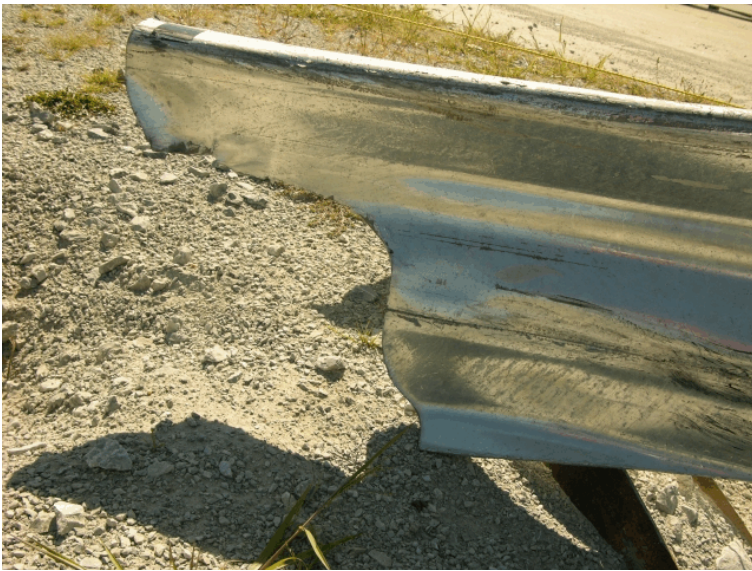
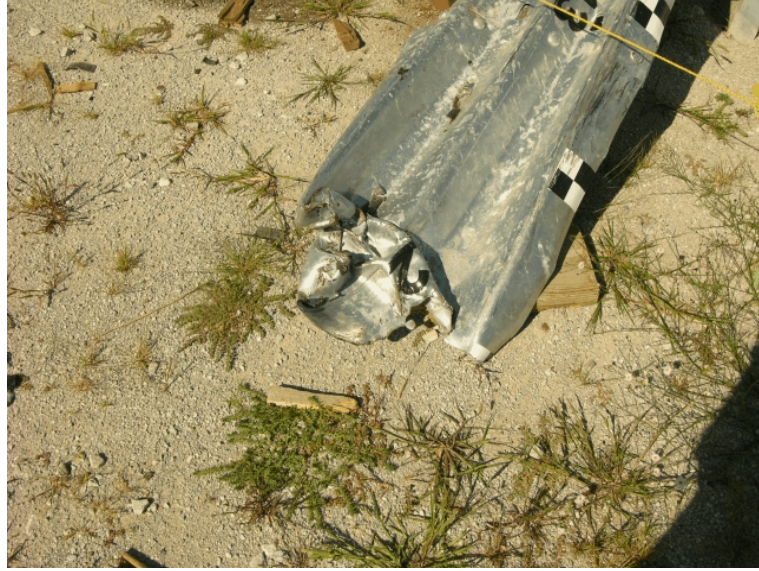
through the cross section, beginning at the bottom of the W-beam to the beam transition element 476 mm (18.75 in.) downstream of the centerline of post no. 11, propagating up vertically 267 mm (10.5 in.), then horizontally 305 mm (12 in.), and then vertically once again ending at the top of the W-beam rail at the centerline of post no. 12 as shown in Figure 72. The W-beam was pulled off of post nos. 6, 10, and 13. The W-beam guardrail sustained significant yielding around the post bolt slots at post nos. 3 through 5 and 7 through 12, and the post bolt slot at post no. 8 also sustained small tears. The three beam guardrail sustained significant yielding around the post bolt slots at post nos. 14 through 18. No significant guardrail damage occurred downstream of post no. 16.

Figure 72. Rail Rupture Damage, Test MWT-4

As the truck progressed into the guardrail during test no. MWT-4, vehicle redirection continued until the front bumper contacted the point of the flat plate extension on the bottom of the transition element. The start of the weldment proved to be a stress concentrator that produced a tear in the W-beam to thrie beam transition section. The tear quickly propagated through the entire segment and ruptured the rail system. Thereafter, all redirection stopped, and the test vehicle moved forward into the end of the stiff transition section where it was brought to an abrupt stop. Although the performance of the guardrail system initially looked promising and the rapid roll velocity associated with test no. MWT-3 was eliminated, the premature failure of the only available transition piece caused this test to be unsuccessful.

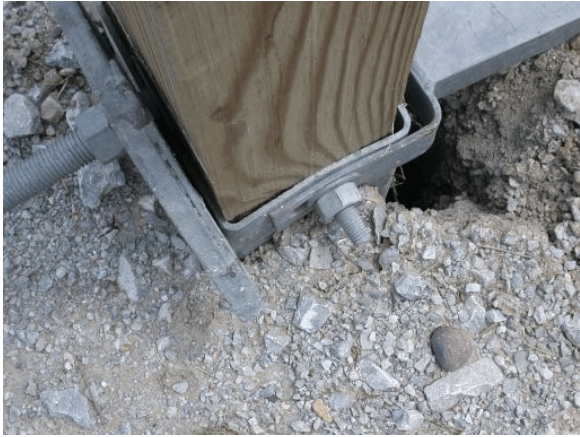
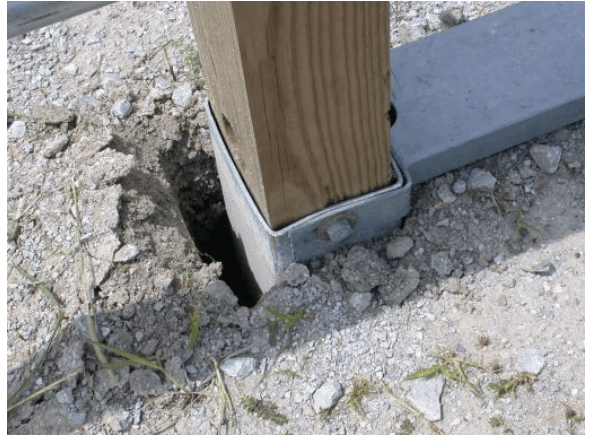
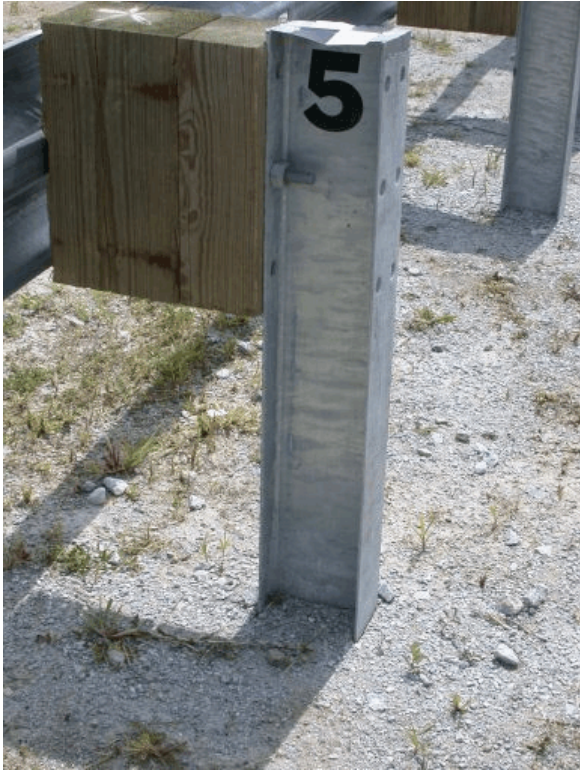
Figure 73. Post Nos. 1, 2, 5, and 6 Damage, Test MWT-4

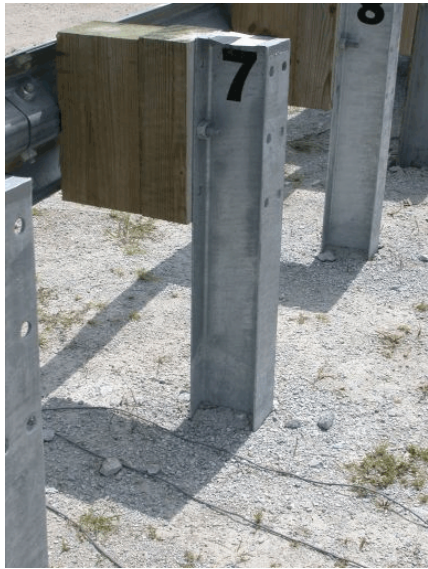
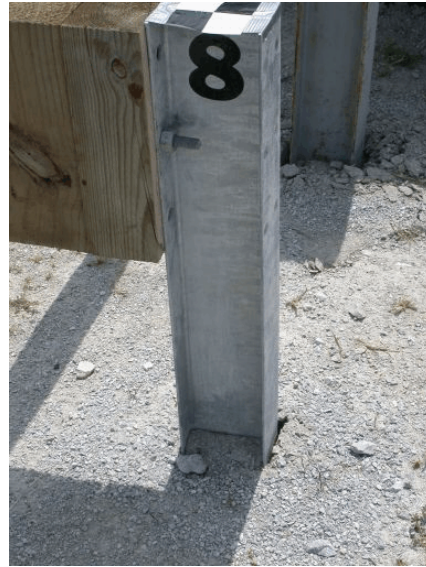
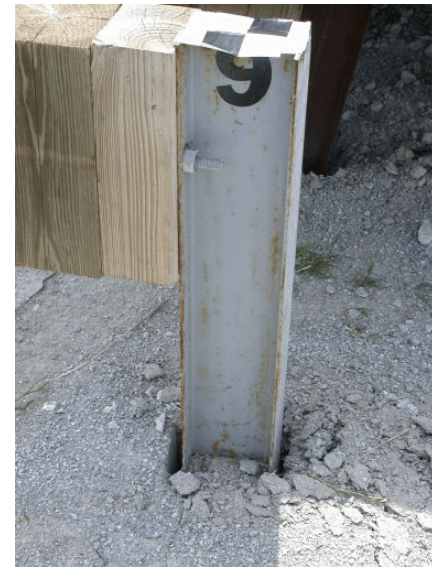
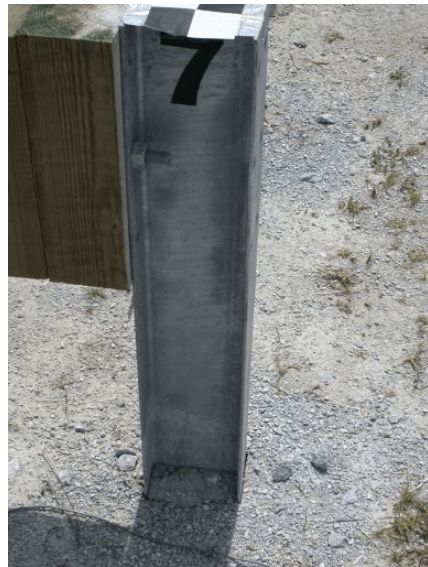
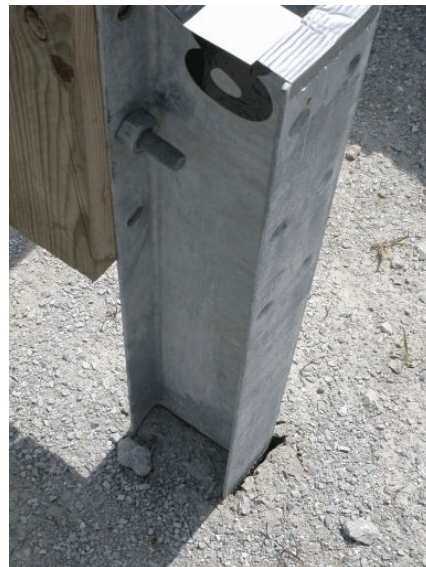
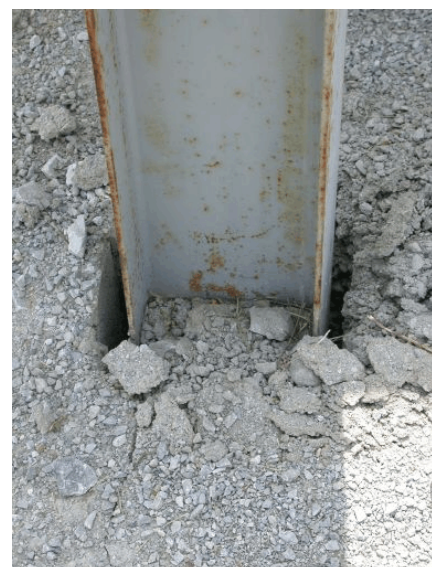
Figure 74. Post Nos. 7 through 9 Damage, Test MWT-4

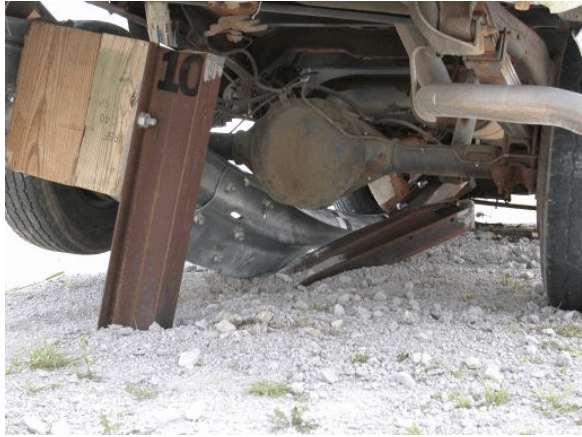
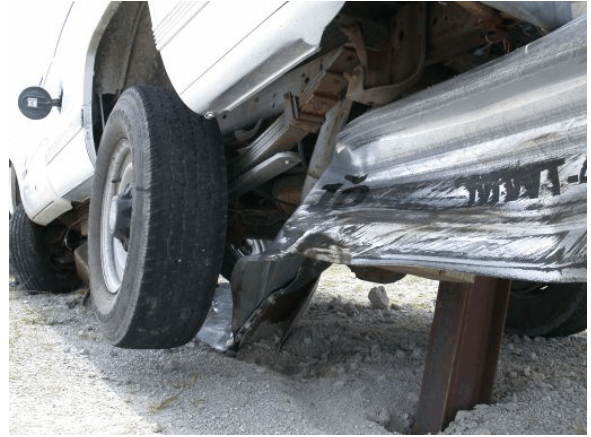
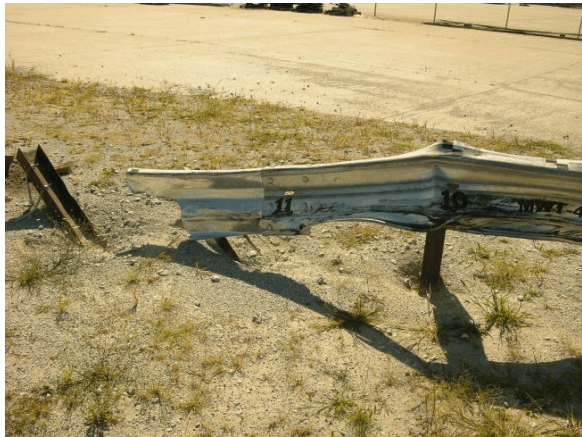
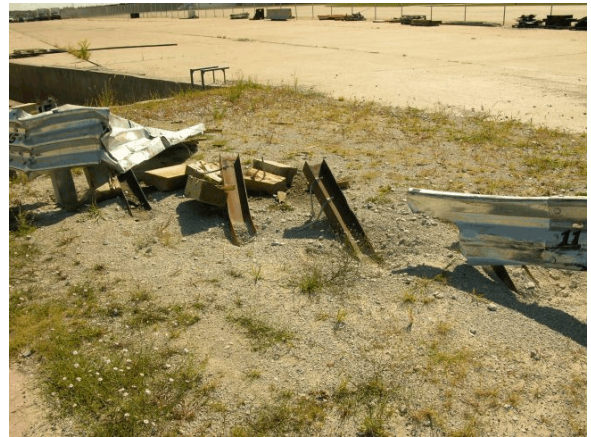
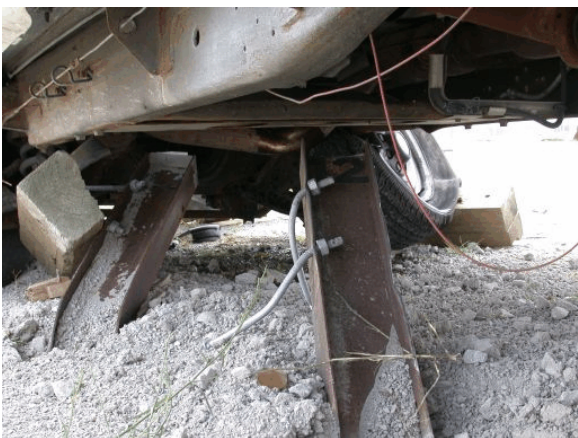
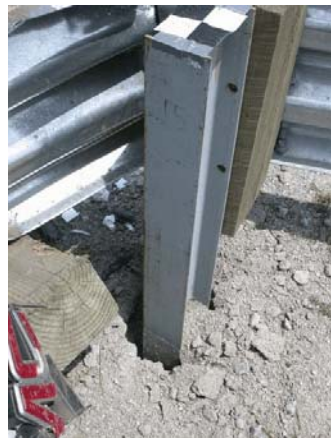
Figure 75. Post Nos. 10 through 15 Damage, Test MWT-4

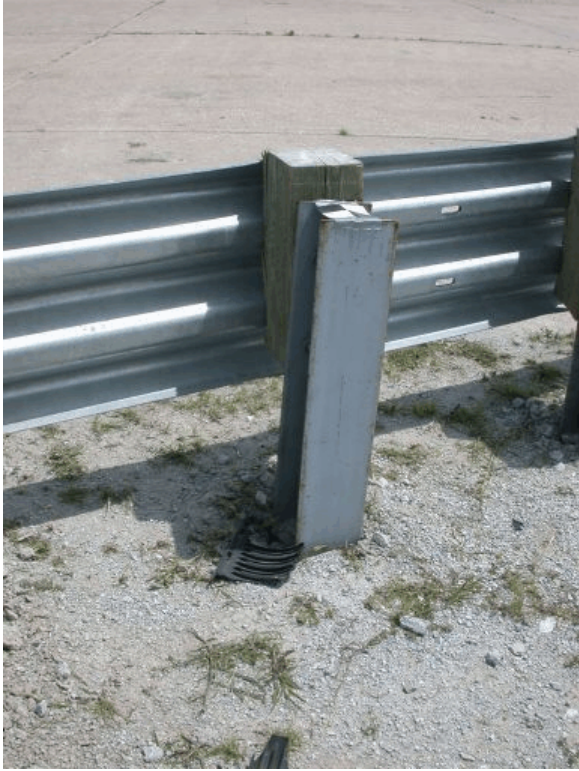
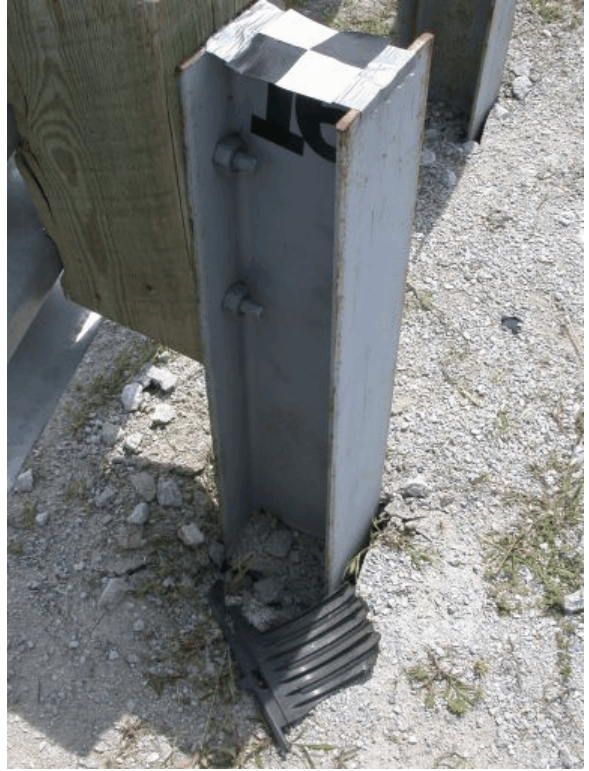
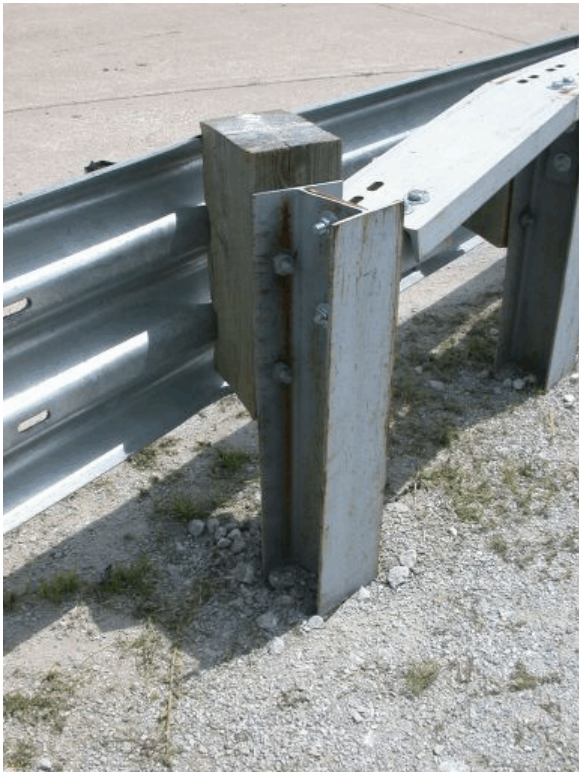
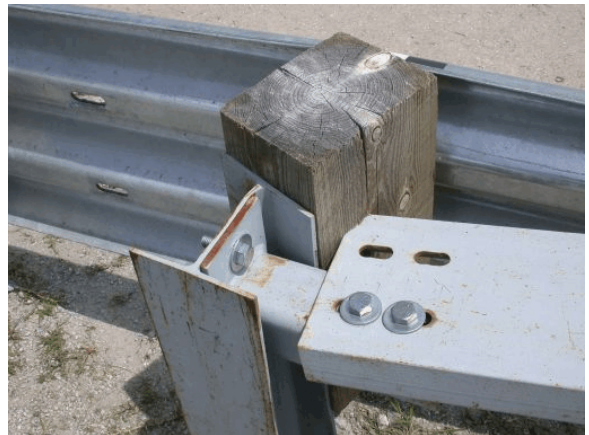
Figure 76. Post Nos. 16 and 17 Damage, MWT-4

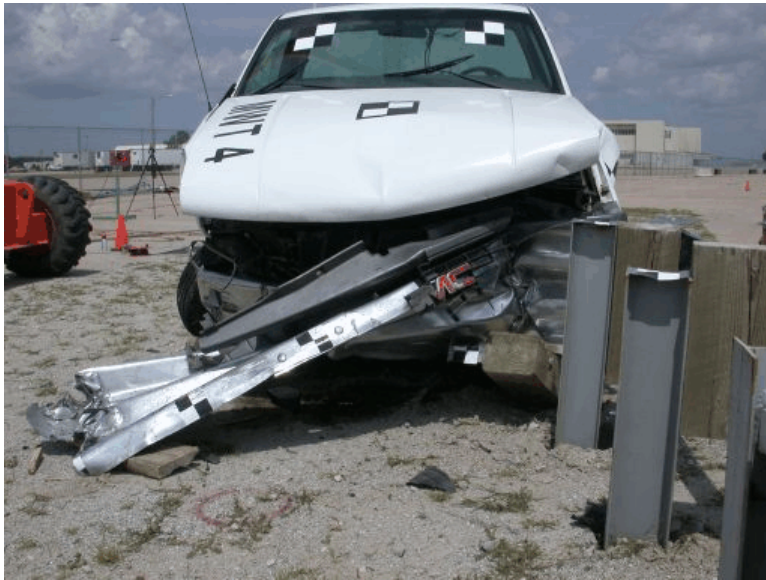
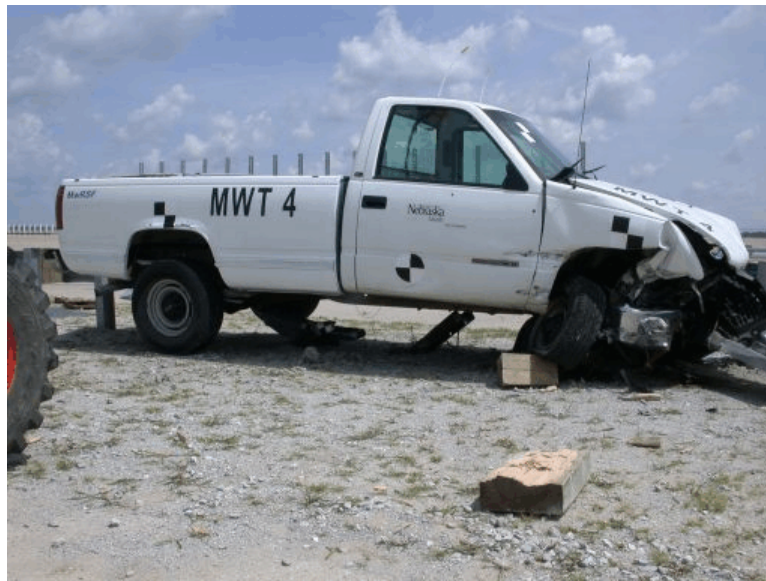
Figure 77. Vehicle Damage, Test MWT-4

Exterior vehicle damage was moderate, as shown in Figures 77 and 80. Extensive occupant compartment deformations occurred with the penetration of the center of the floorboard, as shown in Figure 80. The drive shaft U-joint penetrated through and caused a 178-mm (7-in.) slice in the floorboard. A 64-mm (2.5-in.) dent was also found in the floorboard. Complete occupant compartment deformations and the corresponding locations are provided in Appendix C.

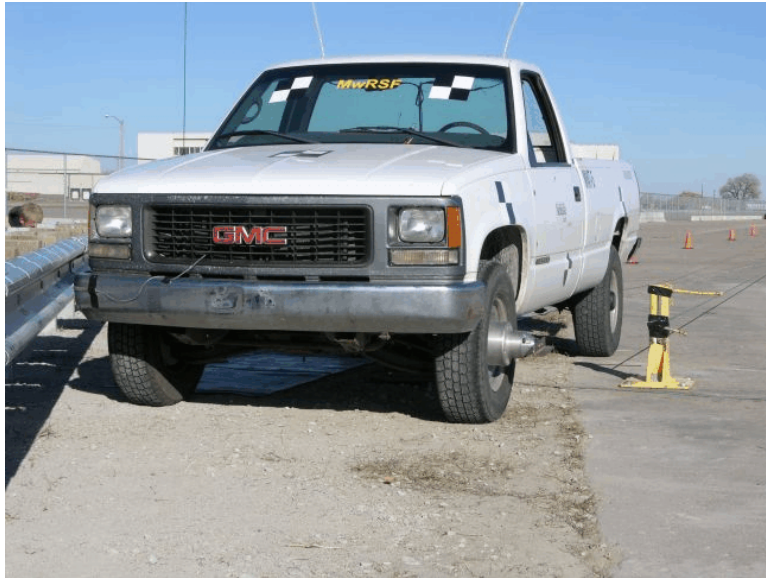
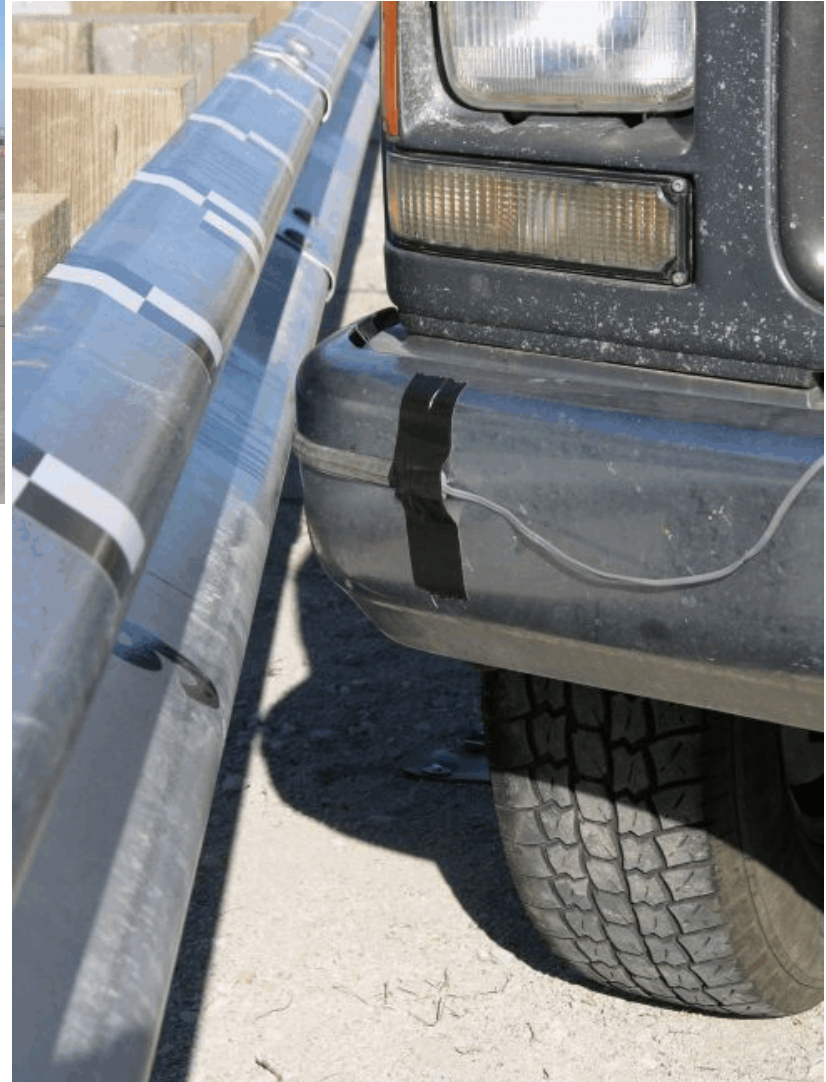
Figure 103. Impact Location, Test MWT-5

Initial vehicle impact was to occur between post nos. 8 and 9, or 330 mm (13 in.) upstream of the centerline of post no. 9, as shown in Figure 101. Actual vehicle impact occurred at the targeted impact location. At 0.016 sec after impact, the pickup bumper and the right-front quarter panel crushed inward towards the engine compartment. At 0.042 sec, post nos. 9 through 11 rotated backwards slightly, and the right-front right quarter panel crushed inward under the hood. At 0.066 sec, post nos. 11 through 13 rotated backward, and the guardrail flattened around the right-front quarter panel of the truck. At this same time, the hood protruded over the rail. At 0.082 sec, the rail buckled at post no. 12, and post nos. 10 and 11 continued to rotate backwards. At 0.096 sec, post nos. 10 and 11 deflected downstream, while post nos. 12 through 14 deflected upstream and rotated backwards. At this same time, the rail continued to flatten around the front of the vehicle. At 0.124 sec, the blackout at post no. 11 disengaged from the system and traveled downstream. By this time, the front bumper was located at post no. 12, and the right-front side of the vehicle continued to crush inwards. At 0.174 sec, the blackout at post no. 12 disengaged from the system and fell to the ground. At this same time, post no. 13 rotated backwards, and a buckle in the rail appeared at post
