Development of the Midwest Guardrail System (MGS) W-beam to Thrie Beam Transition Element

*Midwest States' Regional Pooled Fund Research Program
Fiscal Years 2000-2002, 2005-2006 (Years 11-12, 16)
Research Project Number SPR-3(017)
NDOR Sponsoring Agency Codes RFPF-01-04, RFPF-02-05, RFPF-06-04*

DEVELOPMENT OF THE MIDWEST GUARDRAIL SYSTEM (MGS) W-BEAM TO THRIE BEAM TRANSITION ELEMENT

7.1 Test MWT-3	52
7.2 Test Description	52
7.3 Barrier Damage	53
7.4 Vehicle Damage	55
7.5 Occupant Risk Values	56
7.6 Discussion	57
8 ANALYSIS AND DISCUSSION OF TEST NO. MWT-3	77
9 DESIGN MODIFICATIONS (DESIGN NO. 2)	79
10 CRASH TEST NO. 2	94

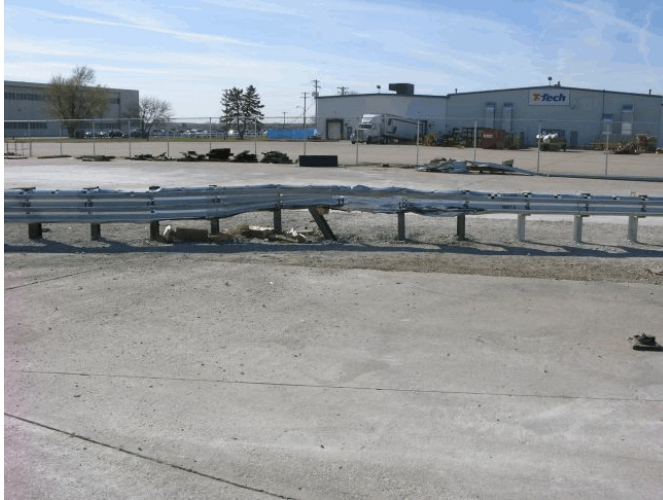
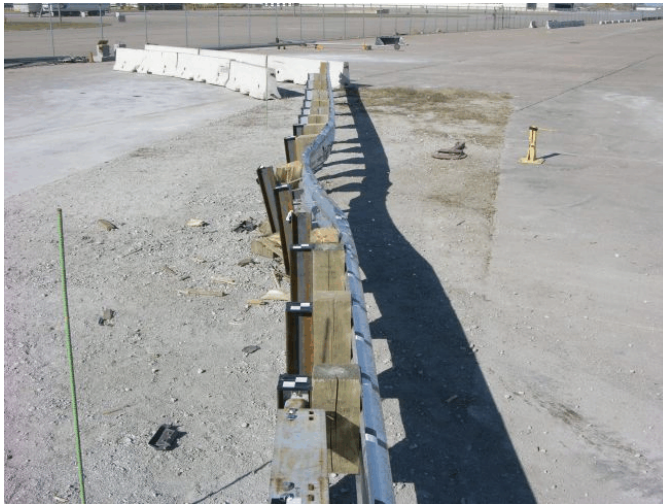
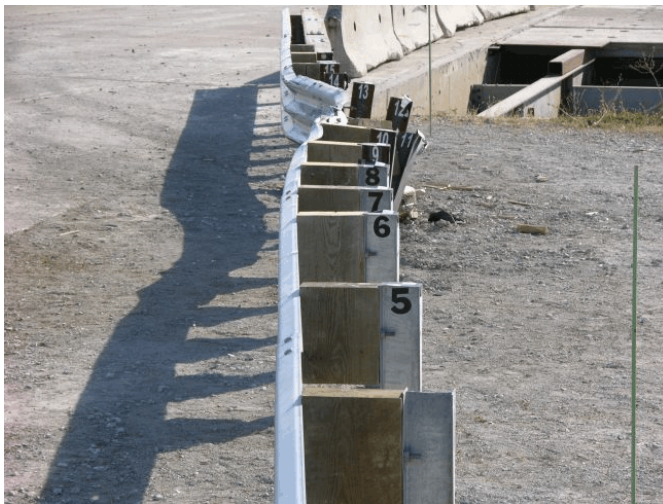
Figure 105. System Damage, Test MWT-5

System damage was moderate as shown in Figures 105 through 112. System damage consisted mostly of deformed guardrail and posts, soil damage, fractured wooden spacer blockouts, and contact marks on a guardrail section. The length of vehicle contact along the approach guardrail

The permanent set of the barrier system is shown in Figures 105 and 106. The maximum lateral permanent set rail and post deflections were 375 mm (14.75 in.) at the centerline of post no. 11 and 318 mm (12.5 in.) at the centerline of post no. 12, respectively, as measured in the field. The maximum lateral dynamic rail and post deflections were 605 mm (23.8 in.) at the midspan between post nos. 11 and 12 and 557 mm (21.9 in.) at the centerline of post no. 11, respectively, as determined from high-speed video analysis. The working width of the system was found to be 1,021 mm (40.2 in.).

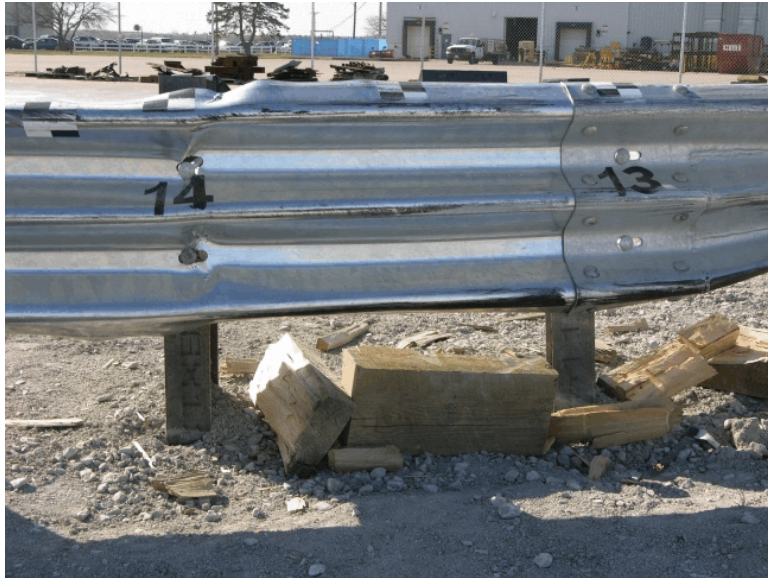
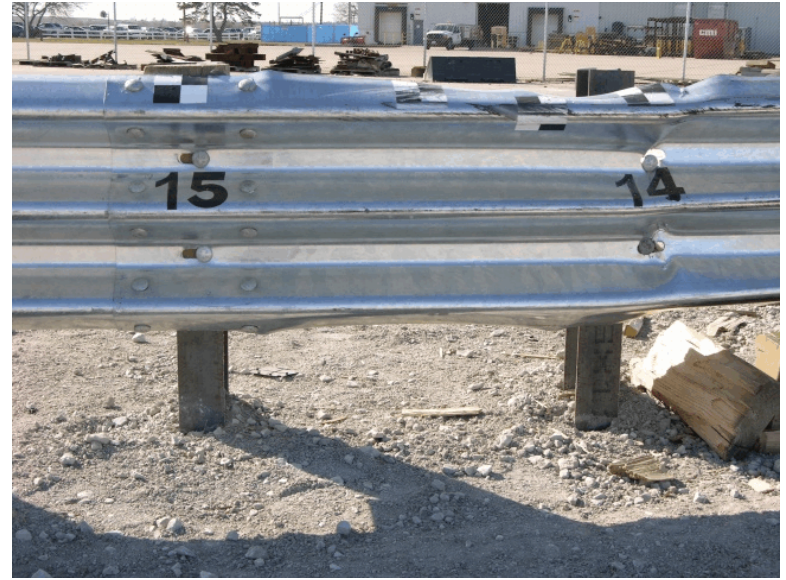
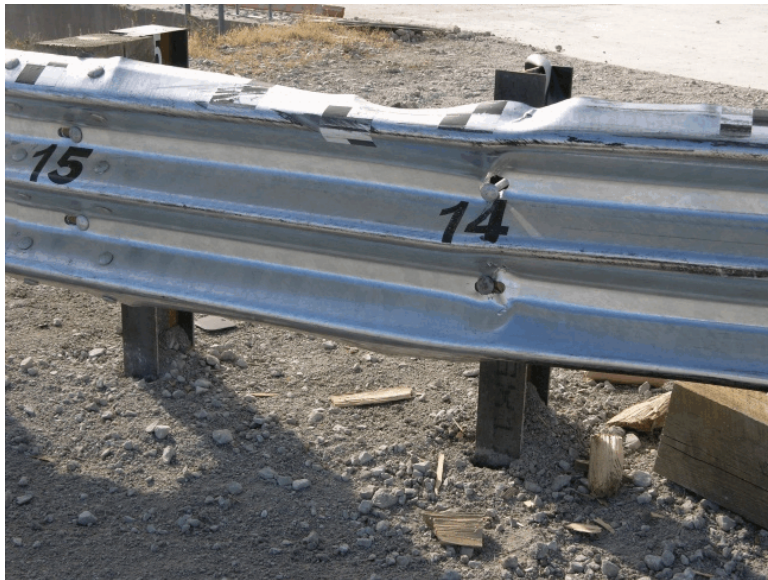
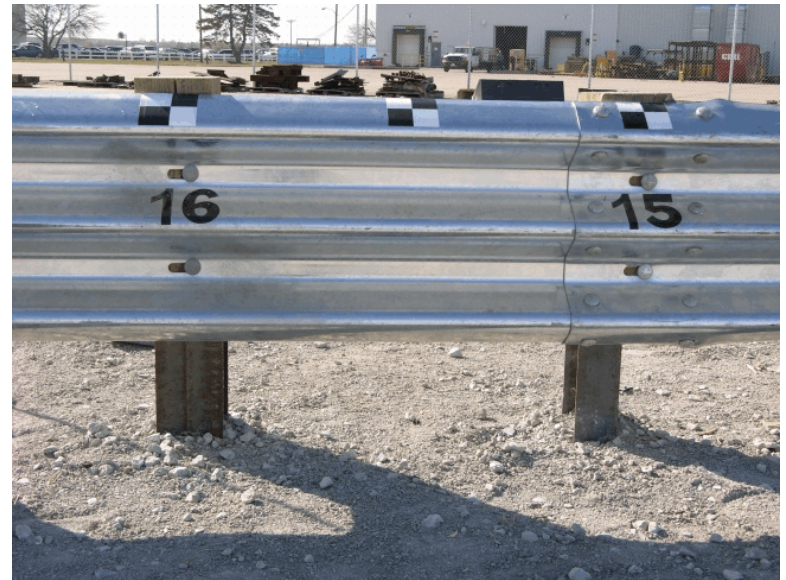
Figure 110. Post Nos. 10 through 13 Damage, Test MWT-5

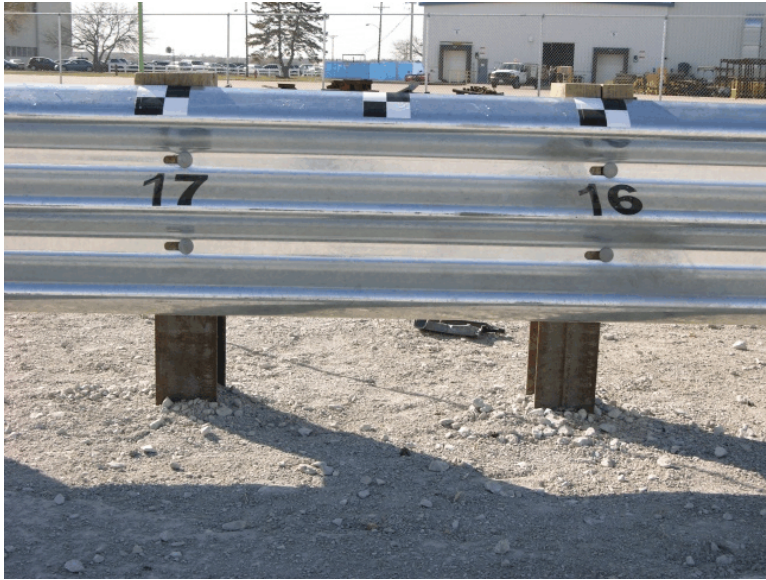
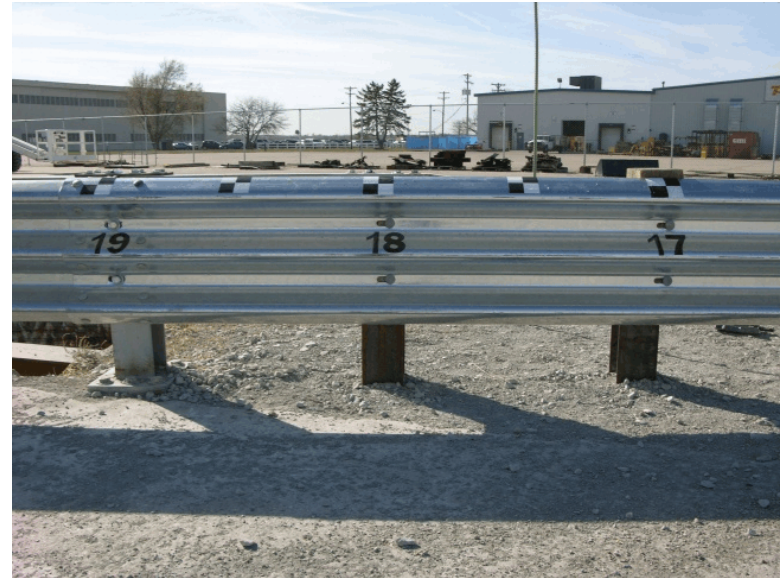
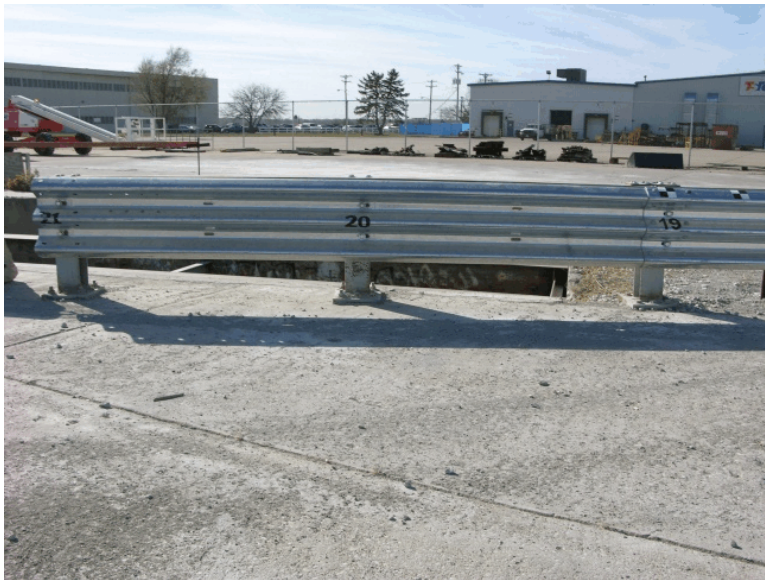
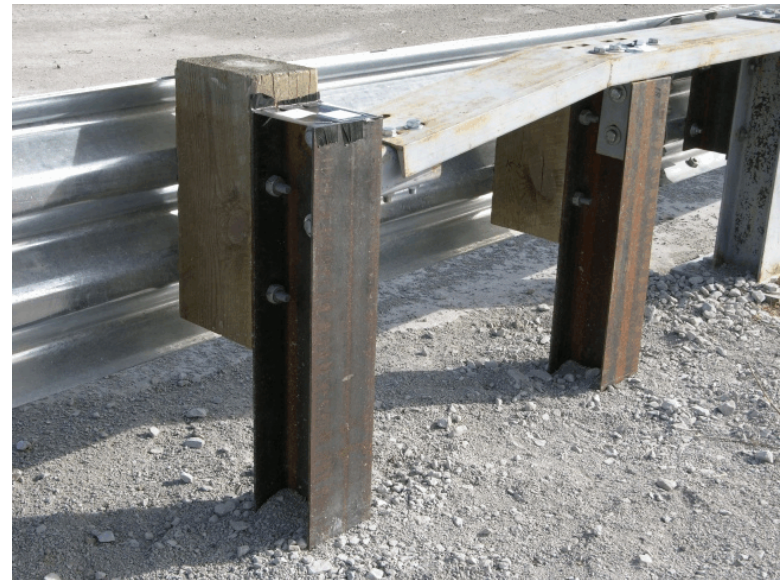
Figure 111. Post Nos. 13 through 16 Damage, Test MWT-5

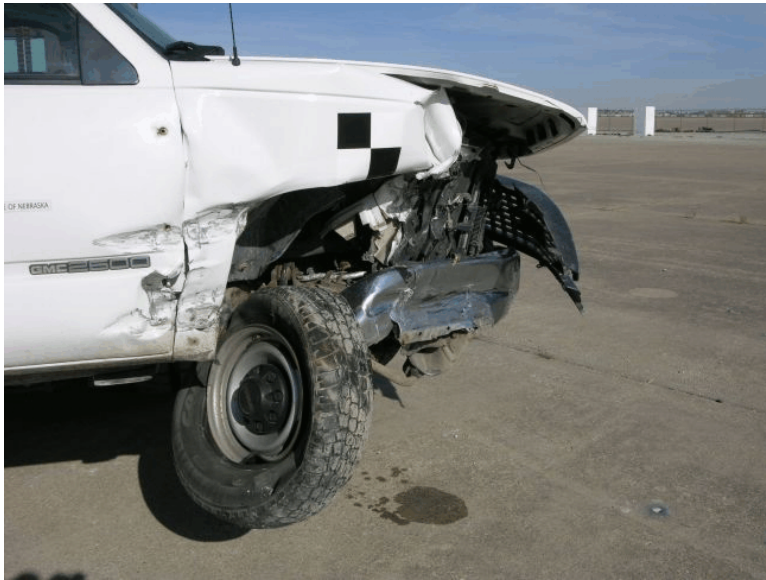
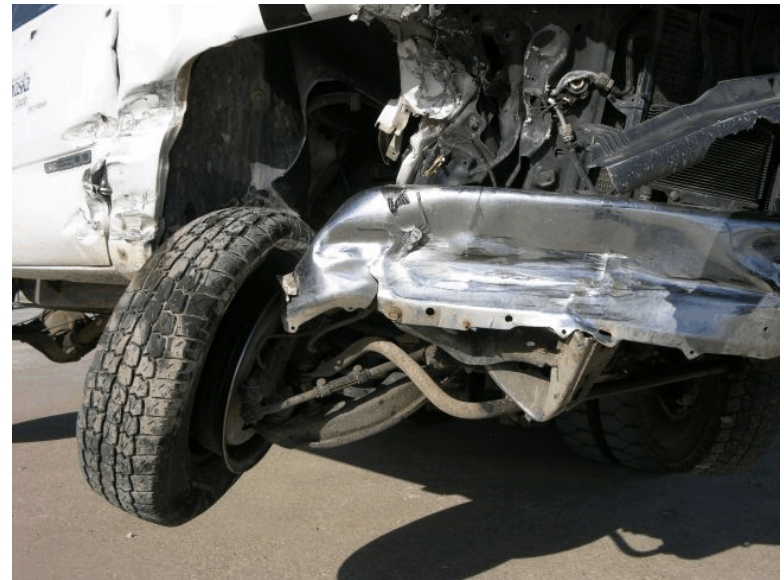
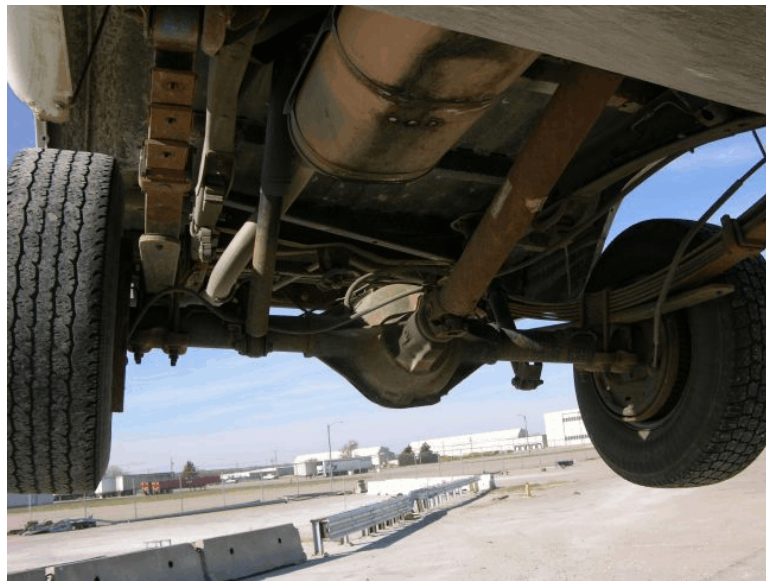
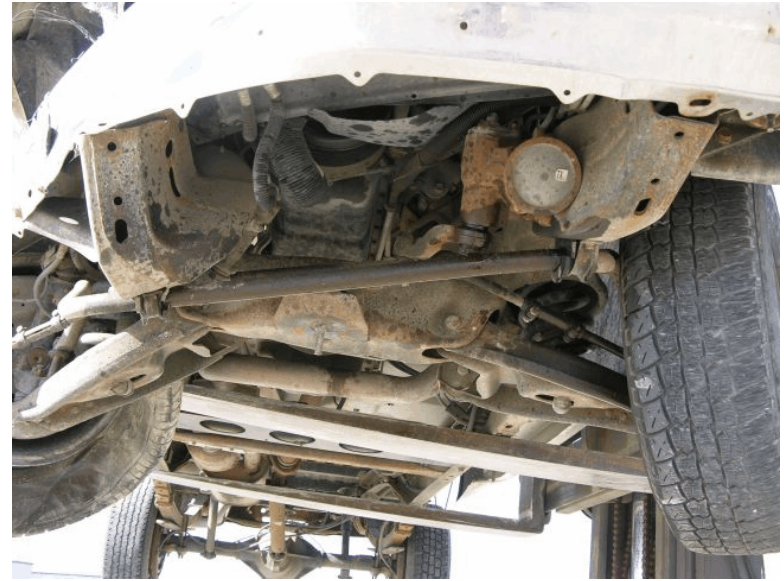
Exterior vehicle damage was minimal, as shown in Figures 113 through 115. Occupant compartment deformations to the right side and center of the floorboard were judged insufficient to cause serious injury to the vehicle occupants, as shown in Figure 115. Maximum longitudinal deflections of 13 mm (0.5 in.) were located near the left-front side of the right-side floorboard. Maximum lateral deflections of 44 mm (1.75 in.) were located near the front center of the floorboard. Maximum vertical deflections of 32 mm (1.25 in.) were located at the front of the floorboard. Complete occupant compartment deformations and the corresponding locations are provided in Appendix C.

Figure 113. Vehicle Damage, Test MWT-5

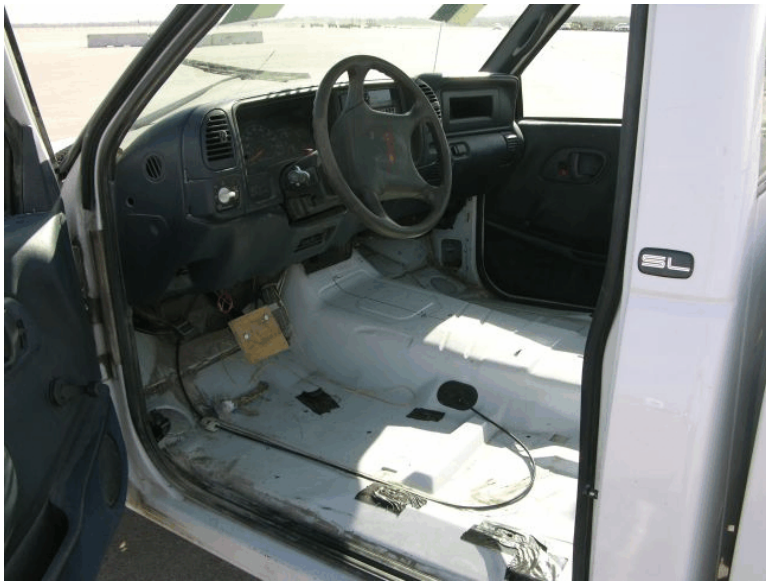
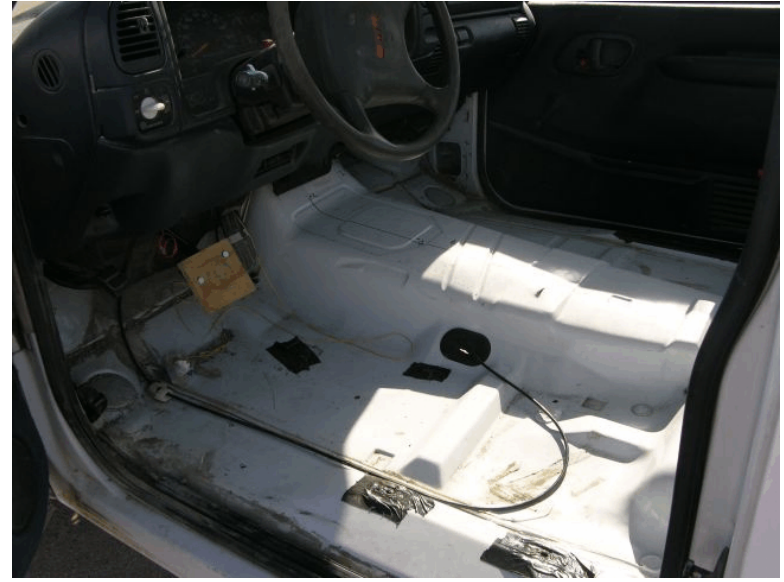
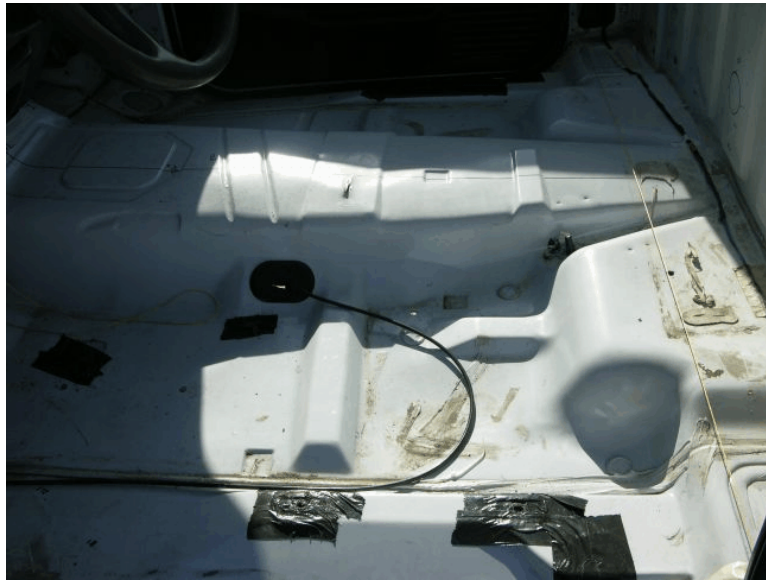
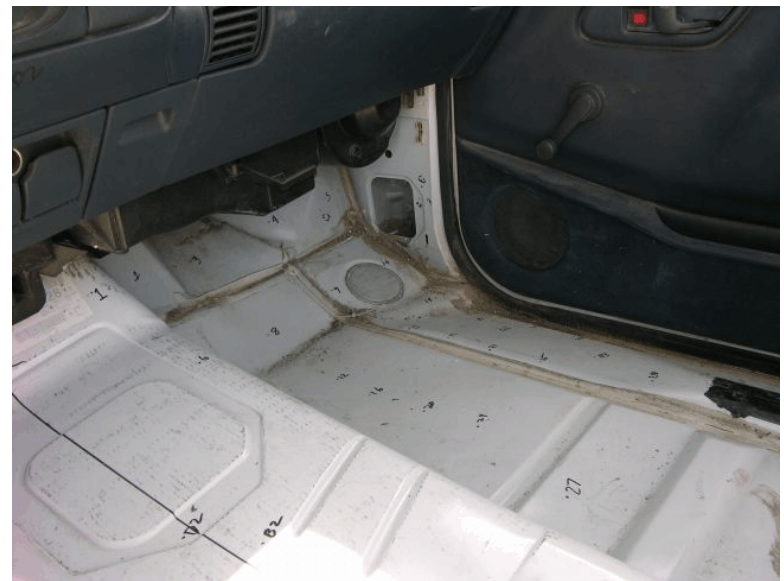
Figure 114. Vehicle Damage, Test MWT-5

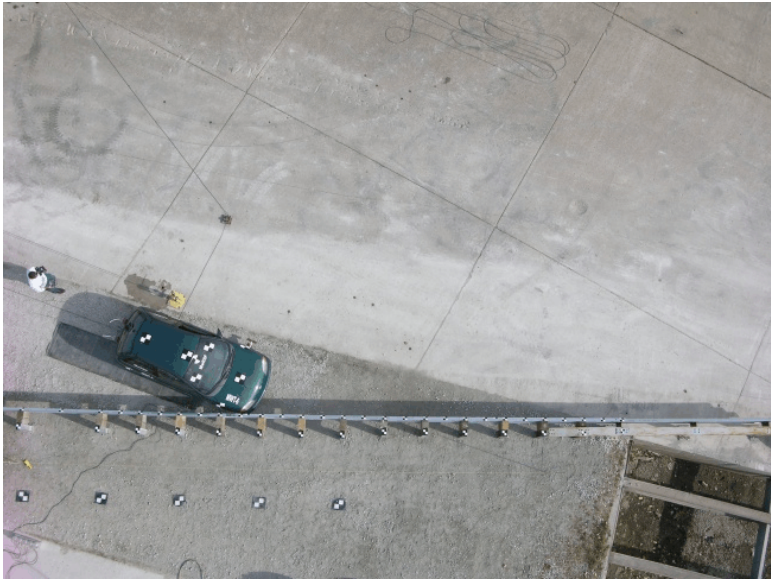
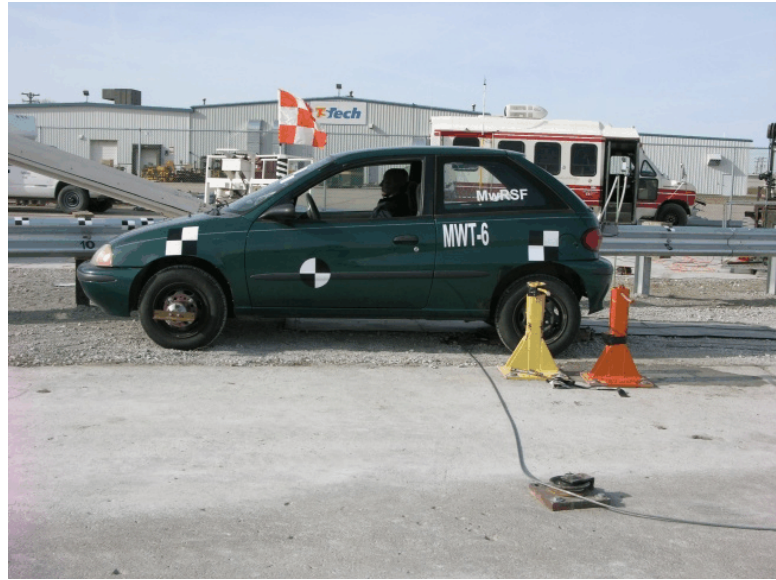
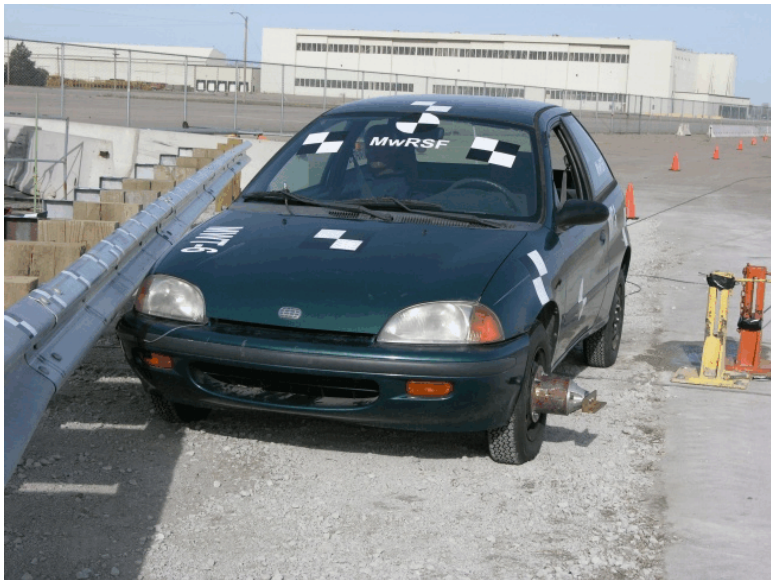
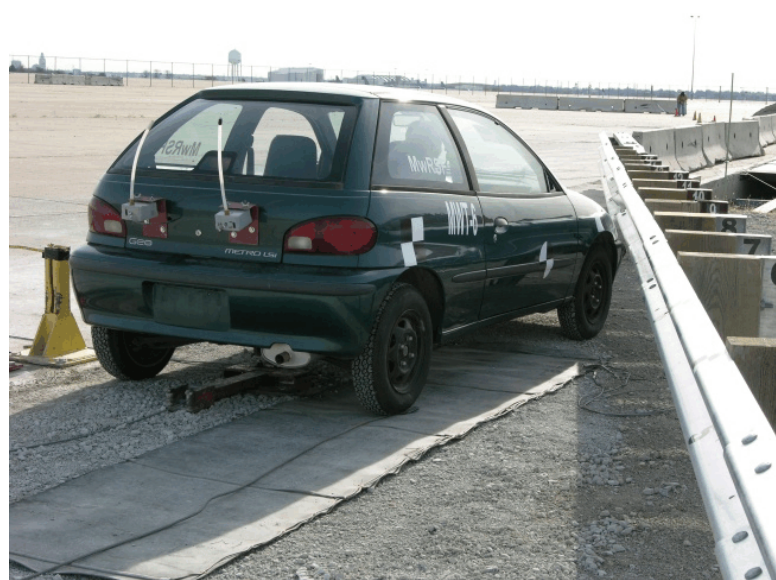
Initial vehicle impact was to occur between post nos. 9 and 10, or 318 mm (12.5 in.) upstream of the centerline of post no. 10, as shown in Figure 121. Actual vehicle impact occurred 235 mm (9.25 in.) upstream from the centerline of post no. 10. At 0.024 sec after impact, the right-front corner of the vehicle was located at the midspan between post nos. 10 and 11. At this same time, post nos. 10 and 11 deflected away from the vehicle. At 0.052 sec, the blockout at post no. 11 fractured, and the rail continued to deflect. At this same time, the front of the vehicle pitched downward. At 0.066 sec, the right-front corner of the vehicle was located at post no. 12. At this same time, the system continued to deflect through post no. 13. At 0.084 sec, the right-side window fractured, and the right-front tire protruded under the rail. At 0.116 sec, the right-front tire was located at post no. 13. At 0.128 sec, the right side of the hood was pushed back toward the windshield, and the system reached its maximum deflection. At 0.160 sec, the front of the vehicle was located at post no. 14. At this same time, the vehicle redirected toward parallel, and the right-front tire was no longer protruding under the rail. At 0.188 sec, the right-rear side of the vehicle

The permanent set of the barrier is shown in Figure 121. The maximum lateral permanent set rail and post deflections were 314 mm (12.375 in.) at the centerline of post no. 11 and 298 mm (11.75 in.) at post no. 12, respectively, as measured in the field. The maximum lateral dynamic rail and post deflections were 314.3 mm (12.375 in.) at the midspan between post nos. 11 and 23 and 307 mm (12.1 in.) at post no. 12, respectively, as determined from high-speed digital video analysis. The working width of the system was found to be 847 mm(33.3 in.).

Figure 121. Impact Location, Test MWT-6

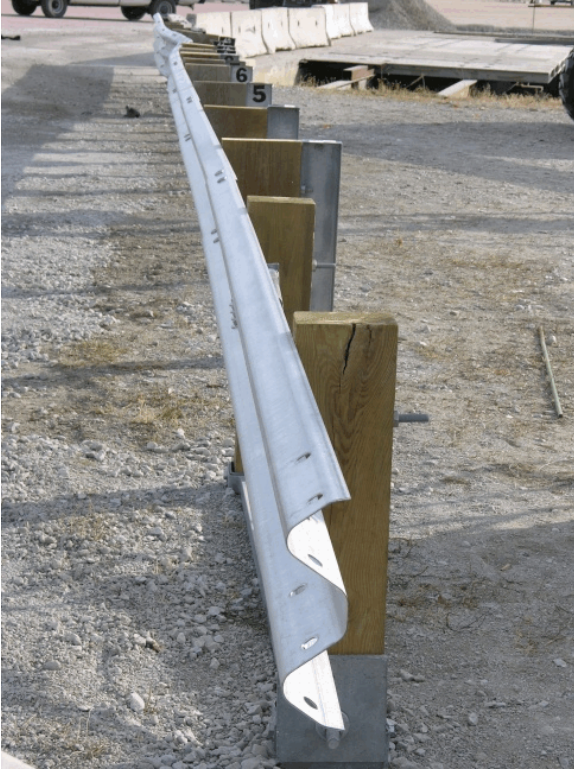
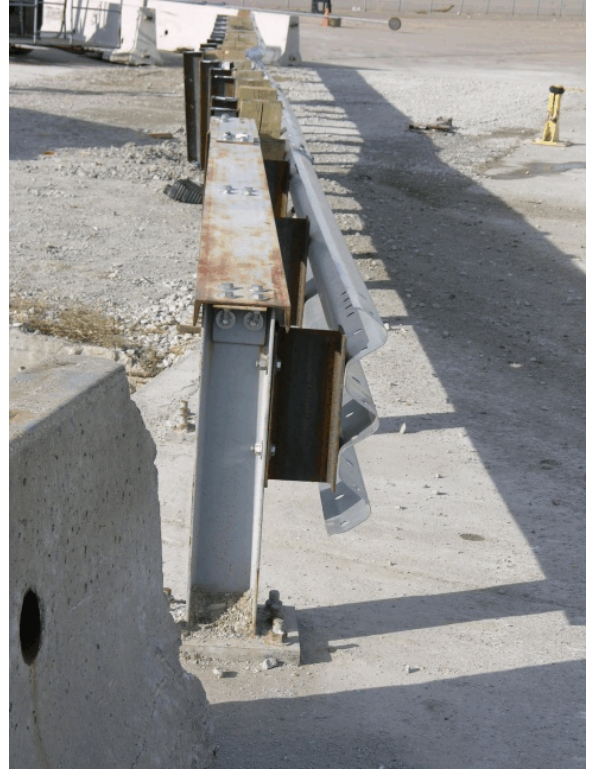
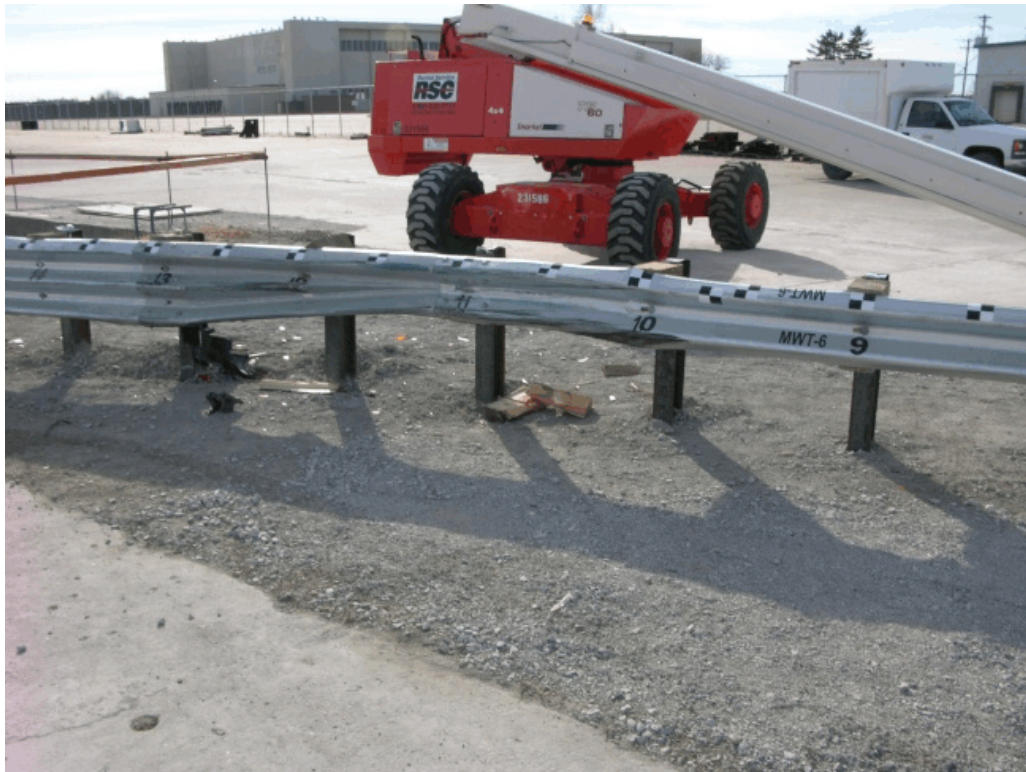
Figure 123. System Damage, Test MWT-6

Barrier damage was minimal, as shown in Figures 121 through 126. Barrier damage consisted of deformed guardrail and posts, damaged blockouts, and contact marks on a guardrail section. The length of vehicle contact along the approach guardrail system was approximately 4.5 m (14.8 ft), which spanned from 235 mm (9.25 in.) upstream from the centerline of post no. 10 through the midspan between post nos. 14 and 15.
