Landslide Investigation and Correction

WILLIAM J. SISILIANO

PHIL JONES

Seymour District Area Engineer
Indiana State Highway Commission

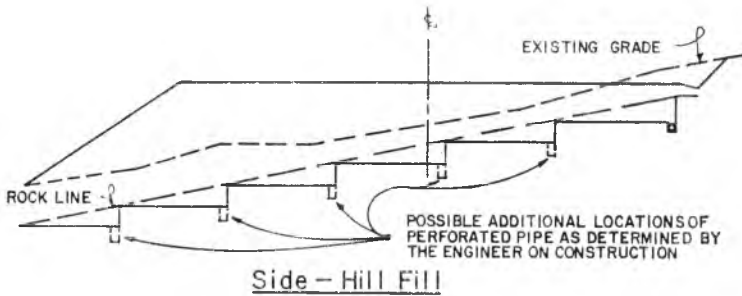
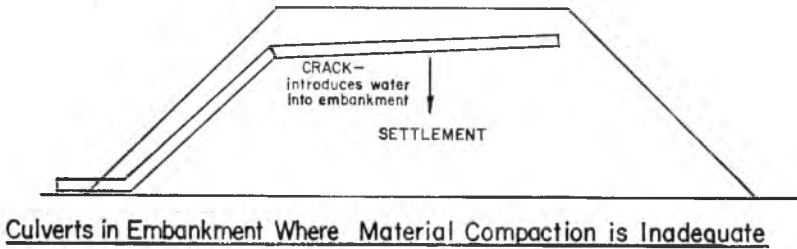
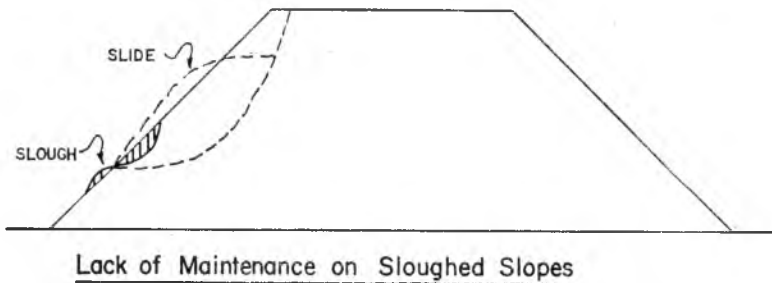
Fig. 1. Some possible causes for embankment failure.

During our analysis and correction work on some slides which have already been corrected, we have encountered certain factors which caused instabilities in localized areas primarily. These possible causes for embankment failure are shown in Figures 1, 2 and 3.

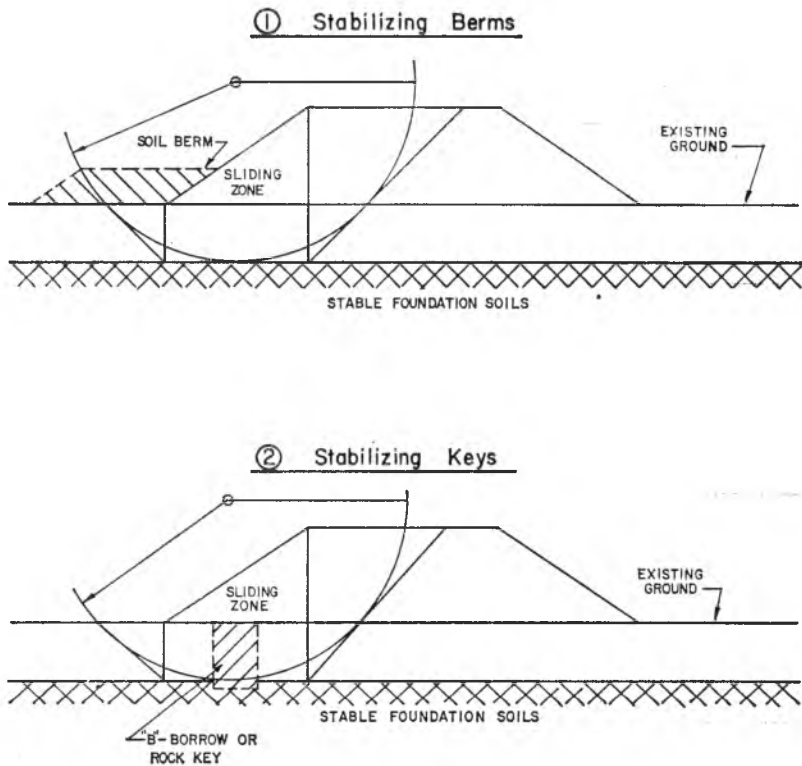
Fig. 4. Methods of slide correction.

Similar methods are used in the correction of slides as were mentioned for the prevention of slides, that is, flattening slopes, lowering grades, providing surface and subsurface drainage, decreasing driving forces, increasing resisting forces, building restraining or retaining structures, complete excavation or relocation of that section of roadway. Two examples of methods used for slide corrections are shown in Figure 4.

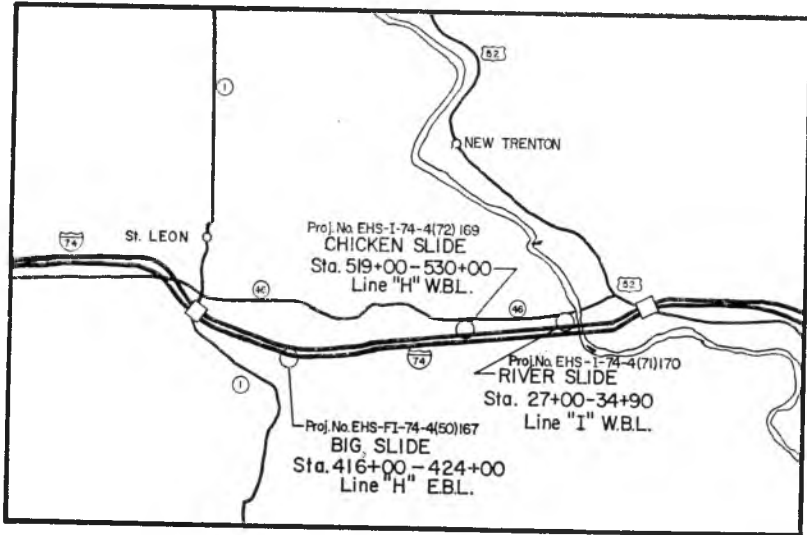
Fig. 7. Project site plan showing actual locations of I-74 corrected landslides.

The general landslide location is shown in Figure 6. The specific location of embankment failures corrected to date are shown in Figure 7.

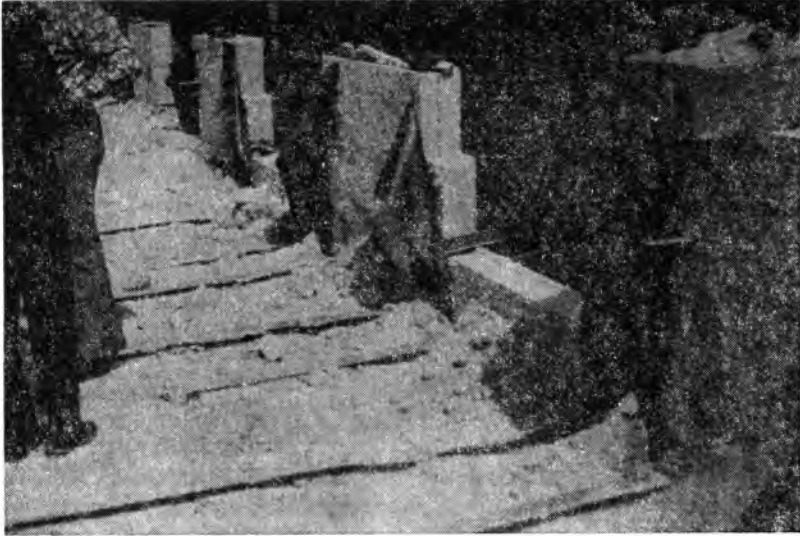
Photograph 7 shows a reinforced earth structure being constructed in Anniston, Alabama. Photograph 8 shows a front view of the partially completed structure. Precast panels were used for this project.

Photo 7. Construction of reinforced earth structure in Anniston, Alabama.

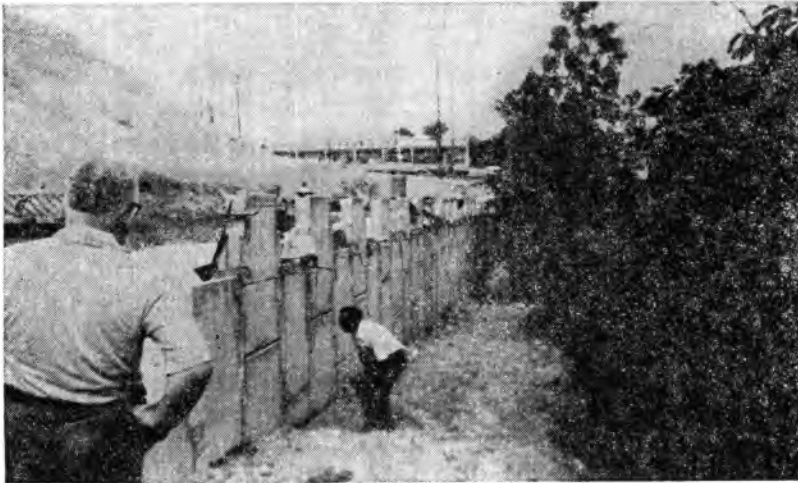
Photo 8. Partially completed reinforced earth structure in Anniston, Alabama.
