Material Evaluation: Self Damping Wire SD/ACSR Conductor Failures

A THESIS

For the Degree of Master of Science
Major: Mechanical Engineering and Applied Mechanics

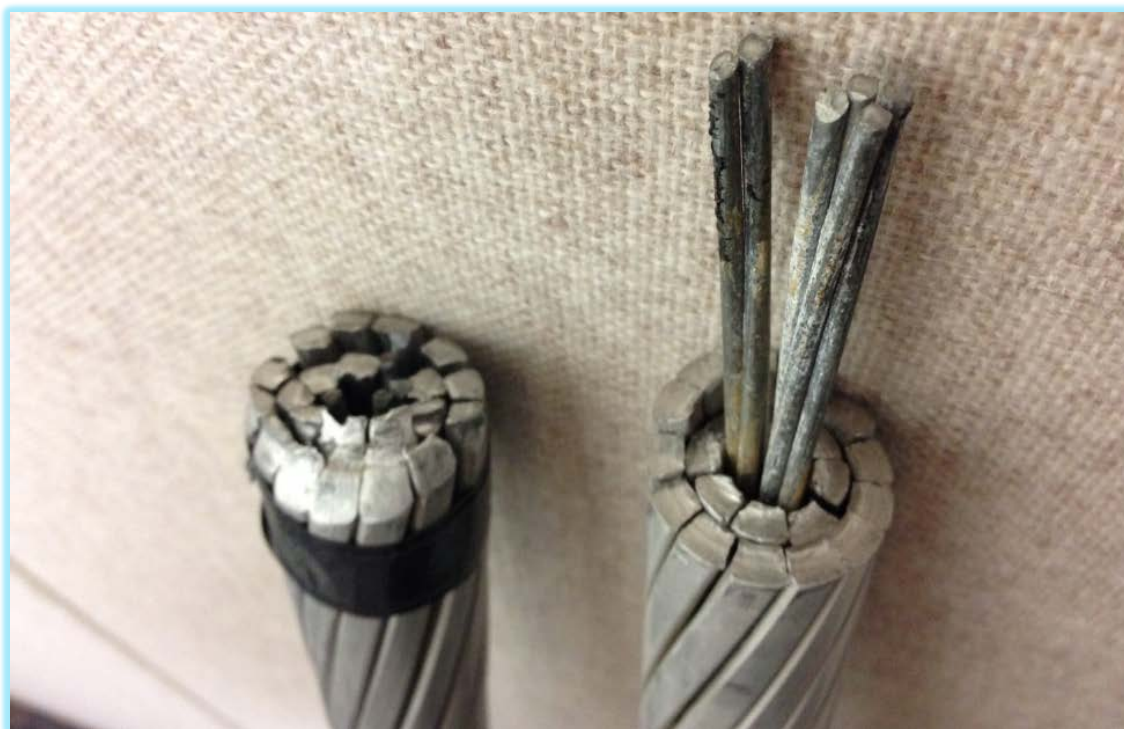
Figure 5 –Example of 954 Type 7 self-damping ACSR installed on over 1400 miles on the NPPD transmission system, center steel strands extended

The 954 Type 7 SD ACSR which was installed in the 1970's contains 21 trapezoidal aluminum strands and 7 steel strands (Figure 5). Following more than 30

years in service, NPPD began to have multiple steel strand failures on the SD/ACSR conductor. Broken steel strands in the conductor are easily identified during line patrol inspections since the conductor tension change results in the span to sag when compared to neighboring spans. This type of ACSR has since been redesigned with 46 smaller circular aluminum strands, resulting in 3 layers of aluminum to better protect the steel core strands.

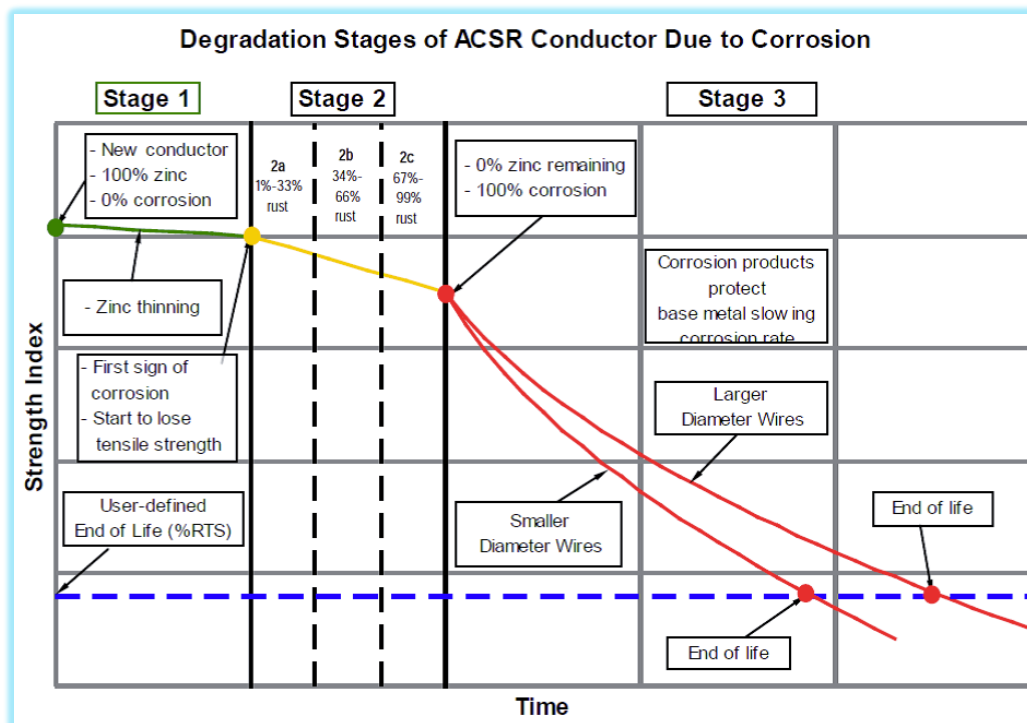
Figure 14 – Degradation stages of ACSR steel core

Corrosion is often a problem encountered with galvanized steel shield wires and became an amplified problem for NPPD for aluminum conductor with galvanized steel core. Prioritizing conductor replacements activated a need to develop acceptance criteria and assessment methods for inspection shown in Figure 14. Determination of the core steel cross-sectional material loss will provide the ability to directly assess the most vital ACSR/SD parameter to determine; steel core remaining strength and determine remaining life with multiple measurements.

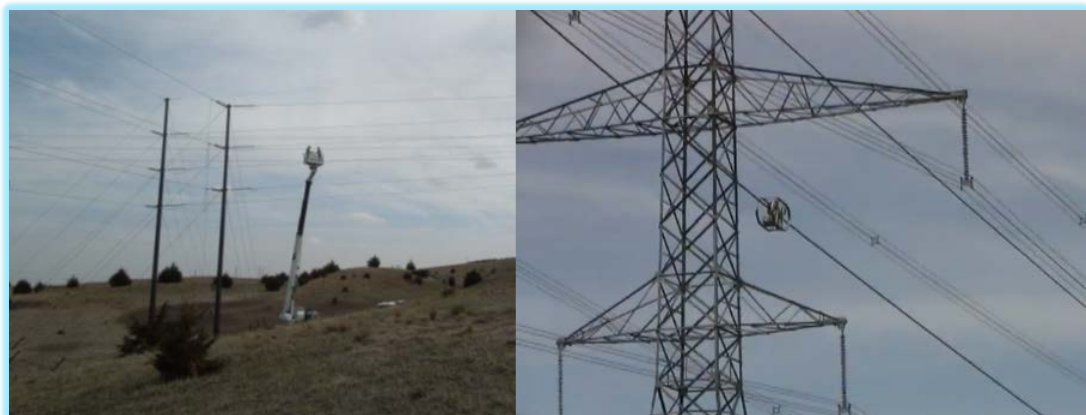
There were 5 spans that were classified as “marginal” during the April 2013 inspection; these deteriorated sections were removed in 2015 with a couple hundred feet of new ACSR being spliced in the span in Figure 29. Of the 54 wire spans inspected, 30 spans contained a compression splice, while the remaining 24 spans did not contain any type of compression connection.

- 96% of spans with compression sleeve splices have corrosion present in various stages. 83% of these spans were considered “Good” or “Very Good”.
- 42% of spans without compression sleeves have corrosion present in various stages. 91% of these spans were considered “Good” or “Very Good”
- About 40% of the spans in the system have localized areas of corrosion that are Category 3 or worse.
- 33 of 36 maximum corrosion locations (91%) occurred within 150 ft. of the low point of the span.

Figure 29 – Transmission line electromagnetic testing
