Analysing a mechanism of failure in retrieved magnetically controlled spinal rods

Vasiliki C. Panagiotopoulou^{1,2} · Stewart K. Tucker³ · Robert K. Whittaker¹ · Harry S. Hothi¹ · Johann Henckel^{1,2} · Julian J. H. Leong^{1,2} · Thomas Ember^{3,4} · John A. Skinner^{1,2} · Alister J. Hart^{1,2}

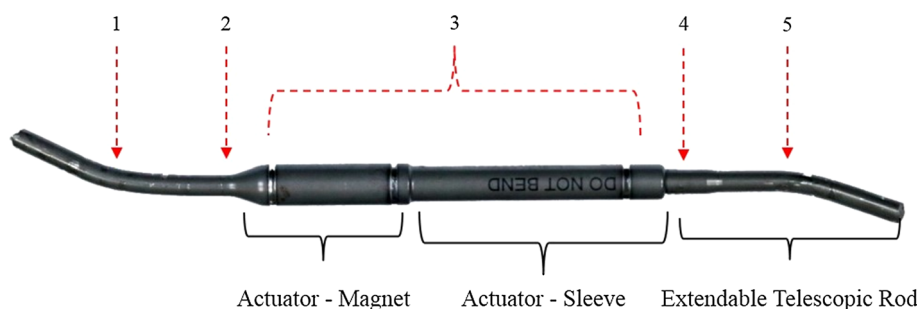
Fig. 3 Image of an explanted MCGR, with labelling of the main parts of the rod (actuator and extendable telescopic rod) and with referencing of the five areas of interest used for comparison of surface damage findings for each rod
