School Conditions Will Continue to Earn Failing Grades

ABSTRACT

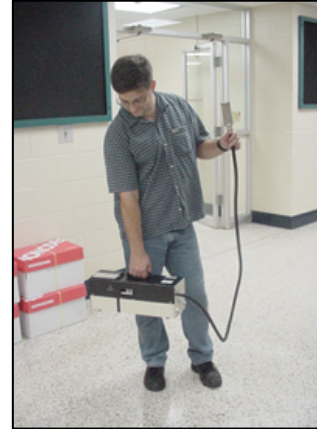
Figure 4. Tracer Gas Ventilation Rate Testing at a Florida School

- zone pressure mapping (measuring pressure differences between different areas in the school and between the school building and outdoors)
- a blower door building airtightness test
- tracer gas decay ventilation rate test (designed to test how much outside air is brought into the building under normal operating conditions)
- sampling and monitoring of indoor conditions (typically including temperature, relative humidity and CO₂ measurements).

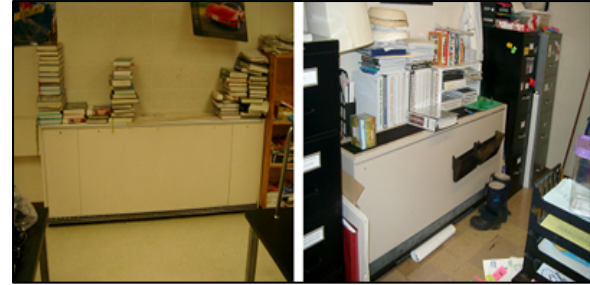
There were several significant audit observations. While the average measured unit ventilator outside air flow rate was 230 cfm, within the 225 cfm and 330 cfm range of required ventilation, three classrooms were found to need maintenance. As was the case in the other audited Oregon elementary school, the common areas of the main building including the gym/cafeteria and auditorium appear to be over ventilated for their occupancy. The main air handler serving these areas is providing outside air for full occupancy during the entire daily-occupied time. Also, a urine smell was observed in two of the portable unit bathrooms.
