Estimation the performance of solar fiber optic lighting system after repairing the glass Fiber Cables in a South Korean Residential Building

Kwang-Seok Cha
Renewable Team Leader
Hyundai Engineering and
Construction, Ltd.
Seoul, South Korea

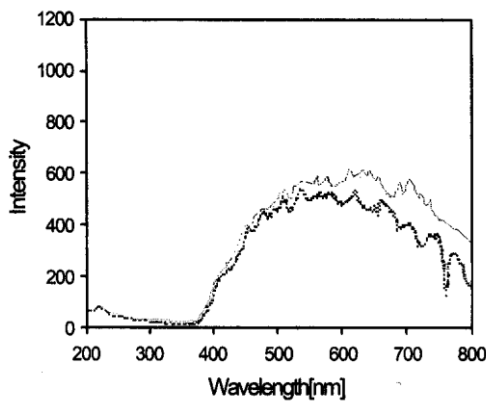
Fig. 15 Results of spectrum analysis

Fig. 15 is a before and after graph of the wavelength distribution of the light emitted. The dark line on the graph indicates the wavelength following the repair. Initially, the wavelength shows a spectrum ranging from white to red. The visible rays are subdivided, according to wavelength, into red (750-620nm), orange (620-585nm), yellow (585-575nm), green (575-

500nm), blue (500-445nm), dark blue (445-425nm), and violet (425-390nm). We find that light from the emission point falls mainly within the red spectrum; this is due to an improper focal distance at the concentration part. Fig. 16 displays, for one particular apartment, the distribution of luminous intensity from mid-morning to mid-afternoon. The left axis indicates the indoor luminous intensity while the right axis indicates that for outdoors.
