45TH **TURBOMACHINERY** & 32ND **PUMP SYMPOSIA**
HOUSTON, TEXAS | SEPTEMBER 12 – 15, 2016
GEORGE R. BROWN CONVENTION CENTER

A High Bearing Temperature Troubleshooting of Centrifugal Heat-Pump Compressor

Woonsil Lee, and Chi Hyuk Kim
Hyundai Oilbank co. Ltd,
Daesan, South Korea

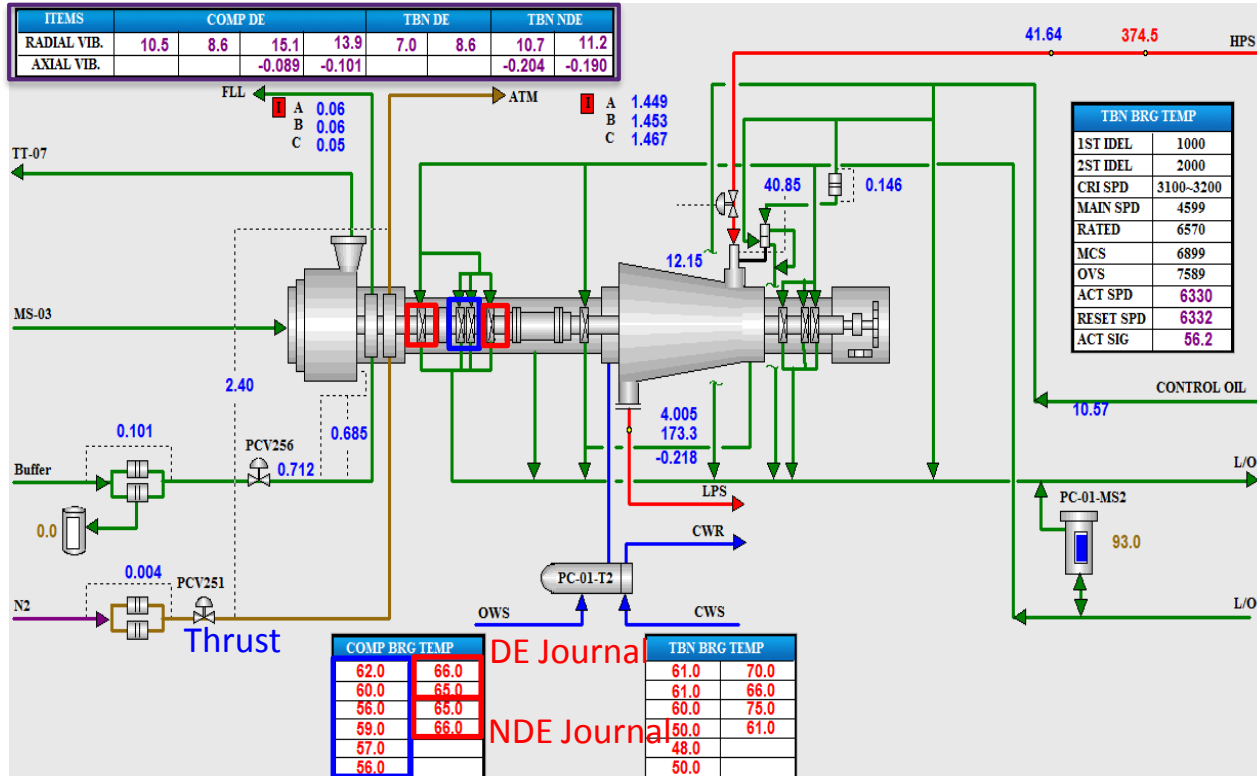
➤ Overview of Machine Monitoring

- ✓ Speed: 6100 ~ 6500 rpm
- ✓ Three (3) RTD for each Thrust bearing
- ✓ Two (2) RTD for DE radial bearing
- ✓ Two(2) RTD for NDE radial bearing
- ✓ Vibration sensors for each radial bearing
