Post-Earthquake Reconnaissance of Unreinforced and Retrofitted Masonry Parapets

Marta Giarretton,^{a)} M.EERI, Dmytro Dizhur,^{b)} M.EERI, Francesca da Porto,^{a)} and Jason M. Ingham,^{b)} M.EERI

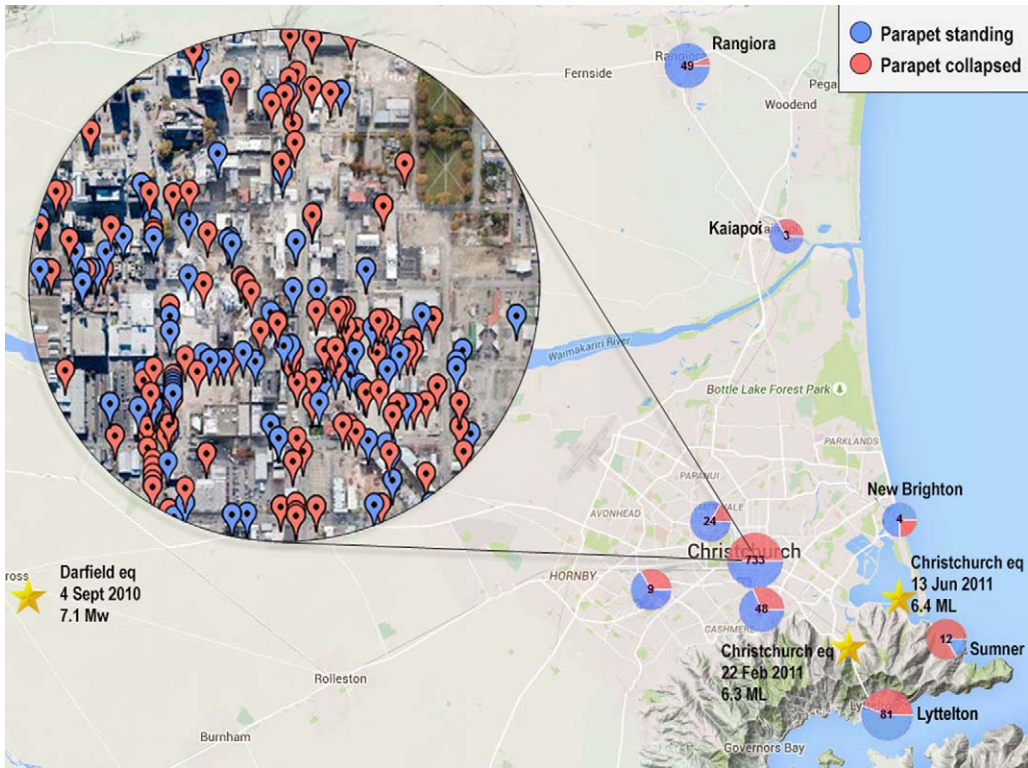
Figure 3. Distribution of surveyed parapets and corresponding damage state following the three major earthquakes that occurred in the Christchurch area on 4 September 2010, 22 February 2011, and 13 June 2011 (background map data ©2015 Google).

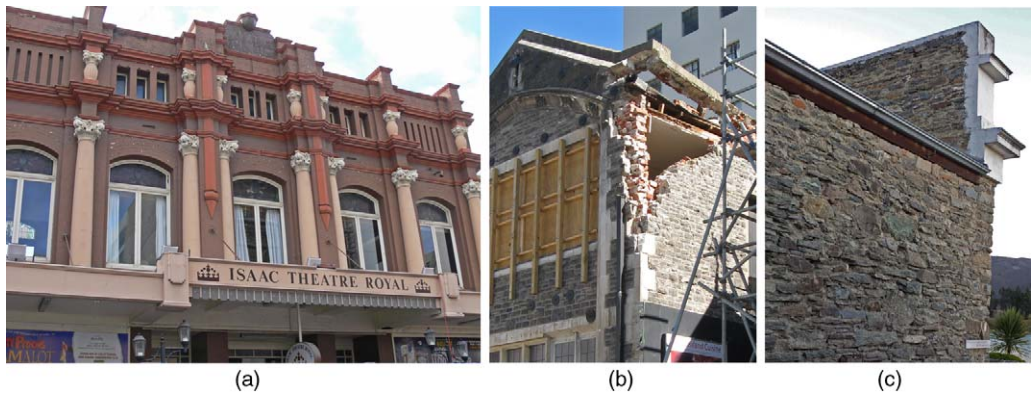
Masonry parapets were used in both clay brick and stone URM buildings (Figure 7), with a typical thickness equal to 230 mm (two-leaf-thick wall) excluding the thickness of a

Figure 7. Examples of clay brick and stone URM parapets: (a) clay brick parapet; (b) combination of stone and clay brick parapet; (c) rubble stone parapet.

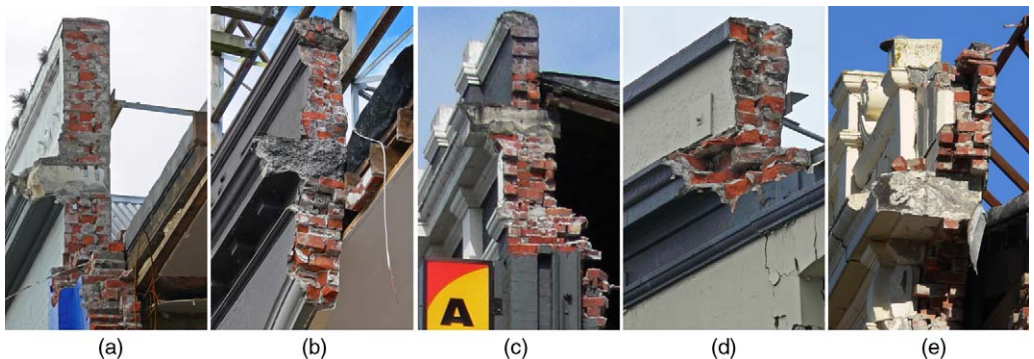
Figure 8. Different positioning of cornice within parapet cross section: (a) limestone cornice, above roof level; (b) concrete cornice, above roof level; (c) concrete cornice, under roof level; (d) clay brick cornice, above roof level; (e) limestone cornice and ornamental features at the top.

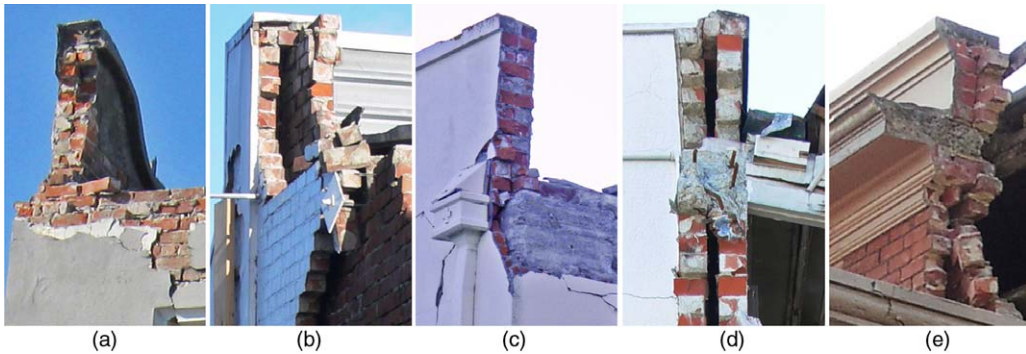
- Continuous wall type (solid wall or cavity wall; [Figure 9a, 9b](#))
- Parapet (solid or cavity) with a RC beam at roof level or a concrete/stone cornice ([Figure 8](#) and [Figure 9c, 9d](#))
- Solid wall-type parapet over a cavity wall ([Figure 9e](#))

Figure 9. Typical parapet cross section and roof diaphragm-to-wall seating arrangement: (a) continuous solid wall-type parapet; (b) continuous cavity wall-type parapet; (c) solid parapet with a concrete beam at roof level; (d) cavity parapet with a concrete beam at roof level; (e) solid wall parapet over cavity wall.

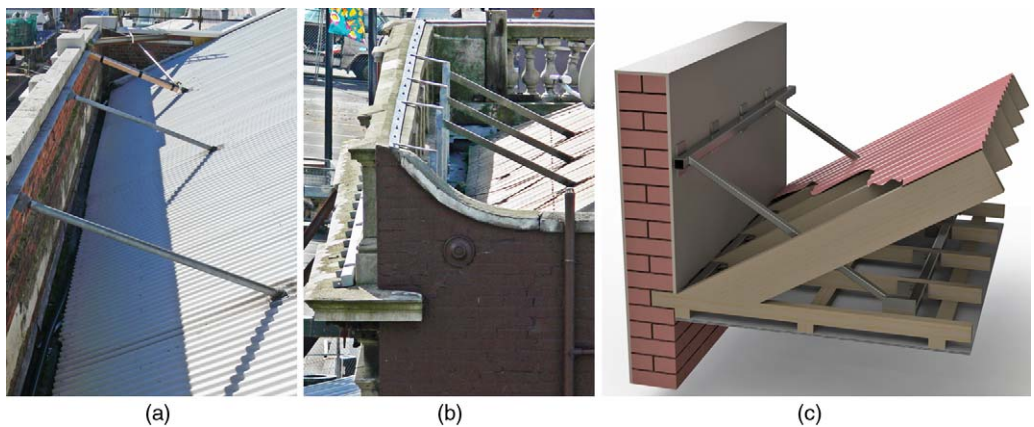
Figure 11. Examples of parapets braced back to structural elements: (a) typical braced parapet; (b) parapet braced back with top connection; (c) design scheme.

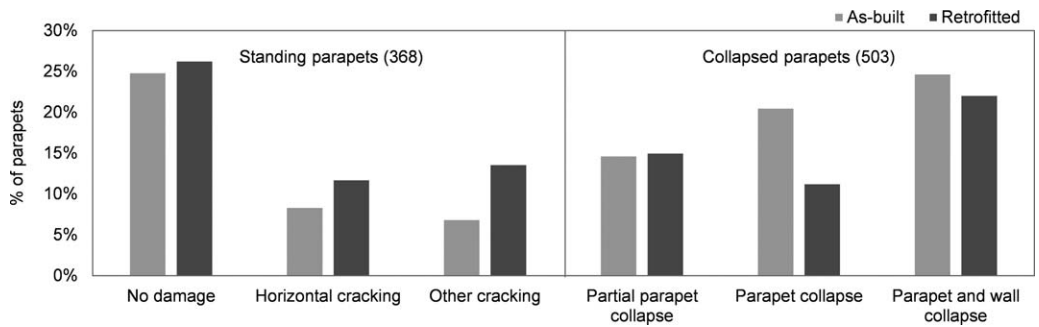
parapets presented an increased occurrence of horizontal or other cracking failures (Figure 17). After the 22 February 2011 event, 40% (269) of the as-built parapets were standing while 60% (403) had collapsed. Retrofitted parapets presented a slightly better performance with 52% (109) of parapets standing and 48% (100) of parapets collapsed. A large percentage of retrofitted parapets collapsed but it has to be considered that in many cases it was not easy to identify from the street the presence of any retrofit intervention, unless the parapet had partially or fully collapsed. Figure 17 shows the improvement in performance of retrofitted parapets when compared with as-built parapets. Note that a large number of parapets (23%, 212) collapsed due to partial collapse of the facade, and hence the adopted retrofit intervention designed only for the parapet was not able to prevent the failure.

Figure 17. Observed failure categories of as-built and retrofitted URM parapets after the 22 February 2011 Christchurch earthquake.

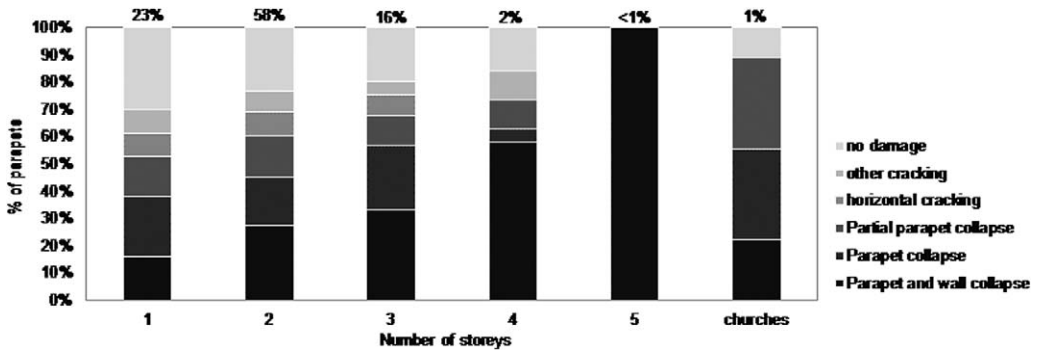
Considering the state of the parapets after the three major earthquake events an increase in the level of damage to parapets proportional to the height of the building (number of stories) was observed as expected (Figure 18). In the case of two story buildings, the most frequent category, 27% (153), of parapets collapsed in conjunction with out-of-plane wall failure, 18% (99) exhibited overturning failure of the parapet and 15% (84) partially collapsed. Of the parapets that remained standing, 9% (48) exhibited the initiation of overturning failure

Figure 18. Observed parapet failure categories and proportion in relation to the number of stories of the building.

indicated by horizontal cracking, 8% (43) had other types of cracks and 23% (130) presented no damage.

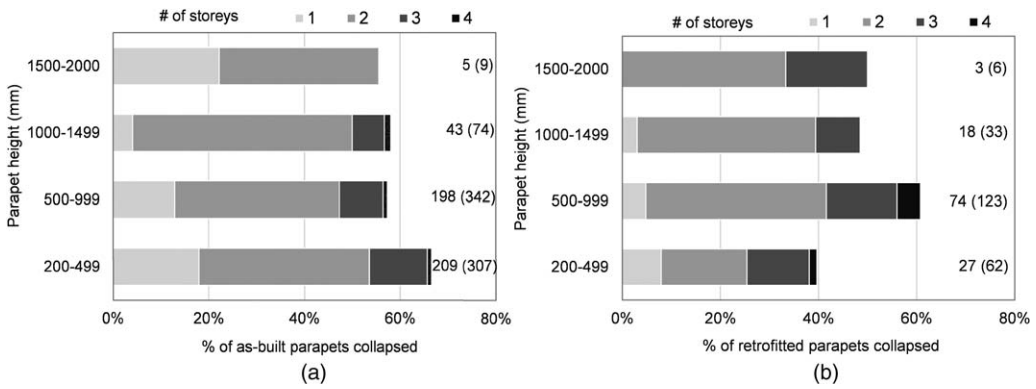
Figure 19 shows the results for only the collapsed parapets, where the data is clustered based on height of the parapet and number of stories of the building, with separate graphs presenting as-built and retrofitted parapets. For each horizontal bar the number outside parenthesis represents the total number of collapsed parapets and the number within parenthesis represents the number of parapets for each category, including both collapsed and standing cases. The data shows a reduction of collapsed parapets when a retrofit system was applied, in particular in the cases of single or two stories buildings. Similar graphs are presented in Figure 20, where data collected after the 22 February 2011 earthquake are clustered by height of the parapet and recorded PGA, both for as-built and retrofitted parapets. The addition of the retrofit system significantly reduced the frequency of collapse, in particular at PGA levels lower than 0.50 g.

Figure 19. Parapet collapse in relation to parapet height and the number of stories of the building: (a) as-built parapets; (b) retrofitted parapets.

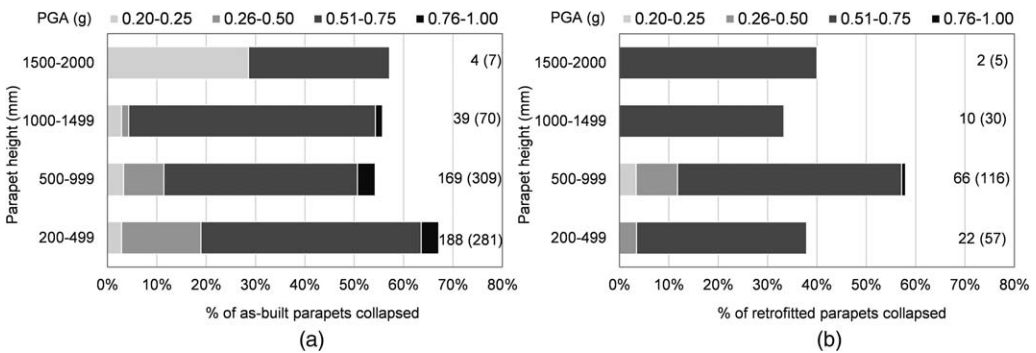
Figure 20. Parapet collapse during the 22 February 2011 Christchurch earthquake in relation to parapet height and the registered PGA: (a) As-built parapets; (b) retrofitted parapets.

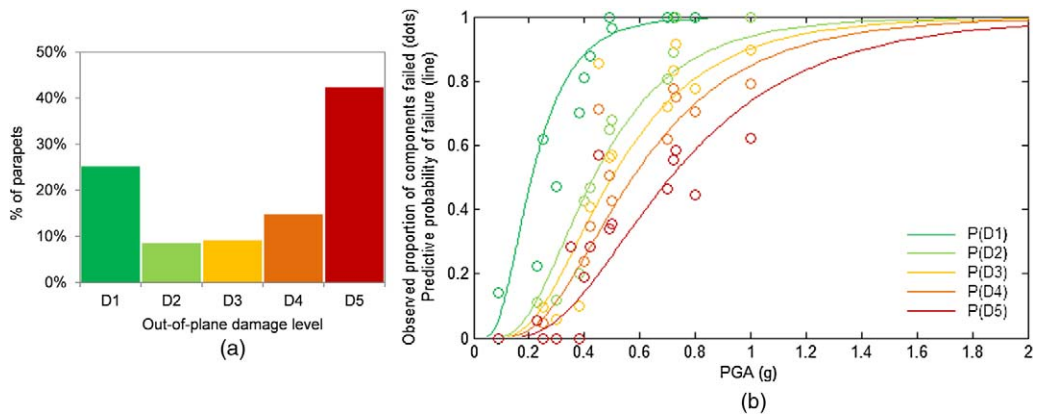
Figure 23. Damage level observed for unreinforced masonry parapets following the Canterbury earthquakes: (a) breakdown of damage levels; (b) fragility curves.

levels, while Figure 23b reports the simulated fragility curves for each level of damage, demonstrating that the median fragility values increase with increasing damage level. The estimated median fragility values are: $P(D1) = 0.21$ g; $P(D2) = 0.43$ g; $P(D3) = 0.50$ g; $P(D4) = 0.57$ g; and $P(D5) = 0.71$ g.

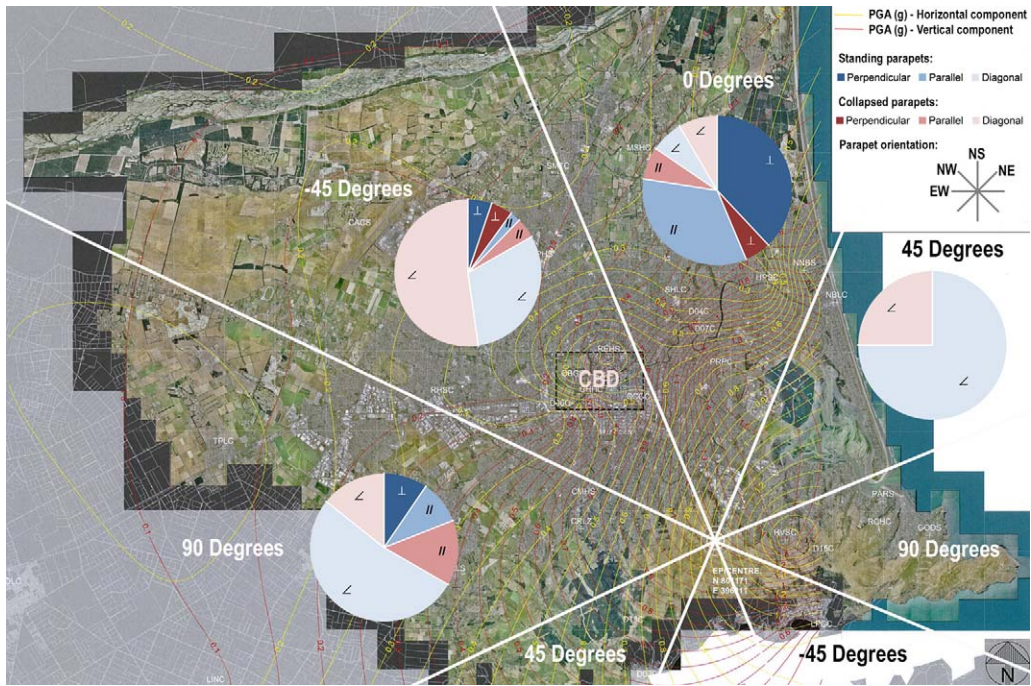
A final comparison was undertaken to consider the orientation of the parapets versus the direction of the earthquake with respect to the data collected after the 22 February 2011 earthquake. As previously described, the orientation of the parapet was identified by the direction of its length and was clustered into four groups: north-south (NS), east-west (EW), northwest (NW), and northeast (NE). The angle between the epicenter and each building was calculated using GPS coordinates. The resulting angles were then clustered into four groups: (1) “0 degrees” that includes the angles from 337.5° to 22.5° and the opposite 154.5° to 202.5° ; (2) “45 degrees” between 22.5° to 67.5° and 202.5° to 247.5° ; (3) “90 degrees” from 67.5° to 112.5° and 247.5° to 250.5° ; and (iv) “-45 degrees” considering the angles from 112.5° to 154.5° and 250.5° to 337.5° (Figure 24). In each group, parapets were clustered as perpendicular, parallel, or diagonal with respect to that angle. For example, in the case of group “-45 degrees” that includes the most populated and effected areas of the CBD (6–12 km from the epicenter) and Lyttelton (5–6 km from the epicenter), all the parapets oriented NE are perpendicular (\perp), parapets oriented NW are parallel (\parallel), and parapets oriented NS and WE are considered diagonal (\sphericalangle). Figure 24 summarizes the results using pie charts divided into sectors representing each angle group. The pie charts present standing (blue portion) and collapsed (red portion) parapets considering their orientation as perpendicular, parallel or diagonal. In the CBD (“-45 degrees” group) where most of the parapets were located, the urban pattern was mainly oriented NS and EW and as a consequence a large number of parapets (650, 83%) were oriented diagonally to the direction of the earthquake and hence it was not possible to clearly observe a predominant response for the perpendicular and parallel oriented parapets. The majority of the parapets (408, 52%) that were located in the CBD and oriented diagonally

Figure 24. Map showing the epicenter and PGA contours (Source: Christchurch City Council) and for each considered angle group a pie chart showing standing and collapsed parapets for each orientation.

collapsed. Parapets were predominantly oriented perpendicular and parallel to the earthquake direction in the area referred to as “0 degrees,” where only 71 URM parapets were identified. Nevertheless, in the “0 degrees” quadrant a large number of parapets remained standing and it was not possible to assess the influence of the directivity effect because of the distance from the epicenter, being 32 km and 22 km, respectively, for Rangiora and Kaiapoi, where in both cases the recorded PGA was lower than 0.20 g. Table 4 presents the results and the number of parapets considered for each group.
