A multidisciplinary approach to assess the health state of heritage structures: the case study of the Church of Monastery of Jerónimos in

Lisbon

Maria-Giovanna Masciotta^{a,1}, João C. A. Roque^{b,2}, Luís F. Ramos^{a,3}, Paulo B. Lourenço^{a,4}

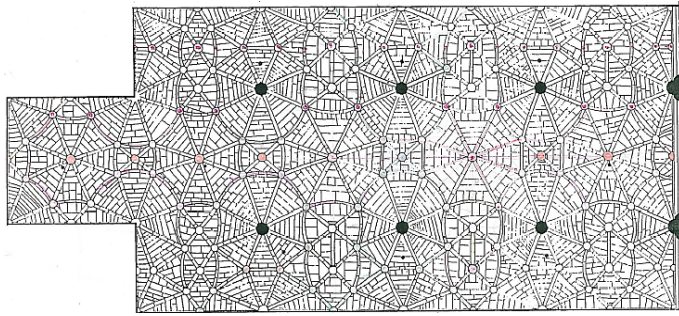
Figure 3 – In situ testing [15]: (a) topographic and photogrammetric survey of nave vault; and (b) out of plumbness of columns and sidewalls.

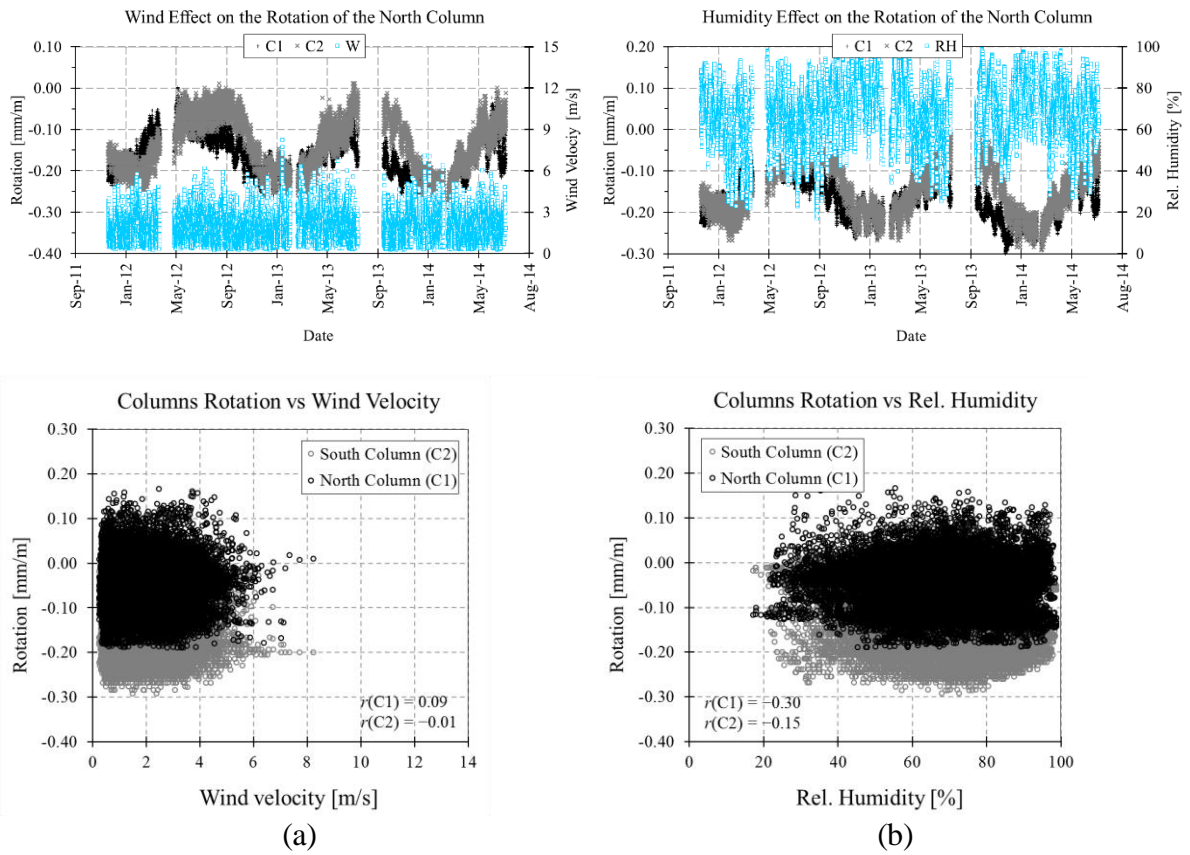
Figure 16 – Temporal variation and correlation of columns rotation with respect to (a) wind speed and (b) relative humidity: close-up of the period from 01/12/2011 to 04/07/2014.

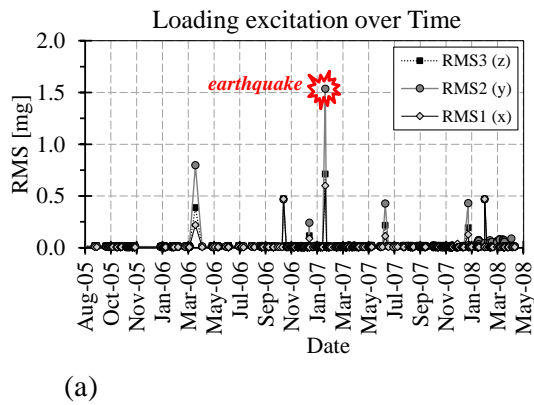
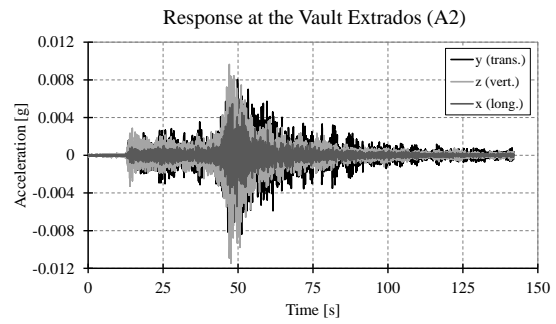
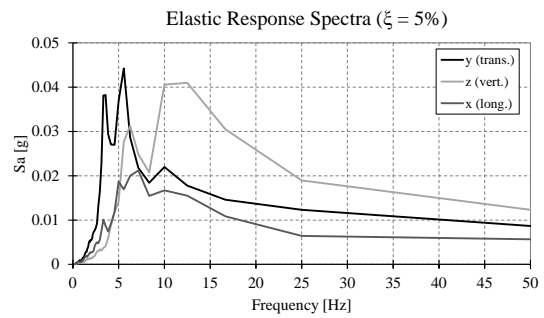
Figure 19 – Ambient noise during the monitoring period: (a) root mean square of the acceleration channels as function of time; (b) response of the church during the seismic event of 12/02/2007; and (c) corresponding elastic response spectra ($\xi = 5\%$).

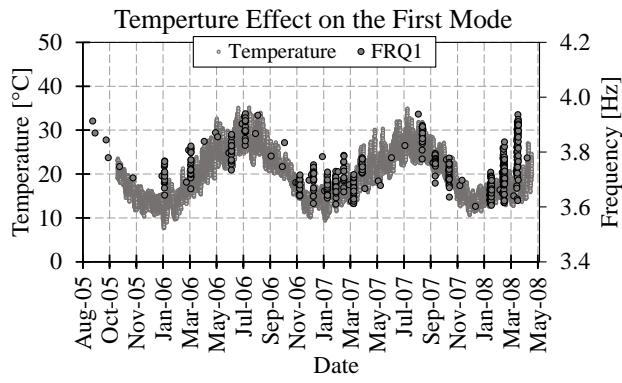
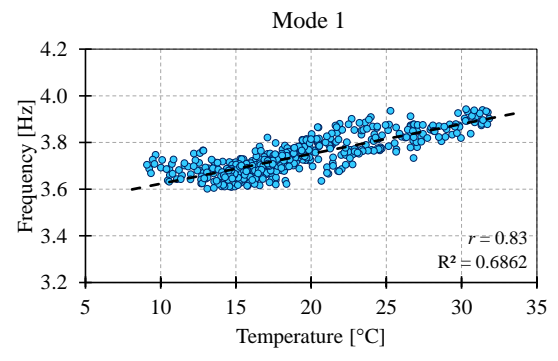
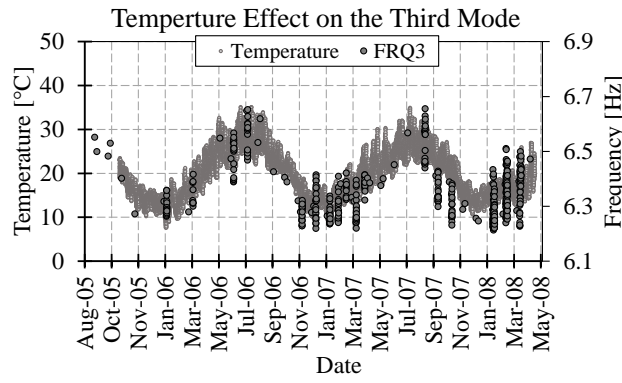
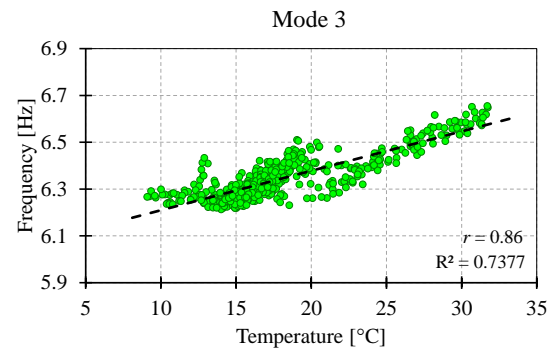
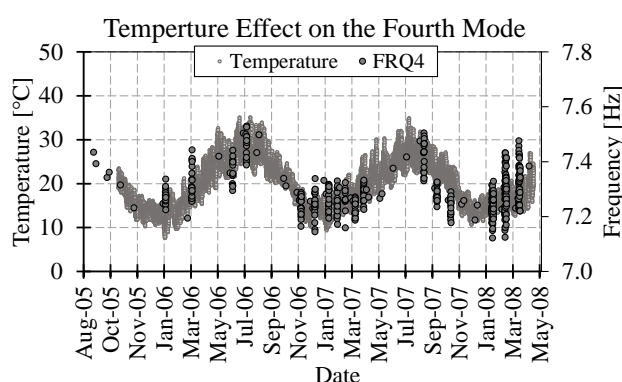
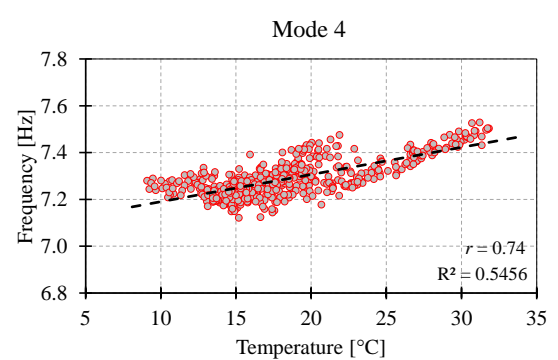
The temporal variation of the natural frequencies with respect to environmental and loading conditions is illustrated in Figure 20 and Figure 21. Given the low levels of ambient excitation and wind speed (cfr. Section 6.1), the variation of the modal frequencies is clearly imputable to the temperature effects and, to a certain extent, the humidity. Figure 20 shows the evolution of the natural frequencies of the global modes with respect to the temperature together with the best trend lines and the coefficients of correlation r and determination R^2 . It can be clearly observed that all investigated frequencies show an almost linear increasing trend with rising

temperature and vice versa. The lower modes exhibit a strong positive correlation, being r and R^2 equal to 0.83 and 0.69 for mode 1, and equal to 0.86 and 0.74 for mode 3, respectively; whereas mode 4 is characterized by a frequency-temperature trend similar to mode 3 but less strong, as pointed out by the lower values of r (0.74) and R^2 (0.55). It is noted that the positive correlation between modal frequencies and temperature is often observed in long-term studies of masonry structures [8-11] and can be explained through the rise in stiffness induced by the thermal expansion of the materials with higher temperatures, lower moisture contents on the walls [7], and the consequent increase in frequency values. The plots relevant to modes 3 and 4 also highlight the considerable change in the frequency-temperature relationships triggered by the seismic event of February 2007. In order to analyse the possible influence of other environmental variables on the global modes of the church, the natural frequencies are plotted with respect to relative humidity, wind speed and ambient excitation (Figure 21). The corresponding coefficients of correlation (r) are given in Table 8. The plots show that the identified modal frequencies are characterized by a moderate linear correlation with the relative humidity, reading values of r between -0.40% and -0.60% . As the relative humidity does increase, the frequencies do decrease. This behaviour can be ascribed to the absorption of moisture by the masonry walls, responsible in turn for the increase of mass and the consequent decrease of frequency values [7], given their inverse relationship. Finally, it is stressed that no trend is found between modal frequencies and wind speed nor between modal frequencies and loading conditions (Figure 21c-d).

Figure 20 – Variation of identified natural frequencies versus temperature from 24/08/2005 to 28/04/2008: (a) first frequency; (b) third frequency; and (c) fourth frequency.

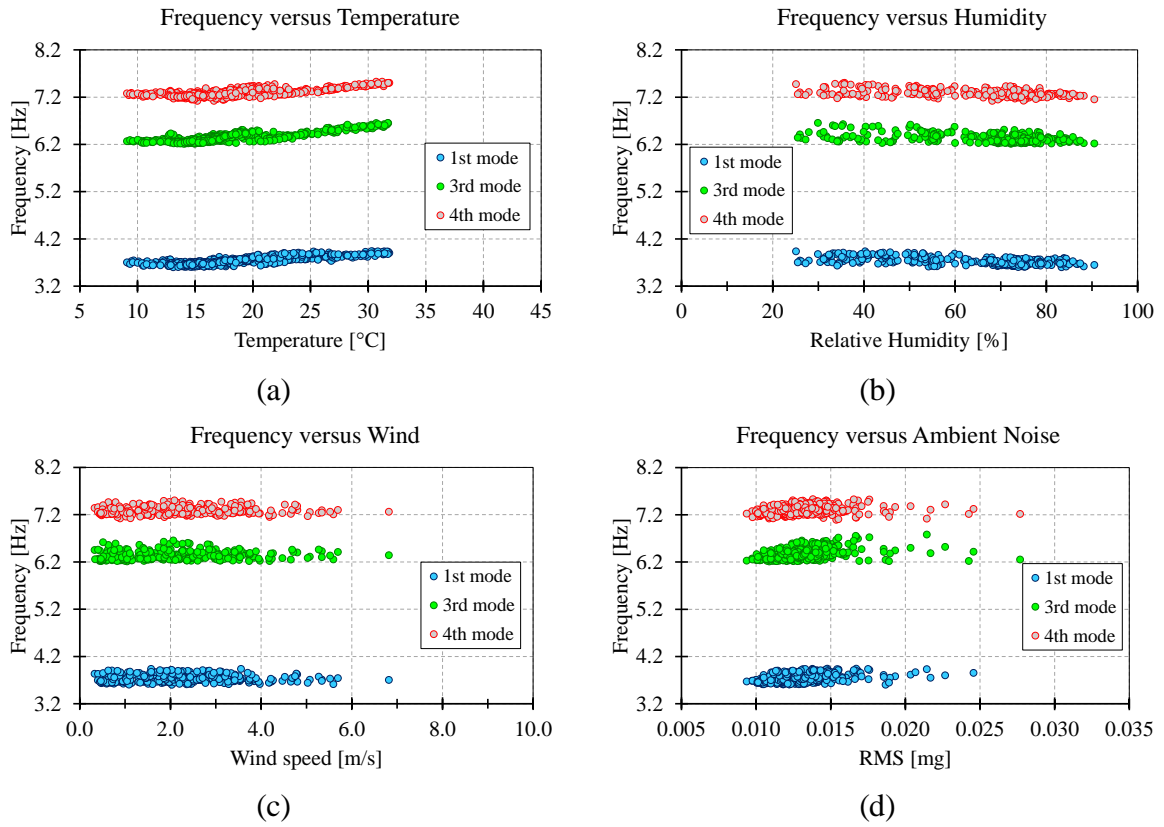
Figure 21 – Variation of identified natural frequencies versus: (a) temperature; (b) relative air humidity; (c) wind speed; and (c) ambient noise from 23/04/2007 to 28/04/2008.
