Durability of Ring-Road II asphalt pavement

Phase I report on forensic analysis of Ring-Road II pavement distresses

Aalto University publication series
SCIENCE + TECHNOLOGY 18/2013

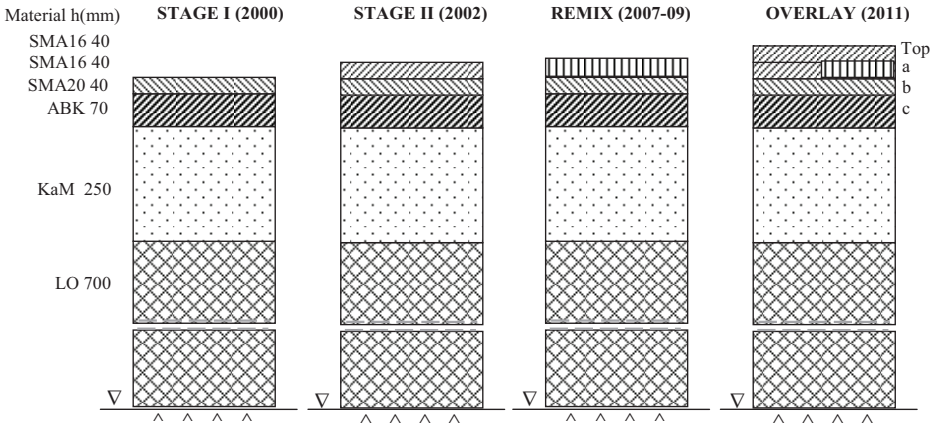
Figure 2. *Kehä II construction history: pavement structural design. Layers are designated as follows: Top is the new SMA16 overlay, (a) is Stage II original binder course layer with or without rehabilitation, (b) is binder layer SMA20, and (c) is ABK layer.*

The ring-road Kehä II was constructed in two stages; the entire construction history is shown in Figure 2. Stage I construction was completed in year 2000. Pavement thickness design included 700-mm thick rock bed base course of blasted rock (LO) over 250-mm thick crushed rock (KaM) layer. The bound base course was 70-mm thick asphalt concrete base layer (ABK), and at top of that was 40-mm thick binder course layer of SMA20 (Pihlajamäki and Sikiö 2001). The SMA 20 binder course was used as a wearing course for two years before completing the road construction for the designed structural thickness. In Stage II construction, 40-mm thick wearing course of SMA 16 (LTA) was placed down in autumn 2002, see Figure 2.

Despite predictions of good performance over 20 years of design life, distresses such as potholes, cracking and raveling started to emerge. Sections of the road surface were rehabilitated using hot in-place Remix technique in 2007, 2008 and 2009 mixing 16 to 19 kg/m² fresh SMA 16 with existing SMA 16 mixture. The multiple attempts of surface rehabilitation were ineffective and, in 2011, road was overlaid with 40-mm thick SMA 16 layer. The Remix treatment was applied only partially for the most deteriorated road sections and Figure 4 show the locations of road where the Remix rehabilitation was applied. Map also shows the locations where cores were taken for laboratory testing.

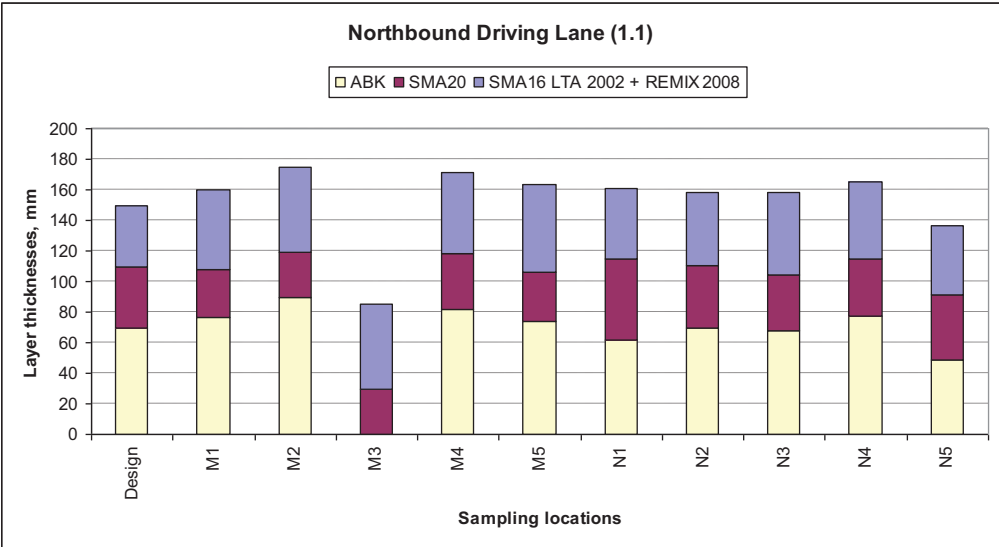
Figure 13. Core thicknesses of northbound driving lane samples.

Figures 13 to 16 show the measured thicknesses of pavement layers in each lane of Kehä II. For some samples it was difficult to see the layer boundaries (locations M and N) but for many samples it was easy as layers were not bonded together. Visual inspection suggested that locations with thin wearing course layer had more distresses and potholes.

Southbound passing lane was badly deteriorated as cores broke, and therefore full depth cores were not obtained from most of these locations (Figure 16). Northbound lanes were in better condition and total pavement thickness generally met or exceeded the total design thickness of 150 mm (70+40+40 mm). This agrees with construction records, as the amount of laid mixture was reported to be 99,06 - 99,93 kg/m², i.e., layer thickness being 40 mm. However, construction records did not indicate how much tack coat (glue) in liters was used during construction. The observed bond failure between layers was caused either by lack of applying tack coat during construction, or by the fact that it was washed away by excessive water infiltration to the pavement, or by the combination of these both.

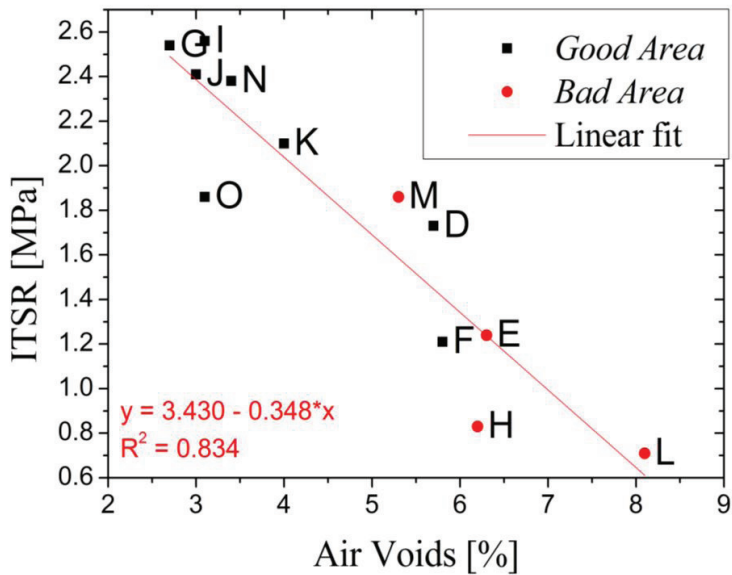
Figure 18. Mixture Indirect Tensile Strength vs. air voids content, layer (a).

A correlation was found between Indirect Tensile Strength values at 10 °C and air voids content (Figure 18), with bad areas of high air voids content giving predicted response of lower strength.

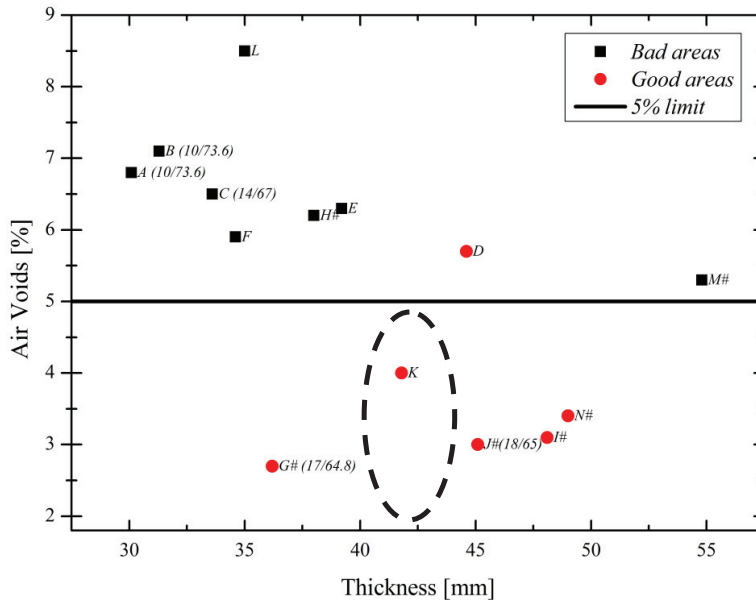
Thickness of the surface layer was found to be between 30 and 55 mm. Figure 19 presents correlation attempt between the air voids content and the layer thickness. Generally for the original surface layer SMA 16 LTA, deteriorated “bad” areas could be characterized by low thickness and high air voids content. Sample set marked inside the dotted line represents rehabilitated areas (REM) and higher pavement thicknesses are due to the addition of fresh material during the remixing process. Analogically, it can be concluded that reheating and additional compaction has contributed to the increase of pavement density compared to the original layer.

It is plausible that the origin of the high air voids content in the SMA16 LTA layer is due to poor compaction of too thin asphalt layer combined with too low compaction temperature. Rule of thumb is that for proper compaction, the layer thickness should be 2,5 to 3 times the maximum aggregate size, which in this case is 40 to 48 mm. In addition, it can be speculated that poor mixture workability (discussed further in section 4.5) has also contributed to the problem.

pavement compaction was acceptable at the time of construction. However, all the bad areas were found to have 5-8 % air voids content and layer thicknesses were less than the required minimum of 40 mm, while the good area K had air voids content of 4 % and 40-mm layer thickness.

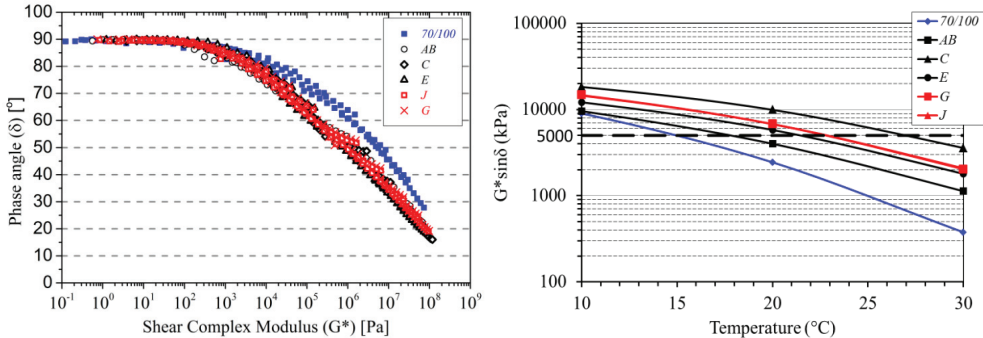
Figure 22: Black curves (left) and Superpave fatigue cracking parameters $G^*\sin\delta$ (right). AB, C and E were Bad areas and J and G were Good areas.

In Figure 22, a semi-logarithmic plot of phase angle δ against complex shear modulus G^* , which is commonly known as Black diagram, is presented for the studied binders. From the plot it can be seen that extracted Kehä II binders exhibited relatively more elastic behavior compared to the reference 70/100 binder. However, no significant differences between the Black curves of aged Kehä II binders could be seen. Susceptibility to fatigue cracking can be predicted with the Superpave fatigue parameter $G^*\sin\delta$, for which a critical temperature is defined to be the temperature at which $G^*\sin\delta = 5000$ kPa (AASHTO M320). From Table 9 it can be seen that Kehä II extracted aged binders had considerably higher critical temperatures compared to 70/100 binder indicating vulnerability to fatigue cracking.

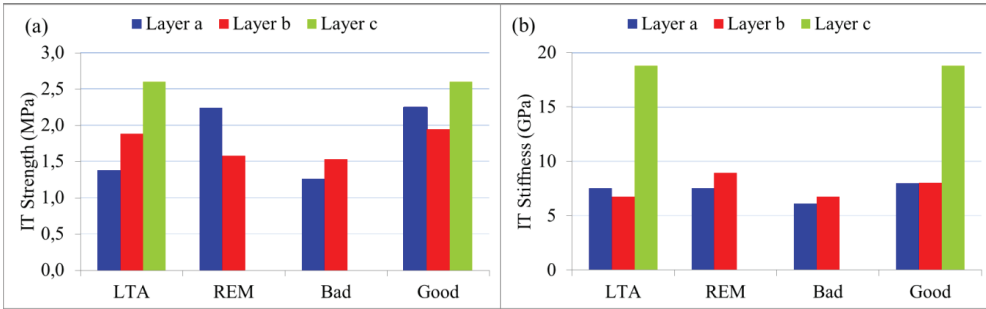
Figure 26. Original 2002 (LTA) and rehabilitated REM sections vs. Bad and Good areas.

Figure 26 summarizes measured stiffness and strength properties for *Kehä II* pavement layers. For all “bad” areas, the Indirect Tensile Strength was less than 1,5 MPa and Indirect Tensile Stiffness was less than 6500 MPa at 10 °C. The strength properties were more affected than the stiffness of the mixture: strength in the bad areas was on average 44 % lower than in the good areas while stiffness reduction was 23 %. Figure 26 also shows that the Remix rehabilitation for layer (a) had restored mixture strength properties due to better compaction but did not seem to affect the stiffness properties.

For the newly laid fresh mixture (area O) stiffness was the lowest being 4572 MPa. For base mixture (ABK) stiffness was quite high being 18 787 MPa due to lower binder content and coarser gradation.

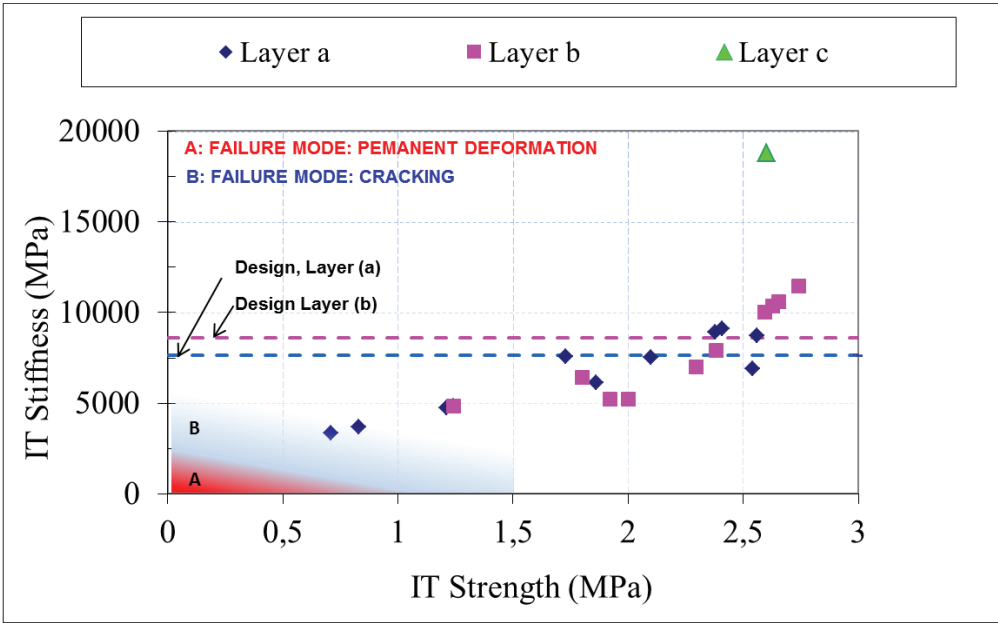
Figure 28. Stiffness vs. strength properties can be used to estimate ductile and brittle mixture properties and to predict durability failure zone for asphalt mixtures.

Figure 28 plots stiffness and strength properties for Kehä II pavement layers. Missing values were estimated assuming linear correlation between stiffness and strength. Figure 28 shows that all “bad” areas are located in the “zone for low stiffness and strength”.

Based on Figure 28 it can be concluded that relative to performance temperature, the low stiffness and strength are governing the durability of the mixture, similarly to the propensity for rutting. The stiffness threshold value for cracking depends on the ability of binder to elongate due to fast loading at intermediate and cold temperatures. The absolute stiffness threshold value to resist permanent deformation depends on the ability of binder to resist shear flow due to slow loading at warm and hot temperatures. Both distresses accumulate with repetitive loading and are thus dependent on the amount of traffic. However, both distresses lead to rapid failure if load levels are high enough to cause large strains in the asphalt mixture.

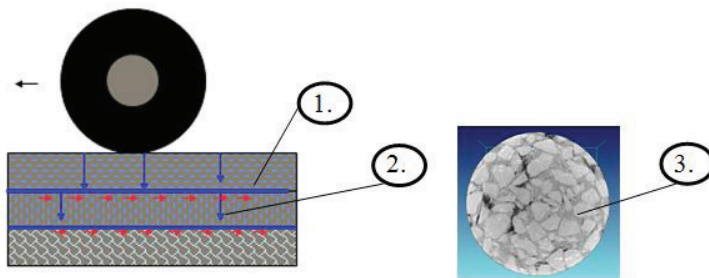
Figure 29. Proposed pavement durability distress mechanism based on Kehä II findings.

The lack of bonding between layers can be explained in two ways: either water that reaches the interface between layers was able to wash off binder due to horizontal water flow or there was not enough glue between layers in the first place. Whatever the reason, the consequence is that bound pavement layers did not form a monolithic layer structure. In this way the traffic load is able to cause horizontal displacements, which in turn are initiating micro-cracking (Laukkanen et al. 2013) and eventually these micro-cracks grow larger, the bond between aggregate and mastic is weakened and pavement starts exhibiting potholes and surface raveling. Figure 29 presents the proposed distress model mechanisms drawn from these findings.

1. Bond separated surface layer is sliding back and forth in front of the wheel and shear stresses start to develop inside layers and within layer boundaries. This initiates and propagates pavement cracking intensified by the high air voids content in segregated and poorly compacted areas. Water from precipitation or melting snow can infiltrate into pavement from these cracks. Cracks keep building up when bitumen shrinks at winter time.

2. Hydrostatic pressure caused by pumping action by wheel loading is spreading inside the layers through crack cavities and this is causing upward lift of layers if they are not bonded properly.

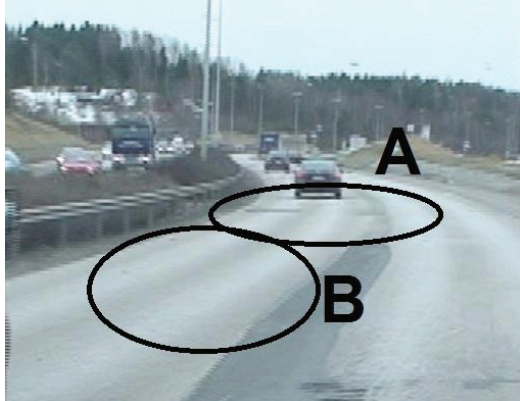
Location: Kehä II: Southbound direction	Lane: 22: SMA 16 LTA 2002	Area: A

Comments:
This was a badly deteriorated area, which has been patched several times. The layer (a) from the sample A 22 1 was not attached to the layer (b). The layer (c) could not be obtained. The layers (a) and (b) from the A 22 2 were glued together but the layer (c) could not be obtained.

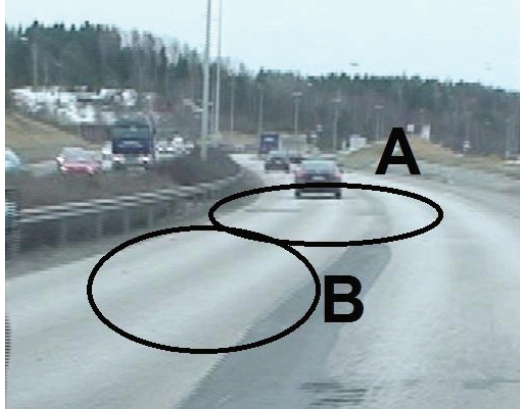
Location: Kehä II: Southbound direction	Lane: 22: SMA 16 LTA 2002	Area: B

This was seemingly a good area. The samples were drilled at some distance from the patches. The upper layer was not attached to the bottom layer. The sample B 22 2 was damaged during coring

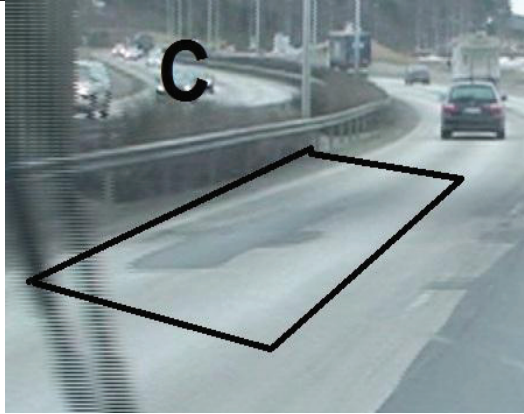
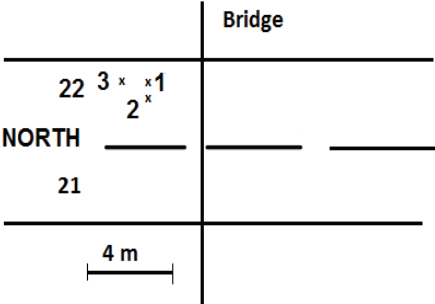
Location: Kehä II: Southbound direction	Lane: 22: SMA 16 LTA 2002	Area: C

There was a bad area under the bridge with several patches. It was not possible to take samples close of patched areas because mixture disintegrated during coring. The upper layer was not attached to the bottom layer. The samples were difficult to get out of the drill. The sample C 22 3 (a) split into two during coring.

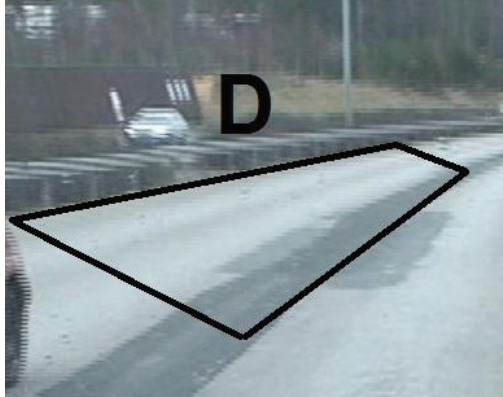
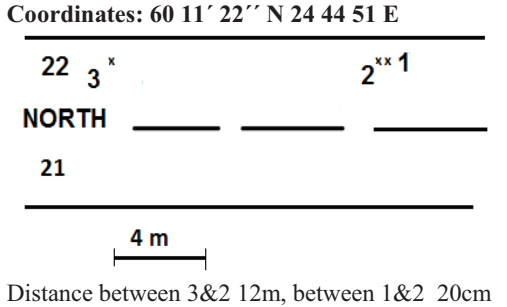
Location: Kehä II: Southbound direction	Lane: 22: SMA 16 LTA 2002	Area: D

This was visibly a good area.

The samples seem to be in good condition and the layers were well glued. However, the layer (a) of the sample D 22 3 was destroyed during release from the drill.

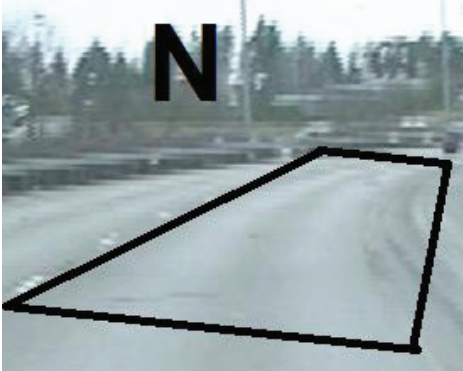
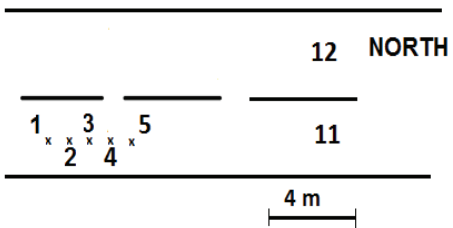
Location: Kehä II: Northbound direction	Lane: 11: SMA 16 REM 2008	Area: N

Comments: This was visibly a good area.

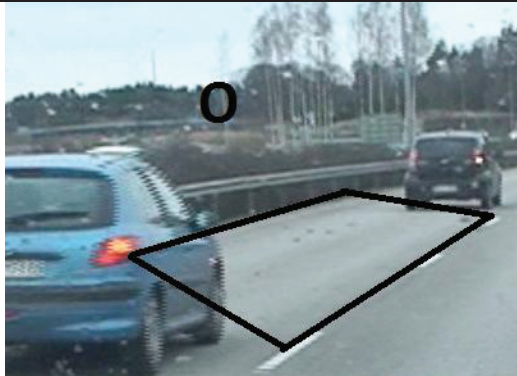
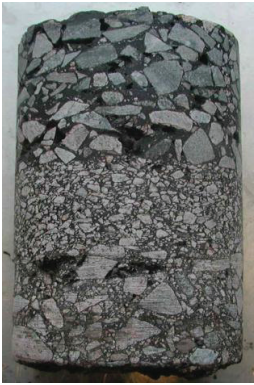
Location: Kehä II: Northbound direction	Lane: 12: SMA 16 LTA 2011	Area: O
---	---------------------------	---------

Comments:
 Sample was taken on 30th of January 2012. This must be a location where road has been fixed due to perhaps base layer settlement with some fine leveling course mixture designated as (d).
