Surface and subsurface changes as a result of tribocorrosion at the stem-neck interface of bi-modular prosthesis

M.G. Bryant, D. Buente, A. Oladokun, M. Ward, G. Huber, M. Morlock, A. Neville

This study presents a detailed multi-scale analysis of the degradation processes occurring on both the CoCrMo and TiZr alloy surfaces at different regions across the taper interface. Co-ordinate measurement machine, scanning electron microscopy, transmission electron microscopy and X-ray Diffraction methods have been utilised to identify the roles of degradation from the mm to nm scale. Dependent on the region of interest, varying topographies and subsurface morphologies were observed across both surfaces. In regions where high pressures are expected, retention of the surface topography was seen on the CoCrMo trunnion. This was complimented by gross shear and plastic deformation of the subsurface material. In regions where maximum penetration was seen, evidence of fretting-corrosion was seen and a loss of the nano-crystalline layer. For the TiZr surface, refinement of the alloy was seen in the top 5  $\mu\text{m}$ , with fatigue cracks within the bulk present. Precipitation and formation of

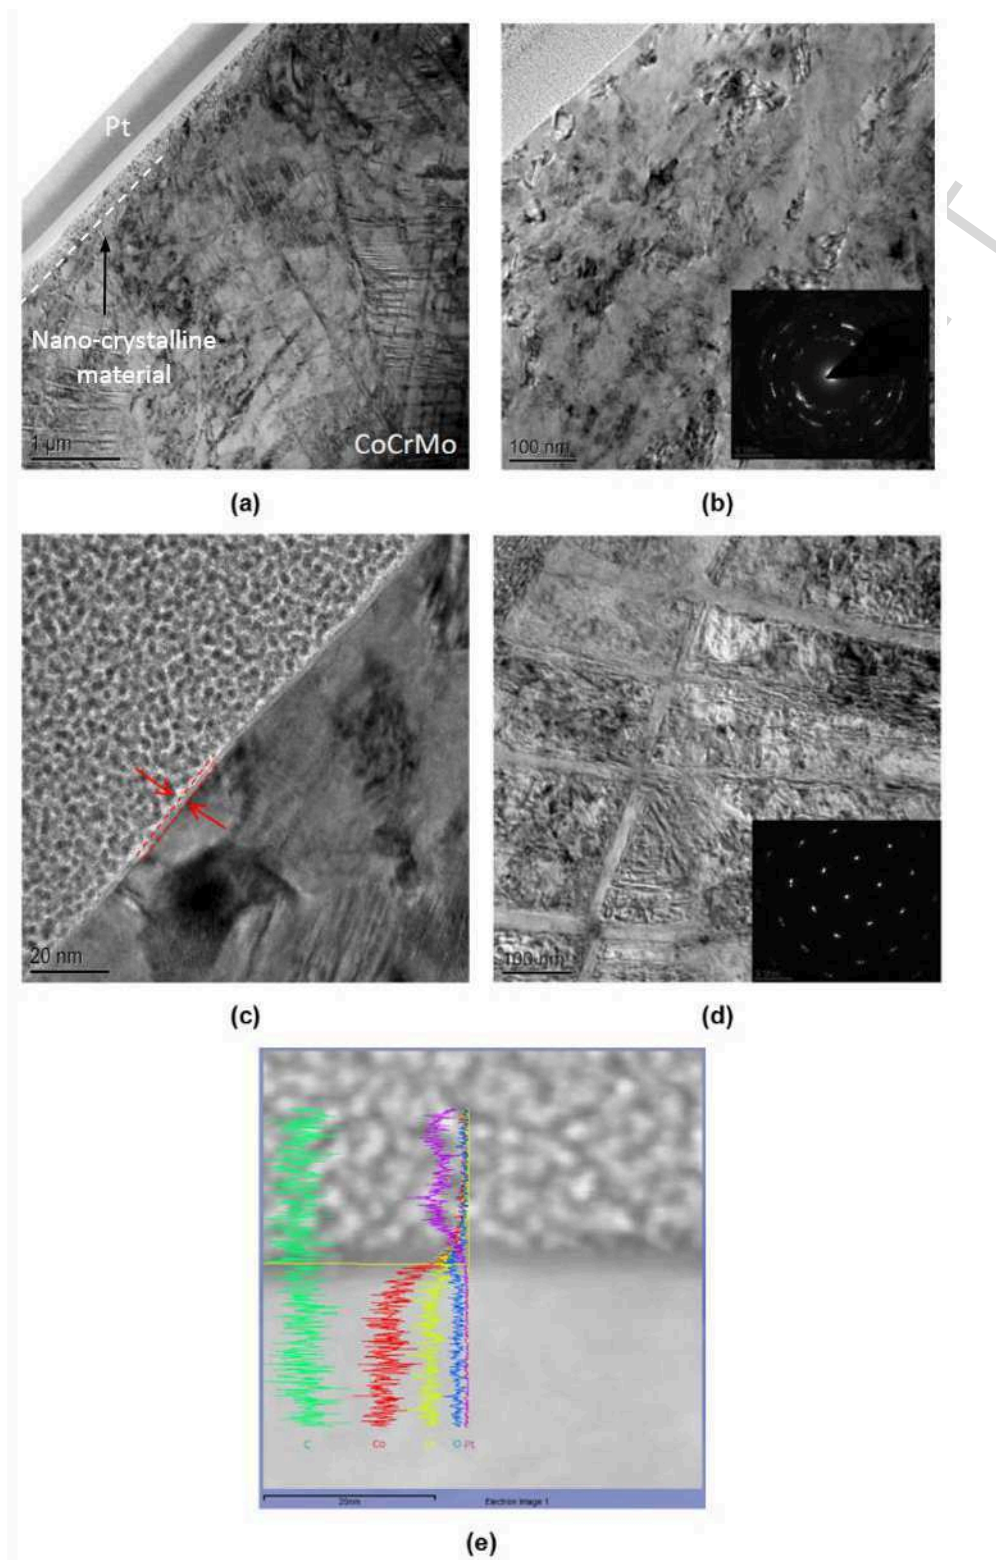
Figure 5

**Figure 5** – Reference CoCrMo alloy of the trunnion component of a) overview of the subsurface b) nano-crystalline uppermost surface ( $\approx 500\text{nm}$ ) c) Pt-CoCrMo interface and d) crystalline subsurface ( $\approx 2\text{-}3\mu\text{m}$ ). Evidence of a Cr and O rich interfacial layer (highlighted between red dashed lines) could be observed (Region 1, Figure 2). This was supported by EDX line analysis (e) where the green spectra = Carbon, red = Cobalt, yellow = Cr, blue = O and purple = Pt.

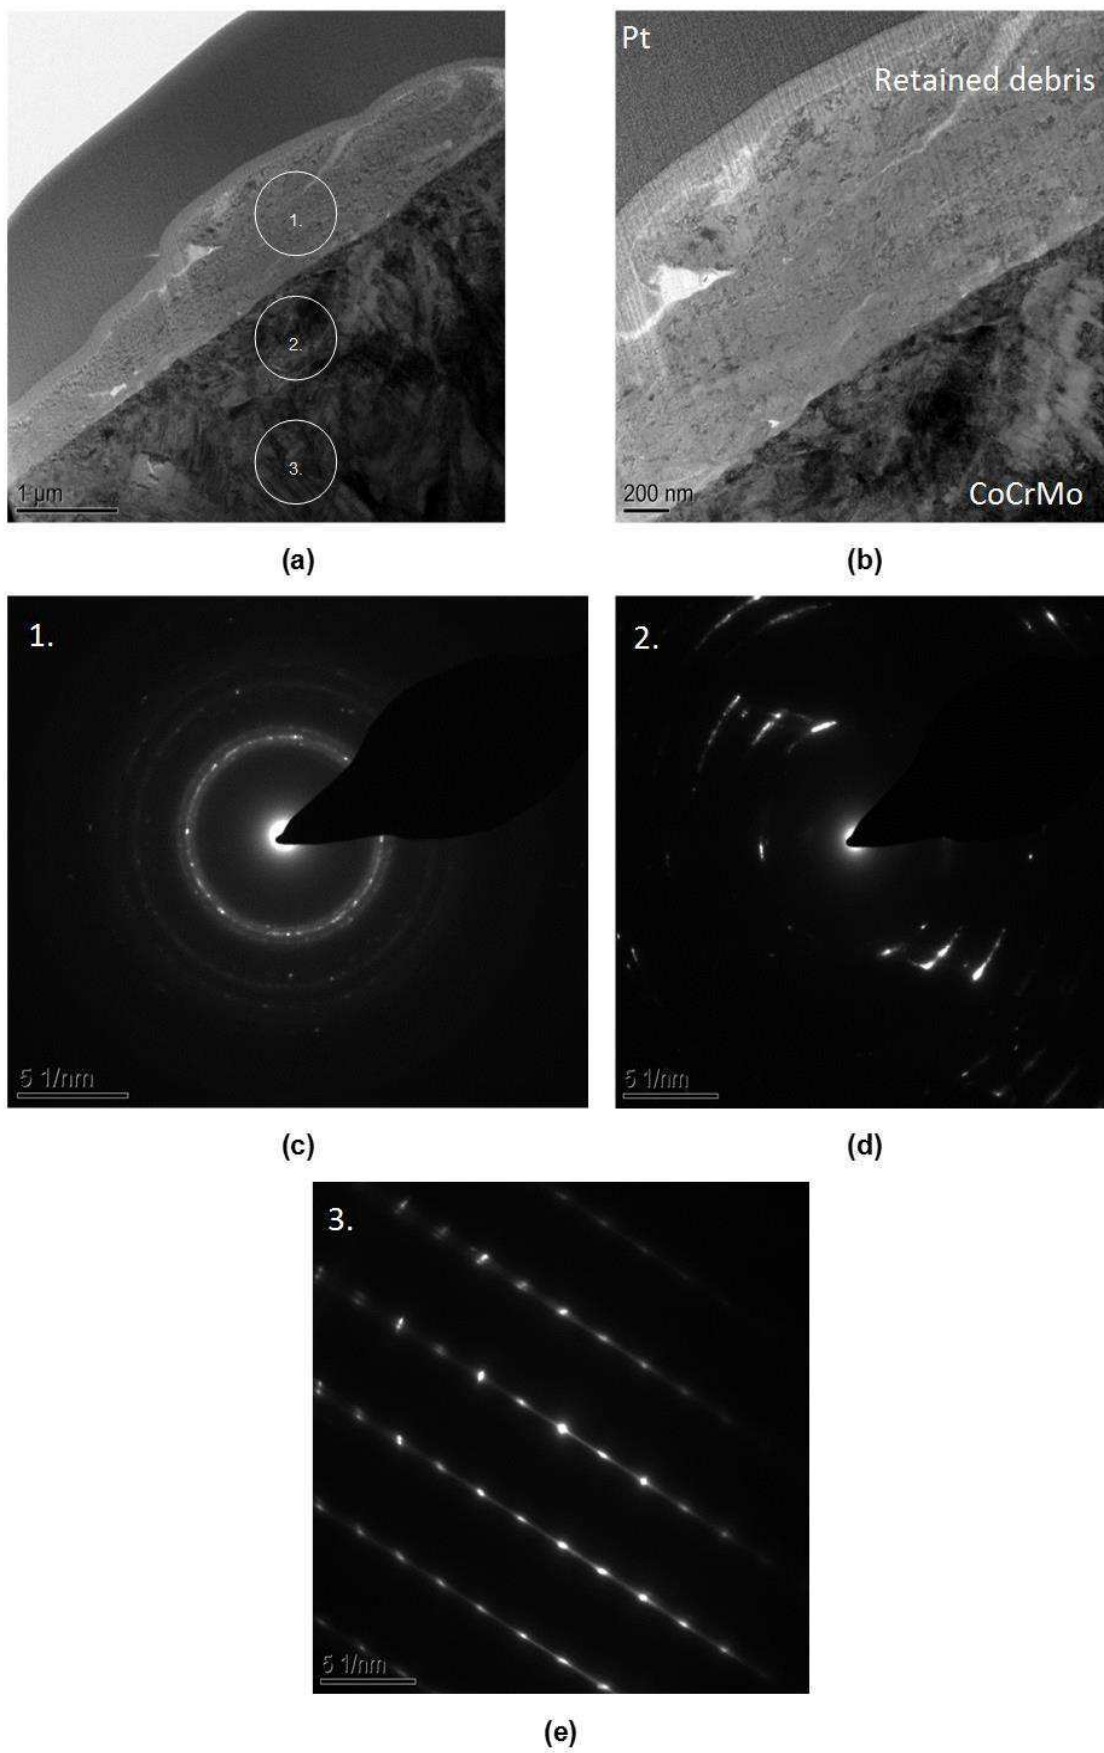
Figure 7

**Figure 7**- Electron microscope and images of a) debris and subsurface morphology on the patch area b) magnified image of the debris-CoCrMo interface c-e) electron diffraction patterns from regions of interest (Region 2, Figure 2).

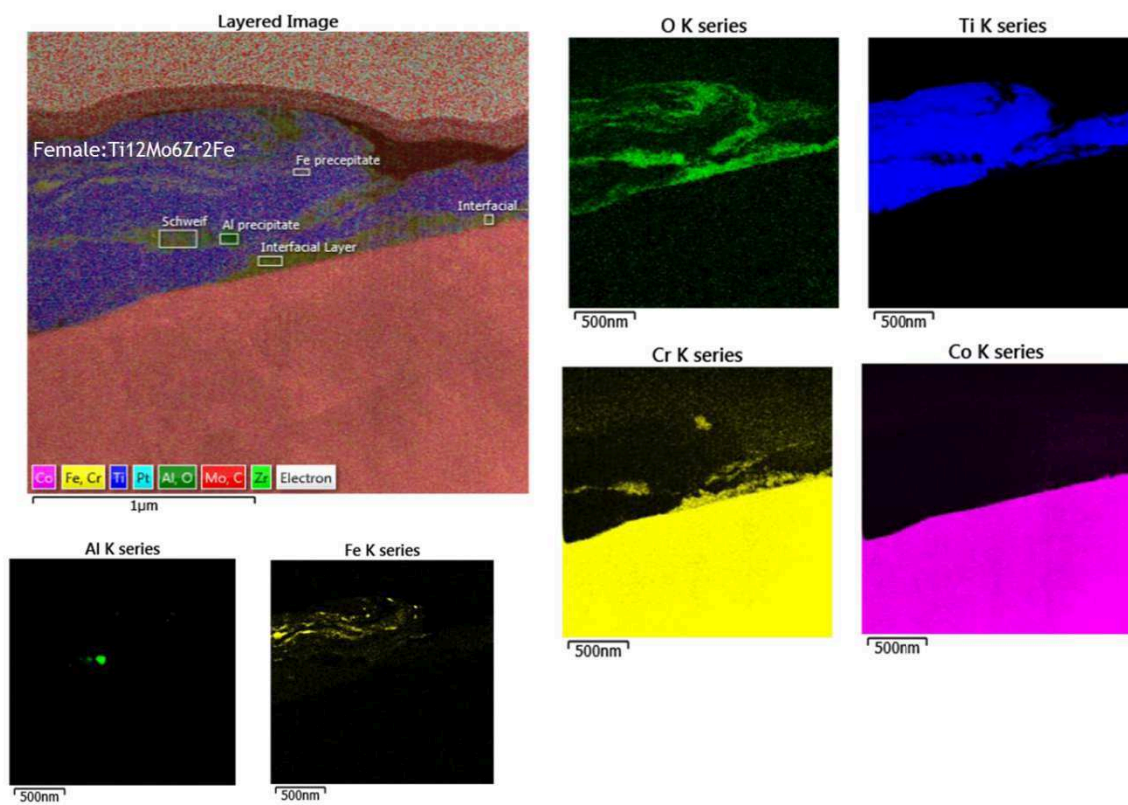
Figure 8

**Figure 8** – EDX analysis of debris isolated on the patch area.

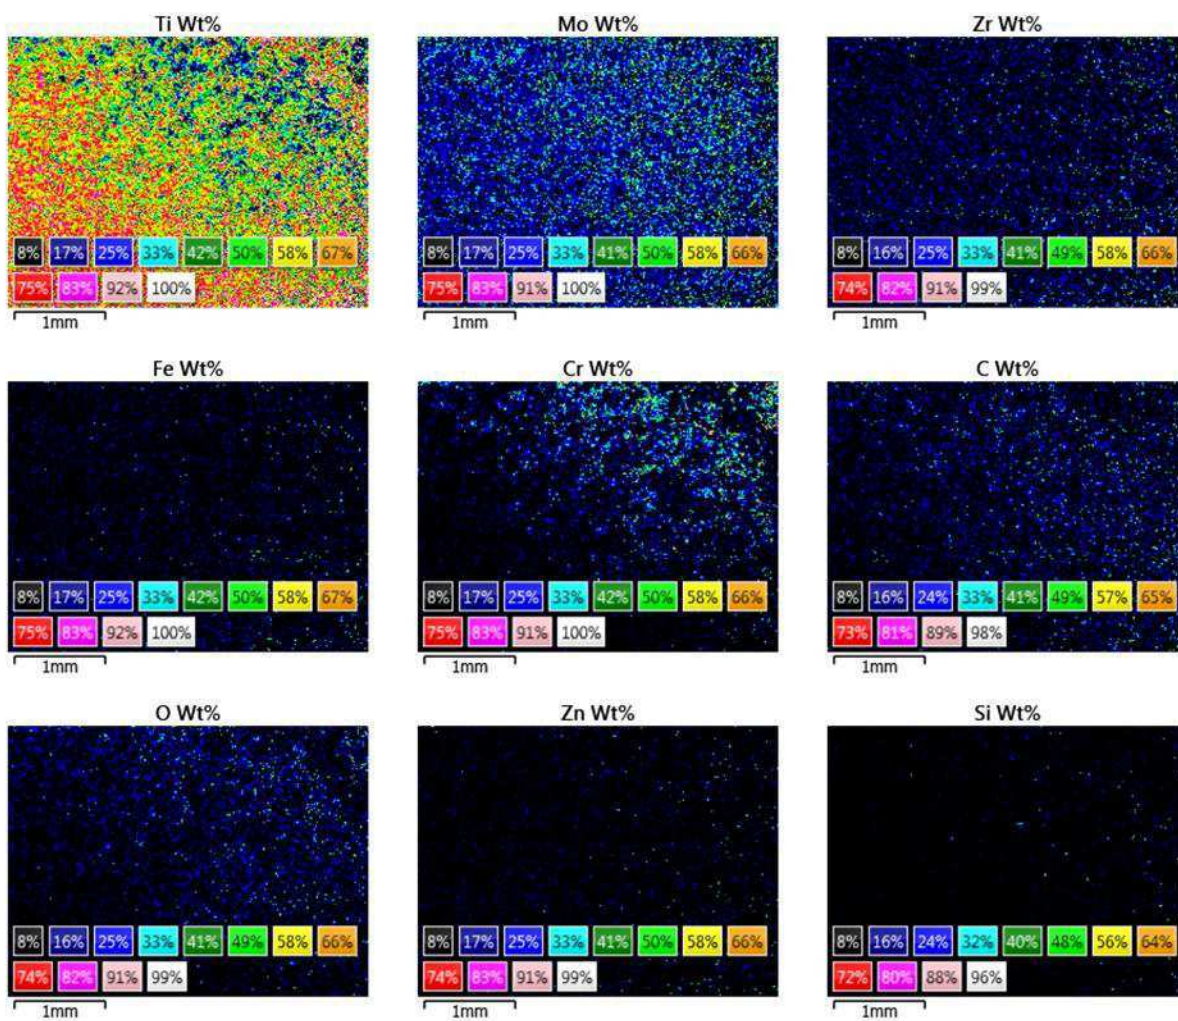
Figure 12

**Figure 12** – EDX mapping for Figure 11b at 20 kV.

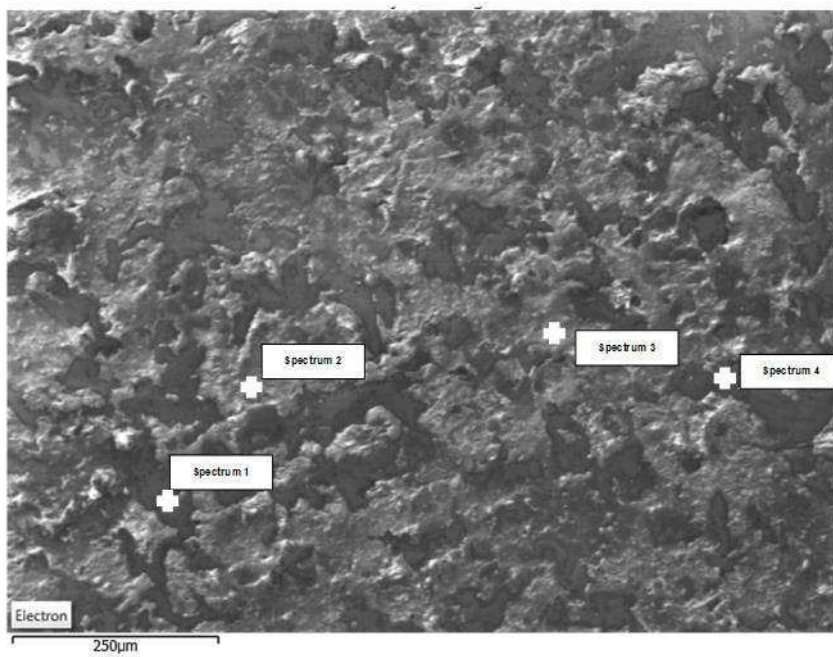
Figure 13

**Figure 13** – SEM image of distribution of debris across the surface of the TMZF Taper.

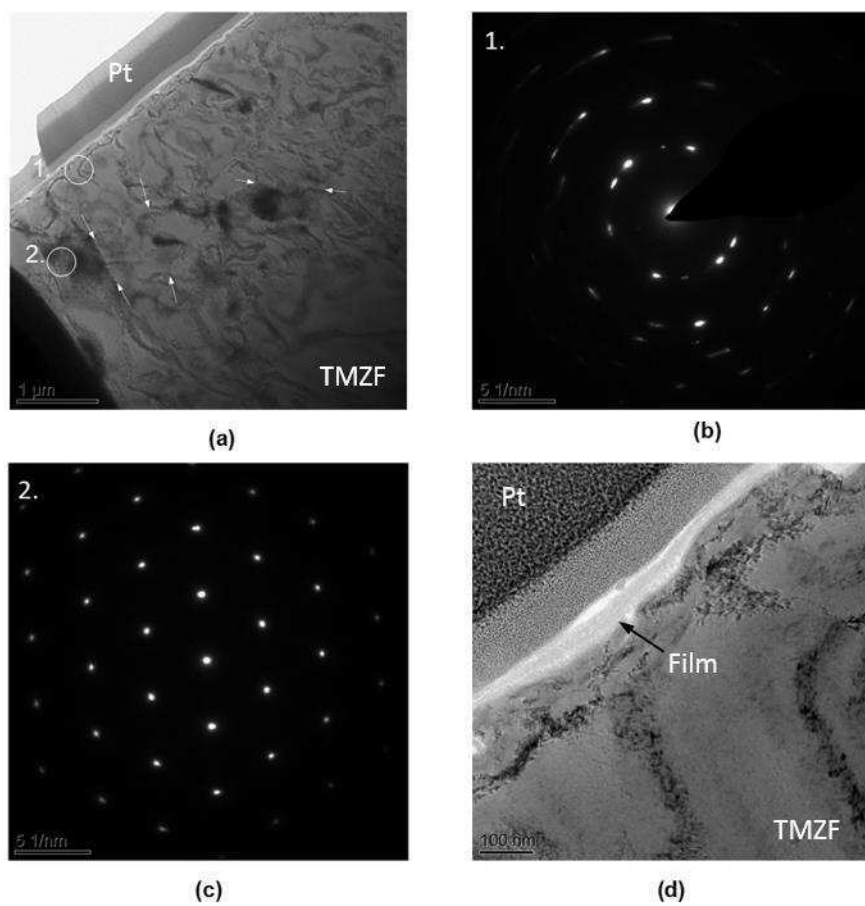
Figure 15

**Figure 15** – a) Reference TEM images for TMZF Taper component with typical diffraction pattern from region b) 1 c) and 2. Figure 10d shows evidence of a films formed on the TMZF surface with possible short range ordering.

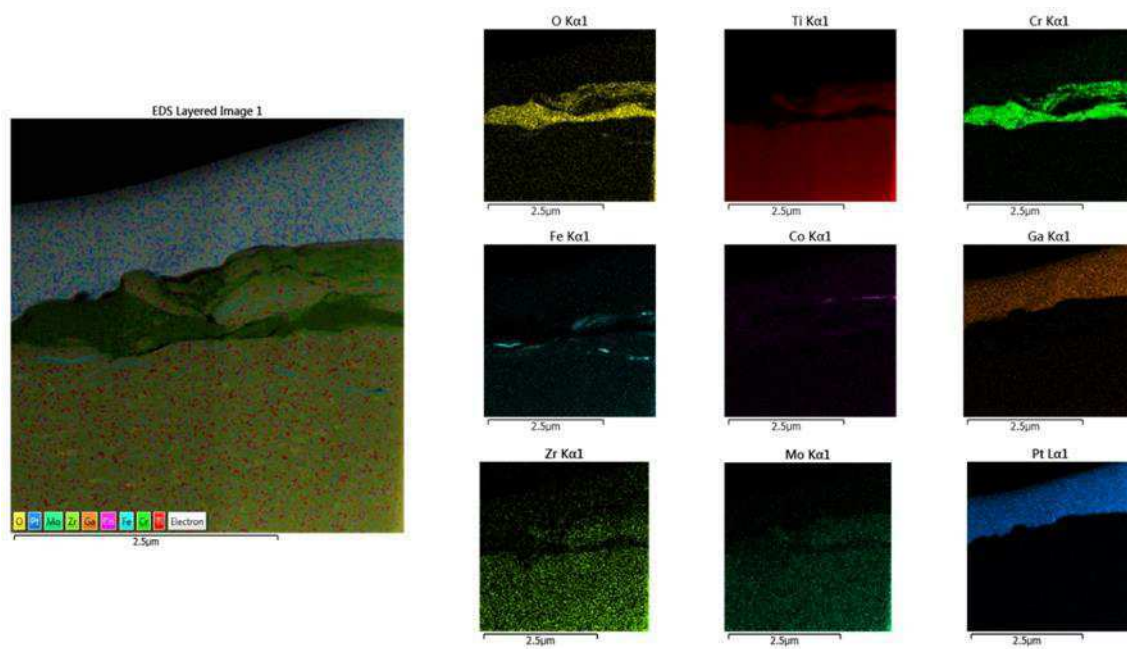
Figure 17

**Figure 17** – STEM-EDX analysis of and subsurface microstructure of TMZF alloy in the patch region 2 on Figure 2.

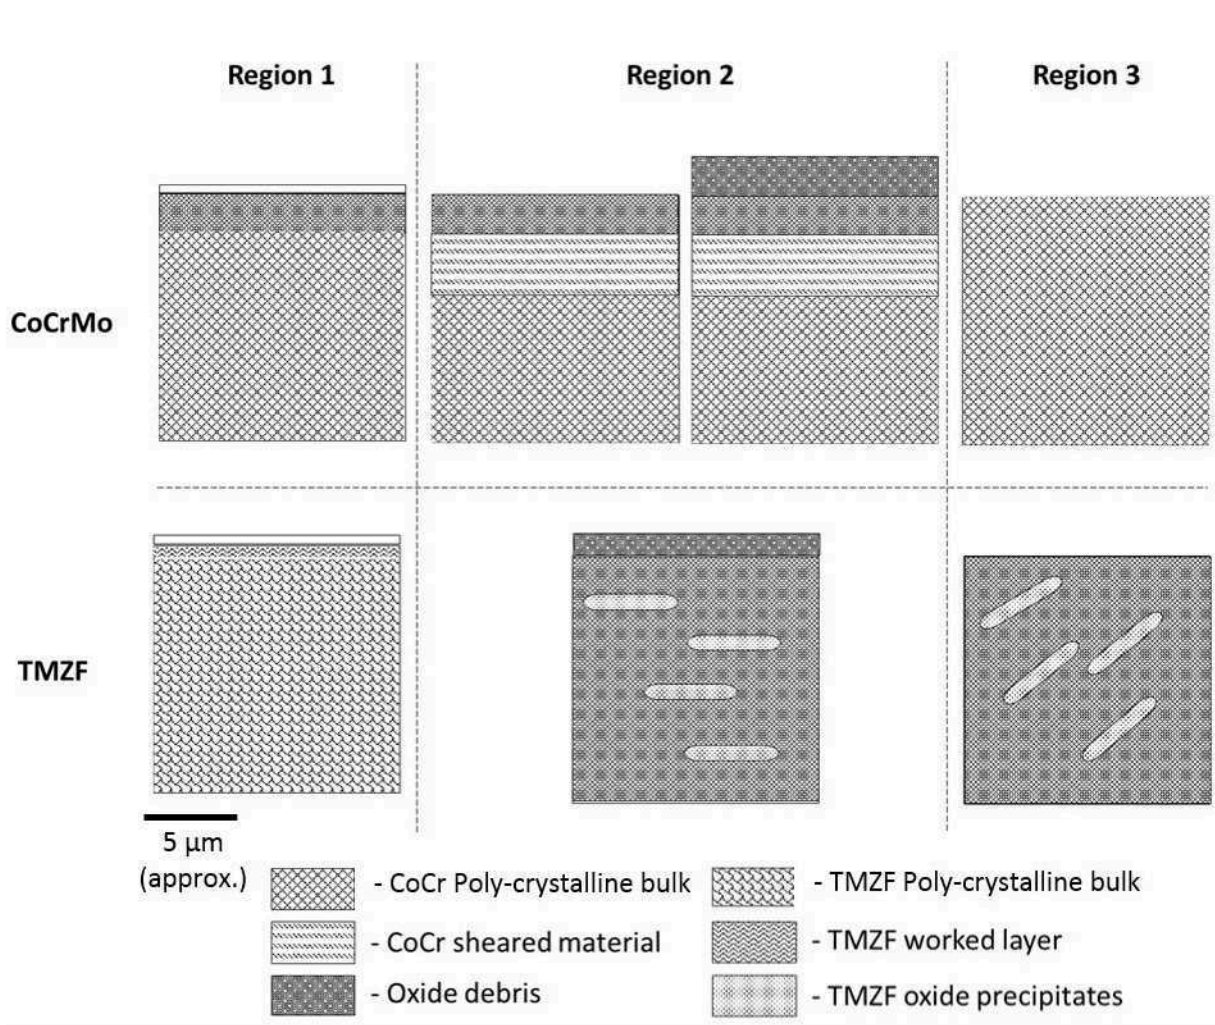
Figure 20

**Figure 20** – illustration of the subsurface morphology for CoCrMo taper and TMZF trunnion in each of the regions analysed.
