## INSPECTING PV-PLANTS USING AERIAL, DRONE-MOUNTED INFRARED THERMOGRAPHY SYSTEM

Buerhop-Lutz Cl.\* and Scheuerpflug H.  
\*Author for correspondence  
Bavarian Center for Applied Energy Research,  
ZAE Bayern,  
91058 Erlangen,  
Germany,  
E-mail: claudia.buerhop-lutz@zae-bayern.de

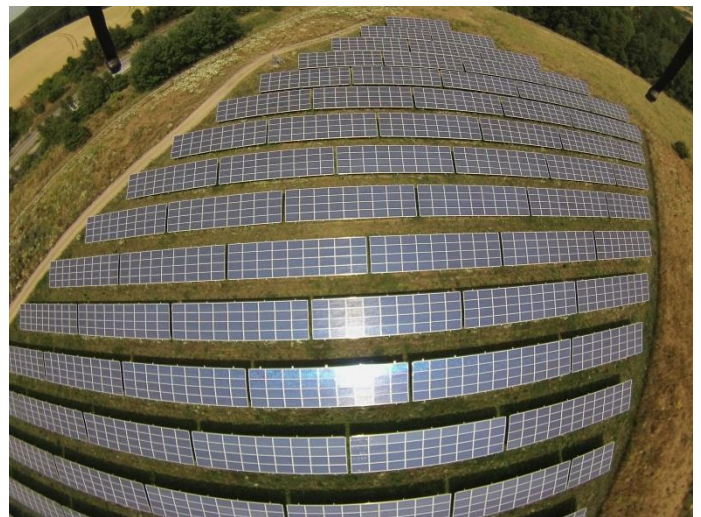
**Figure 1** Aerial Photograph of 3 MW solar park, optics with focal length 10 mm and aperture of 2.8

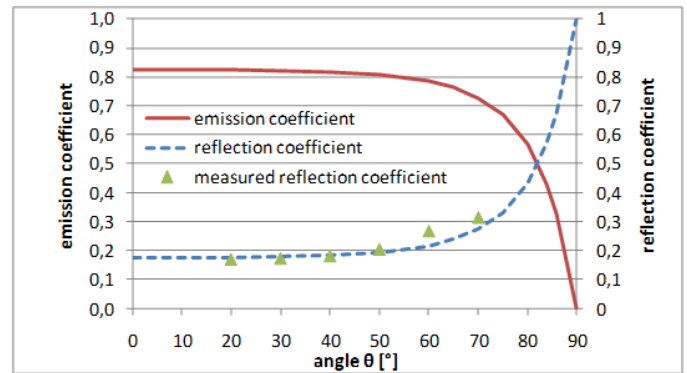
PV-modules typically are covered with a glass sheet. The emissivity of glass in the infrared spectral range is much higher than in the visible spectral range. It is highest at a perpendicular view  $\varepsilon \approx 0,82$  and reduces drastically with increasing angle, see Figure 2. Since the emissivity is much less than 1, significant amounts of reflected radiation from surrounding heat sources

**Figure 2** Measured reflectivity, respectively emissivity, of glass surface in the infrared spectral range from 8 to 10  $\mu\text{m}$  [13]

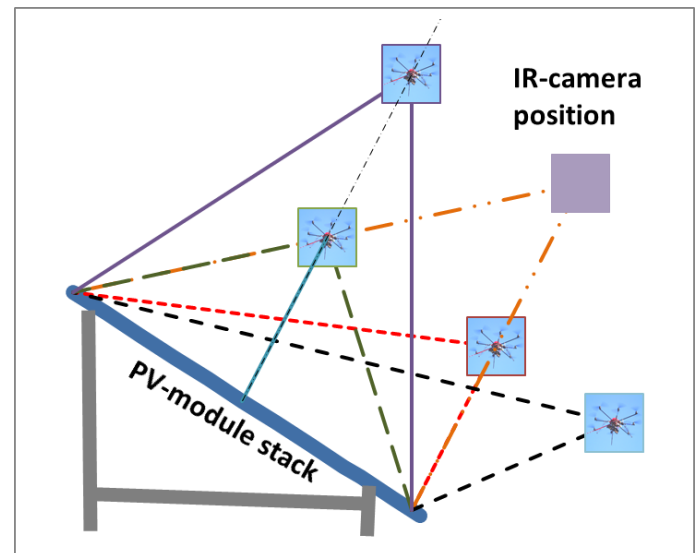
Thus, different camera positions with respect to the module surface may result to differing observation angles, see Figure 3. Consequently, the emissivity of the heat radiation changes with the angular dependence. For camera position with flat view angles the emissivity of the modules differs strongly. For this example, the angle varies from 45° to 75° from one edge to the other. Even at a camera position in the middle of the stack the view angle increases up to 45° at the edges. Increasing the distance between IR-camera and modules the view angle decreases to 30°.

**Figure 3** Schematic of different camera positions and the corresponding view angles for a module stack of about 11 m length and an inclination angle of 30°

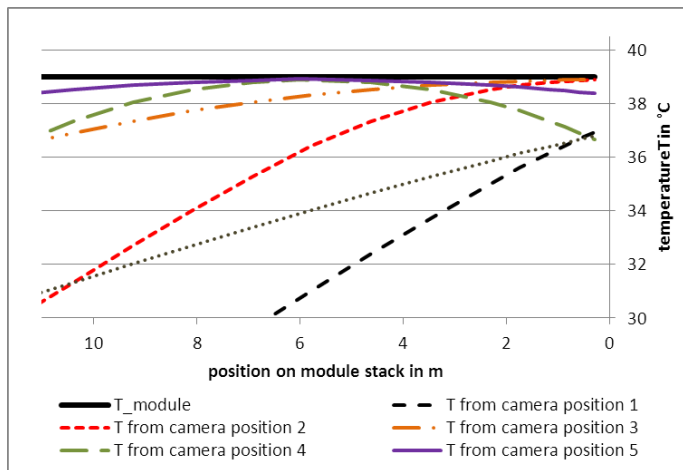
**Figure 4** Calculated temperatures for an inclined module stack for different camera positions (camera positions correspond to the ones in Figure 3, same line styles).

The results are shown in Figure 4, the data correspond to the camera positions shown in Figure 3. For symmetric camera positions (4 and 5) with respect to the module stack, the emissivity stays fairly constant within the stack length because the change of view angle does not exceed 45°. Thus, the temperature is close to the real module temperature. The temperature deviation is within the measurement uncertainty. For the asymmetric camera positions (1, 2, and 3) the temperature drop on the left side (Figure 4) due to the large view angle is obvious. Here, the calculated temperature differs from the module temperature for more than 10 K easily. Thus, a not existing temperature gradient is suggested. This change of emissivity cannot be compensated by standard camera software.

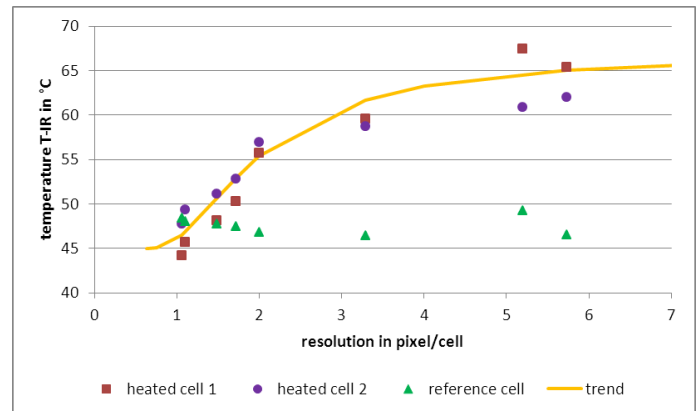
pixel/cell) the measured temperature is close to the real cell temperature. By decreasing the resolution (increasing the distance) the temperature drops continuously. At a resolution of about 1 pixel/cell it approaches the temperature of the surrounding neighbour cells. That means local heat sources, defects have the same temperature as their surrounding and are not visible anymore.

**Figure 5** Optically measured temperature of small heat sources (heated solar cell 1 and 2) and extended areas (adjacent good cell acting as a reference cell) as a function of resolution [14]

Therefore, getting reliable temperature data using IR-cameras for inspecting PV-plants the resolution should be as high as possible.

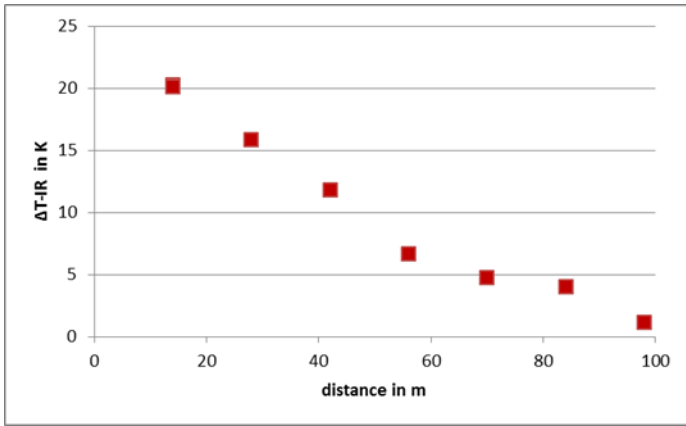
**Figure 6** Temperature difference of the optically measured infrared temperatures of the hot defect cell and a regularly warmed good neighbour cell [14]

The previously described considerations have two contrary conclusions for the IR inspection of PV-plant using aerial drones: first, the distance to the panels should be rather short in order to realize a high lateral resolution and reliable temperatures, compare Figure 5. Figure 6 points out how the temperature difference, which is often taken as a measure of defect strength, decreases with increasing height. Second, the distance should be fairly large so that that motion blurring is minimized. Here, a compromise has to be found.

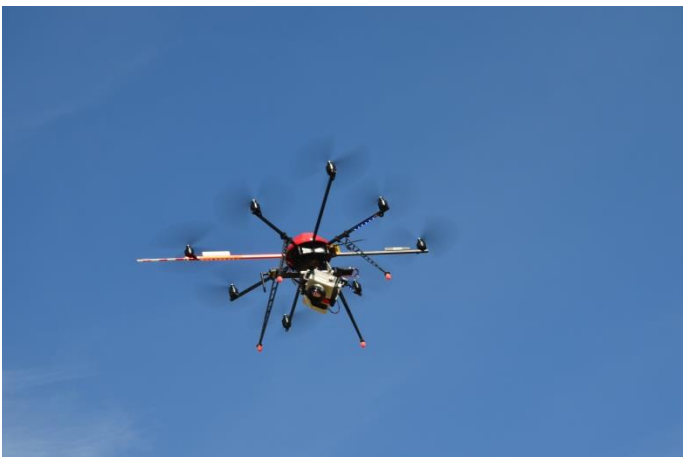
For executing installed PV-modules or PV-plants aerial, drone mounted IR-imaging systems are used. The measurement system, as shown in Figure 7, consists of an unpiloted drone (Multikopter), a lightweight IR-camera PI 450 (Optris), a visible camera GoPro and equipment for navigating. The navigation system also allows the determination of the x, y, z-coordinates, so that the altitude of the camera is known. Using this setup the ideal perpendicular view on the modules can be easily realized and the crucial parameters, distance to the modules and flight velocity, adjusted properly.

**Figure 7** Measurement system consisting of an octocopter carrying an IR bolometer and navigating equipment
