Numerical investigation into the failure of a micropile retaining wall

ABSTRACT: The paper presents a numerical investigation on the failure of a micropile wall that collapsed while excavating the adjacent ground. The main objectives are: to estimate the strength parameters of the ground; to perform a sensitivity analysis on the back slope height and to obtain the shape and position of the failure surface. Because of uncertainty of the original strength parameters, a simplified backanalysis using a range of cohesion/friction pairs has been used to estimate the most realistic strength parameters. The analysis shows that failure occurred because overestimation of strength and underestimation of loads.

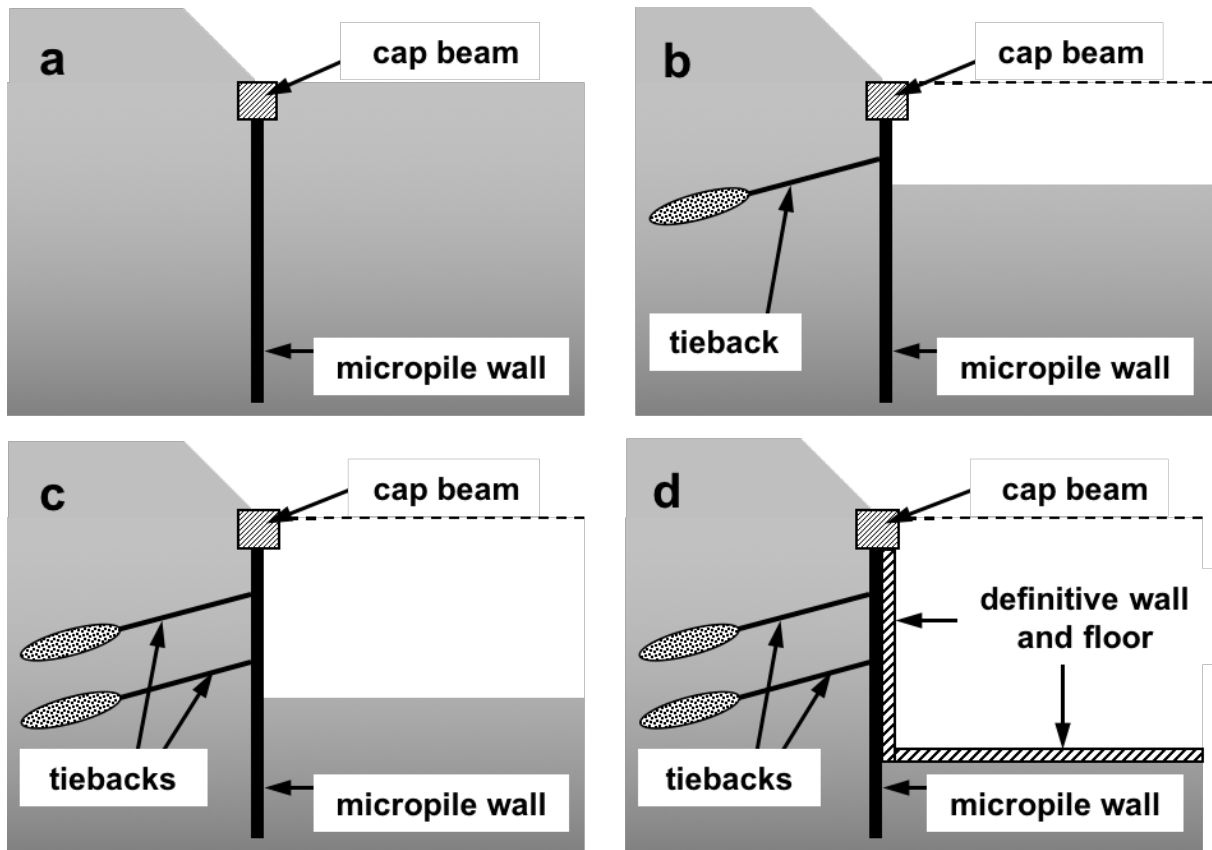
Figure 1. Schematic sequence of the excavation: a) execution of the micropiles; b) and c) intermediate stages including excavation and execution of the tiebacks; d) final state.

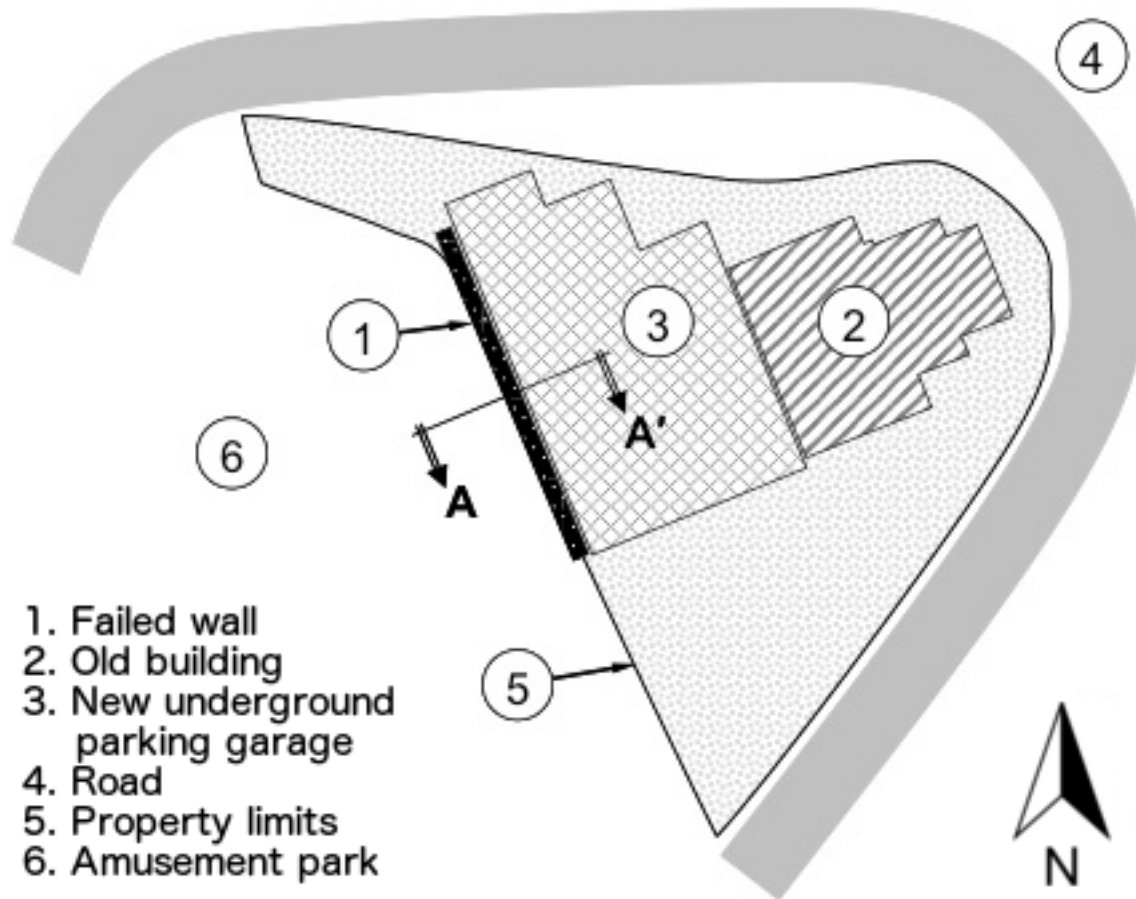
1. Failed wall
2. Old building
3. New underground parking garage
4. Road
5. Property limits
6. Amusement park

Figure 2. Sketch of the area showing the original position of the collapsed wall. Section AA' is shown in Figure 5.

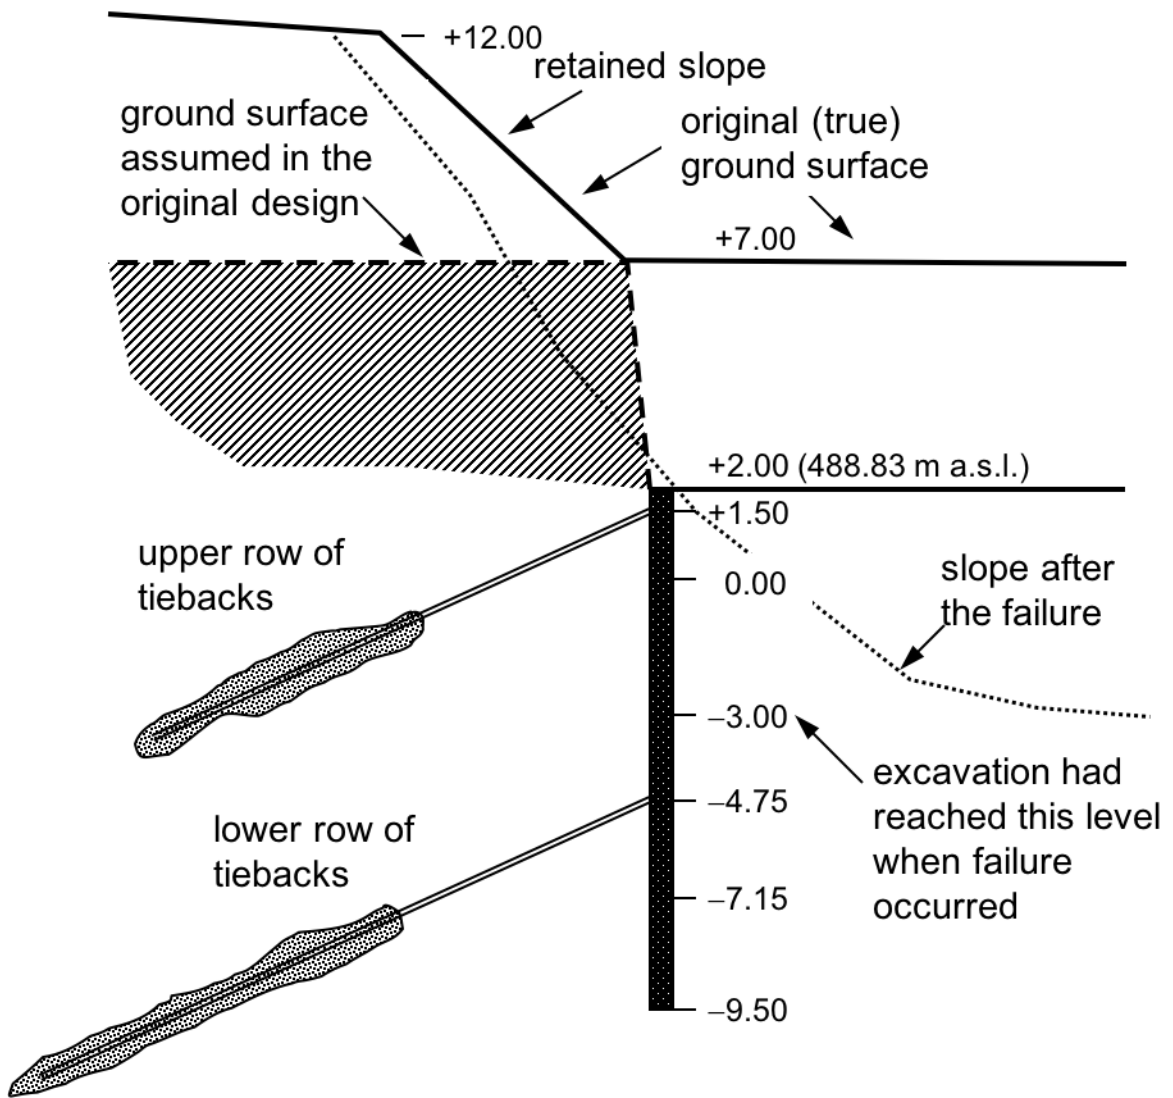
Figure 5. Typical cross-section used in the analysis (AA' in Figure 2)

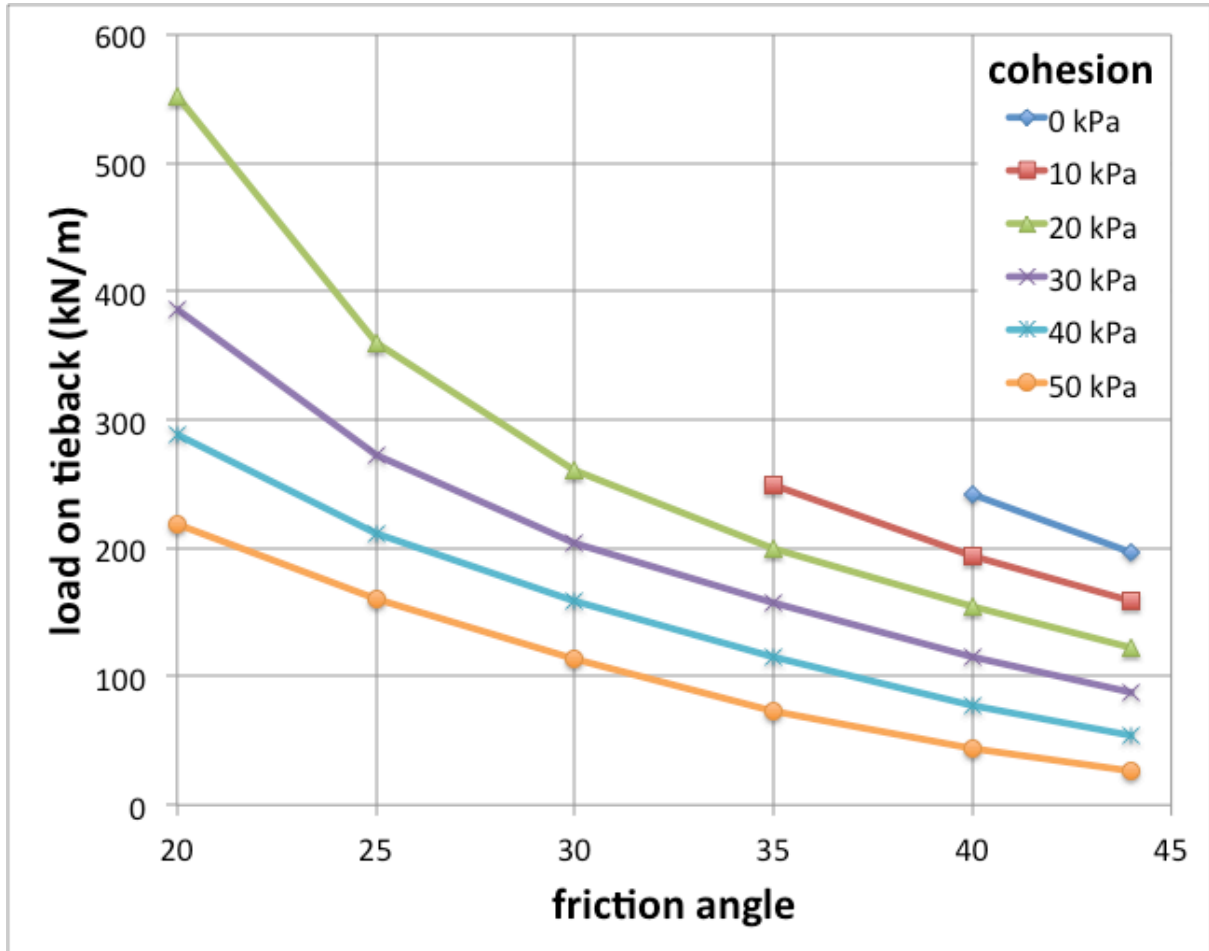
Figure 11. Predicted load on the upper tieback row at the end of construction for all strength parameters combinations analyzed. Missing points indicate failure before reaching this stage.

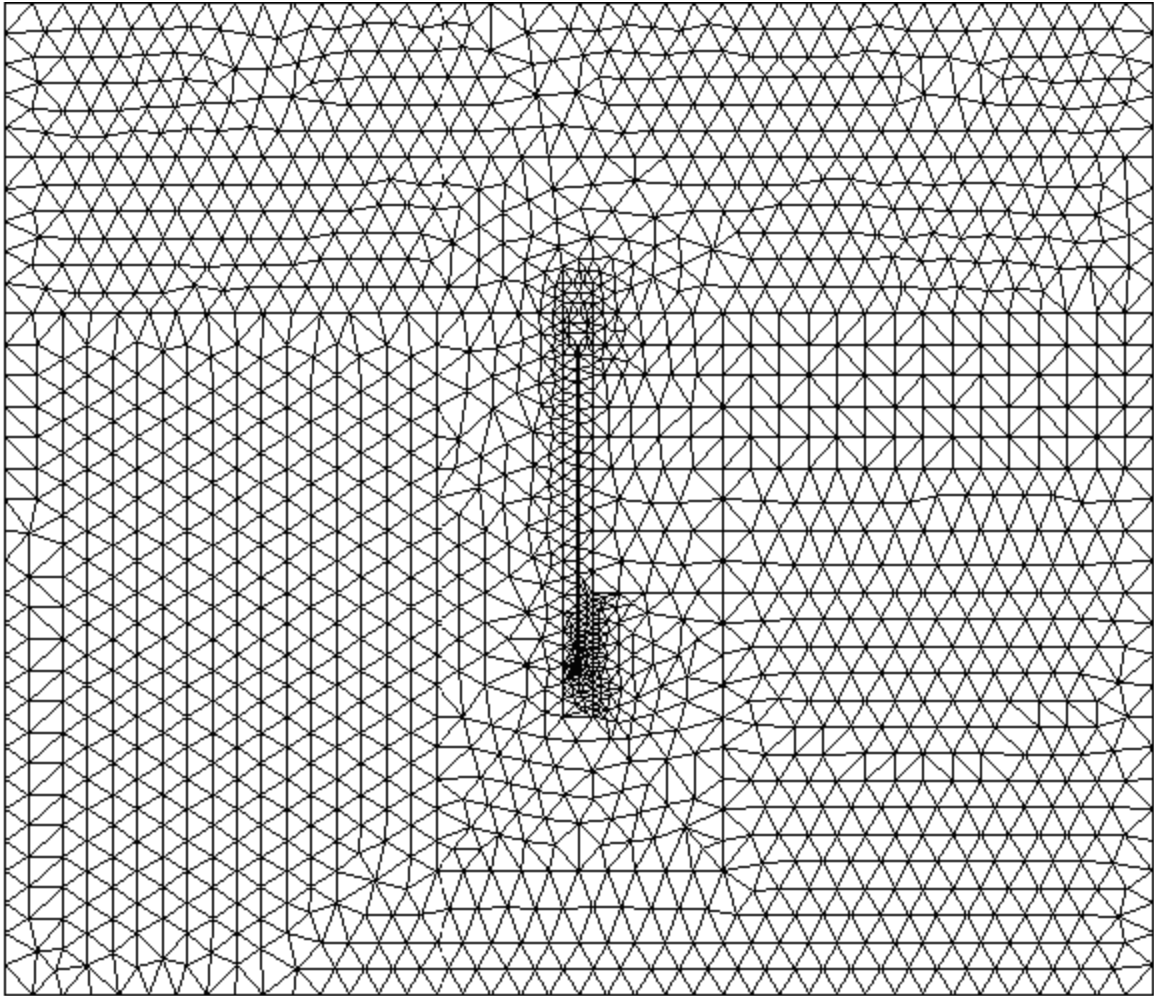
The second numerical analysis has been carried with the computer code DRAC [35], a general purpose finite element system developed specifically to perform analysis of geotechnical engineering problems. DRAC is a nonlinear code allowing 2D and 3D analysis, and includes zero thickness interface elements used in solving soil and rock mechanics problems to simulate discontinuities and contact surfaces. Also available are rod elements, used in the simulation of anchorages, tiebacks and struts. For the current analysis, a 2D finite element model in plane strain has been developed (Figure 13).

Figure 13. Initial (step 1) finite element mesh used with DRAC

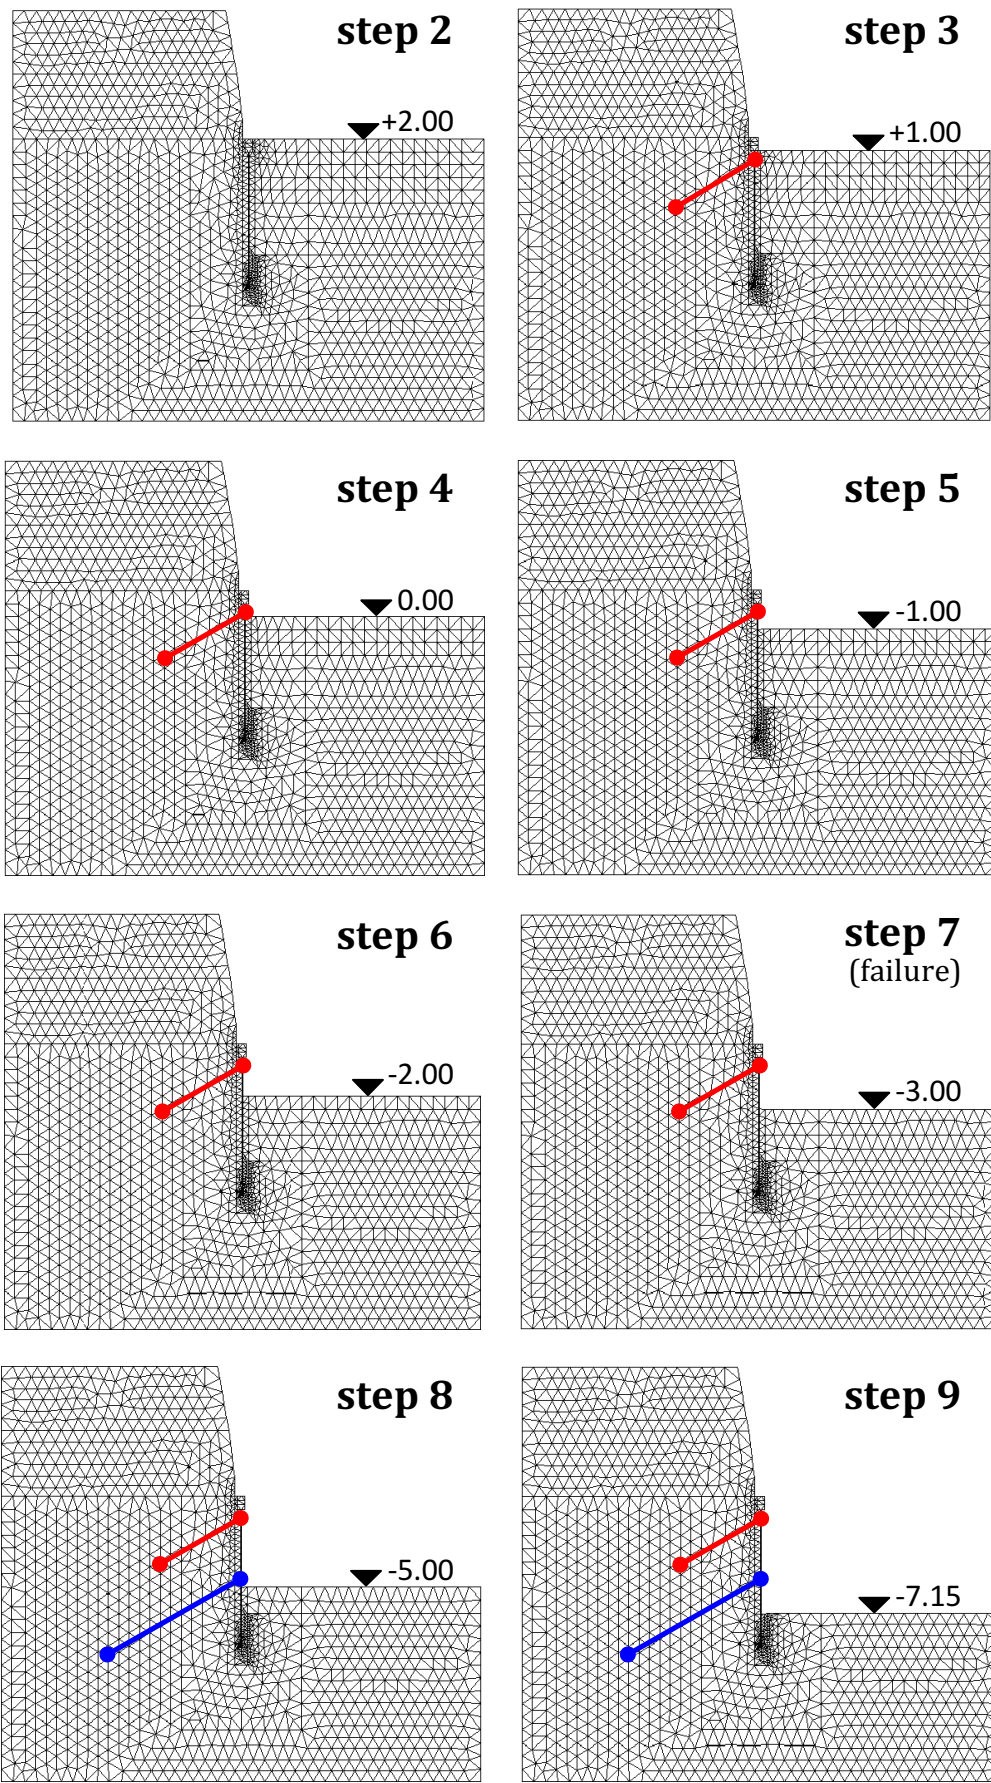
The sequence of excavation and construction of the micropiles and tiebacks has been simulated in 8 numerical steps, graphically described in Figure 14, with the C1 load setup. The numerical steps do not necessarily coincide with the construction steps defined previously. Thus, numerical step 1 (Figure 13) is the generation of the whole finite element mesh and the assigning of the initial stresses at the integration points. Although failure occurred when excavation reached the depth corresponding to numerical step 7, the analysis has been carried out to the end of the described sequence, except when prevented by lack of convergence, an indicator that failure conditions were reached.

Figure 14. Excavation sequence with DRAC (step numbers refer to the numerical analysis, not to the construction sequence)

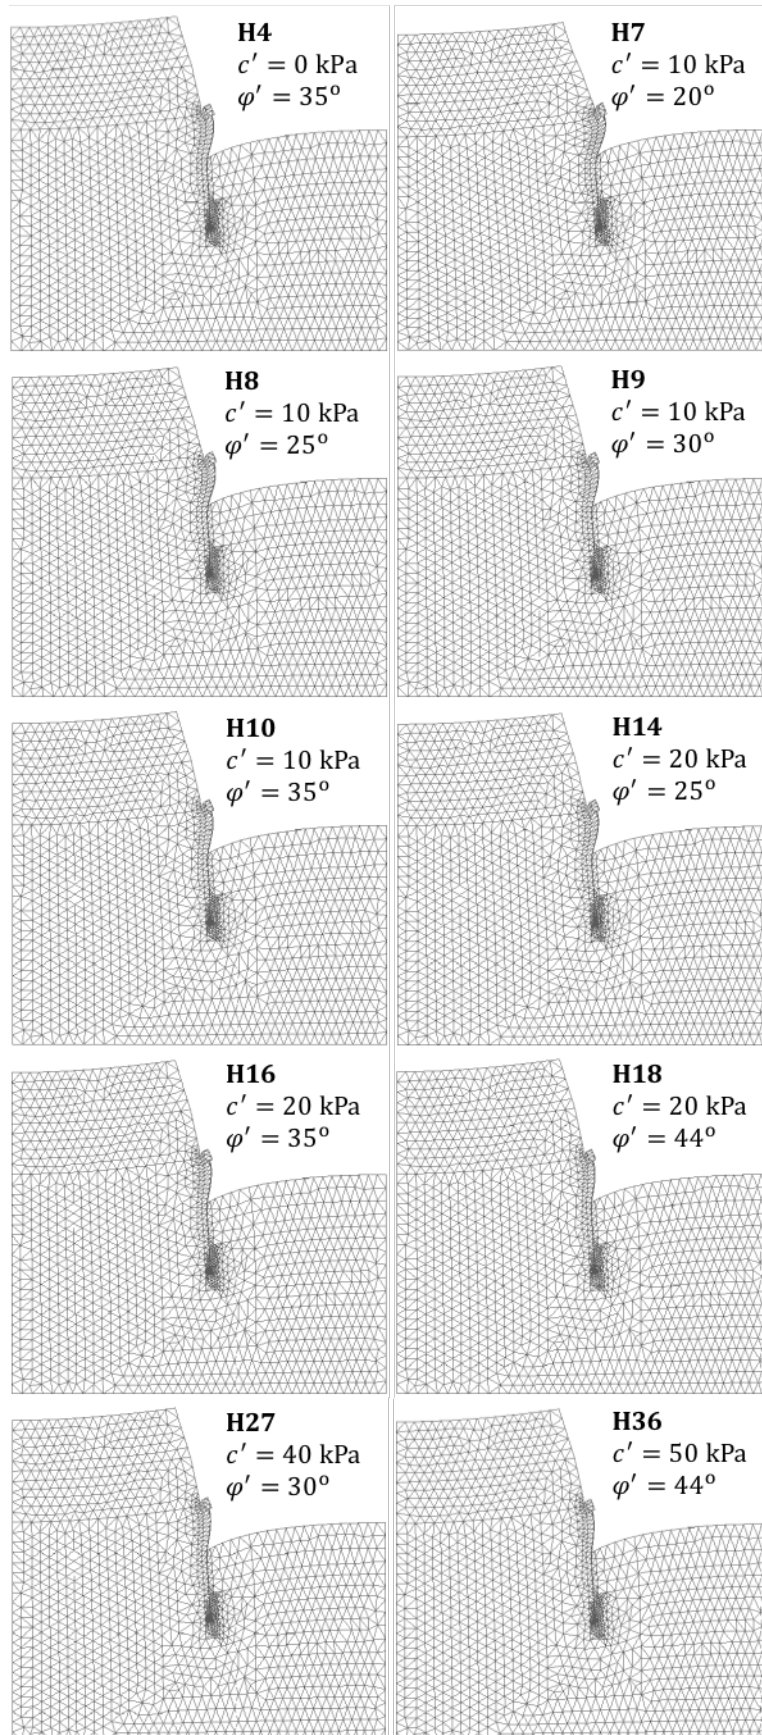
Figure 16. Deformed mesh obtained with DRAC near the micropile wall after step 7 for the selected sets of strength parameters indicated (magnification: 100×)
