TITLE: Slope stability in slightly fissured claystones and marls

AUTHORS: Eduardo E. Alonso and Núria M. Pinyol

AFFILIATION: Department of Geotechnical Engineering & Geosciences, UPC, Barcelona, Spain

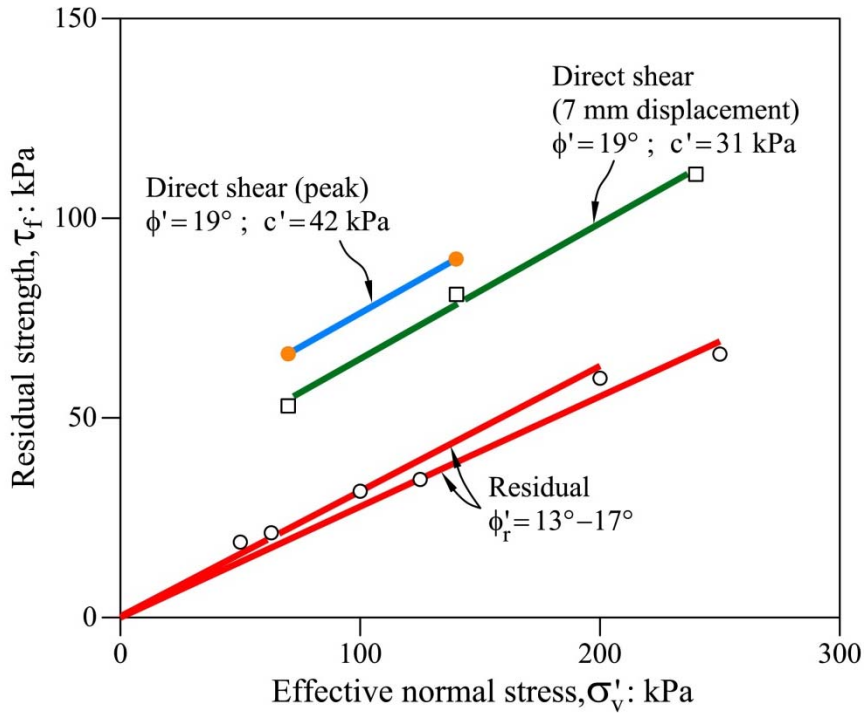
Figure 6: Shear tests on Sabadell slope claystone

The case is interesting because equilibrium was achieved for a friction angle similar to the minimum measured residual friction angle. Stabilization was achieved by a pile barrier that was designed accepting that the minimum residual friction angle was operating on the shearing surface. The failure surface was probably located within the high plasticity claystone layer (Figure 5).

The measured strength envelopes indicate that failure was most probably preceded by a progressive failure mechanism induced by the excavation. Tertiary deposits in the region are known to exhibit high horizontal stresses. In an investigation of the “in situ” stresses in a shallow tunnel excavated in Tertiary claystones in the neighboring city of Tarrassa, Gens et al. (1996) reported K_0 values of 1.7 – 2.2. A previous “damage” (slip contact) of the shearing strength of sedimentary planes may also explain the failure, but no evidence of striations was found in the cores recovered or in the visual inspection of the exposed slope.

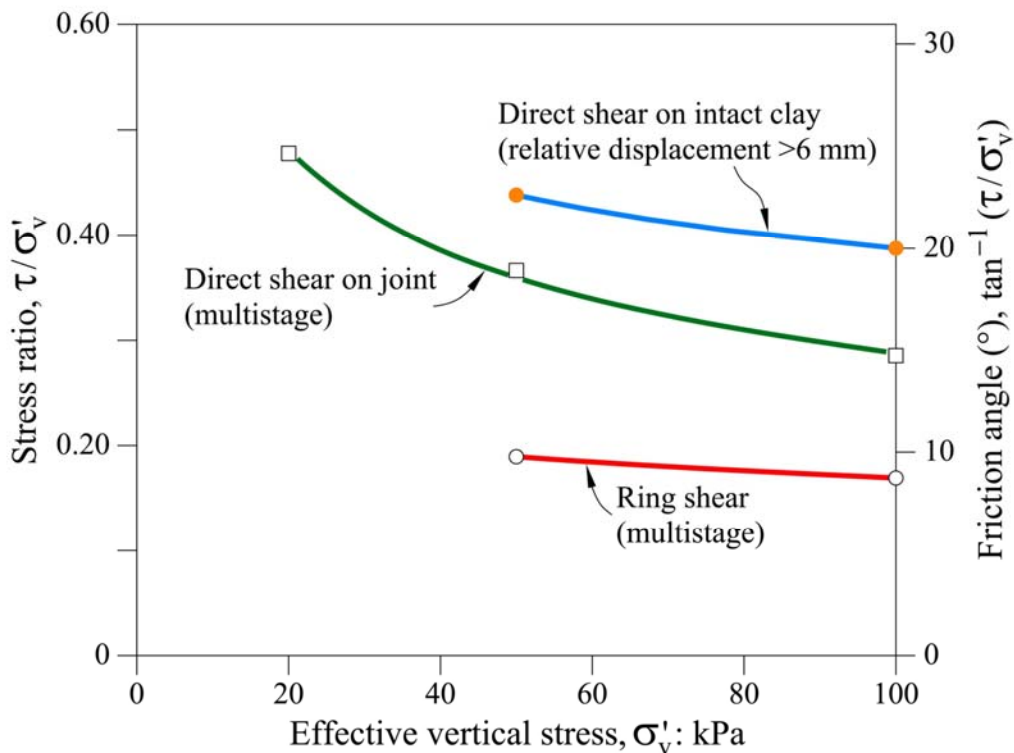
Figure 9: Stress ratios and secant friction angles for different shearing conditions. Viladesens clay.

The minimum residual friction was found in ring shear tests on remoulded material ($\varphi'_{res} \cong 9^\circ$). This friction angle is equal to the natural slope inclination.

The backanalysis of the failure provided friction angles for the embankment-clay contact slightly above the minimum residual friction mentioned before. A reasonable estimate was $\varphi' \cong 11.5^\circ$. Therefore, it was expected that additional slide displacements, once the slope was stabilized, could reduce somewhat the available basal resistance.

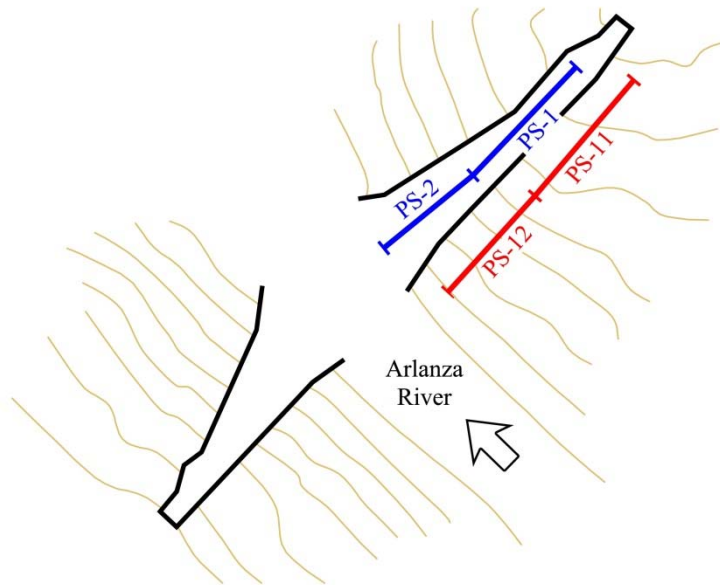
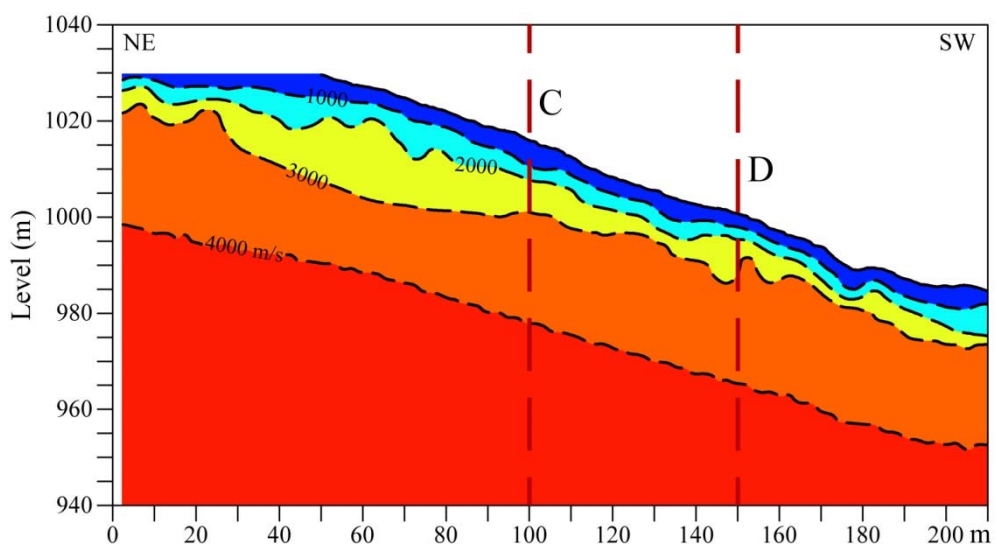
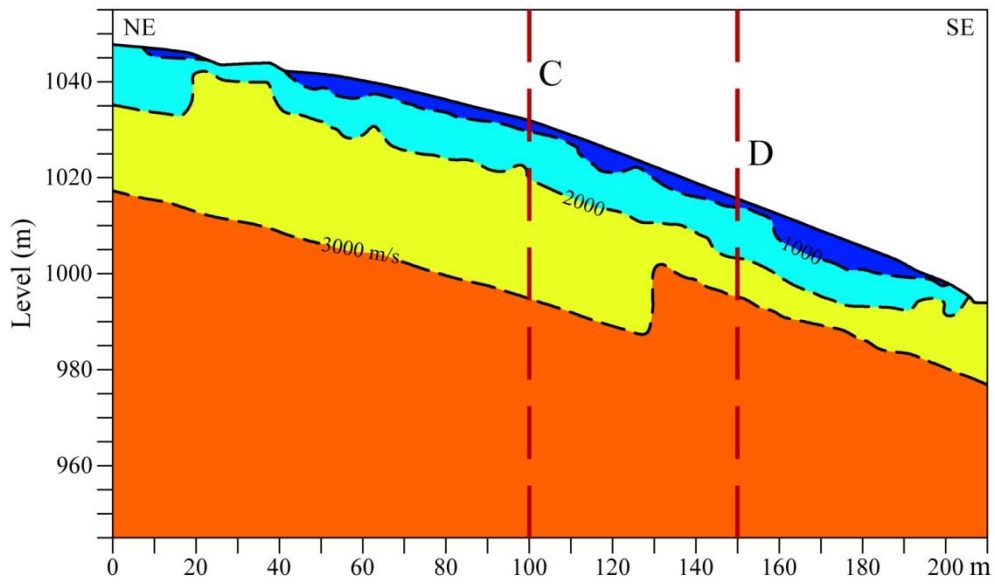
Figure 13: (a) Arlanza Valley in Weald claystones and contours of Castrovido dam. Also indicated is the position of P-wave vertical profiles; P-waves seismic profiles: (b) PS-1 and PS-2 and (c) PS-11 and PS-12.

The P-wave seismic profiles are given in Figures 13 b and c. Long-term natural weathering (Fig. 13b) reaches deeper levels than the short-term (3 yrs) exposure to atmosphere (Fig. 13c). This is better appreciated if vertical profiles of P-wave velocity are compared at two given positions (profiles “C” and “D” in Fig. 13 b and c). The comparison is shown in Figure 14. In both cases all profiles show a distinct

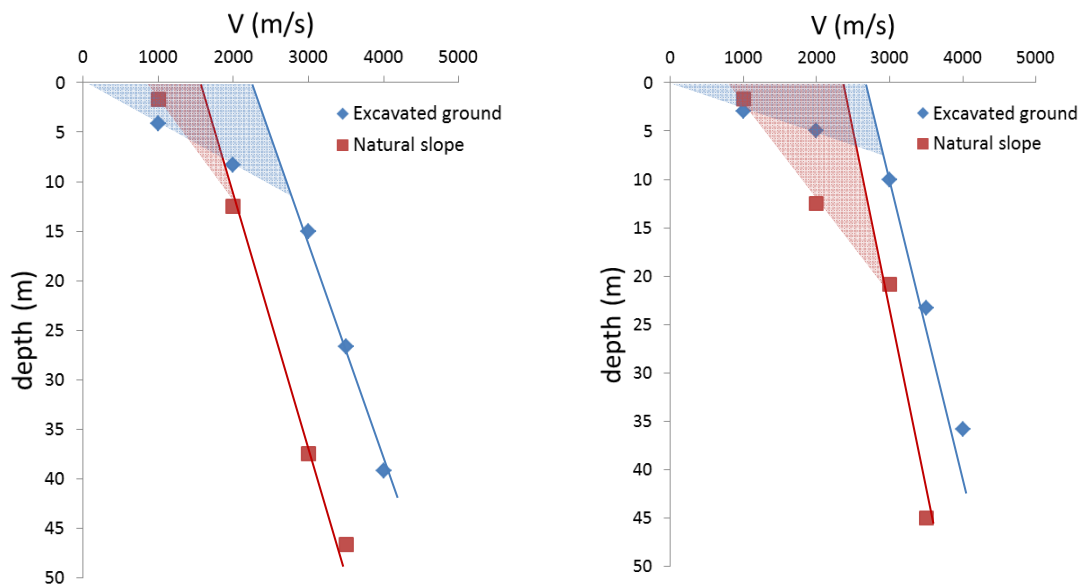
Figure 14: Vertical profiles of P-wave velocity in positions C and D (Fig. 16).

pattern: the rate of increase of V_p with depth is relatively high in the upper levels and decreases to a lower, approximately constant value at depth. The deep trend of V_p increase with depth may be interpreted as an indication of undisturbed claystone. Then, the plots in Figure 14 may indicate some maximum depth of the weathering action (7-10 m in the excavated abutment, and 12-20 m in the natural ground). Note that the origin of the plot in Figure 14 does not correspond to the same elevation for the two cases shown. If the plot for the excavated ground is displaced vertically downwards 10 m (the depth of the excavation) the straight lines describing the increase in seismic velocity in the undisturbed rock essentially coincide.

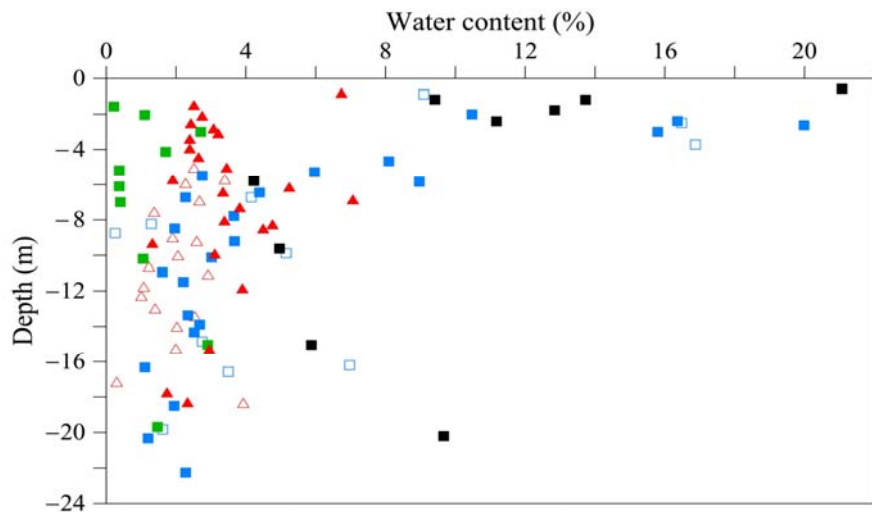
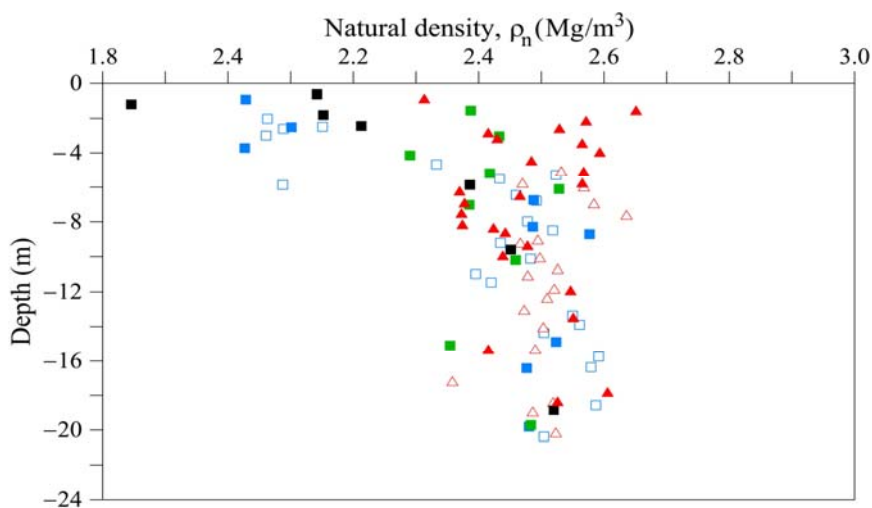
Figure 15: Castrovido Weald claystone. Variation with depth in the exposed excavation of (a) water content and (b) natural density. Symbols refer to different borings

The profiles of water content and density of Figure 15 are reasonably consistent with the V_p plots vs. depth (for the excavated ground) shown in Figure 14. A weathering depth of about 6 m may be identified in Figure 15. This weathering is the result of 3 years of exposure to atmospheric action and also the result of the large stress reduction implied by the abutment excavation.

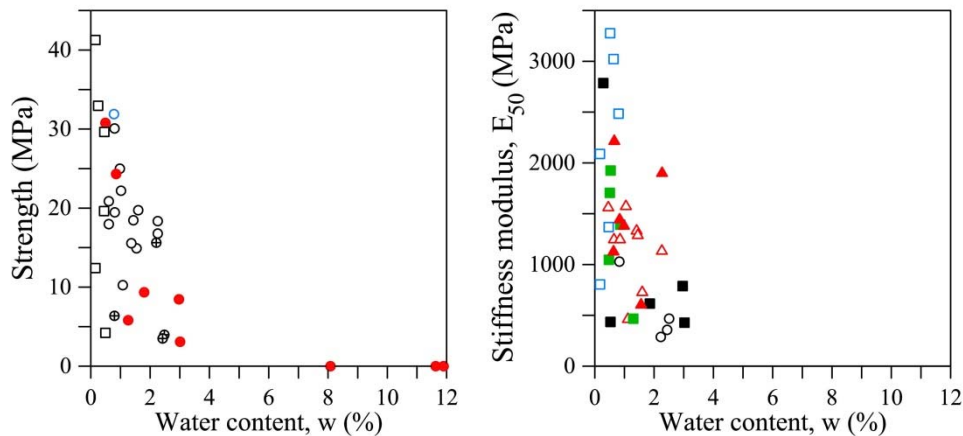
Castrovido Weald claystone in its undisturbed state is a dense mixture of Calcite, Quartz, Muscovite and Kaolinite. It has a low plasticity ($w_L = 24\text{--}35\%$; $PI = 10\text{--}15\%$) and its unconfined compression strength is rather variable (2–40 MPa). Strength and stiffness is lost at a fast rate when water content increases and this is shown in Figure 16. The implication in terms of slope stability is the development of shallow failures. Instabilities are typically triggered by intense rainfall events but, in this case, the main factor was the slope deforestation which reduced the suction induced by the tree roots.

Figure 16: Variation of unconfined strength and stiffness measured in cores recovered from the Weald formation in Castrovido. Symbols refer to different borings

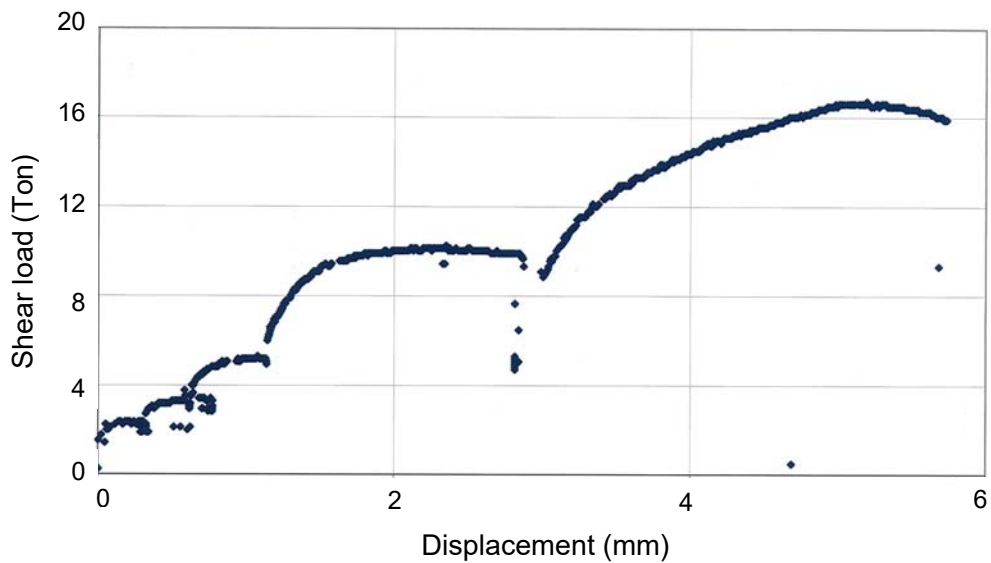
“In situ” tests were performed in a “staged” manner by applying an increasingly large normal stress and shearing the joint until limiting conditions for each normal stress applied. Shear displacements to reach the joint strength were very small (a few mm), as shown in Figure 21, and the reduction of contact area was of no concern. The sheared plane was maintained under water during the test preparation and the shearing stage.

Figure 21: Staged shearing of an "in situ" 80x80 cm sample.

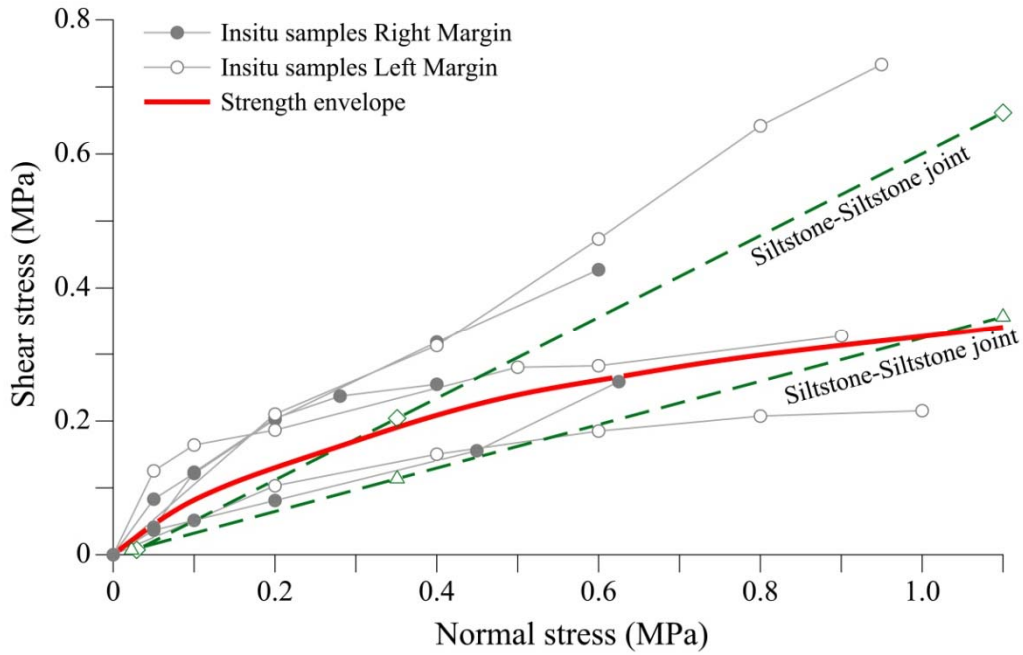
Figure 22: Strength envelopes determined by different tests on claystone –sandstone sedimentation contacts. Castrovido Weald formation

The most significant difference, when comparing the tests at the two different scales (80 cm “in situ” and 20–30 cm in the laboratory) was the nonlinear response of the “in situ” specimens that resulted in relatively high friction angles (but extremely variable) at low confining stresses (say lower than 0.2 MPa). An educated average strength envelope for the entire area is also shown in the figure.
