Using resistivity measurements for dam safety evaluation at Enemossen tailings dam in southern Sweden

Sjödahl, Pontus; Dahlin, Torleif; Johansson, S

Published in:
Environmental Geology

2005

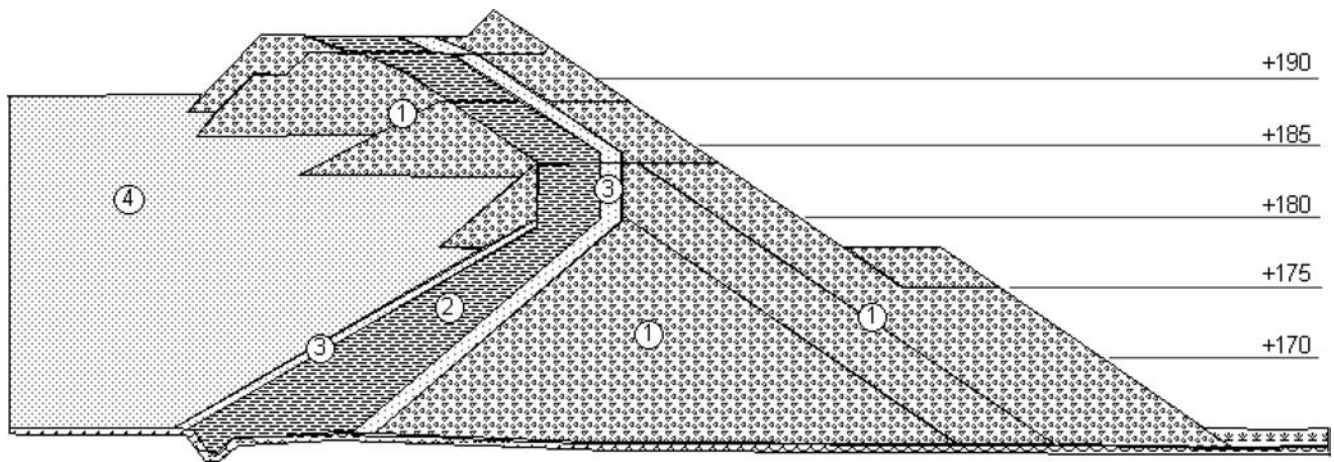
Both dams are constructed according to conventional methods for construction of tailings dams. The main part is founded on soil or pervious rock. In case of foundation on soil, at least 4 m have been excavated for the dam core. The core consists of a fine-grained till with a fines content of 40–45% and a low hydraulic conductivity of about 10⁻⁸–10⁻¹⁰ m/s (SWECO 2003). The minimum width of the core, measured perpendicular to the core, is 3 m. Considering the slope of the latest dam raise, this corresponds to a core width of 5.5 m at the crest (Fig. 1).

Fig. 1 Cross section of the X-Y dam. 1 Support fill (downstream and upstream), 2 core, 3 filter, 4 tailings. Level refers to meter above sea level

As a part of the dam safety, work at Enemossen piers of rockfill has been constructed parallel to the dam 30–40 m upstream in the tailings. In the area between the dam and the piers, tailings are deposited 0.5 m higher than the reservoir water level. Furthermore, to increase stability, a 7-m-wide zone of downstream support fill was put out starting in 1997. Currently, the level of this supporting berm is at elevation 178 masl (Fig. 1).
