## Design of Safe Timber Structures - How Can we Learn from Structural Failures in Concrete, Steel and Timber?

**Division of Structural Engineering**  
Lund Institute of Technology, Lund University

Report TVBK-3053  
Lund 2007

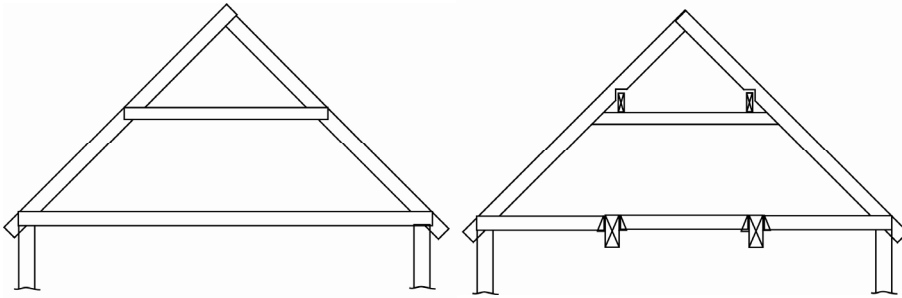
Inclined exterior walls indicate problems with horizontal forces from the roof structure. The investigation showed that the roof structure of the log house was executed differently from the design. The design was made for a roof with collar beam, where the beams in the slab between ground floor and first floor should serve as tie beams, see figure 56-1 (left). However, the roof structure was executed with intermediate purlins above the collar beam that were not in contact with the rafters and thus not statically used at all. However, notches had been prepared, which weaken the cross-section (about 30% reduction) and load-bearing capacity of the rafter. The rafter dimensions were smaller than in the design. The smaller dimensions and notches imply that the stresses exceed the design stresses by 25%. Furthermore, due to the long span in the ground floor (living room), two binding beams are used and the tie beams were jointed with the binding beams via sheet metal joist hangers. However, the joist hangers were not properly nailed to neither binding beams or tie beams and were only supposed to transfer vertical loads. Horizontal loads cannot be transferred here, but have to be taken in the joint between rafters and exterior walls. This led to an outward compression on the exterior walls. Additionally, the tie beams were drawn out of the bag of joists (about 5 cm). Due to risk of collapse of the whole construction, the residents were evacuated and the structure had to be changed. The failure in this case was due to changes on the building site, compared to the design (on-site alterations).

*Figure 56-1: Designed roof structure (left) and executed roof structure (right).*

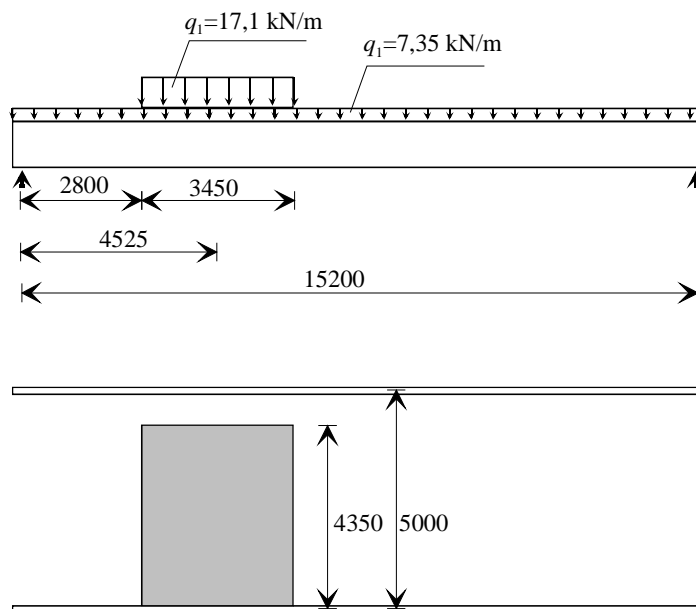
The roof structure of an industrial building was made from glulam beams about 30 years ago. The height of beams was 1045 mm, width 160 mm, span 15.2 m, and spacing between beams was 5 m, see figure 69-1. Below the beam, attached to it, was a heat insulated air pipe, transporting air at a temperature of 180°C. The air temperature close to the beam was 50-60°C continuously. The load of the beam had been raised during the year preceding failure due to structural changes in the building. No snow was on the roof at any time because of high temperature.

Figure 69-1: Dimensions of the main beams and top view of 2 beams and the insulated air pipe in-between.

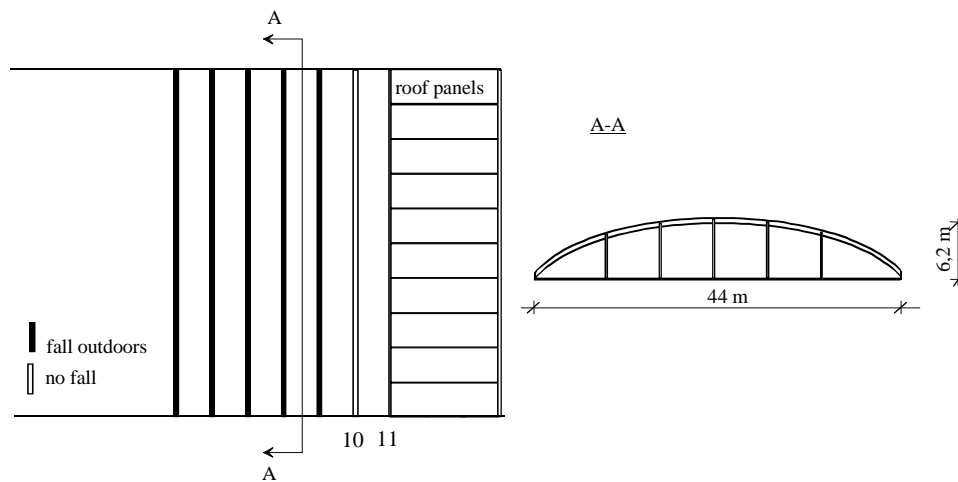
The structure consists of three-hinge-arches supported by columns. Span width is 44 m and the rising height of the arch is 6.2 m. The cross-section of the glulam arch is  $b \times h = 190 \times 1260$  mm. Roof panels were planned to be installed on top of the arches. Vertical members were fixed between the arches. Lateral tension loads between arches during installation were carried by temporary rope type binders. In the final structure, lateral tension loads are carried by the roof structure. Figure 73-1 below illustrates the structures installed at the time of collapse.

Figure 73-1: Structures installed at the time of failure.

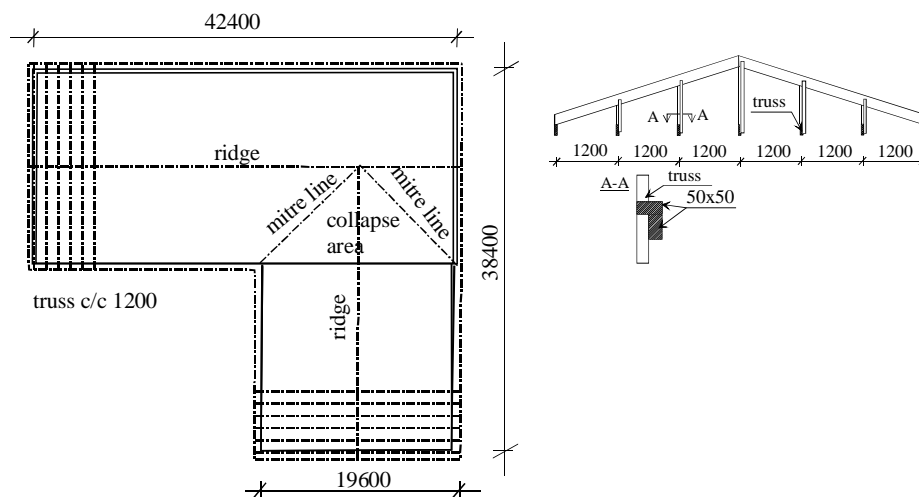
The roof structure consists of 20 m long nail plate connected trusses. At one end, on top of the trusses, a frame was built to reshape the roof as needed for an L-shaped building, see figure 74-1. The frames were located at 1200 mm distance from each other. In the design calculation, weight of the roof structure was  $0.3 \text{ kN/m}^2$  and snow load was  $1.8 \text{ kN/m}^2$ . In addition, in the collapsed part, there was a  $400 \text{ m}^2$  area covered by 200 mm wood chips and a  $70 \text{ m}^2$  area covered by maximum 2 m cutter chips.

Figure 74-1: Roof structure of market building.

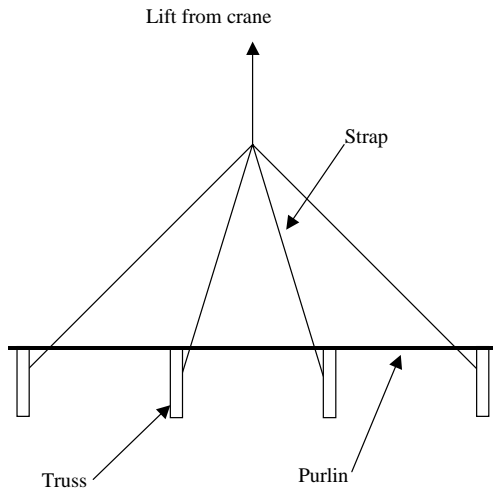
After finalising the roof structure with four trusses and purlins, a crane was used to raise it in place on top of supporting columns. The straps used during rising of the structure were placed according to figure 104-2. The forces in the straps lead to a compressive force in the glulam parts, as indicated below. In addition, the purlins are also subjected to compressive forces, see figure 104-3. Just before putting the roof structure down on its supports, the structure collapsed. According to witnesses, one of the outermost trusses tilted and the structure failed.

Figure 104-3. Strap placement.

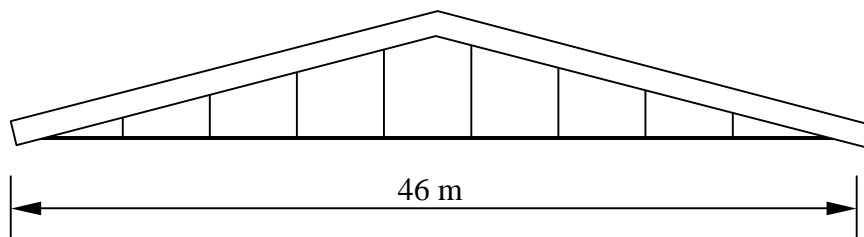
This structure is a roof structure of an ice-hall. The structure is a three-hinged roof truss with a tensile rod as depicted in figure 112-1. A total of 11 roof trusses at a spacing of 6 m make up a total of 60 metres length of the building. The building was erected in 1964.

Figure 112-1. Roof structure.

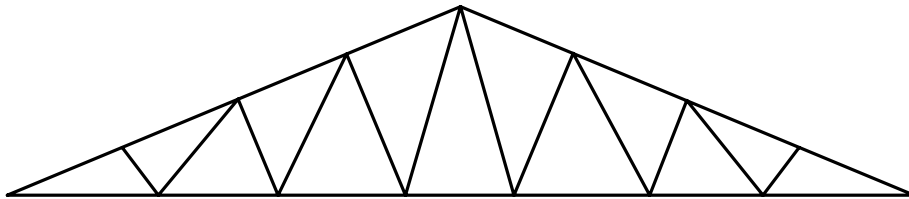
A large number of similar structures were built in Sweden for a chain of stores. The structure is based on nail-plate connected roof trusses, see figure 114-1. The battens, for support of the roof tiles, are nailed directly to the upper chord of the roof trusses. The roof structure also includes a reinforced plastic sheeting or a hard fibre board, covering the roof trusses, for draining of rain water. At least 26 cases have been documented, where the same principle was used for the load bearing structure. The buildings are relatively large, with free spans of 20-25 m and lengths of up to 65-70 m.

Figure 114-1. Example of roof truss

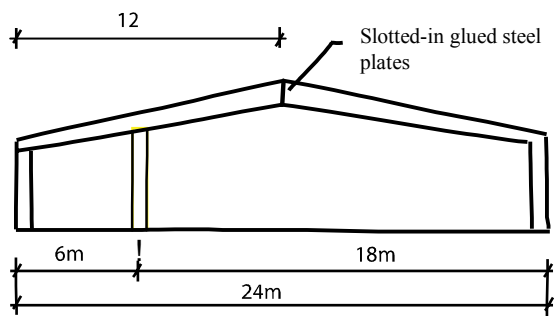
A school building was built in 1998 with a glulam structure as shown in figure 122-1, using glulam columns and single tapered beams. The spacing between the beams is 6 m. The beams are connected at the ridge by a glued connection with slotted-in steel plates, see figure 122-2.

Figure 122-1: Glulam structure.
