Post-fire investigations of prestressed concrete structures

**Fifth International Workshop on
Performance, Protection & Strengthening of Structures
under Extreme Loading
June 28-30, 2015**

Title: Post-Fire Investigations of Prestressed Concrete Structures

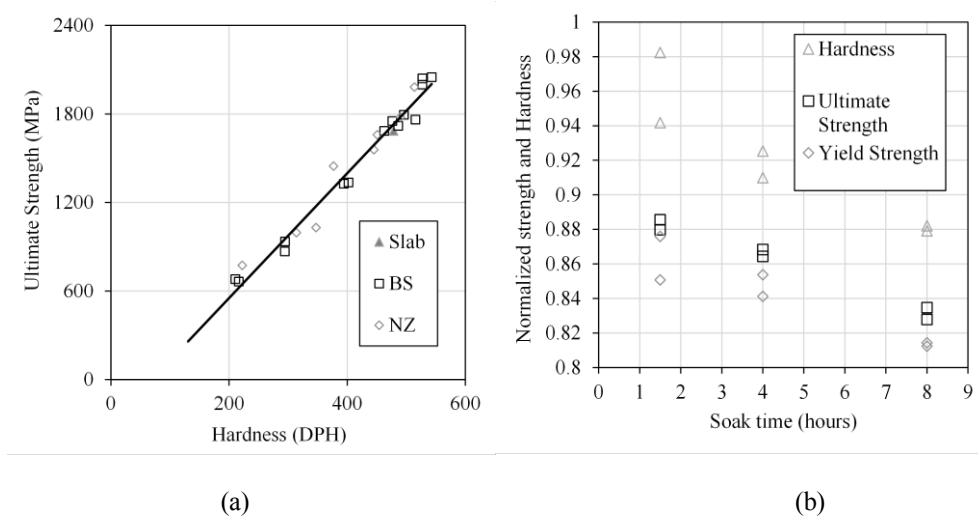
Research undertaken by Robertson et al. provides a correlation between hardness and strength of (various) prestressing steels (BS, NZ) after having been submitted to temperatures up to 800C for various soak times (1.5, 4, and 8 hours). The hardness values were obtained by means of Vickers Hardness testing to provide Diamond Pyramid Hardness (DPH). The surface of the prestressing steel was first ground to obtain a small flat area at least 3 mm wide to avoid edge effects which would give false readings. Four readings were taken for each sample and averaged to obtain a final value. A correlation between strength and hardness is expressed in Figure 1a. The best fit correlation is expressed with the below relation:

Investigation [6] indicated that the hardness provides an estimate of the residual strength with an accuracy of +/-10%. For exposure temperatures of 600C and over, the ability of hardness to be used as an indicator for the yield strength of the prestressing steel is more tenuous due to material properties. However, with regards to ultimate strength, derivation via hardness values maintains its accuracy. Although reference [6] considered prestressing steel from one mill, further research in this test program indicated that the behavior of other prestressing steels from different mills in general was similar. Therefore the same hardness-strength correlation could be used.

Figure 1. (a) Variation of Hardness with Ultimate Strength (b) Variation of Hardness with Soak time at 400C
