Corrosion failure analysis of hearing aid battery-spring contacts

Published in:
Engineering Failure Analysis

Publication date:
2017

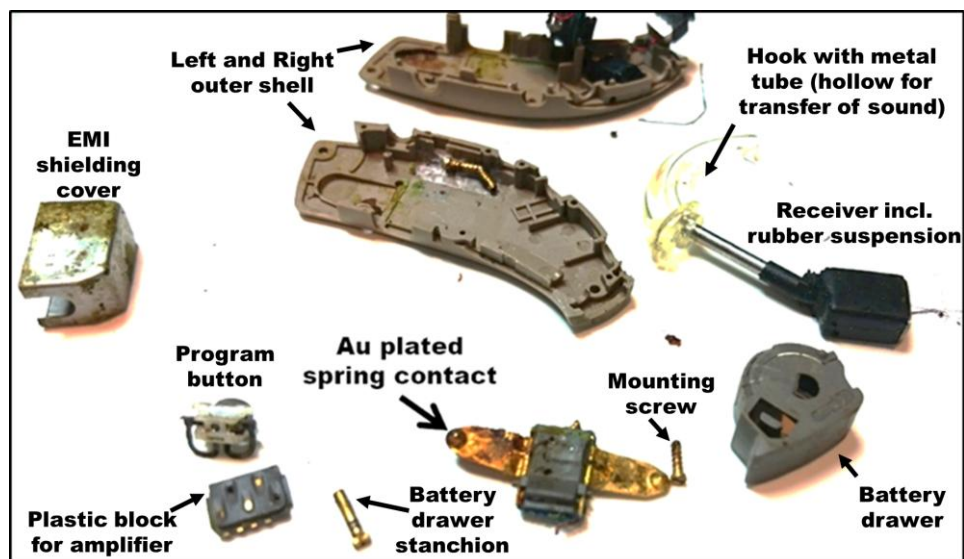
Figure 2: Photograph showing a representative Au plated spring contact separated from the rest of the hearing aid device.
